HERITAGE REPORT FOR ALTERATION (MAINTENANCE) AND PARTIAL DEMOLITION AND RECONSTRUCTION (OUTBUILDING), IN TERMS OF THE NATIONAL HERITAGE RESOURCES ACT, 1999 (ACT 25 OF 1999) FOR STRUCTURES OLDER THAN 60 YEARS SITUATED ON ERF 369 VICTORIA WEST (1 VICTORIA STR), UBUNTU MUNICIPALITY, NORTHERN CAPE PROVINCE

CLEAR COLOUR AND LABELLED PHOTOGRAPHS

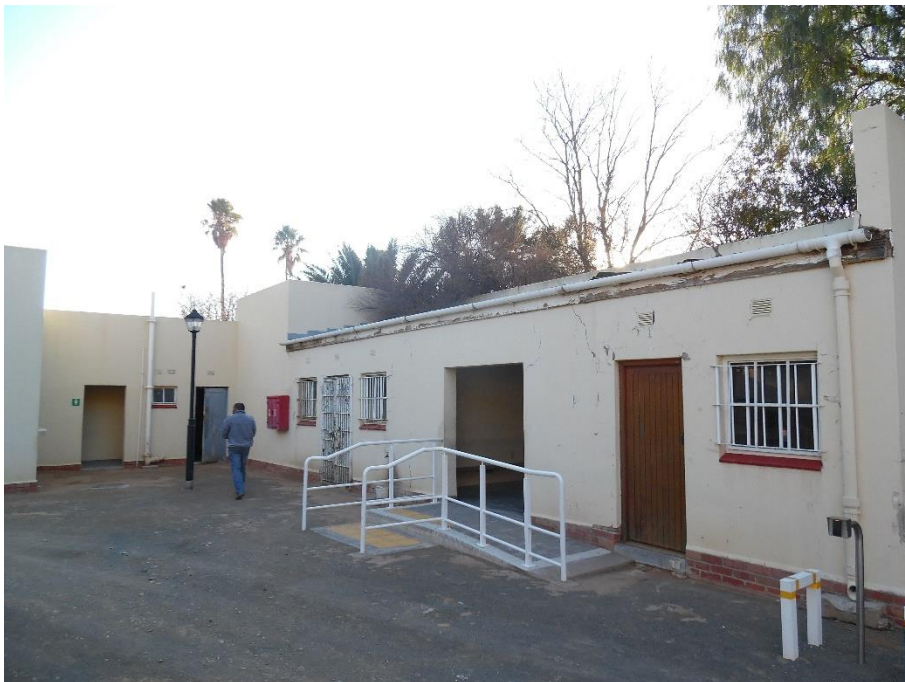
Photograph 20: Outbuilding (to be demolished and reconstructed, exact footprint)
