**SECTION B (12.56ha):**

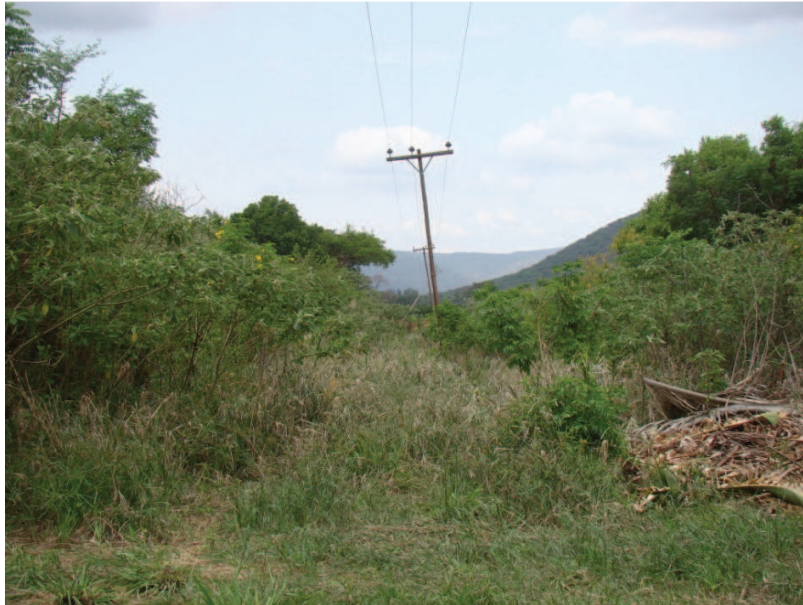
Fig. 54: Section B is situated next to the Waterfall River. The area was dense with indigenous as well as alien vegetation. A power line runs through this section.

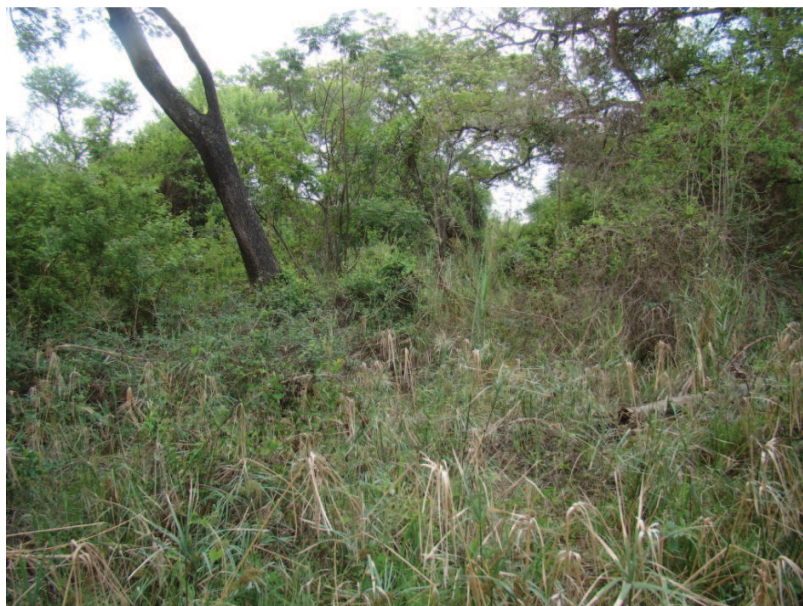
Fig. 55: The middle area of Section B.

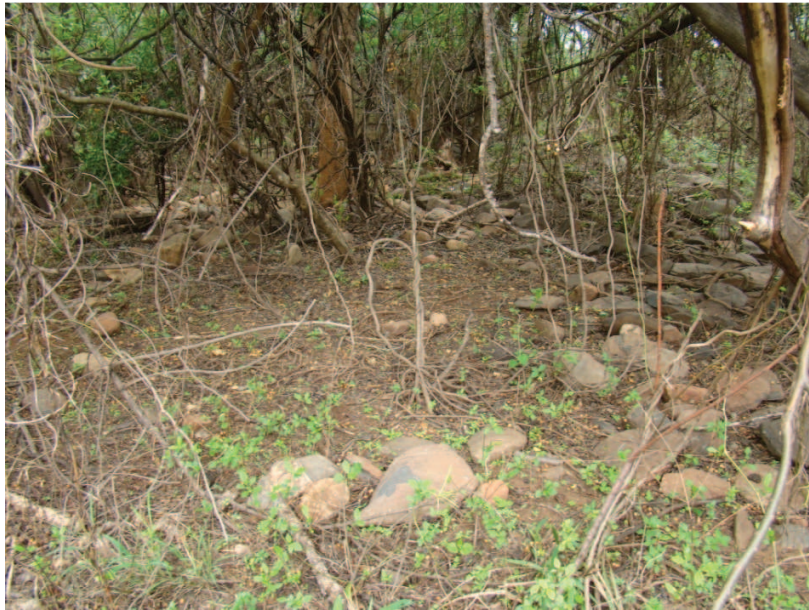
Fig. 56: A poorly defined LIA stone wall was identified in the southern part near the entrance gate.

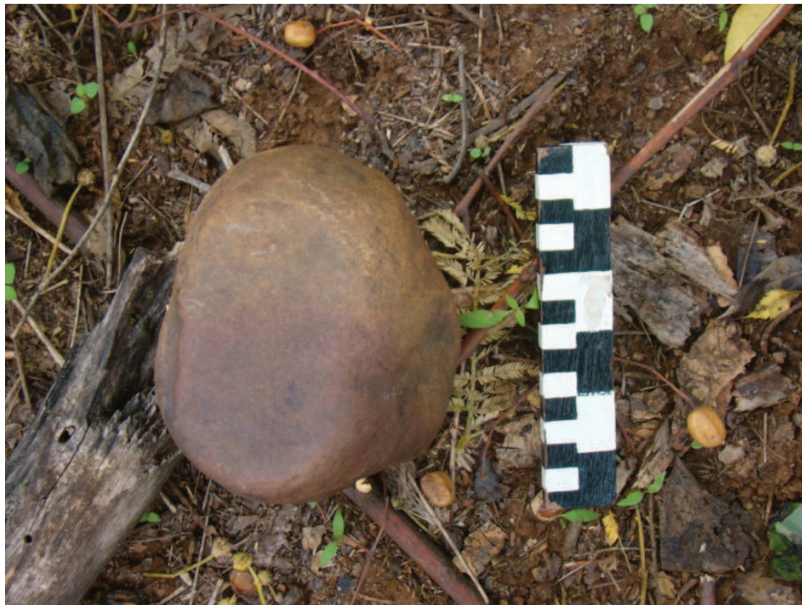
Fig. 57: An upper grinder was identified within the stone walls.

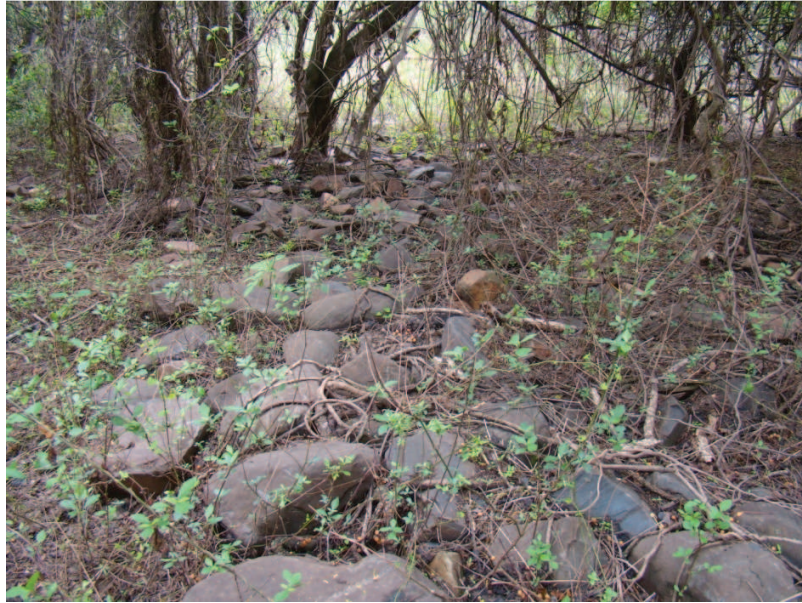
Fig. 58: The LIA stone wall is damaged by alien vegetation.

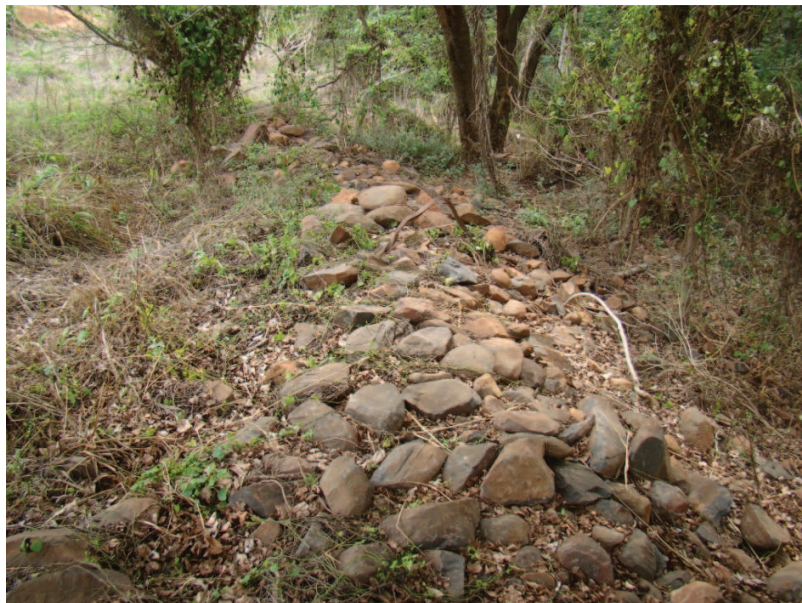
Fig. 59: Another LIA stone wall was identified in the eastern part of Section B. Dense vegetation made it impossible to determine a layout pattern.

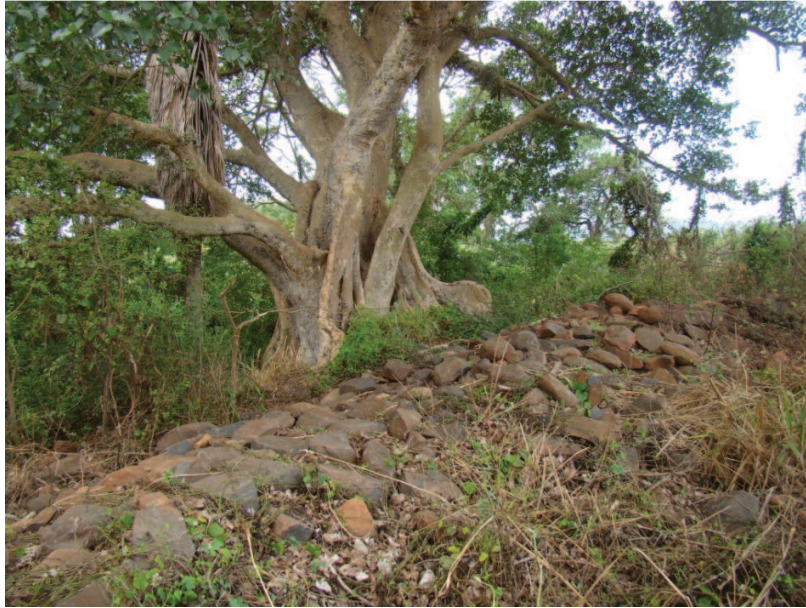
Fig. 60: The LIA stone wall in this section is approximately 40m long.

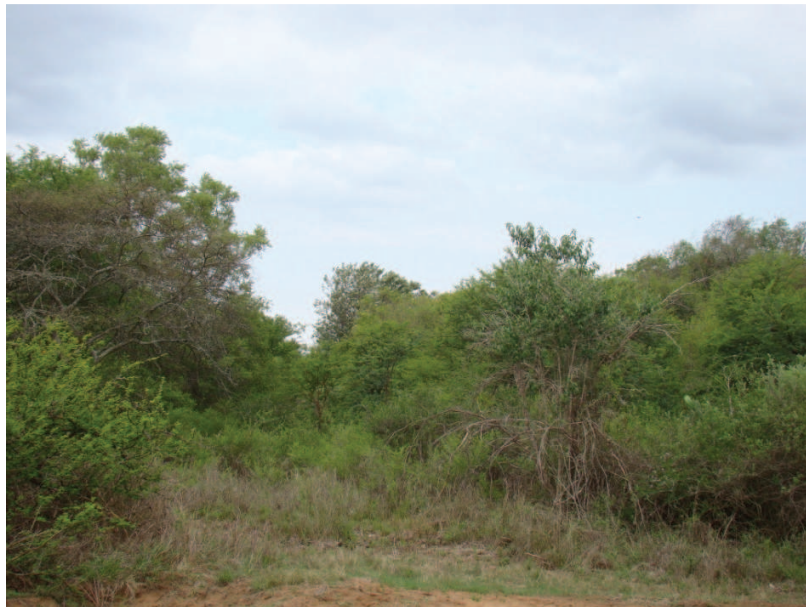
Fig. 61: Section C is also situated next to the Waterfall river. The vegetation was mostly dense.

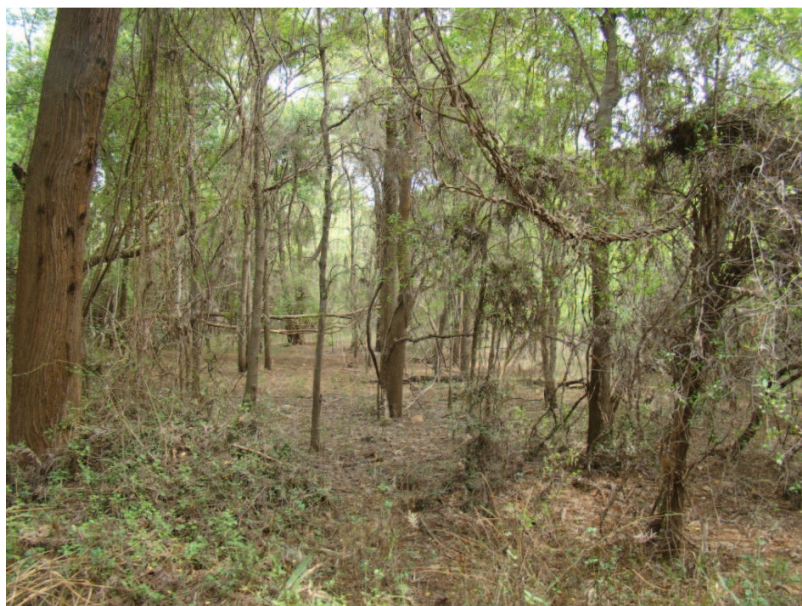
Fig. 62: Visibility was fair in the northern parts of section C.

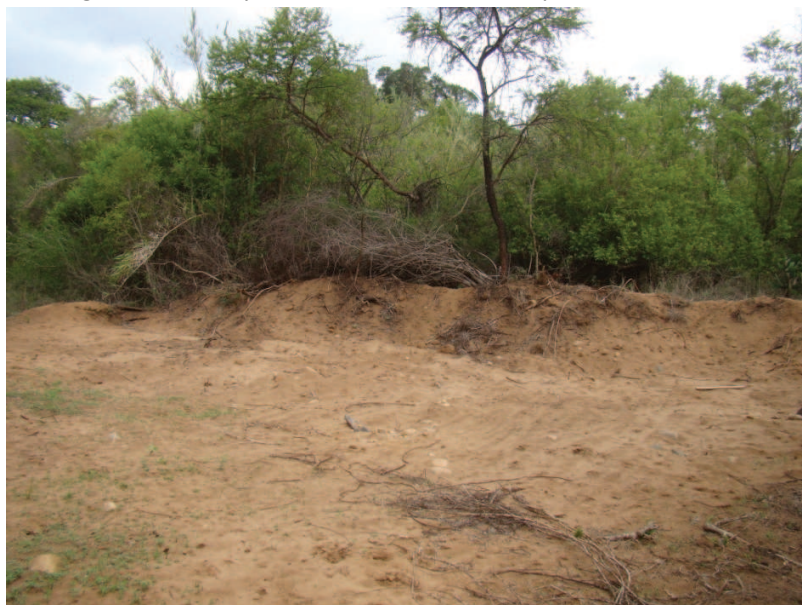
Fig. 63: A sand quarry in section C was investigated for archaeological or cultural material, but none was found.

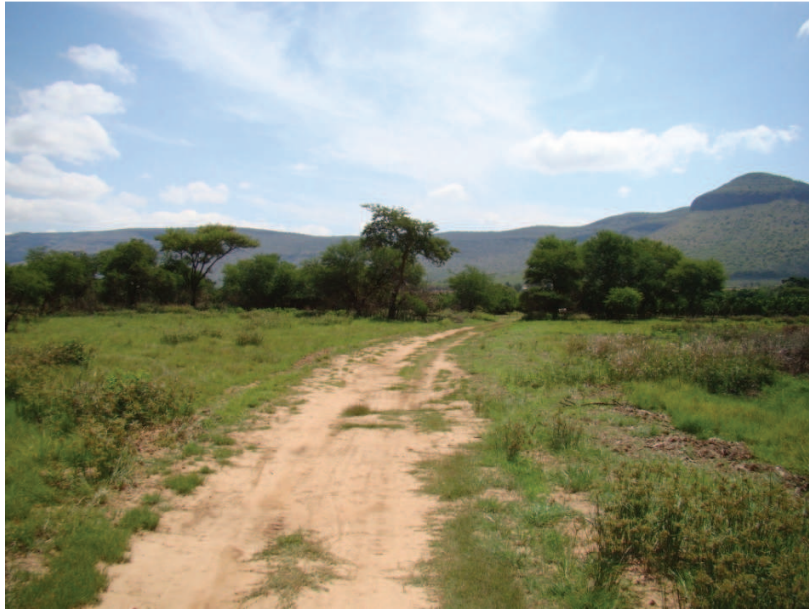
Fig. 64: Section D is historically disturbed land. The above photo is taken in the middle of this section facing south-west.

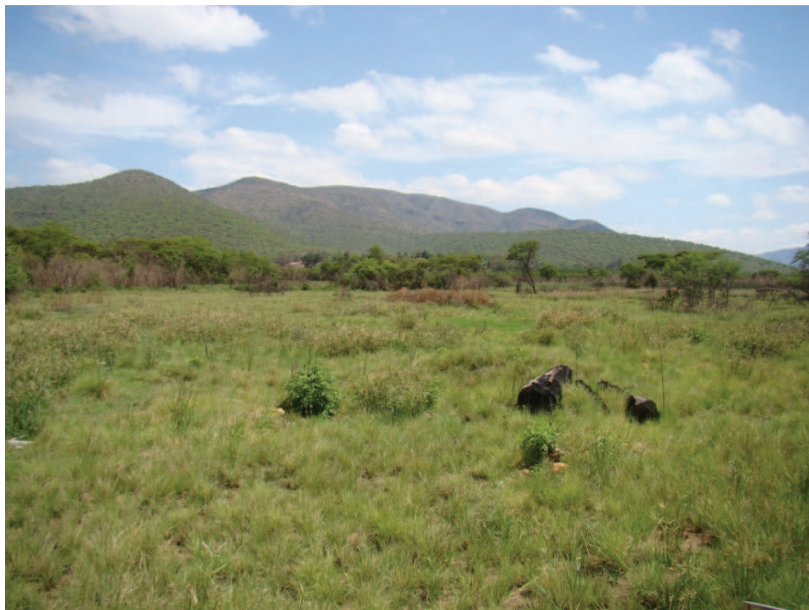
Fig. 65: South-eastern view of Section D. No archaeological or cultural material was found in this section.

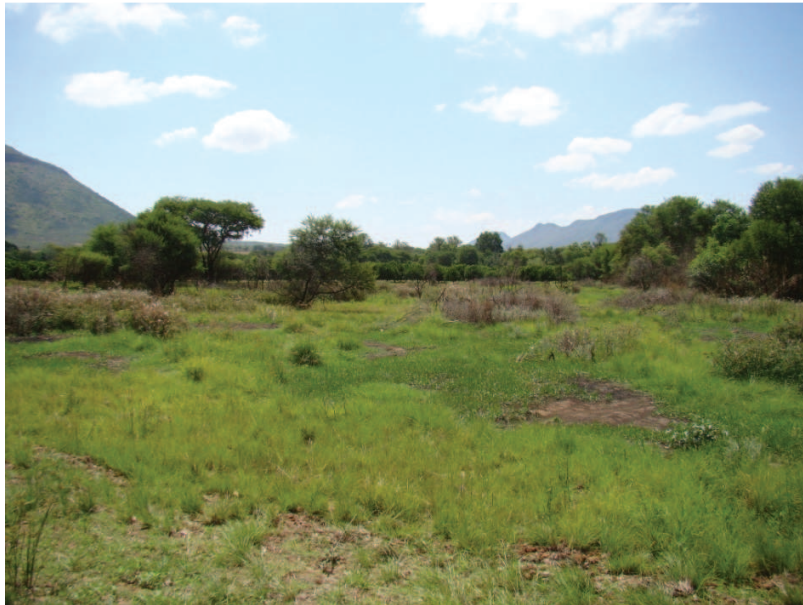
Fig. 66: North-western view of Section D. No archaeological or cultural material was found in this section.

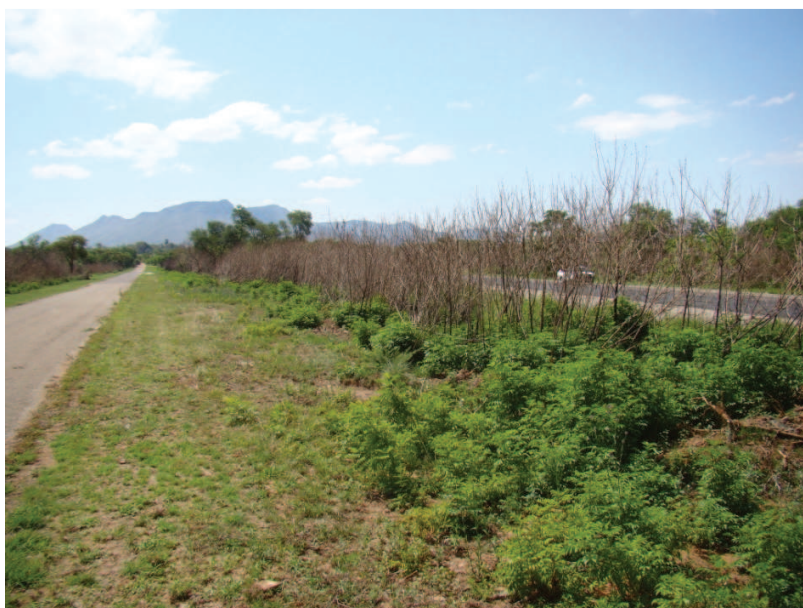
Fig. 67: Section E is a narrow strip situated between two roads and was also historically disturbed land.

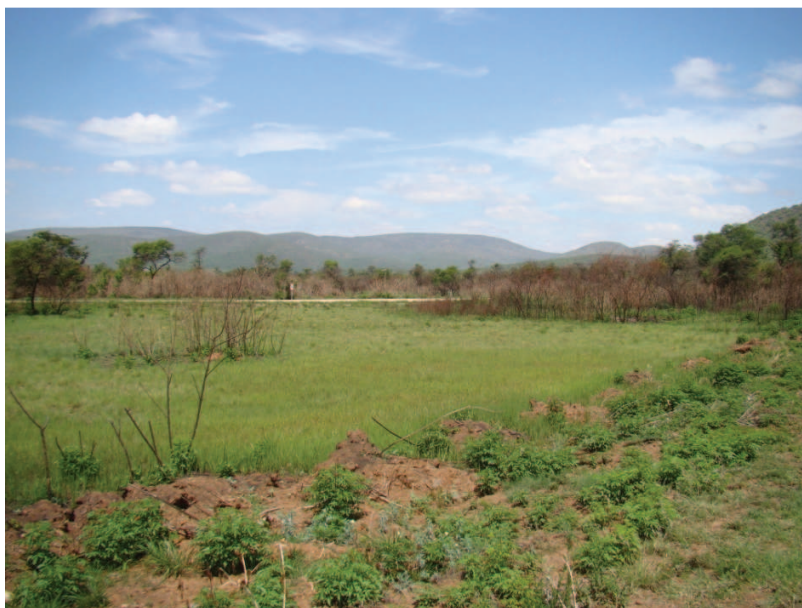
Fig. 68: The middle part of section E. Previous agricultural activities as well as road infrastructure disturbed this section.

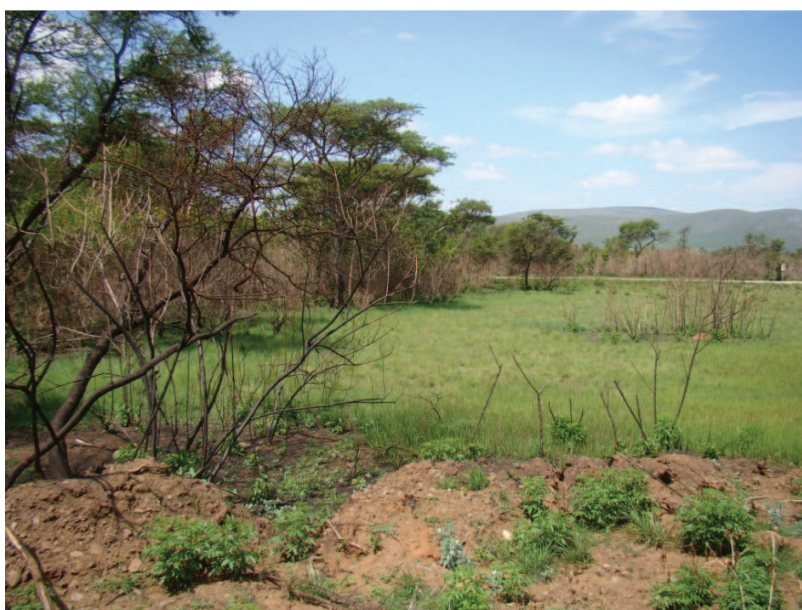
Fig. 69: No archaeological or cultural material was found in Section E.
