APPENDIX 3: PHOTOGRAPHIC DOCUMENTATION OF KABOKWENI / NGODINI ROAD UPGRADE PROJECT

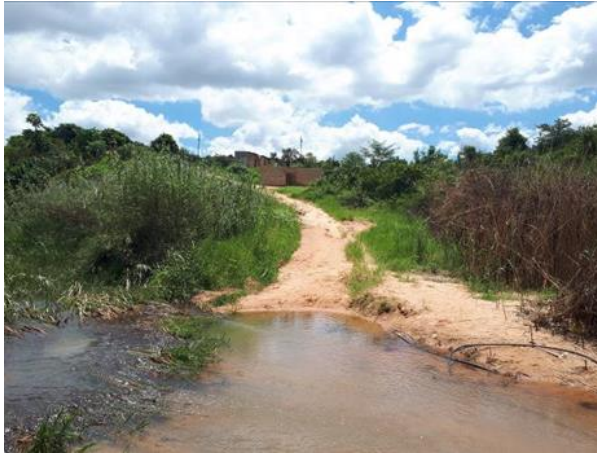
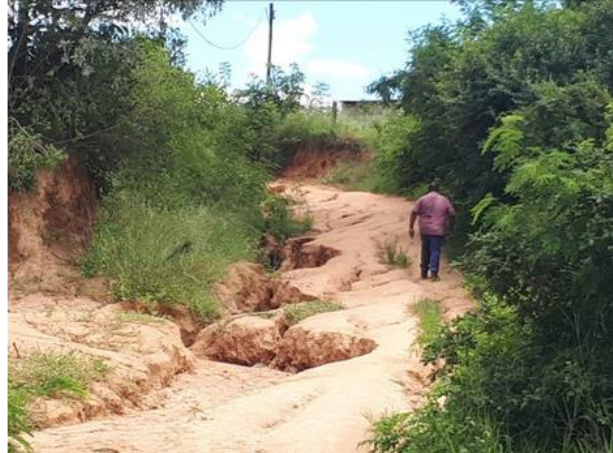
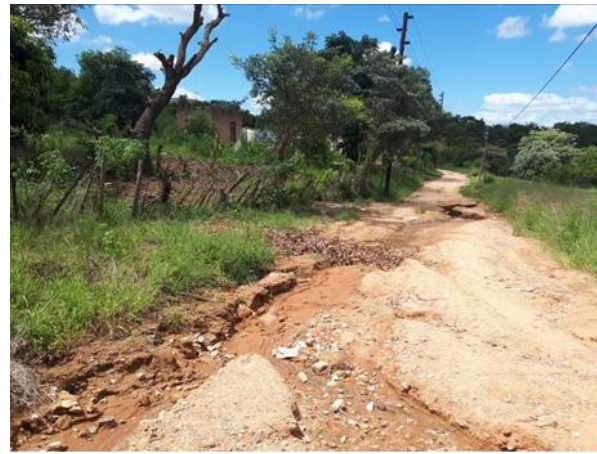
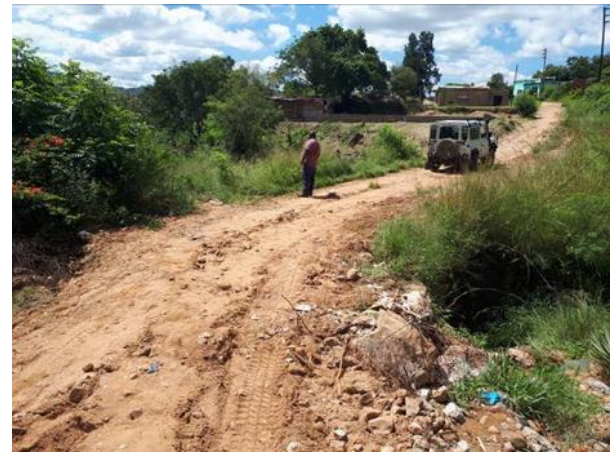
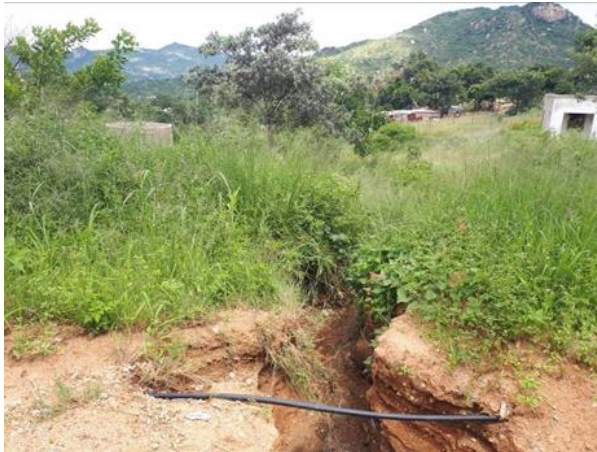
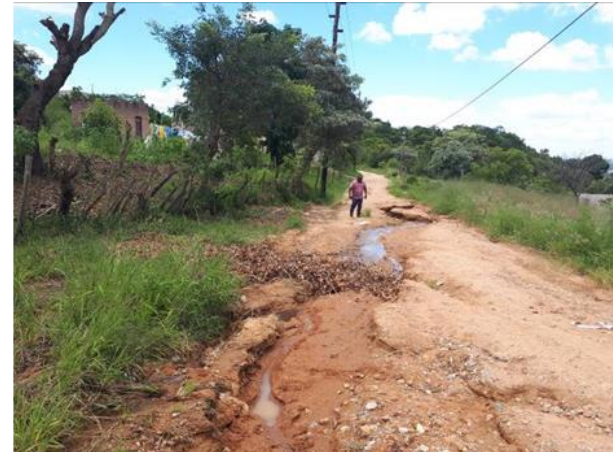
Figs. 1 – 6: The general condition of the informal roads is severely eroded and flooded in places. The upgrading of the roads will ensure accessibility to the residential area (courtesy AFRIKA Enviro & Biology).

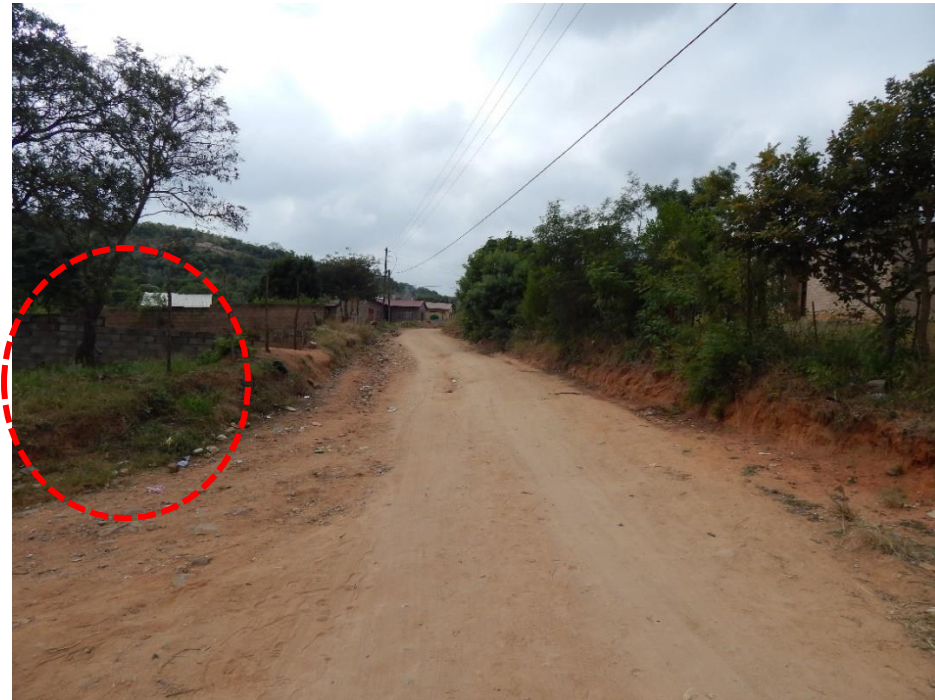
Fig. 30: Road A to D starts at the center (point A), and continues in an eastern direction. The road is in an extremely bad condition. The oval indicates the small family graveyard at Point A (just off the picture).

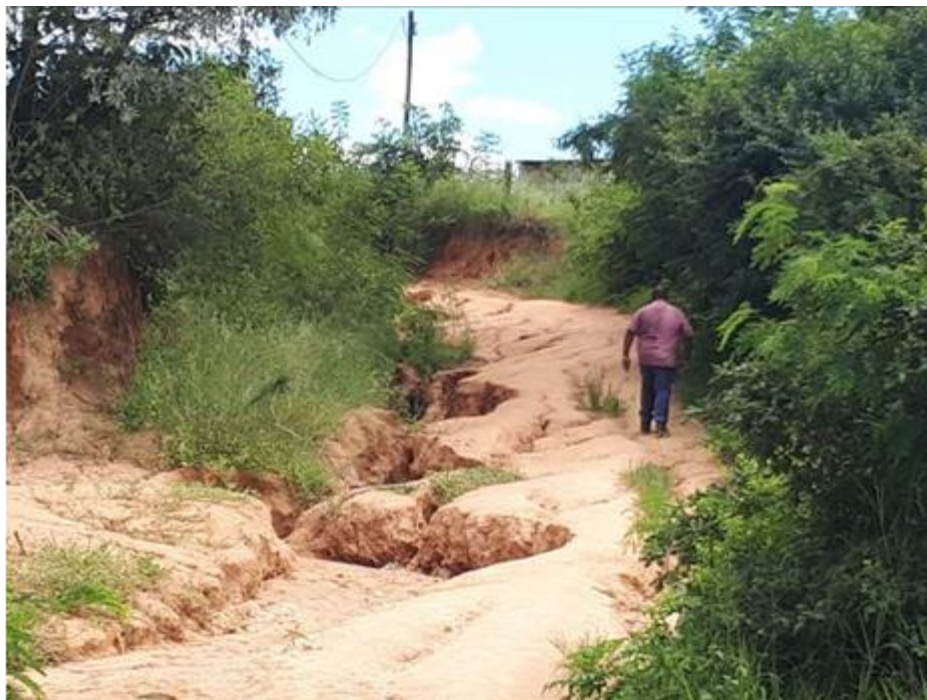
Fig. 31: The general condition of the road further east, towards point D (courtesy AFRIKA Enviro & Biology).

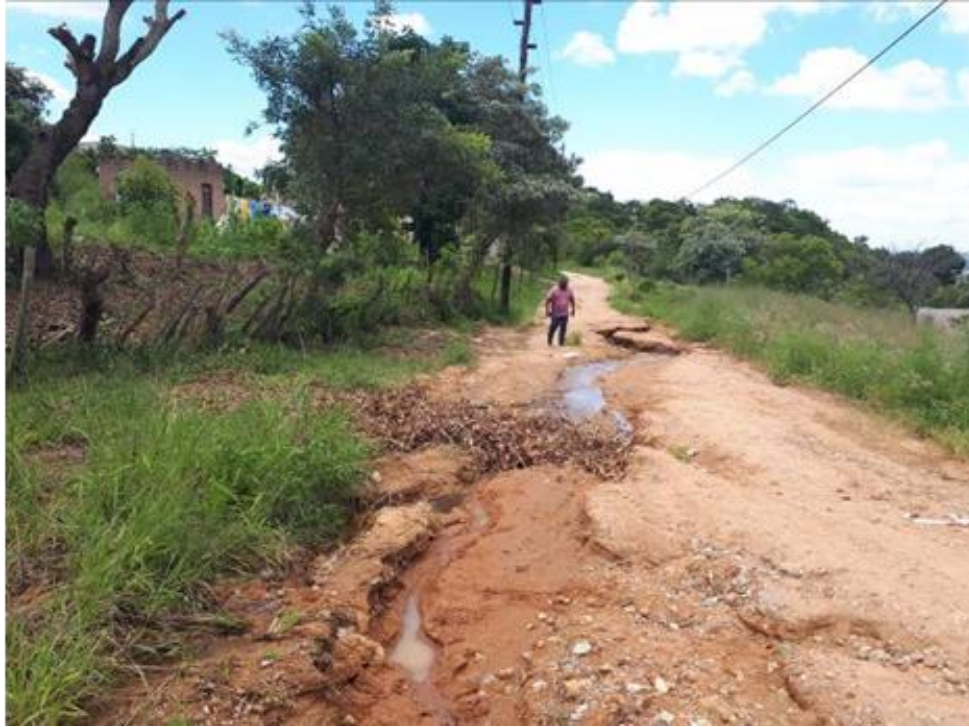
Fig. 32: The proposed upgrading of the roads will greatly improve living conditions in the residential area where most of the informal roads are severely eroded (courtesy AFRIKA Enviro & Biology).
