Jagersfontein Heritage Impact Assessment  
 Structures: Mino Area a  
 31/03/2009

**Jagersfontein Heritage Impact Assessment  
Compound with surrounding structures  
31/03/2009**

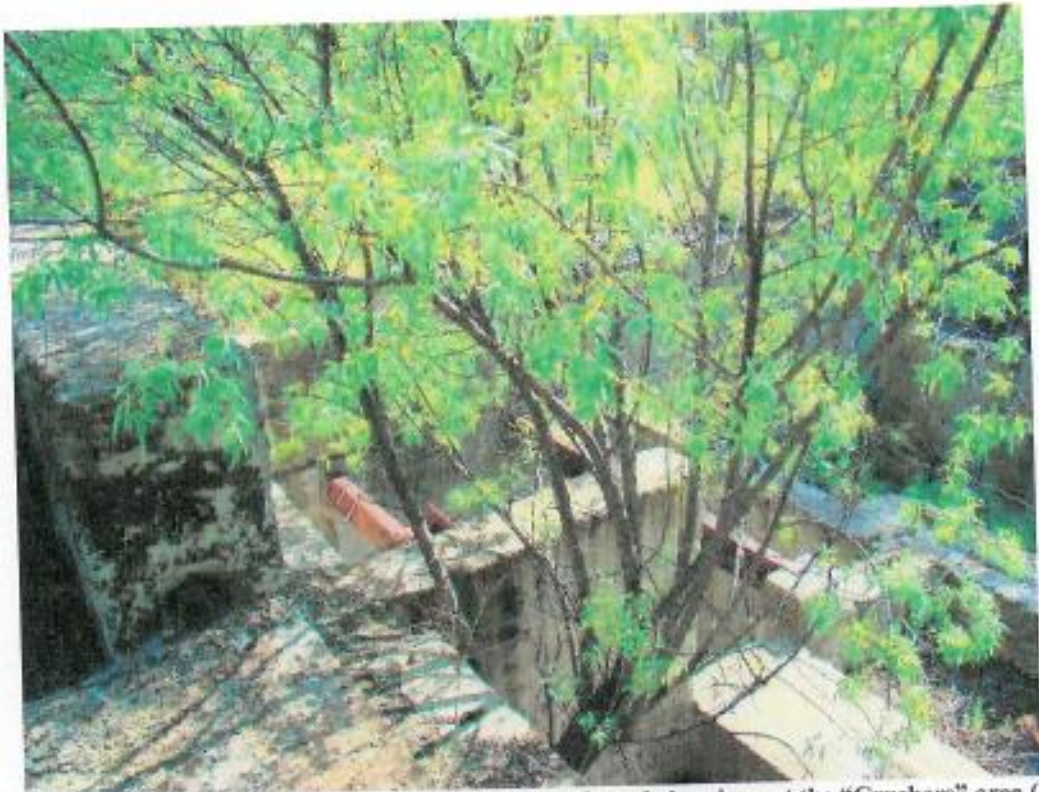
Figure 32: Detail of the sub-surface concrete channels and chambers at the "Crushers" area (1)

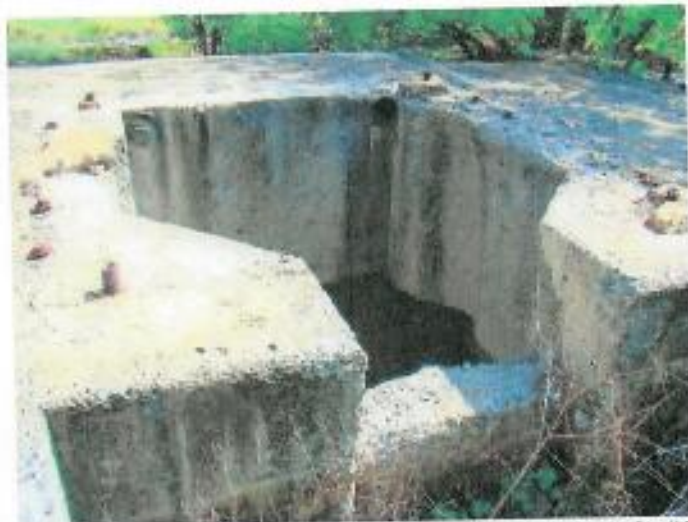
Figure 33: Detail of the sub-surface concrete channels and chambers at the "Crushers" area (2)

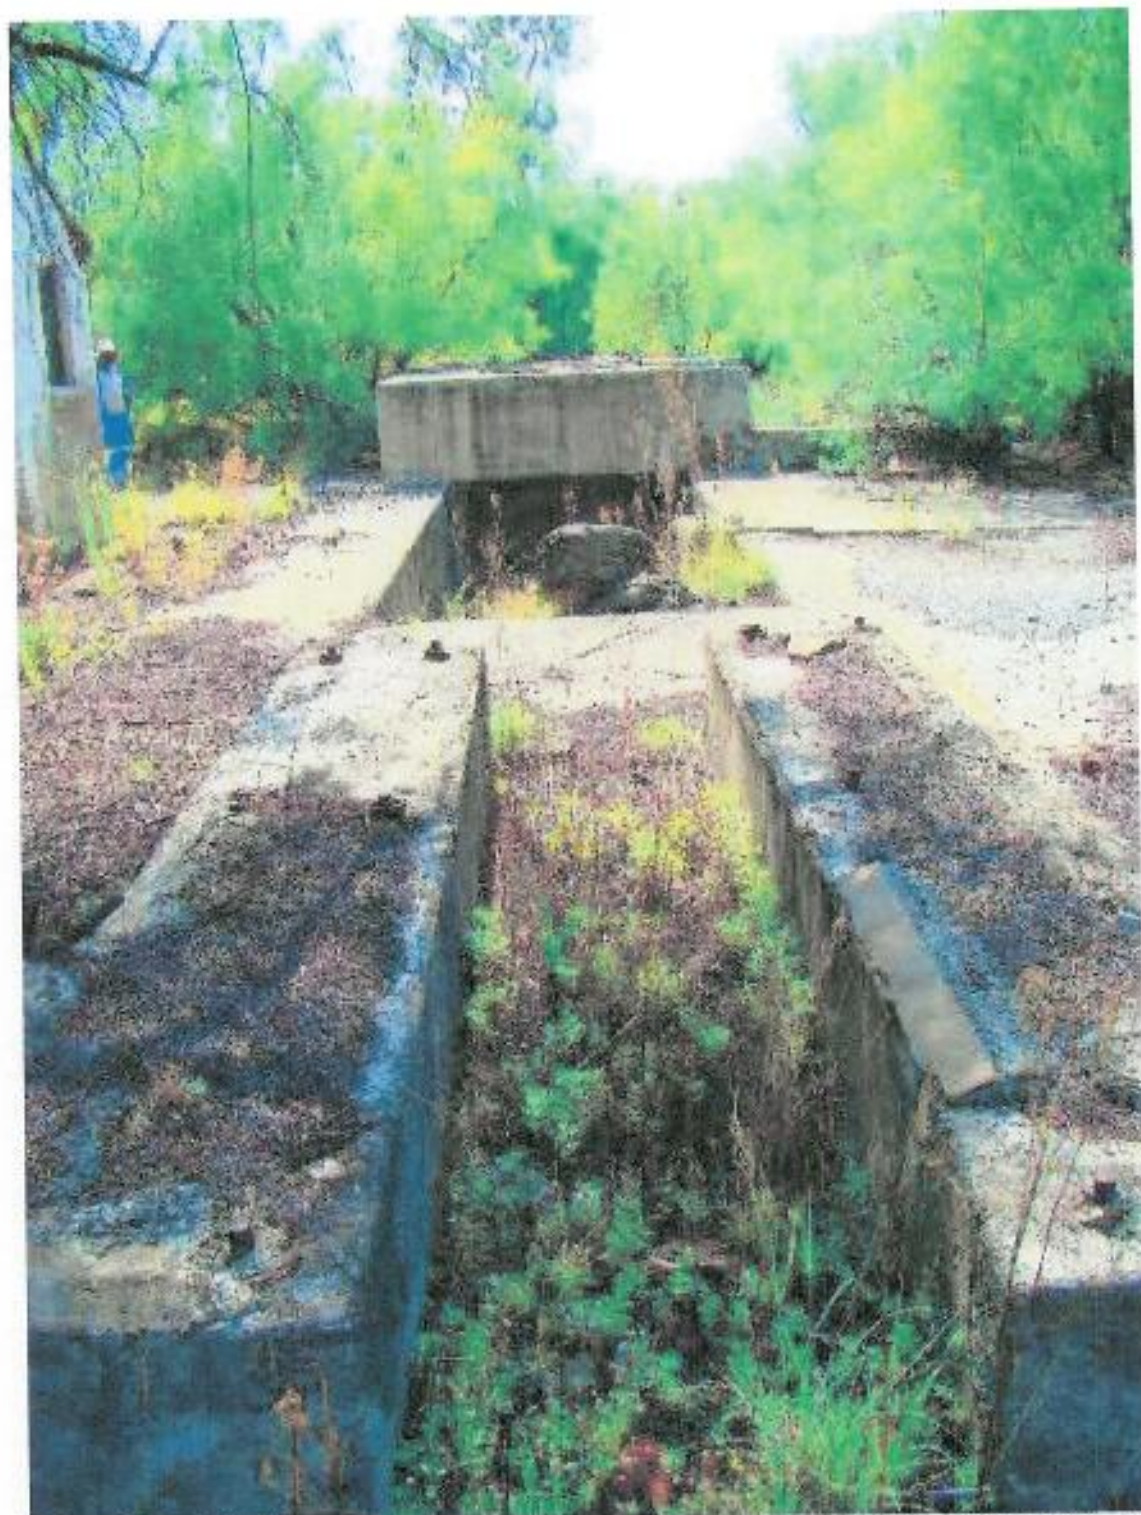
**Figure 34: Details of the concrete channels and sub-surface channels at the "Crushers" area (3)....to the left (north) is the Engineers Offices at the Plant**

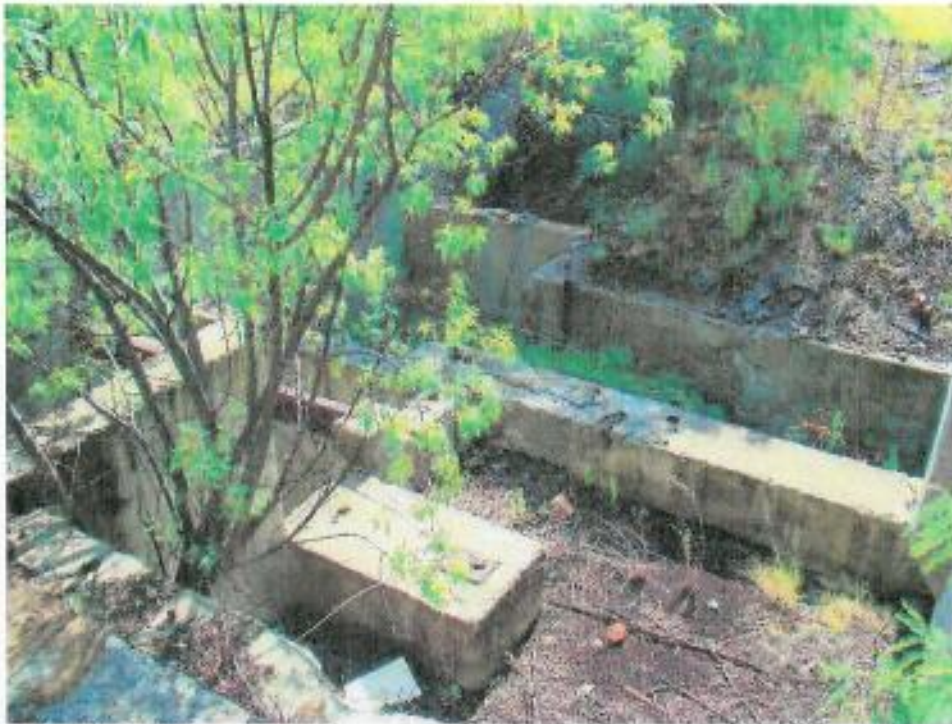
Figure 35: Detail of the concrete channels and sub-surface chambers at the "Crushers" area (4)

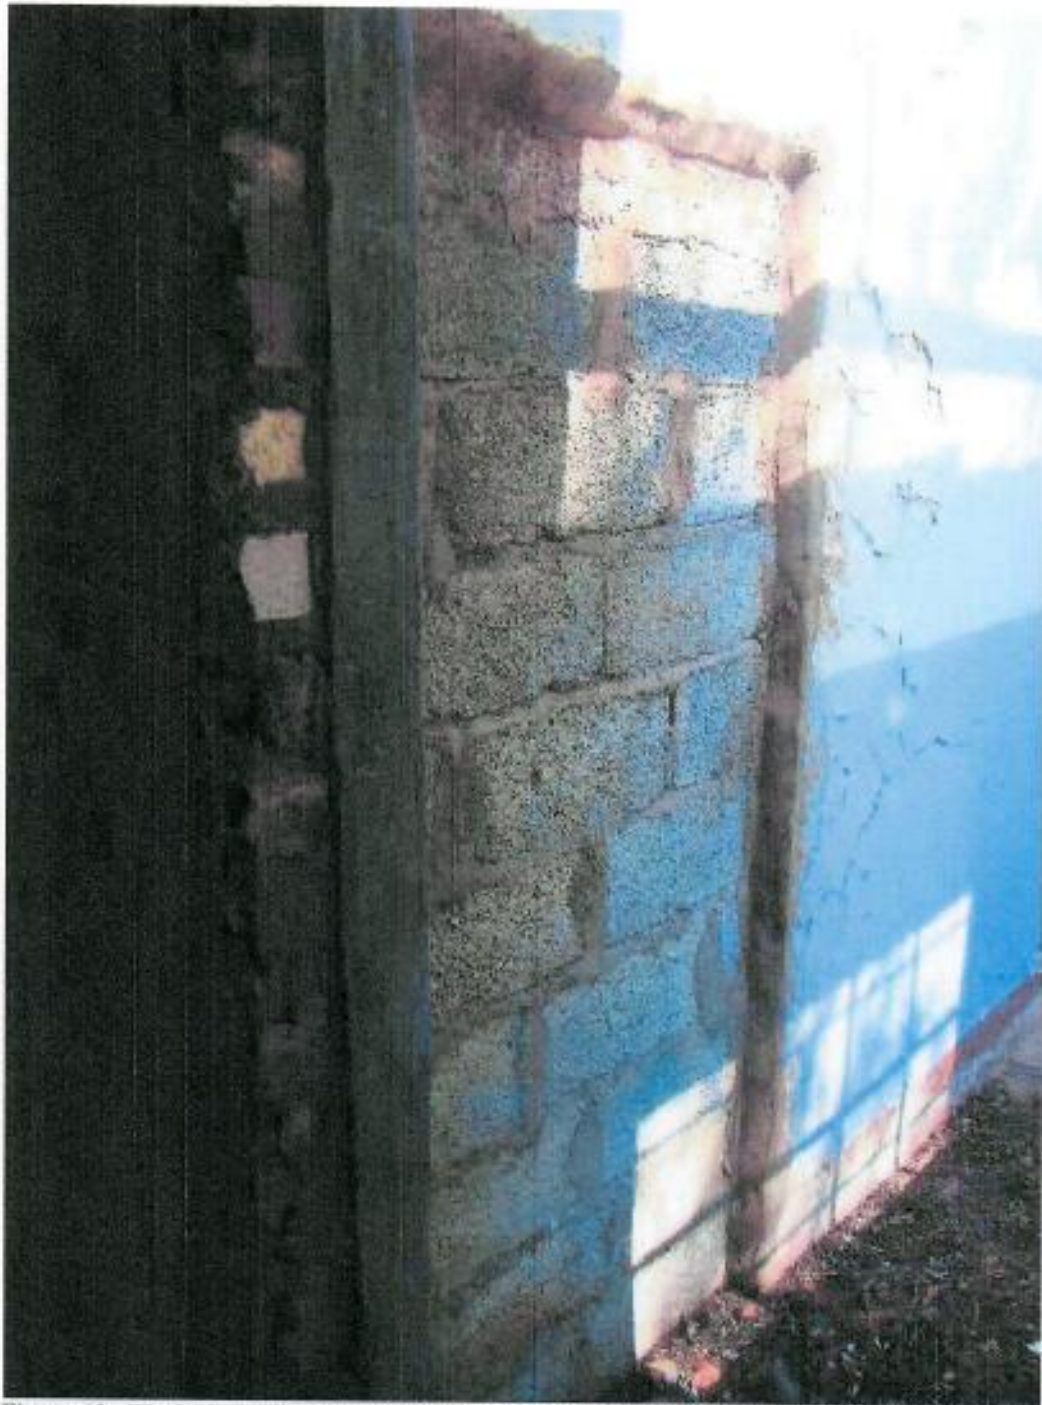
**Figure 42: Blocked up entrance to tunnel that connects compound to the change room and the change room to the mine (situated on the western side of the Change Room)**

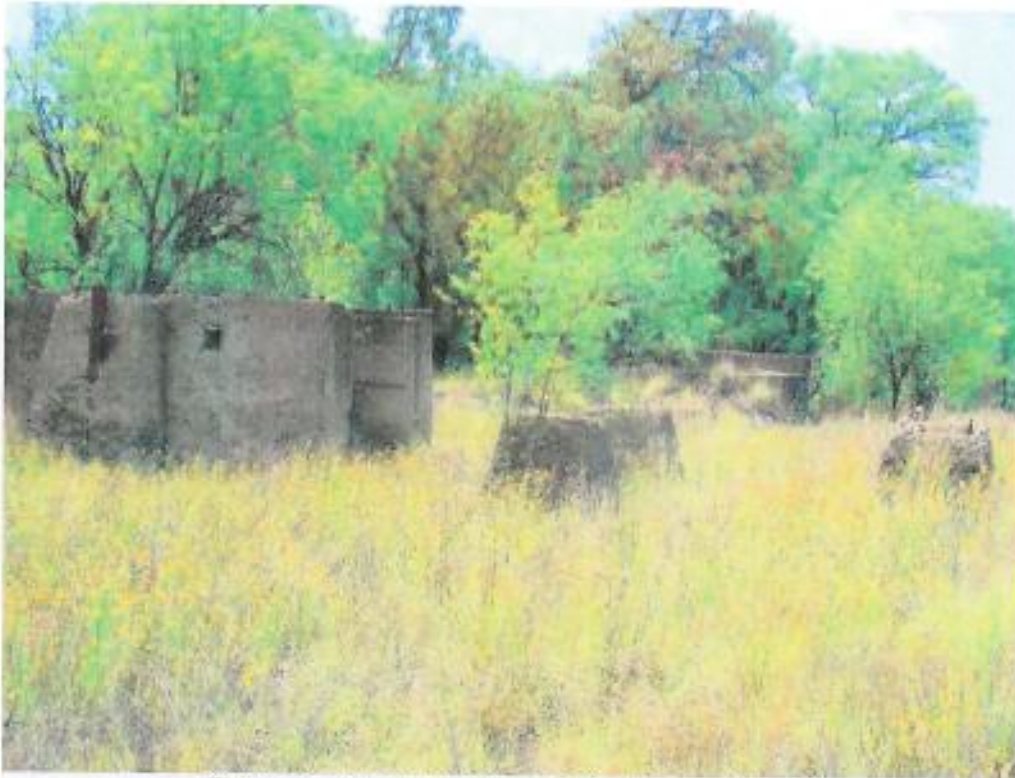
**Figure 51: Remains of Riggers (orientation north-east)**

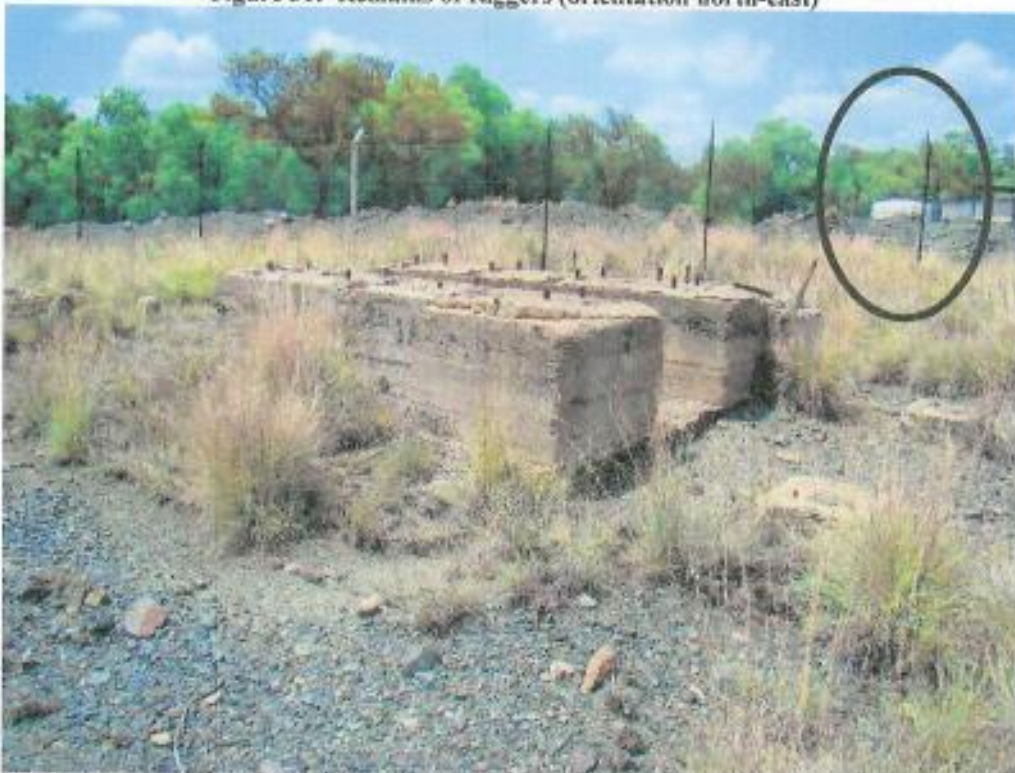
**Figure 52: Remains of Riggers (orientation south-east) Encircled area in back is the No 1 Main Rock Shaft remains**

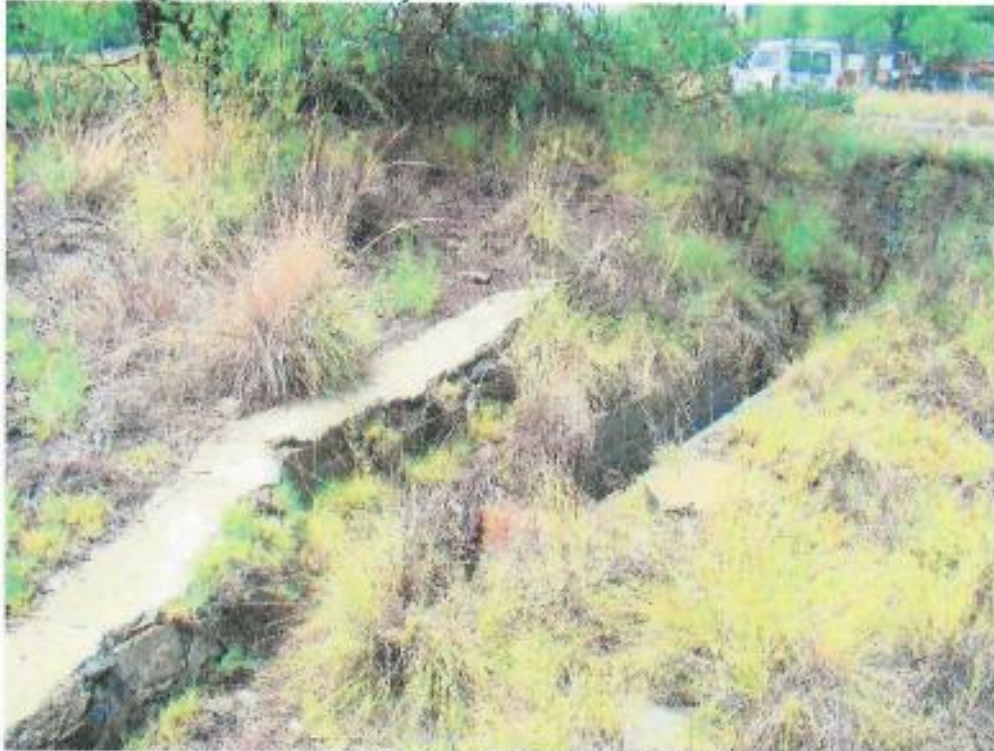
**Figure 53: Remains of foundation of unknown structure with ditch on side (south-easterly orientation)**

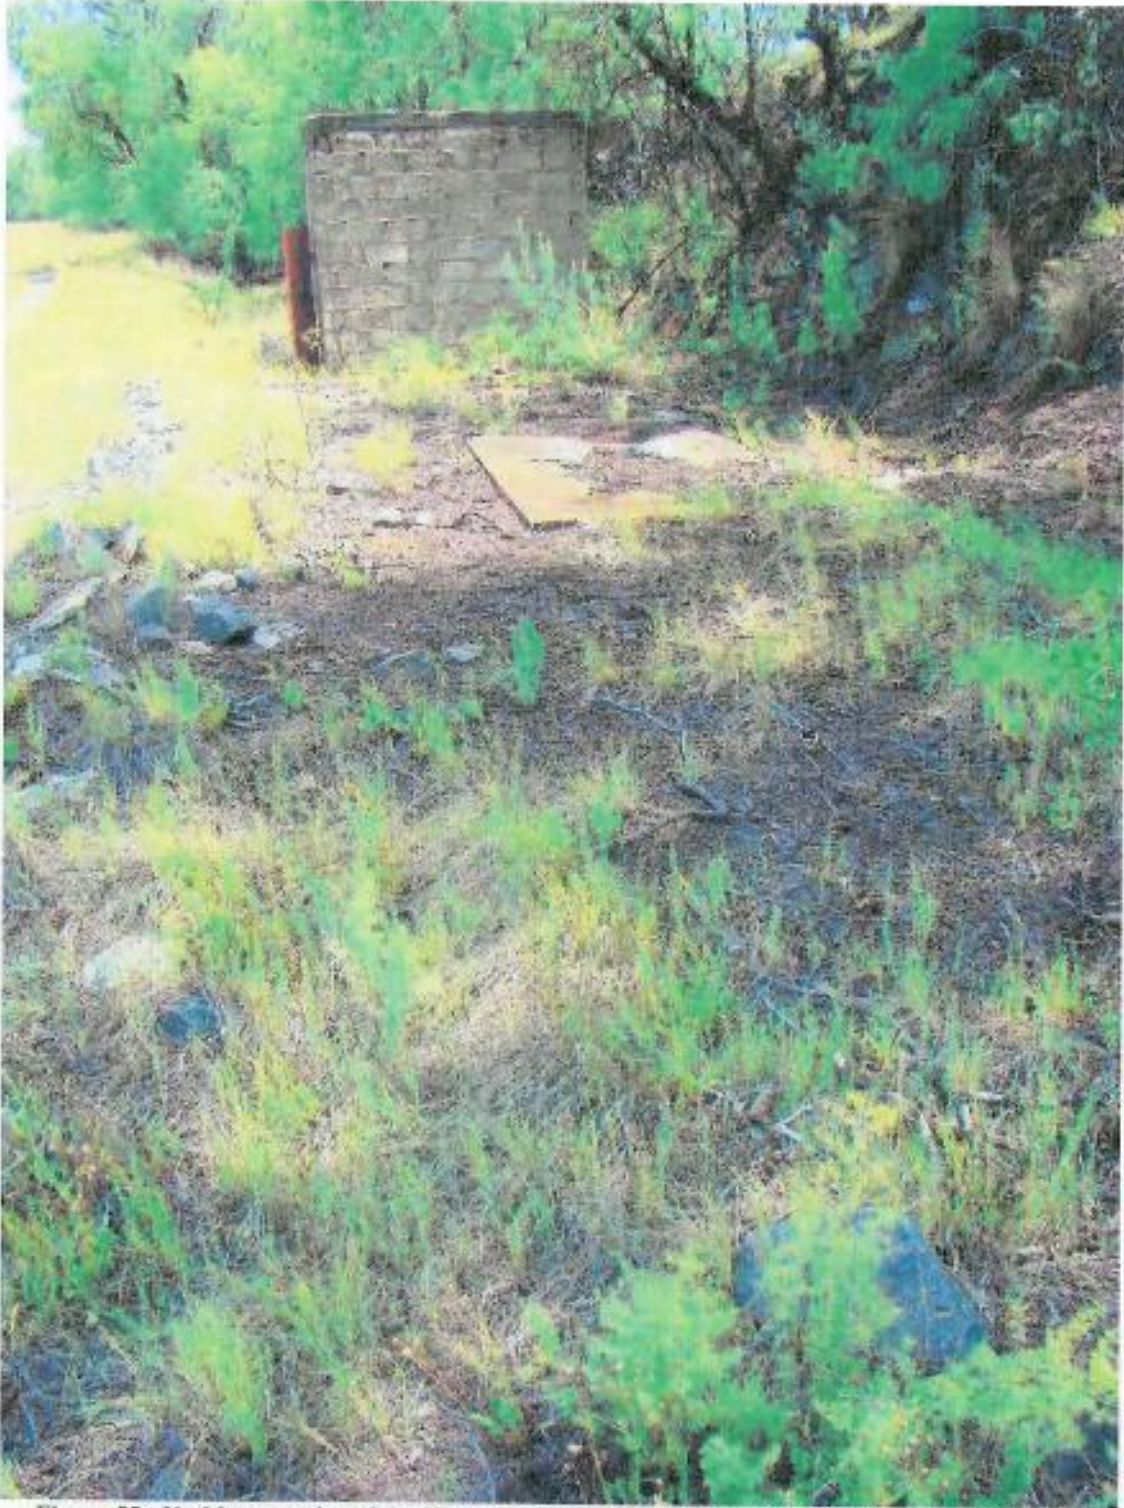
**Figure 55:** Nothing remains of the Timber area that is on the southern side of the retainer wall discussed below. The cement slab and cement structure seem to be later additions

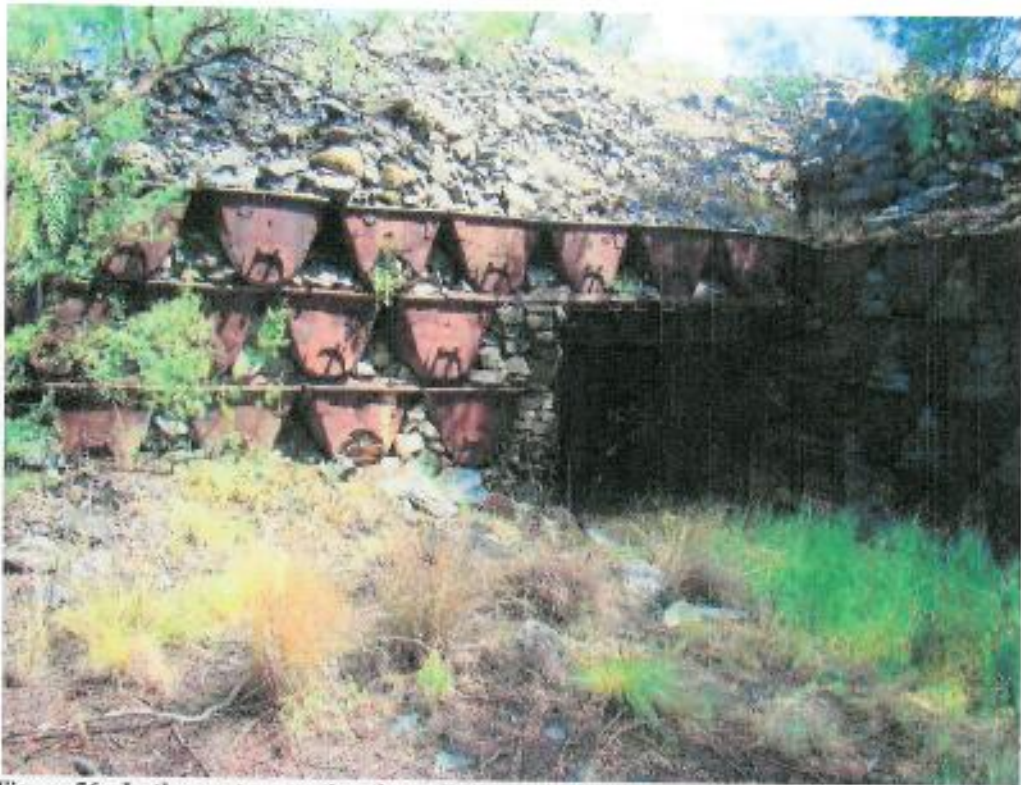
**Figure 56:** In the western section the wall has a small outcrop to form a bridge over the canal

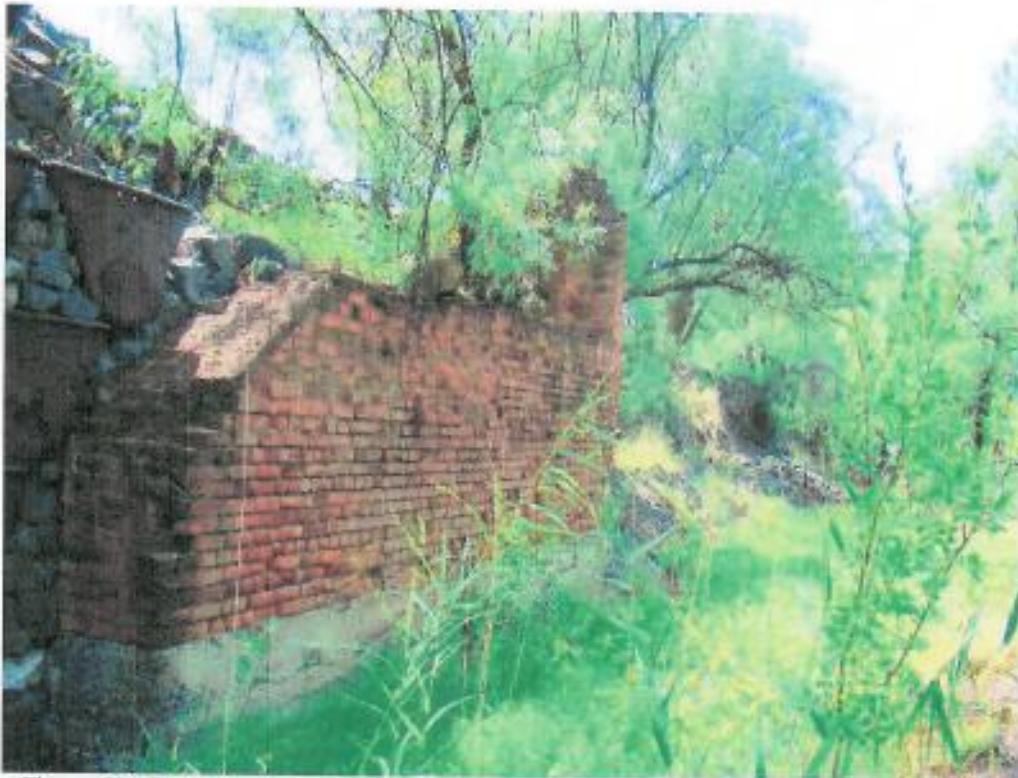
**Figure 59:** From the cocopan section of the wall a section of wall constructed with bricks

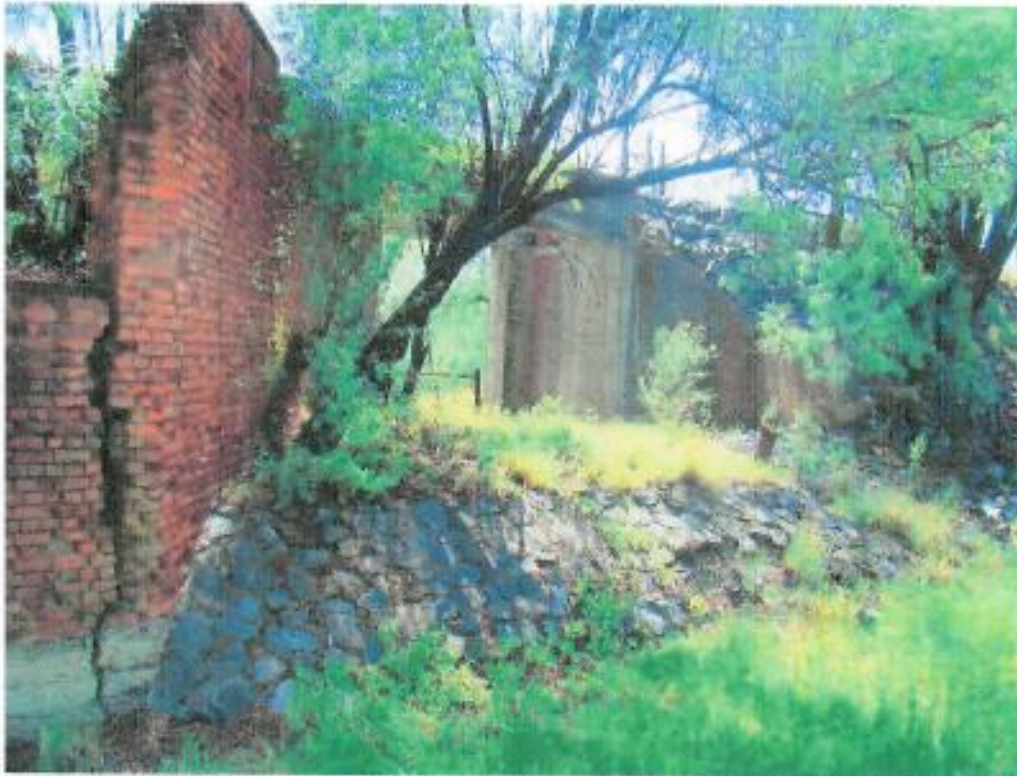
Figure 60: The brick reinforced section curves north-east towards an opening in the wall (cement-constructed bridge)

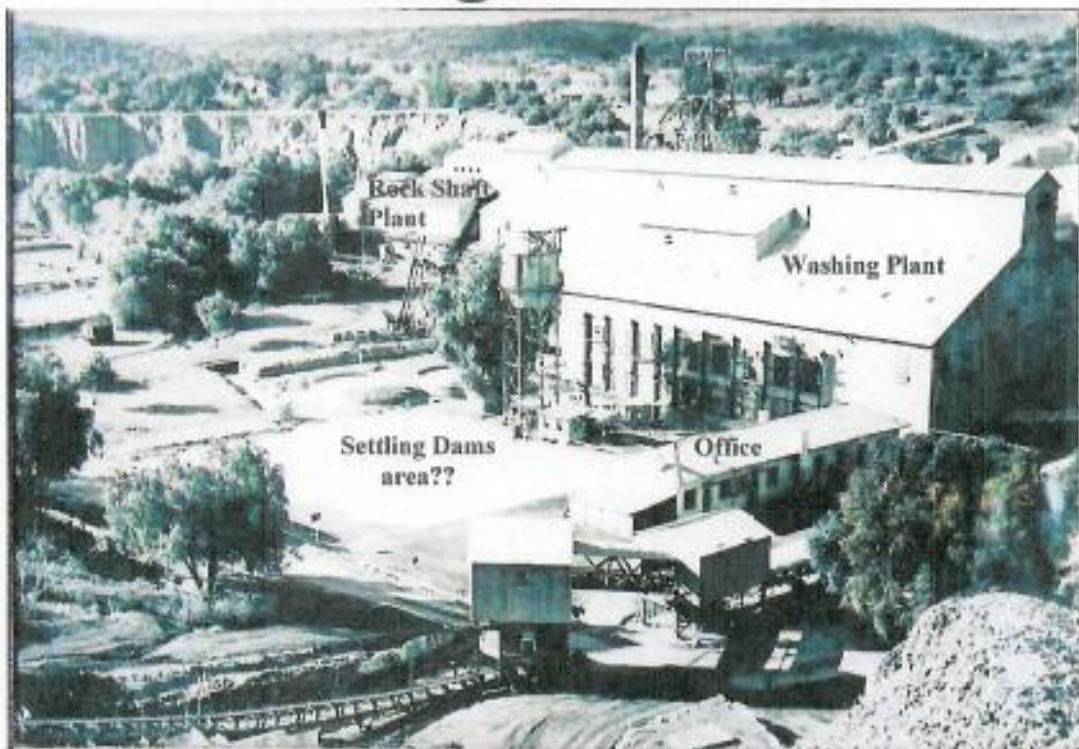
Figure 62: DBMC Archive photograph of Washing Plant Area. (Only the office building remains standing)

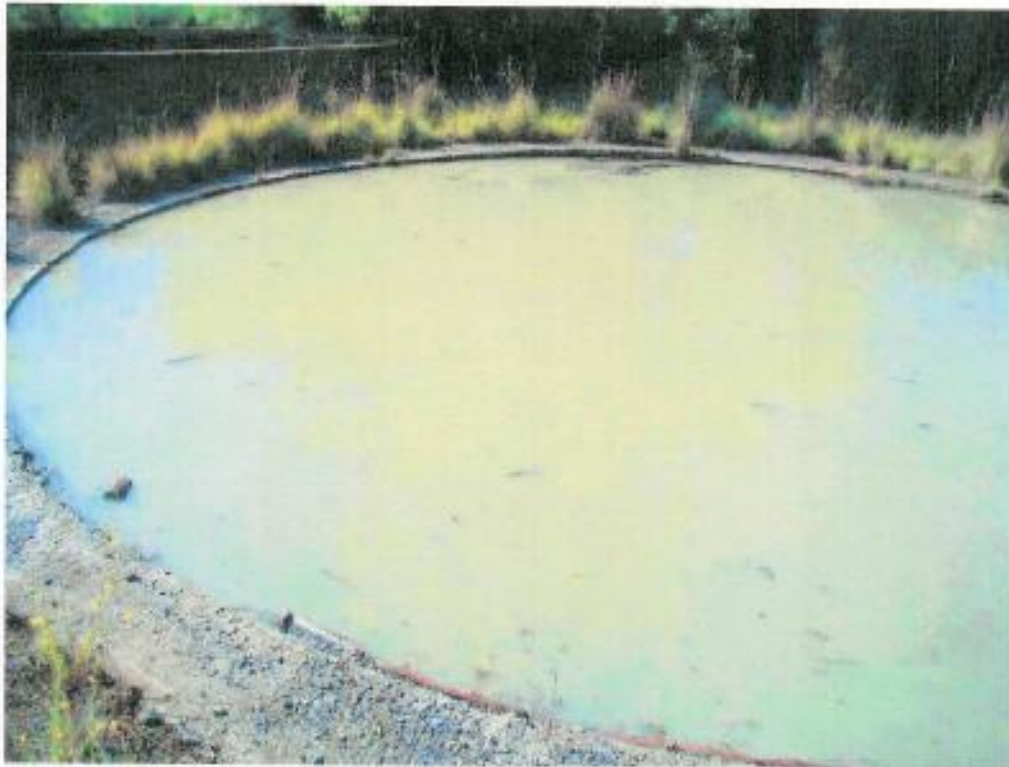
**Figure 81: Detail of sunken dam in picture 36 above. Depth unknown.**

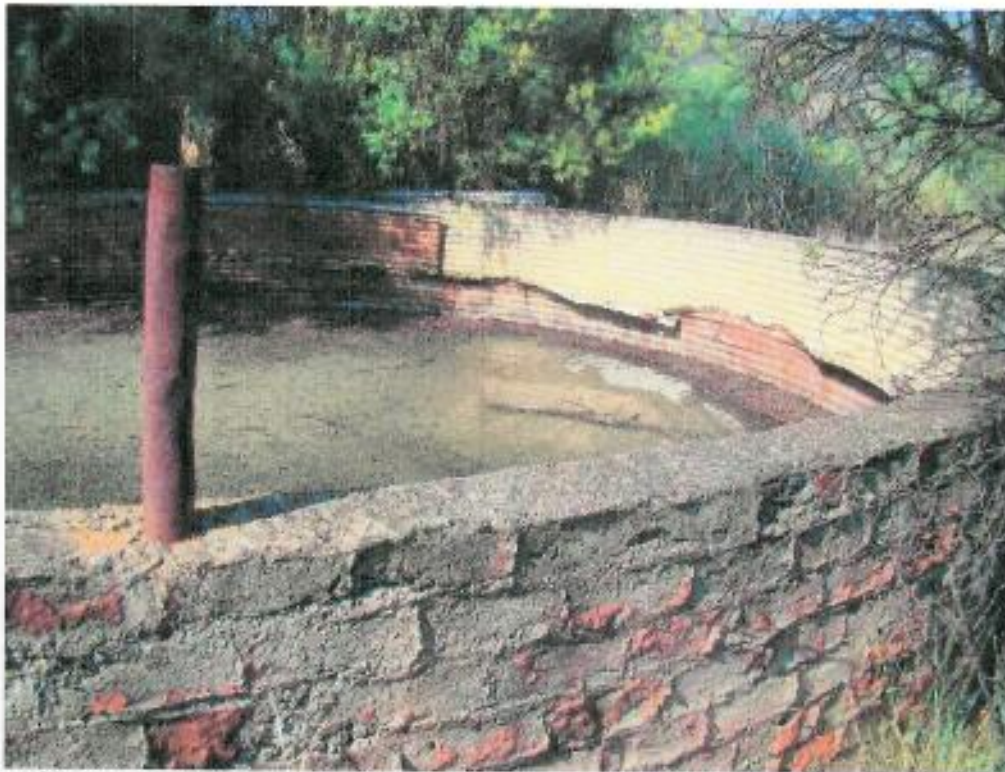
Figure 82: Detail of raised dam in picture 36 above - constructed of bricks & mortar and lined with sheets of corrugated iron

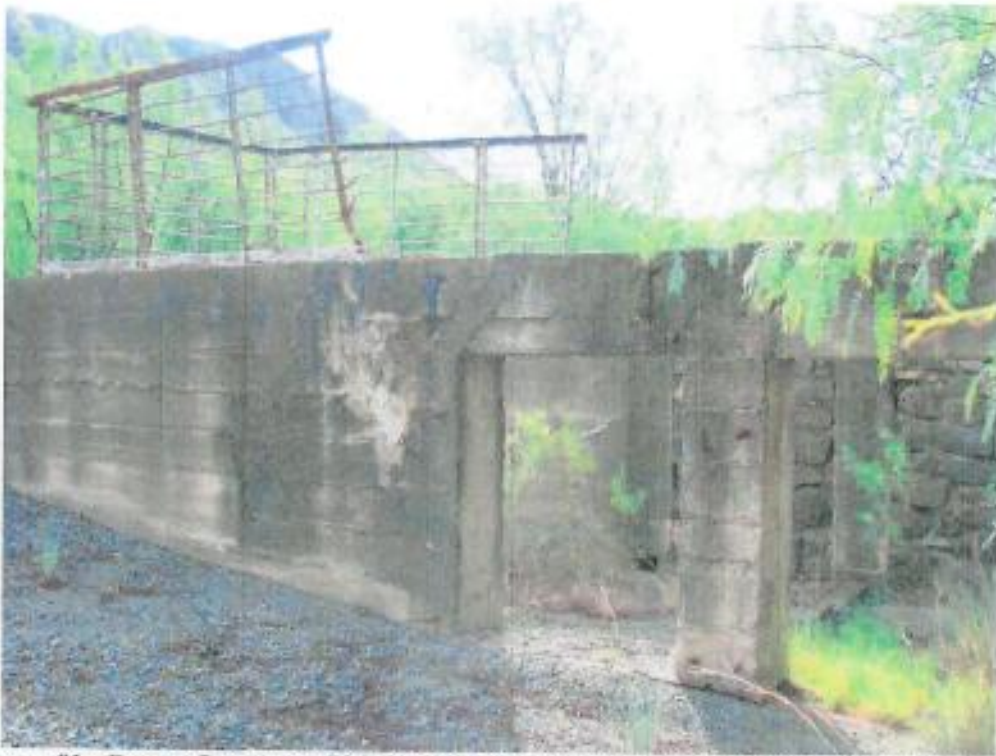
**Figure 91: Cement Structure which probably served as foundation for the shaft gear (Modern Tailings Dump in background). Orientation south-west.**

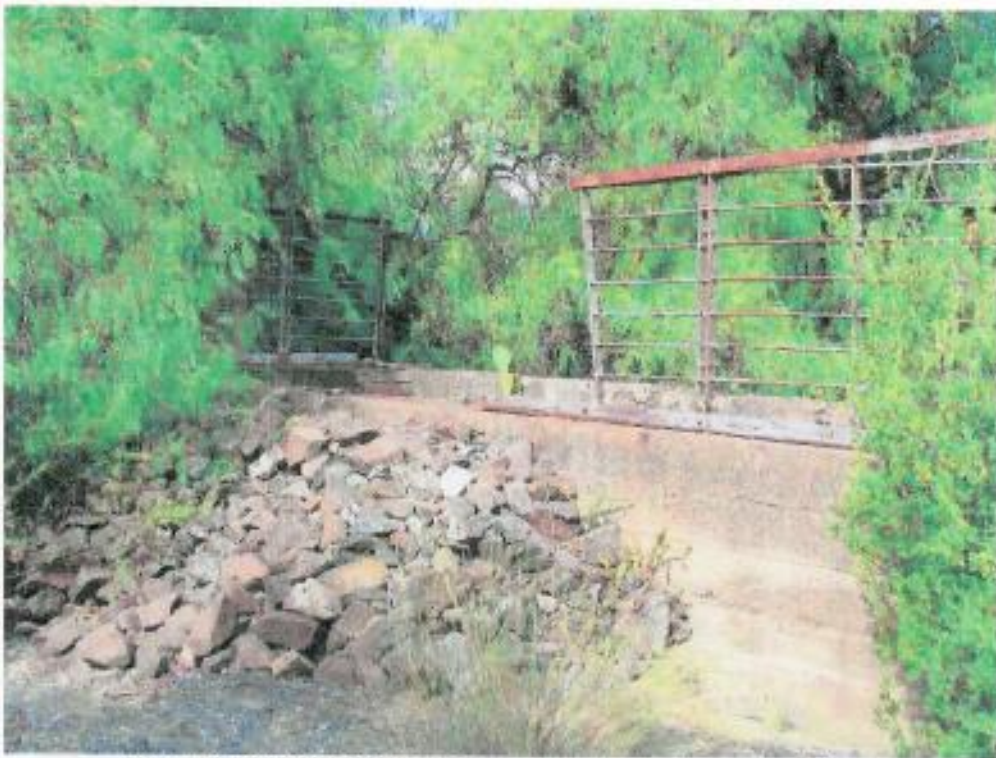
Figure 94: Debris of dismantled structure on top of cement platform

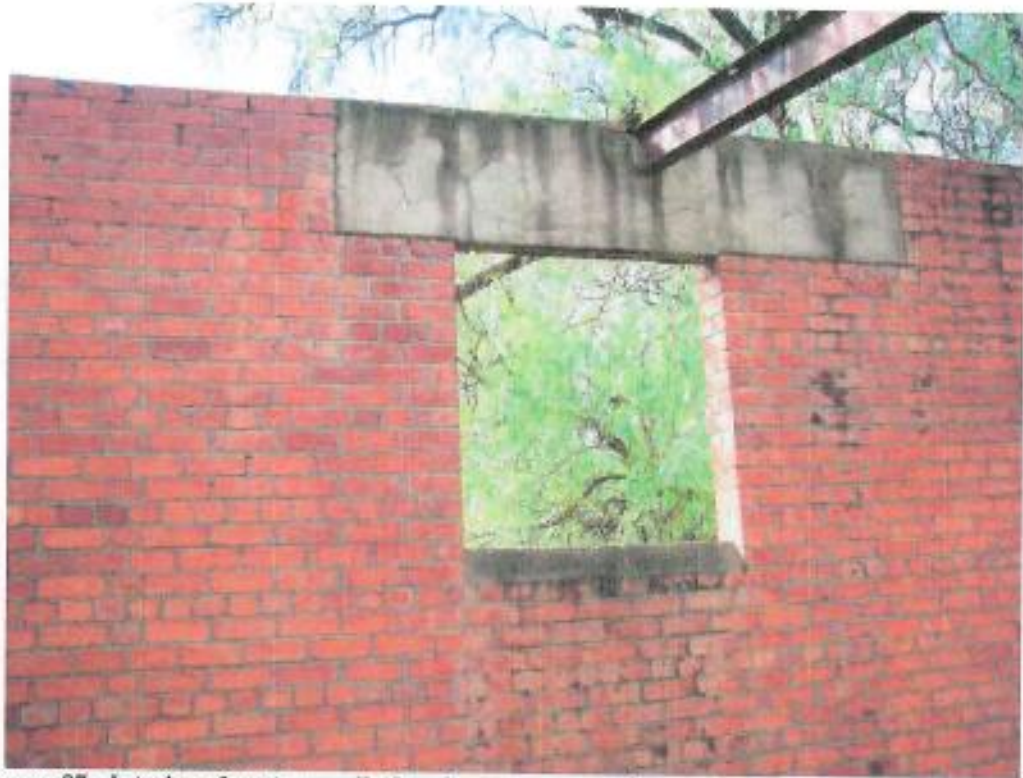
**Figure 97: Interior of western wall of engine room – metal beam that connected the engine room with the shaft**
