Native Hostel (Compound)

5.3.2.2 Mine Area B

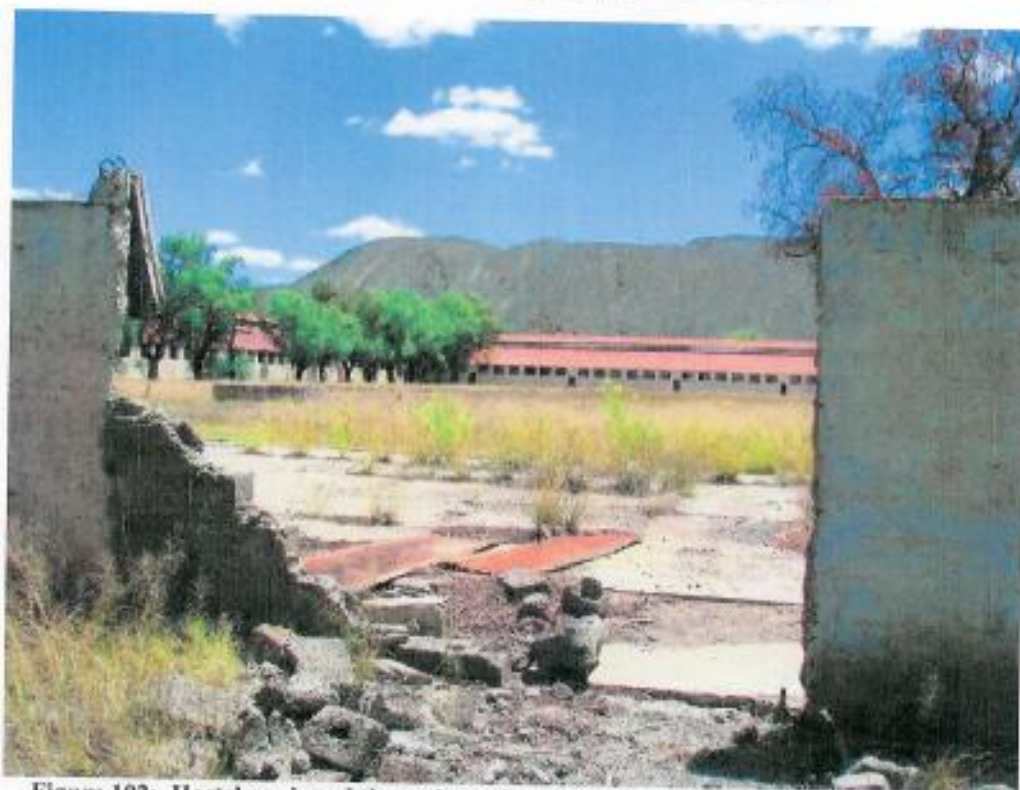
Figure 102: Hostel as viewed through gap in wall at Bayleys Lucern Storeroom section

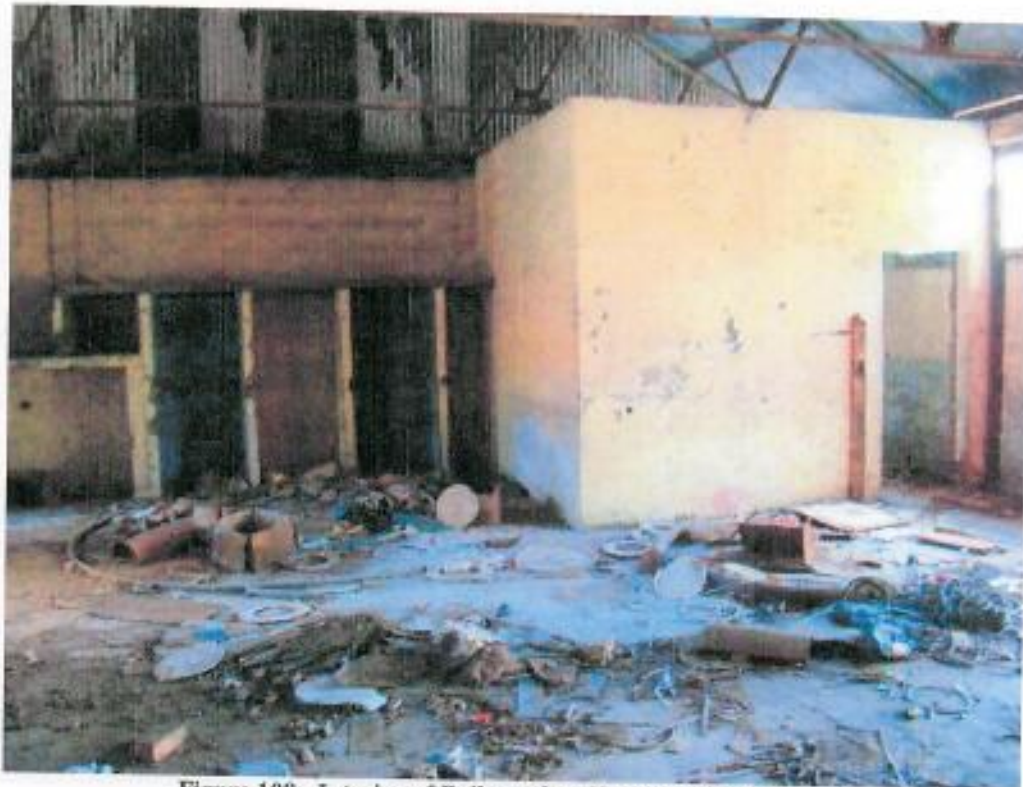
Figure 107: Interior of Boilermaker Shop – orientation south-west (Refer to hostel plan on page 124 for location)

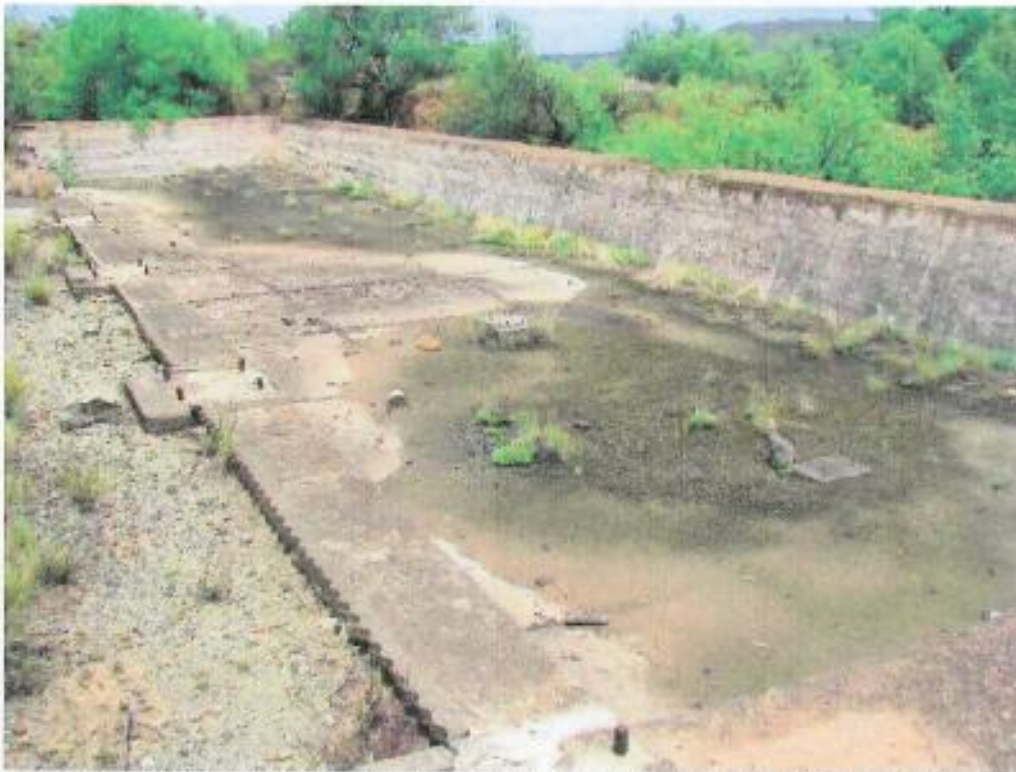
Figure 152: To the west of this lies a succession of cement channels that leads from this reservoir (view photographs below) Judged by the bolts and nuts in both the middle and sides of the dam as well as the patterned edge this structure probably served as foundation for machinery or tanks that were housed in a corrugated iron structure.

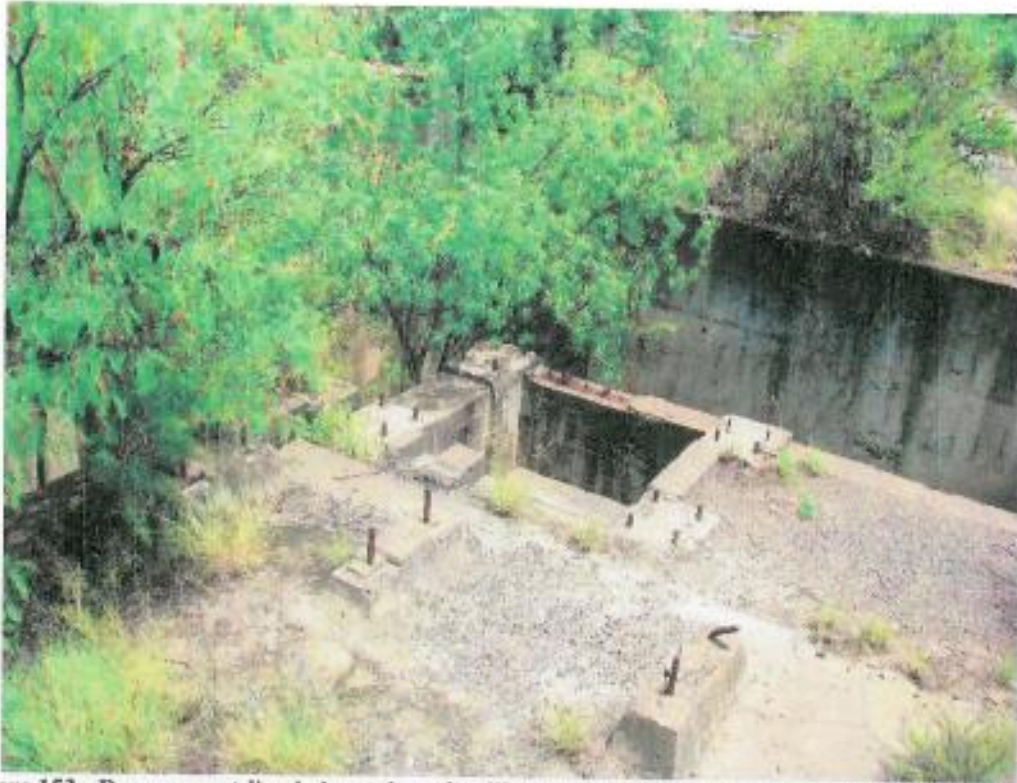
Figure 153: Deep cement-lined channels and gullies that leads from the structure in the photograph above

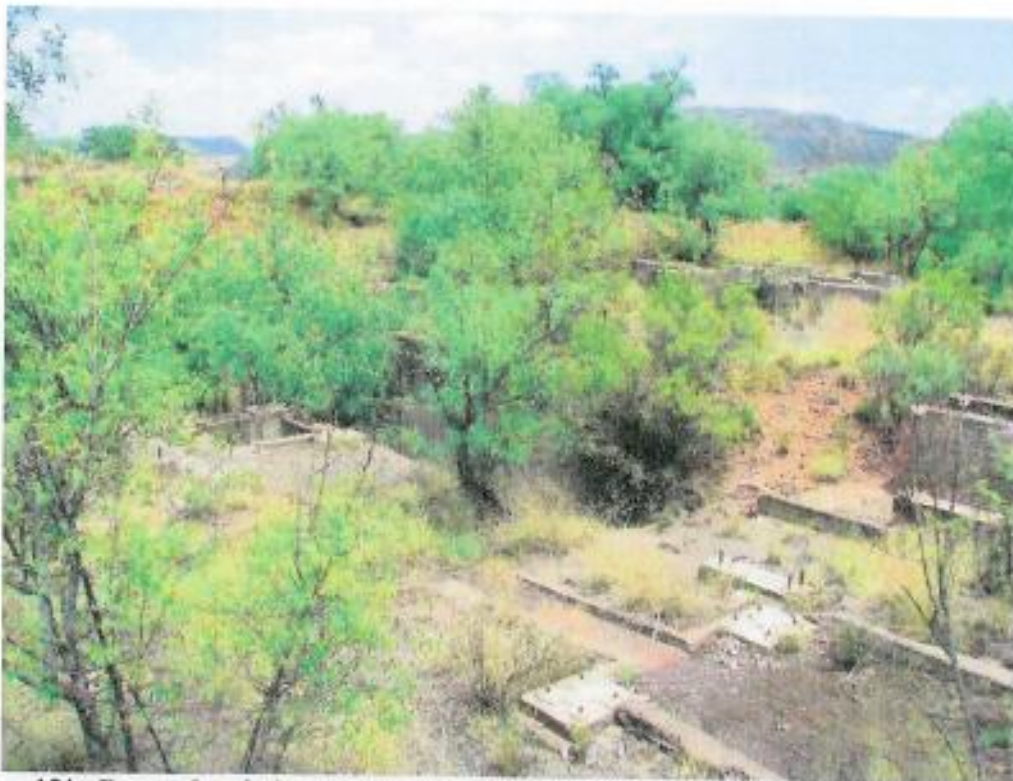
Figure 154: Cement foundations that presumably held more tanks or machinery occur directly west of the gullies in the photograph above

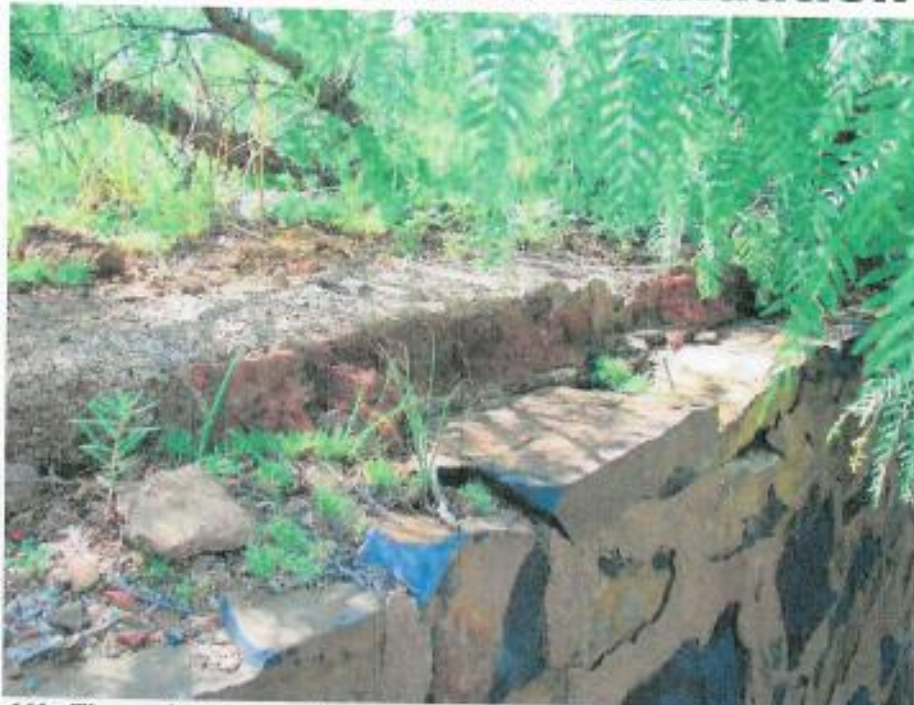
Stone and Cement Foundation 3

Figure 161: The north eastern section of this building has a stone foundation with a cement and brick layer on top

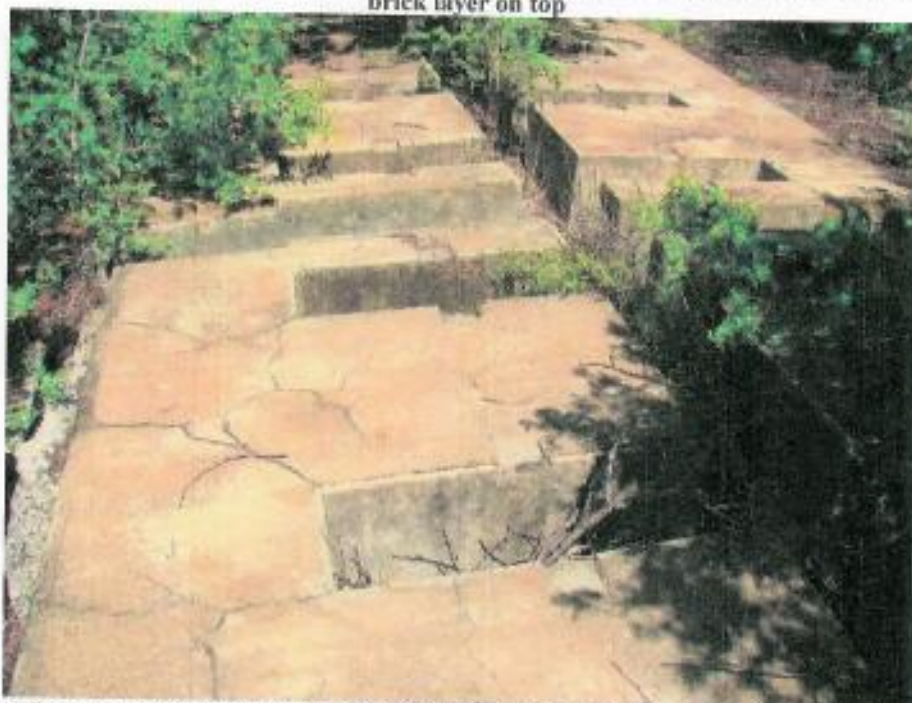
Figure 162: The south-western section of this building has a similar stone foundation but with a cement slab with deep slots on top. This could possibly have been the earlier garage building.

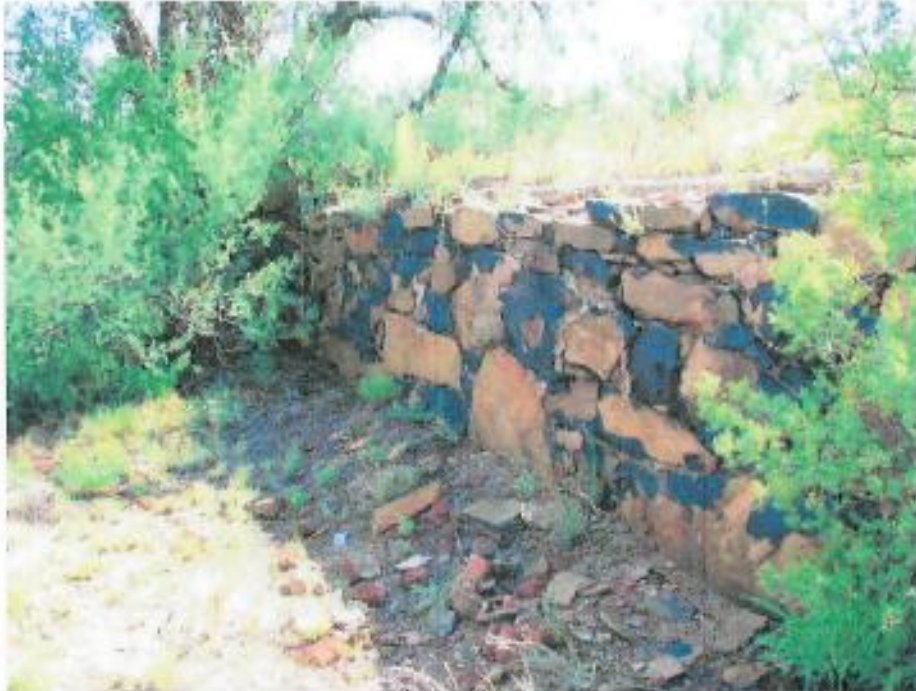
Stone Foundation 2

Figure 163: Similar to the previous structure this also has a stone foundation with cement and bricks on top (only traces visible)

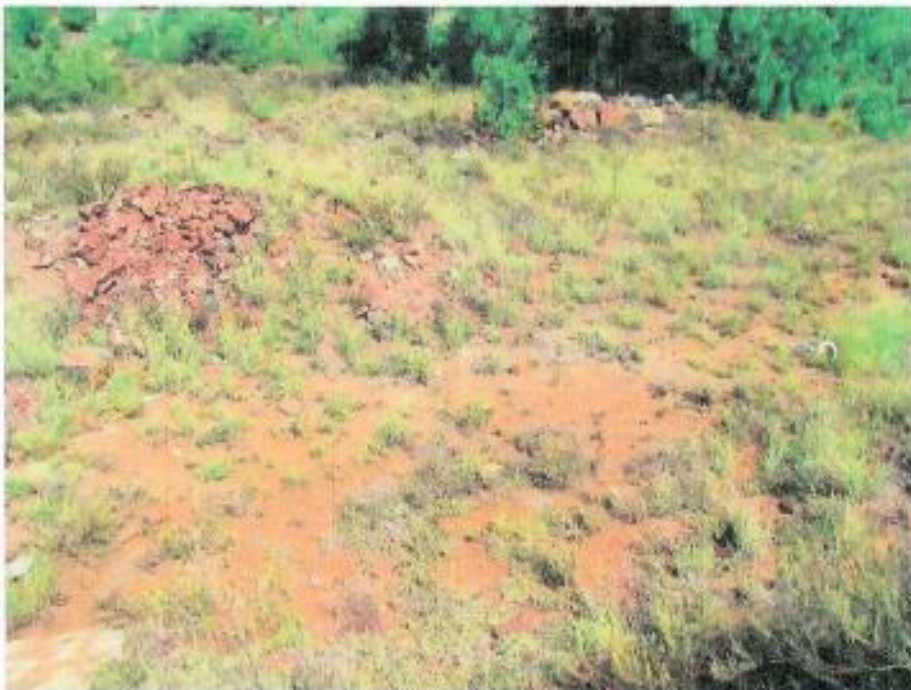
Figure 164: Piles of bricks from the demolished building

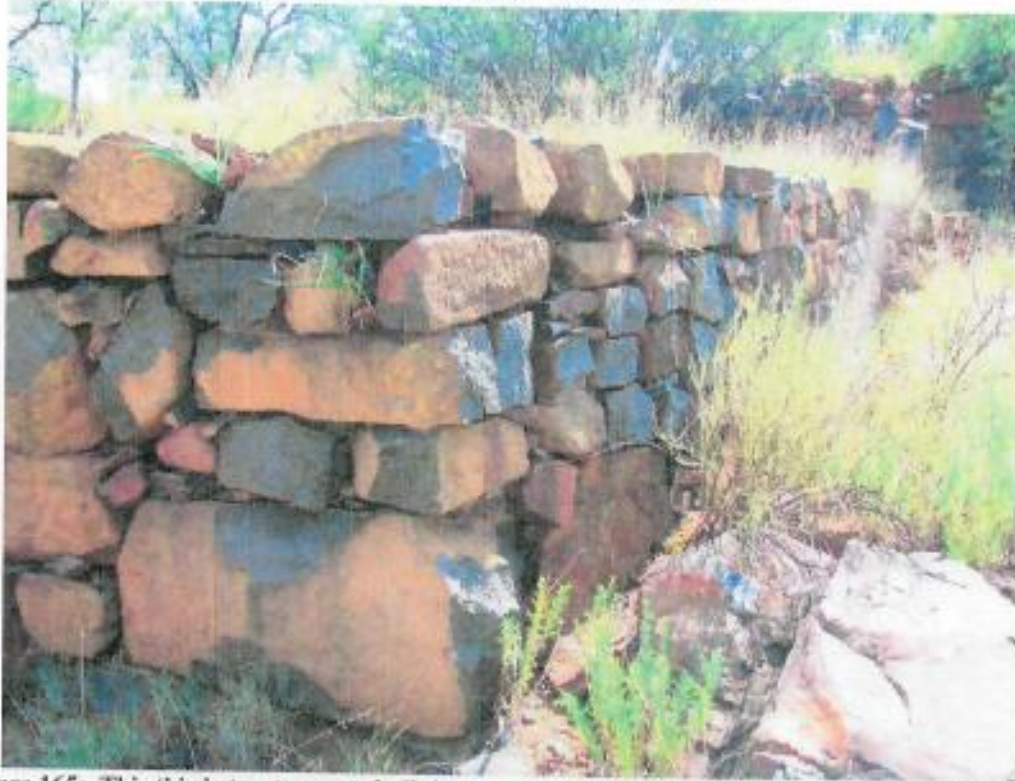
Stone Foundation 1

Figure 165: This third structure was built in a similar fashion to the previous two buildings but has two distinct levels as can be seen in this photograph

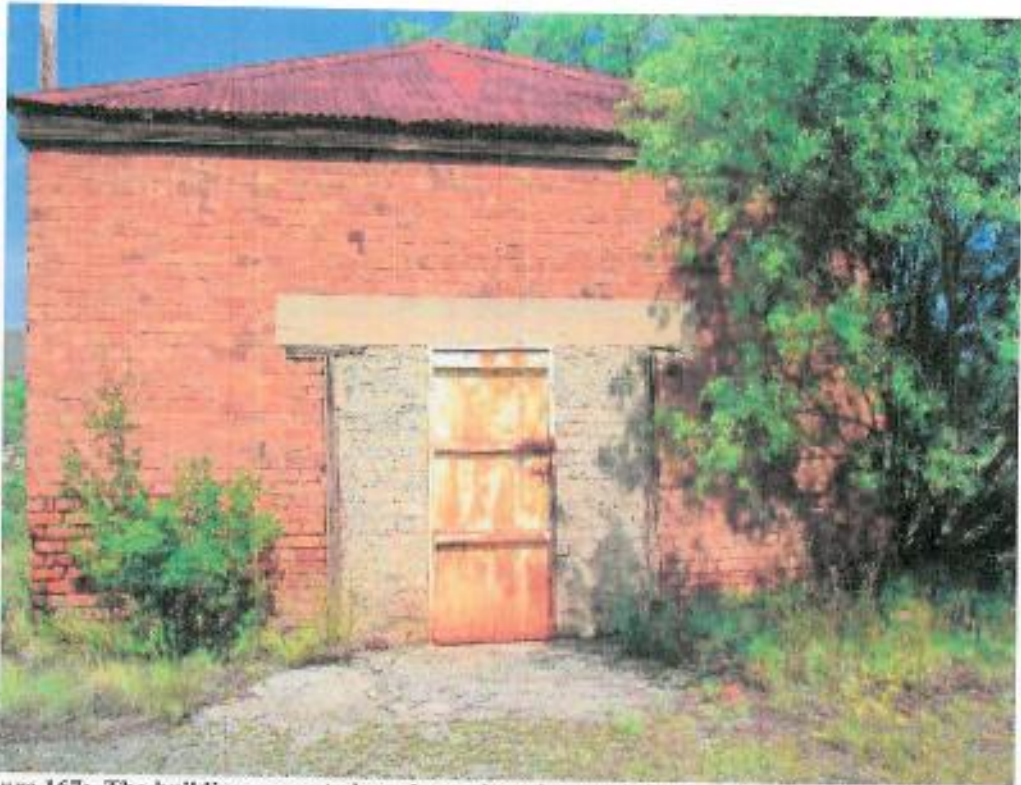
Figure 167: The building seems to have been altered several times – this side originally had a wide entrance as on the other end

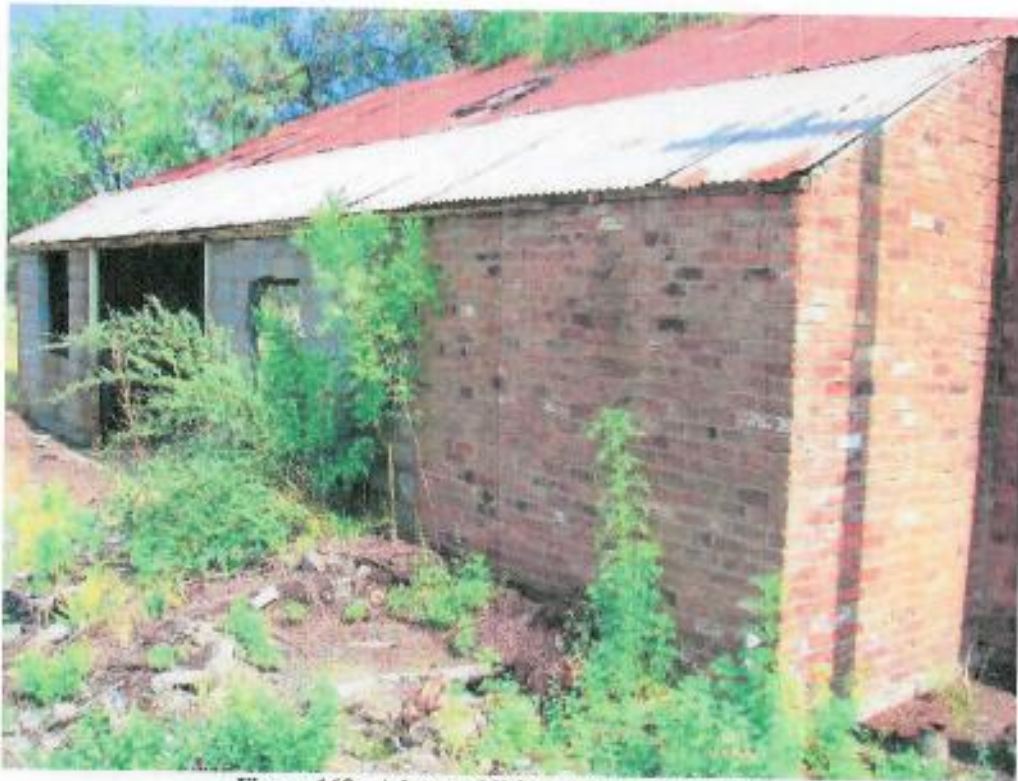
Figure 168: A later addition to the main building

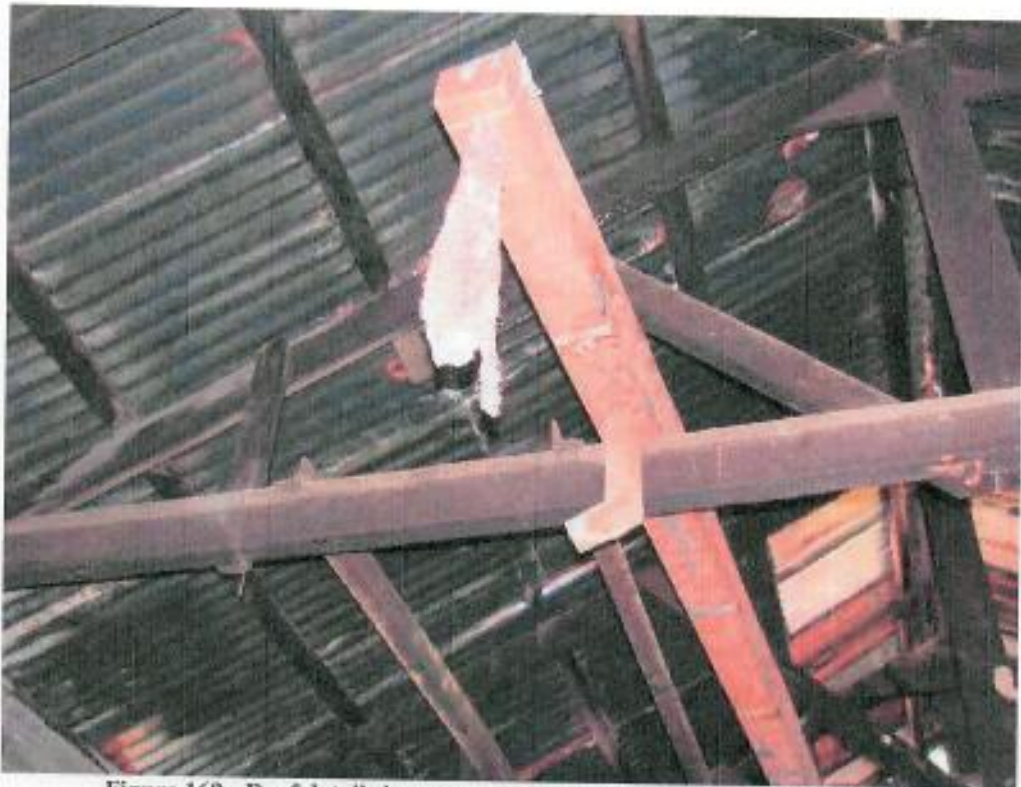
Figure 169: Roof detail shows a gutter resting on the roof support beams

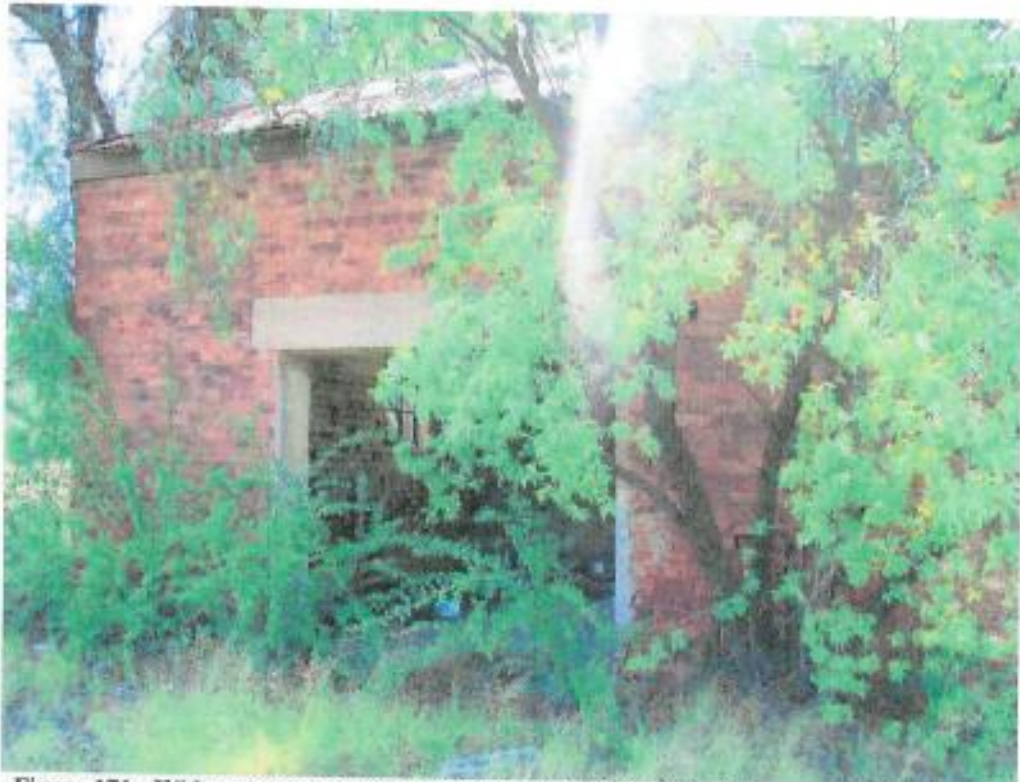
Figure 171: Wide entrance – appears to have been reinforced with cement at a later stage

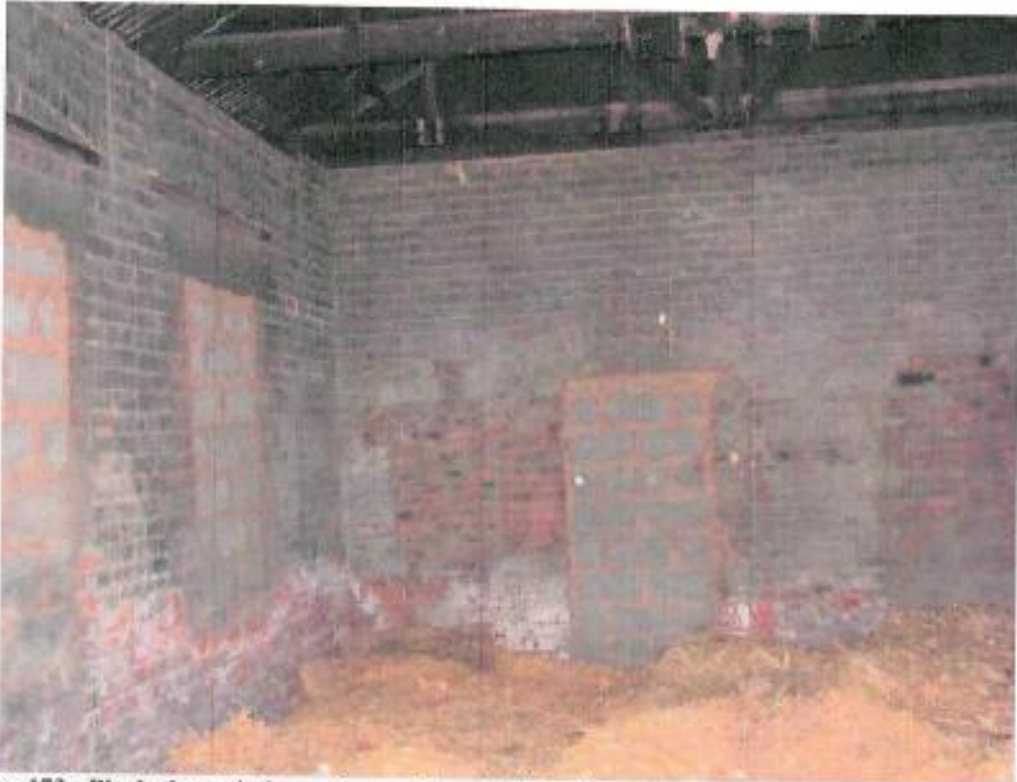
Figure 173: Blocked up windows – hay on floor indicate it could have been used for animal shelter or storage for animal feed

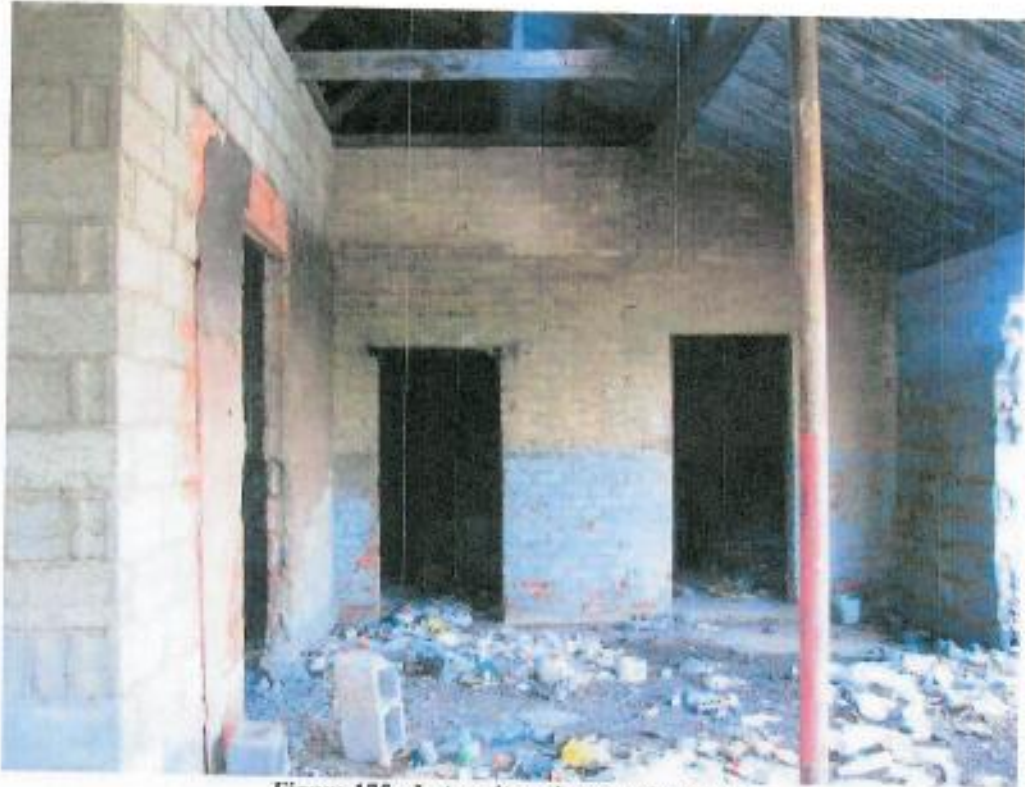
Figure 175: Later alterations on the inside

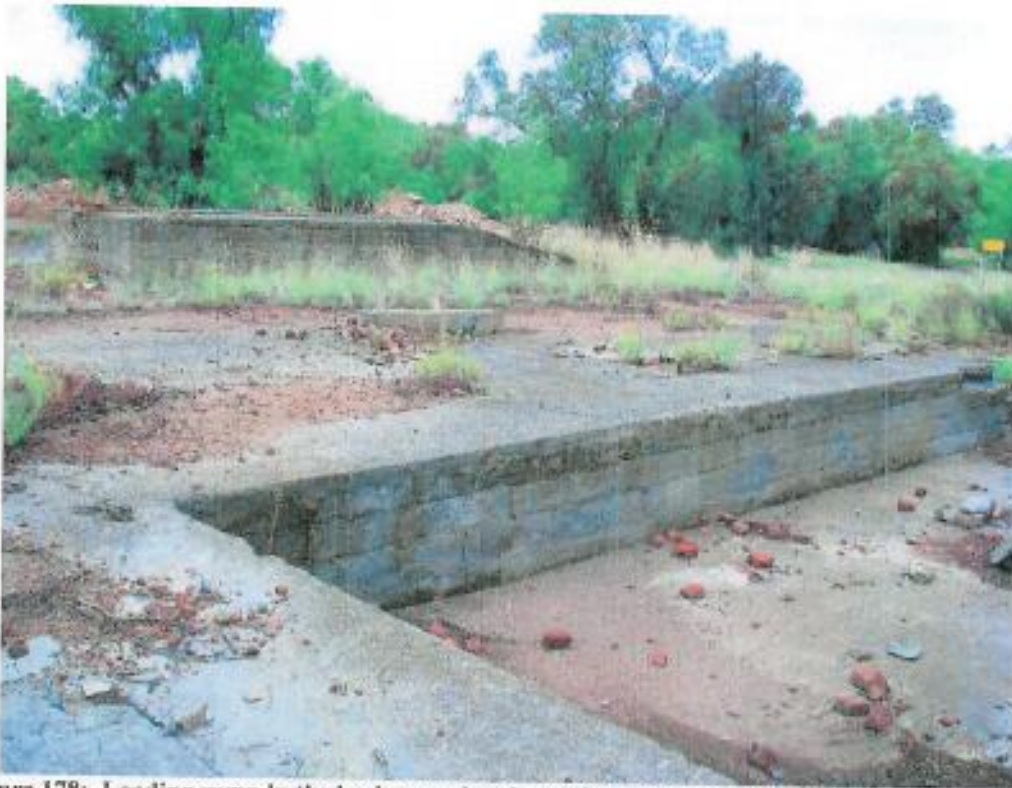
Figure 178: Loading ramp in the background and a sunken rectangular construction with an open end in the foreground
