**Jagersfontein Heritage Impact Assessment
Structures: Mine Area b
31/03/2009**

5.3.2.3 Central Section

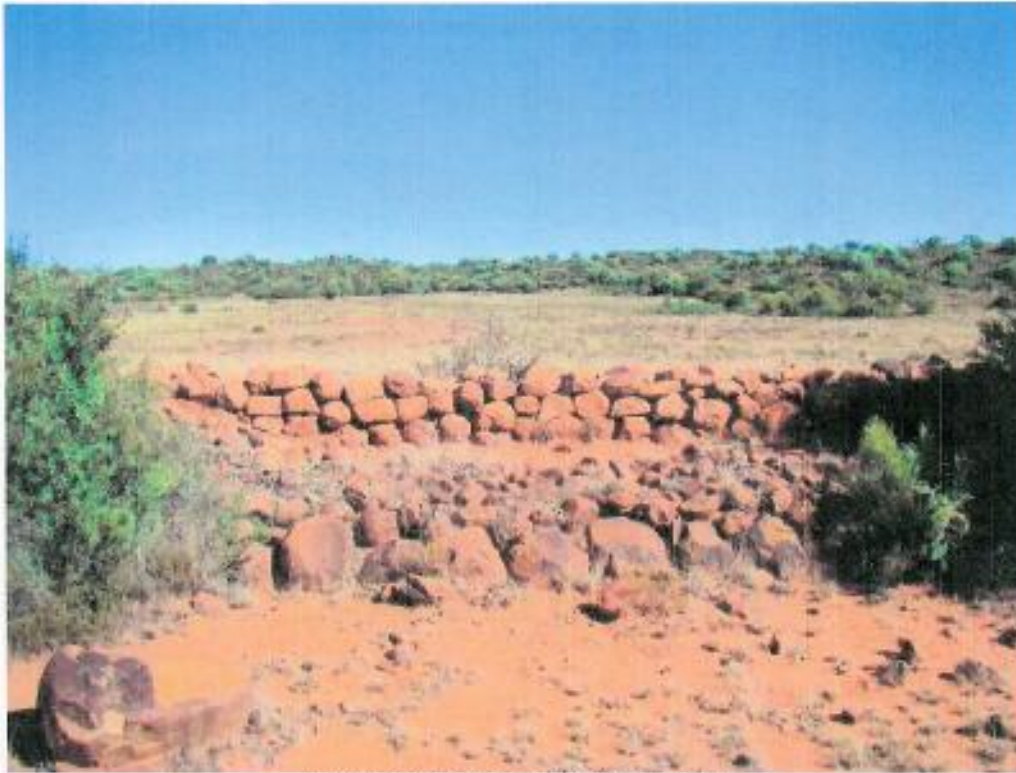
Figure 183: Retainer wall at dam area

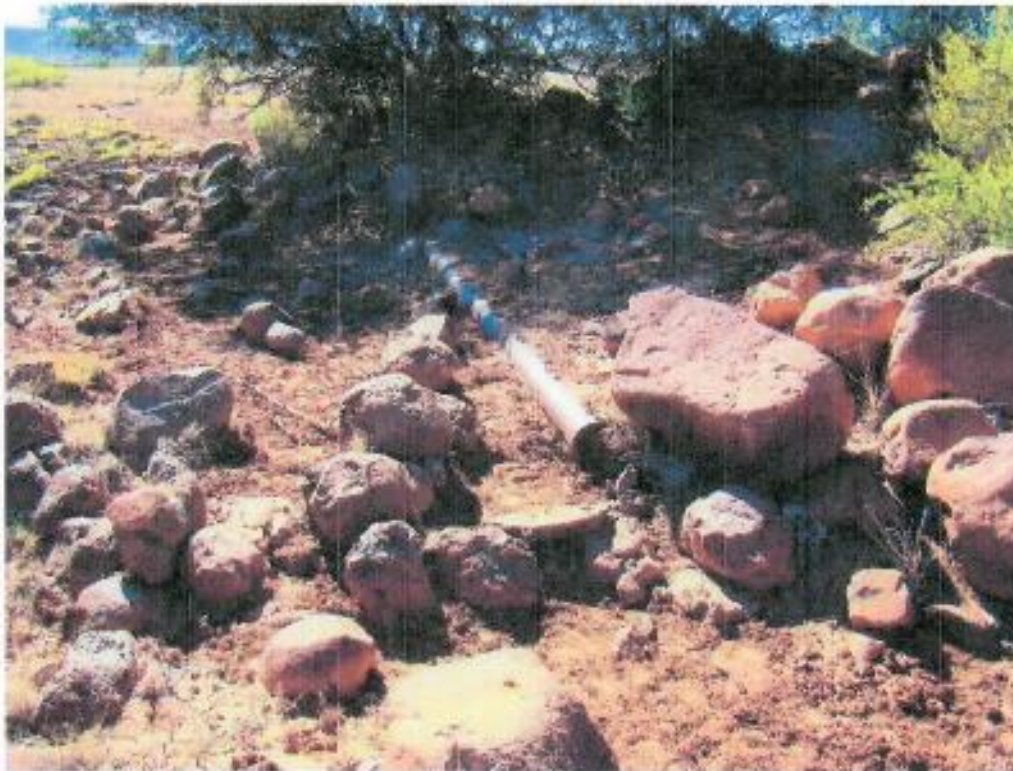
Figure 184: Demolished section in the middle of the dam retainer wall exposes a water pipe

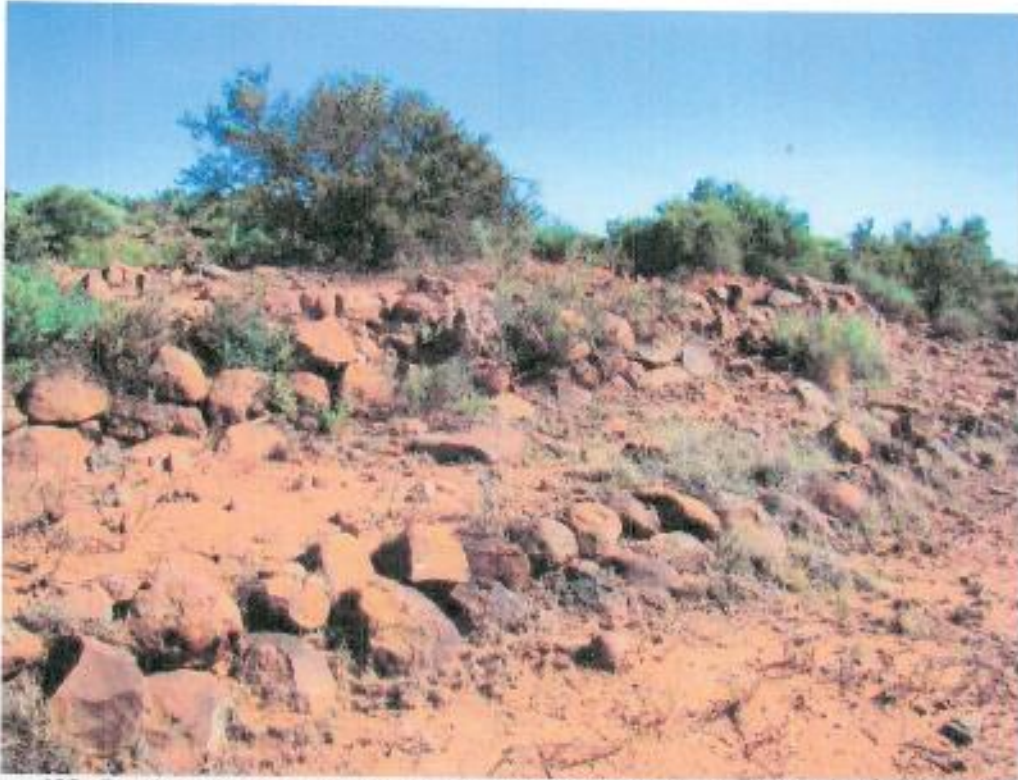
Figure 185: Retainer wall at dam – constructed in terraces with flat surface on top (see photograph below)

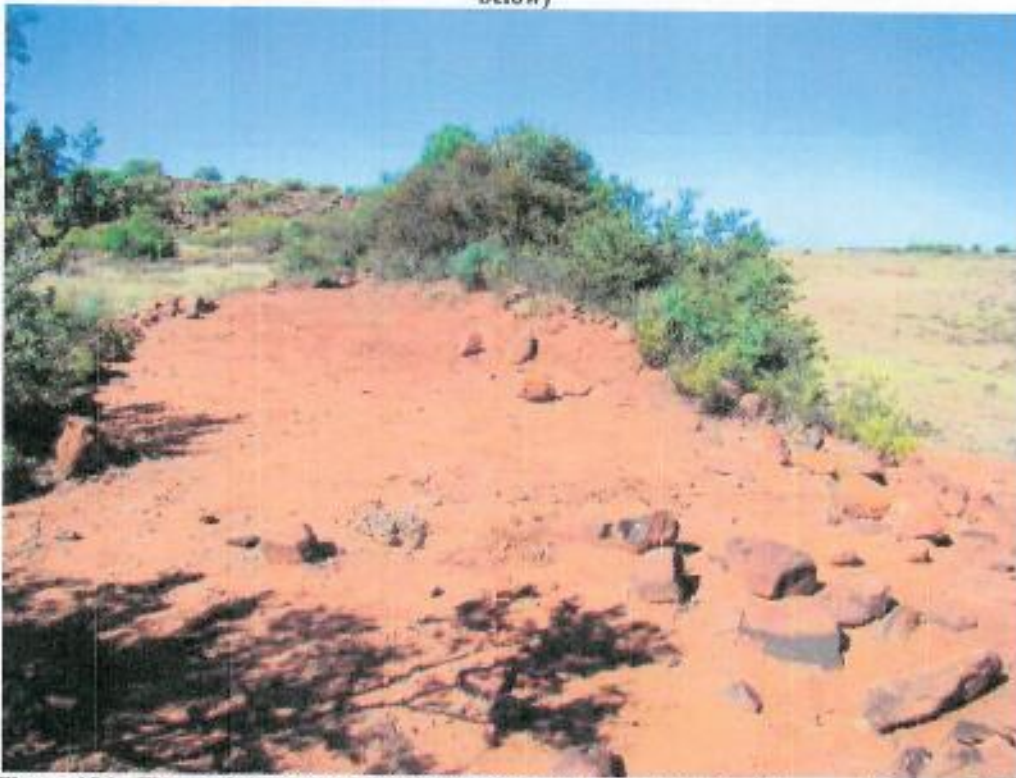
Figure 186: Flat surface on top of terraced retainer wall for dam is wide enough for a vehicle

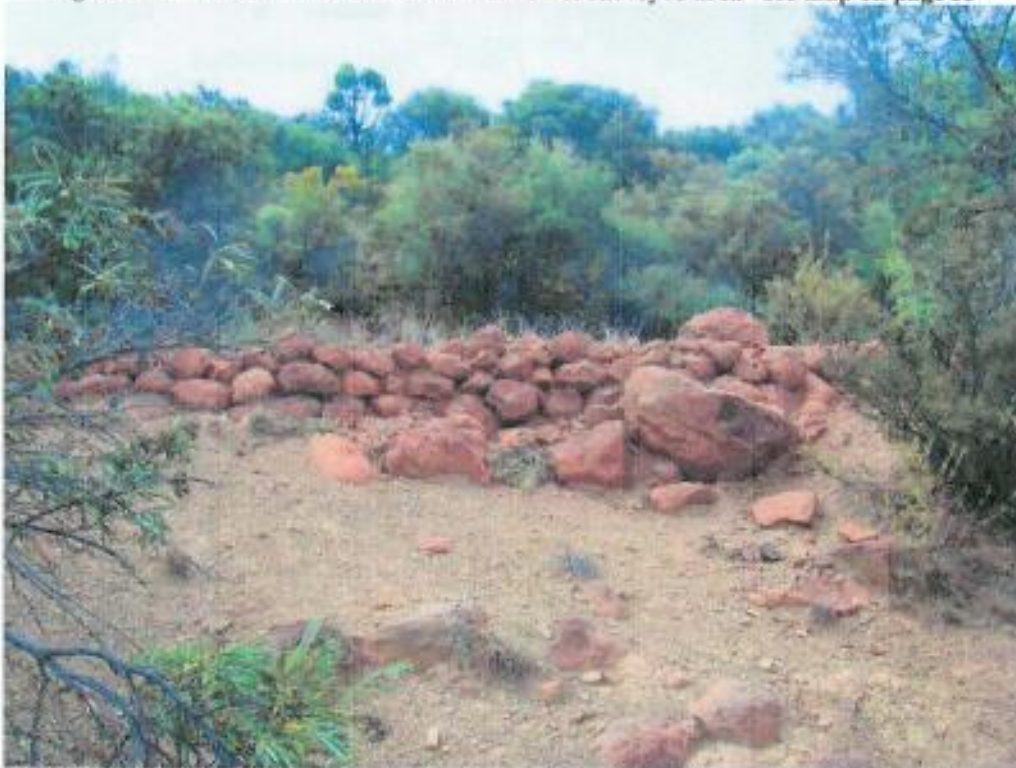
Figure 188: This wall in the southern section has a similar flat surface to that of the retainer wall at the dam in the central section. Both these walls run on the same contour line and could possibly have been connected

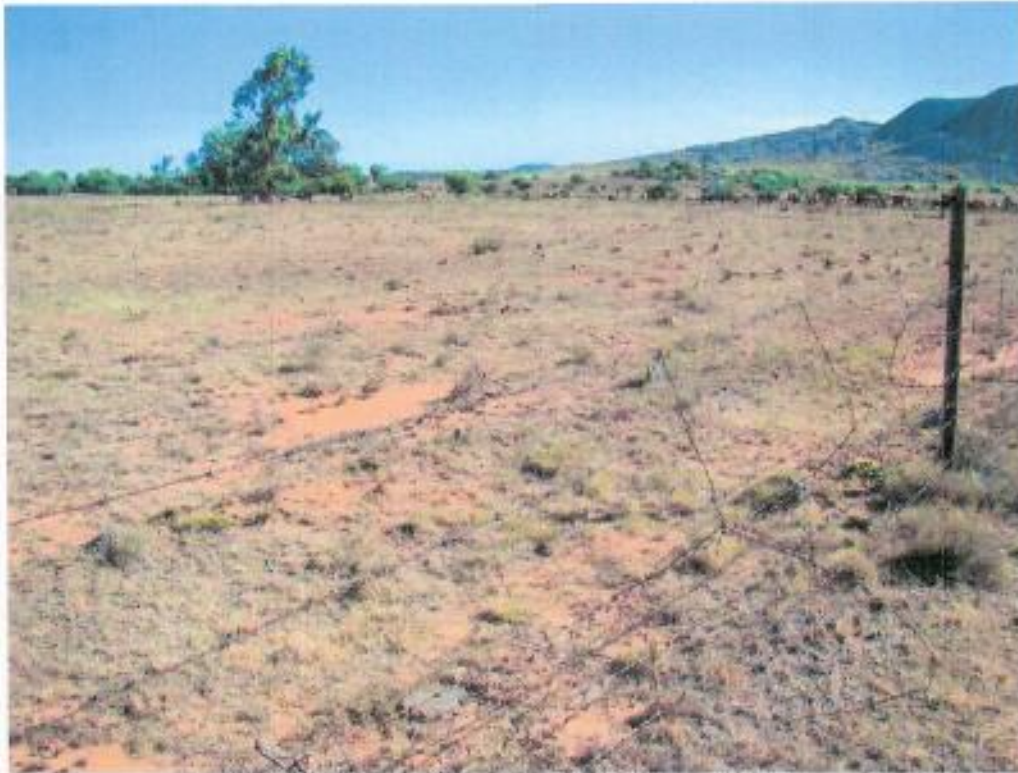
In the central section (refer to section map on page 1a) a burial area was found. Although an attempt has been made to fence off the area it is not sufficient to keep out animals. Immediately adjacent this burial area on the northern side is a cattle pen. Stones packed in a T-shape form a passage through the larger area that leads to a smaller section with more "formal" type graves (refer to map of graveyard on page 162). For the purpose of this report the large section will be referred to as the "informal" section and the smaller section the "formal" part.

Figure 191: Condition of fence

This entire burial area is in need of maintenance and repair and requires urgent attention.

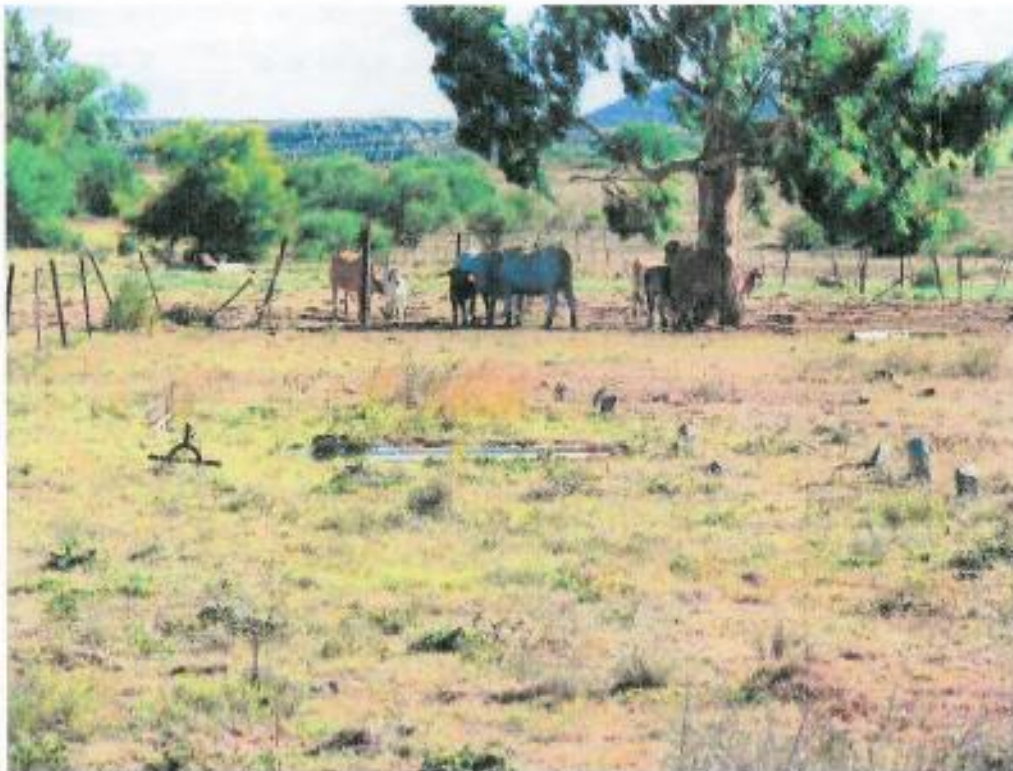
Figure 192: Close proximity of cattle pen to graves (note condition of fence)

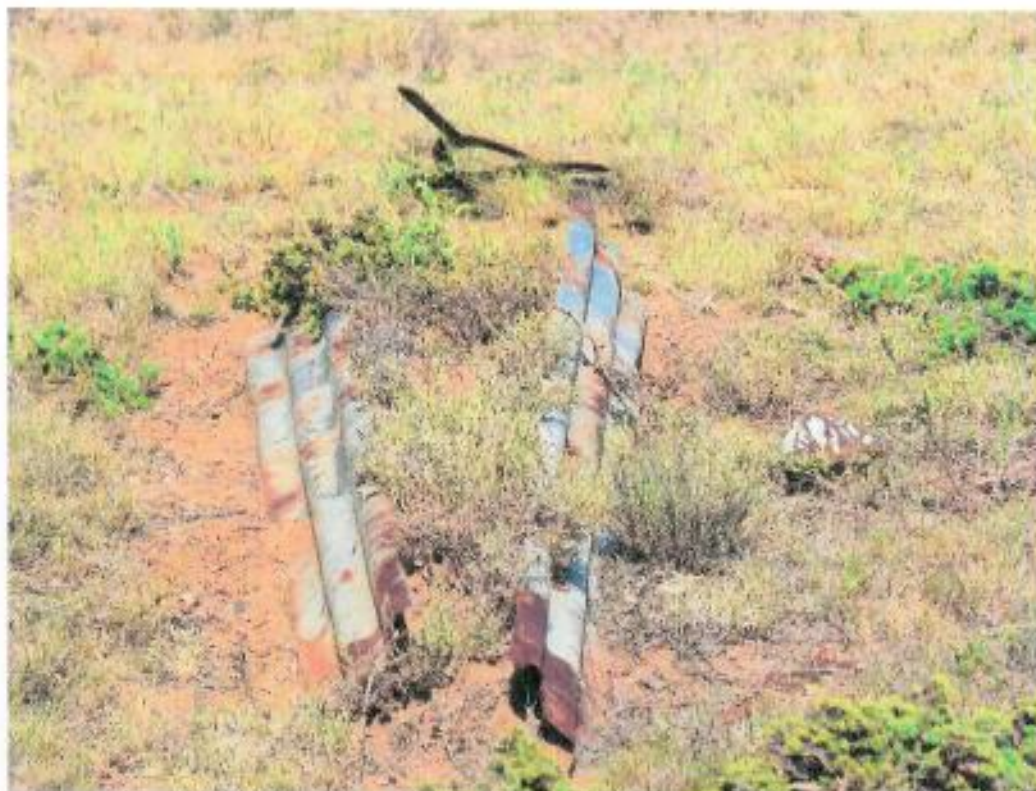
Figure 199: Exposed corrugated iron sheets from grave in formal area (1)

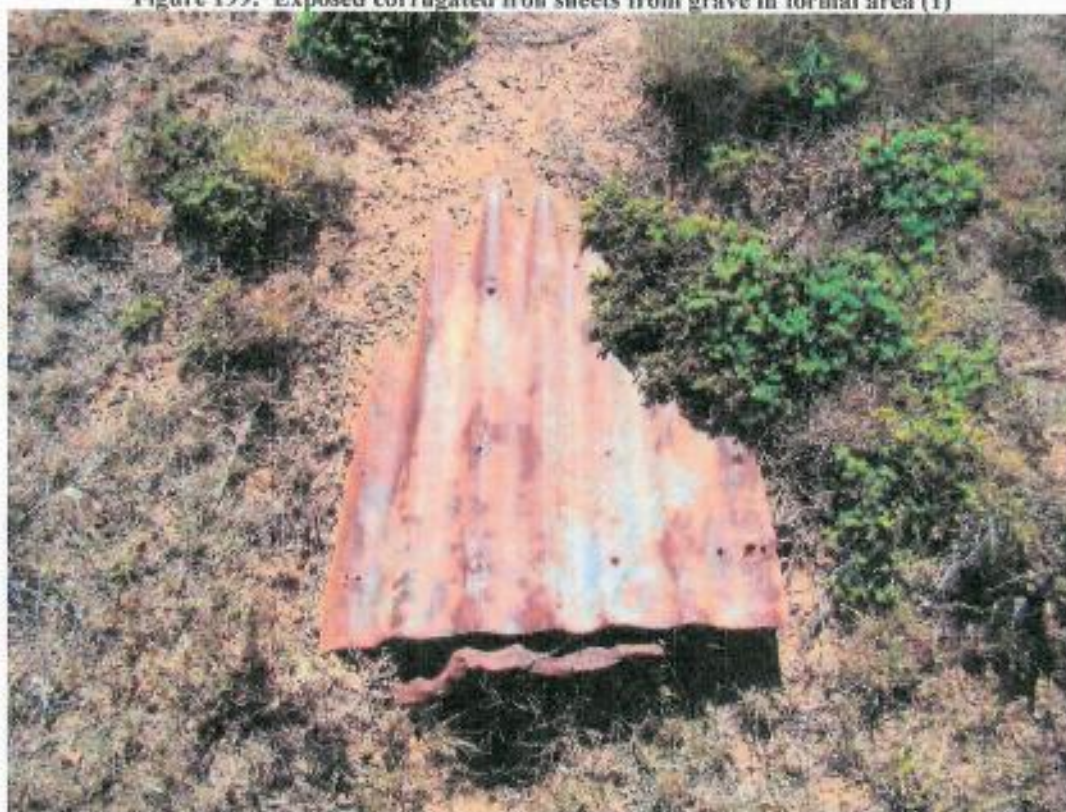
Figure 200: Exposed corrugated iron sheets from grave in formal area (2)

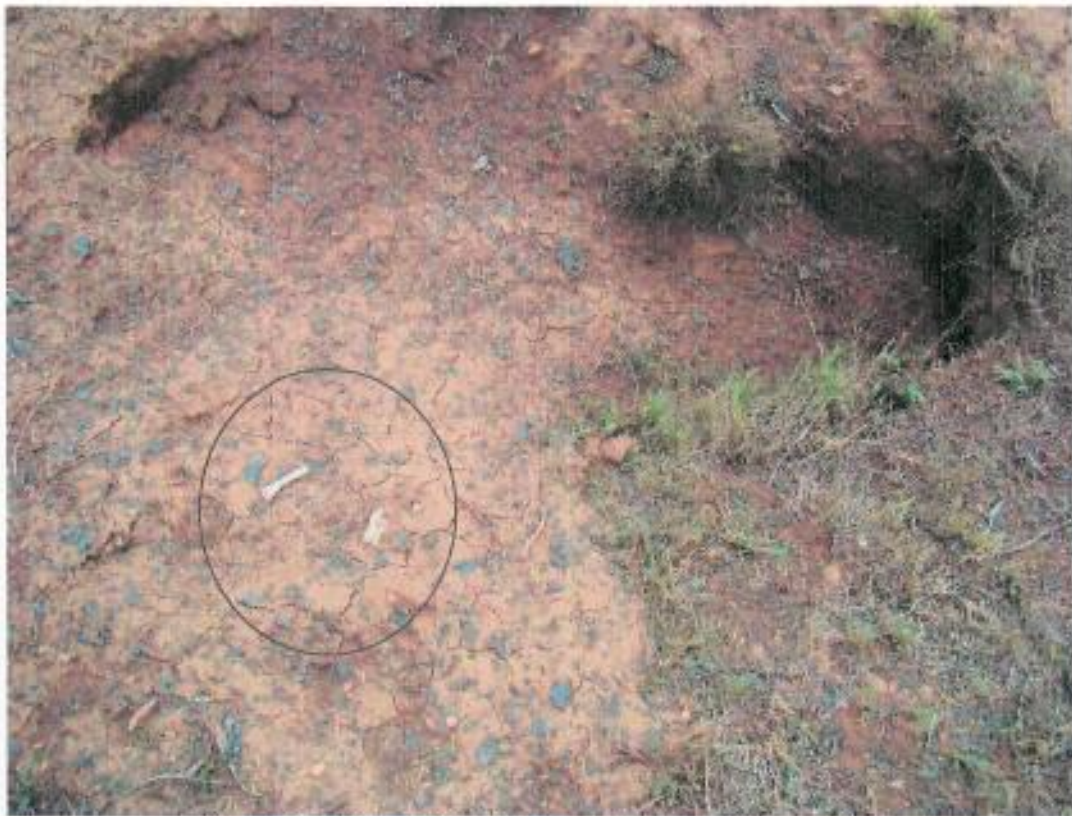
In one specific place in the informal section human bones were lying on the surface at an area where animal burrowing took place. Similar to the formal section these graves might also not be very deep.

Figure 201: Exposed human bones at grave in informal section

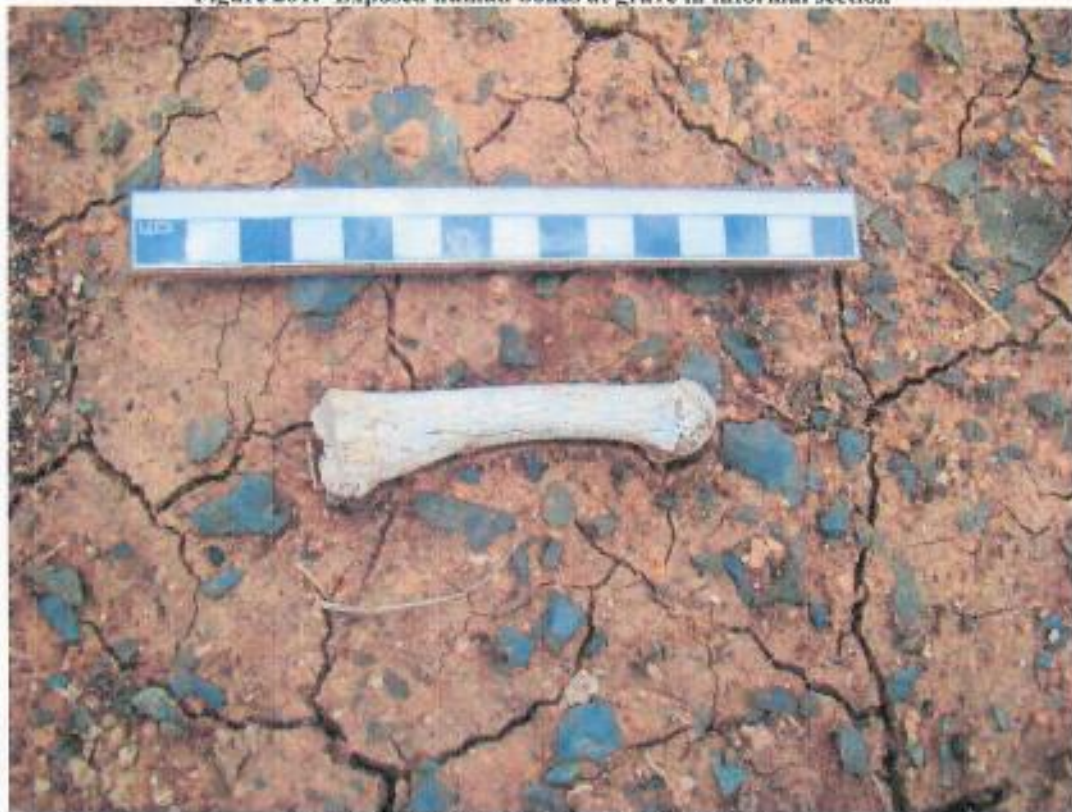
Figure 202: Close-up of exposed human bone

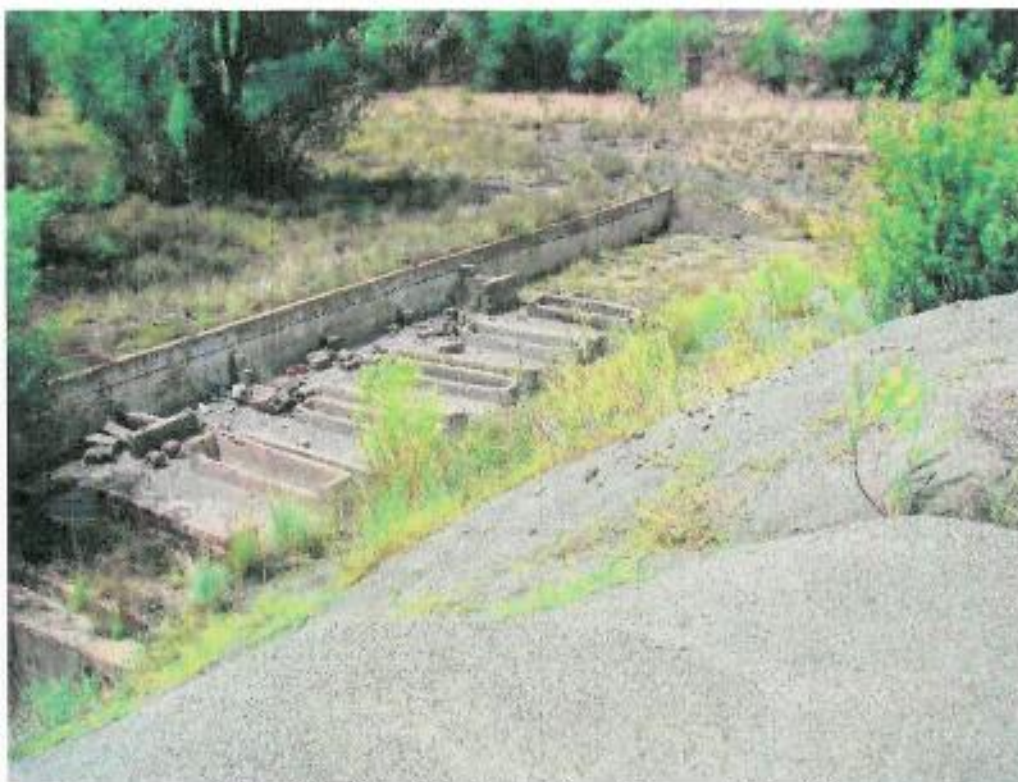
Figure 204: Remaining foundations of power station (1)

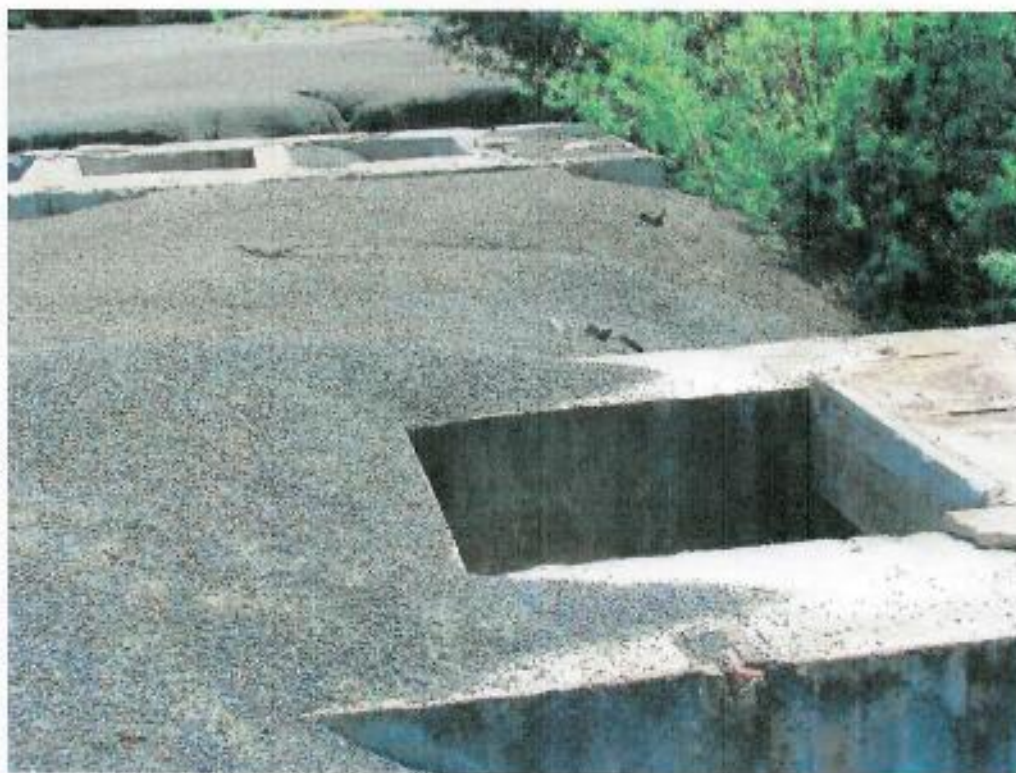
Figure 205: Remaining foundation of Power Station (2)

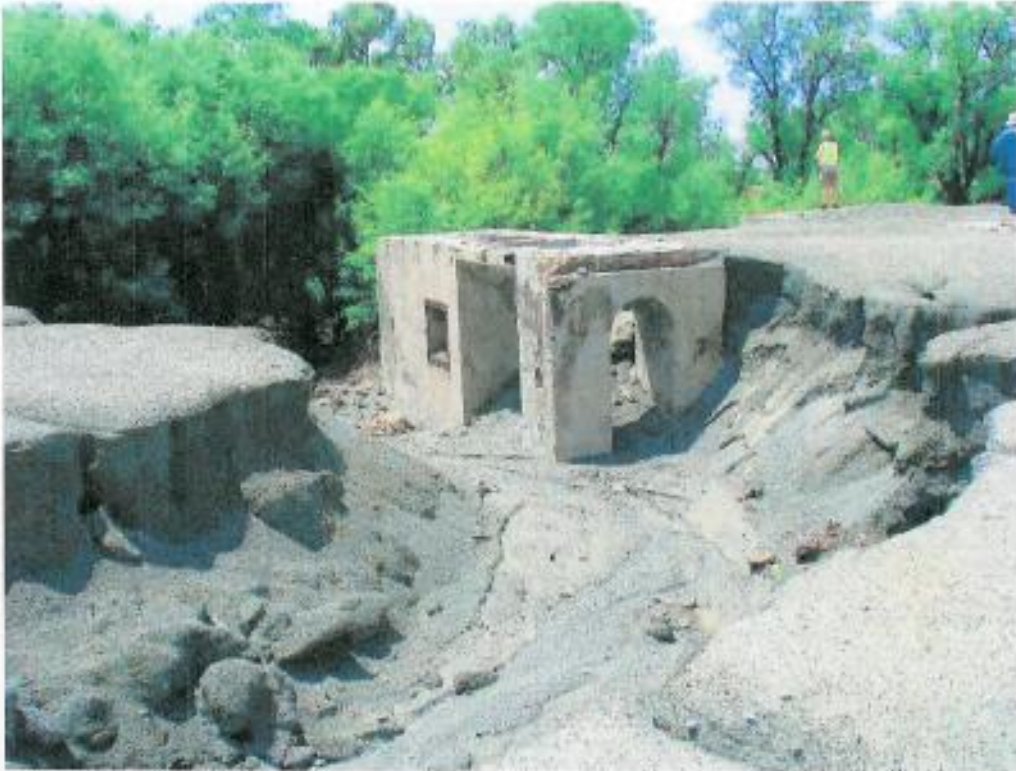
Figure 206: Remaining foundation of Power Station (3)

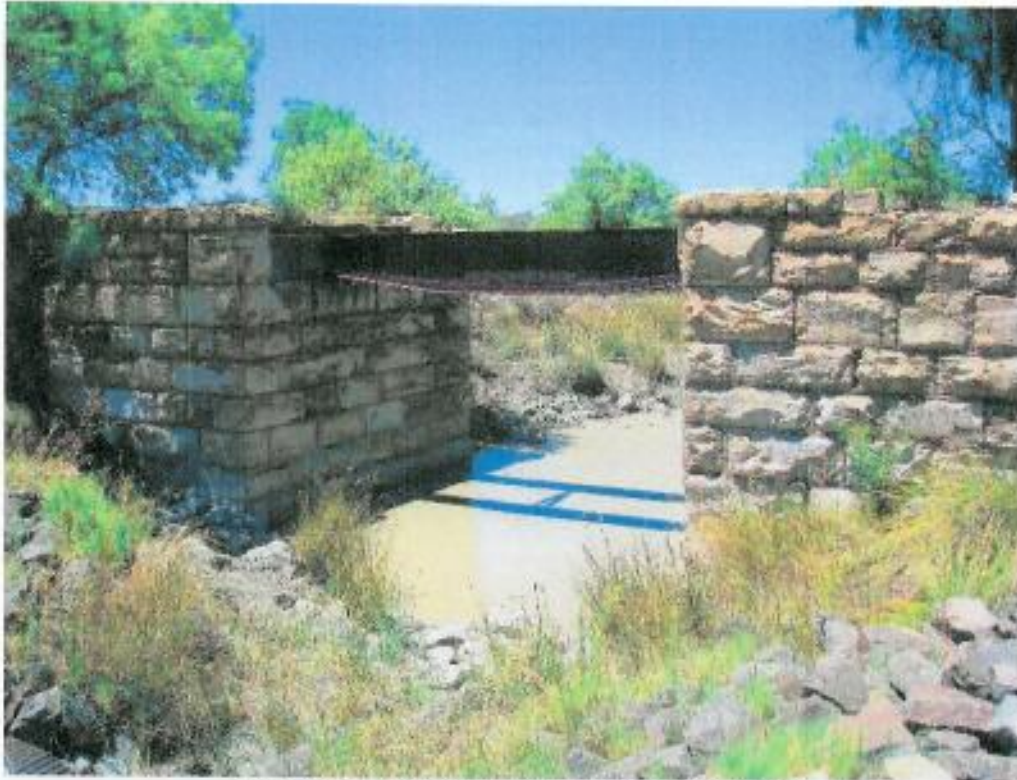
Figure 220: Remains of sideline railway bridge (1)

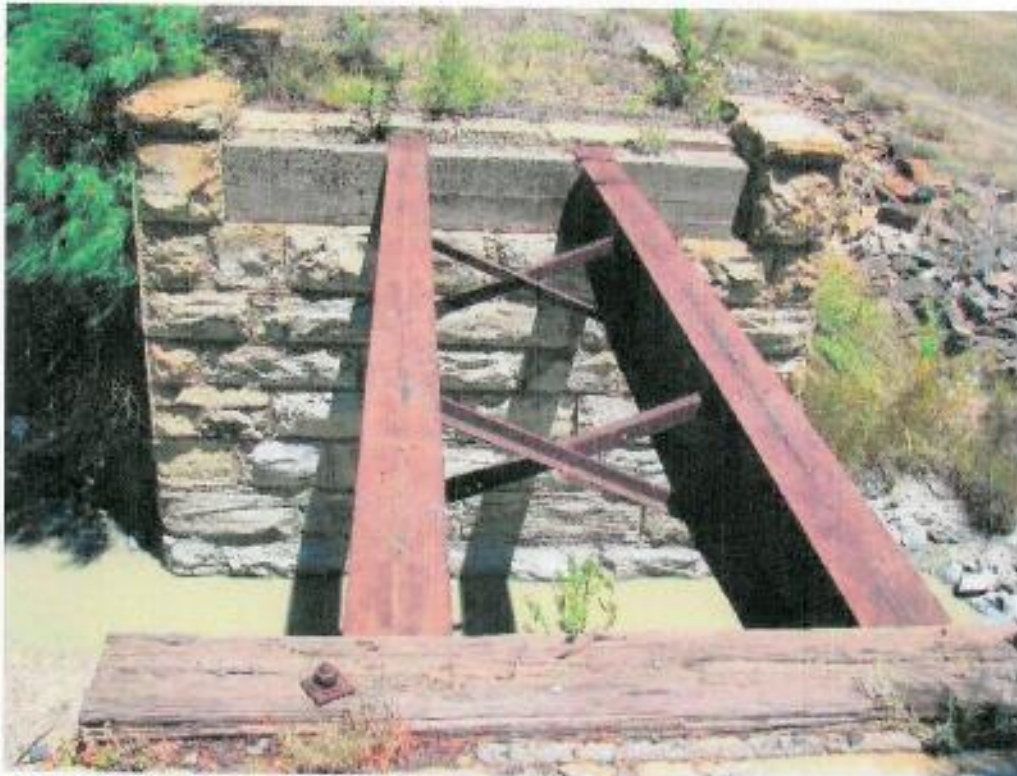
Figure 221: Remains of sideline Railway Bridge (tracks removed)

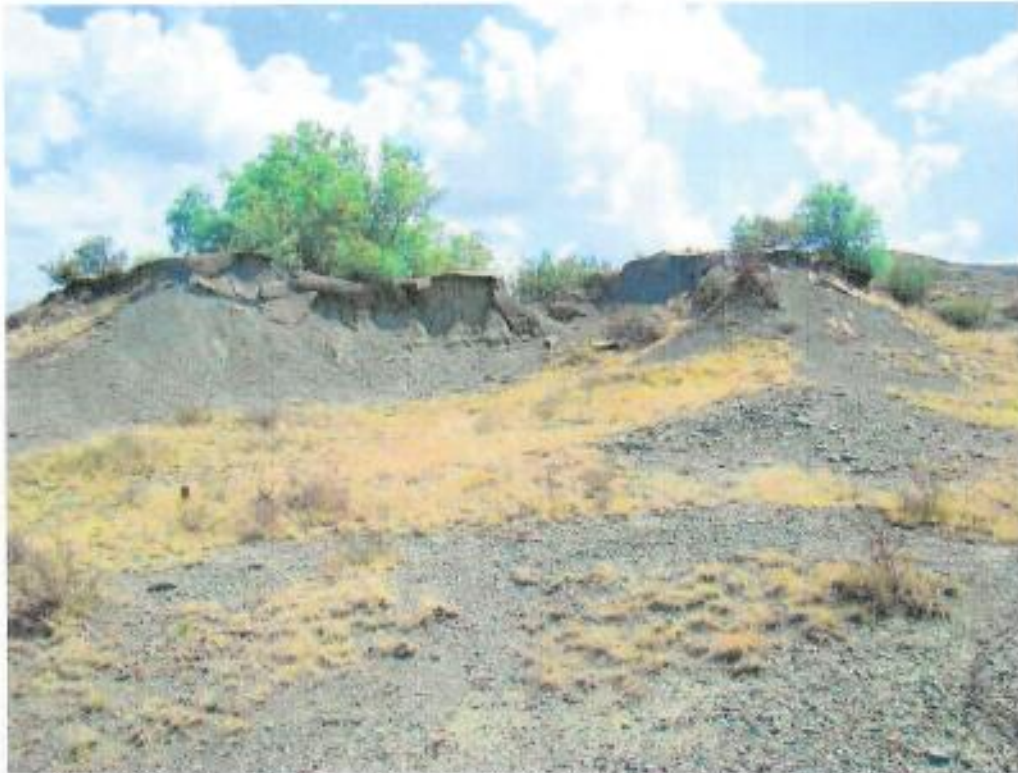
Further south from the train bridge is a large dam constructed by hollowing out a section in what seems to be machine dump waste, lined with a layer of mesh wire and a thin cement layer on top to form a deep receptacle shaped like a cone. No records were found to explain this structure.

Figure 223: side view of the hollowed out structure (partially dismantled or collapsed)

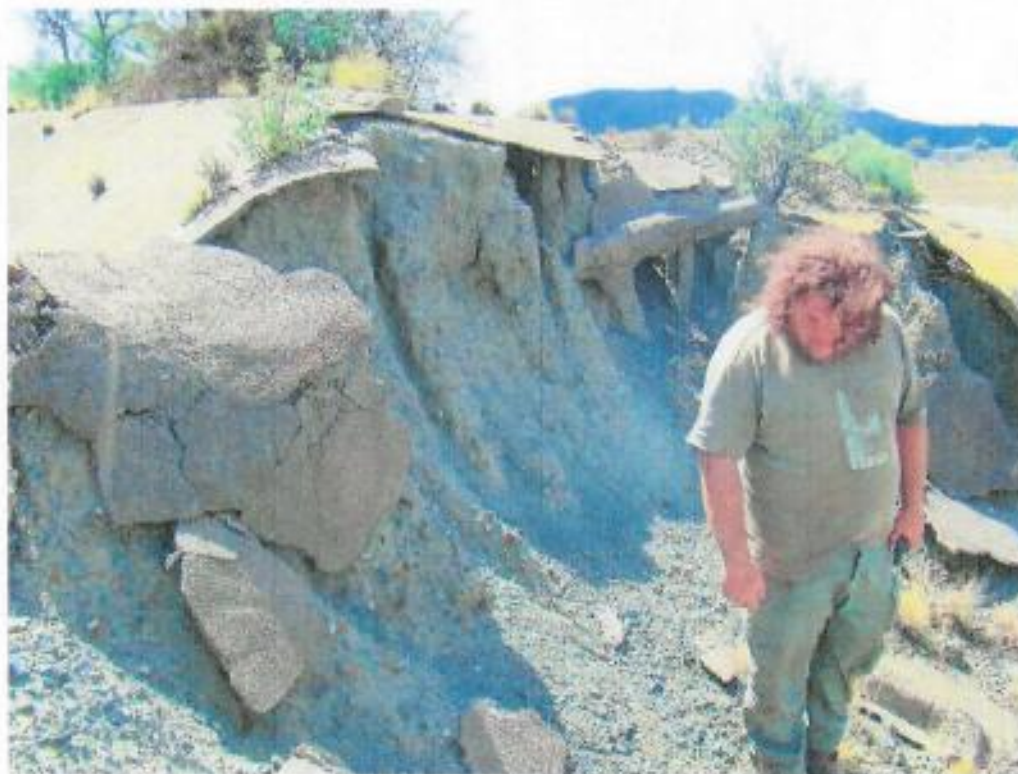
Figure 224: viewed from top of broken lip

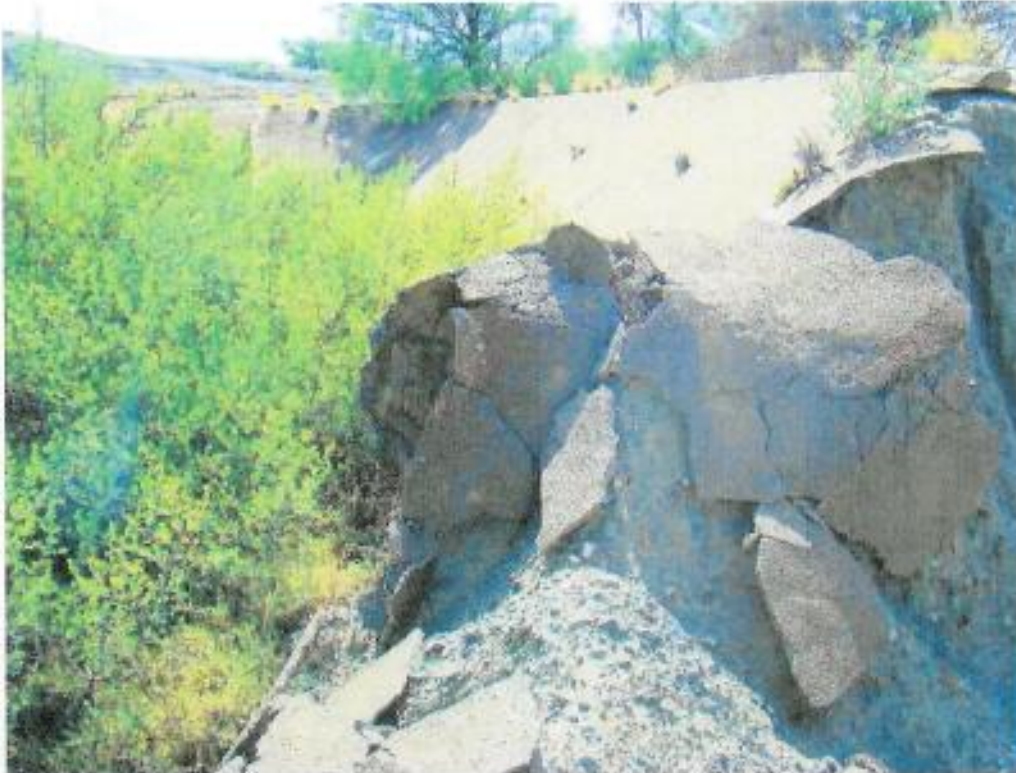
Figure 225: Inside of "dam" (now overgrown with vegetation)

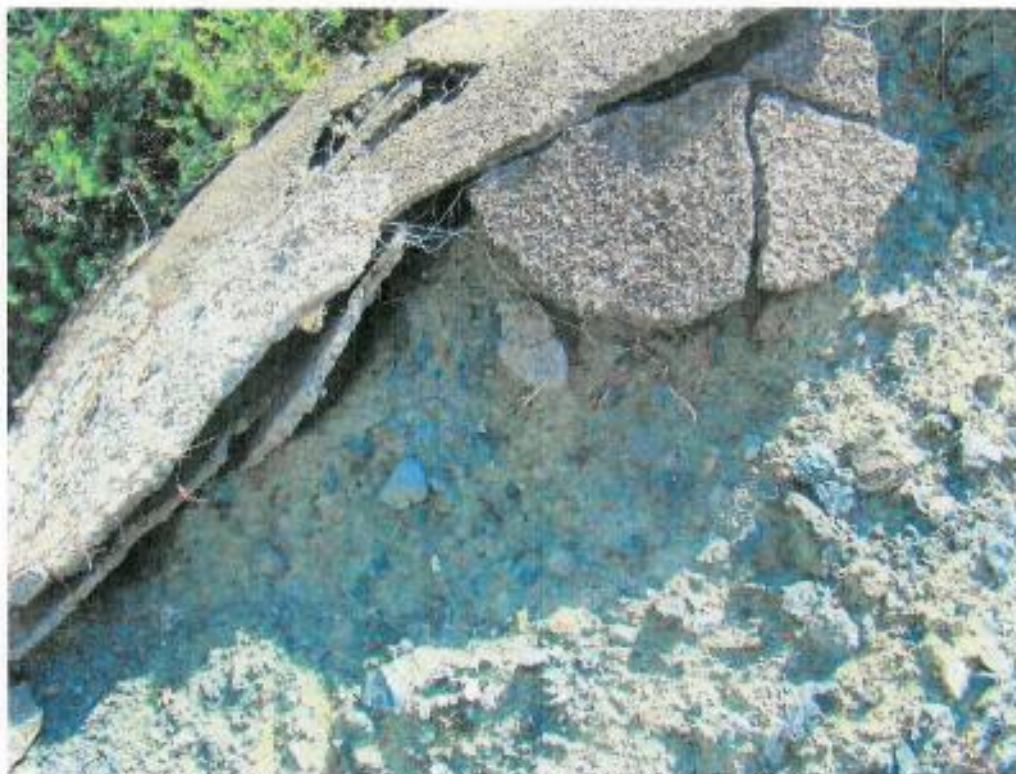
Figure 226: Close-up view shows the mesh with thin layer of cement on top

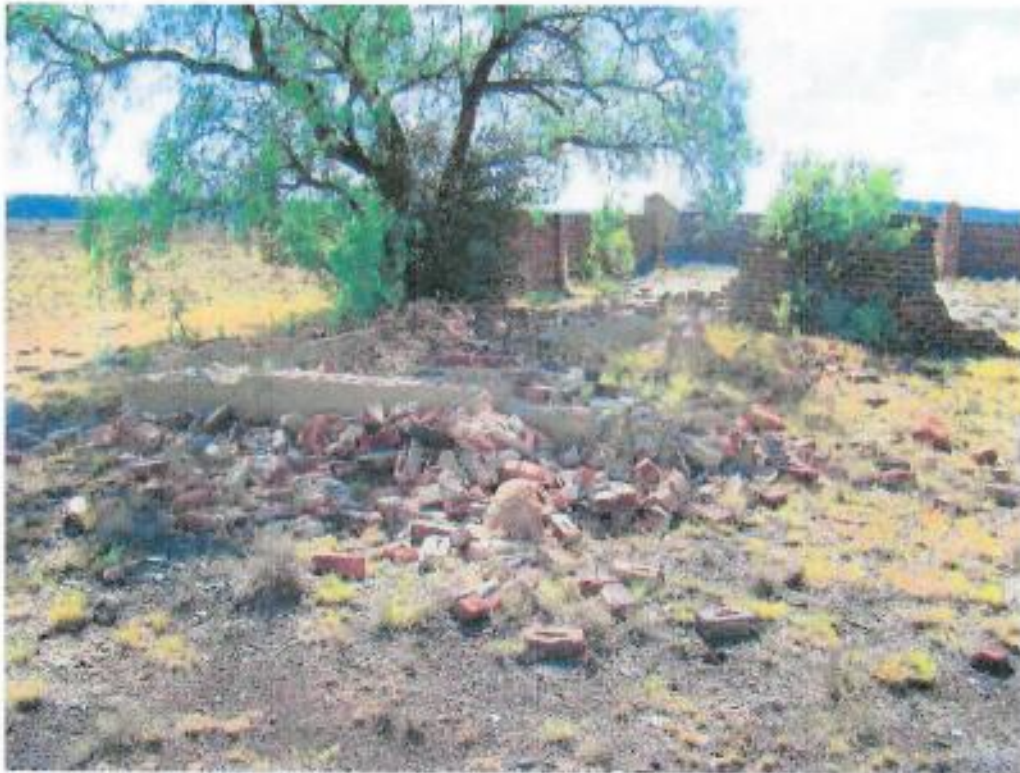
Figure 229: Demolished section (orientation south-west)

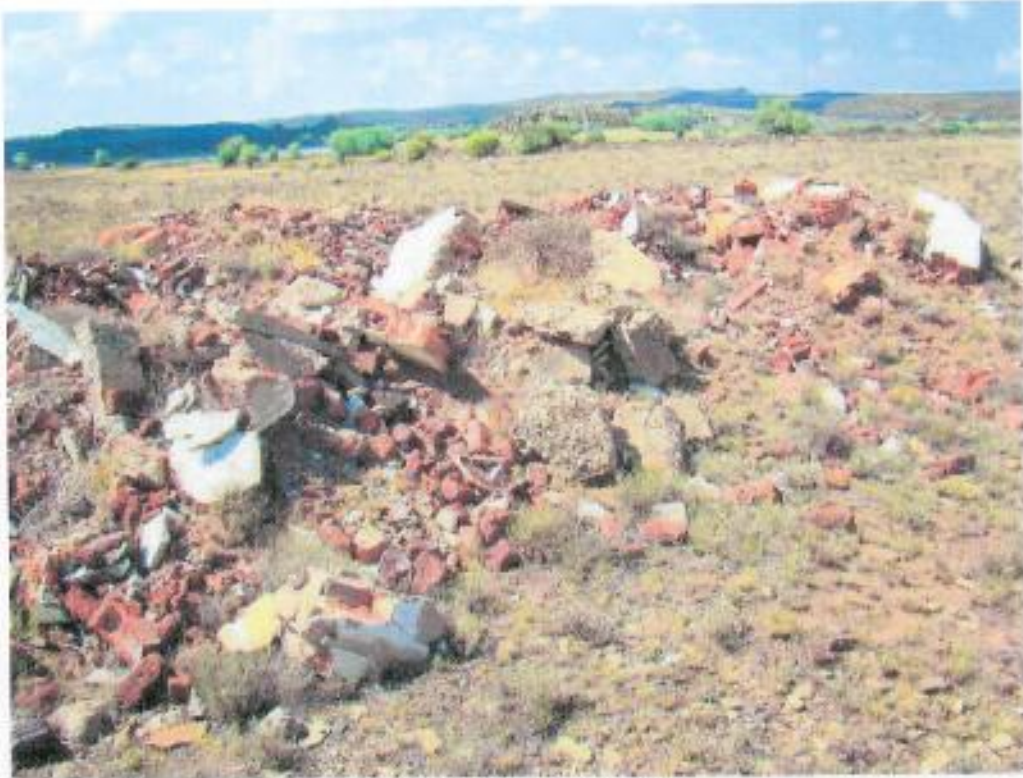
Figure 230: Building rubble
