5.3.2.6 Cavalry Section

“Cavalry” Structure

Jagersfontein Heritage Impact Assessment
"Farmstead" buildings
31/03/2009

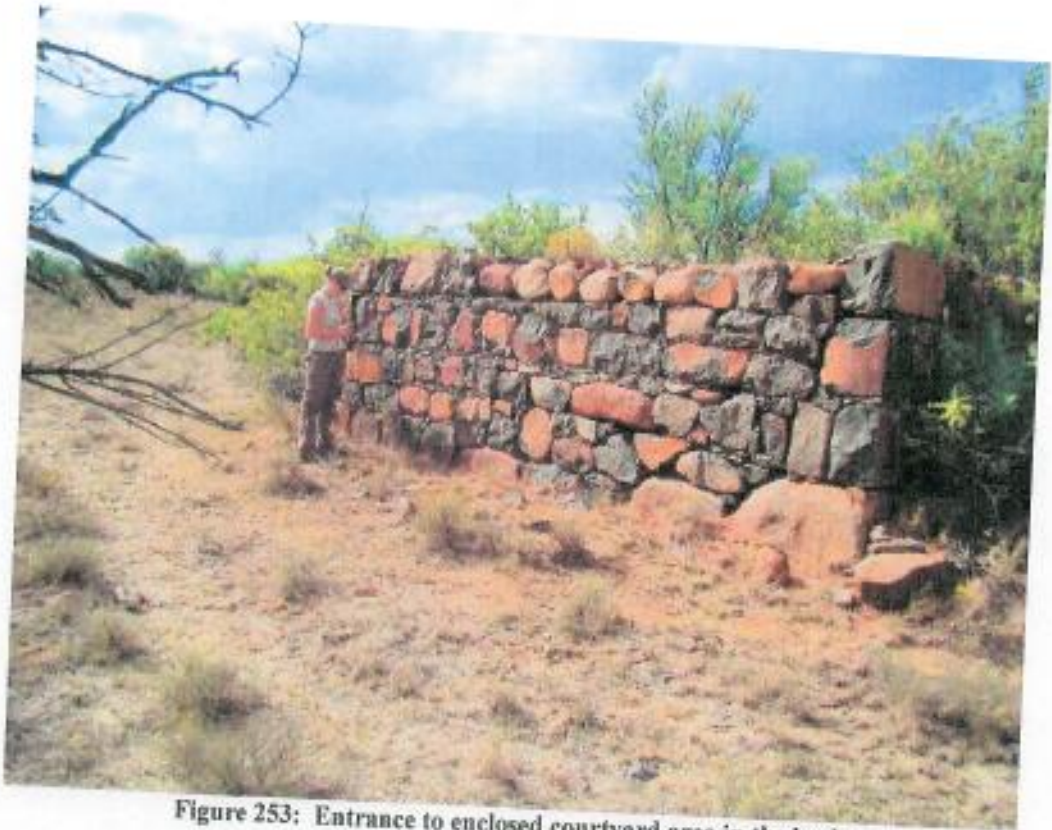
Figure 253: Entrance to enclosed courtyard area in the back

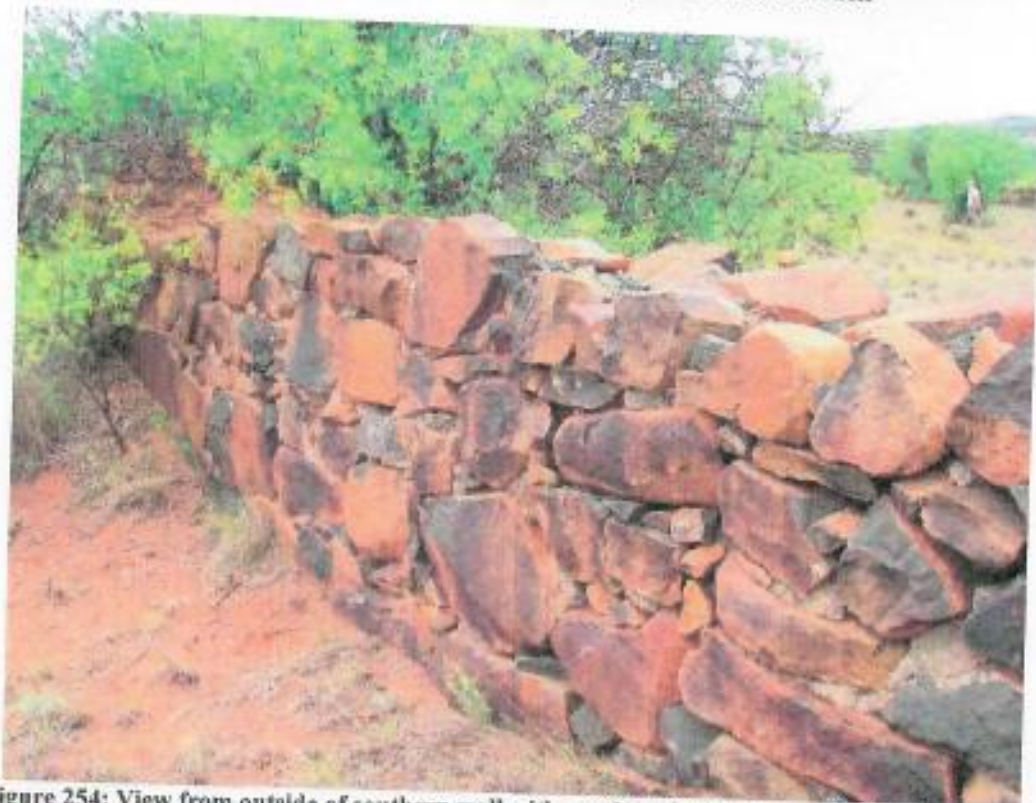
Figure 254: View from outside of southern wall with northern boundary wall in the background

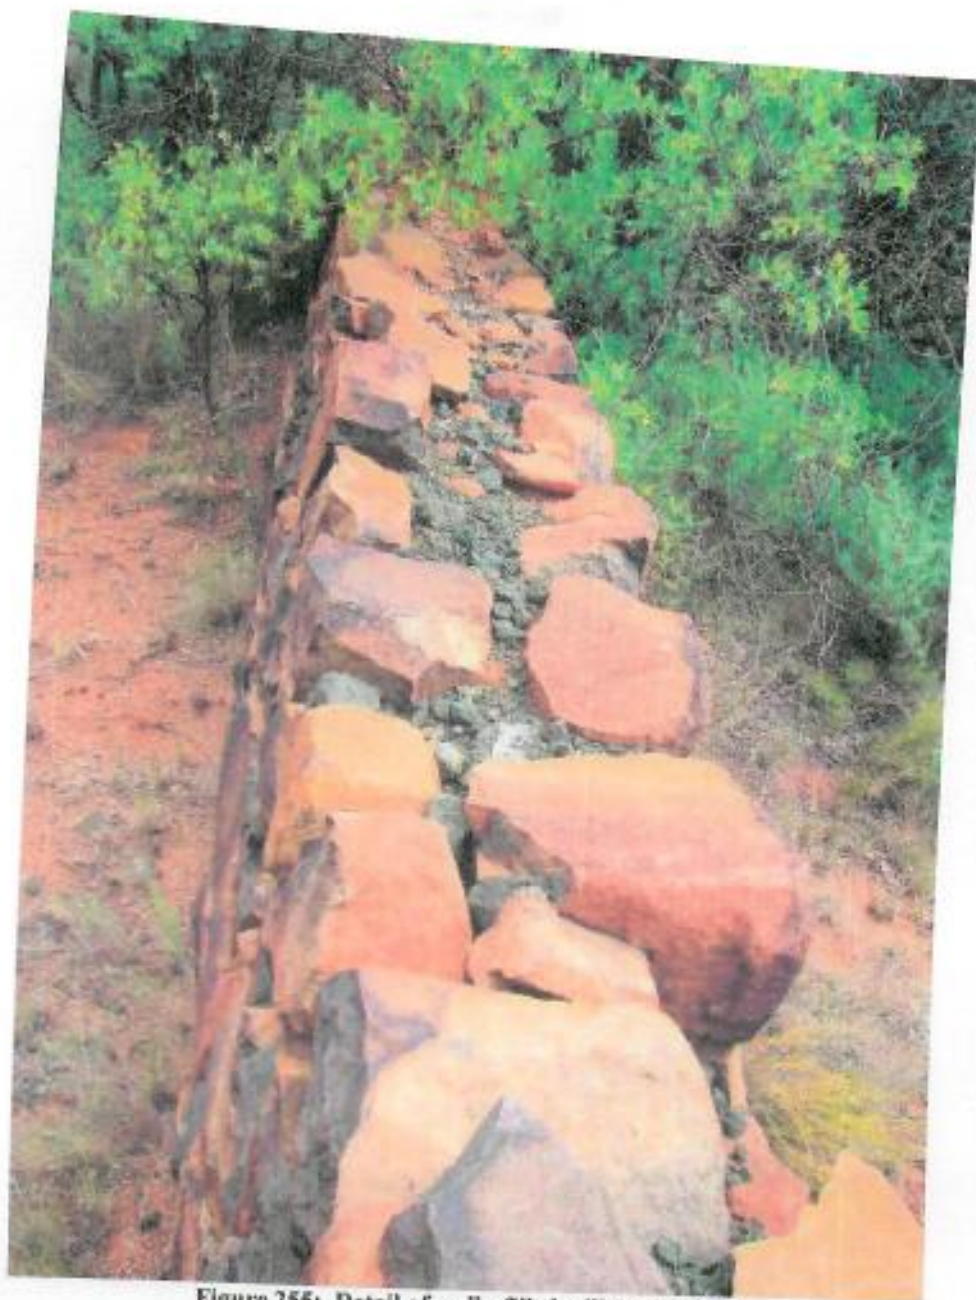
Figure 255: Detail of wall - filled will blue gravel

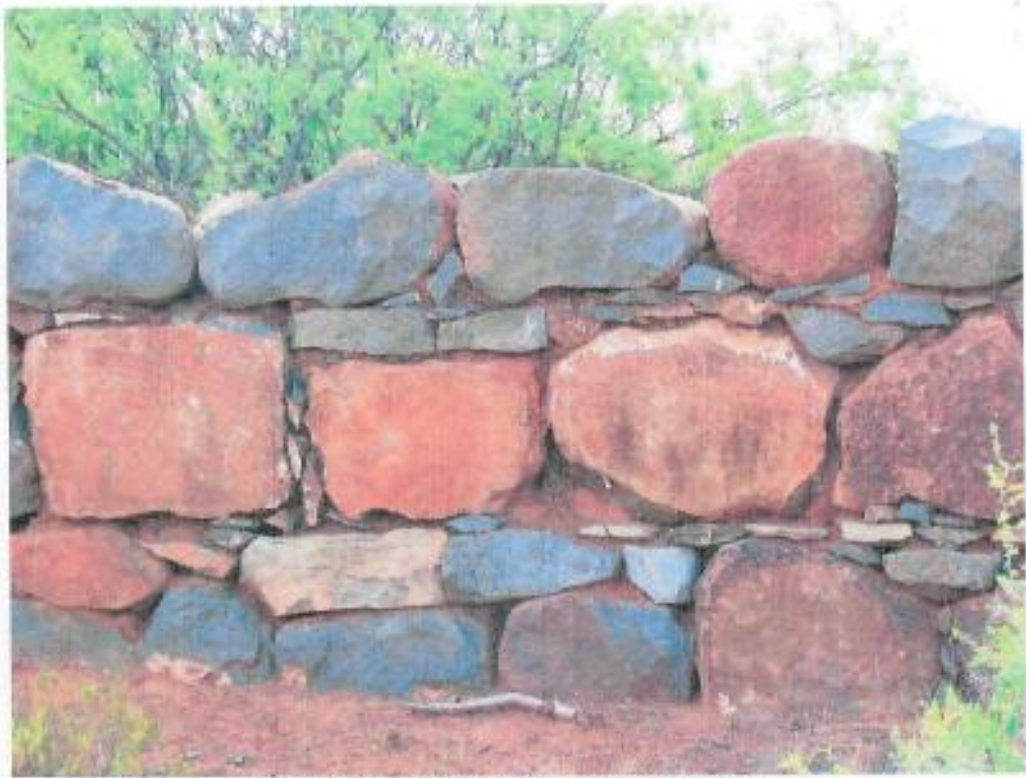
Figure 256: Detail of constructed stone wall (1)

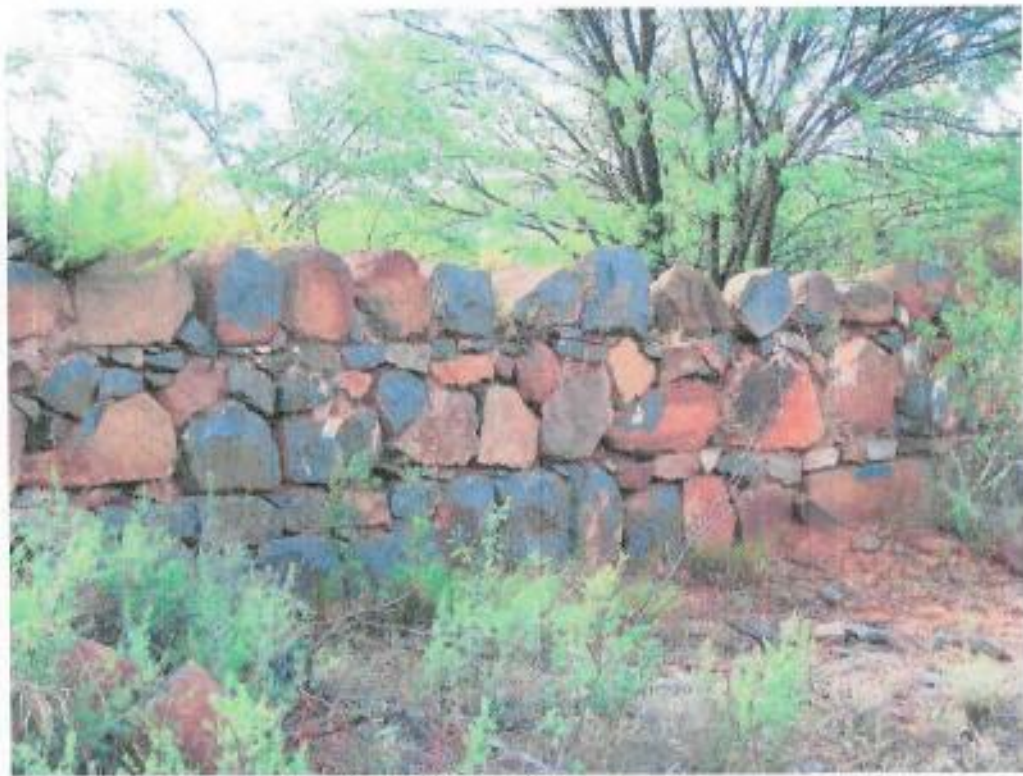
Figure 257: Detail of construction

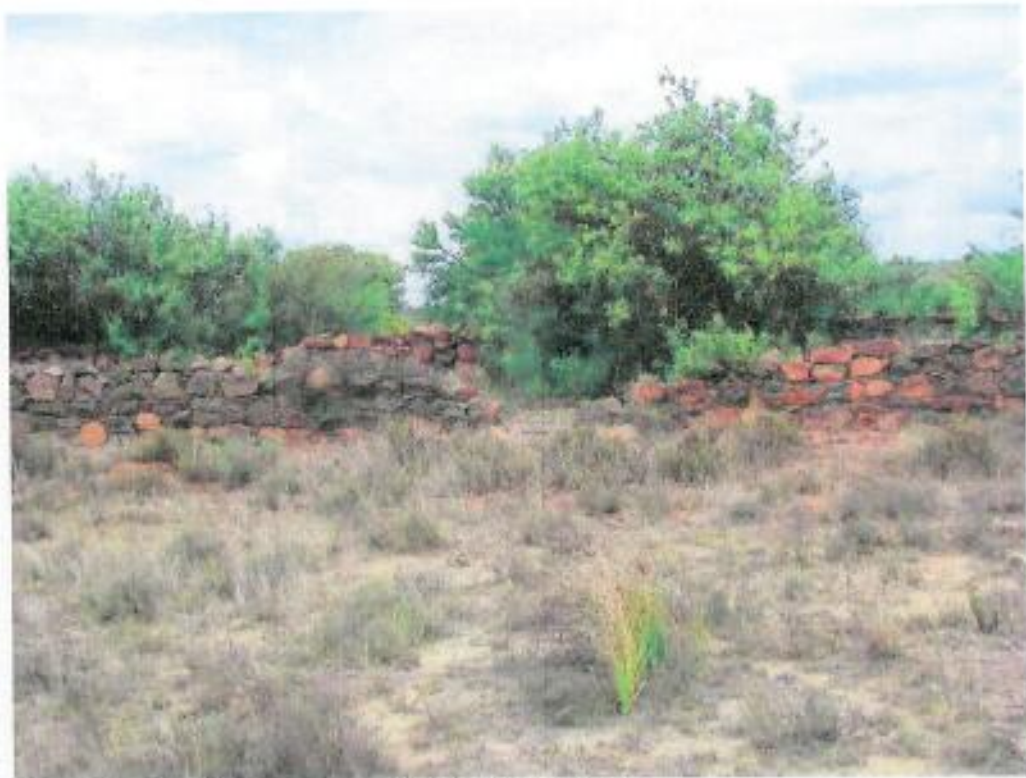
Figure 260: As Above

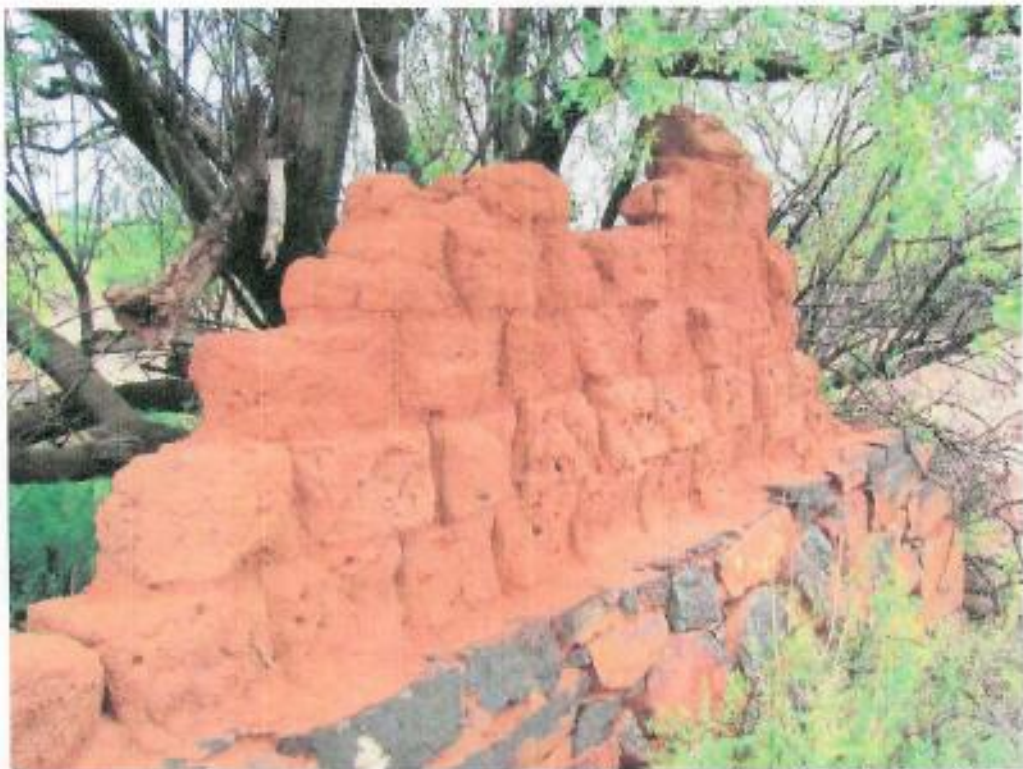
Figure 263: Remains of sun-dried mudstone bricks on top of stone foundation wall

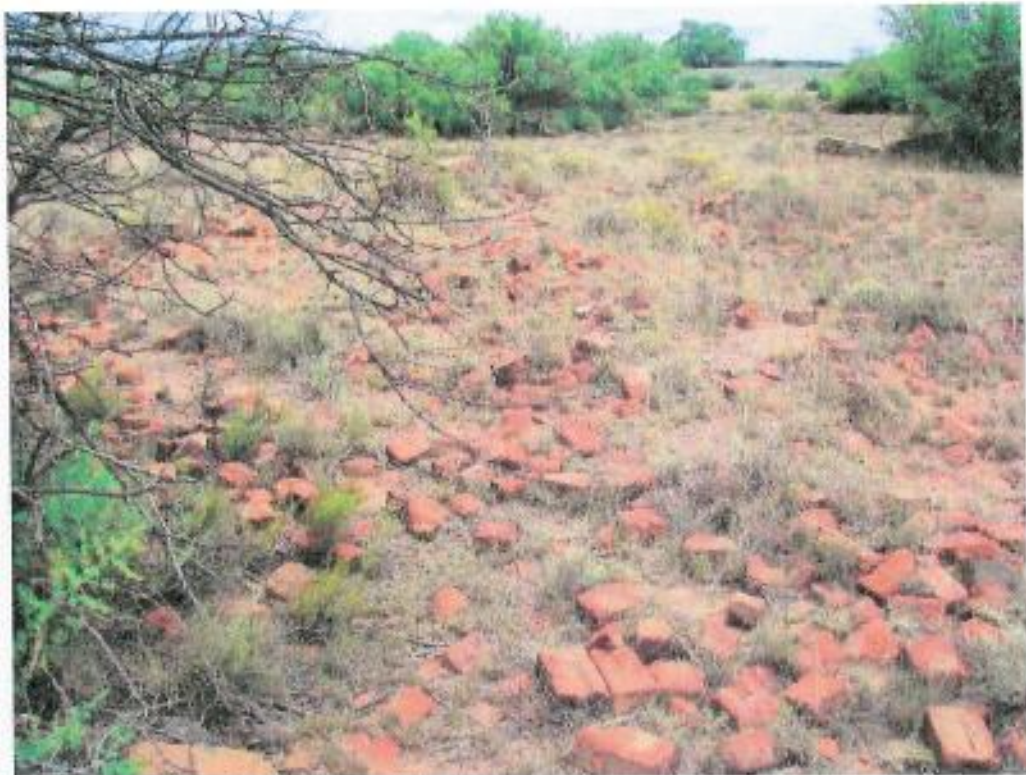
On the outside of the western wall are a long thin cement foundation and a scatter of more modern bricks.

Figure 264: Scatter of "modern" bricks on outside of western wall

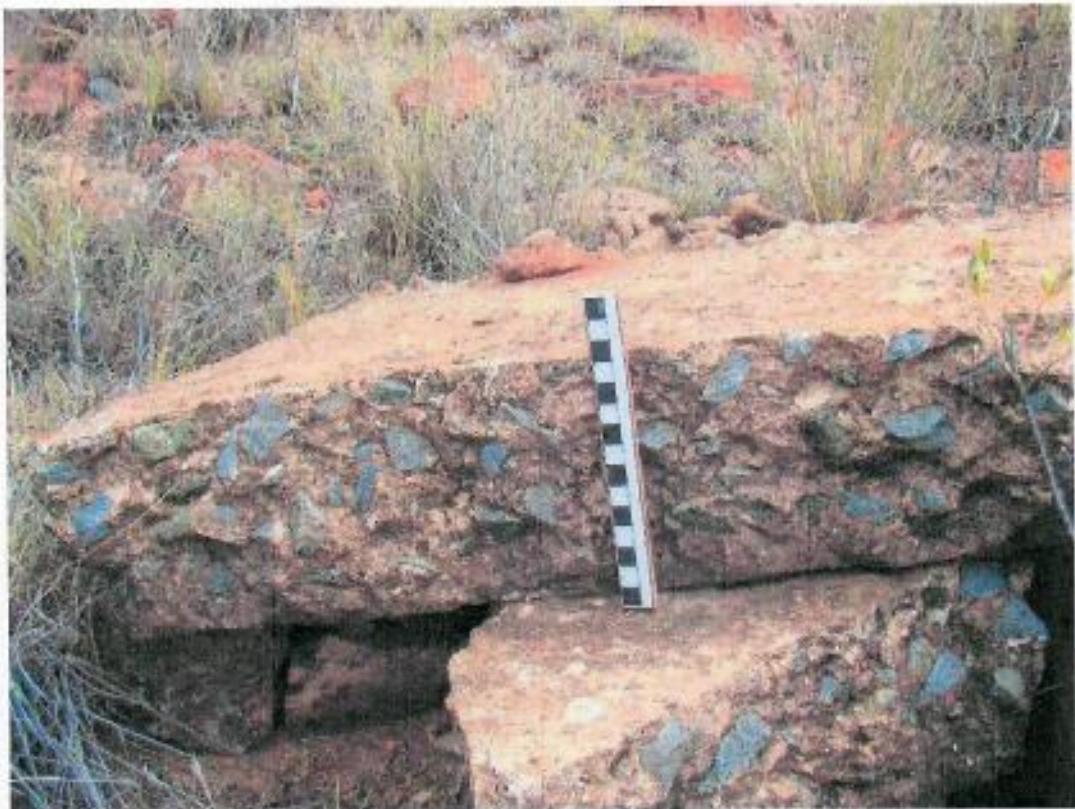
Figure 265: Portion of cement slab on outside of western wall

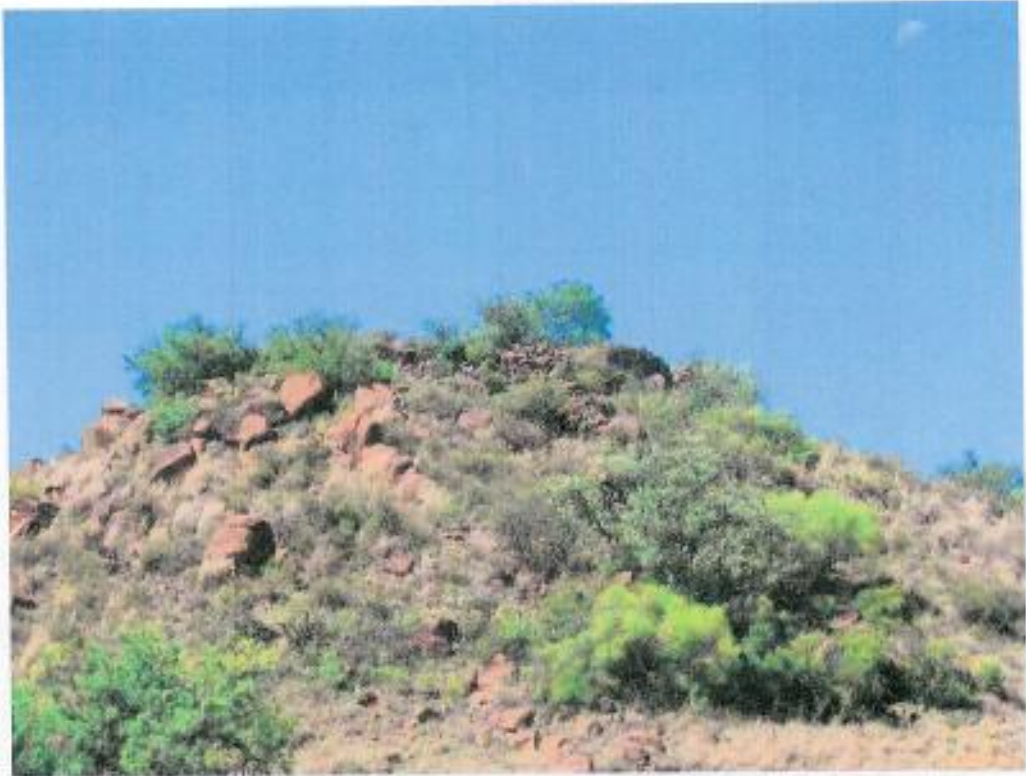
Figure 268: Southern side of hill (orientation north). Note stone terraces near top.

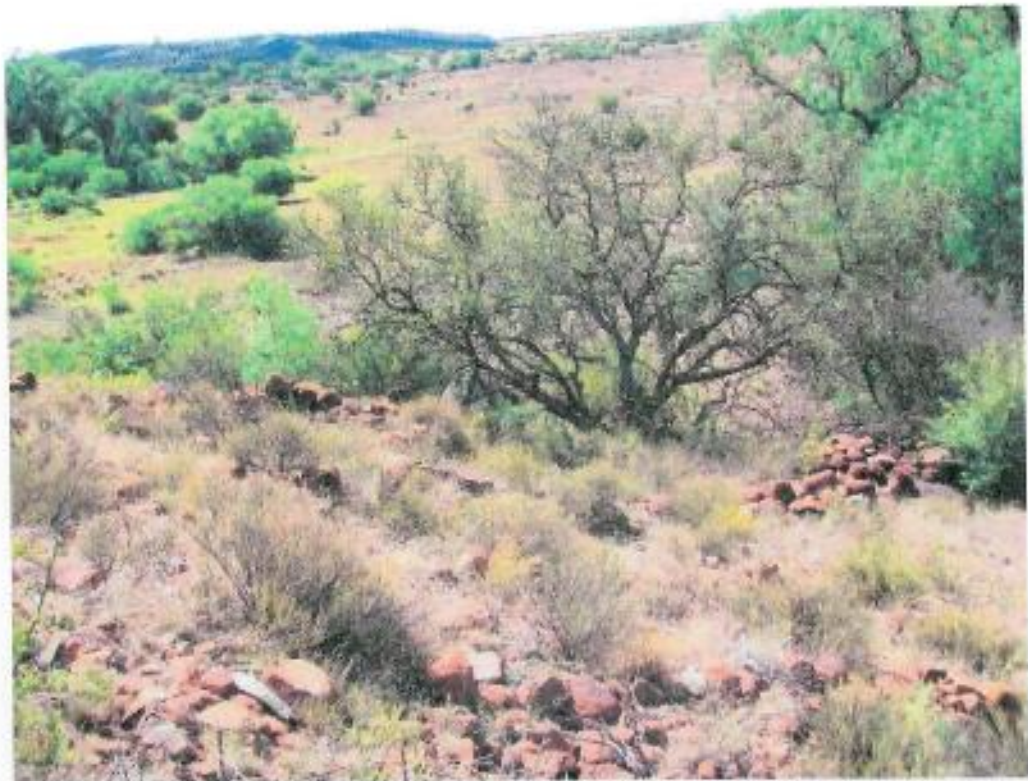
Figure 270: Terraced northern side of hill

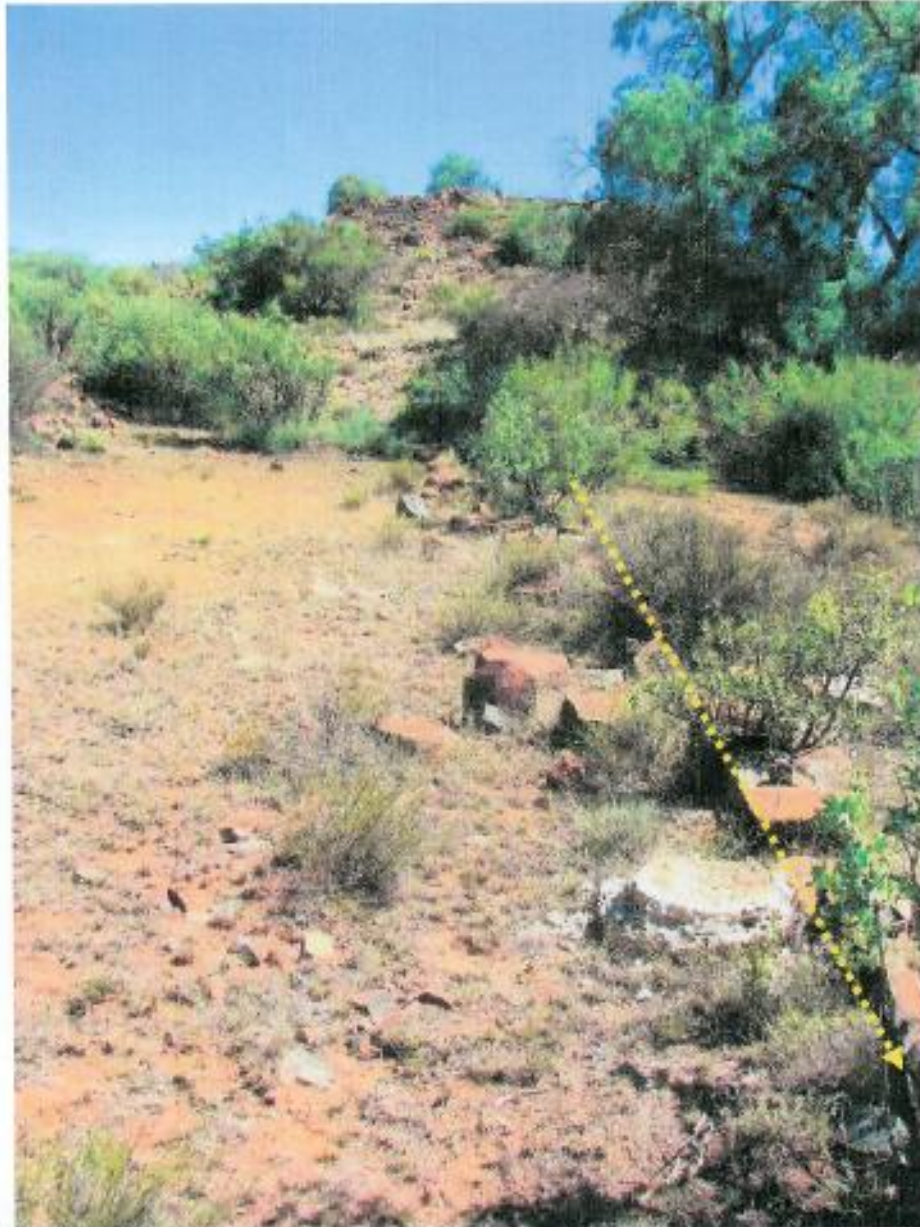
Figure 272: View from side of rectangular building towards hill. Line indicates eastern boundary of the stone foundation of the long rectangular structure

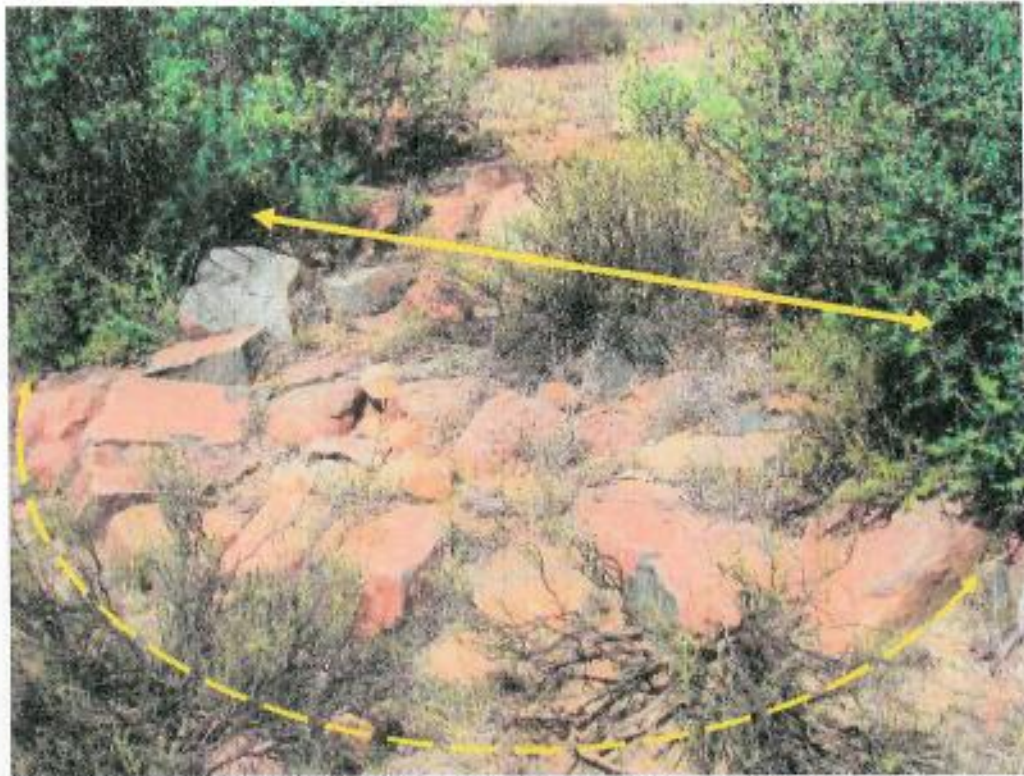
Figure 273: Semi-circular stone steps indicate that the long rectangular building faced west. Solid line indicates threshold whereas broken line indicates edge of curved step

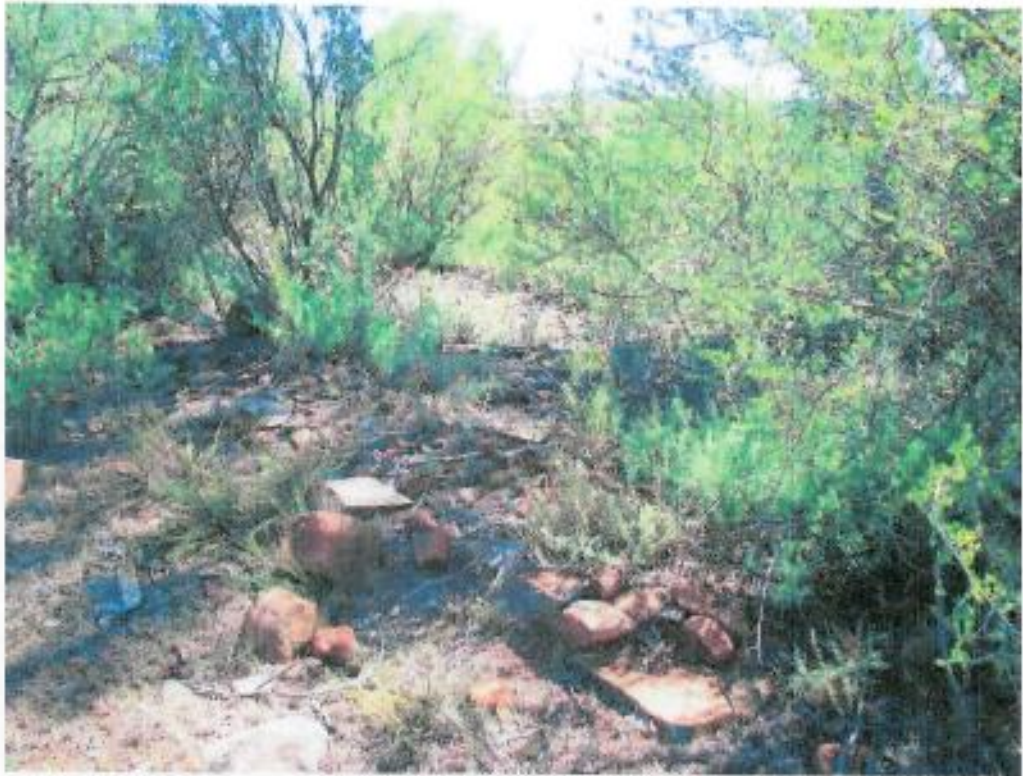
Figure 275: North-eastern cornerstone of rectangular stone-foundation building

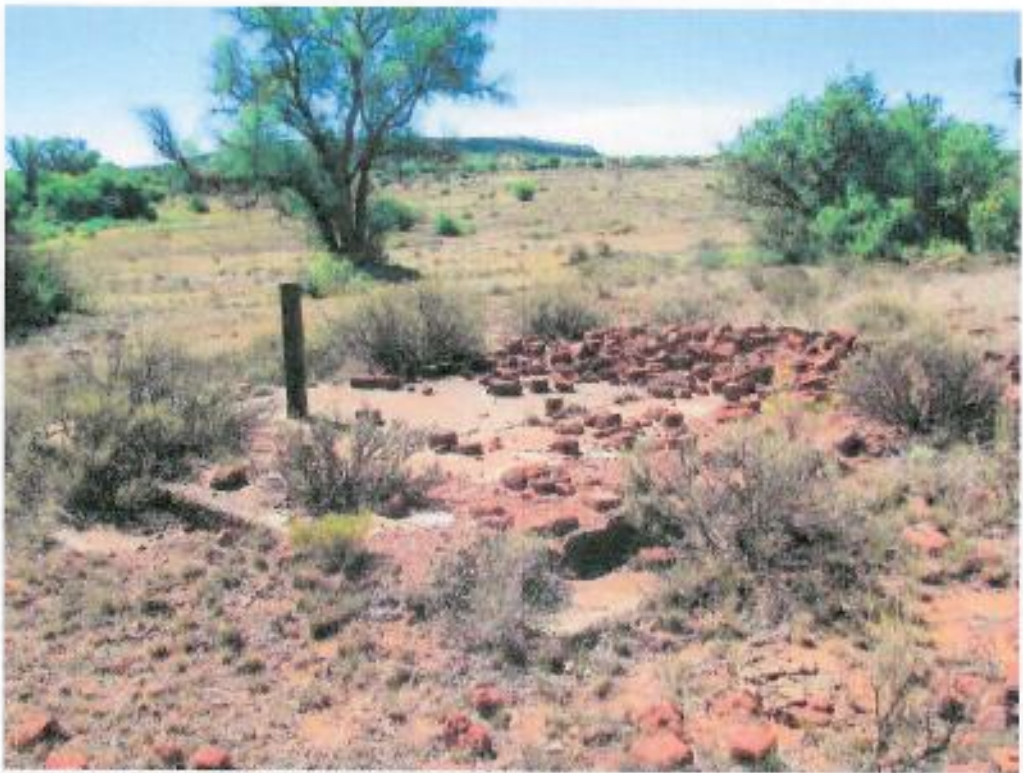
Figure 276: Cement foundation with pipe - immediately north of rectangular stone-foundation building

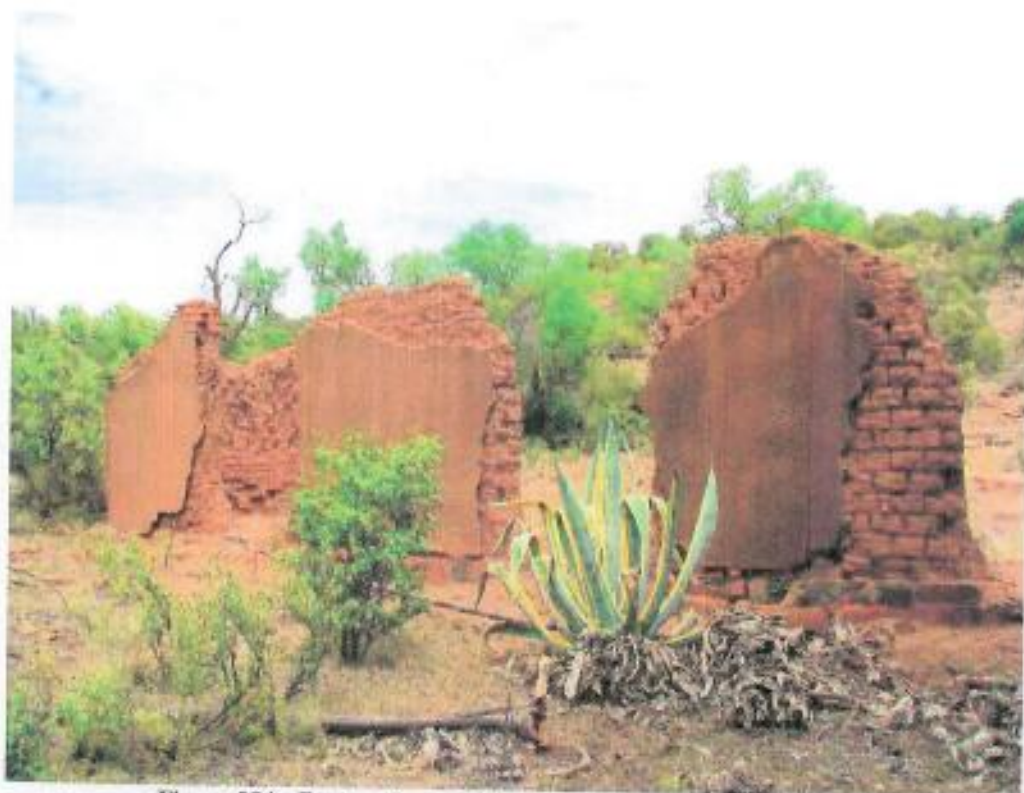
Figure 284: Eastern face of the remains (orientation south-west)

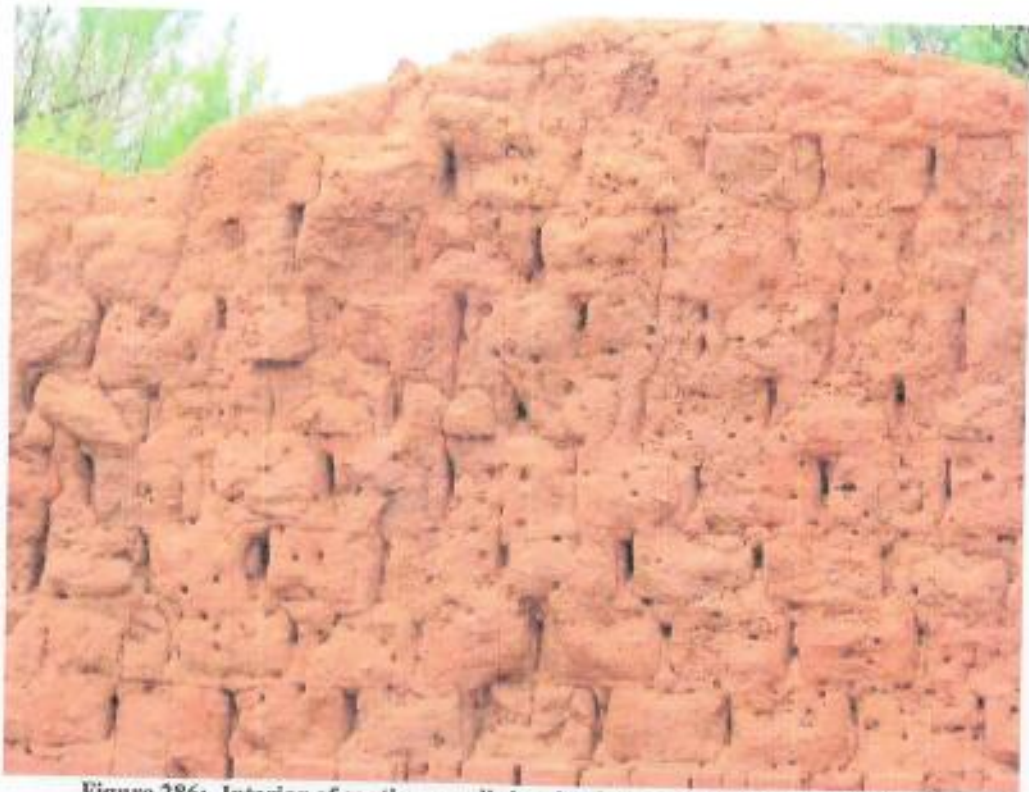
Figure 286: Interior of southern wall showing holes where plaster was affixed

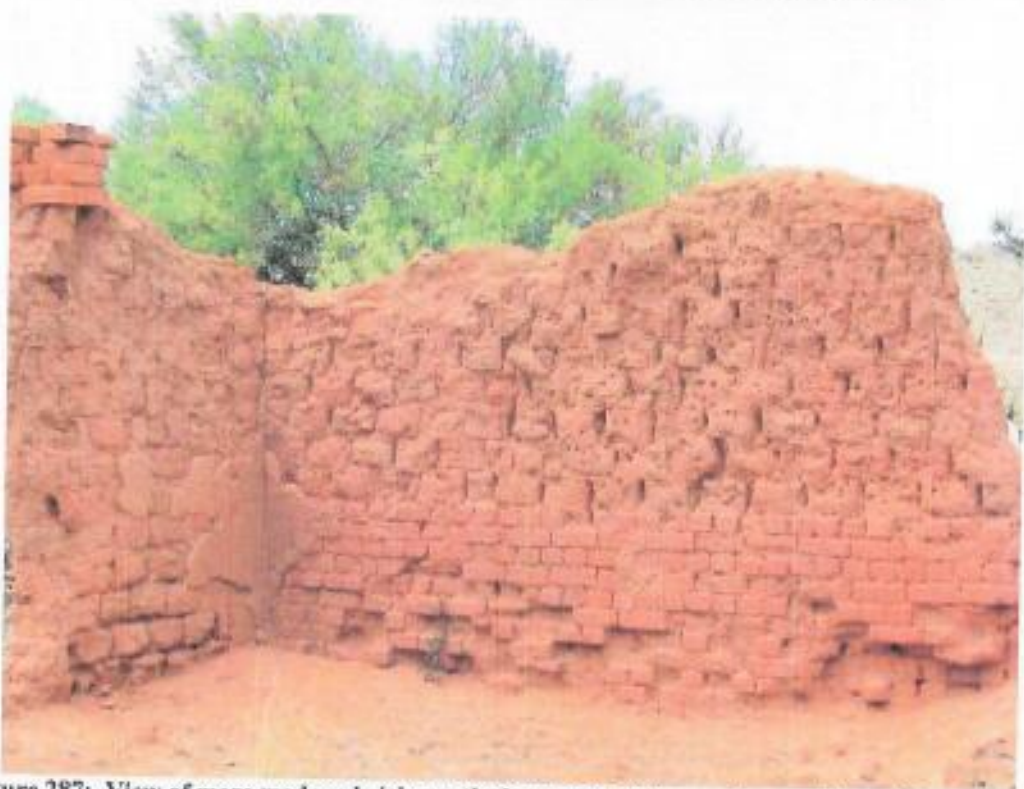
Figure 287: View of more modern bricks on the lower end of the southern wall as well as on top of the wall section on the eastern side

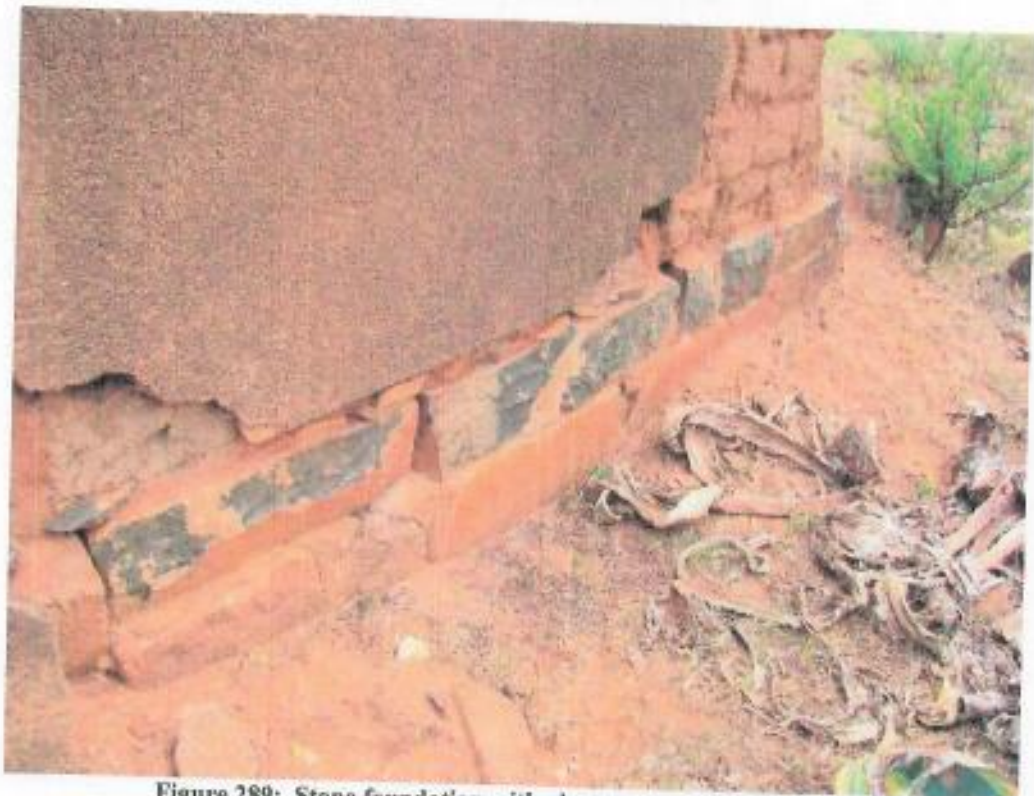
Figure 289: Stone foundation with plaster over mudstone bricks

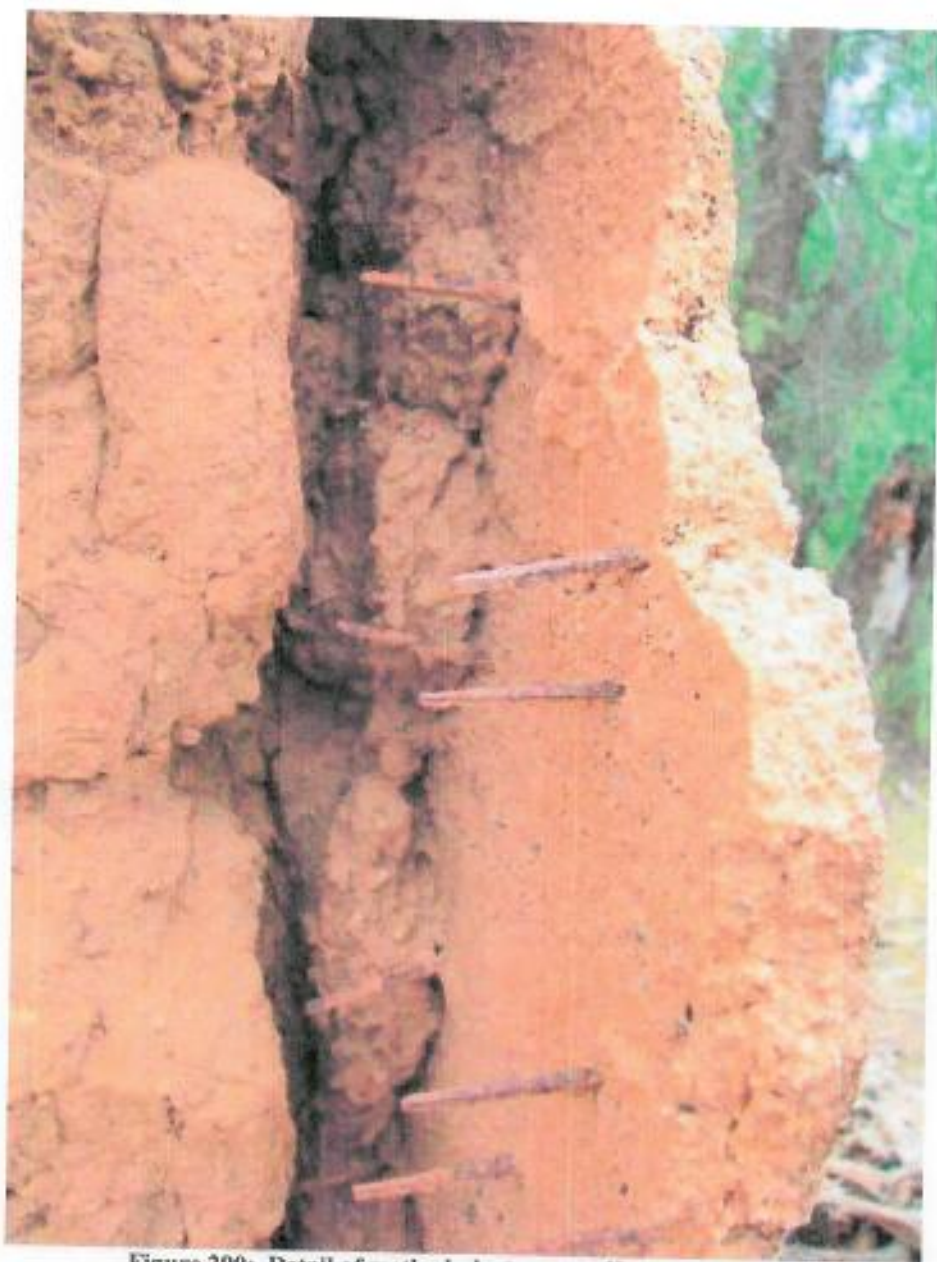
Figure 290: Detail of method plaster was affixed to the walls

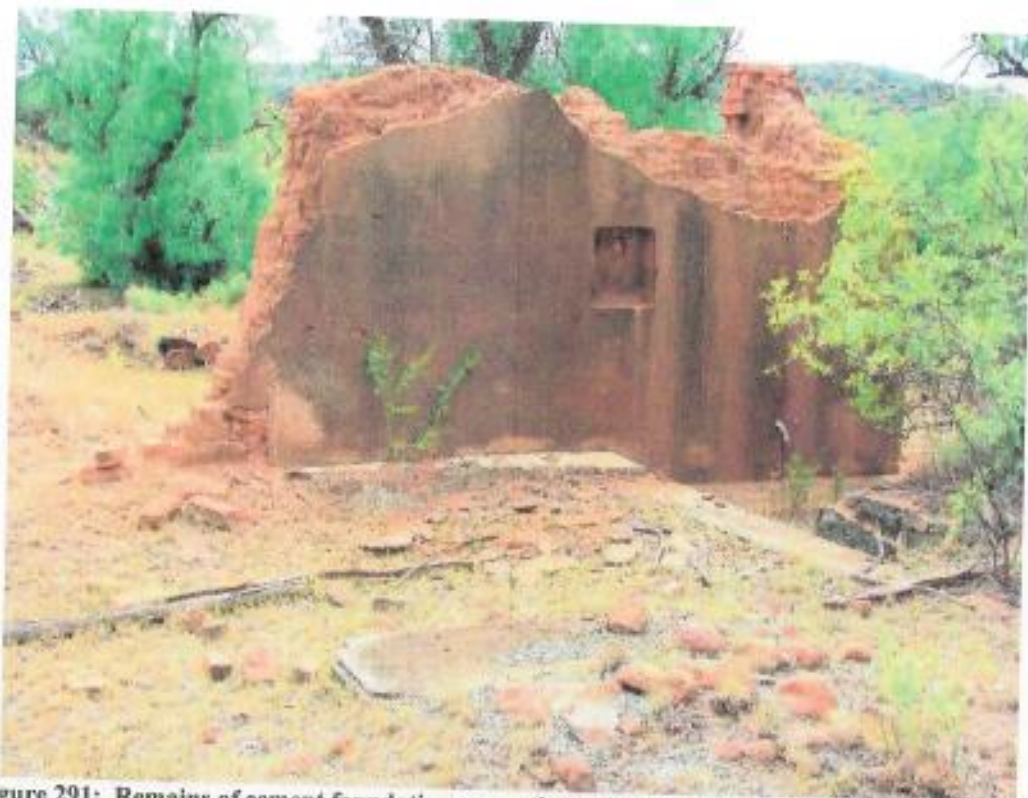
Figure 291: Remains of cement foundation on southern side of structure (orientation north-east)

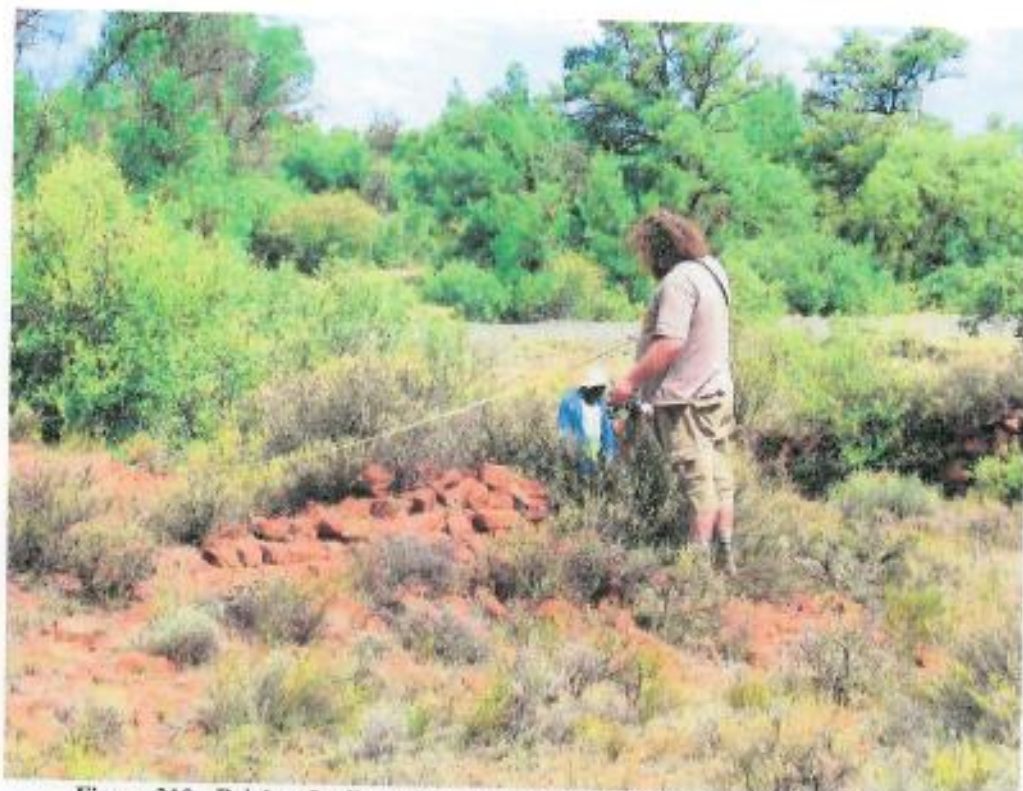
Figure 310: Bricks of collapsed "southern wing" of the house (orientation east)

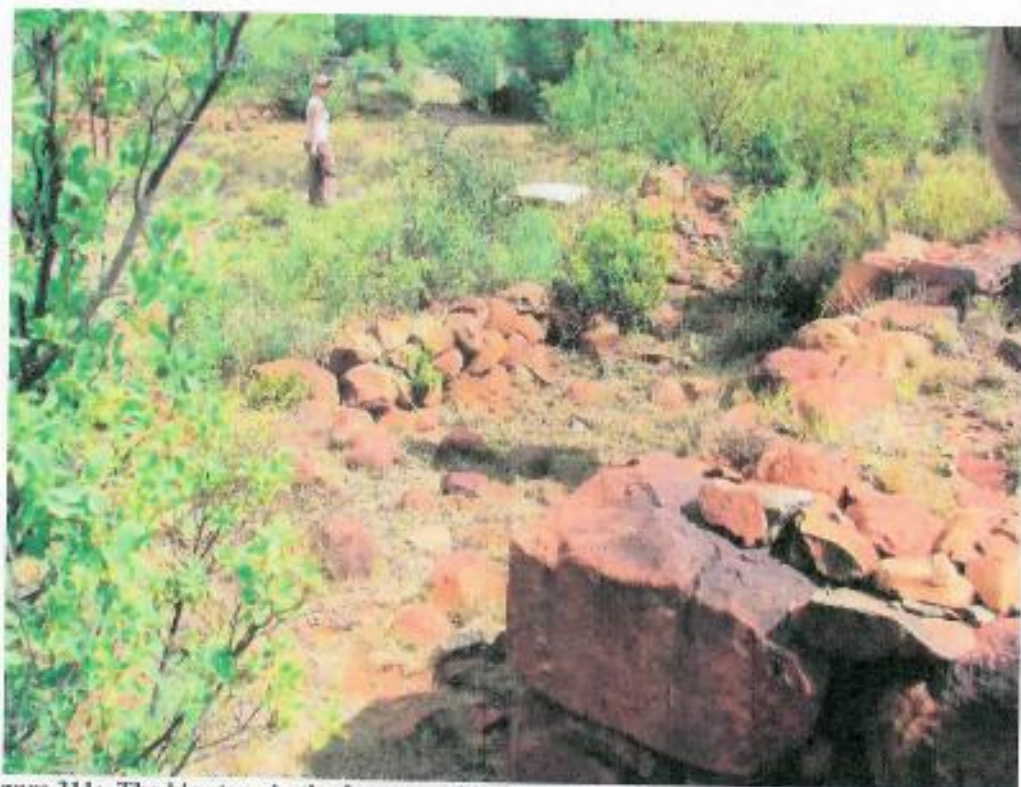
Figure 311: The big stone in the foreground is the north-eastern corner of the house – the row of stones in front of that is the eastern section of what appears to be a verandah – from the remains this verandah ran along at least the northern and eastern side

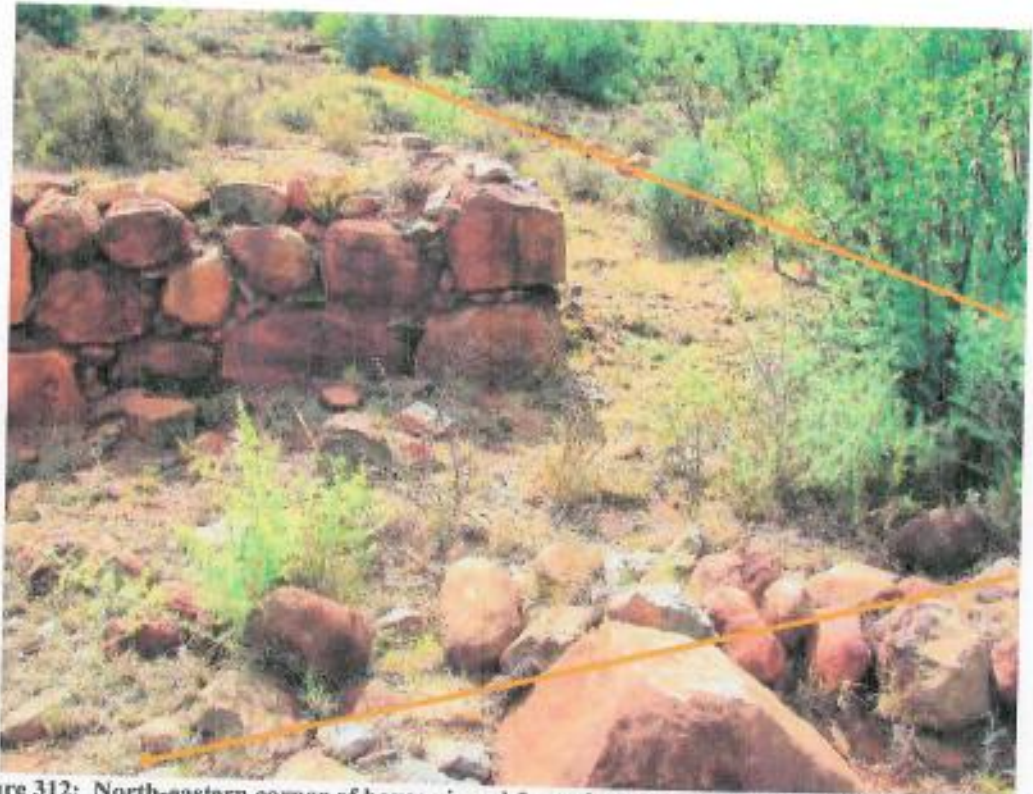
Figure 312: North-eastern corner of house viewed from the eastern side – arrows indicate boundary of verandah

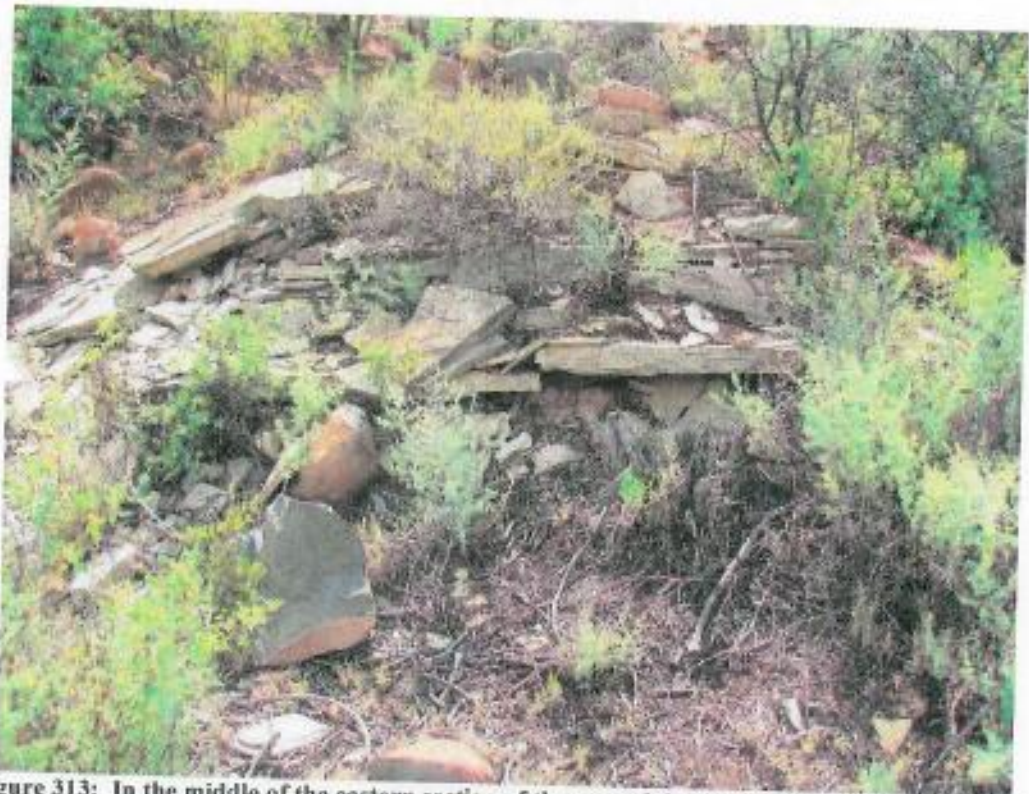
Figure 313: In the middle of the eastern section of the verandah is an opening with a pile of slate stone that appears to have been steps leading up to the verandah
