5.3.2.6 Cavalry Section

“Cavalry” Structure

Jagersfontein Heritage Impact Assessment
"Farmstead" buildings
31/03/2009

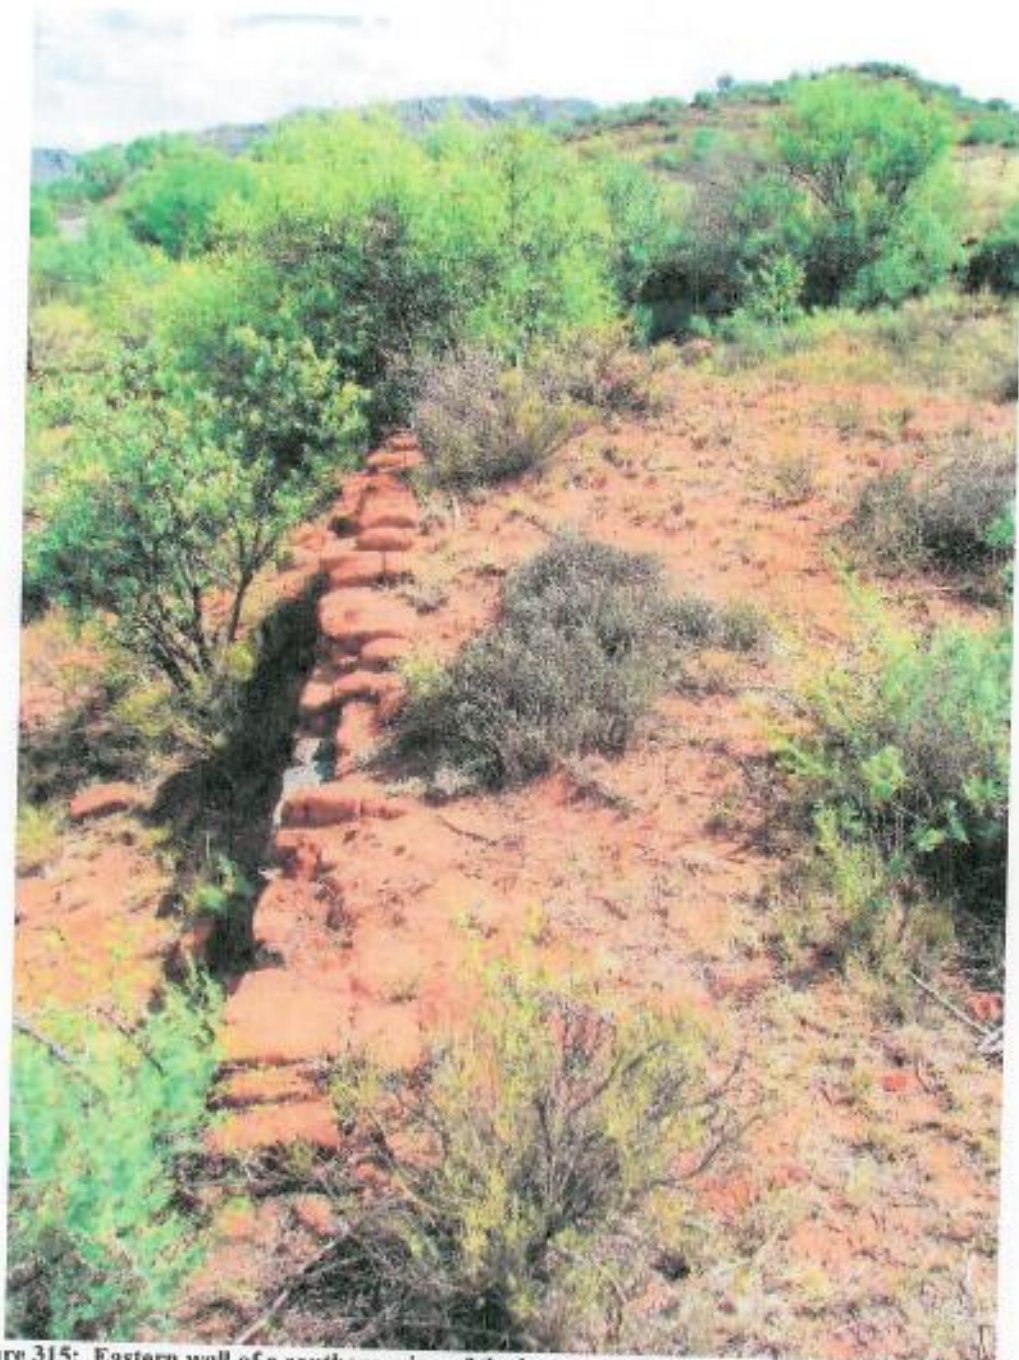
Figure 315: Eastern wall of a southern wing of the house – stone foundation with layer of bricks on top (orientation south)

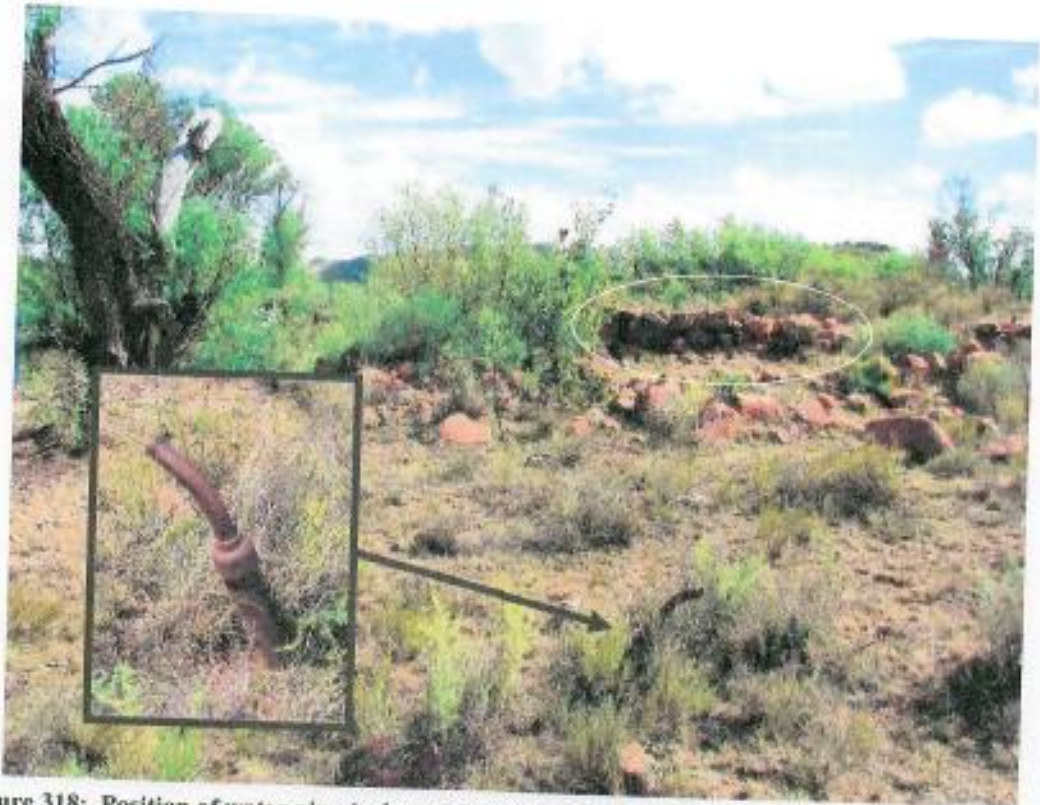
Figure 318: Position of water pipe (enlarged inset) in relation to foundation of house remains in the middle of the stone enclosed yard – encircled area is northern wall of house (Orientation of photograph south-west)
