SPECIALIST REPORT

A PHASE 1 ARCHAEOLOGICAL AND HERITAGE IMPACT ASSESSMENT OF THE
STONE WALLED SETTLEMENTS ON TAURUS PLANTATION, BARBERTON
DISTRICT, MPUMALANGA PROVINCE

**REPORT PREPARED FOR
YORK TIMBERS**

APRIL 2015

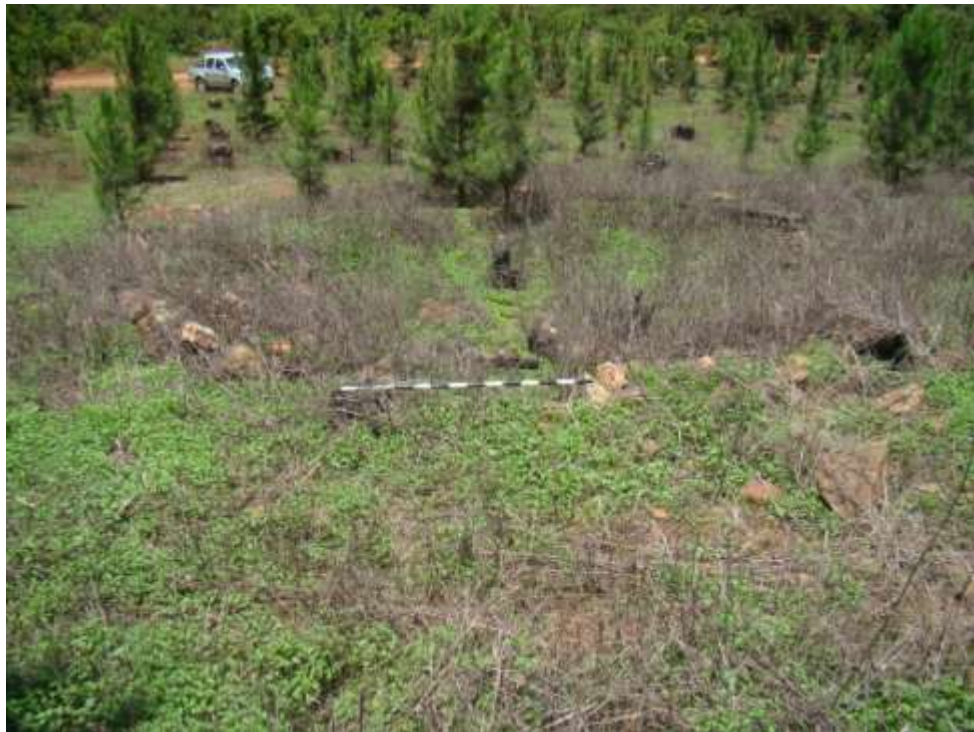
Fig. 11: A12 is an indistinct circular unit which is overgrown with vegetation.

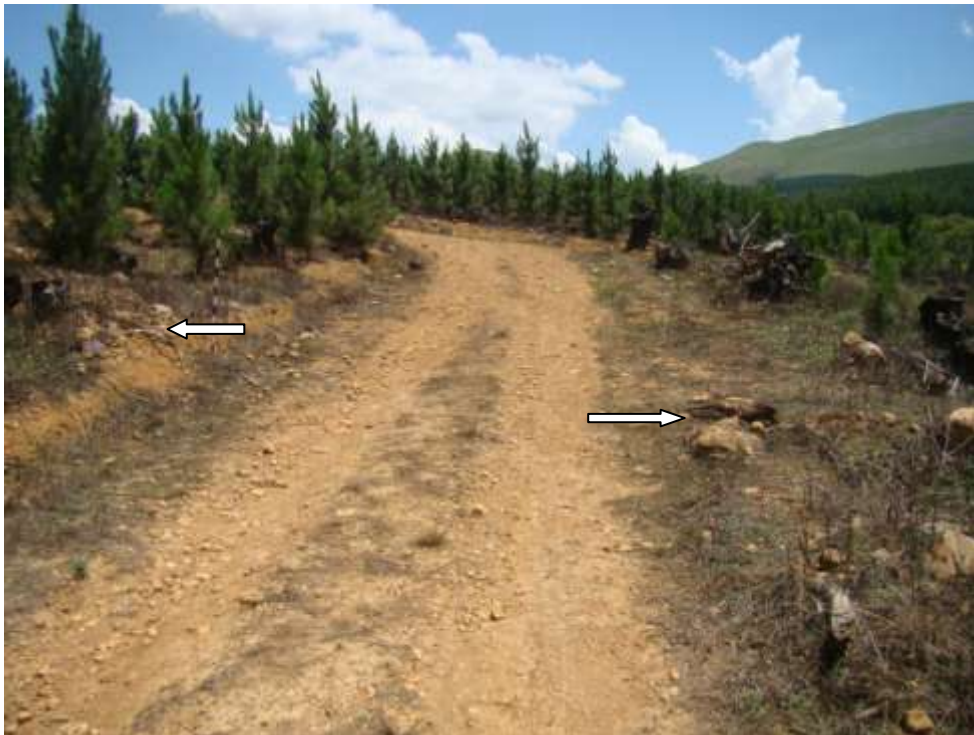
Fig. 13: Terrace walls which were damaged by road activities are visible on both sides of the road.

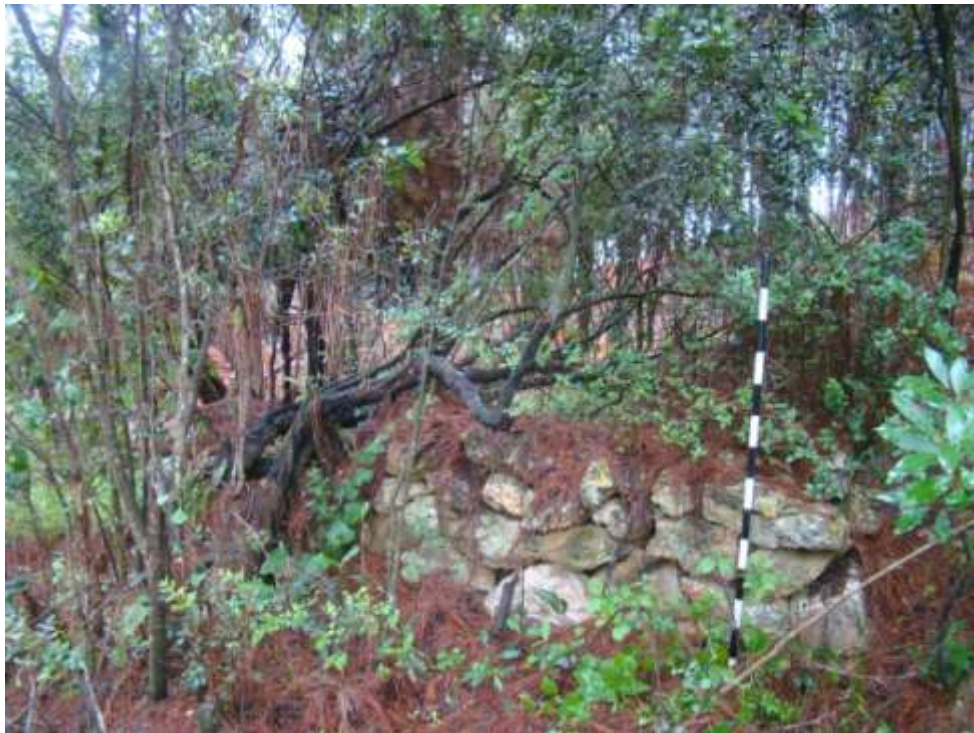
Fig. 58: A circular stone wall which is still in good condition. Sections of this wall are approximately 800mm high. The wall is covered with pine needles and overgrown with vegetation.

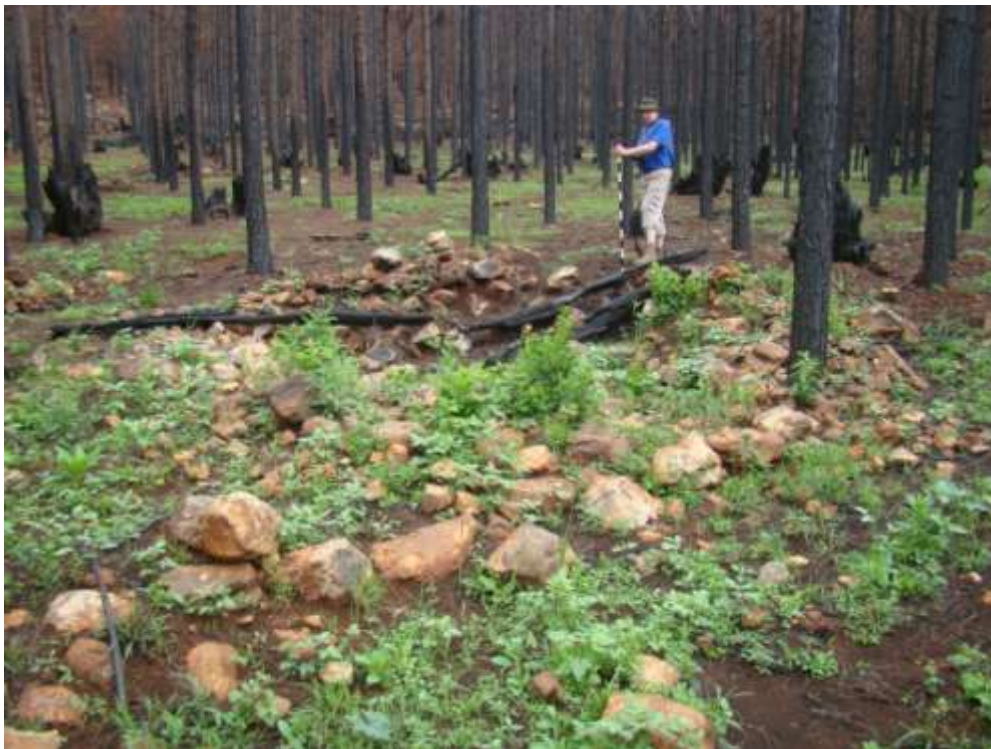
Fig. 66: Some of the walls are higher and more visible, but not in a good condition.

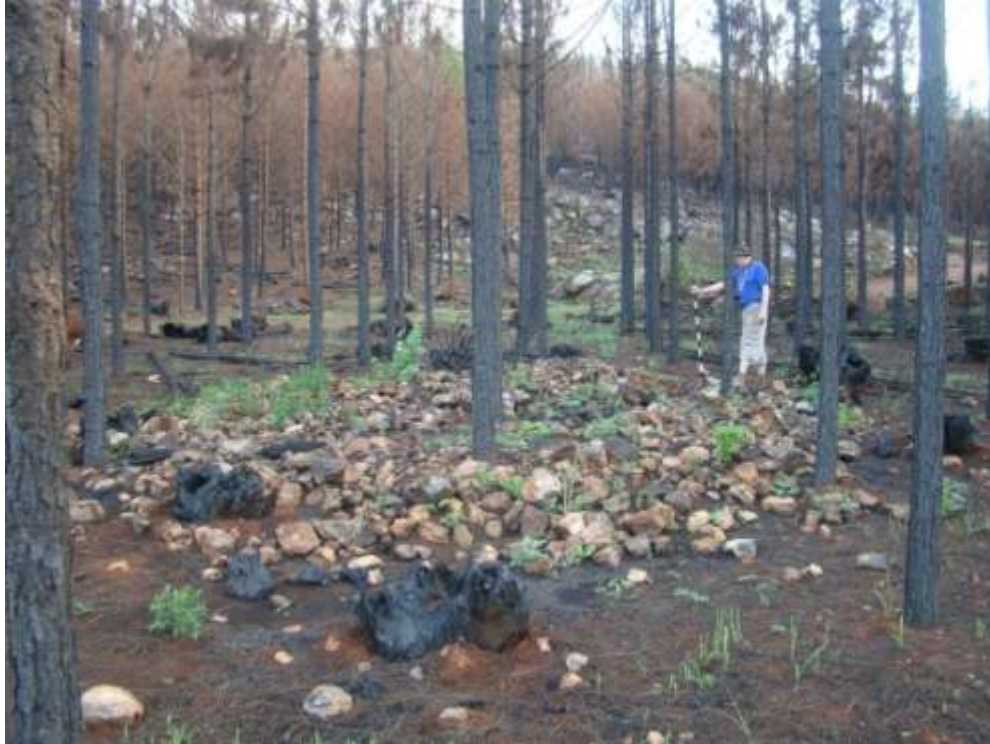
Fig. 71: Two indistinct units to the east of the settlement where two plantation roads come together. The units are disturbed by plantation and road activities.

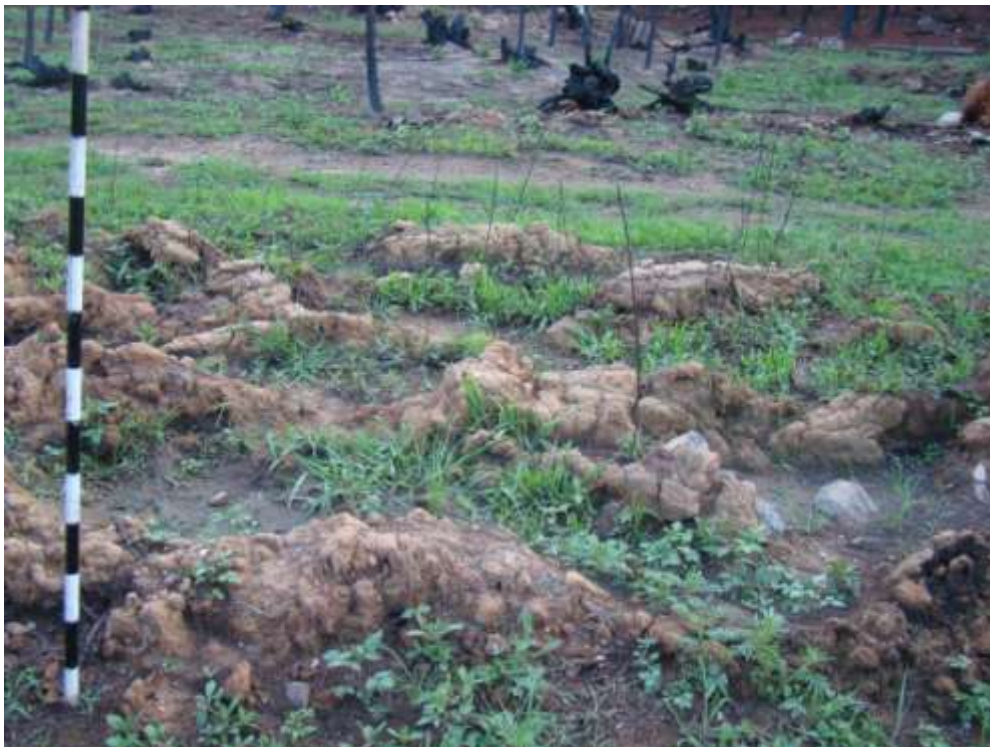
General comments C04: Some historic features were observed in the area of the Outspan Post and Old Drift. The clay and stone remains are extensively disturbed and it is not possible to identify the function thereof. It is possible linked to the cattle dip and Outspan post.

Fig. 83: Historic clay and stone remains close to the above units are the remains of stone and clay which have been impacted upon by a plantation road.

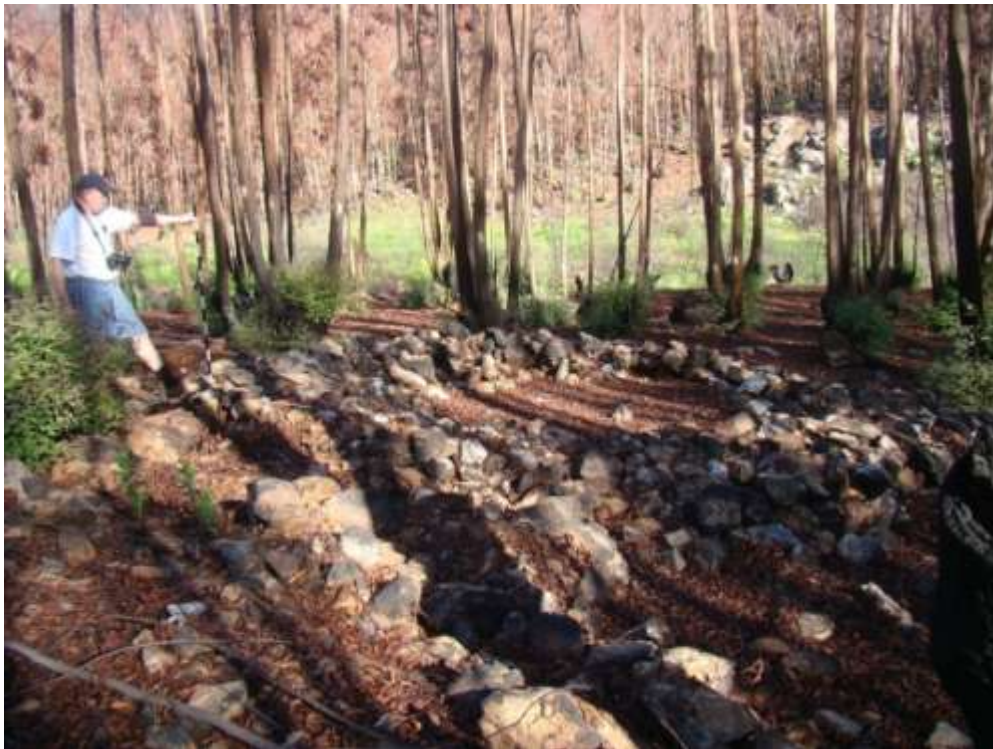
Fig. 88: This circular unit with a straight “track” is disturbed by plantation activities. The section has burnt but piles of leaves restrict visibility. The walls are approximately 500 – 600mm high.

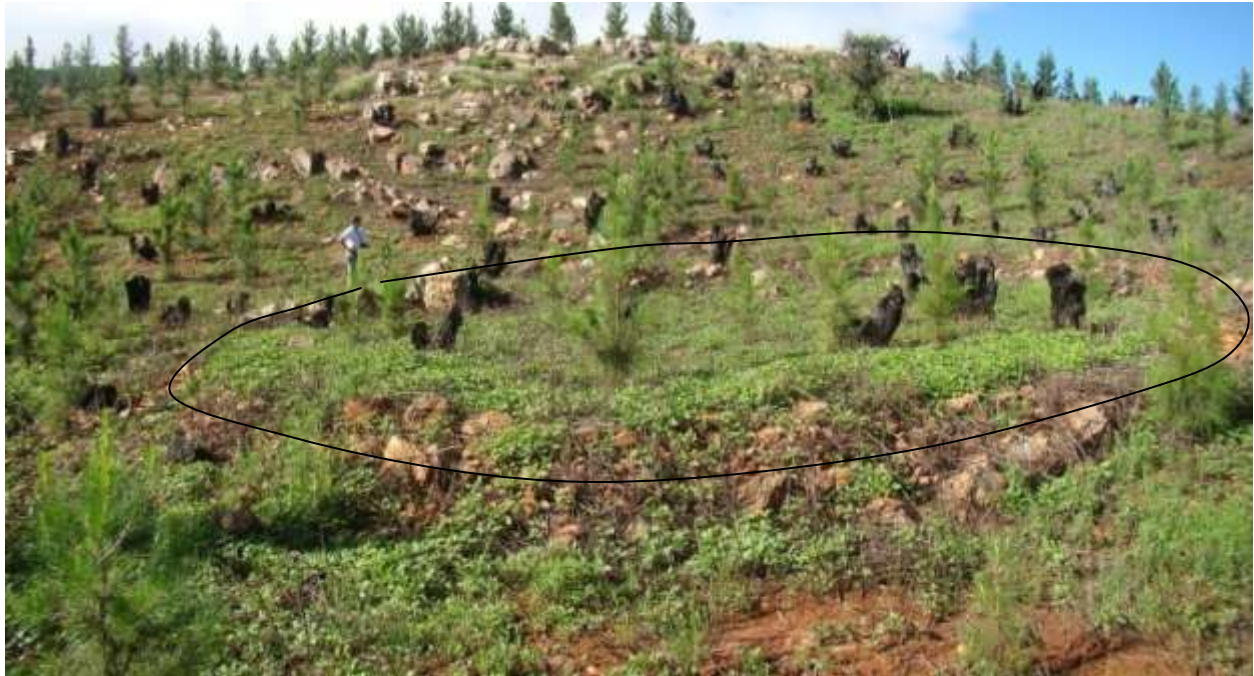
Fig. 95: Unit A21 – 4 is barely visible and deteriorated.

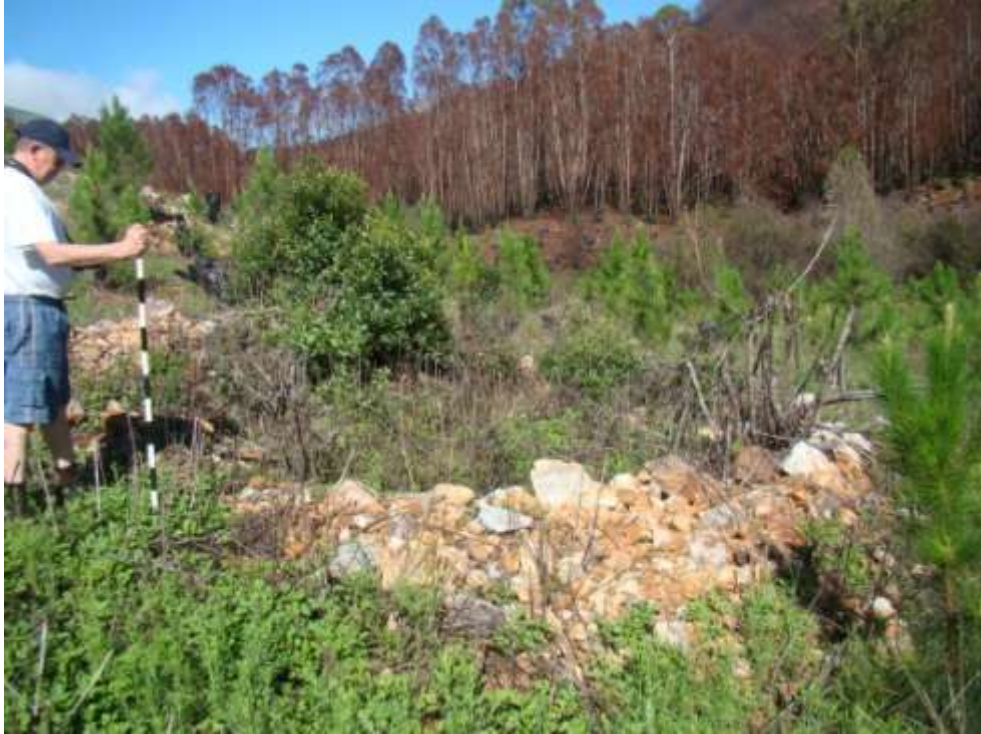
Fig. 99: Unit A21 – 14. The walls are fairly well preserved and sections are up to 400mm high.

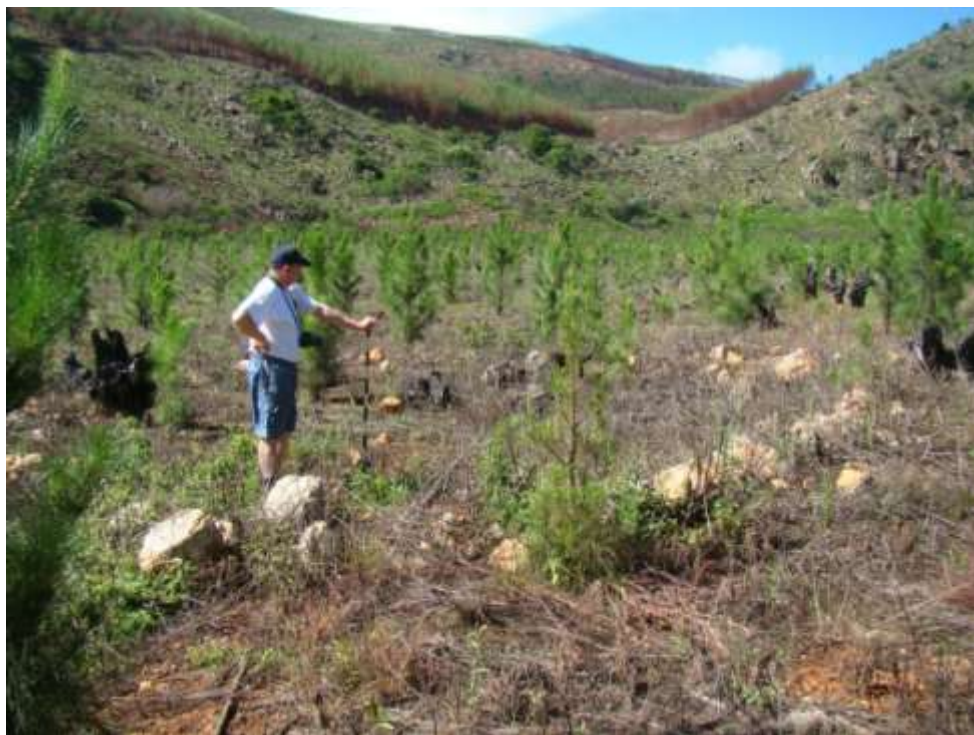
Fig. 104: A distinct, as well as several indistinct units was observed below / south, of the plantation road. The units are located in a young pine plantation, but are very disturbed by plantation activities.

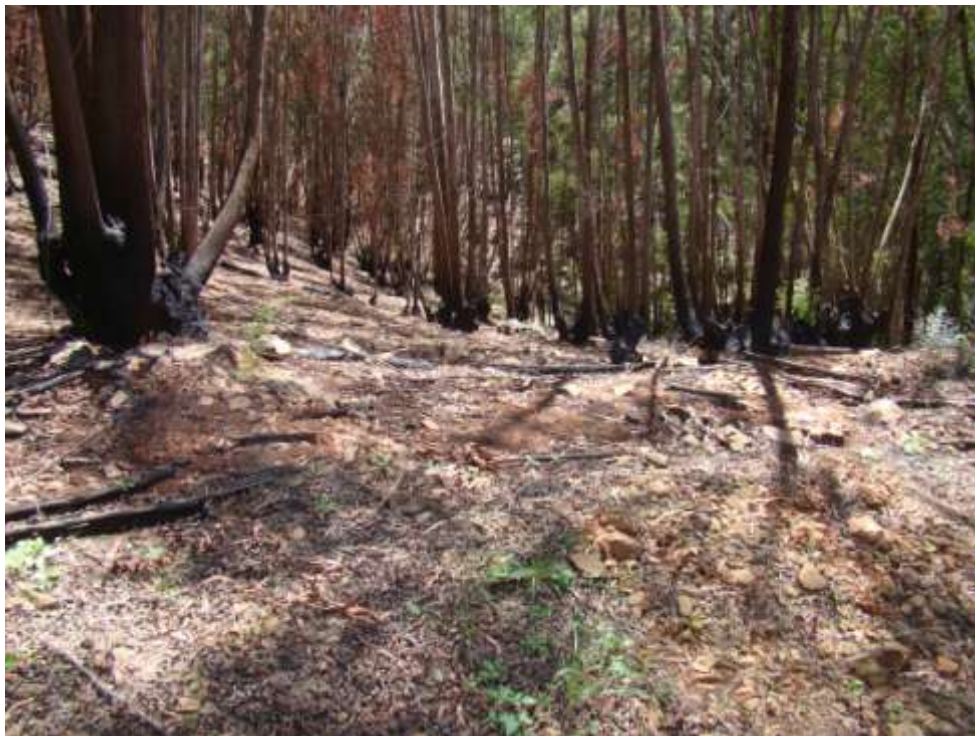
Fig. 107: A circular unit which is disturbed by bluegum plantation and road activities.

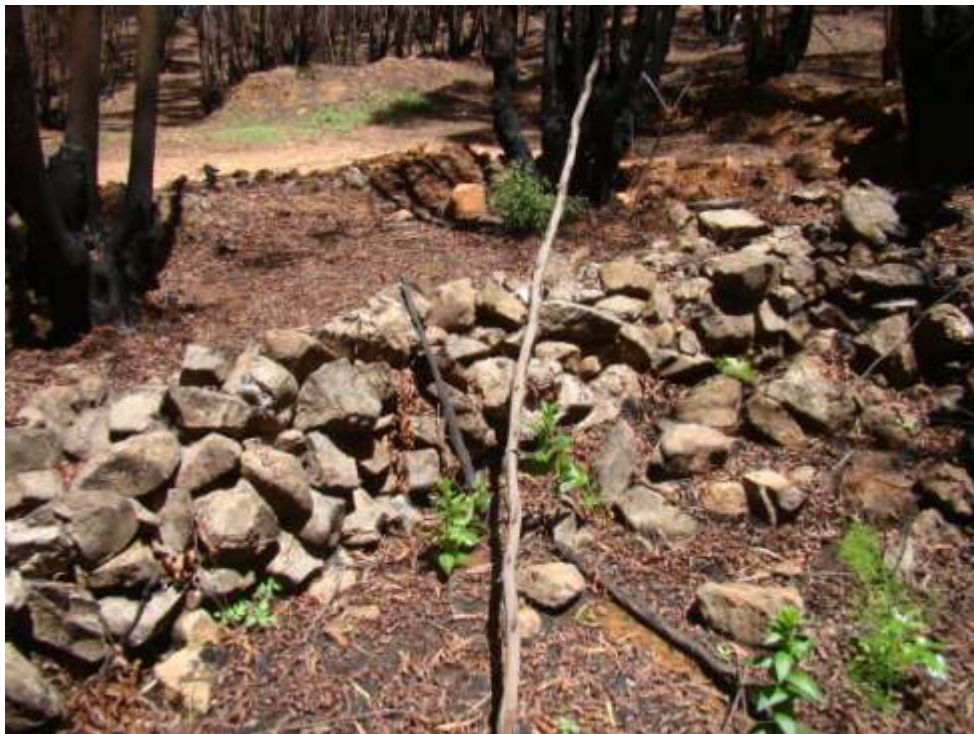
Fig. 109: The walls are in a fairly good condition and approximately 800mm high in sections.

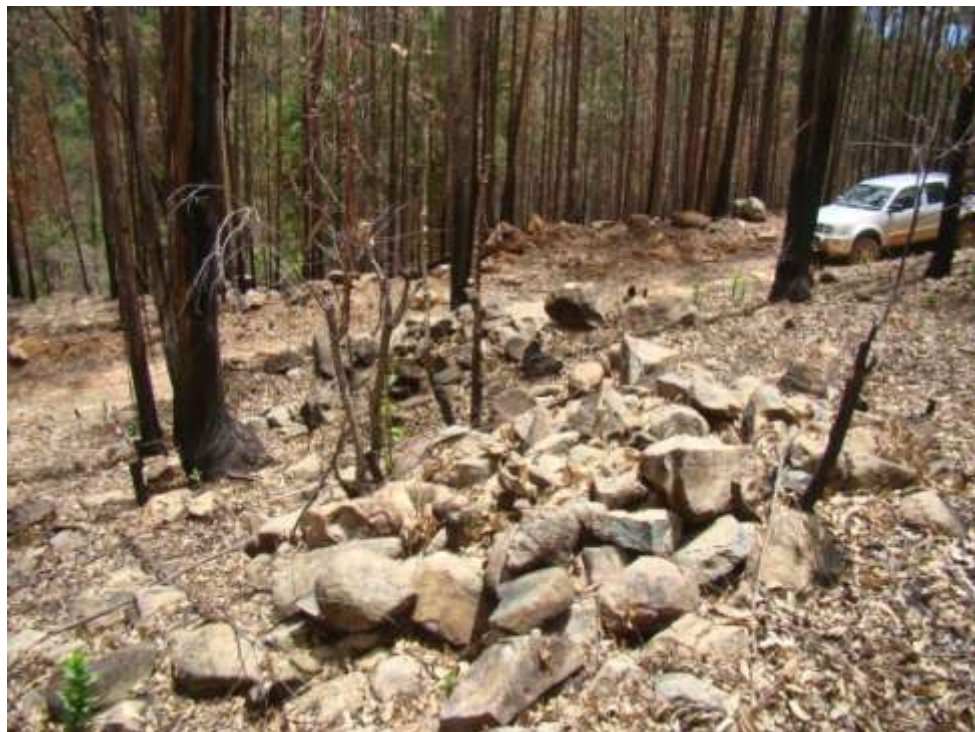
Fig. 137: Further down the southern slope are several more units which are linked. At least 4 were identified but are damaged by road and plantation activities.

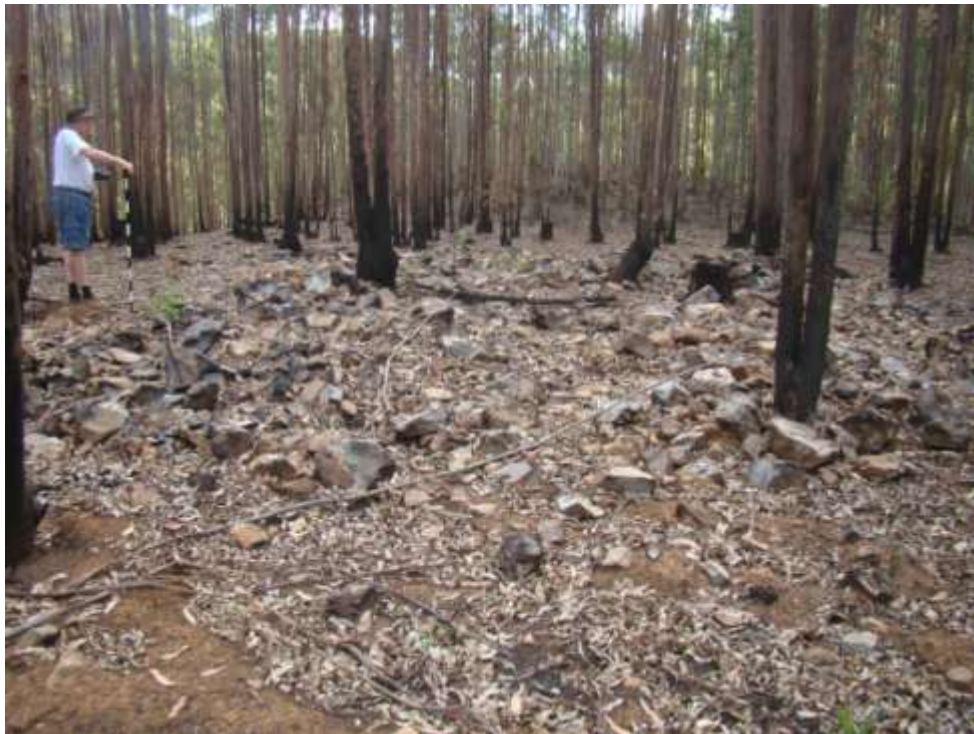
Fig. 159: This unit has two divisions. The walls are indistinct and deteriorated.

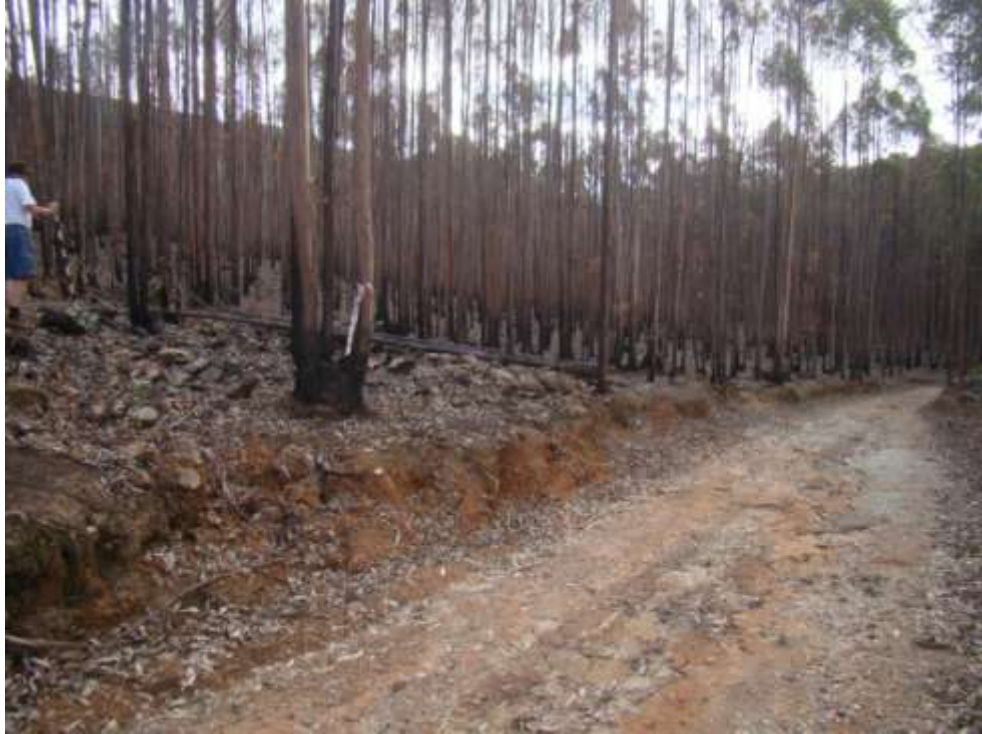
Fig. 164: This circular unit was damaged by the plantation road.

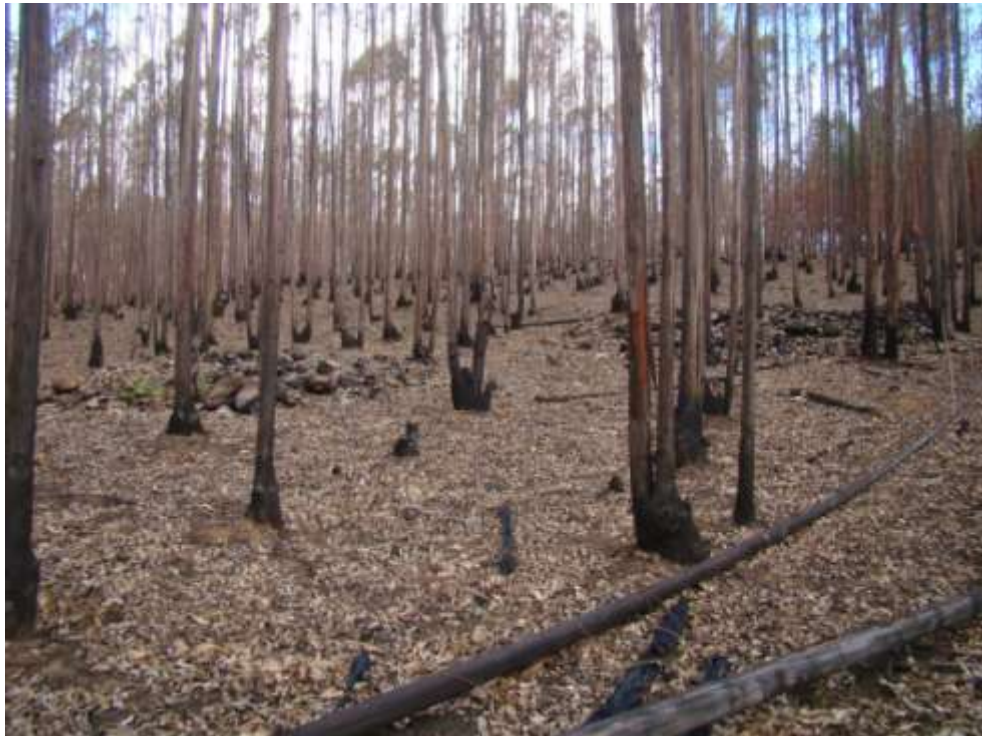
Fig. 165: Four units are linked together with clear walls. This section is disturbed by the access road. It is further disturbed by plantation activities.

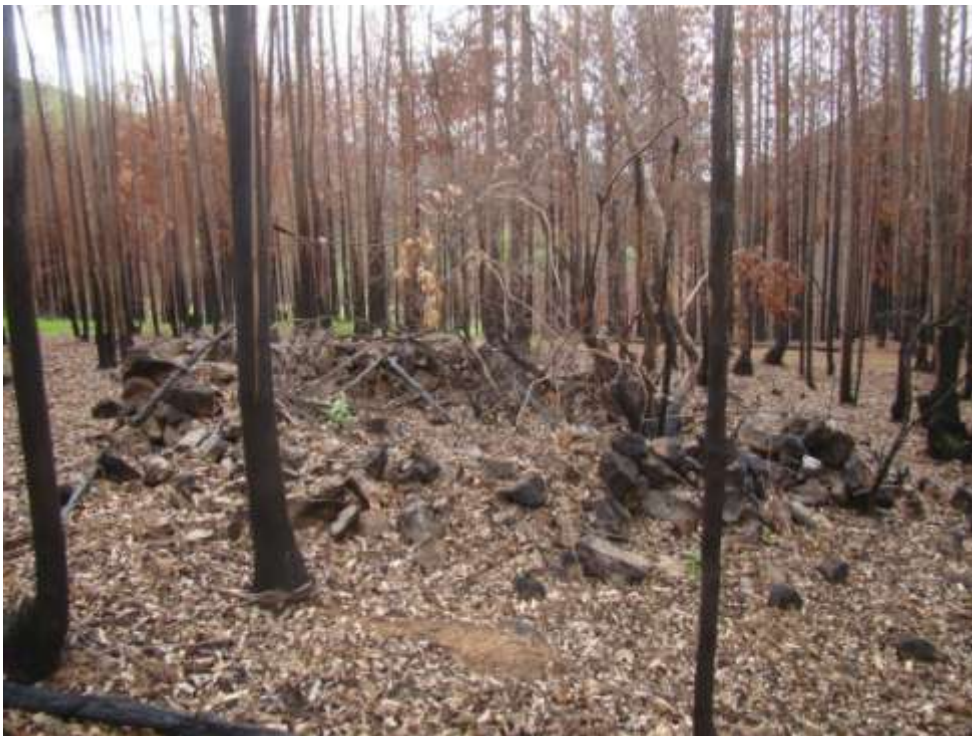
Fig. 192: Another stone wall which is damaged by vegetation.

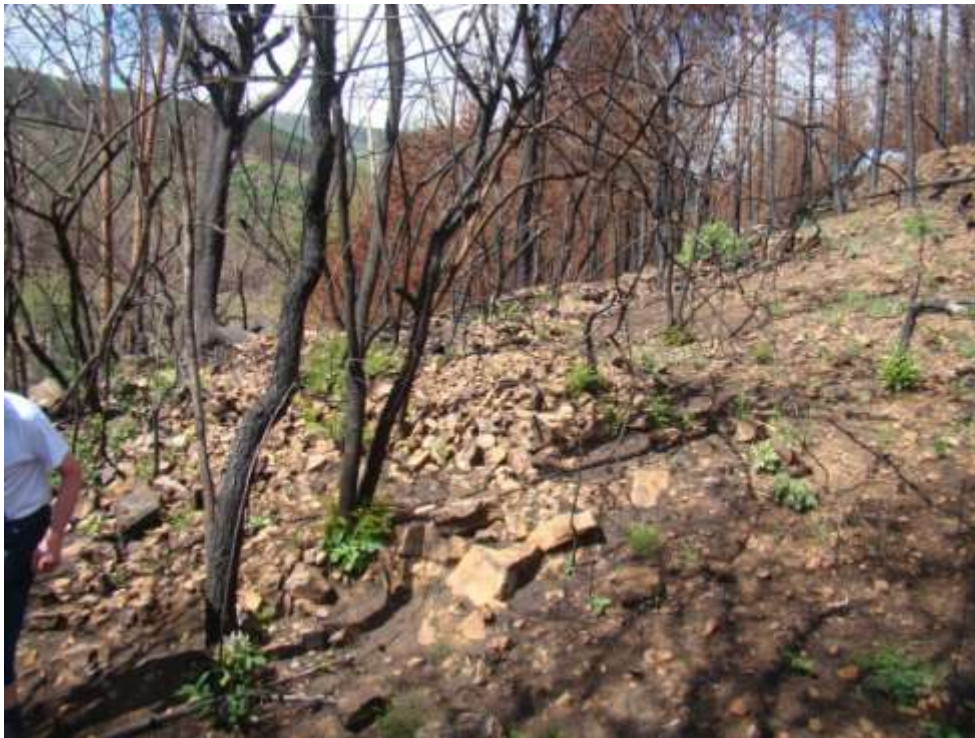
Fig. 197: The walls on the slope are mostly extremely deteriorated. Natural vegetation is seen in this section.

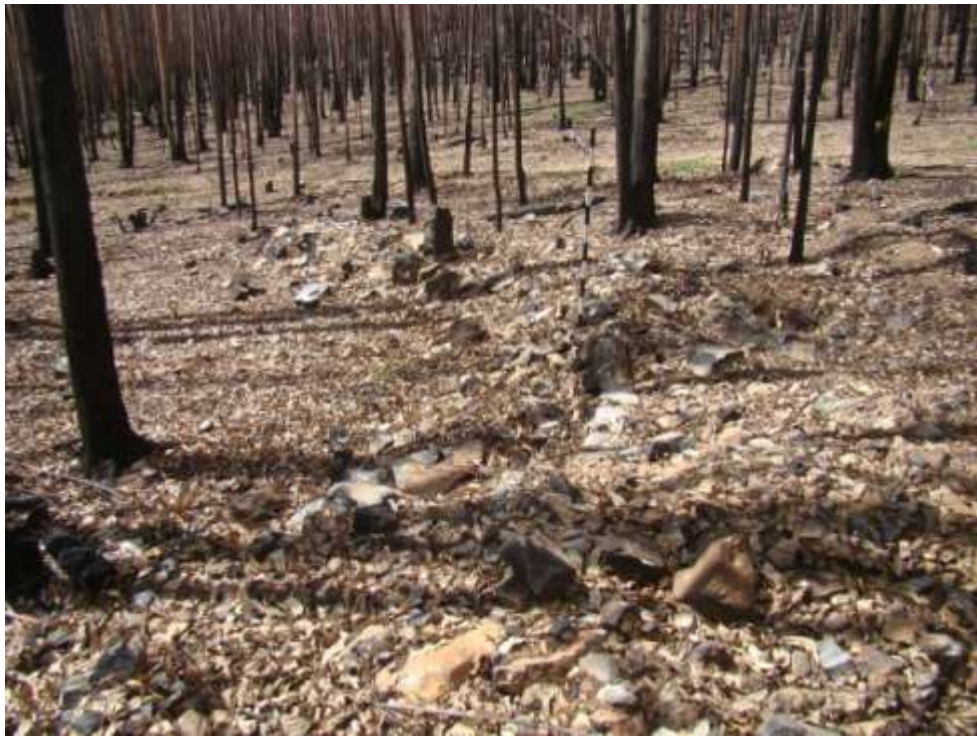
Fig. 204: Circular stone wall (not complete) which is damaged by the road and plantation activities.

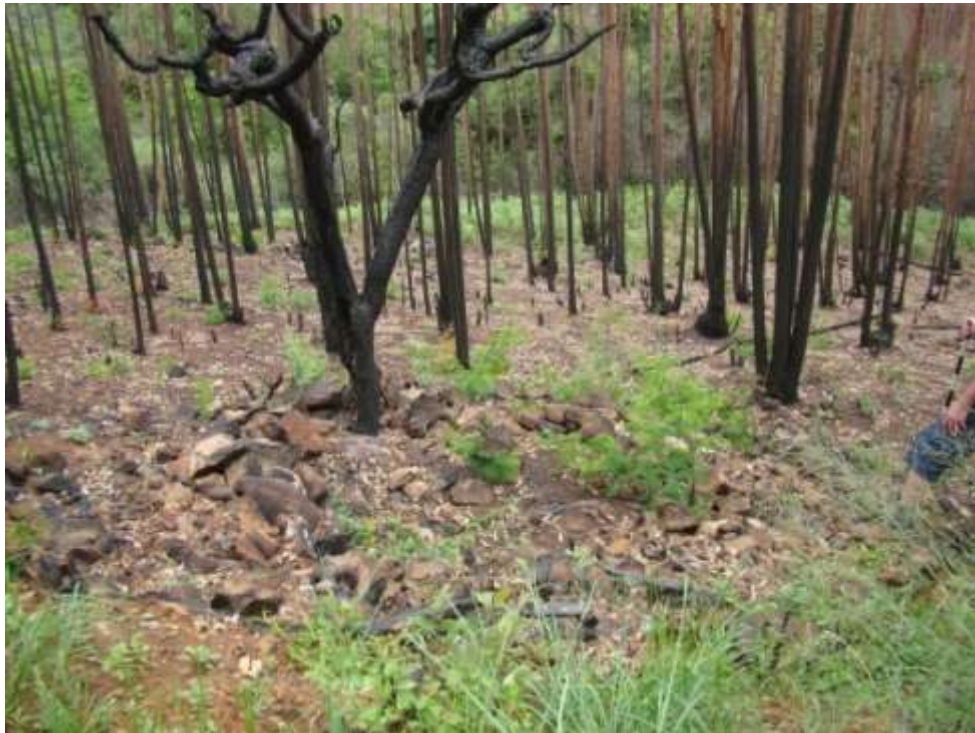
General comments D02: D02 is situated next to the main access road on a slope and has been damaged by the road infrastructure.

Fig. 221: A small circular unit is situated next to the road. It has been damaged by the main access road.

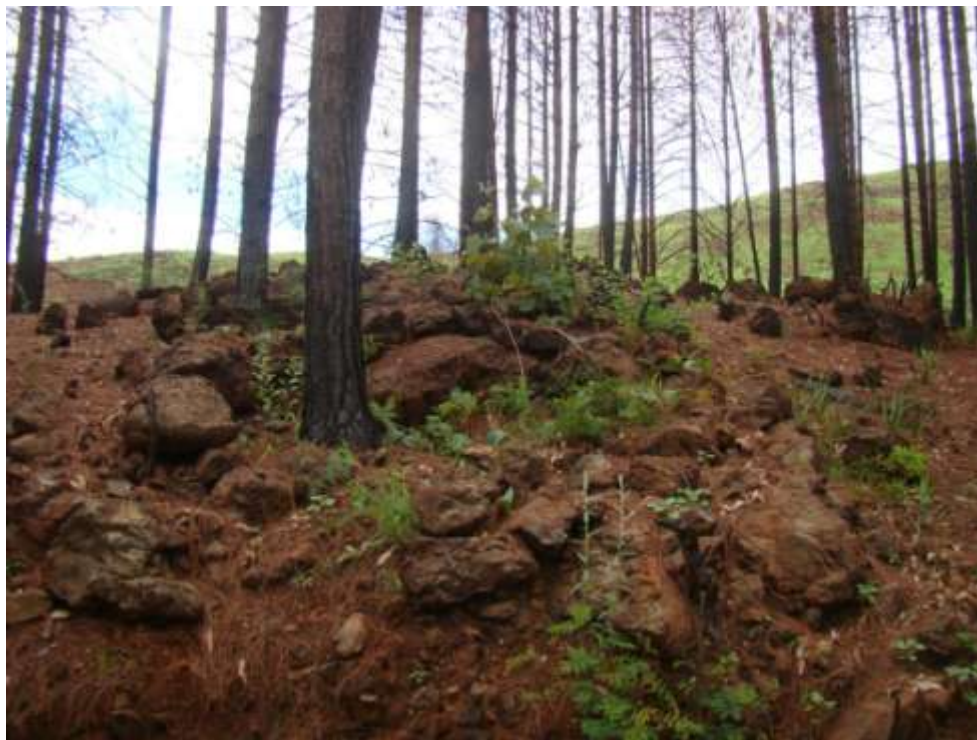
General comments D03: This unit is situated on a slope above the main access road, and has been damaged by the road.

Fig. 222: A small unit is situated south of the main access road.

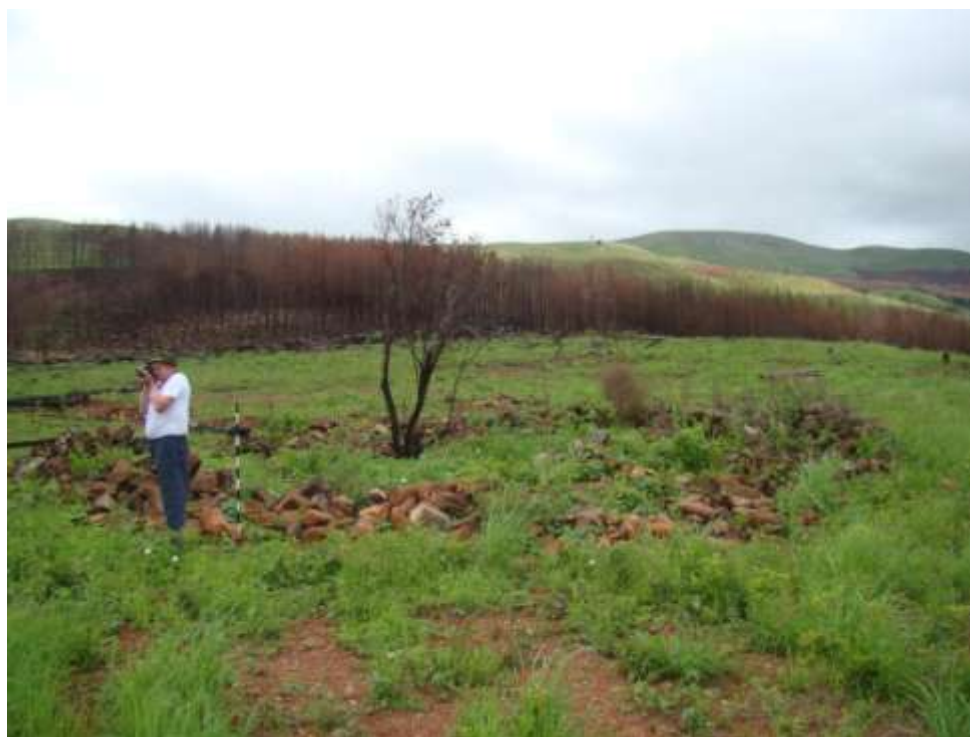
Fig. 226: A circular unit connected to another unit. It is overgrown with vegetation and visibility was not good.

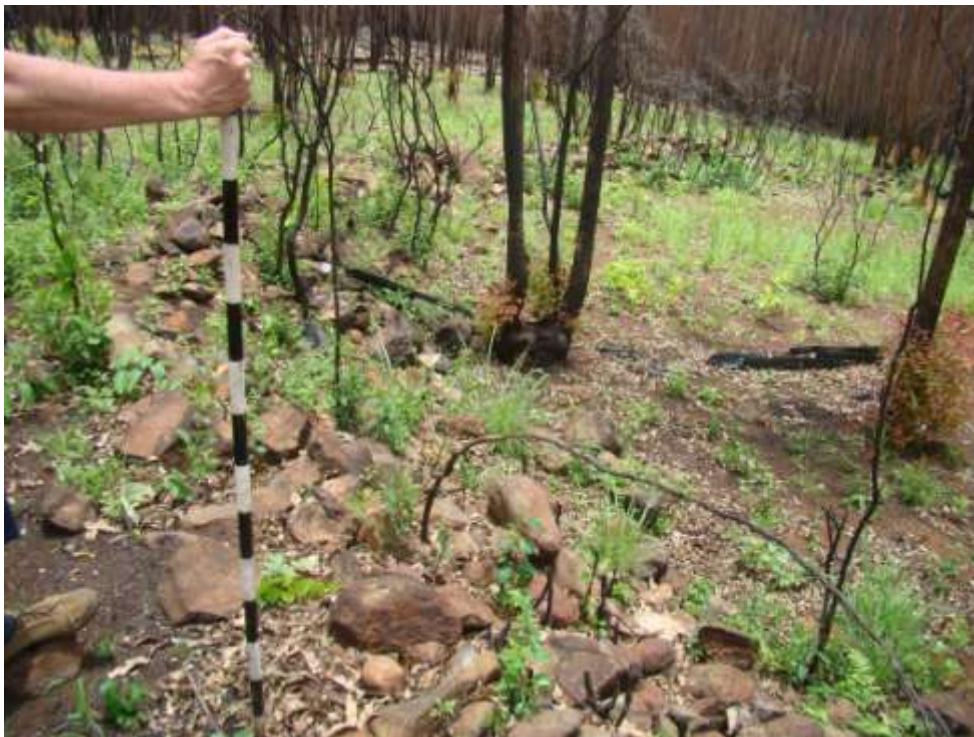
Fig. 237: Detail of the unit as described above.

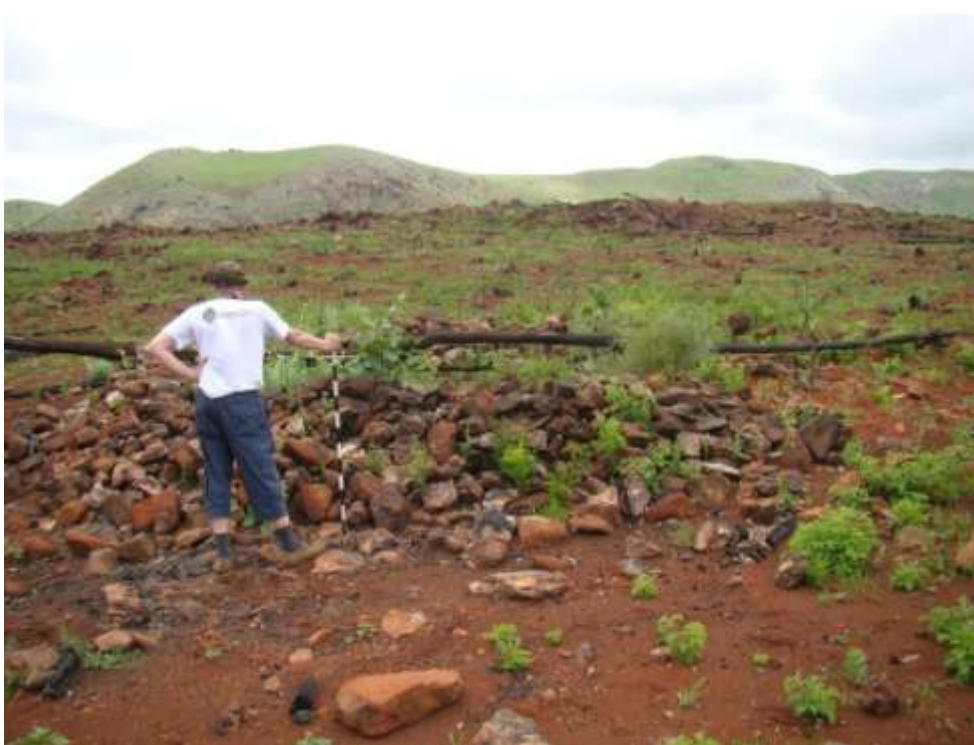
Fig. 247: A circular unit to the east of C22 – 4. The area was burnt recently and visibility was good. The unit is damaged by felled trees which is visible in the unit.
