PHOTOGRAPHIC EVIDENCE

SECTION 1: Includes features 1, 1a, 10 and 11 on map:

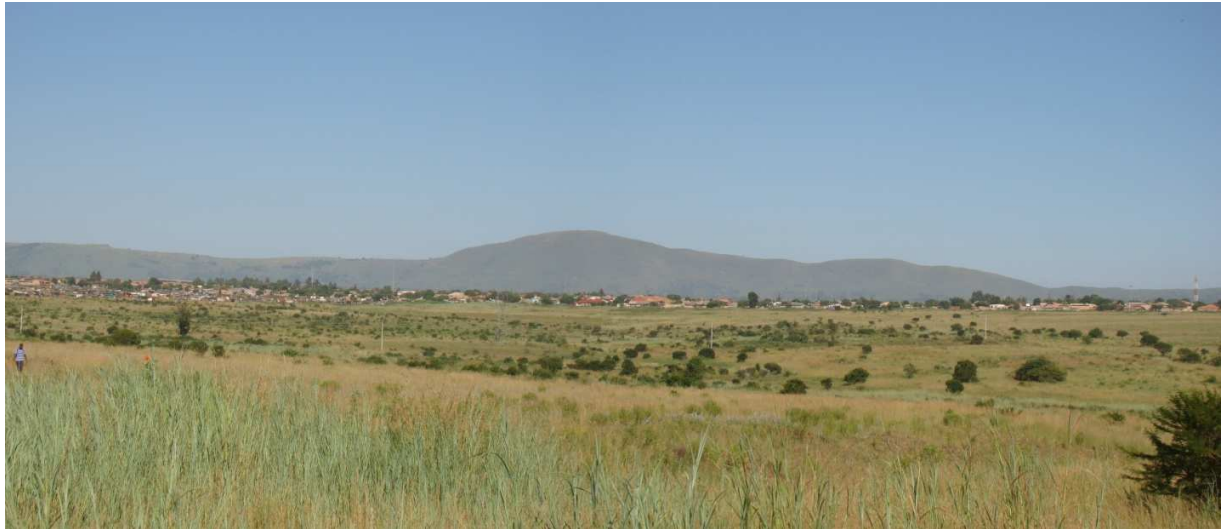
Fig. 3: The study area as seen from east to west. Mashishing township is located in the background. A drainage line is situated in the gravity low area (2015).

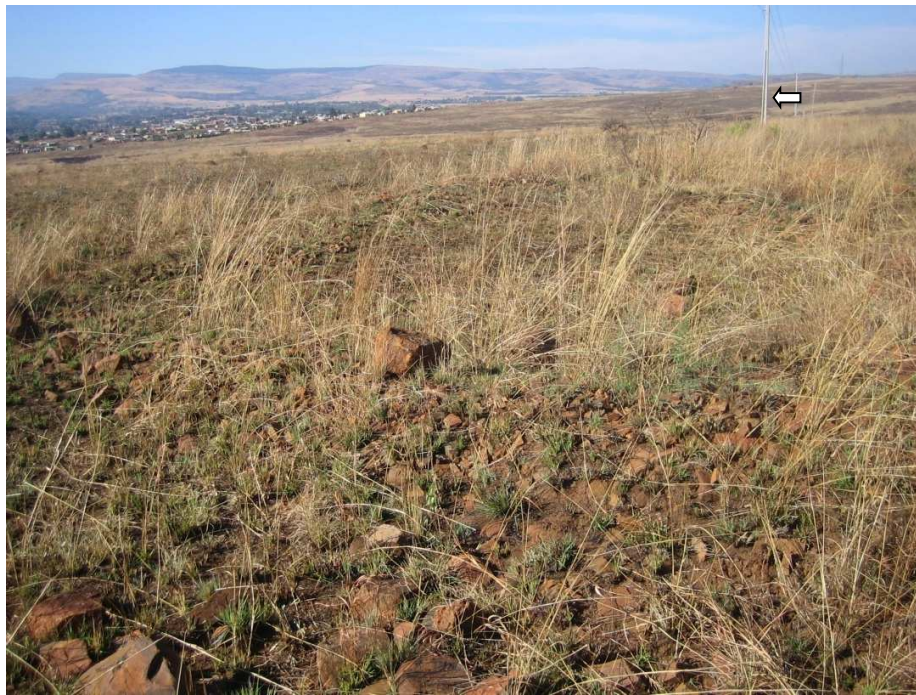
Fig. 4: The view from the north-western corner to south-east. Note the Eskom lines.

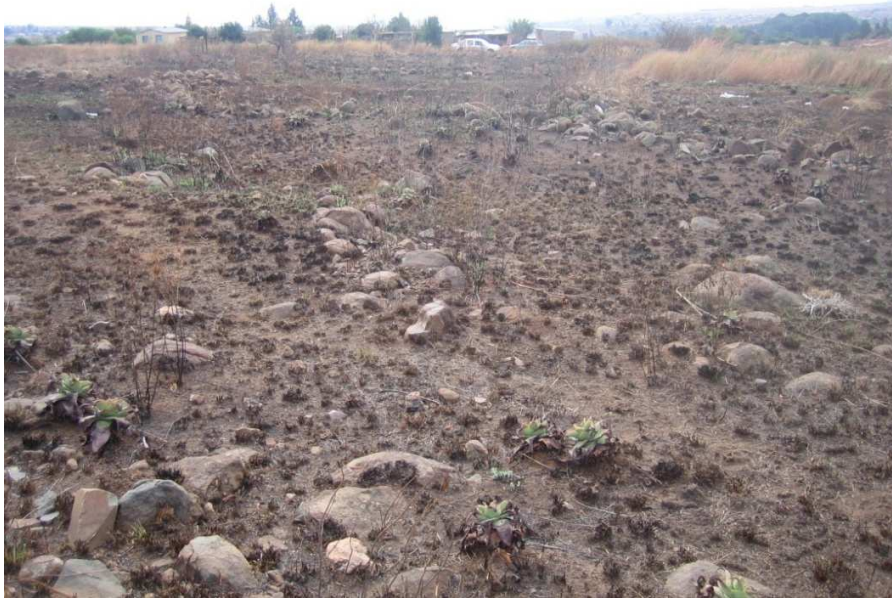
Fig. 5: Site 1: The LIA stone walled sites in section 1, include features 1, 10 and 11 which are situated close together, and borders extension 2 in the north, and extension 6 in the east (photo 2009). Most of the stone walls at section 1 have been destroyed by a recent soccer field.

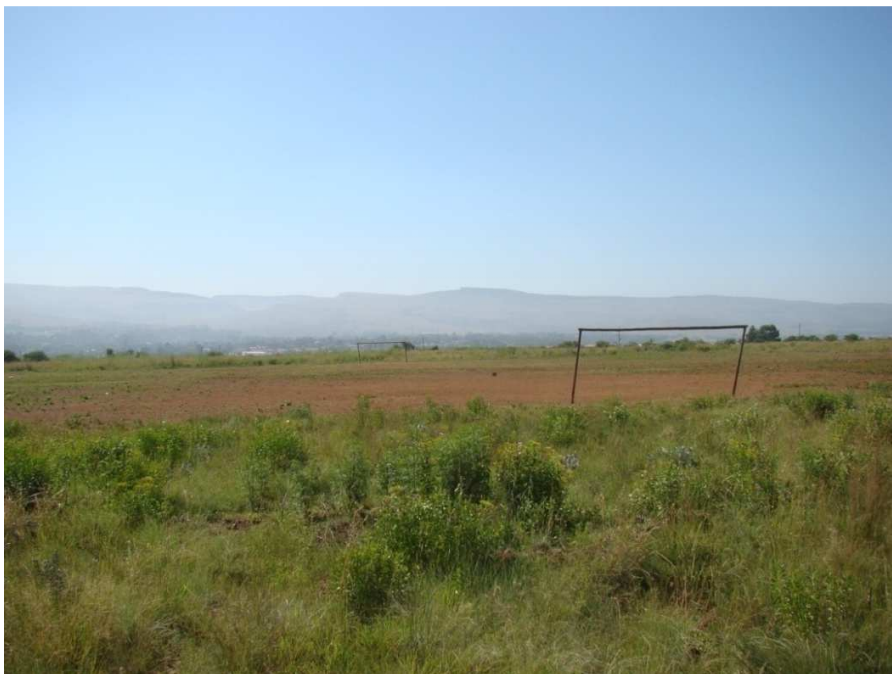
Fig. 6: The recent soccer field, directly south of extension 2, has destroyed most of the stone walls in section 1 (photo 2015).

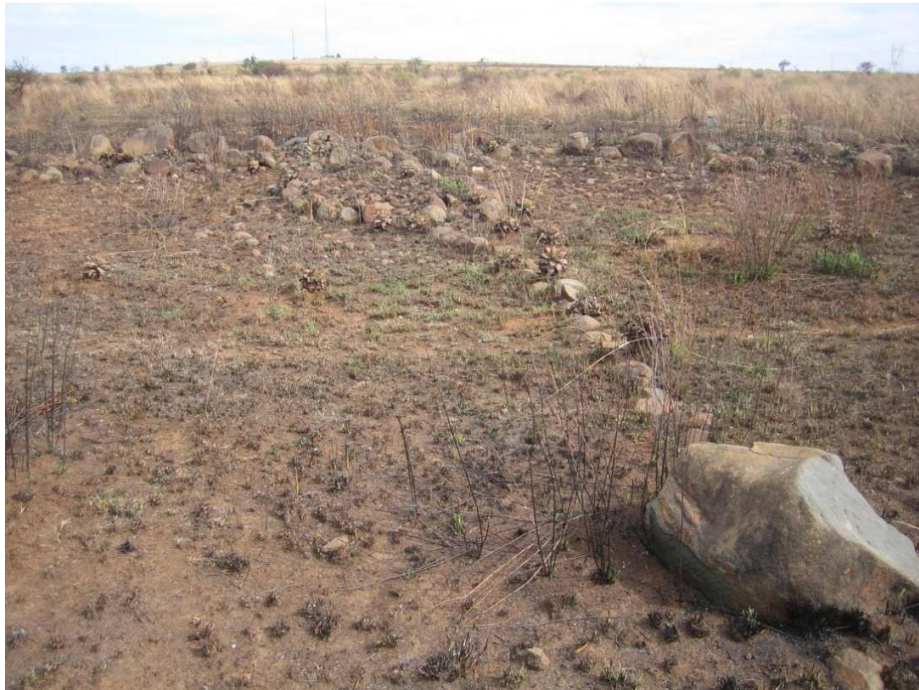
Fig. 7: A distinct layout pattern at feature 1a, which has been impacted upon by the soccer field.

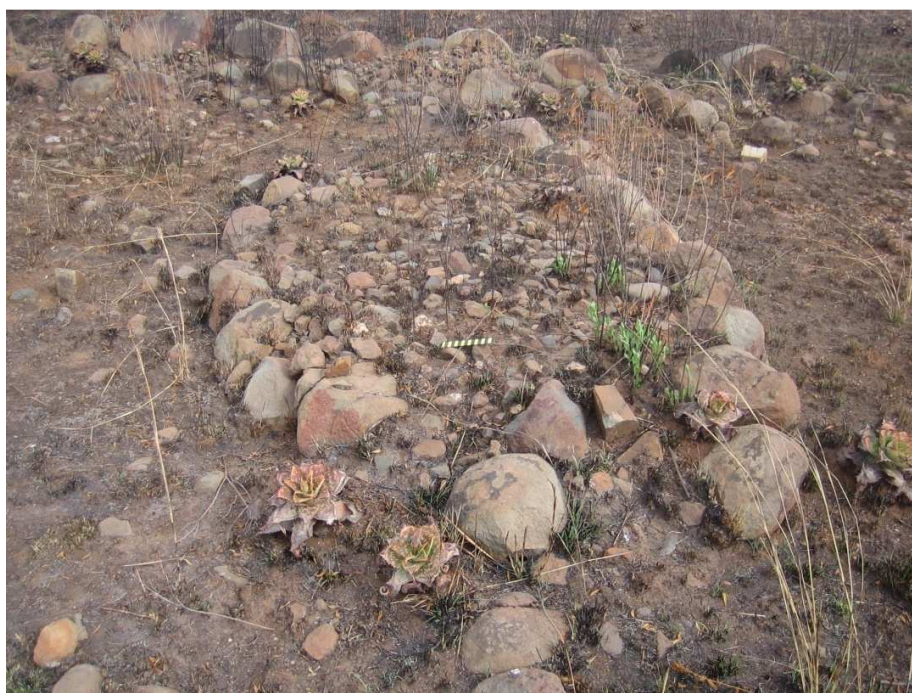
Fig. 8: Detail of an oval formation at feature1a (2009) which had been impacted upon by the recent soccer field.

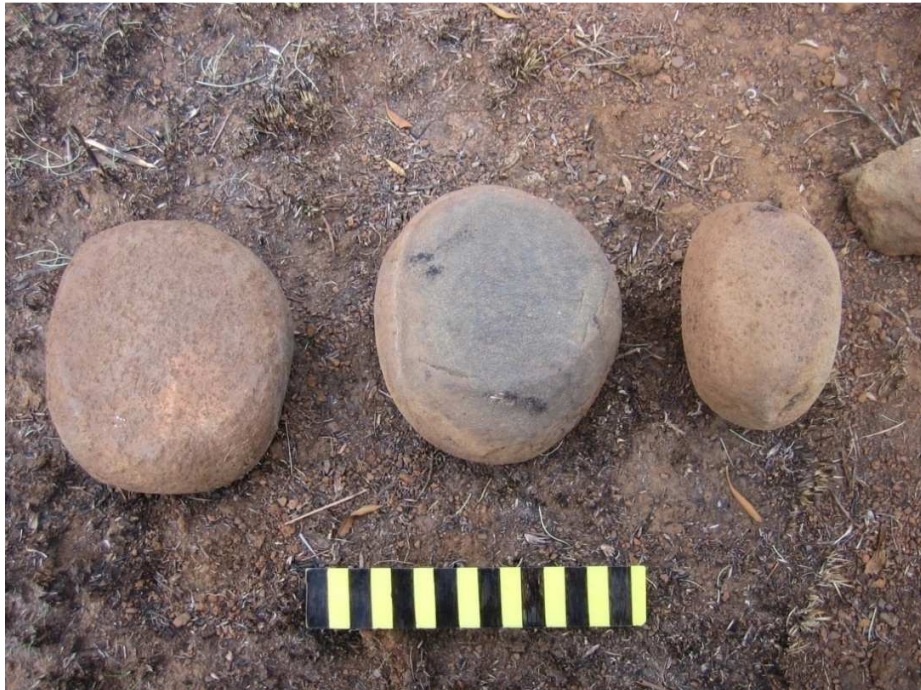
Fig. 9: Many upper grinders were identified at section 1 and 1a in 2009.

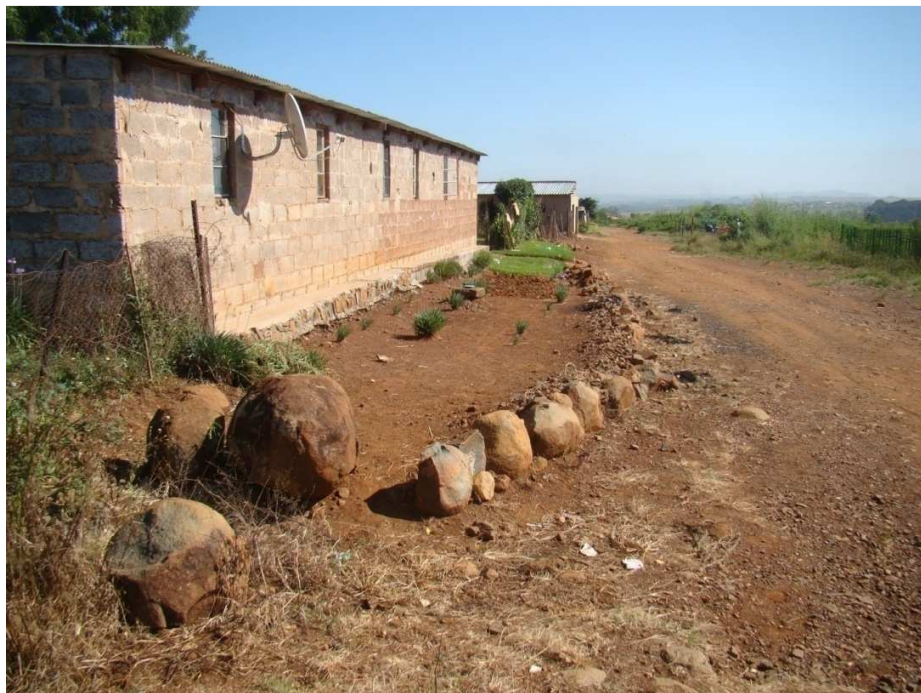
Fig. 10: Some of the residents at extension 2, which borders section 1 in the north, have removed larger stones of the LIA settlement to be used at their houses, as seen above.

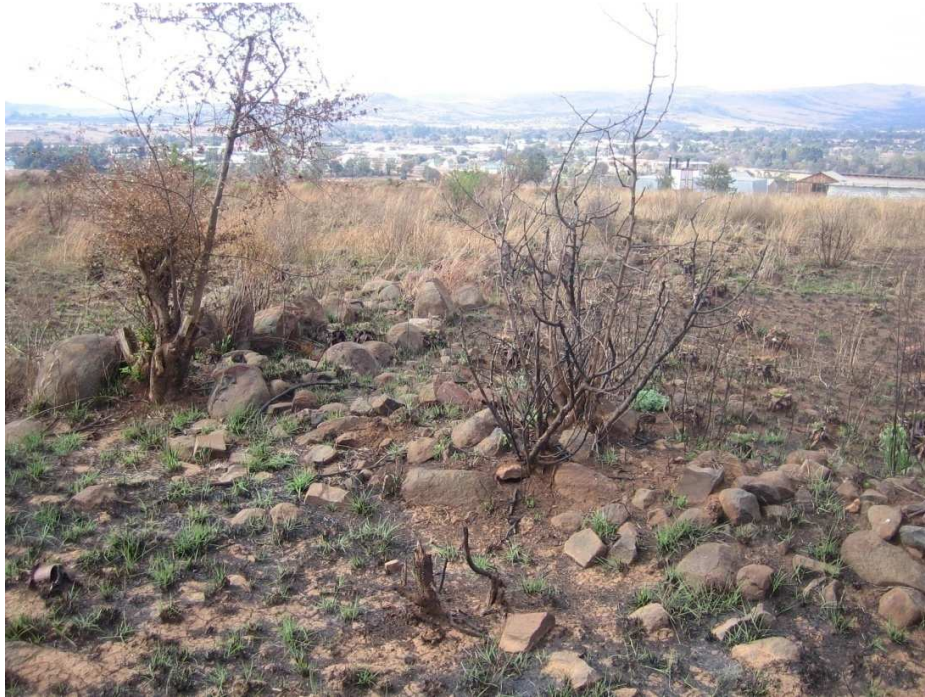
Fig. 11: Features 10 & 11 are grouped with section 1 and are located further south of extension 2 and west of extension 6.

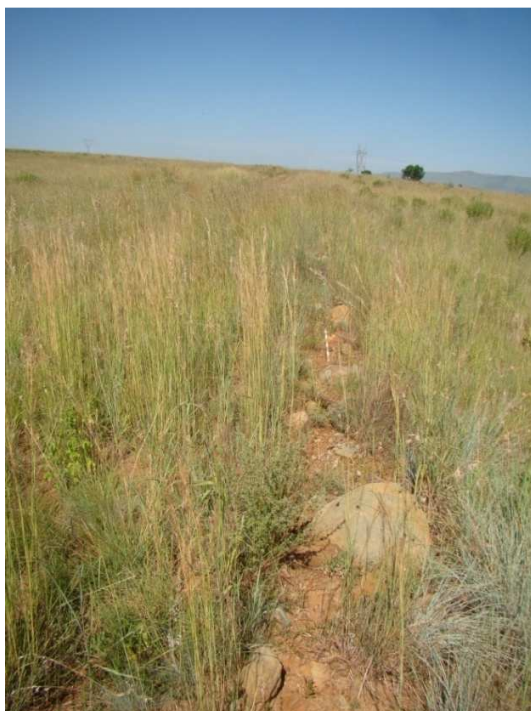
Fig. 13: This photograph of feature 11 was taken in 2015 and visibility was restricted by thick vegetation cover.

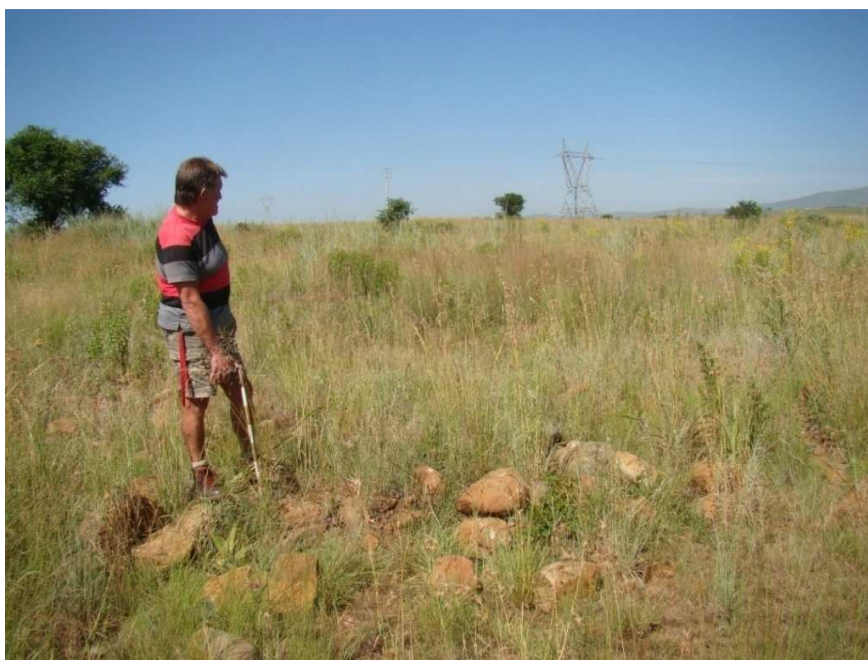
Fig. 14: A recent 2015 photo of section 2 (feature 2a), where visibility is restricted.

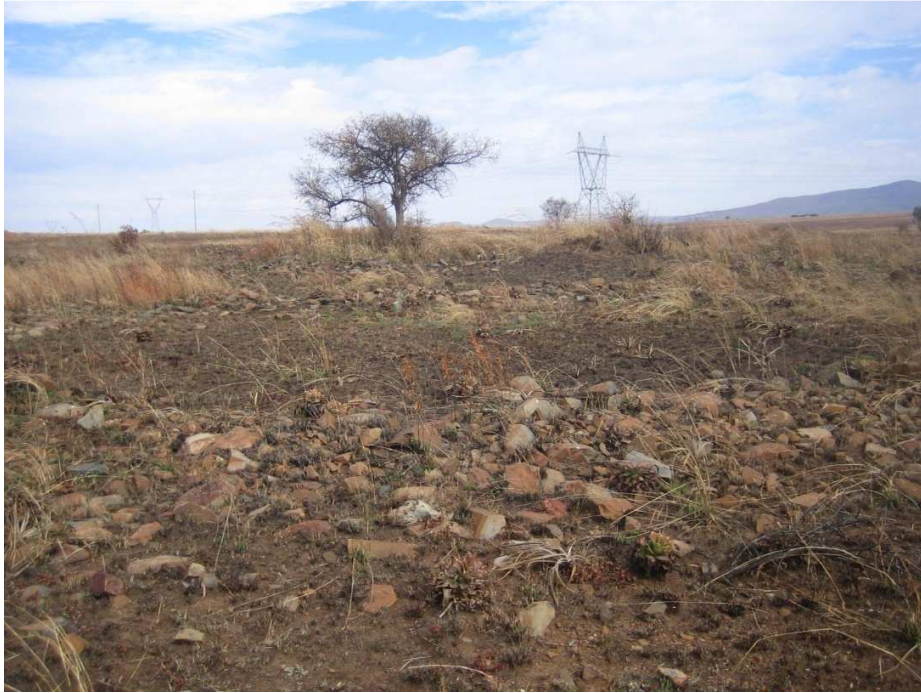
Fig. 15: Section 2, (feature 2a) taken at the same angle as the photo above, in 2009.

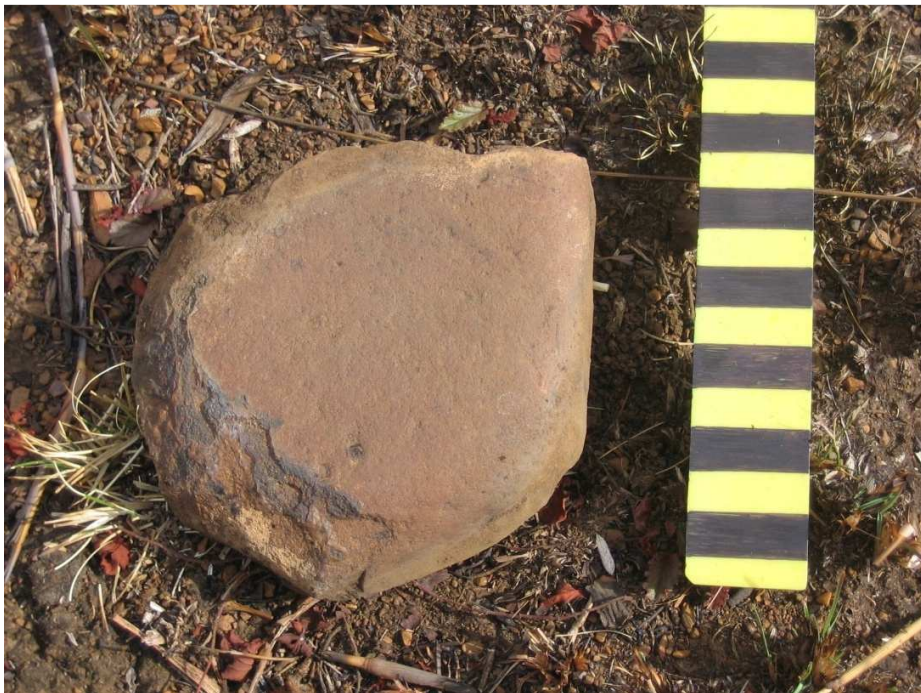
Fig. 16: A broken upper grinder. There are many upper grinders in section 2, 7, 8 ,9 & 12.

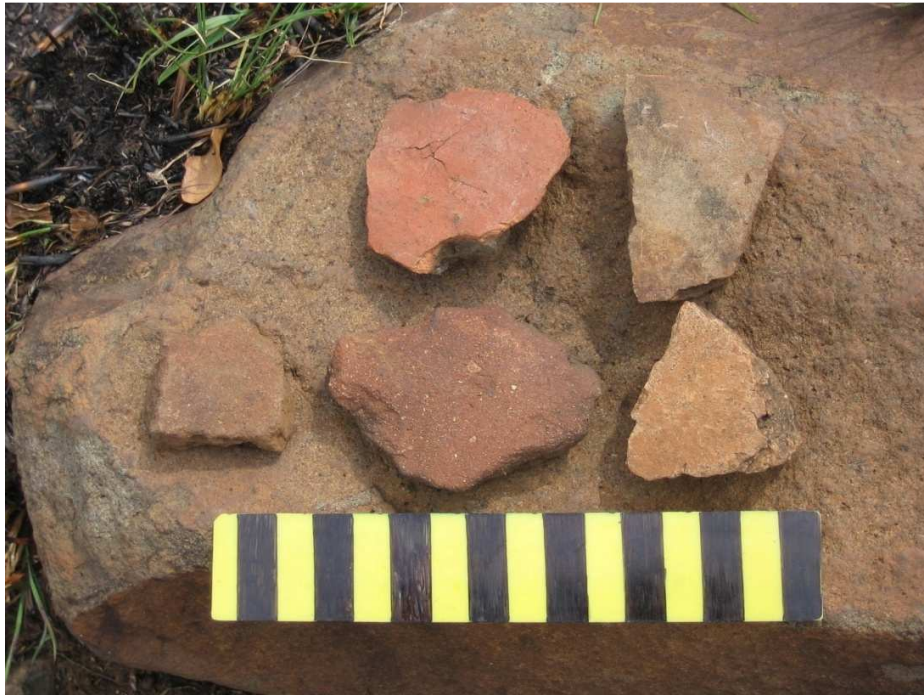
Fig. 17: Many potsherds were observed in section 2, 7, 8, 9 & 12.

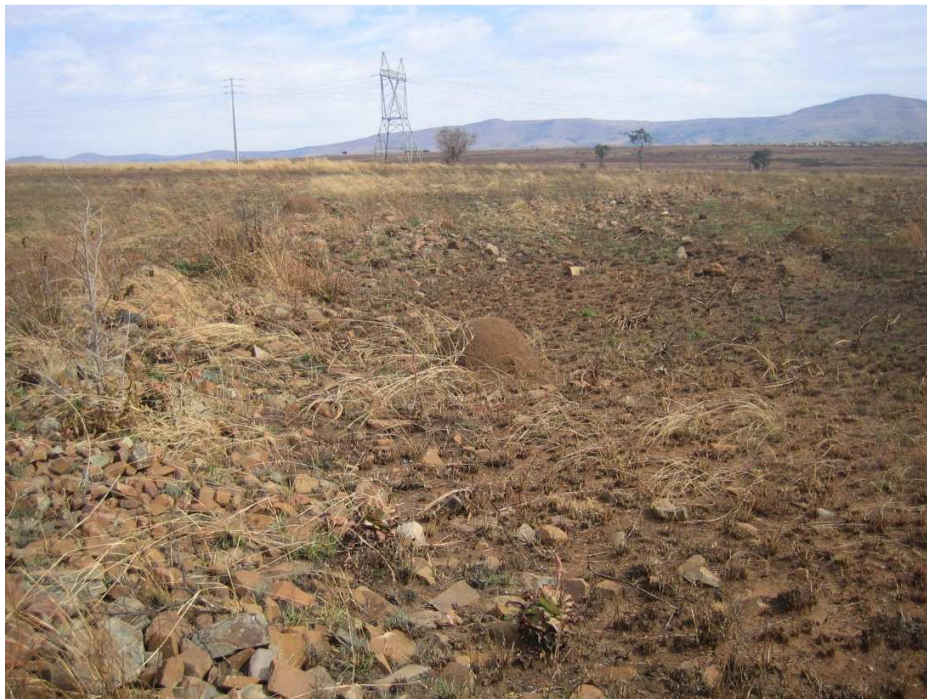
Fig. 18: Section 2, Feature 7. This section has distinct and indistinct LIA features.

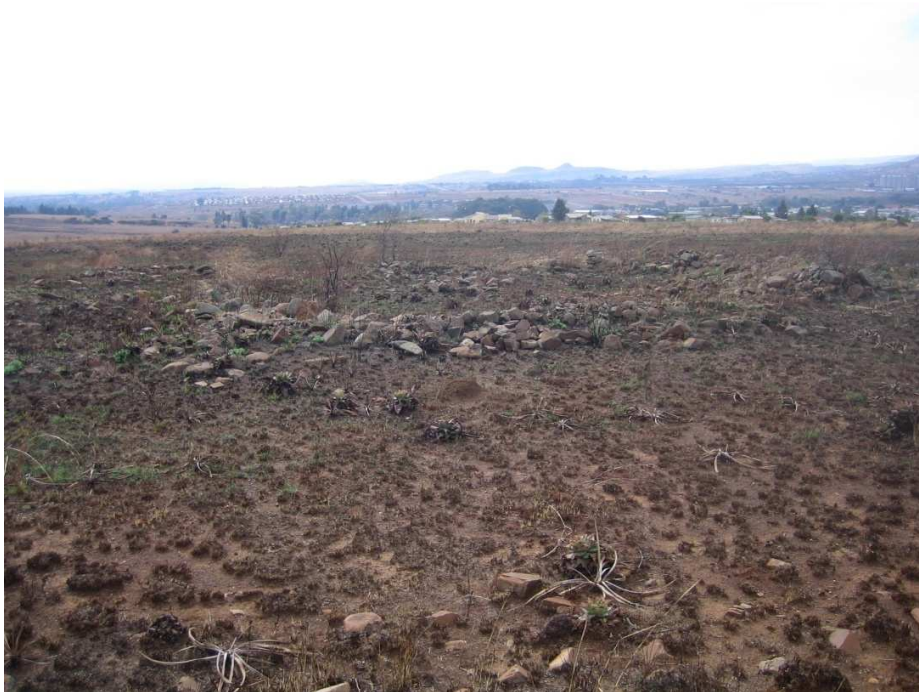
Fig. 19: Section 2 – A distinct LIA stone wall, feature 8.
