**SURVEY OF WATTLE WOODLOTS AT THE INGULA
PUMPED STORAGE SCHEME,**

FOR ESKOM HOLDINGS (PTY) LTD

DATE: MAY 2009

**Umlando: Archaeological Tourism and Resource
Management**

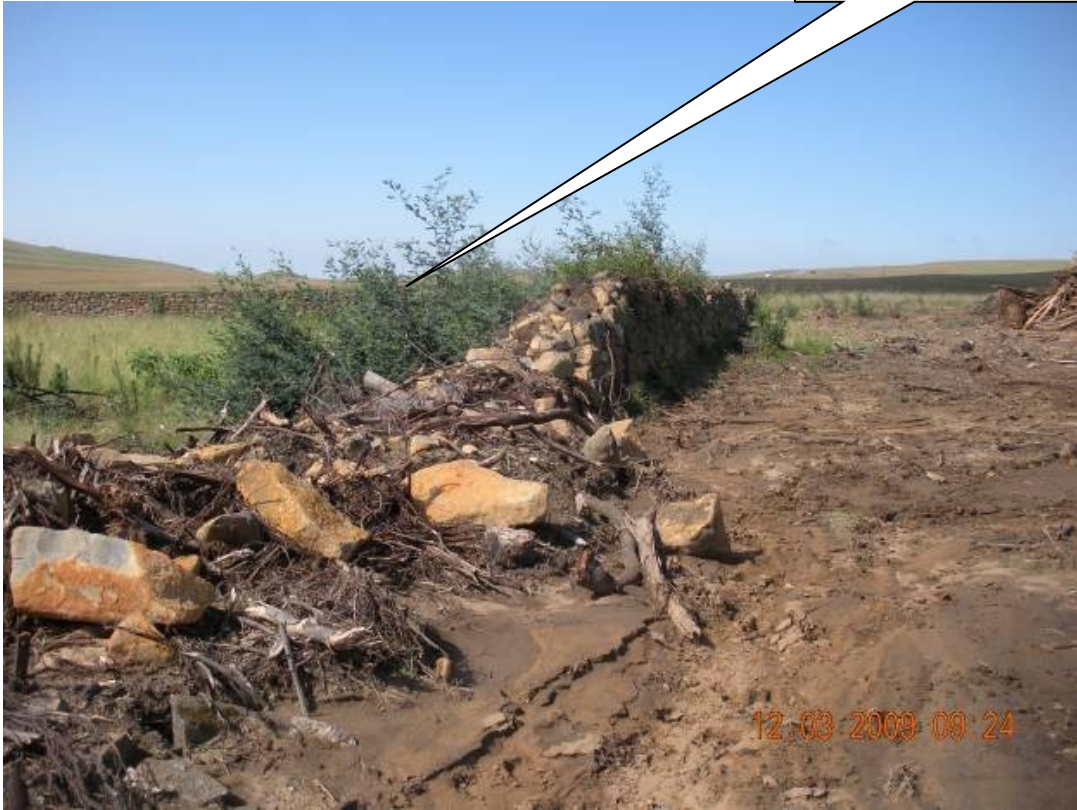
Approximately 2m of stone walling was damaged when a contractor, clearing the wattle area, drove into and knocked over part of the main cattle byre wall. The full report of the damage and ‘wrong doings’ by the contractor are given in Appendix A. The contractor had been given a site instruction to fence of the walling, but had not, and there was no supervision by the contractor in the area when there was heavy machinery. Eskom has fined the contractor who was clearly responsible for the damage. SAHRA will need to make a statement regarding the damage and place it through their system.

Damaged portion
of stone wall

<i>Event Number</i>	ELC No: ED No:08- INO No: 08-024
<i>Reference legislation</i>	EMP (Sect 165), National Heritage Resources Act, 25 of 1999 (Sect 35 (4) (a).
<i>Nature of Event</i>	Ingula Project – Main Underground Civil Works The Main Underground Civil Works contractor was clearing wattle in the designated area on the upper site for establishment of labour accommodation. The area had been pre-determined for labour accommodation due to prior disturbance and wattle infestation. However, the camp area is abutting a stone cattle byre, which had been identified as a heritage structure of low significance during the Heritage Specialist study conducted in 2006, due to its partial demise. A letter requesting the fencing of the stone byre was issued to the Contractor prior to work commencing in this area. During a routine inspection by the ECO of the earthworks for the construction of the upper labour camp, it was identified that the cattle byre (stone walled kraal) had been damaged during the earthworks operation. During a follow-up investigation by the EM and EO on Friday, 14 March 2009, it was established that approximately 2m of the stone wall structure was damaged by plant during the clearing of the wattle stand. The structure had been demarcated with danger tape as a precursor for formal fencing of the structure.

Mitigation: Eskom does have a SAHRA permit to damage sites in the Free State, however, this may only occur with approval of the Project Archaeologist, and this was not given. The site is of low significance; however, there was no need to destroy the site. I suggest that the damaged part of the site is rebuilt to resemble the original version as close as possible. The length of the walling can be deduced from high-resolution aerial photography, while the construction technique can be deduced from the rest of the wall. This should be undertaken with the Project Archaeologist on site. Costs (in time and labour) should be charged to the contractor if possible.

<i>Actions to prevent occurrence</i>	<ul style="list-style-type: none"> ✓ The cattle byre is to be fenced off immediately once the wattle from the area has been removed manually. ✓ The Contractor supervisor was made aware of the importance of the structure and was asked to keep all machinery away from the byre until it is fenced off.
<i>Current Status</i>	✓ The Project Archaeologist will complete an assessment of the damage and report to SAHRA.
<i>Date of Resolution / Expected date of resolution</i>	21 April 2009, after archaeologist report.
<i>Responsible Manager and Contact Details</i>	Mr James Richards (Project Manager: MUCW) Cell: 083 472 8037
<i>Previous Events</i>	No similar previous events occurred.
<i>Proposed SI Status</i>	Legal Contravention

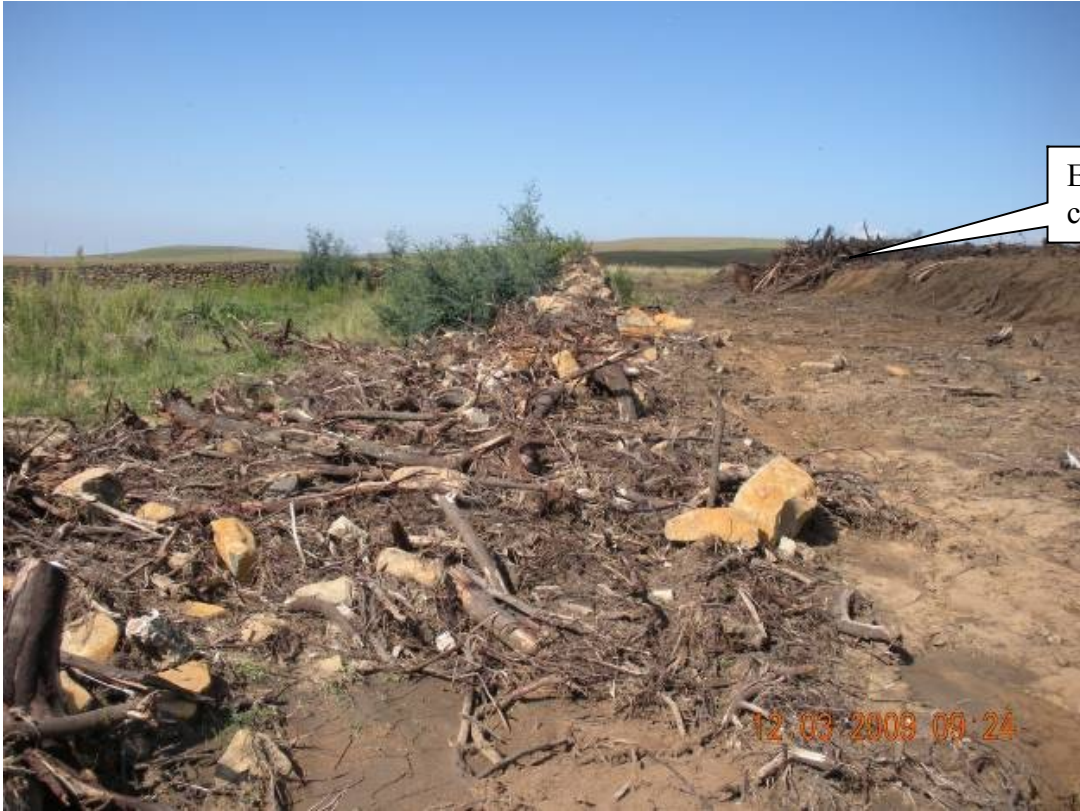
Earth platform & cleared wattle
