INSPECTION REPORT OF DAMAGED PEDESTRIAN SUSPENSION (CABLE STAYED) BRIDGE CROSSING THE MSUNDUZI RIVER JUST WEST OF CHIEF ALBERT LUTHULI BRIDGE (S1 – 36), PIETERMARITZBURG.

Report by: AJ Bresler PR.ENG. As requested by Msunduzi Manager O&M (Bheki Sosibo)

Date: 17 November 2022.

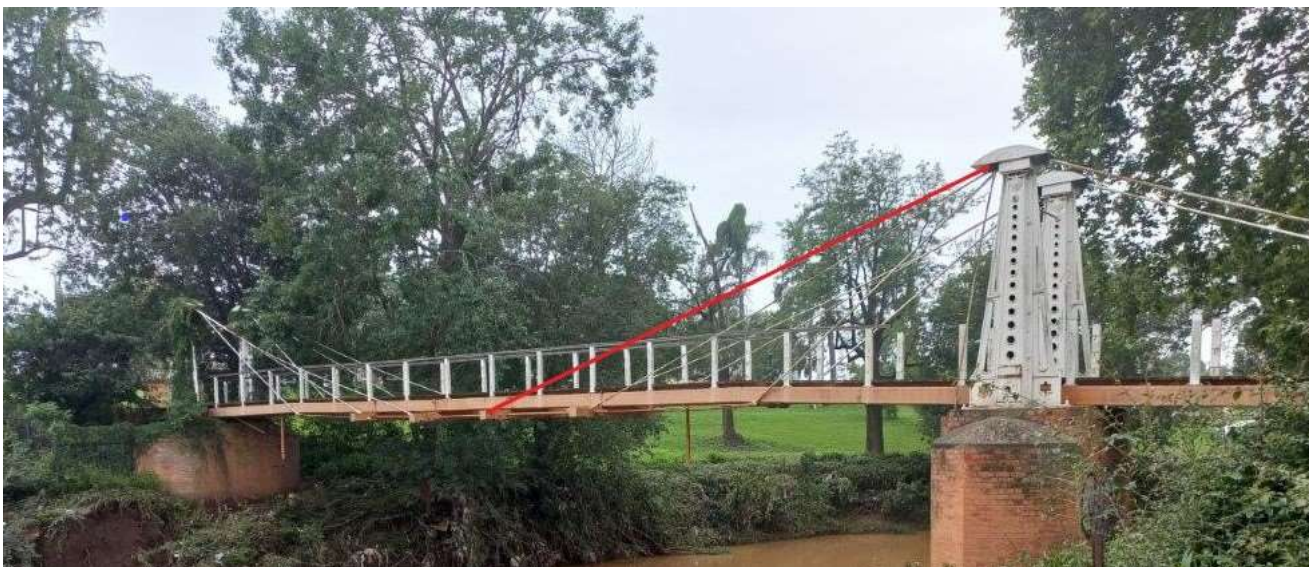
- 1.1 One of the 12x angled 32mm dia. tie rods between the undercarriage and the steel pylon / tower on the western bank of the river broke off where it connected to the a support beam of the under carriage. It should be possible to fix this tie rod by adding a short length of 32mm dia. round bar to it. This can be done by cutting thread into the end of the existing shortened round tie bar and the round bar to be added and connecting them by screwing them into a threaded connecting bush. An angled structural component also needs to be made to replace the component through which the rod passes and against which it is bolted to transfer the load of the tie to the supporting beam. The component required, possibly dropped into the river and has gone lost when the angled tie rod broke off. (Refer Picture 1 for the position of the tie.)

Picture 1 Angled tie to be re-instated, shown with red line:

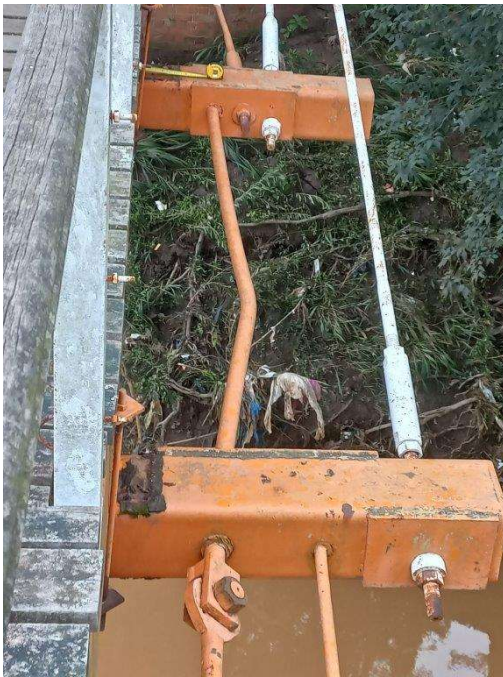
Picture 2 Bent tie rod downstream. **Picture 3** Bent tie rod upstream. **Picture 4** Connecting bracket pipe brace

- 1.2 Horizontal bent tie rods. These tie rods need to be removed and straightened out in a work shop and then put back. Before these rods are however removed, a temporary connecting steel strap or something similar needs to be installed between the two structural members which the tie rods connect, to temporally take over the ties function. This is to make sure that the structural integrity of the bridge is not compromised. (Refer Pictures. 2 & 3)

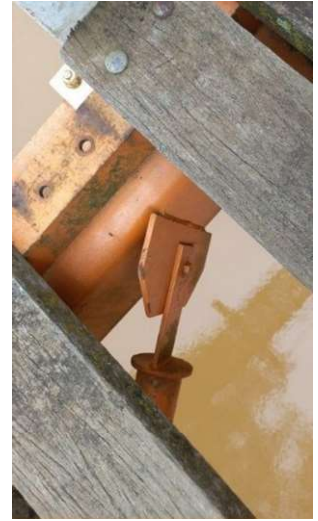
- 2.1. Three of the pipe sections which form part of the bracing between the main walkway beams; broke loose when the bolts connecting these braces sheared where the braces were bolted to connecting plates. New galvanised high tensile bolts, grade 8.8 need to be used to reconnect the braces to the connecting plates. Replace the bolts either side of the brace. (Refer Pictures 4 & 5)

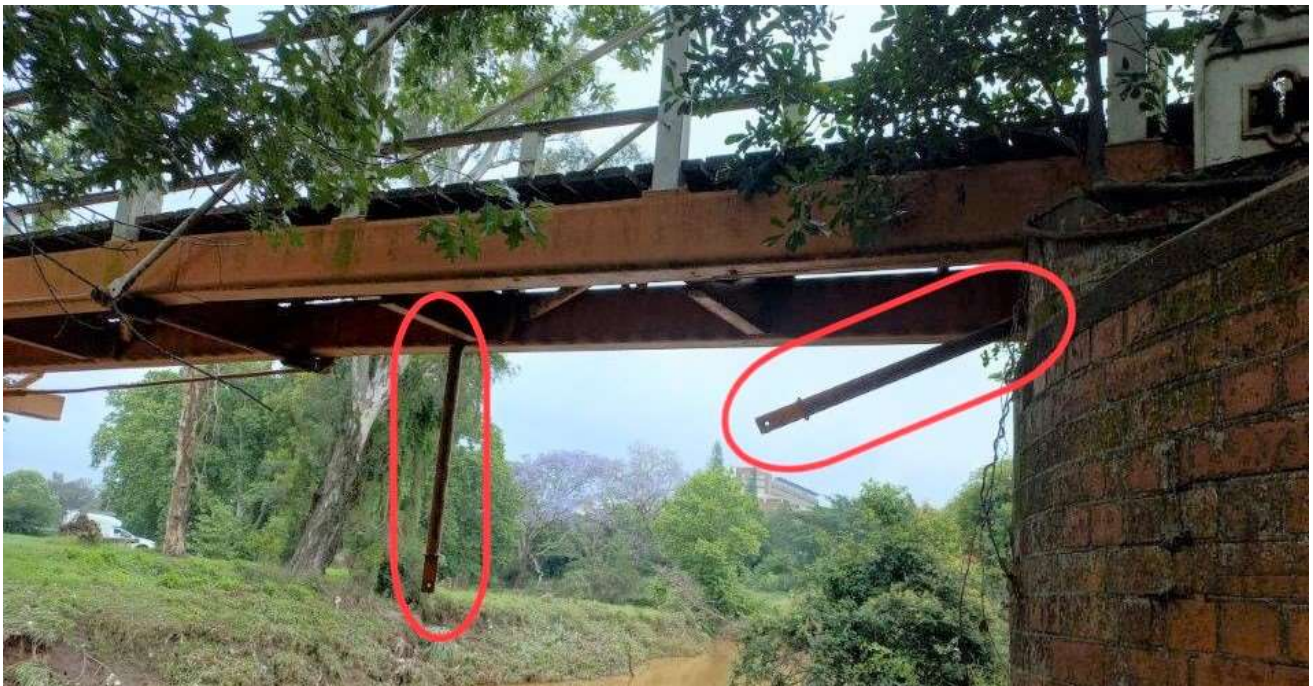
Picture 5 Pipe braces which form part of walkway to be fixed by replacing sheared bolts.

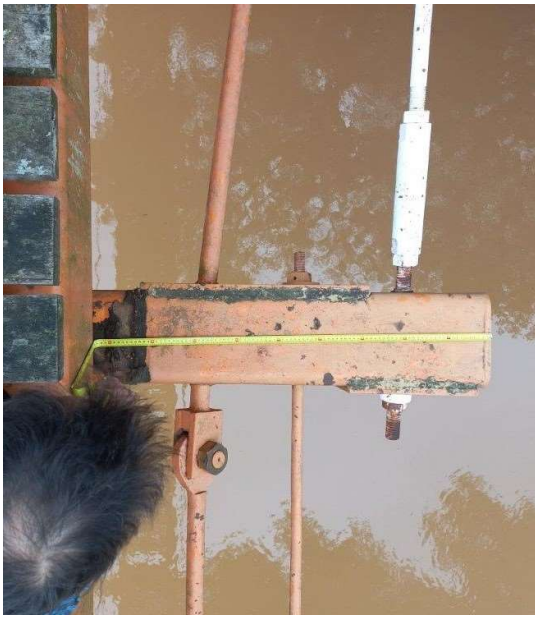
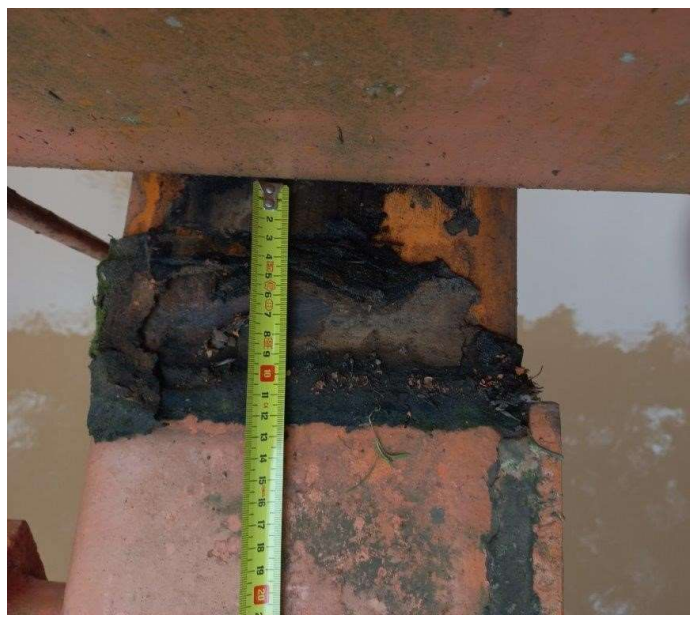
- 3.1. At two places where the walkway shifted horizontally with about 10 cm. on the support beams of the walkway, the 4x (damaged connecting brackets) need to be replaced with new similar brackets.
- 3.2. While these brackets are being replaced, the shifted walkway needs to be moved back to its original position by means of horizontal jacking. (Refer Pictures 6 & 7)

Pictures 6 & 7 Walkway shifted 10cm relative to support beam of the under carriage, at two places.

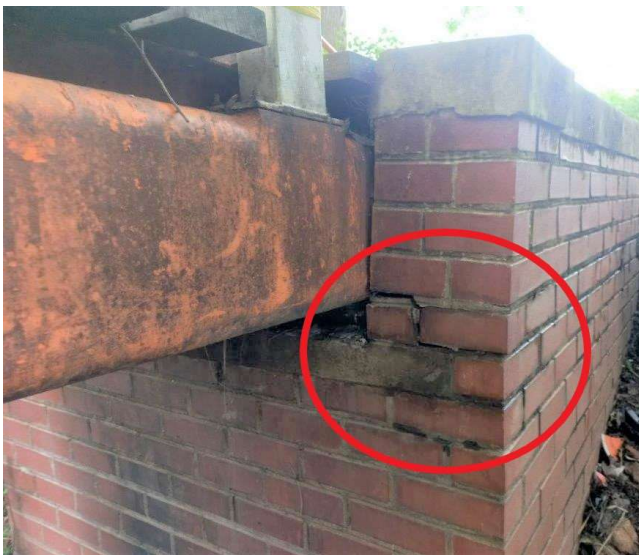
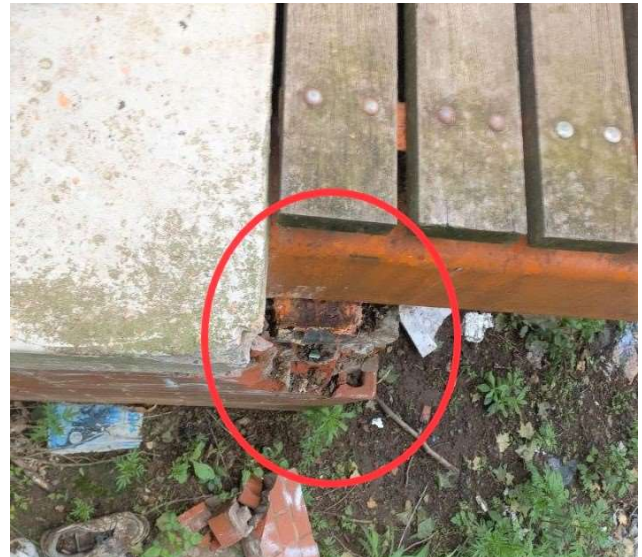
- 4.1. The brickwork on the downstream side of both abutments broke away from the rest of the abutment due to the lateral force applied to it by the walkway. The walkway needs to be shifted horizontally to its original position both sides and the damaged brickwork reinstated.(Pictures 8 & 9)

Pictures 8 & 9 showing damage to brick work where walkway ties into the abutments.

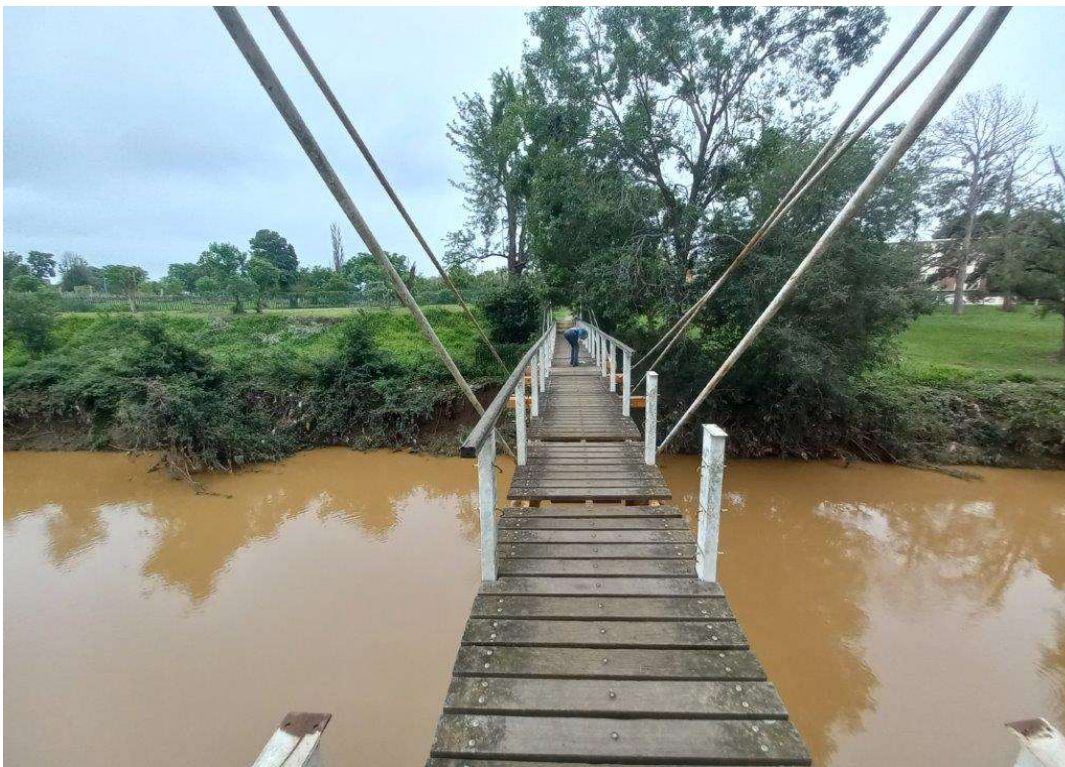
1. Unfortunately over and above damages occurred on the 9th of November, the bridge has also been the target of opportunistic theft. In picture 10 it can be seen that horizontal pipes which form part of the parapet, have been illegal removed (stolen). Part of the wooden handrail (probably made from balau) has also been removed. It would make sense that these stolen components also be replaced while the bridge is being repaired.

Picture 11 showing missing components removed (Expected stolen) from walkway

2. This work would however have to be treated as a separate cost item not linked to the cost occurred due to the damage incident which occurred on the 9th November. To make theft of the horizontal pipes more difficult, it is suggested that they be welded to the vertical posts of the parapet and not bolted to the posts with brackets which can easily be unbolted.
