MECHANICAL ASSESSMENT REPORT

WIMS070196 THE REPAIRS TO THE ROOF TO THE DEPARTMENT OF TRANSPORT MLB DURBAN OFFICE BUILDING, ETHEKWINI REGION

PREPARED: 15 March 2022

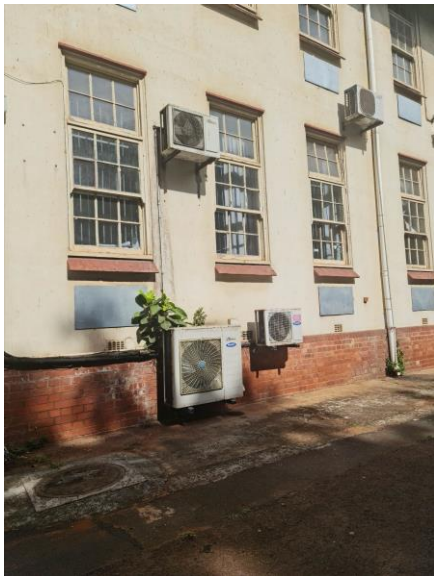
Figure 1: MLB Building Outdoor Units

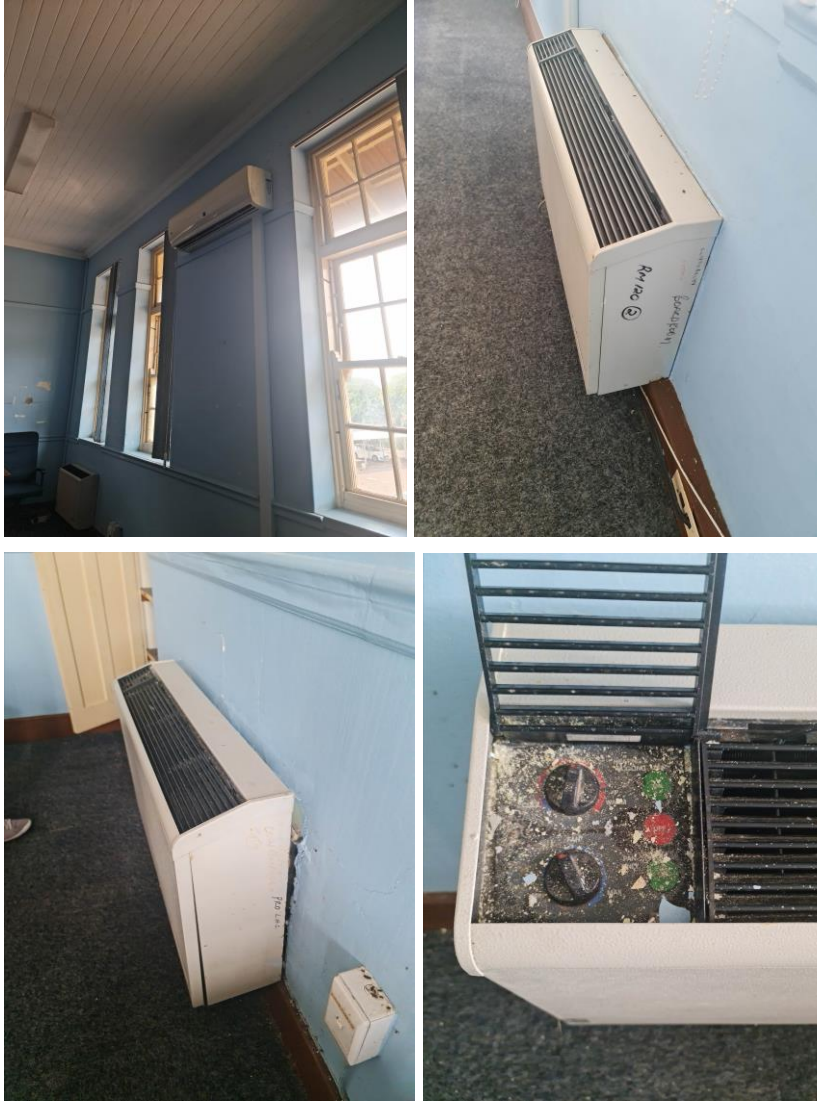
Figure 2: First Floor Boardroom aircon

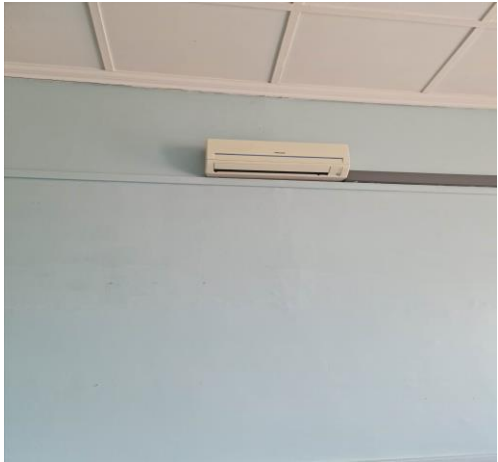
Figure 3: First floor split

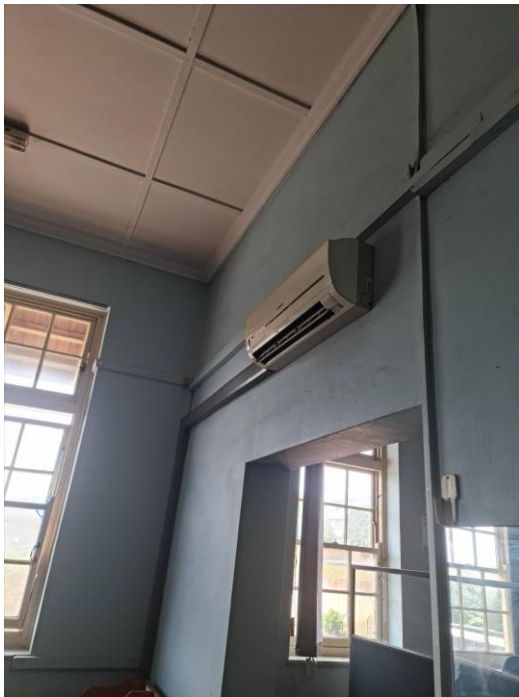
Figure 4: Dispatch Area Cassette and Fresh Air Diffuser Installation is Complete

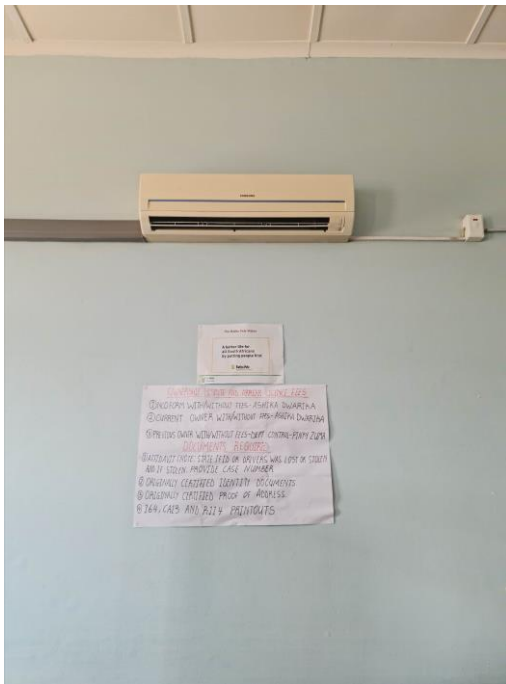
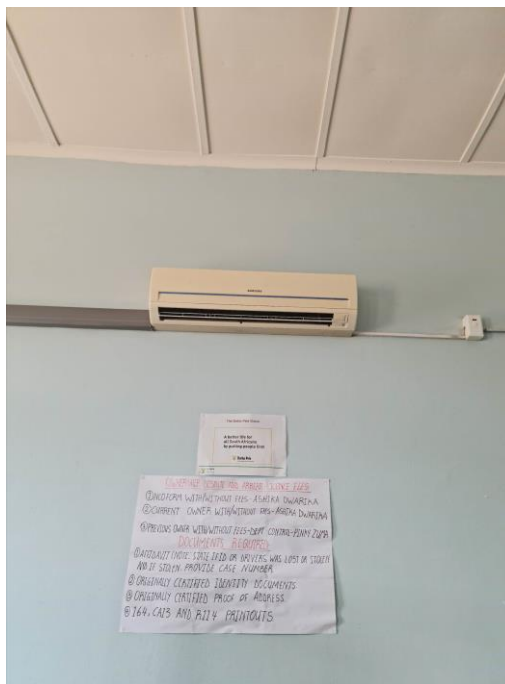
Figure 5: Staff room /office high wall split unit and fresh air supply diffuser installed

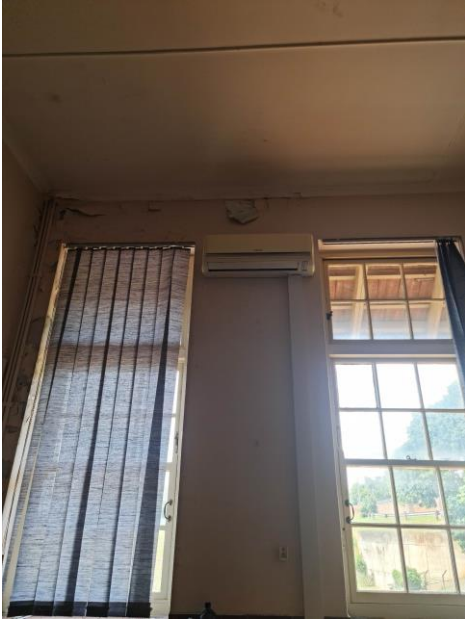
Figure 6: Room xx aircon is old and need to be replaced

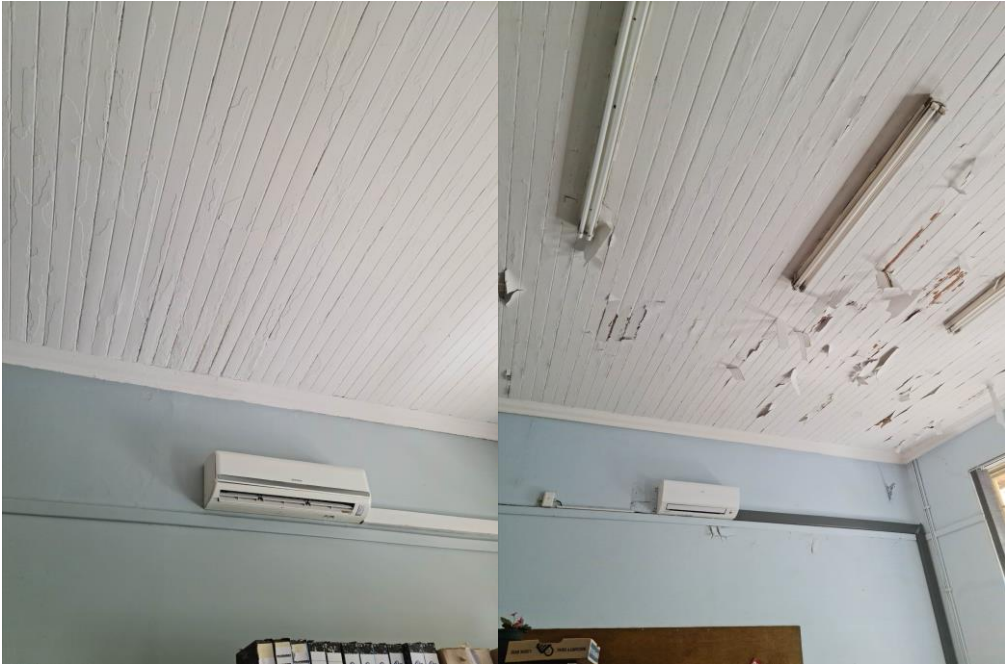
Figure 7: Rooms 116 & 118 aircons are old

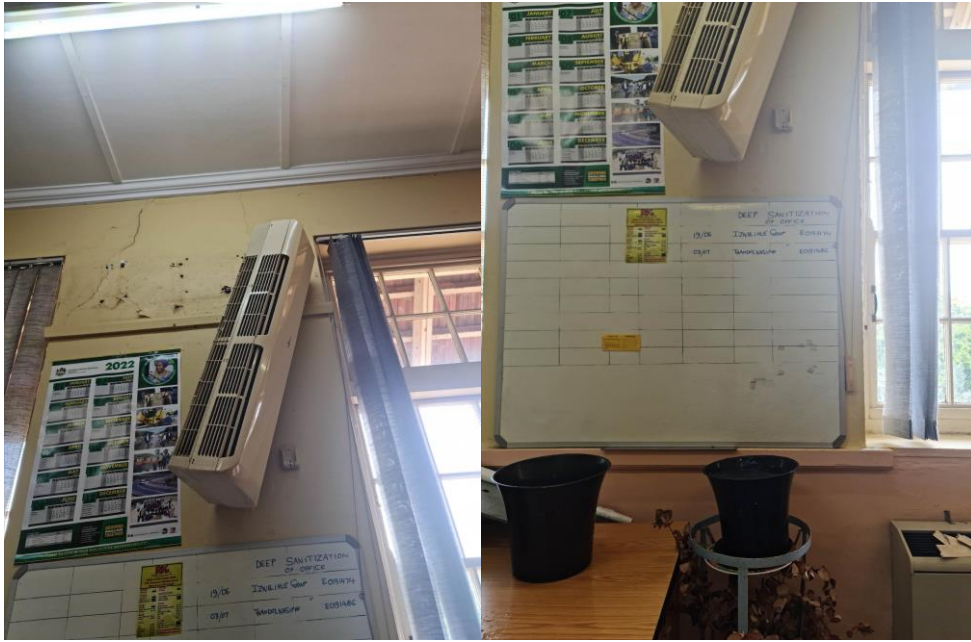
Figure 8: Room 114 aircon is broken and not working

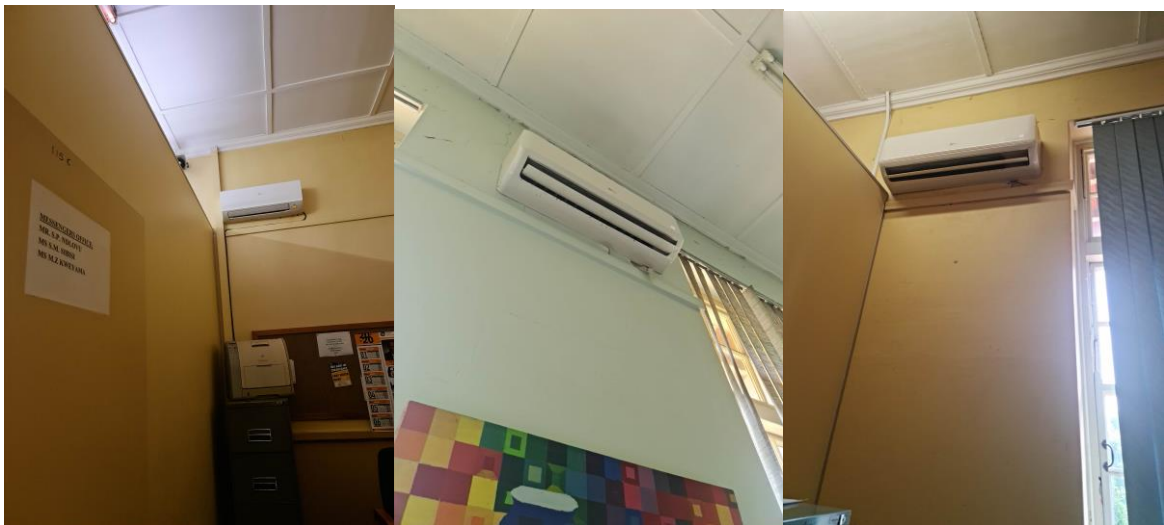
Figure 9: Room 115 (115a, 115b and 115c) aircons

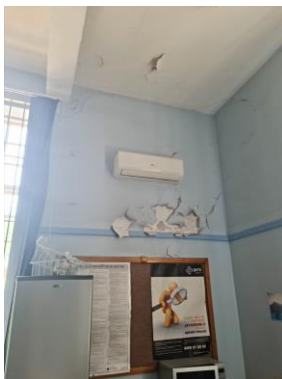
Figure 10: Ground floor Admin office Room 26 aircon

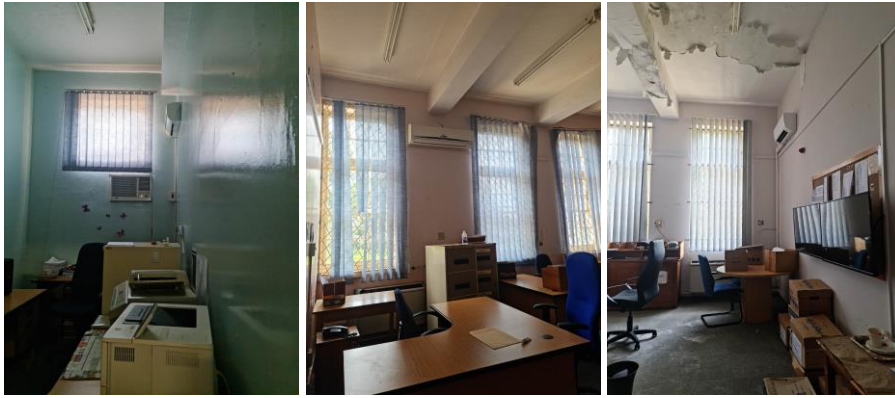
Figure 11:Ground floor Rooms 30, 30a and 33a aircons

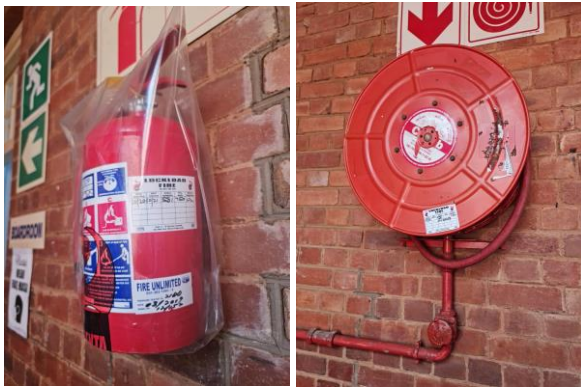
The fire extinguishers and hose reels of the whole building need to be serviced.

Figure 12: Fire Extinguishers and Signage installed

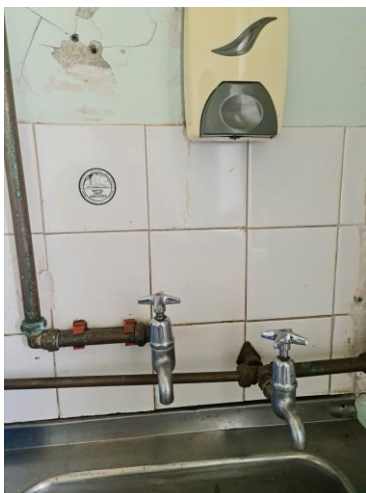
Figure 13: Hot & Cold-Water pipes need to be replaced

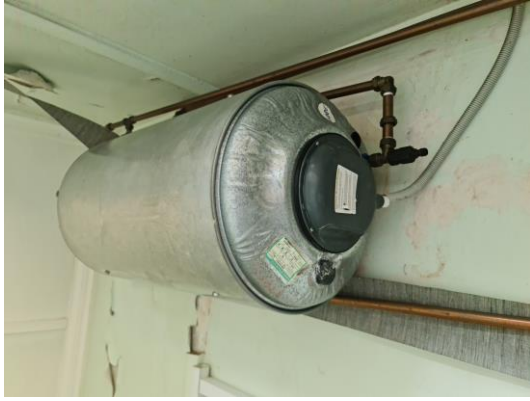
Figure 14: Geysers 100L need maintenance

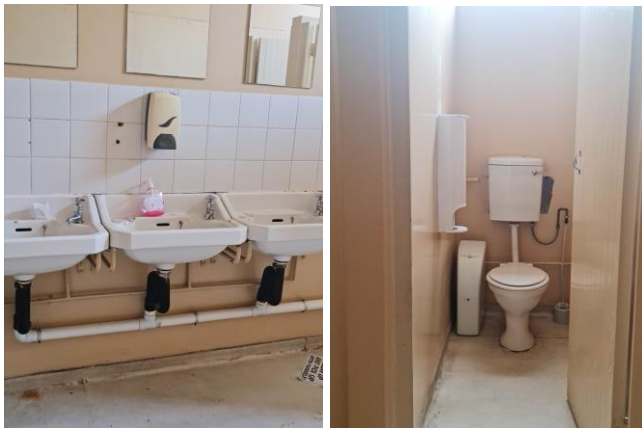
Figure 15: Drainage pipe need to be maintained (Room 35)

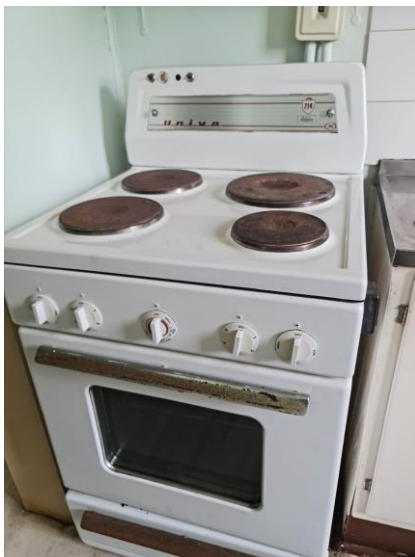
Figure 16: The stoves (x2) is old and not functioning

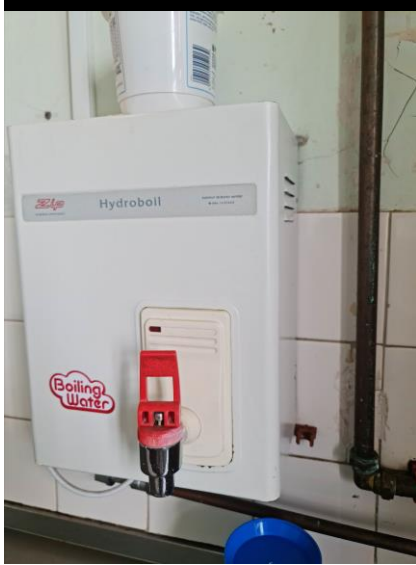
Figure 17: Hydro boil need to be replaced

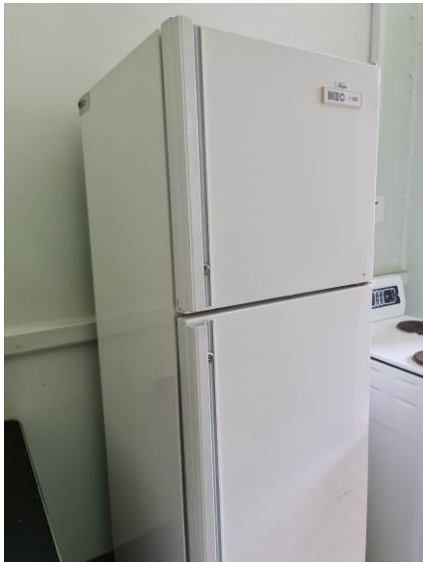
Figure 18: Fridge is old and need replacement

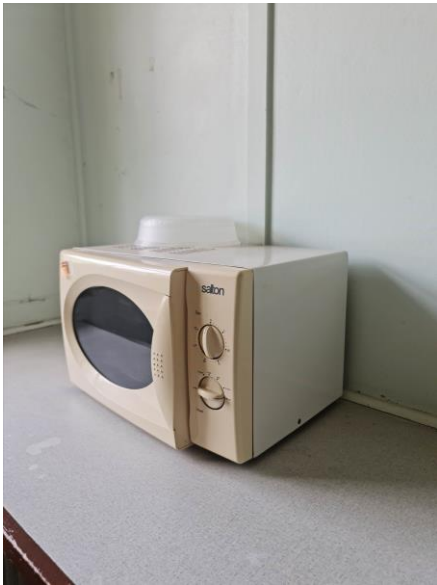
Figure 19: Kitchen first floor microwave is old need replacement

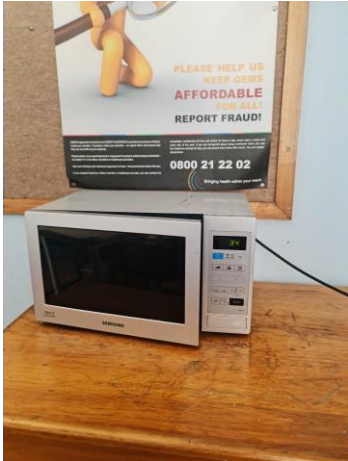
Figure 20: Ground floor admin microwave need replacement

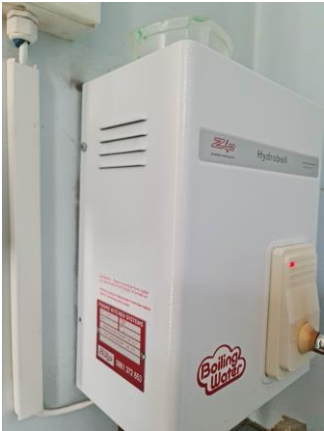
Figure 21: Ground floor admin hydro boil need replacement

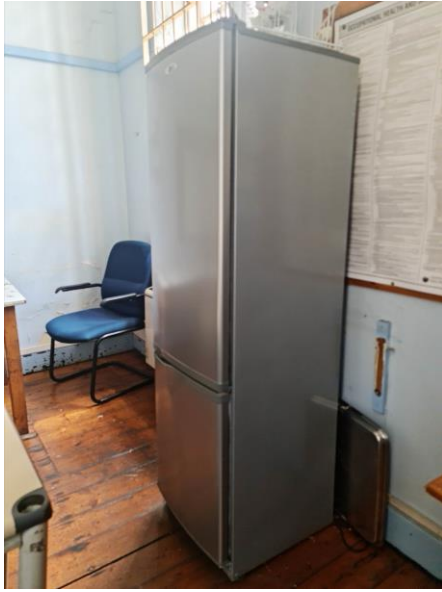
Figure 22: Ground floor admin fridge need replacement
