An inspection of the buildings in Church Street, Tulbagh, was done on behalf of the N.M.C. by Kirstin Van Tonder and Gwen Fagan on the 12th and 13th November, 1997. The following report summarises the legal and illegal changes which were found and provisional recommendations on how these might be addressed and the general image of the street be enhanced.

Kerkstraat in't Land van Waveren

GENERAL ISSUES:

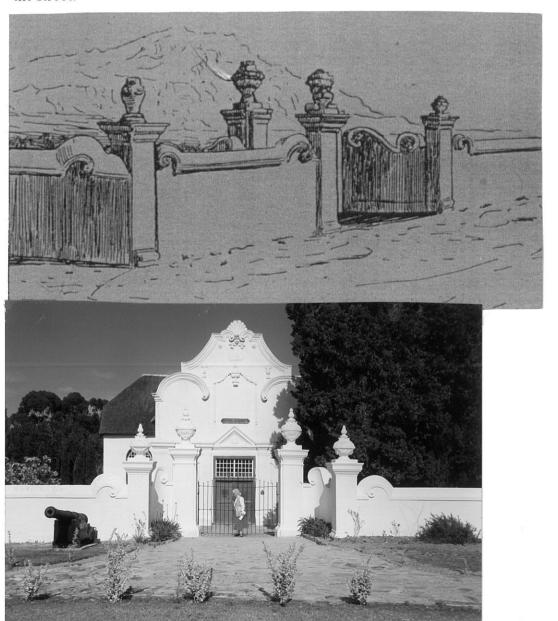
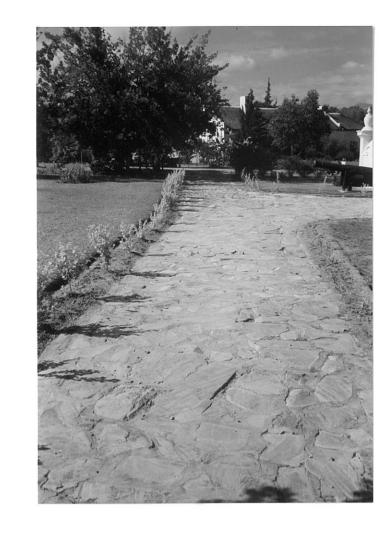
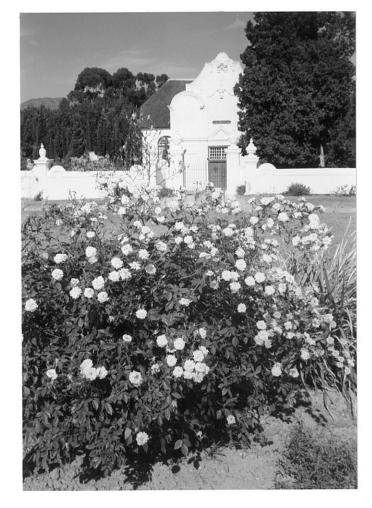
THE CHURCH MUSEUM

The church is in a good state of repair.

The church would, however appear at its best in a simple landscape of grass spilling up against the white walls with no hard paths, flower beds with stone edging, hedges and spotty planting of various shrubs unrelated to the period when the church was built.

The surrounding landscape should be simplified not only to create a more sympathetic environment to the most beautiful church in the country, but also to provide the lowest possible maintenanc.

Kikuyu which has to be regularly cut and manicured, giving the impression of a suburban lawn, should be killed with a weed-killer.

Planting of an indigenous grass like Kweek or buffalo, both of which need much less watering and are also low maintenance, should be done.

Into the grass should be planted many small spring bulbs like oxalis, chinkerechees, lachenalias, babiana, sparaxis and the other small local bulbs for which Tulbagh is famous. Once these bulbs start growing, the grass is left uncut until the summer, after they have flowered and seeded themselves.

The grass should stretch from the road to up against the walls of the church without a break. Footpaths should be of concrete grass blocks (e.g. Terraforce) planted with the same grass to provide an unbroken grass surface.

All hedges, rose clumps and other shrubs should be removed, perhaps for re-use elsewhere in the street.

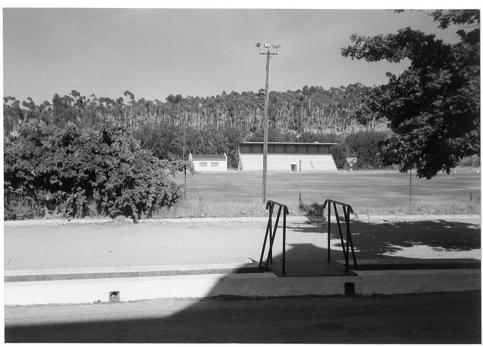
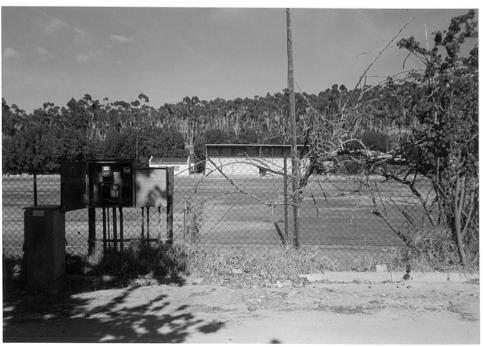
THE PARKING AND FENCE ON THE CHURCH STREET BOUNDARY OF THE SPORTS FIELDS AND PAVILION

The oaks in this area have grown well, but the bougainvillea on the fence is interrupted and tatty-looking. When it is not flowering in winter these shrubs look even worse. Bougainvillea does not contribute to the authentic historic atmosphere of the street.

More oaks planted in a row next to the fence would provide more shade which in summer is sorely needed for parking.

It is suggested that the rose "Macartney" be planted against the fence to form a permanent evergreen hedge. This rose is disease-resistant, vigorous, needs no pruning and flowers throughout the year. Because of its thorns it is also valuable from a security point of view. It can be planted in the gaps between the bougainvillea.

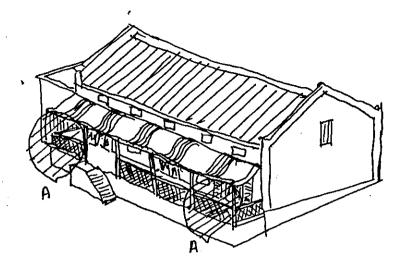
Housenumber 10

Ē	HOUSE NO 10
	The plan is largely unchanged and the building in a satisfactory condition. However, a veranda has been enclosed with a wall on the east side of the house so that the original kitchen has now been considerably darkened.
	Pillars have been built in the back yard to carry a pergola and the area under this paved with modern tiles. A retaining garden wall has been added.
L	RECOMMENDATIONS:
	A plan of the changes with motivation, should be presented to the N.M.C for consideration. The garden on the street needs to be upgraded.
7

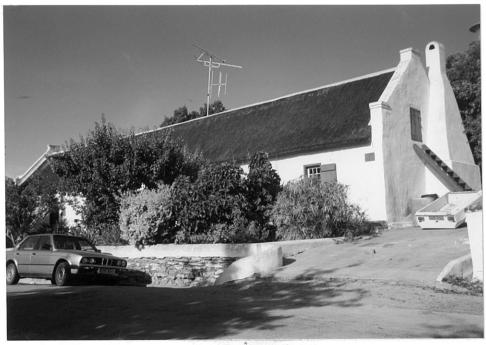
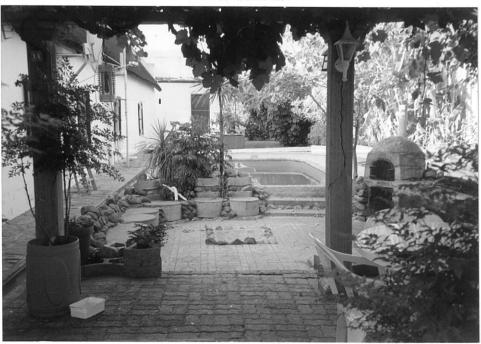
The exterior colour of this building, which was ochre, has now been changed to white and is not finished with a lime paint, but PVA. This paint is already showing signs of cracking and water build-up behind it. This was one of two outbuildings in the street which were at a stage adapted to become living quarters. As the ochre finish was often used for outbuildings, the ochre colour found on the base layer of the walls also in the fireplace, is therefore of special significance.

A swimming pool has been constructed in the back yard.

A pergola with brick pillars has been erected and the area beneath it paved with tiles. Various other level changes and floor finishes have been done around the pool.

As none of these changes have been approved by the N.M.C., the owner should be requested to send plans, photographs, and motivations for these changes to the N.M.C. for consideration by their planning committee.

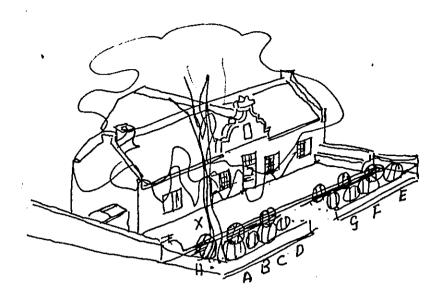
"Oude Bakkerij" (Behind house number 22)

· · ·	HOUSE BEHIND NO 22 (OUDE BAKKERIJ)
	The building is intact and is put to good use as offices for a firm of attorneys and a small gift shop in one room.
	RECOMMENDATIONS:
	The garden is well kept, but would benefit by adding heritage roses.
	•

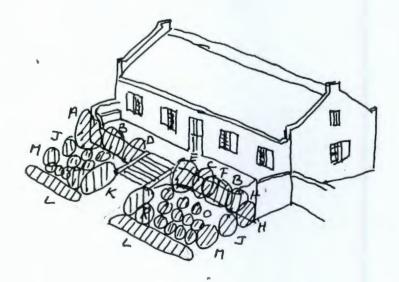
House number 38

This house, originally donated by the Tulbagh Restoration Committee to the Tulbagh Municipality for use as a local art and community centre, is now being used as a shop. The building has remained unchanged.

A plan for more suitable planting should be considered.
