KLEREFONTEIN FARM SQUARE KILOMETRE ARRAY (SKA), KAROO

by MAYAT HART ARCHITECTS & HERITAGE PRACTITIONERS

2023

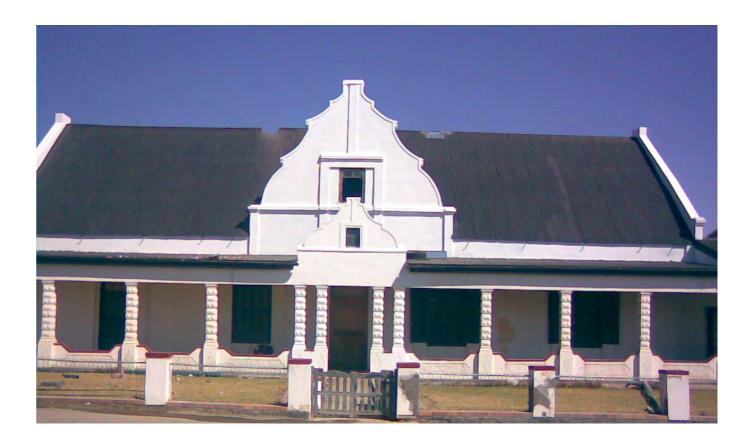
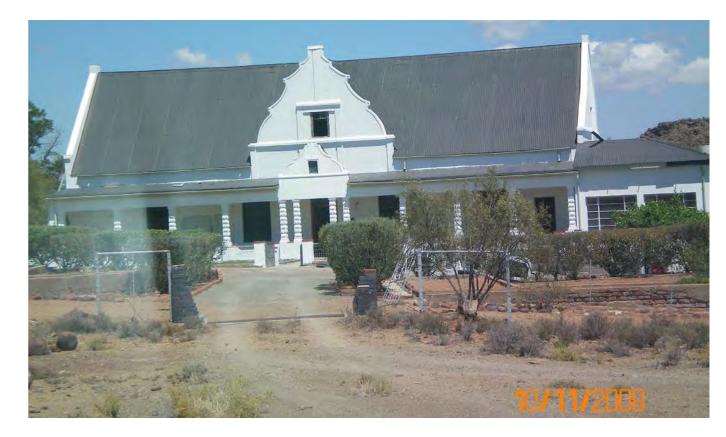
Figure 29 & 30: The Klerefontein farmhouse in 2008 prior to repair/restoration. Note the holes in the roof where the original chimneys were removed (SARAO).

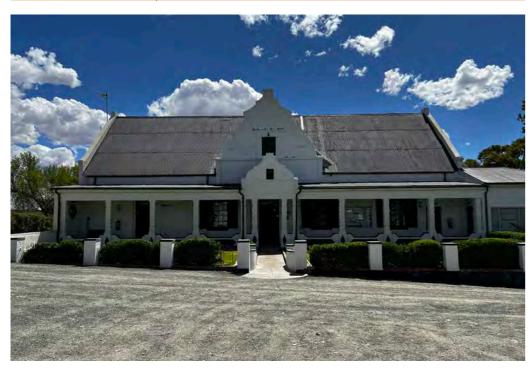
Figure 46: The Klerefontein Farmhouse

- The building is in a good state of repair.
- Internally the building has some original features such as ceilings, cornices, internal doors and some original windows. There has however been substantial internal alteration to services spaces.

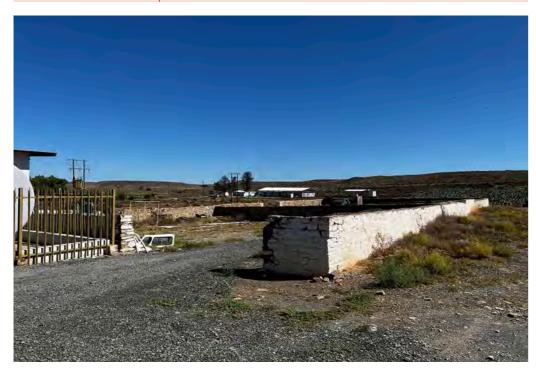
Figure 47: The Klerefontein Kraal

- The kraal is a good example of an early stone type kraal dating from the 19th century
- The kraal is in a fair state of repair but is showing ome damage/collapse in places.
- The relationship of the kraal to the other original building is of significance. Some of the significance of the relationship of the kraal to the farmhouse has been lost due to the construction of the new support base building.
- The kraal is significant as part of the collection of buildings and structures of the Klerefontein farm werf.
- The location of the kraal, particularly as viewed from the main road and its association with the farmhouse behind is of significance.
- In isolation the kraal has a Grade 3C grading. Due to its association with the farmhouse and werf it should be treated as having a grade 3B grading as per the farmhouse.

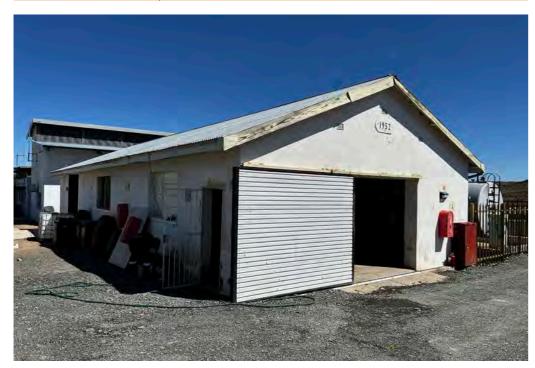
Figure 48: The Klerefontein Workshop

- The workshop building is a typical example of a utilitarian farm building from the mid 20th century.
- The building has been substantially altered internally for its current function. It is in a good state of repair.
- The relationship of the workshop building to the other original building is of significance.
- The building is significant as part of the collection of buildings and structures of the Klerefontein farm werf.
- In isolation the workshop building does not meet the criteria for grading. Due to its association with the farmhouse and werf it should be treated as having a Grade 3C grading.

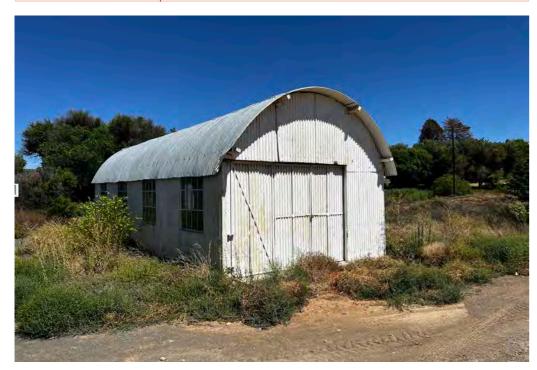
Figure 49: The Klerefontein Barn

- The barn building is a typical example of a utilitarian farm building from the early to mid 20th century.
- The building is original with no notable changes. It is in a fair state of repair.
- The relationship of the barn building to the other original building is of significance.
- The building is significant as part of the collection of buildings and structures of the Klerefontein farm werf.
- In isolation the barn building does not meet the criteria for grading. Due to its association with the farmhouse and werf it should be treated as having a Grade 3C grading.

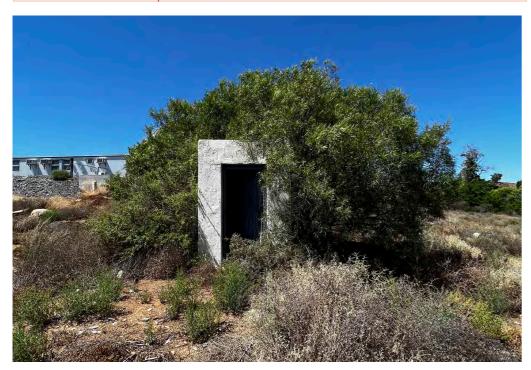
Figure 50: The Klerefontein Outhouse

- The outhouse building is a typical example of a utilitarian farm building from the late 19th to early 20th century.
- The building is original with no notable changes. It is in a poor state of repair.
- The relationship of the outhouse and the farmhouse is of significance.
- The building is significant as part of the collection of buildings and structures of the Klerefontein farm werf.
- In isolation the outhouse does not meet the criteria for grading. Due to its association with the farmhouse and werf it should be treated as having a Grade 3C grading.

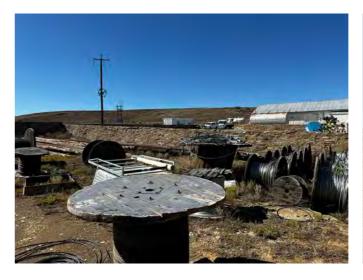
Figure 51: Damaged portion of kraal wall
