**MDALA MKHOMBO DEVELOPMENT AND UPGRADING OF INFRASTRUCTURE
HERITAGE IMPACT ASSESSMENT REQUESTED IN TERMS OF SECTION 38 OF
THE NATIONAL HERITAGE RESOURCES ACT (NO 25/1999)**

Tuesday, 13 June 2017

Project name: MDALA MKHOMBO DEVELOPMENT AND UPGRADING OF INFRASTRUCTURE - HERITAGE IMPACT ASSESSMENT REQUESTED IN TERMS OF SECTION 38 OF THE NATIONAL HERITAGE RESOURCES ACT (NO 25/1999)

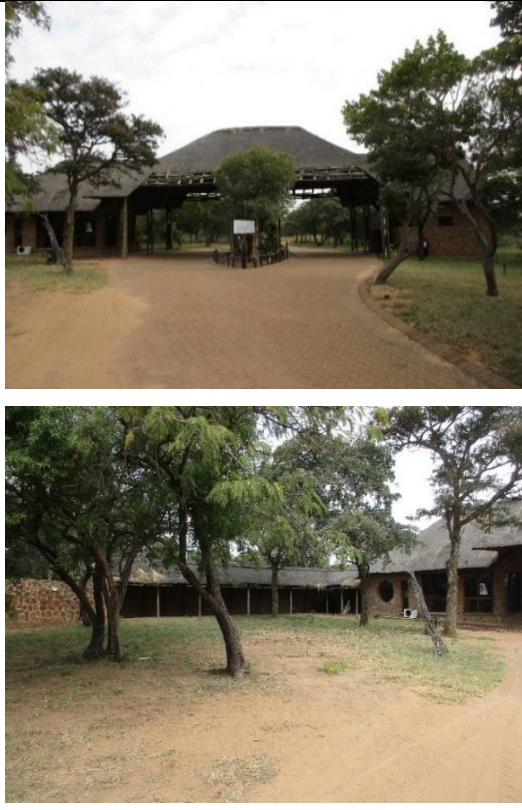
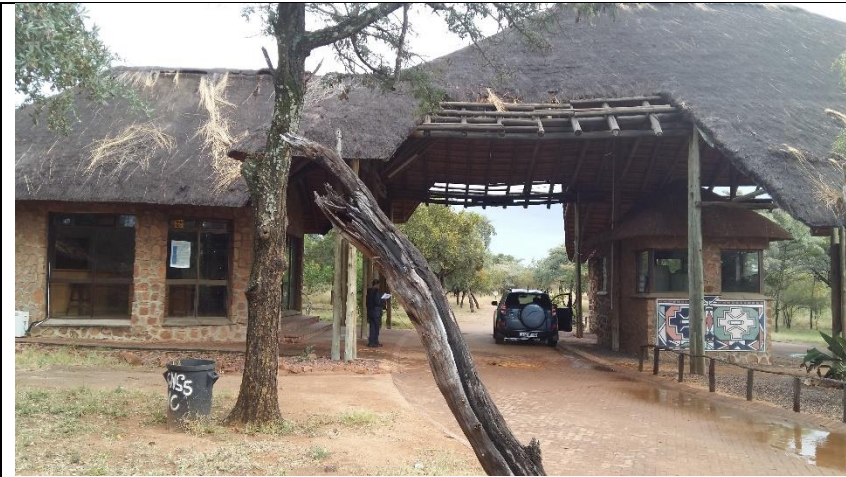
S1-2 Ndlulamithi Gate & Admin Office	COORDINATES	25°11'27.40"S	28°53'14.20"E

OBSERVATIONS: Thatched structure / complex which comprise the entrance and administration office. Surrounded by natural Savana woodland. Broken thatch and general disrepair of structure.

HERITAGE STATUS	Built in 1991 and less than 60 years old
POTENTIAL IMPACTS & PROPOSED MITIGATION	No heritage value, renovations can go ahead.

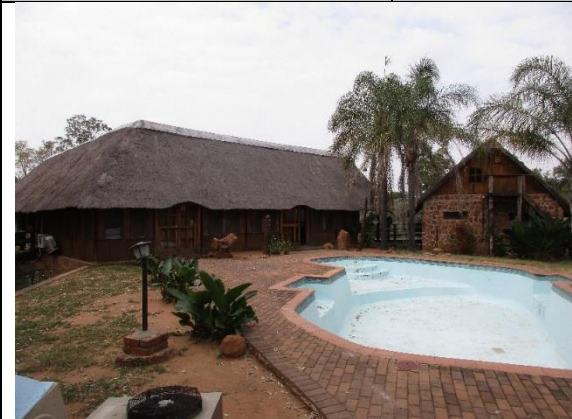
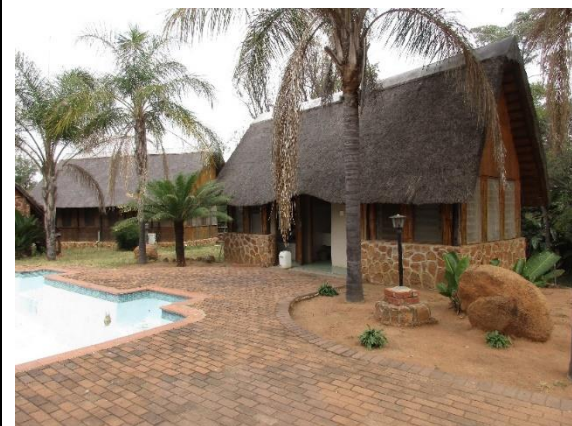
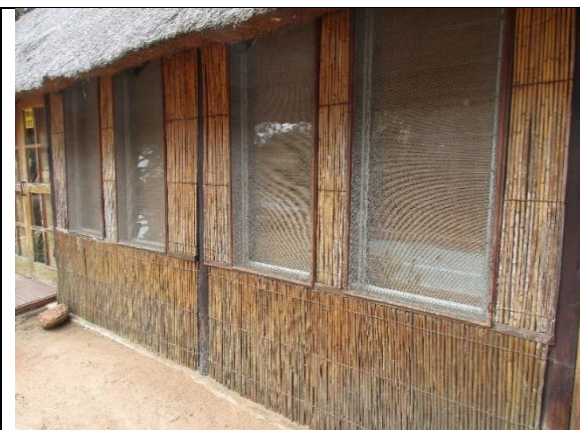
S3-4 Mkhohlwane Lodge	COORDINATES	25°14'28.00"S	28°49'16.60"E
------------------------------	--------------------	---------------	---------------

OBSERVATIONS: Lodge which comprise a number of thatched buildings and walls made of reeds. State of general disrepair and decay of thatch and reeds.

HERITAGE STATUS	Built in 1994 and less than 60 years old.
POTENTIAL IMPACTS & PROPOSED MITIGATION	No heritage value, renovations can go ahead.

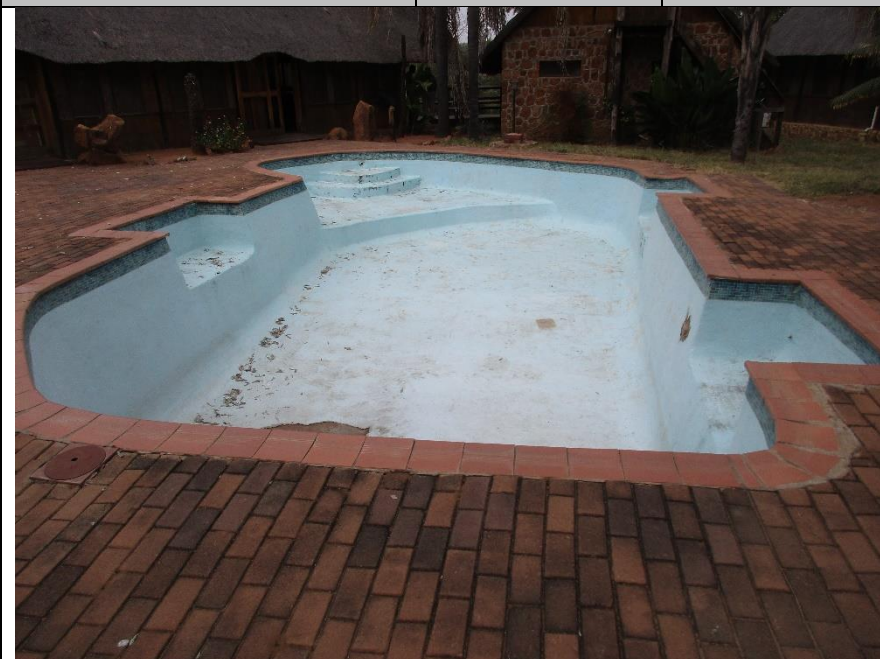
S3-4b Mkhholwane Swimming Pool	COORDINATES	25°13'16.70"S	28°50'58.20"E
---------------------------------------	--------------------	---------------	---------------

OBSERVATIONS: Swimming pool located in a square between buildings. In a state of disrepair.

HERITAGE STATUS	Built in 1994 and less than 60 years old.
POTENTIAL IMPACTS & PROPOSED MITIGATION	No heritage value, renovations can go ahead.

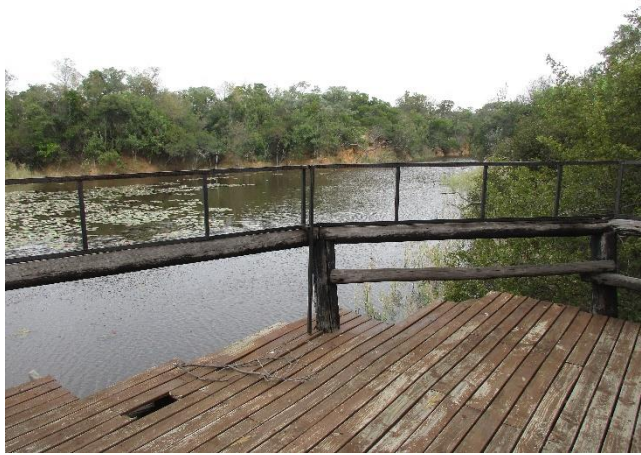
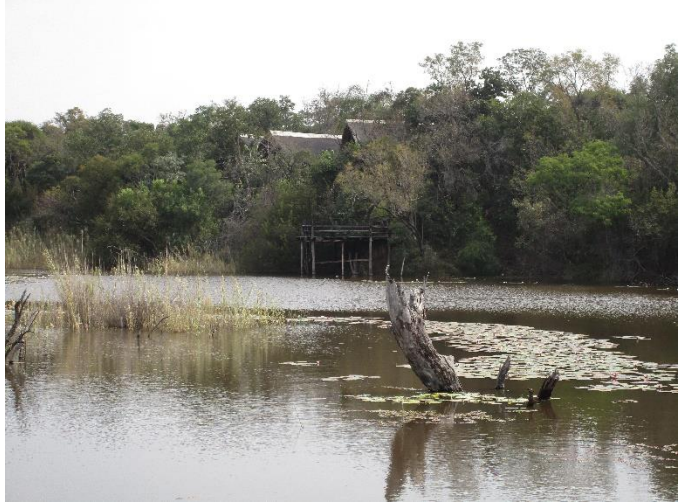
S3-4c Mkhholwane lakeside deck	COORDINATES	25°13'16.70"S	28°50'58.20"E
---------------------------------------	--------------------	---------------	---------------

OBSERVATIONS: Lakeside deck of timber flooring and standing on wooden poles. Timber generally decayed and there is risk that the deck may collapse.

HERITAGE STATUS	Structure less than 60 years old.
POTENTIAL IMPACTS & PROPOSED MITIGATION	No heritage value. Replacement of wood/ reconstruction may go ahead.

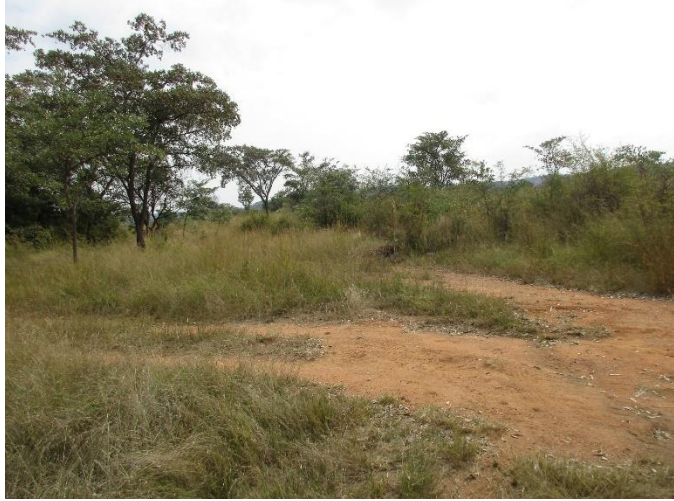
S3-4d Proposed Boardroom / Conference Centre	COORDINATES	25°13'16.70"S	28°50'58.20"E

<p>OBSERVATIONS: Flat area and good woodland to the west of the lodge. Ground visibility good on pathways, poor elsewhere due to grass. Site of the proposed construction of a boardroom / conference facility.</p>			
HERITAGE STATUS	No heritage resources found.		
POTENTIAL IMPACTS & PROPOSED MITIGATION	The proposed development may go ahead.

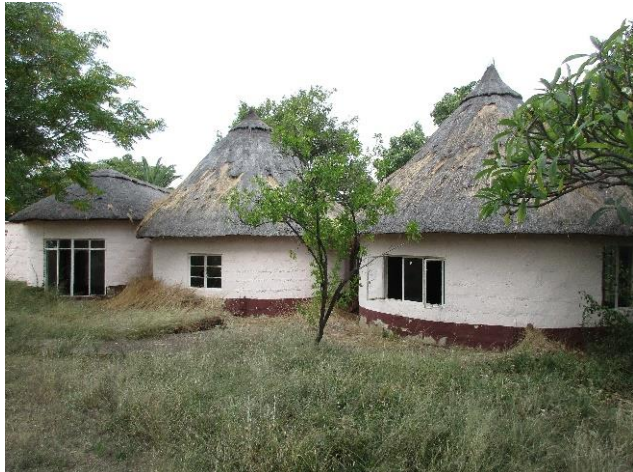
S6 Zandspruit Guesthouse	COORDINATES	25°13'16.70"S	28°50'58.20"E

<p>OBSERVATIONS: Old abandoned lodges consisting of three thatched rondavel</p>			
<p>HERITAGE STATUS</p>	<p>Structures dating back to the 1990s and less than 60 years old</p>		
<p>POTENTIAL IMPACTS & PROPOSED MITIGATION</p>	<p>No heritage significance. The proposed renovations may go ahead.</p>

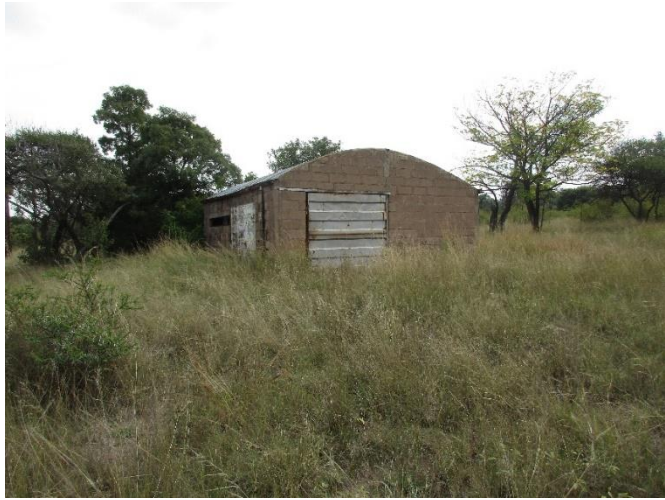
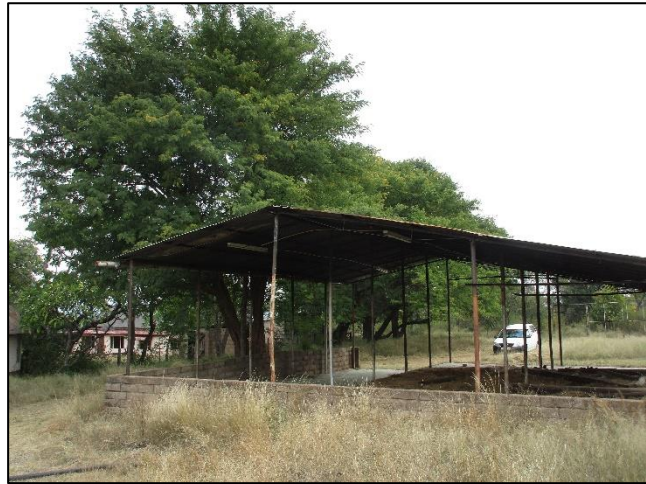
S6b Zandspruit Garages	COORDINATES	25°13'16.70"S	28°50'58.20"E
-------------------------------	--------------------	---------------	---------------

OBSERVATIONS: Derelict garages, outbuildings of the lodge.

HERITAGE STATUS	Structures date back to the 1990s, thus less than 60 years old.
POTENTIAL IMPACTS & PROPOSED MITIGATION	No heritage significance. The structures may be renovated or demolished.

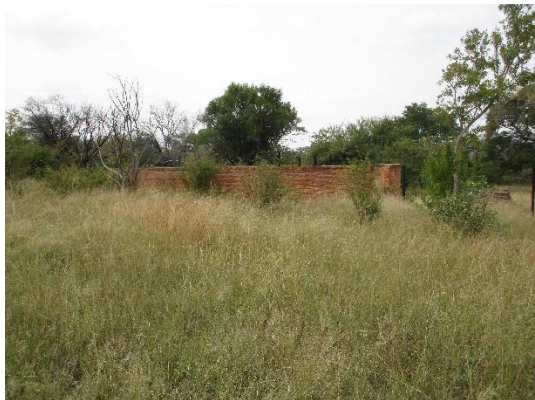
S6c Zandspruit Lapa	COORDINATES	25°13'16.70"S	28°50'58.20"E

<p>OBSERVATIONS: An old circular lapa which carried a conical thatched roof. It was destroyed by a fire.</p>			
HERITAGE STATUS	Structure built in the 1990s, thus less than 60 years old.		
POTENTIAL IMPACTS & PROPOSED MITIGATION	No heritage significance. The structure may be demolished or repaired.

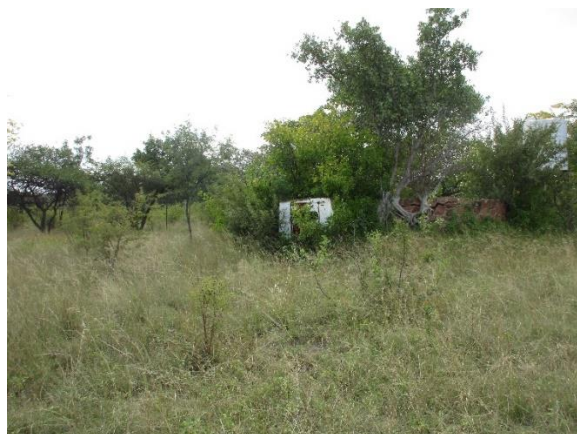
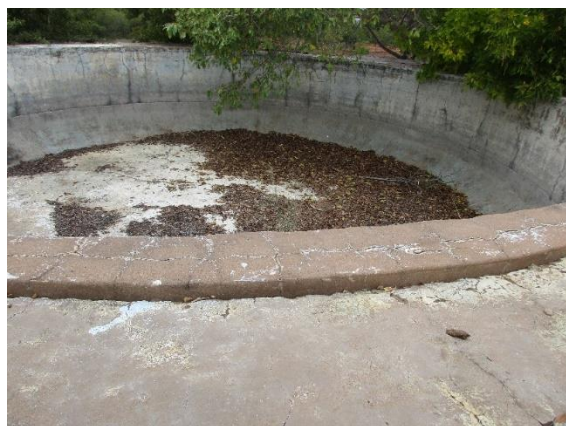
S6d Zandspruit Swimming Pool	COORDINATES	25°13'16.70"S	28°50'58.20"E
-------------------------------------	--------------------	---------------	---------------

OBSERVATIONS: A derelict concrete swimming pool.

HERITAGE STATUS	Structure built in the 1990s, thus less than 60 years old.
POTENTIAL IMPACTS & PROPOSED MITIGATION	No heritage significance, structure may be destroyed or repaired.

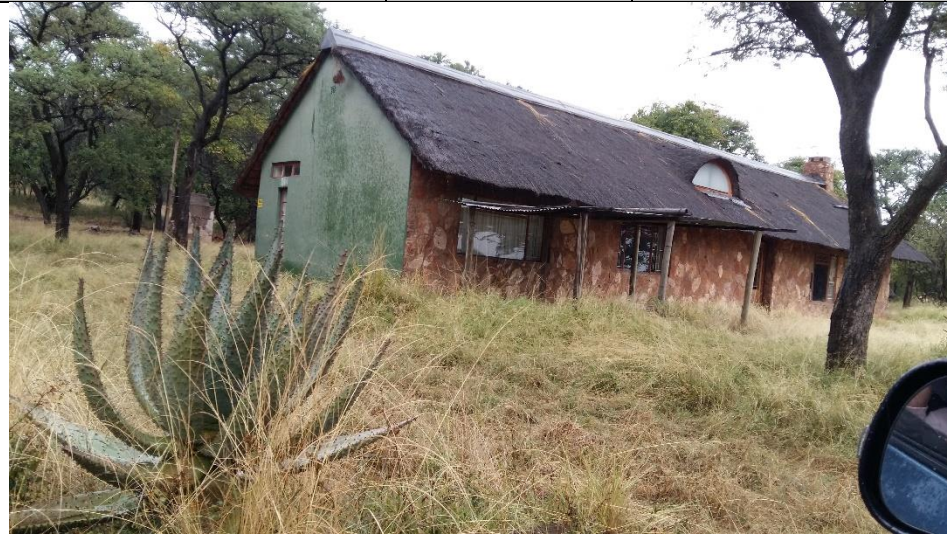
S8 Zandspruit Picket & Pump house	COORDINATES	25°12'28.50"S	28°51'51.10"E
----------------------------------------------	--------------------	---------------	---------------

Gabled building, front with stone with cement cladding. Decayed grass thatch.

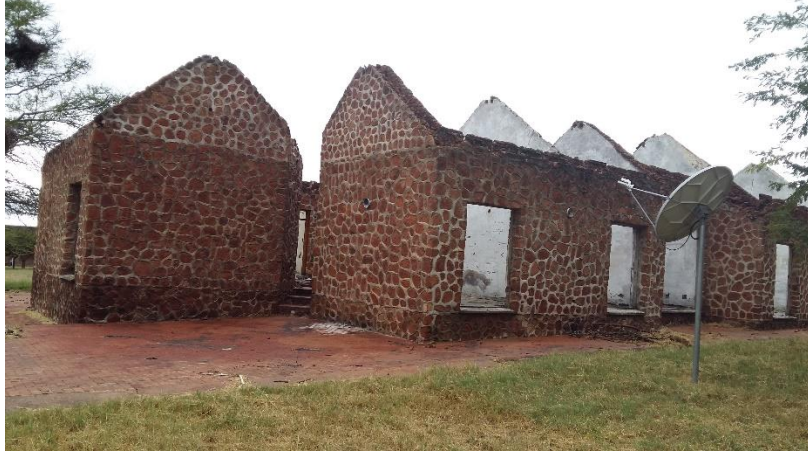
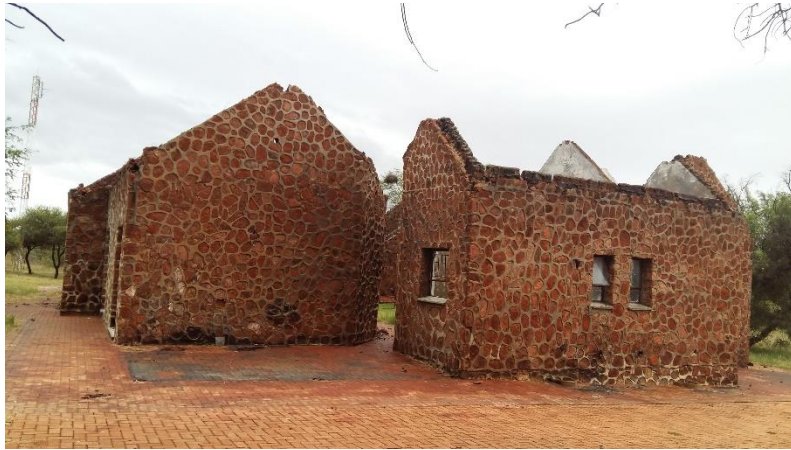
S9 Education centre	COORDINATES	25°11'24.15"S	28°52'49.88"E
----------------------------	--------------------	---------------	---------------

OBSERVATIONS: Building complex dating back to the 1990s which was destroyed by a fire.

HERITAGE STATUS	Structures built in the 1990s, thus less than 60 years old.
POTENTIAL IMPACTS & PROPOSED MITIGATION	No heritage significance, structures may be reconstructed.

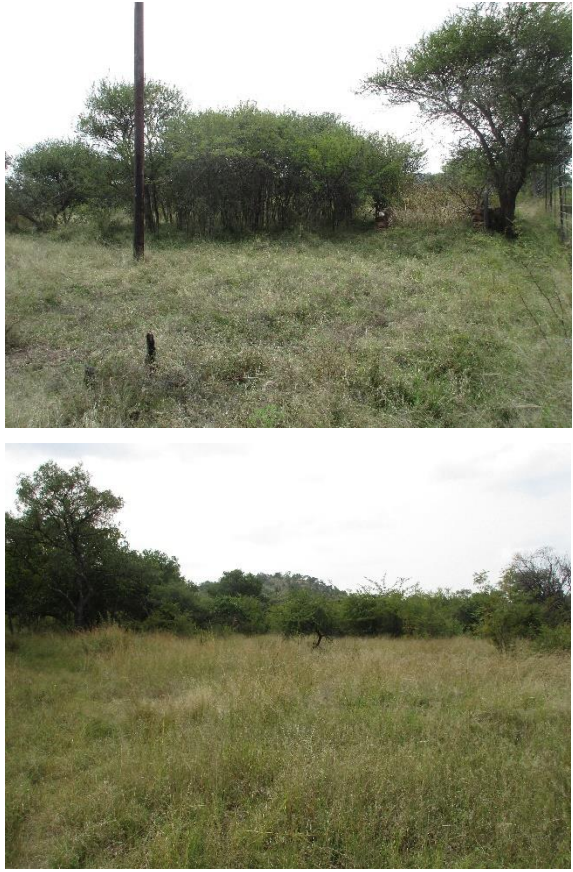
S7&10 Zwalebo Development	COORDINATES	25°11'55.30"S	28°49'44.20"E

OBSERVATIONS: Flat area, Savana woodland and grass. Ground visibility poor. No heritage resources.			
HERITAGE STATUS	No heritage resources found.		
POTENTIAL IMPACTS & PROPOSED MITIGATION	The proposed development may go ahead.

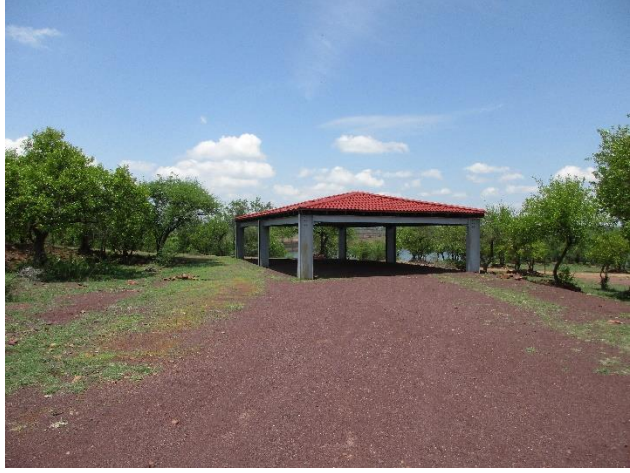
S1 - Kitchen	COORDINATES	25° 5'45.54"S	28°55'3.63"E

<p>OBSERVATIONS</p> <p>A shed, tiled hipped roof standing on heavy steel columns. It was built in 1990. It was to be custom-designed into a camping kitchen. The project was not completed.</p>			
HERITAGE STATUS	Building less than 60 years old		
POTENTIAL IMPACTS & PROPOSED MITIGATION	N/A

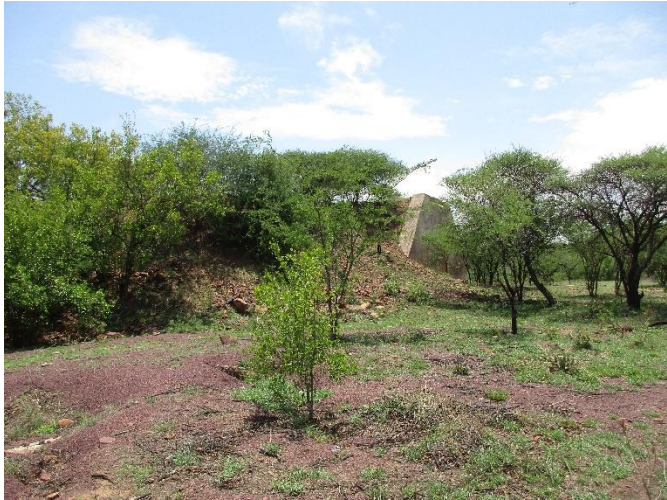
S2 - Offloading Ramp	COORDINATES	25° 5'43.50"S	28°55'6.04"E

OBSERVATIONS			
An earth ramp with a concrete revetment on the north-eastern side served trucks offloading quarry into the plant for crushing.			
HERITAGE STATUS	Structure less than 60 years		
POTENTIAL IMPACTS & PROPOSED MITIGATION	N/A

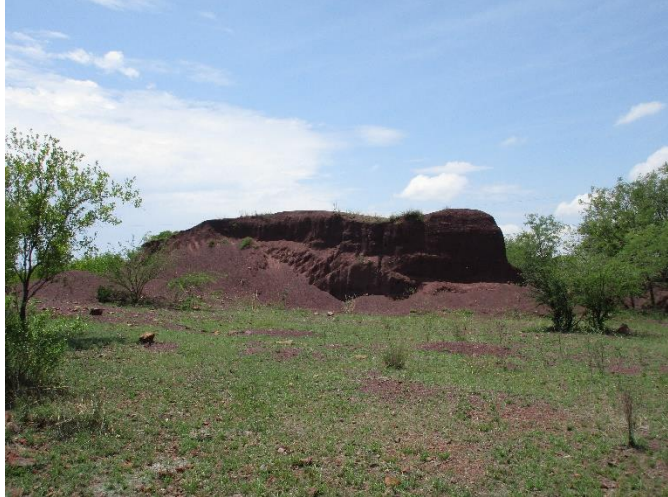
S3 – Gravel discard	COORDINATES	25° 5'40.07"S	28°55'7.32"E

OBSERVATIONS			
Fine grade concrete stone discard, leftovers from the dam building in the mid-1980s.			
HERITAGE STATUS	Less than 60 years		
POTENTIAL IMPACTS & PROPOSED MITIGATION	N/A

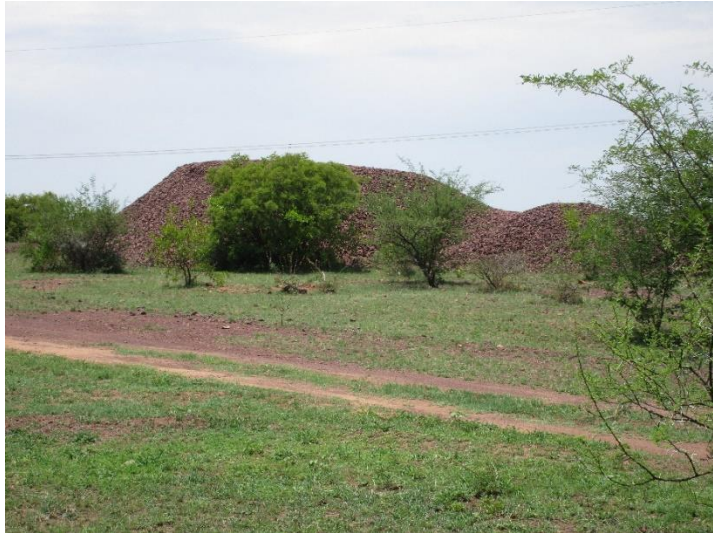
S4 - Gravel discard	COORDINATES	25° 5'40.28"S	28°55'11.70"E

<p>OBSERVATIONS</p> <p>Concrete stone discard, leftovers from the dam building in the mid-1980s.</p>			
HERITAGE STATUS	Less than 60 years		
POTENTIAL IMPACTS & PROPOSED MITIGATION	N/A

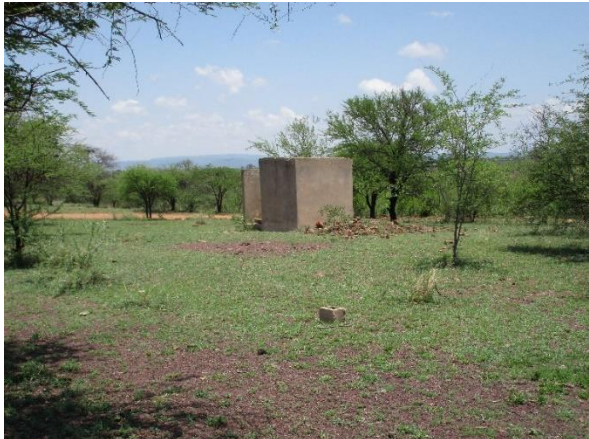
S5 - Lavatory disused	COORDINATES	25° 5'45.94"S	28°55'7.21"E

OBSERVATIONS			
Disused lavatory located near the stone crushing plant. It therefore dates to the dam construction period 1984-1986.			
HERITAGE STATUS	Structure less than 60 years old.		
POTENTIAL IMPACTS & PROPOSED MITIGATION	N/A

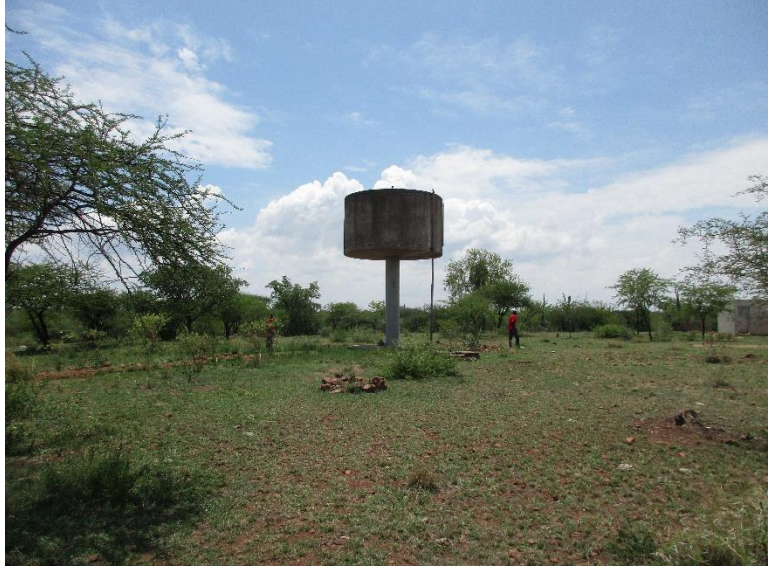
S6 – Concrete Reservoir	COORDINATES	25° 5'47.45"S	28°55'10.95"E

OBSERVATIONS			
Gravity reservoir of concrete standing on a concrete column. In current use. Water supply installation after the commissioning of the dam in 1987.			
HERITAGE STATUS	Structure less than 60 years old.		
POTENTIAL IMPACTS & PROPOSED MITIGATION	N/A

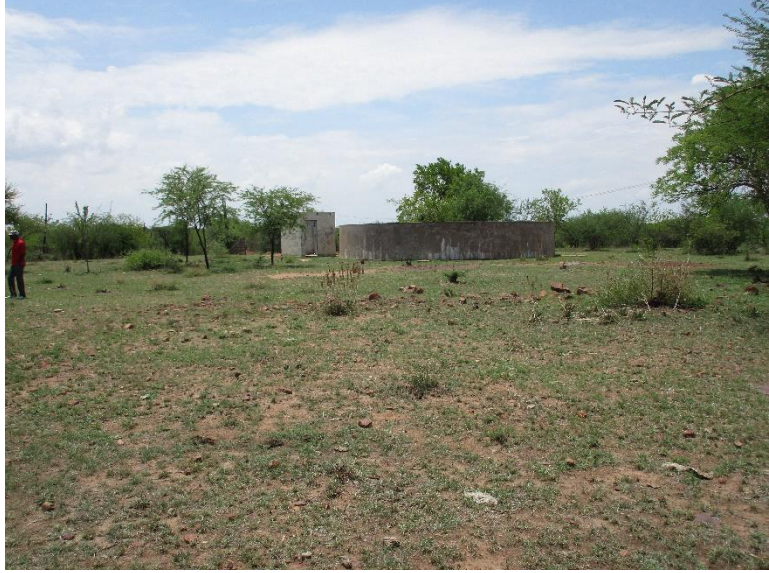
S7- Derelict Concrete reservoir	COORDINATES	25° 5'46.42"S	28°55'11.54"E

<p>OBSERVATIONS Derelict concrete water reservoir.</p>			
HERITAGE STATUS	Structure less than 60 years old.		
POTENTIAL IMPACTS & PROPOSED MITIGATION	N/A

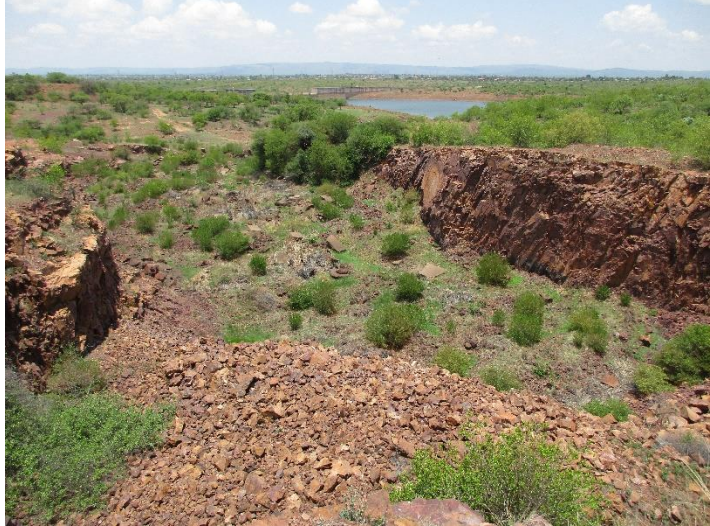
S8- Quarry	COORDINATES	25° 5'38.74"S	28°55'1.22"E

<p>OBSERVATIONS</p> <p>A stream inlet where a large quarry was operated for concrete raw material. Part of the quarry is flooded and creates a bay at full capacity.</p>			
HERITAGE STATUS	Structure less than 60 years old.		
POTENTIAL IMPACTS & PROPOSED MITIGATION	N/A

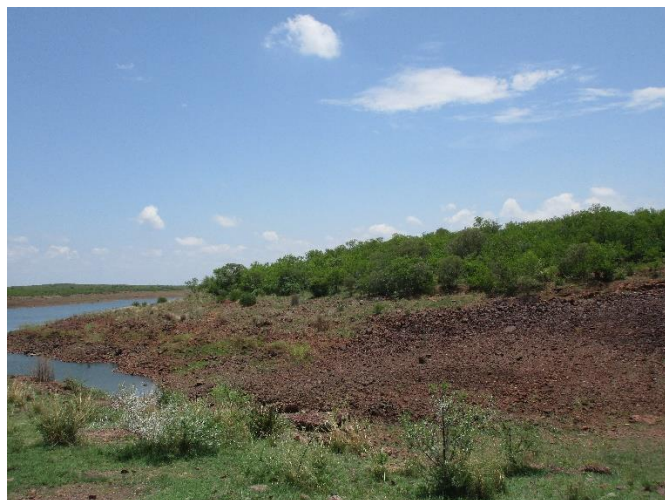
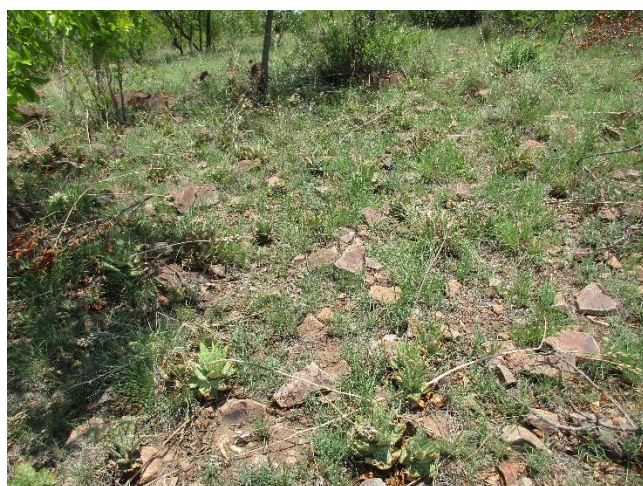
S9- Aloes	COORDINATES	25° 5'44.45"S	28°54'54.78"E
------------------	--------------------	---------------	---------------

Rocky spur facing the northern shore of the dam. Good Combretum woodland. Aloes identified as the stem-less species – *Aloe striata* grow are spread out in the woodland.

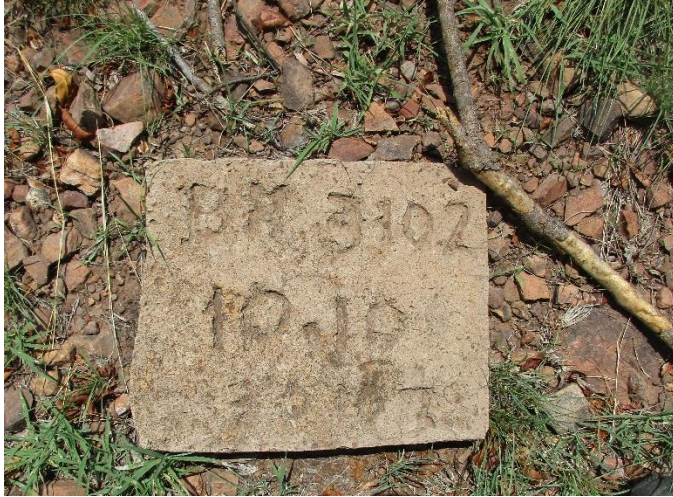
S10 – Survey Point	COORDINATES	25° 5'45.00"S	28°54'55.80"E
---------------------------	--------------------	---------------	---------------

This appears to be a survey point dated 31/10/78 (31 Oct 1978). It is pointer to the preconstruction planning phase of the dam project in the late 1970s.

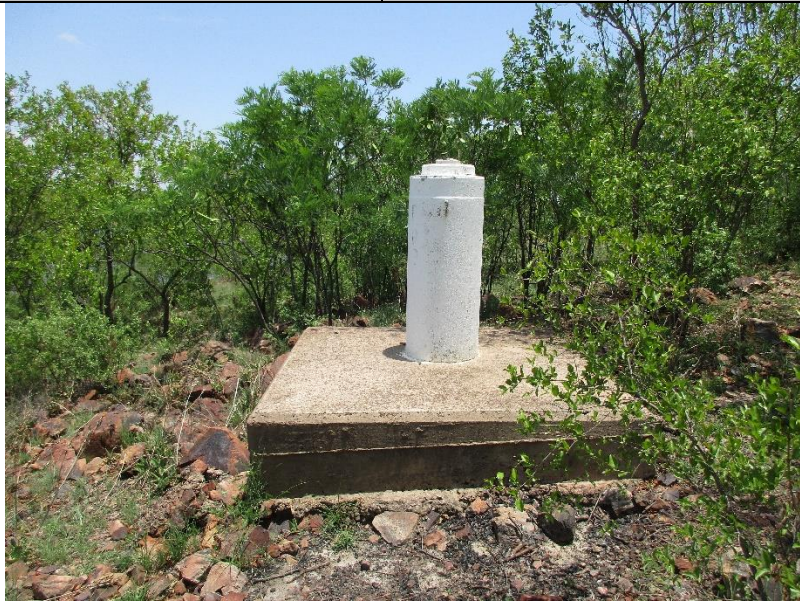
S11– Inundation Peg	COORDINATES	25° 5'45.58"S	28°54'56.75"E

OBSERVATIONS			
This inundation peg seems to lie outside the area where the buildings will be located.			
HERITAGE STATUS	Structure less than 60 years old.		
POTENTIAL IMPACTS & PROPOSED MITIGATION	It will not be affected by the proposed development.
