Final Report of Excavations at Robben Island - Old Power Station Cooling Pond

March 2012

Cape Archaeological Survey cc

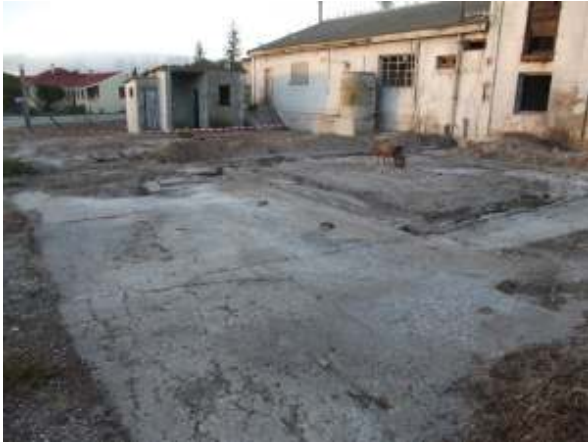
Figure 6: View of cement capping in front of Power Station.

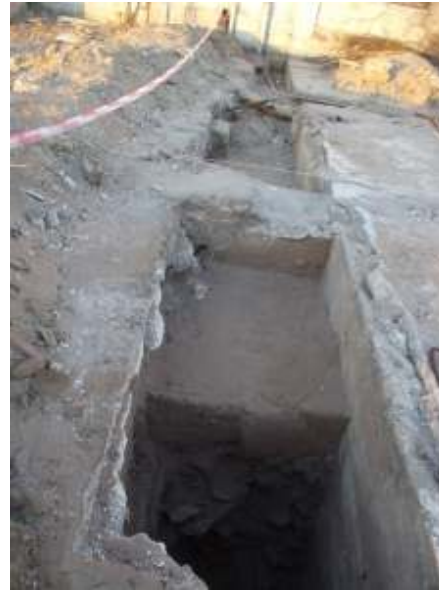
Figure 7: View of trench 1 excavated next to east wall of cooling pond.

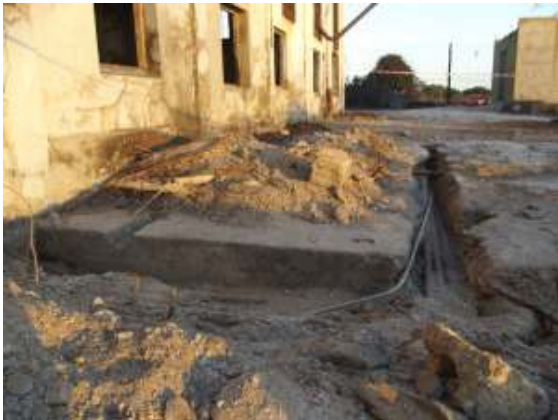
Figure 9: View of the gravity tank and pipes in front of power station.

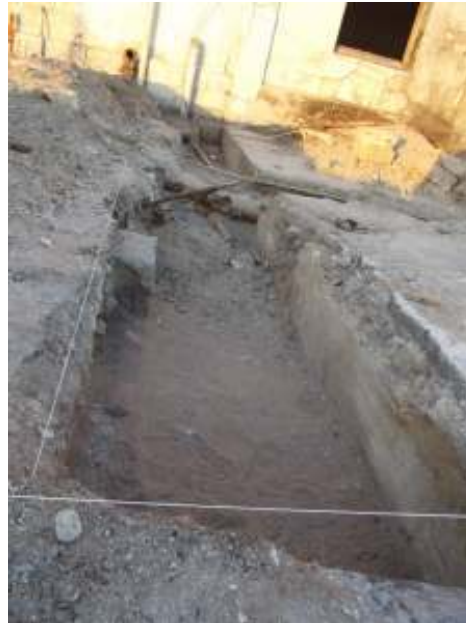
Figure 10: Pipes in the east wall of cooling Pond (trench 2).

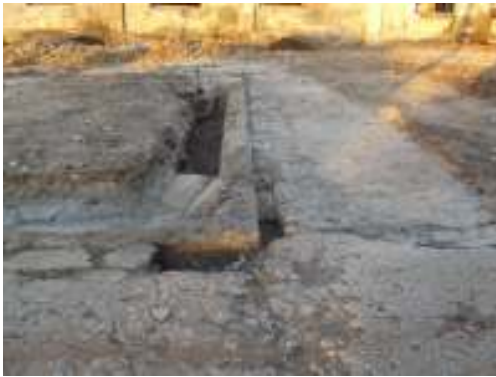
Figure 12: NE corner of cooling pond exposed.

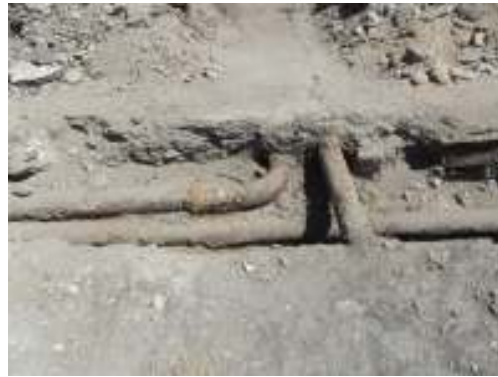
Figure 13: Rusty pipes in trench.

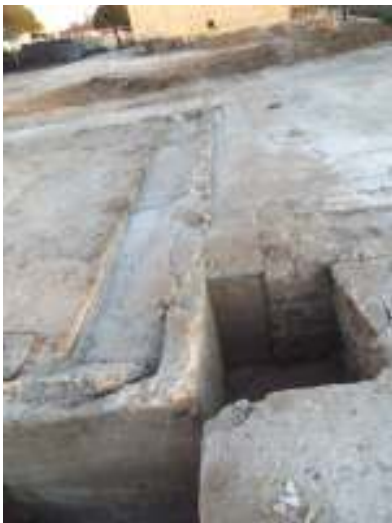
Figure 14: NE corner of cooling pond wall.

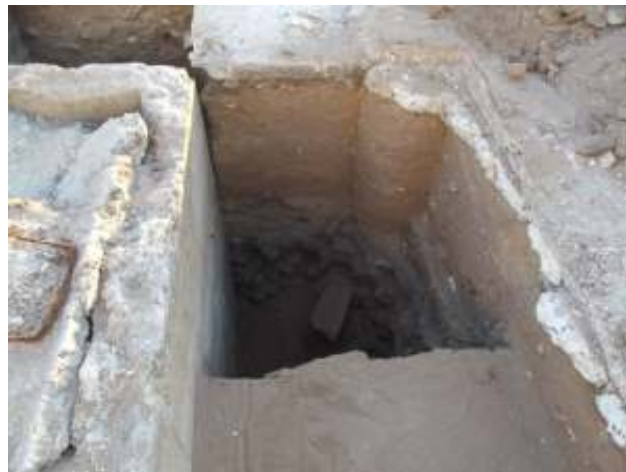
Figure 15: View of deposits with boulders at the base.
