Heritage Impact Assessment: Ship Repair Facility, Port of Mossel Bay

Transnet National Ports Authority

2 October 2018

Final Report

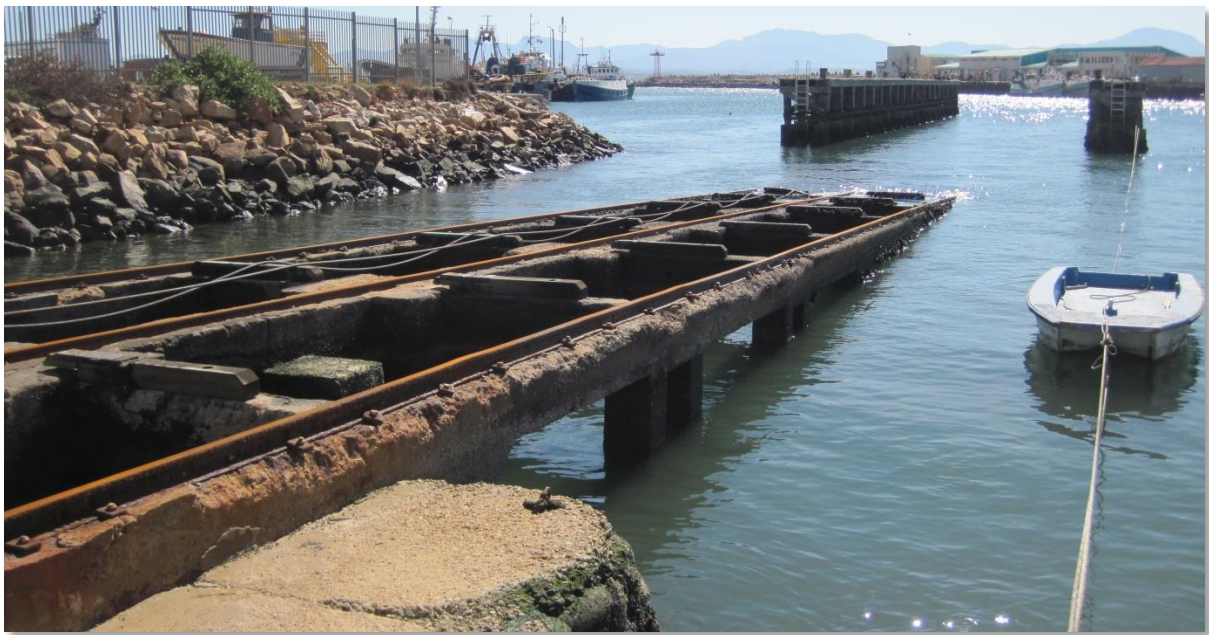
According to the engineers' report in the TNPA Feasibility Study Report (March 2018) the concrete beams in the tidal zone are in poor condition and show signs of severe erosion. There is no visible damage or signs of distress on the exposed concrete faces of the beams above the waterline.

Plate 6: View of marine portion of the slipway structure. Note the condition of the concrete on the nearest longitudinal beam.

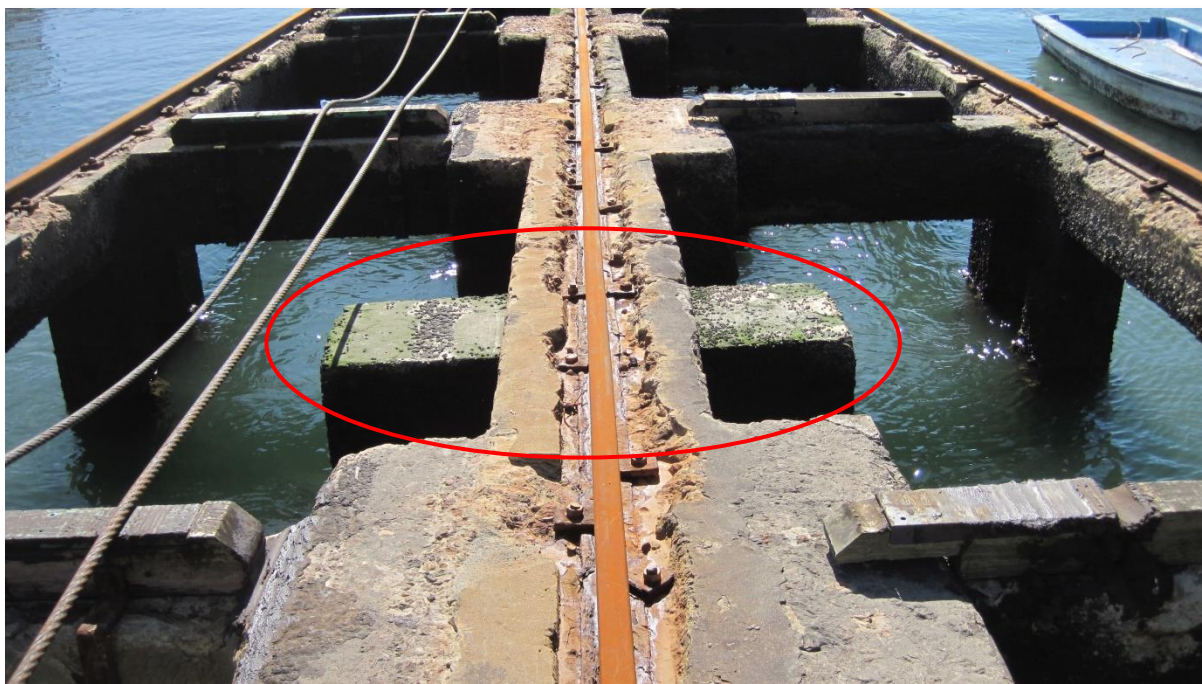
The slipway is a concrete beam structure comprising three longitudinal beams supported at regular intervals by transverse beams (**Plate 6** and **Plate 7**). The longitudinal beams run from the seaward end of the lead-in jetties up to the winch house, although between the retaining wall at the water's edge and the winch house only the top faces of the beams are visible in the surrounding concrete surface of the slipway. Each longitudinal beam supports one of the three rails on which the wooden ship cradle runs. The slipway structure has been strengthened over the years with the addition of new concrete beams (**Plate 7**)

Plate 7: Slipway structure showing the three cradle rails. Note the more recent concrete support (marked in red).

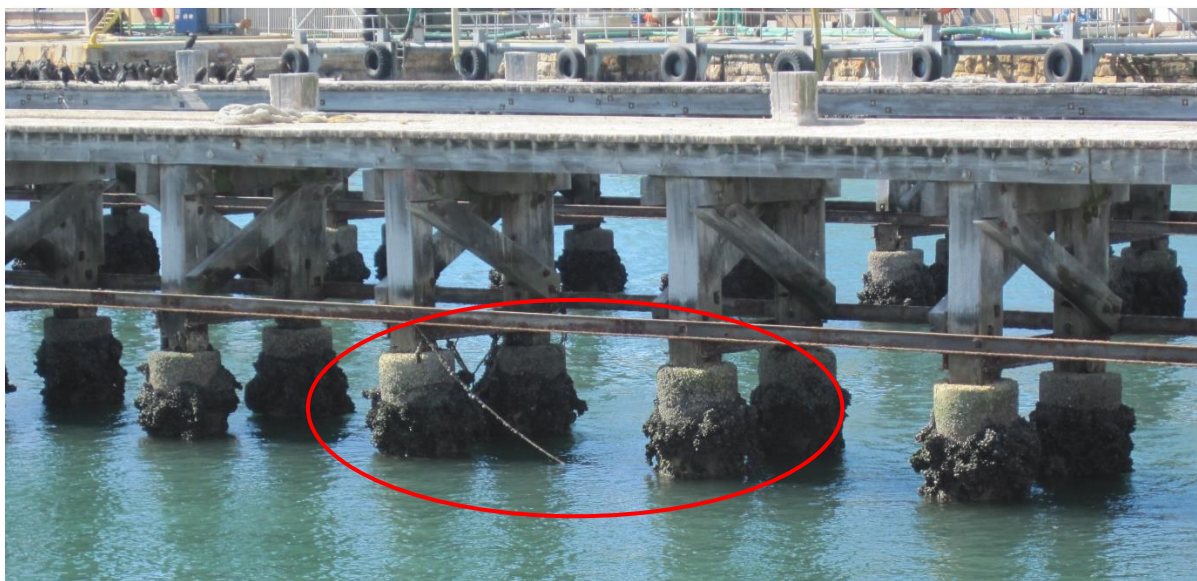
According to TNPA, at some stage in the recent past the wooden piles of the jetties were encased in concrete to strengthen them (**Plate 9**).

Plate 9: Concrete reinforcing around the wooden piles supporting the lead-in jetties.

A structural assessment of the lead-in jetties in the TNPA Feasibility Study Report (March 2018) indicates that they are in a poor condition with major deterioration of both the pile supports and superstructure. There is concern that any impact by vessels could result in a catastrophic structural failure of the jetties.

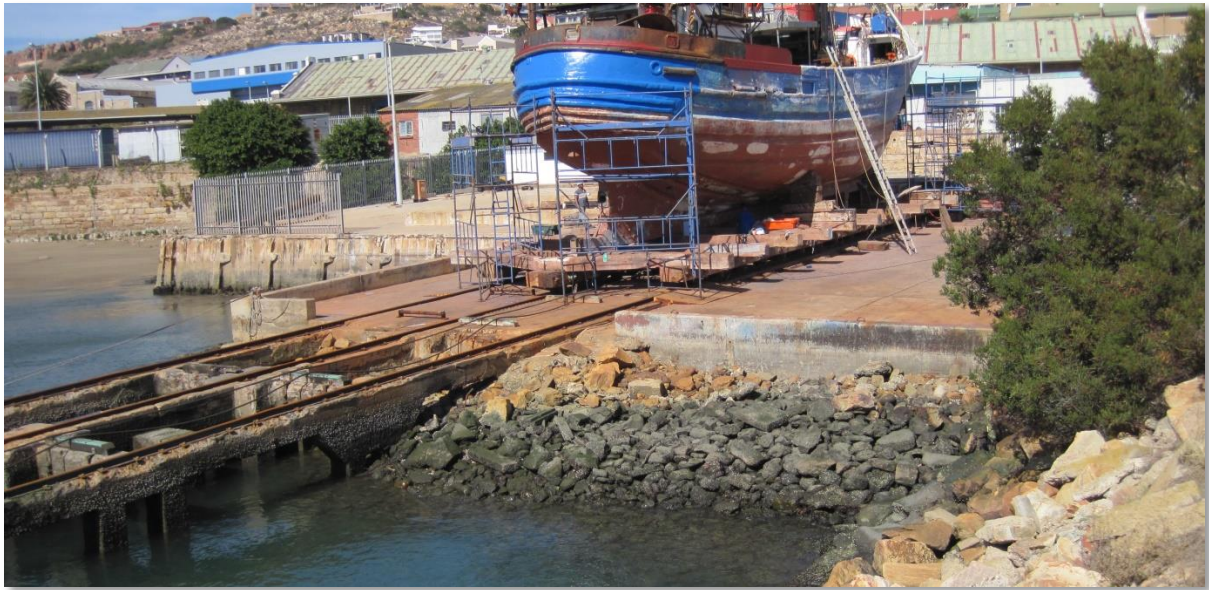
Plate 12: View of the seaward end of the slipway cradle. The portion of the cradle removed c.10 years ago was taken from this end of the structure.

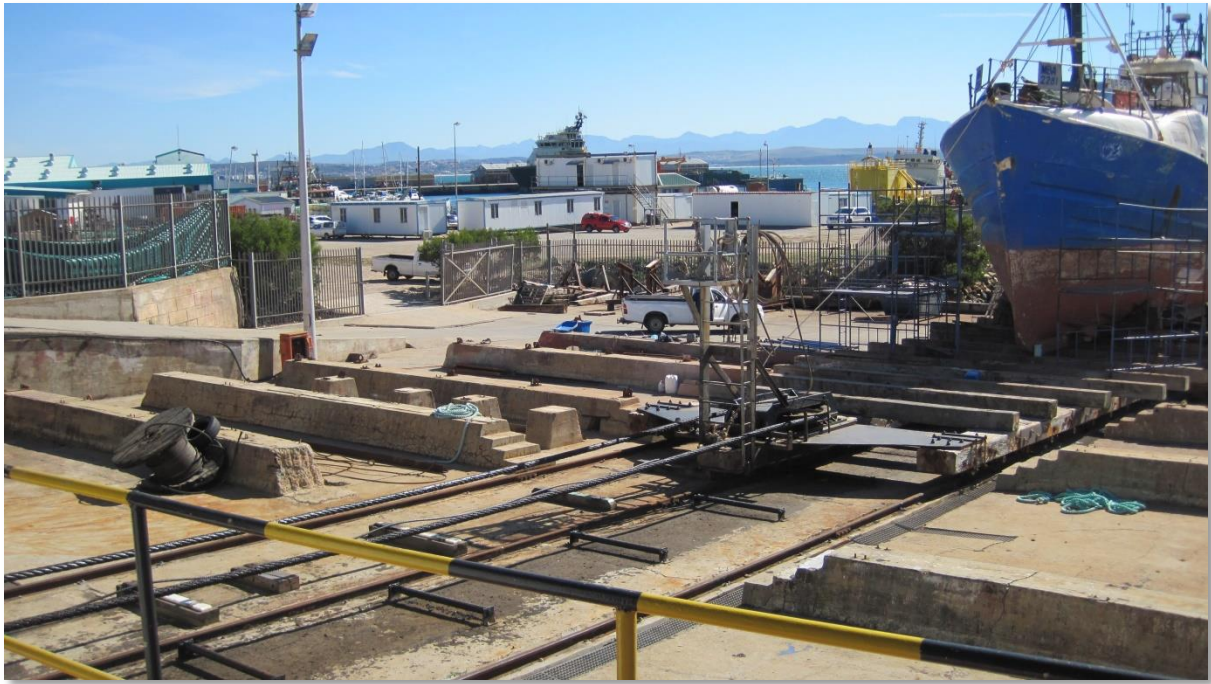
Plate 14: View of the sideslip areas from the top of the seawall outside the administration building. Some of the concrete structures are damaged and the wooden beams that originally lay on top of each concrete rib are no longer present.

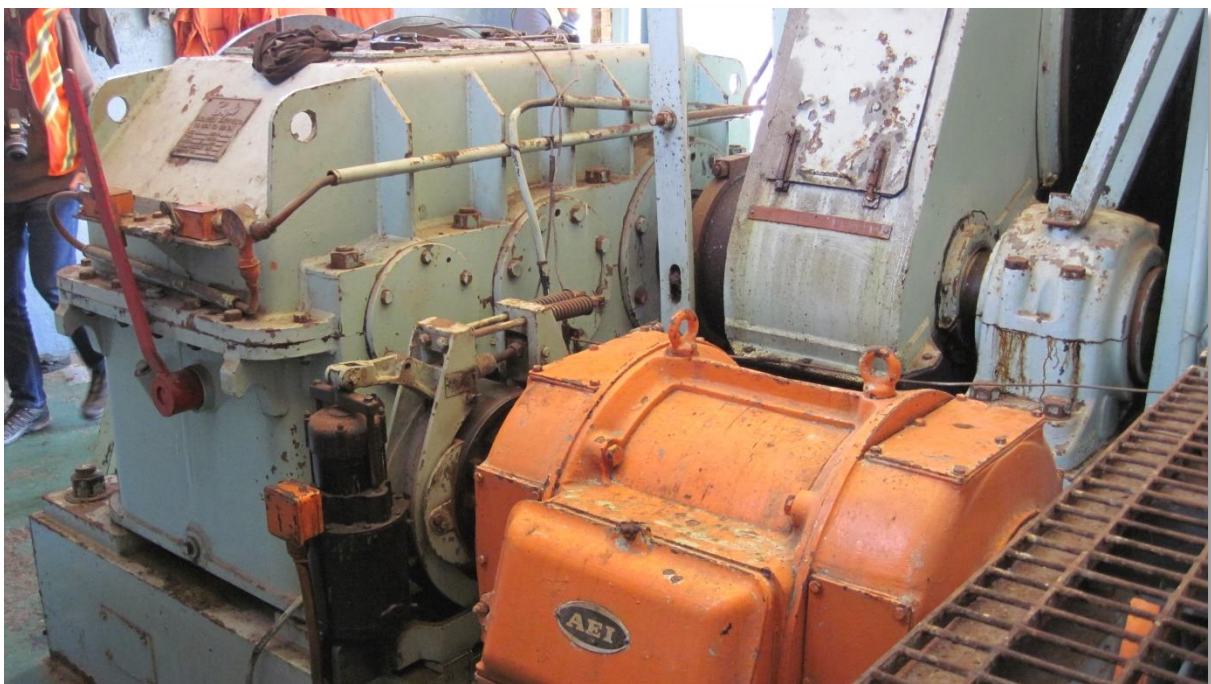
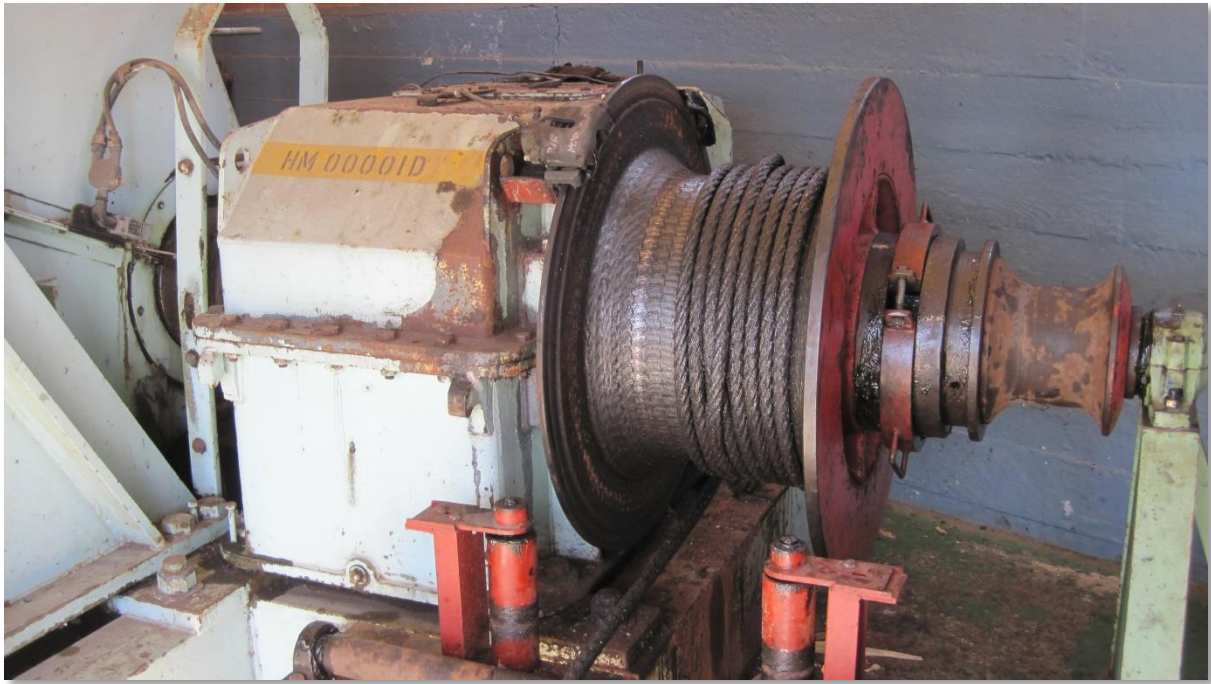
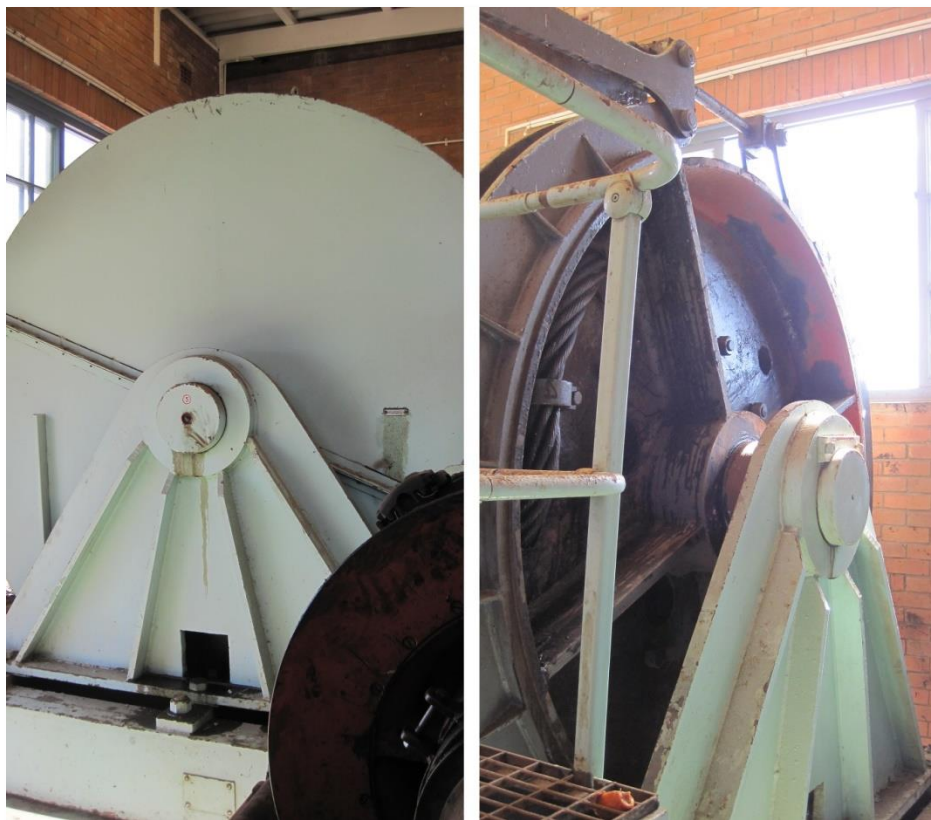
The winch house machinery consists of an electric motor, a gearbox and couplings, down-and up-haul drums and wire rope, wire rope supports, band brakes and a mounting structure (**Plate 19 - Plate 21**). Although there is not clear proof of this it is likely that the machinery is original.

According to the report, the equipment is unlikely to align with the minimum 20 year operational requirements as imposed by the TNPA on new designs being incorporated in the upgrade of the ship repair facilities at the Port of Mossel Bay and it seems likely that the winch system in its entirety will need to be replaced as part of the upgrade. If this does occur it is suggested that the old machinery is either offered to a suitable local museum or provision is made for its retention and display at the ship repair facility.

It is recommended that the existing ship cradle and winch house machinery that is to be removed is recorded before removal and is then either offered to a suitable local museum or that provision is made for its retention and display at the ship repair facility.

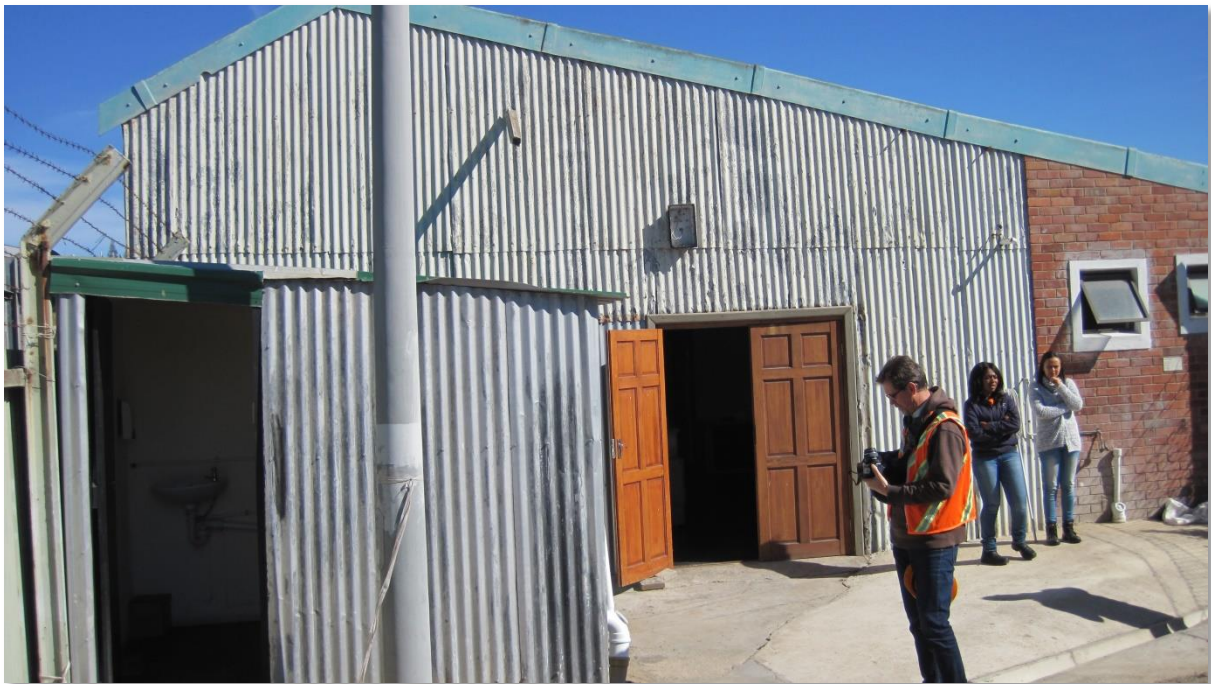
Plate 24: View of the eastern end of the smaller administration building. Note the replacement of corrugated iron with brick on the seaward corner of the building.

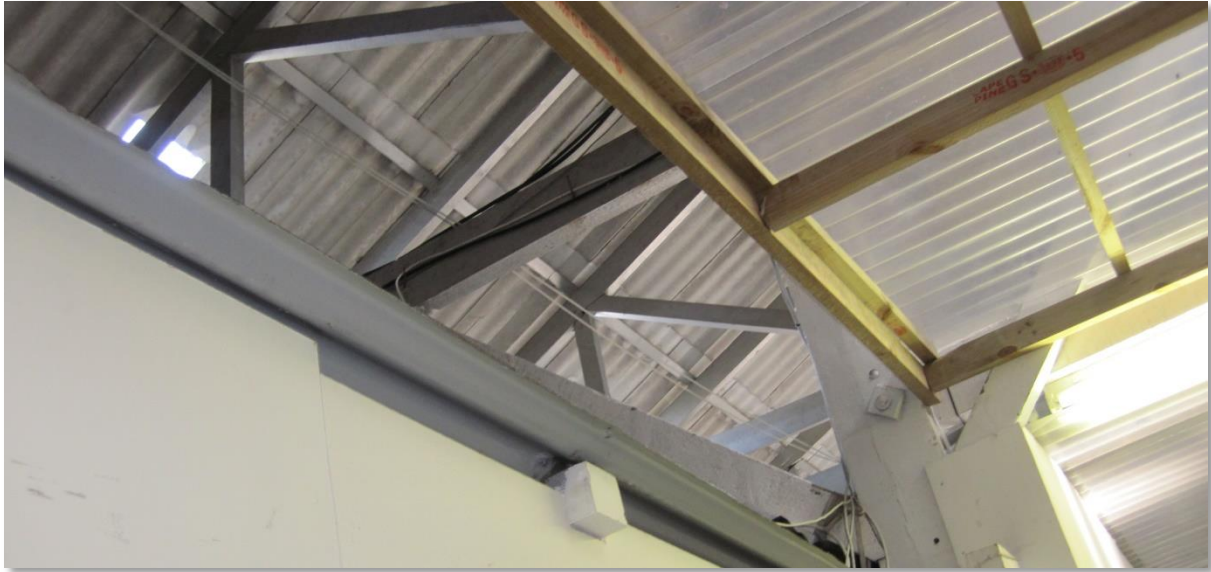
Plate 27: Steel framed structure of the large administration building. Prefab office lower left with open asbestos roof sheets visible above.
