NAS II Robben Island Report

22 February - 10 March 2010

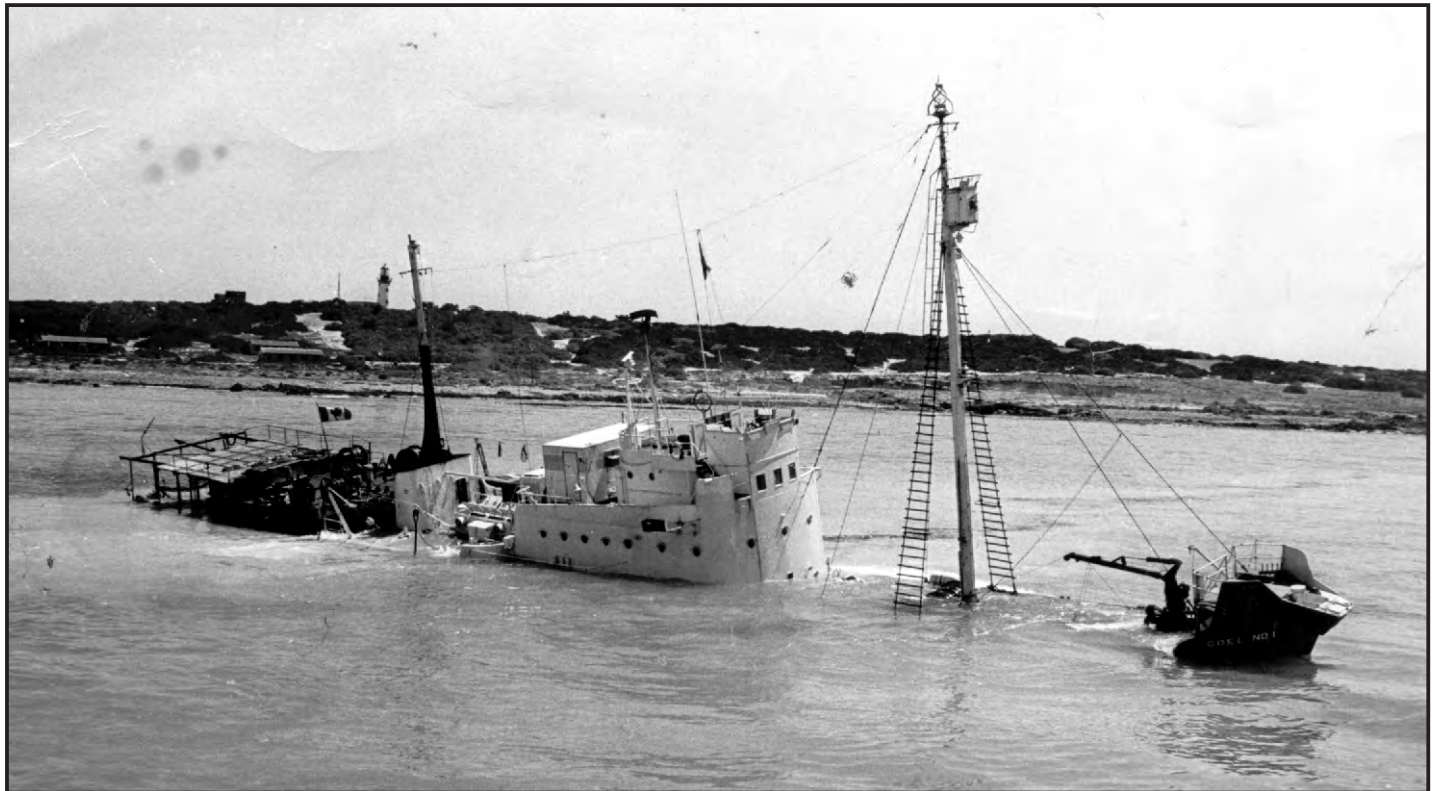
Figure 48: The wreck of the *Goel No. 1* in 1976. In this photograph the vessel is lying almost parallel to the shore. Her bow has started to shift seaward. (Photo: George Young, courtesy www.sashipwrecks.com)

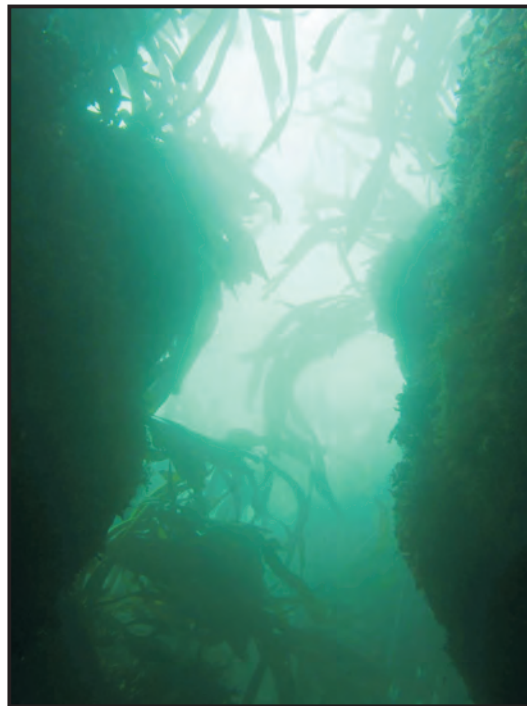
Figure 52: Kelp growing on the *Goel No. 1*.
(Photo: du Plessis 2010)

The *Goel No. 1* is situated in a high energy zone due to the shore's proximity; the main disturbance factor is wave action. The *Goel No. 1* would probably be more deteriorated and scattered, were it not for the dense kelp forest. The kelp serves as a damper on wave action, reducing its energy (Branch and Branch 1981:66). Future surveys or excavations on the wreck should take this into consideration and investigate methods that will not remove excess amounts of kelp.

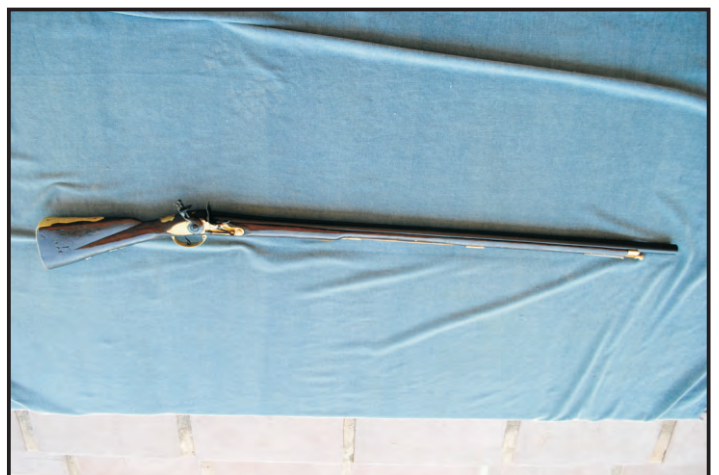
Figure 62: Conserved and incorrectly restored musket, owned by G. Clackworthy. It makes an attractive ornament, but information has been lost or distorted. (Photo: Maitland 2011)

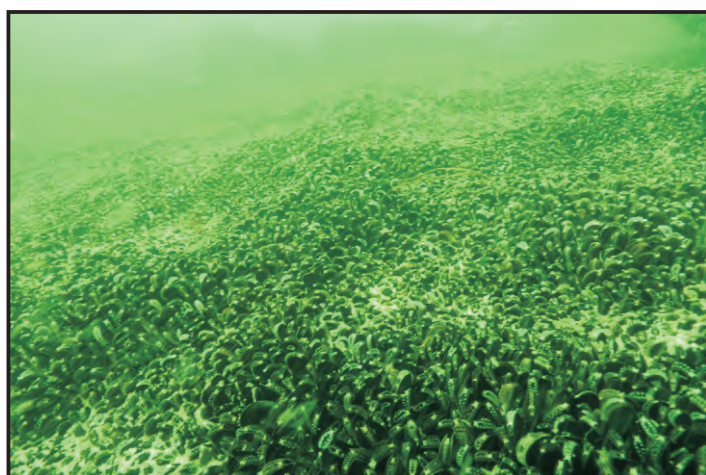
During our survey of the Barrel Wreck, it was partially exposed with young colonies of benthic life. The most dominant species on the wreck were black mussels, *Choromytilus meridionalis*. They covered more than 60% of all exposed surfaces (Fig. 71). None of the mussels on the wreck were longer than 40 mm, indicating they are younger than one year (Branch *et. al* 2007: 114). At the time of our field trip, the Barrel Wreck had not been exposed for more than a year. Barnacles, *Octomeris sp.* were also observed in large quantities. The rest of the benthic community consisted of sea sponges, *Haliclona sp.*, anemones, starfish, *Patiria granifera*, urchins, *Parechinus angulosus*, and predators, such as west coast rock lobster, *Jasus Lalandii* (Branch *et. al.* 2007:78). All these organisms are dispersed by ocean currents during larval stages and will colonize unused habitats (Branch and Branch 1981:223).

Figure 71: Section of the wreck colonised by black mussels. (Photo: Jeffery 2010)

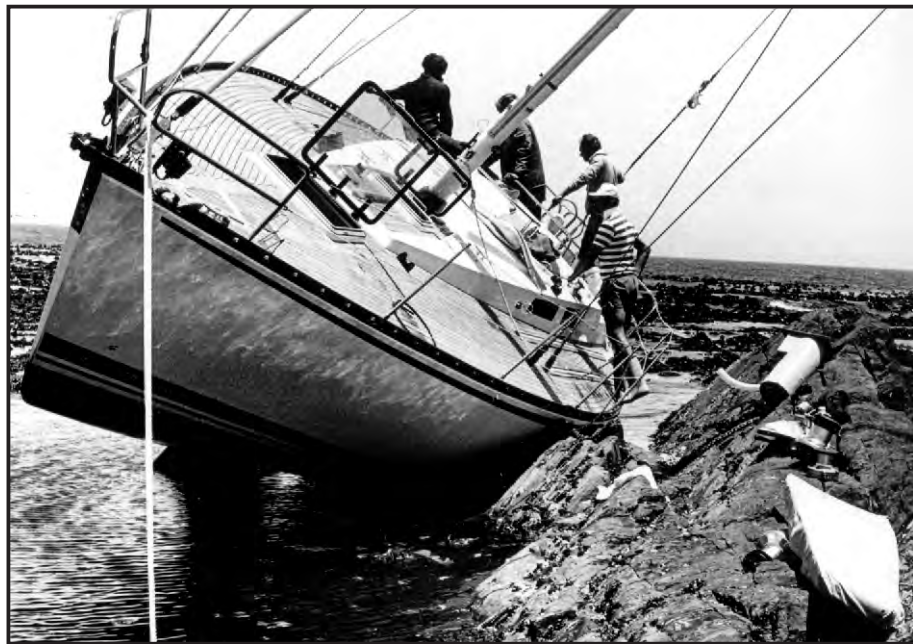
Figure 73: The *Chanson de la Mer* in 1986, just after she was wrecked. (Photo: Jeltje van dan Bosch, courtesy www.sashipwrecks.com)

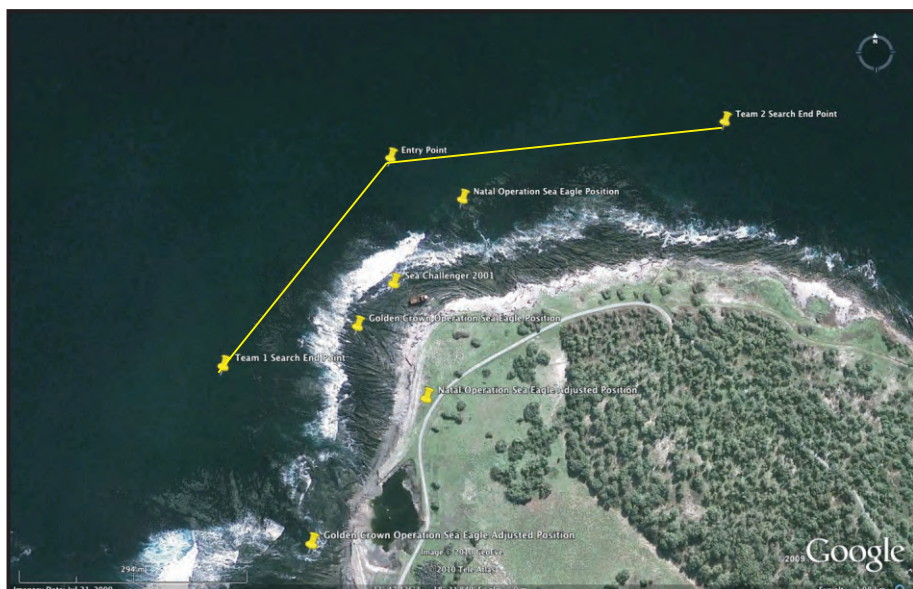
Figure 77: Satellite image from July 2009 showing place marks relating to this search. Notice the *Sea Challenger* (1998) has moved 400 m inshore since the 2001 image. (Google Earth 2010: Accessed 04-10-2010)

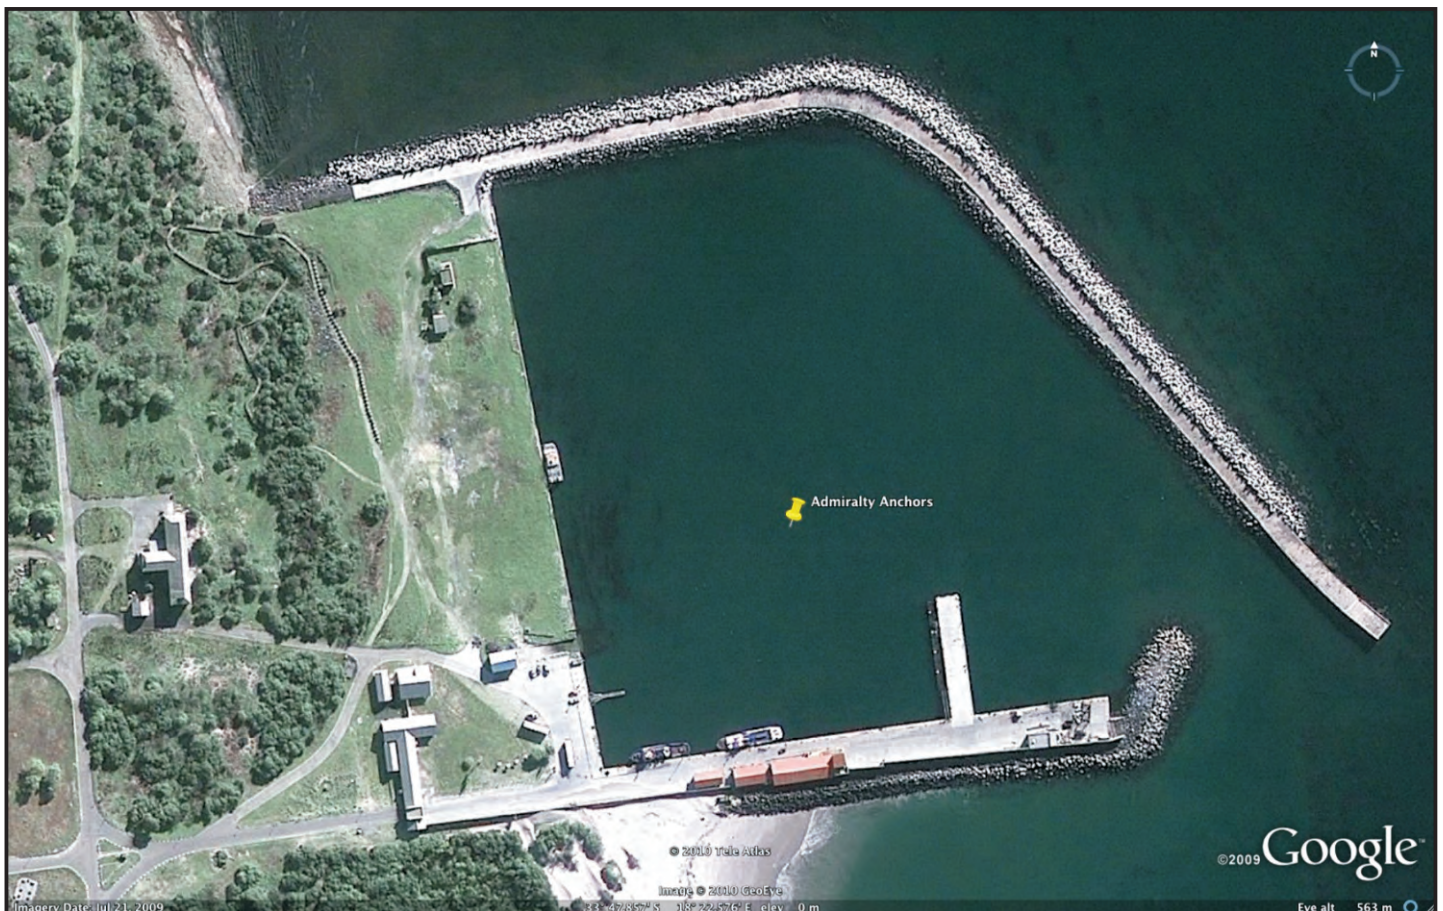
The seabed was undulating silt. Approximately 100 metres east of the west quay, a rocky outcrop covered in kelp, was found. Embedded in this area, were two heavily encrusted and corroded, medium-sized admiralty anchors. The survey was done largely by touch and there seemed to be large quantities of chain attached. We think the anchors may have been part of a mooring system.

Figure 79: Satellite image of Robben Island Harbour showing the approximate position of the admiralty anchors. (Photo: Google Earth: Accessed 2010-08-23)

The historical importance of the site could not be ascertained within the available time. The anchors were left in situ and there are no plans to raise the artefacts. Although they may need to be removed if they become a shipping hazard. GPS coordinates were not recorded.
