# PHASE 1 HERITAGE MITIGATION FOR THE NMPPP PIPELINE

FOR TRANSNET

DATE: July 2009

By Gavin Anderson

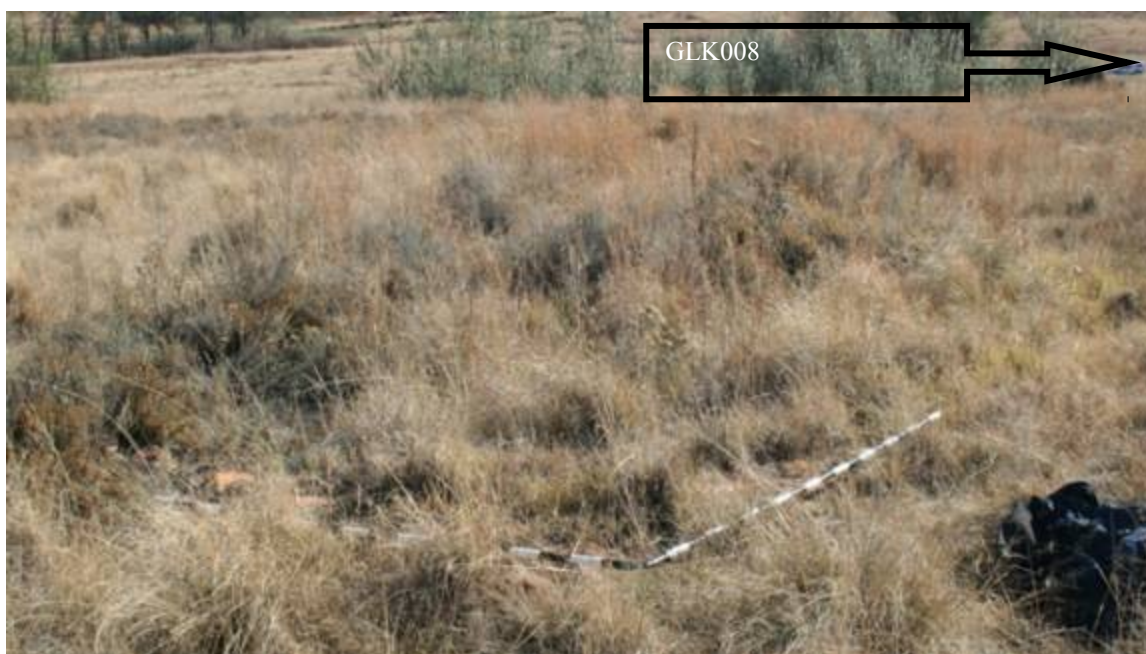
FIG. 2: SMALL KRAAL UPSLOPE OF GLK008

GLK008 was divided into two areas: on top of the hill, and below the hill (fig. 1). The lower part of the site consists of two small kraals (fig. 2) approximately 80m southeast (and upslope) from the two houses. These kraals are at right angles to each other and are 5m x 3m in diameter. The pipeline passes between these two kraals and the house. The houses consist of two rectangular houses and a long low stone wall. The smaller house is a mud-brick construction with some mud plaster on both sides of the wall. The main house is a built from sandstone blocks with a mud plaster on both sides of the wall (fig. 3). The interior dividing walls do not appear to have plaster, although this may have disintegrated. Only two exterior walls, and a small section of one interior wall, of the main building, remain. The rest of the building has collapsed. The main entrance has been filled in, and presumably relocated to another part of the building. Figure 4 illustrates the site.

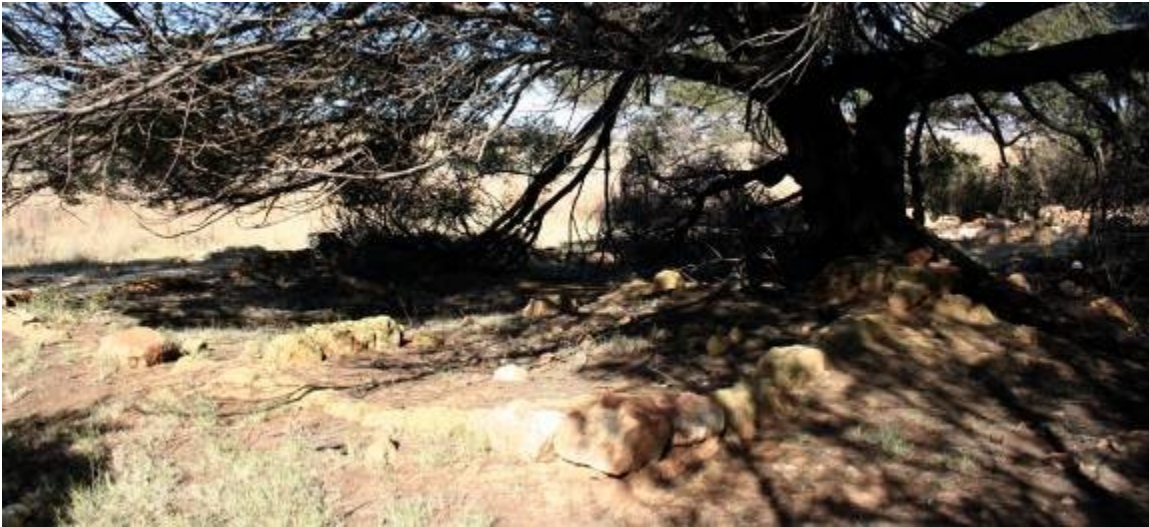
**FIG. 5: STONE FOUNDATIONS AT UPPER GLK008**

The upper part of GLK008 consists of stone foundations, where there were presumably wattle and daub walls. There is no visible evidence for mud-brick structures. There are four rectangular features of various sizes (fig. 5), and a larger central foundation. There is a stone circle foundation and a stone cairn to the north of the main buildings (fig. 6).

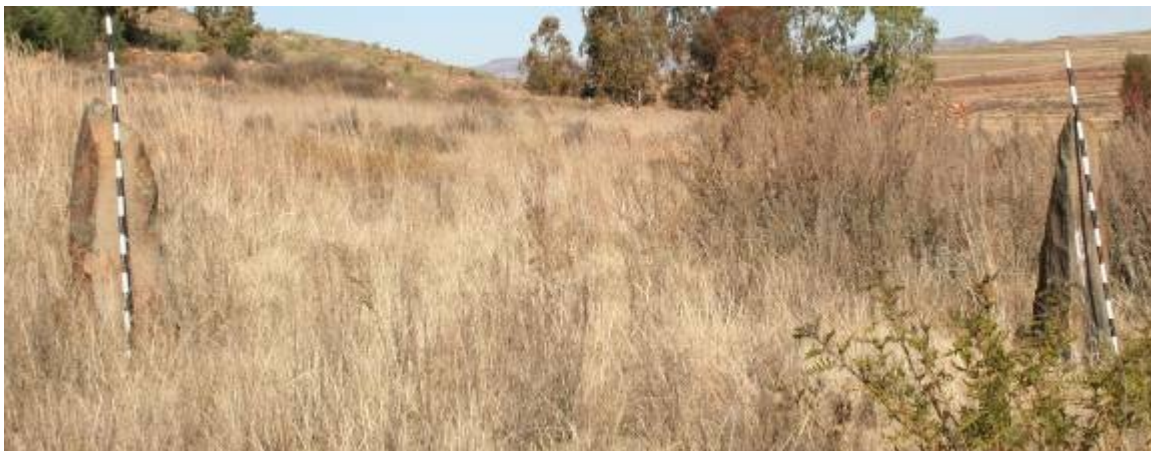
**FIG. 7: TWO STONE PLINTHS AT UPPER GLK009**

The site has been mapped and photographed. The site consists of several buildings and features. The “entrance” to GLK009 appears to have been from the northwest (towards GLK008), and is marked by two stone plinths (fig. 7). The plinths are about halfway between GLK008 and GLK009, and ~2m away from the centre of the pipeline and may be affected. While the plinths are not significant, there should be little impact on them. If they are knocked over, or removed, for the pipeline, then they should be erected in the same position afterwards.

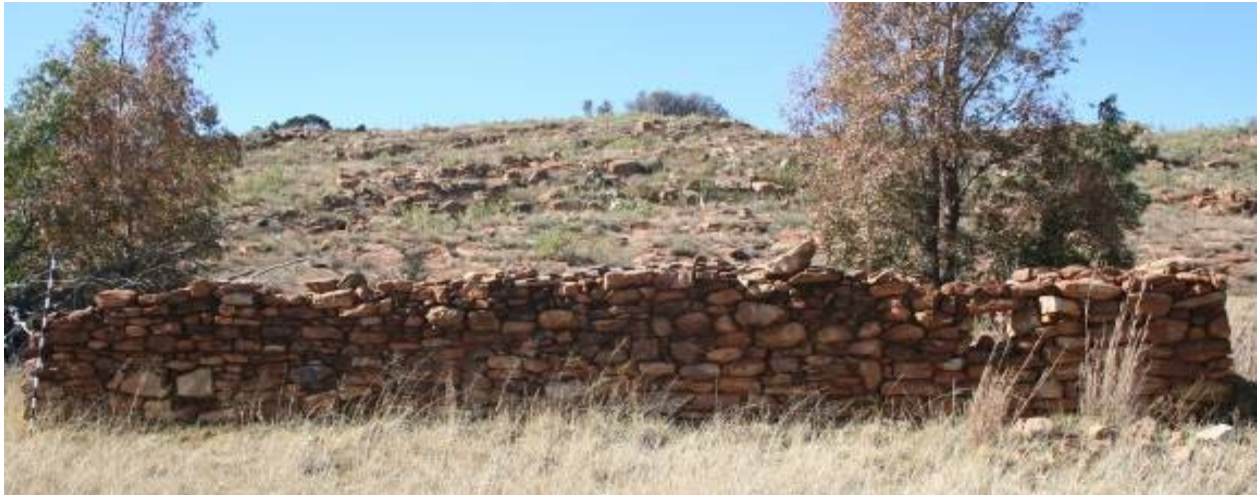
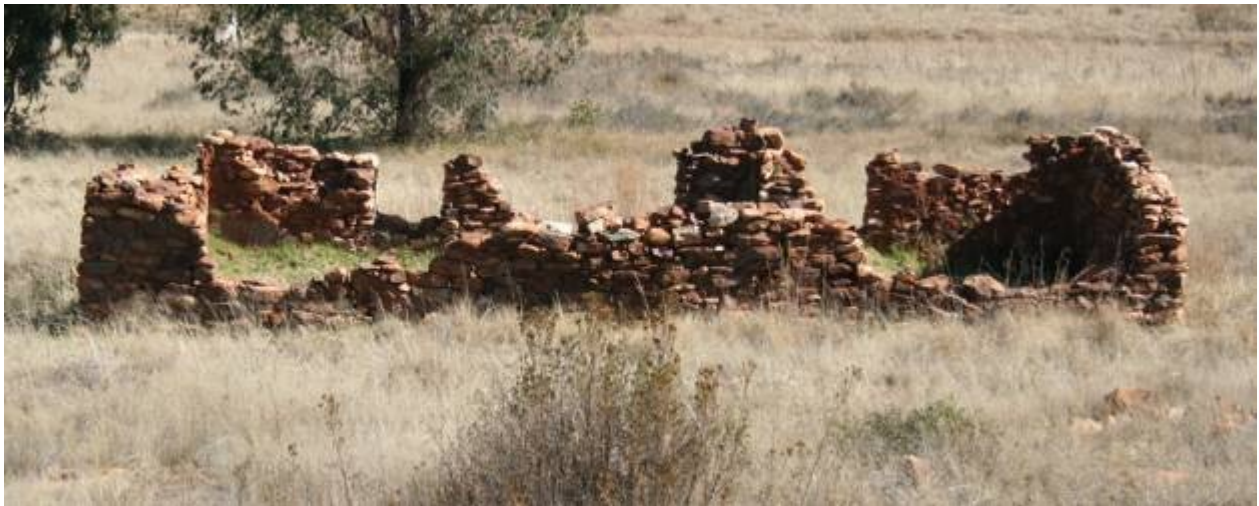
**FIG. 8: NORTH & SOUTH FACING WALL OF GLK009**

GLK009 consists of two houses and a few kraals. The first is a rectangular stone-walled house 11m x 5m in size (fig. 8). There is an internal dividing wall with a door, along the southern part of the house. The main door and two windows are southwest facing, while another window is south facing.

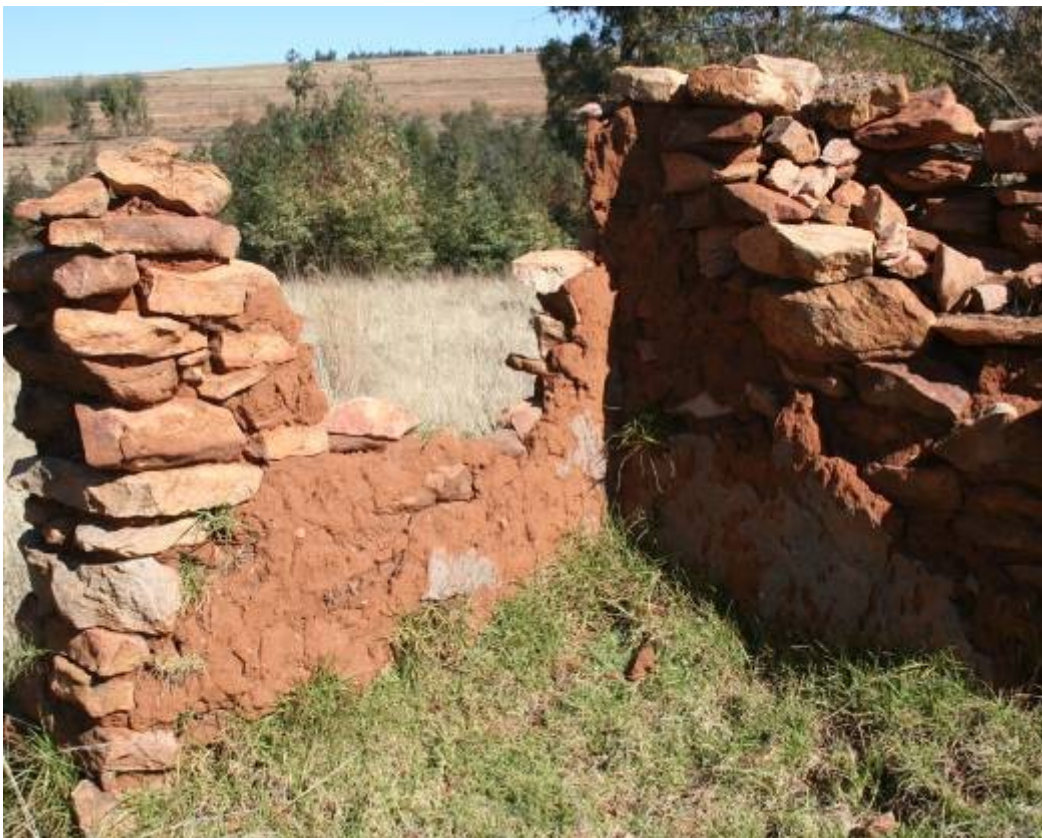
**FIG. 9: SOUTHERN ROOM EXTENSION AND PLASTERING AT GLK009**

The main part of GLK009 consists of a house with several rooms and stone walled kraals. This is ~100m southeast of the other house. The main house is ~7m x 5m in size (fig. 8). The windows are southwest facing, while the main door is east facing. There is a dividing wall in the interior of the house with a presumed

doorway. There are two stone cairns outside the windows of the house. These initially appear to be small graves; however, they are probably related to some other activity<sup>2</sup>. The house has had three rooms added on at a later stage: these are at the northeast, southeast and southern sides of the house. Only the southern room is mostly intact. All rooms, or houses, have plastering on the inside and outside walls.

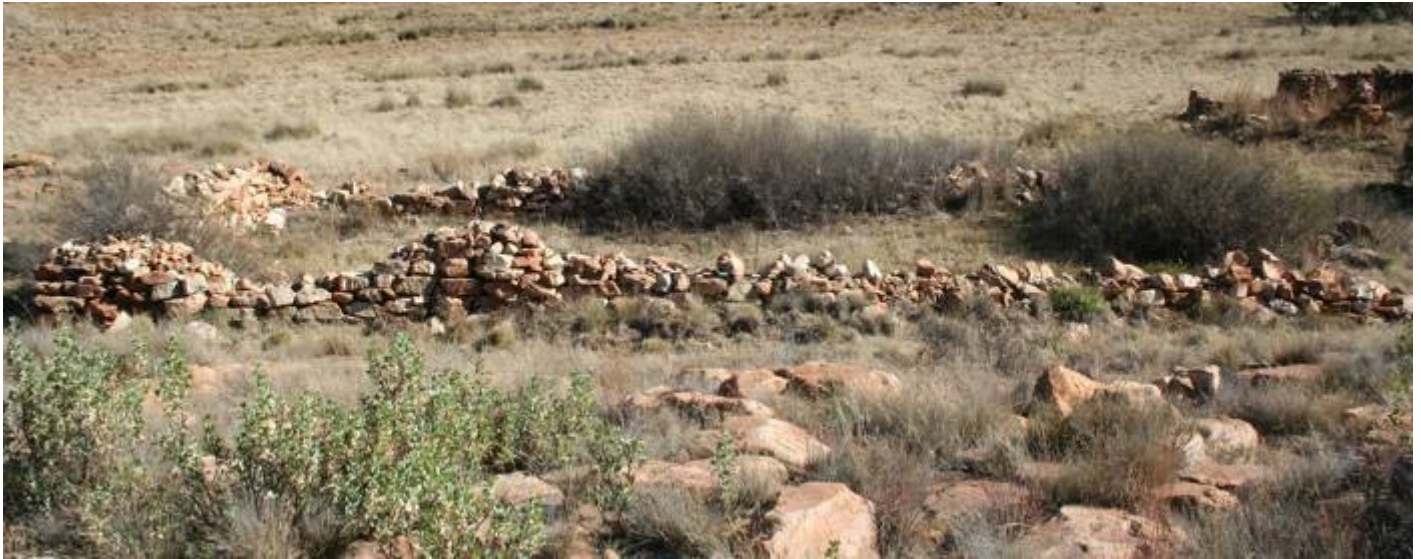
**FIG. 10: LARGE KRAAL AT GLK009**

To the east of the house, and against the rocky hill, are several kraals. The first two kraals are small (3m x 2m) kraals that abut a natural rock outcrop. To the southeast of these two small kraals is a large (17m x 6m) with three smaller kraals attached to it (fig. 10). These smaller kraals are 2m x 3.5m, and 4m x 5m

in size. All of these use the natural rock outcrop as part of the walling. Figure 11 illustrates these houses.

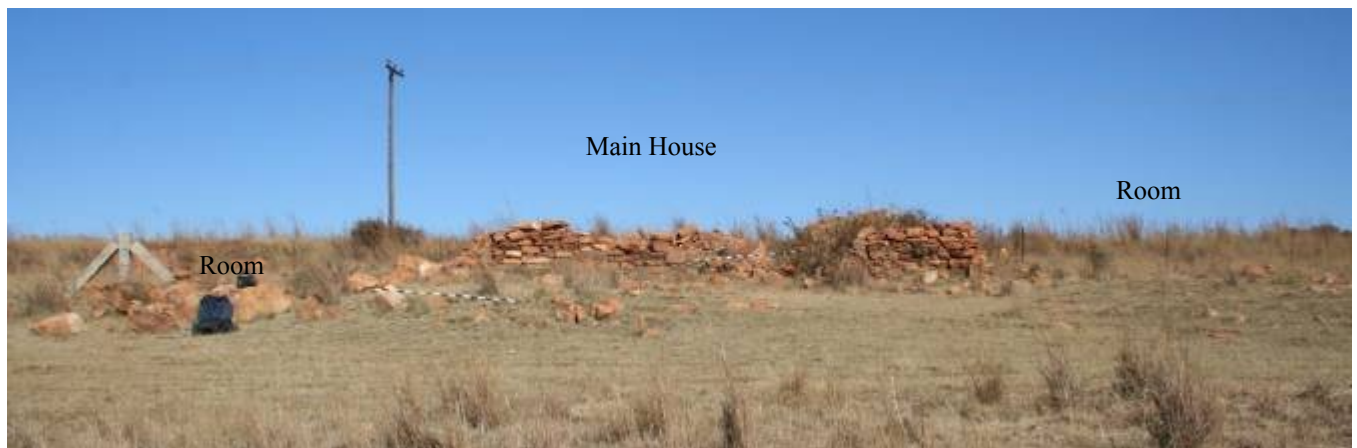
**FIG. 12: NORTHERN HOUSE AT GLK0010**

GLK0010 was mapped and photographed. The site consists of two stone walled houses ~120m apart (fig's 12 - 13). There is a low wall, or terrace that connects the two houses (fig. 14). The northern house consists of a main house with a dividing wall. There are two rooms added to the north eastern and southeastern part of the house. Only parts of the main house are intact, while the other rooms have collapsed. There is a small stone cairn to the north of the extended room: this is unlikely to be a grave.

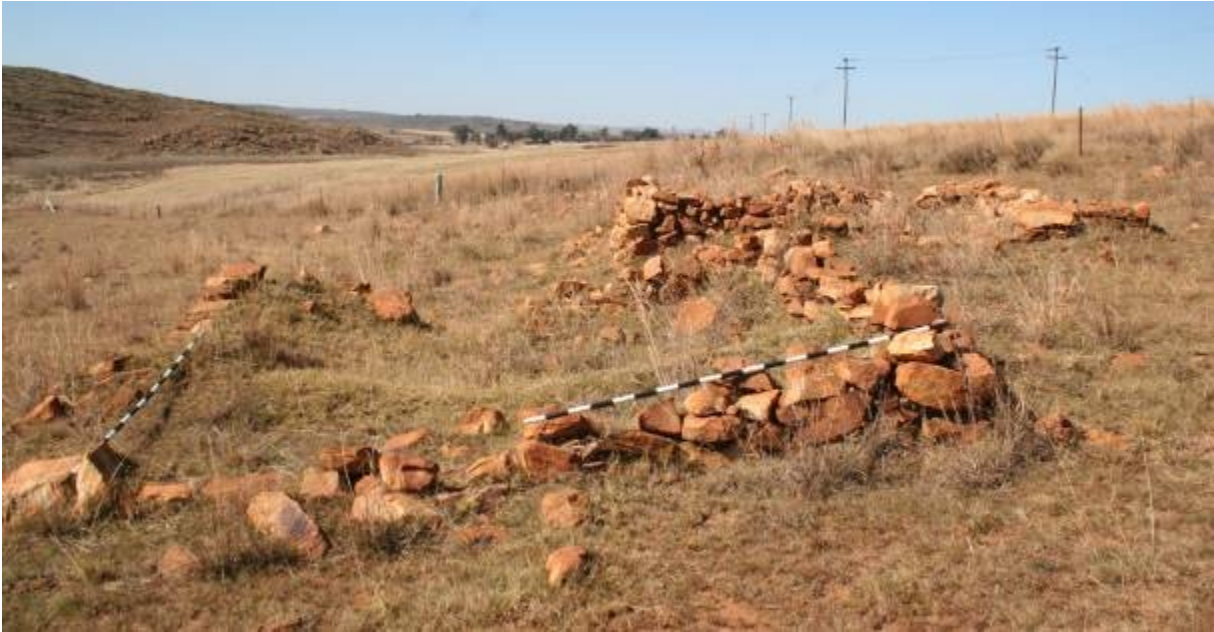
**FIG. 13: SOUTHERN HOUSE AT GLK0010**

The southern house (fig. 13) consists of two buildings and a large area of basal foundations. The two rooms have doors that face each other. Figure 15 illustrates GLK0010.

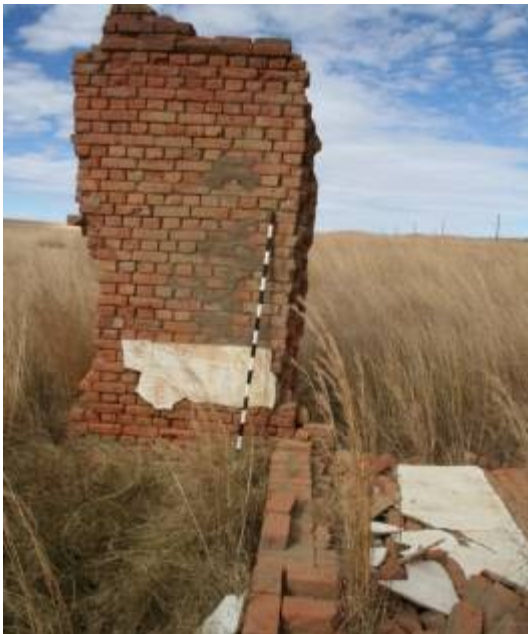
**FIG. 16: REMAINING WALL OF GLK0012**

The site was mapped and photographed. The area was densely vegetated during mitigation, making photography difficult. The site is on the opposite side of the road of the proposed pipeline, and is thus unlikely to be directly affected. More of the walling has collapsed since our original recording in 2008 (fig. 16). The site consists of a school building (11m x 8m) in size, with steps along the

northern wall. The building consists of a stone foundation and a double row of bricks in an English Bond for the wall. To the northeast of the buildings stairs, are the foundations of two rooms and these are possible toilets. Between these two buildings is a three-tiered circle that was presumably a flowerbed. There is a small stone cairn ~16m northwest of the school building. Figure 17 illustrates this site.

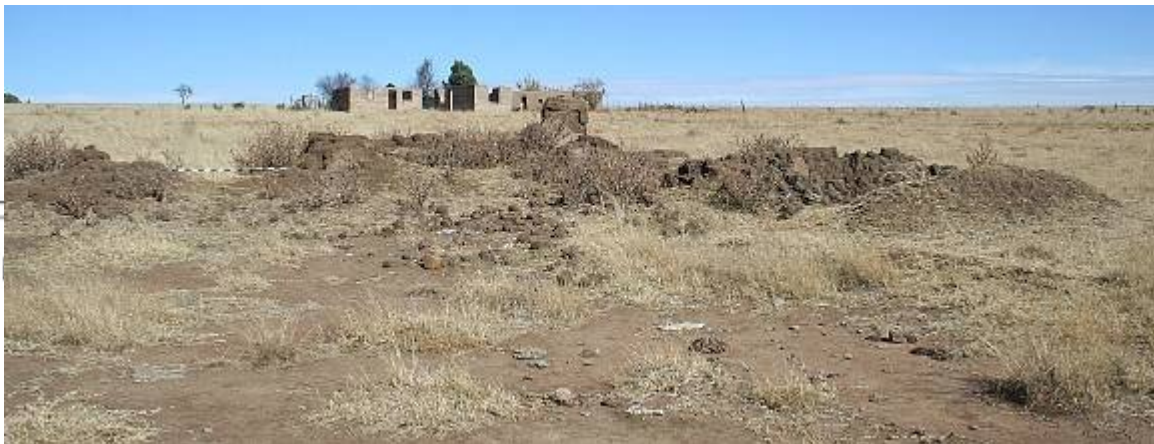
**FIG. 18: WEST VIEW OF GLK0013**

Only the most eastern house at GLK0013 was photographed and mapped (fig. 18), as this was the only feature that fell within the 100m boundary. I did however photograph nearby houses that still had *ilemba* designs on their walls<sup>4</sup>. The eastern house consists of a mud-brick house with five connecting rooms in an L-shape (fig. 19). There are two smaller mud-brick buildings on each side of the main building, and are not attached to it. The rooms varied in size, but were consistently 3m wide. We surveyed the immediate area for graves, and did not locate any.

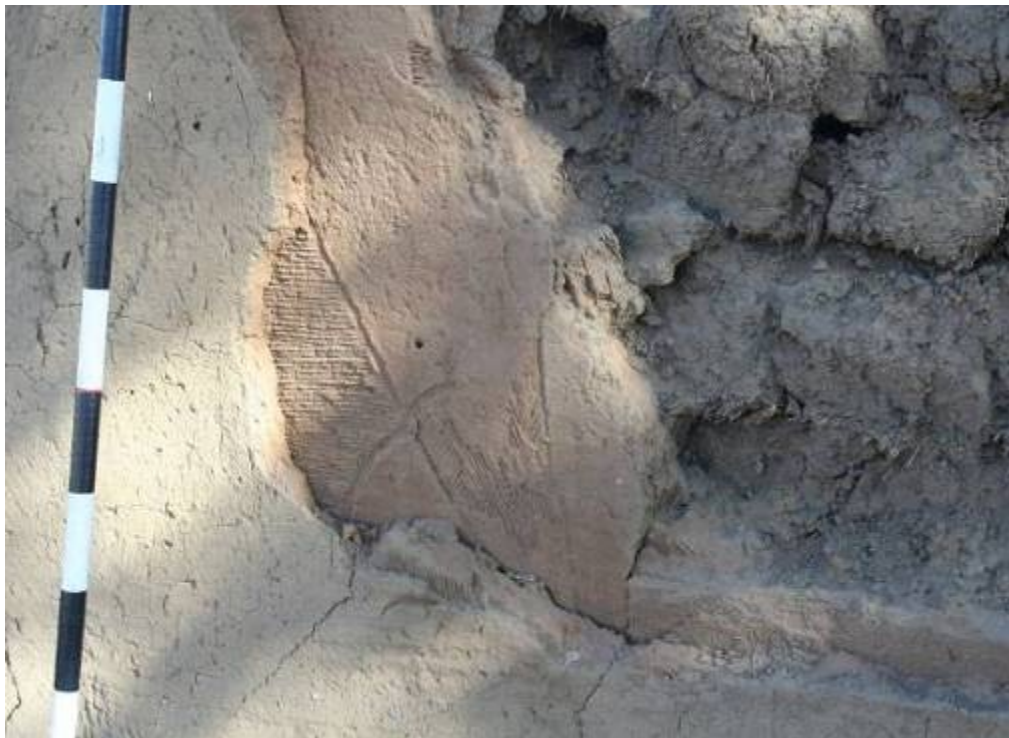
**FIG. 21: CLOSE UP OF PLASTER LAYERS SHOWING DIFFERENT ILEMBA**

GLK0015 was photographed and mapped, and the area was resurveyed. The pipeline will not directly affect the site. The site consists of two households with similar architectural designs. The southern household is built in the 'wattle and daub' style, with some mud-bricks (fig. 20). Several items have been placed within the daub to strengthen the structure. This includes, glass, wire, metal rods and plastic. The main doors face north, although one faces west. Some of the rooms have interconnecting doors, while others can only be entered via the outside. There is a separate house next to the main house. The interior and exterior walls are plastered and decorated with *ilemba*. It is interesting to note that the plaster consists of several coats, and each coat has *ilemba* on it. This suggests that the plaster is not pasted in one episode, but repeatedly over several years. The plaster in fig. 21 has at least six layers.

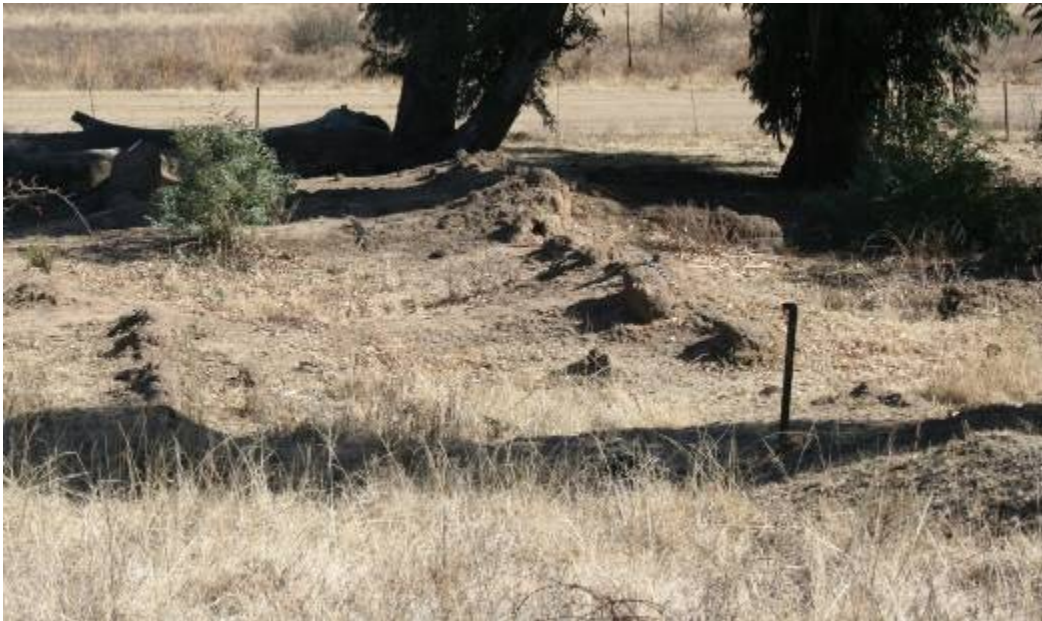
FIG.22: VIEW OF THE NORTHERN HOUSE AT GLK0015

The northern household is much older than the southern house, and only the foundations are visible. This house is made from mud-bricks. The walls have collapsed and nearly disintegrated. This household consists of a double row of rooms with extended rooms at the east and western sides of the house. No entrances were visible. The entire settlement is illustrated in figure 23.

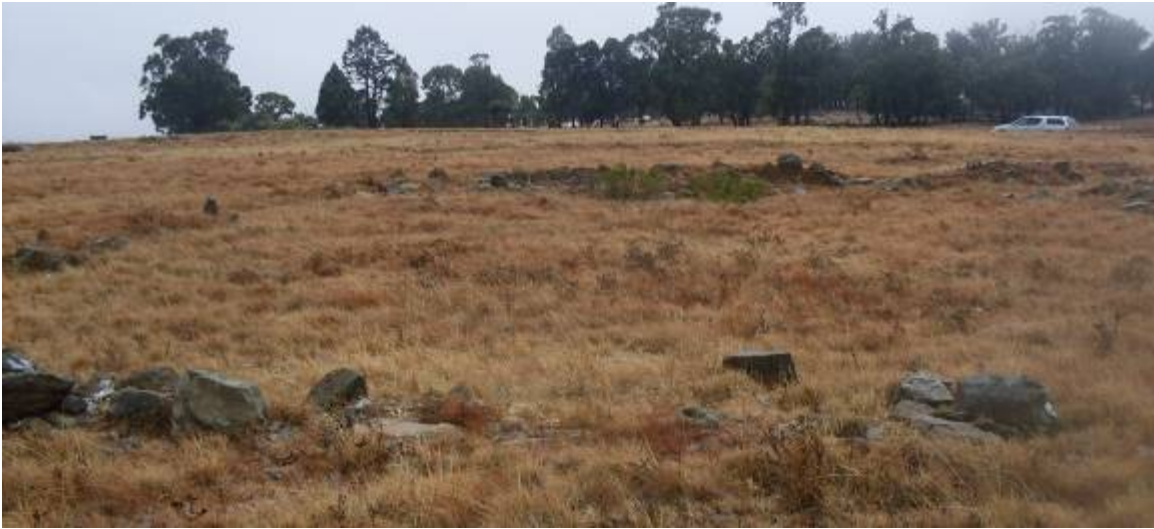
FIG. 26: OUTLINE OF KRAAL AT GLK0035A

The kraal is a large rectangular kraal (21m x 17m), with a small secondary kraal (5m x 7m) attached to it (fig. 26). There is a small semi-circular kraal within the main wall and abutting the northern wall. This small kraal is ~1.7m in diameter (fig. 27). The main kraal consists of a double row of large boulders with a small stone infill (fig. 28). The kraal probably relates to the colonial occupation of the area; however, it will be difficult to date. Figure 29 illustrates the site.

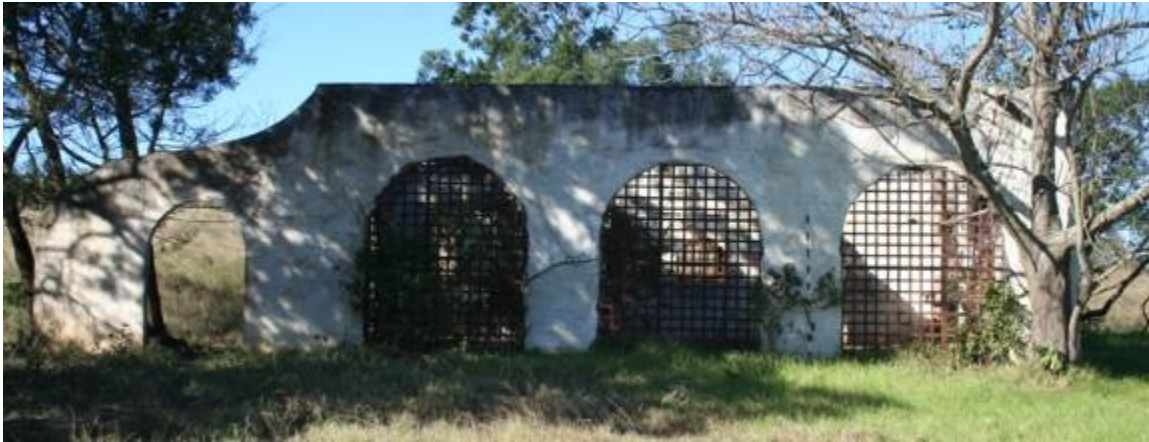
**FIG. 30: BUILDING AT GLK0111**

briefly photographed the buildings, but did not map it (fig. 30). No further mitigation is required.

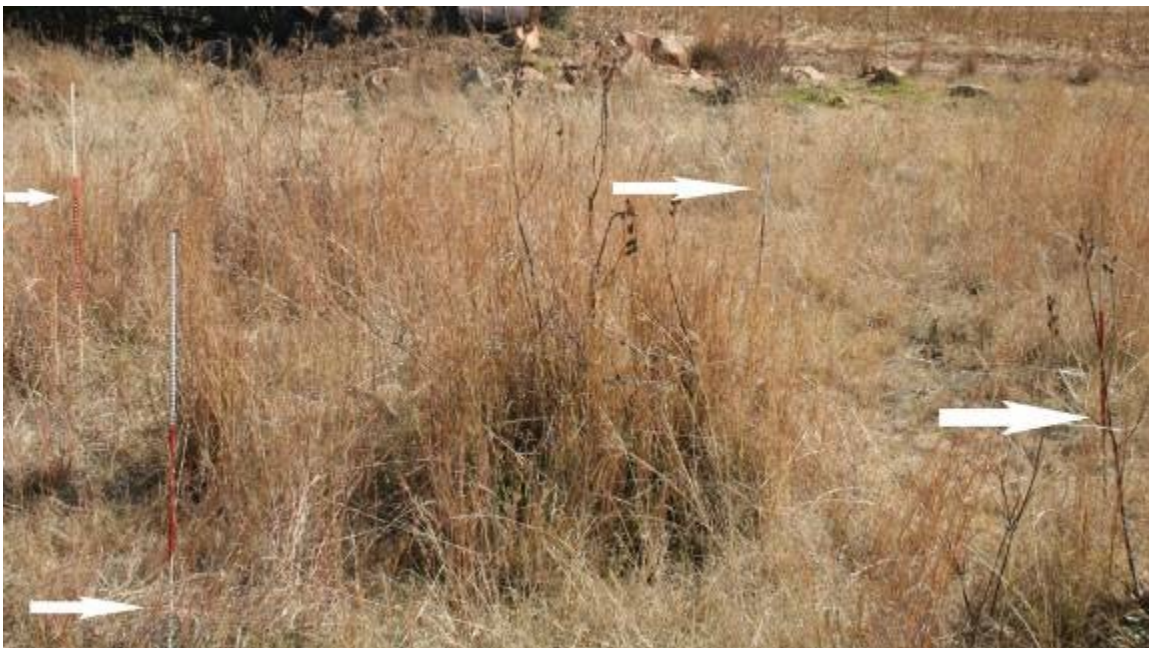
**FIG. 32:**

possible graves are related to collapsed walling. The possible grave was demarcated with coloured fence droppers (fig. 32).

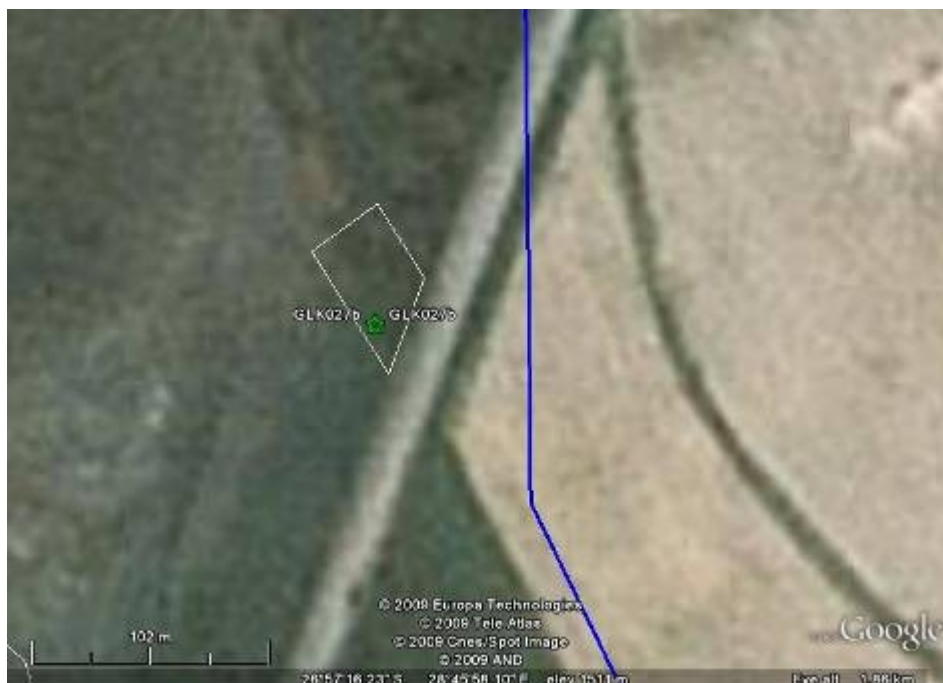
**FIG. 33: EXTENT OF CEMETERY AT GLK0027B AND THE PIPELINE**

We contacted the landowner to gain access to the land; however, we were not well received during the conversation. We decided that since the pipeline passes the cemetery on the opposite side of the road, then it would not be affected and would not require demarcation. Furthermore, the cemetery is already demarcated with fencing. Figure 33 indicates the location of the pipeline in relation to the cemetery.

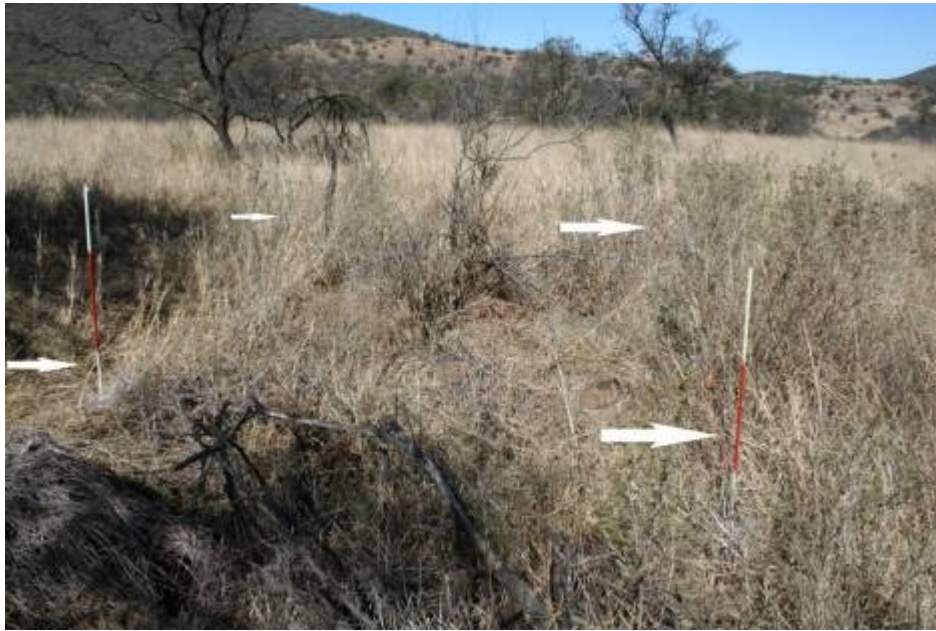
**FIG. 36: EXTENT OF UNAMRKED GRAVES AT GLK075**

The site was photographed and the grave was demarcated (fig. 36). The vegetation was less dense during this field trip and we noted two stone walled kraals to the northeast and southeast of the two houses. The houses and kraals were photographed. The houses are made in the 'wattle and daub' design and are both ~ in diameter. The kraals are large (~12m in diameter) and consist of two large stone rows with small pebbles used as infill. The latest route re-alignment (i.e. after the site was photographed and demarcated) places the pipeline within 2m of the graves. The pipeline will need to be moved either to the west (i.e. closer to the fence), or between the stone walled kraals and 'wattle and daub houses'. Figure 37 indicates the locations of these structures.

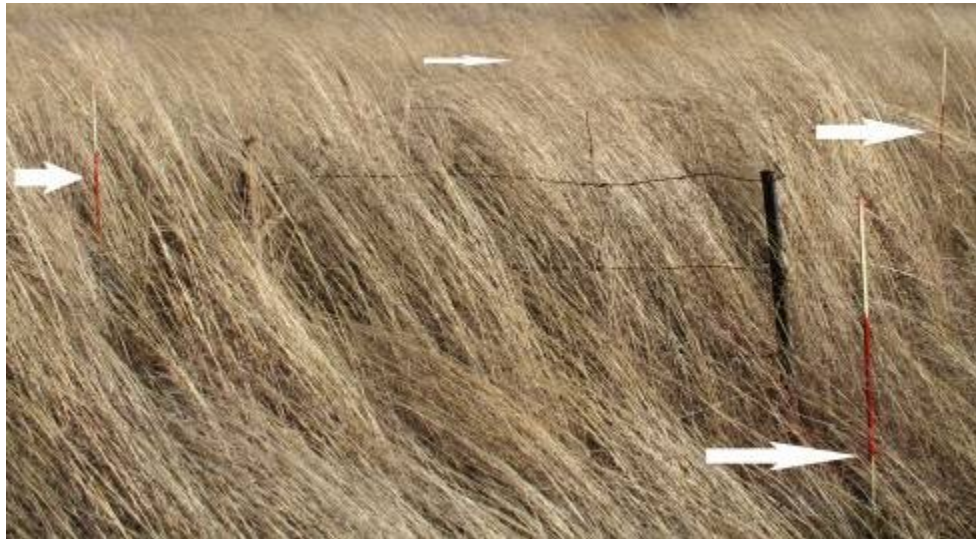
**FIG. 38: EXTENT OF UNAMRKED GRAVES AT GLK0127**

The grave was demarcated with coloured fence droppers (fig. 38).

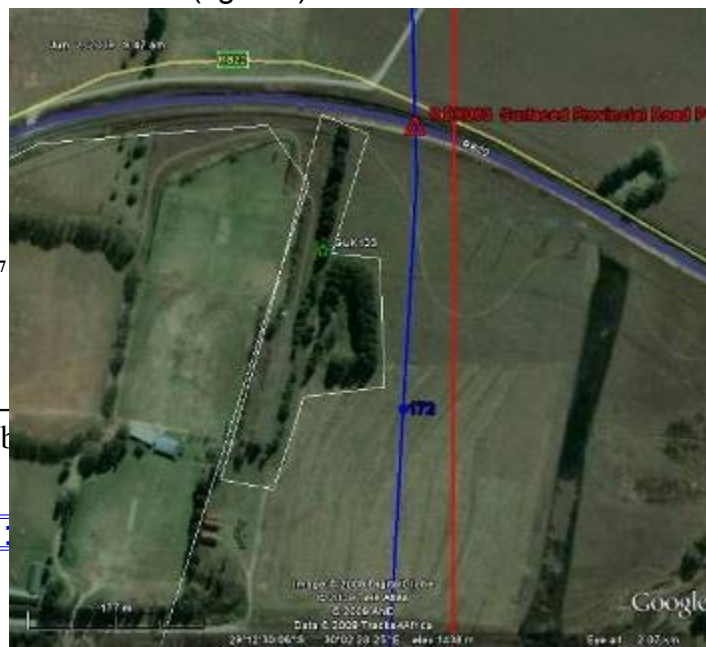
**FIG. 39: TREE MARKERS IN THE PIPELINE<sup>7</sup>**

The pipeline was re-aligned to have no impact on the trees, and is now 30m – 120m east of the trees (fig. 39). The tree boundaries were photographed (fig.40).

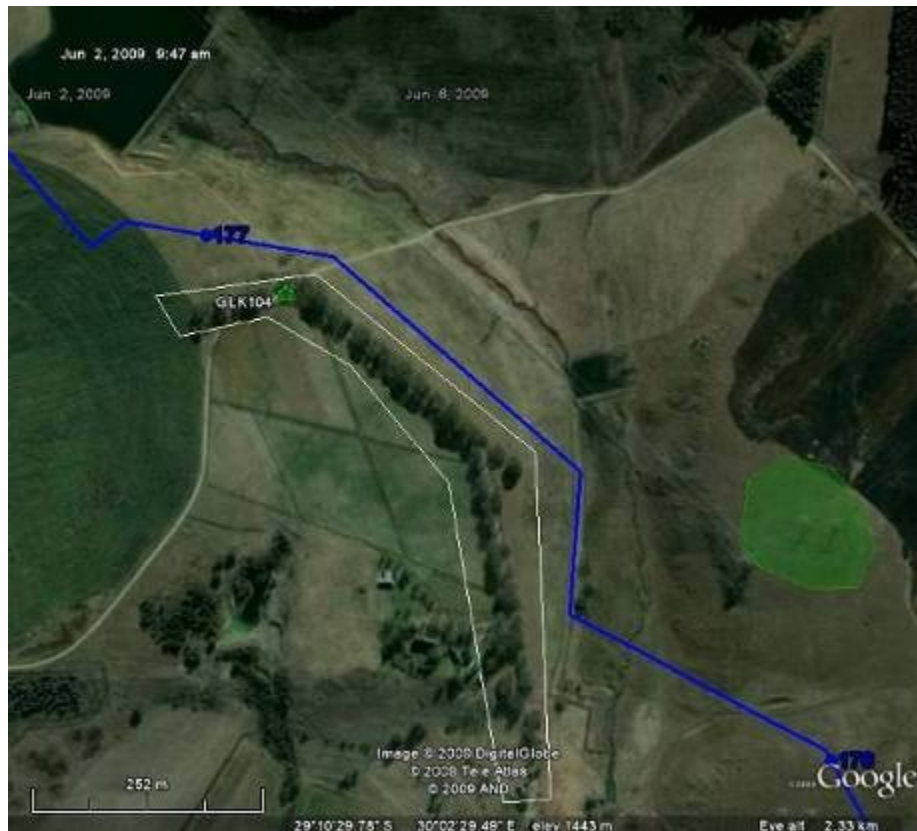
**FIG. 41: AERIAL VIEW OF THE FARM BOUNDARY IN RELATION TO THE PIPELINE**

The pipeline was re-aligned to have no impact on the trees, and is now 30m – 90m away from the trees. The rows of trees were photographed from various angles. Fig. 41 show the line of trees in relation to the pipeline, while fig. 42 indicates the row of trees
