**SKA BUILT HERITAGE SPECIALIST STUDY**

Revision C – 10 July 2018

This report is a specialist report that forms part of the larger HIA report being compiled by Digby Wells Environmental for the proposed SKA project. The purpose of this report is to identify and assess the impact and make recommendations for the built heritage resources located in the core area of the SKA project.

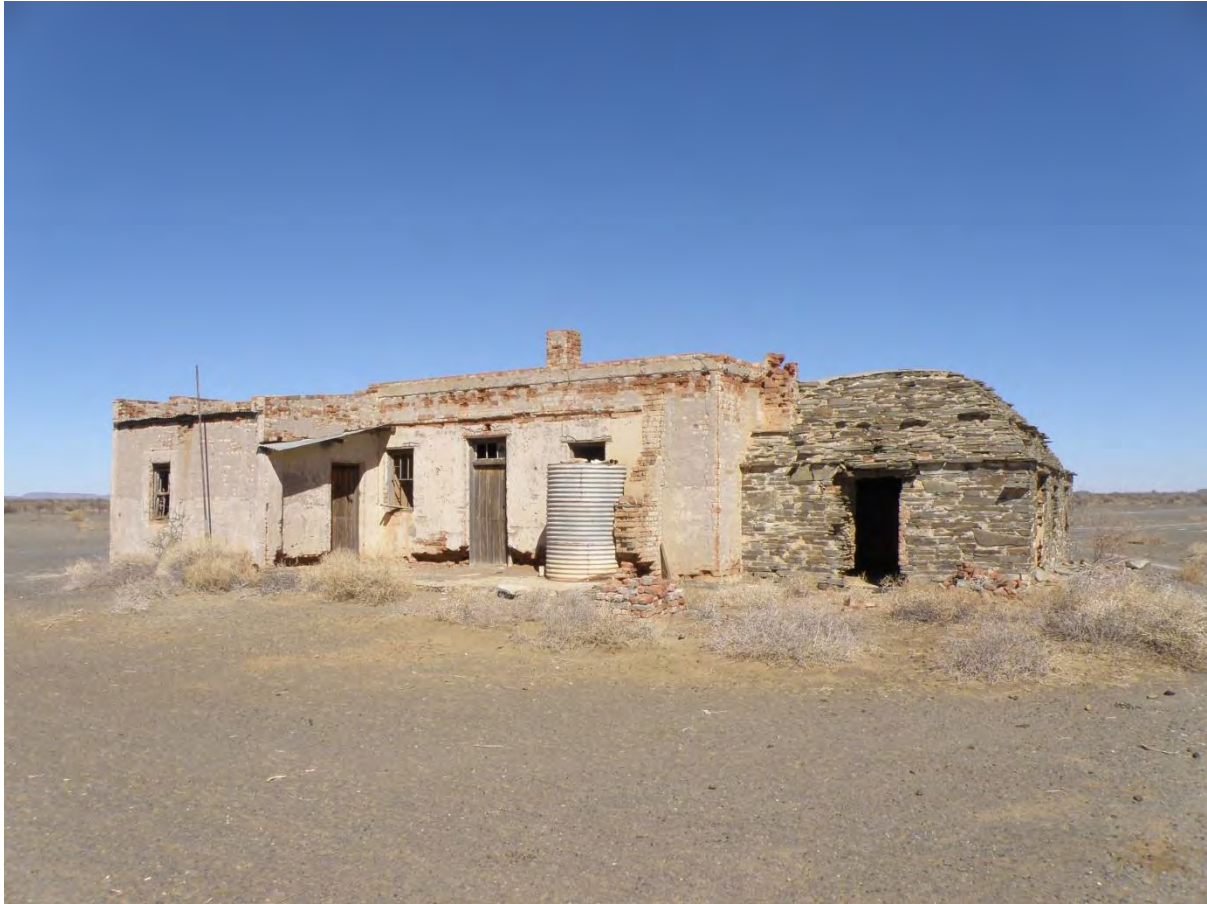
Reference	Built Heritage Site 1
SAHRIS ID	93470
Name	Farmstead (Corbelled House)
GPS Coordinates	-30.691160°; 21.204750

**Figure 13:** Corbelled house with subsequent additions

- The building is in a poor state of repair with severe degradation of some of the later additions to the original corbelled building
- The building, despite its ages and lack of maintenance retains many original fittings and features

- The context of the building has largely been degraded with it now located in a service area of the farm
- The original corbelled building has a relationship with the two successive farmsteads located nearby. Collectively they demonstrate the evolution of farmstead architecture from its early settler origins to the late 20<sup>th</sup> century.

RISKS	<ul style="list-style-type: none"> <li>• Existing SHARIS listing and grading do not identify the building as a corbelled house</li> <li>• The building is in a poor condition</li> <li>• Risk of squatting and vandalism if not actively used</li> <li>• Loss of historical context if adjacent buildings are demolished</li> <li>• Accessibility – a long way from main roads</li> </ul>
OPPORTUNITIES	<ul style="list-style-type: none"> <li>• Opportunity for educational purposes on early farmsteads, vernacular architecture</li> <li>• Research opportunities</li> <li>• Tourism, accommodation or reuse of in adjacent farm buildings</li> </ul>

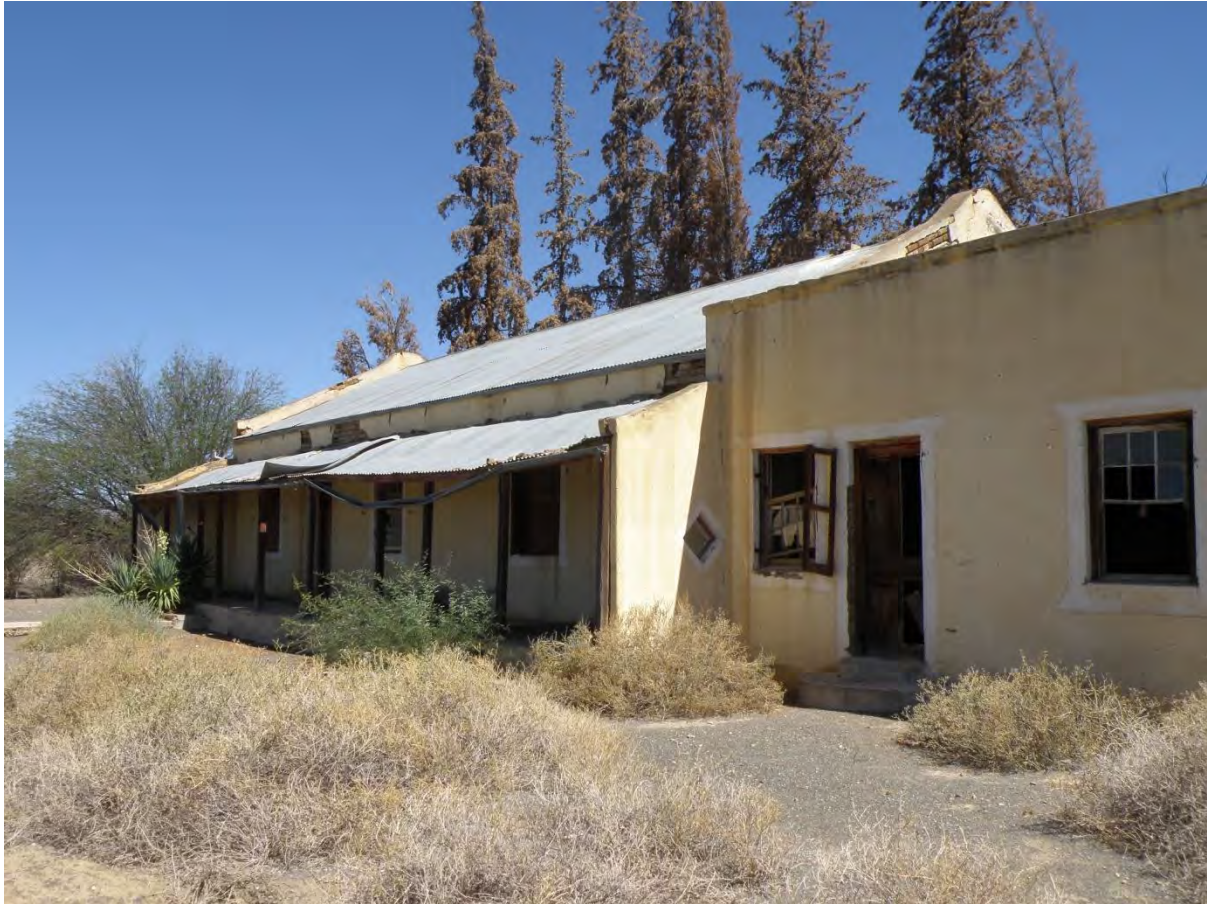
Reference	Built Heritage Site 2
SAHRIS ID	93473
Name	Farmstead 'Ruins'
GPS Coordinates	-30.650545°; 21.265110°

Figure 14: Main façade with stoep

- The building is a good example of a second generation farmstead dating from the latter half of the 19<sup>th</sup> century
- The building, while having successive layers of additions, has a visual and aesthetic unity to its architectural language.
- The building is in a poor state of repair.
- Internally the building has few fittings or features of historical significance.
- Externally the building, despite its ages and lack of maintenance retains many original fittings and features
- The immediate farm werf and context of the building is largely intact and adds to the structures cultural significance.
- The relationship of the building with its associated farm buildings and kraals is of importance.

RISKS	<ul style="list-style-type: none"> <li>• The building is in a poor condition</li> <li>• Risk of squatting and vandalism if not actively used</li> <li>• Loss of historical context if adjacent buildings are demolished</li> <li>• Accessibility – a long way from main roads</li> </ul>
OPPORTUNITIES	<ul style="list-style-type: none"> <li>• Opportunity for educational purposes on early farmsteads</li> <li>• Research opportunities</li> </ul>

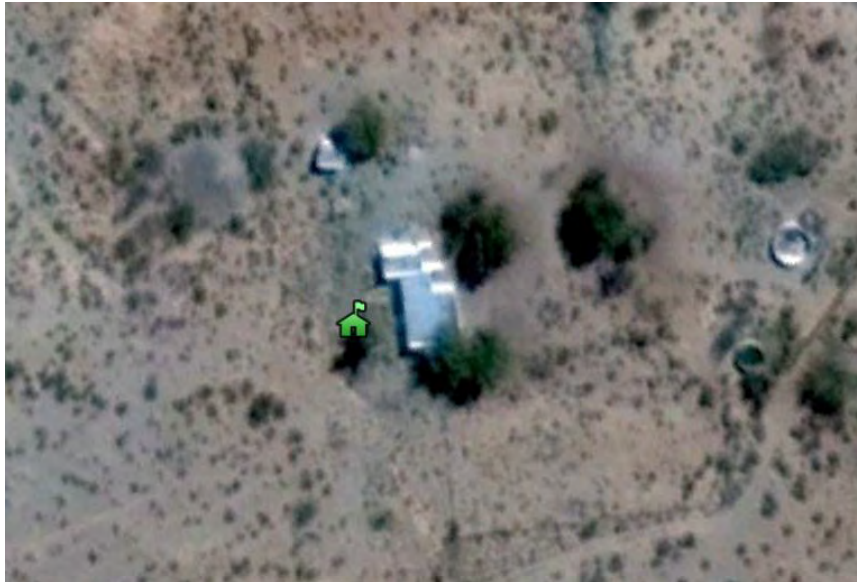
Reference	Built Heritage Site 3
SAHRIS ID	46497
Name	Farmstead Building
GPS Coordinates	-30.701430°; 21.335660°

**Figure 15:** Aerial view of building

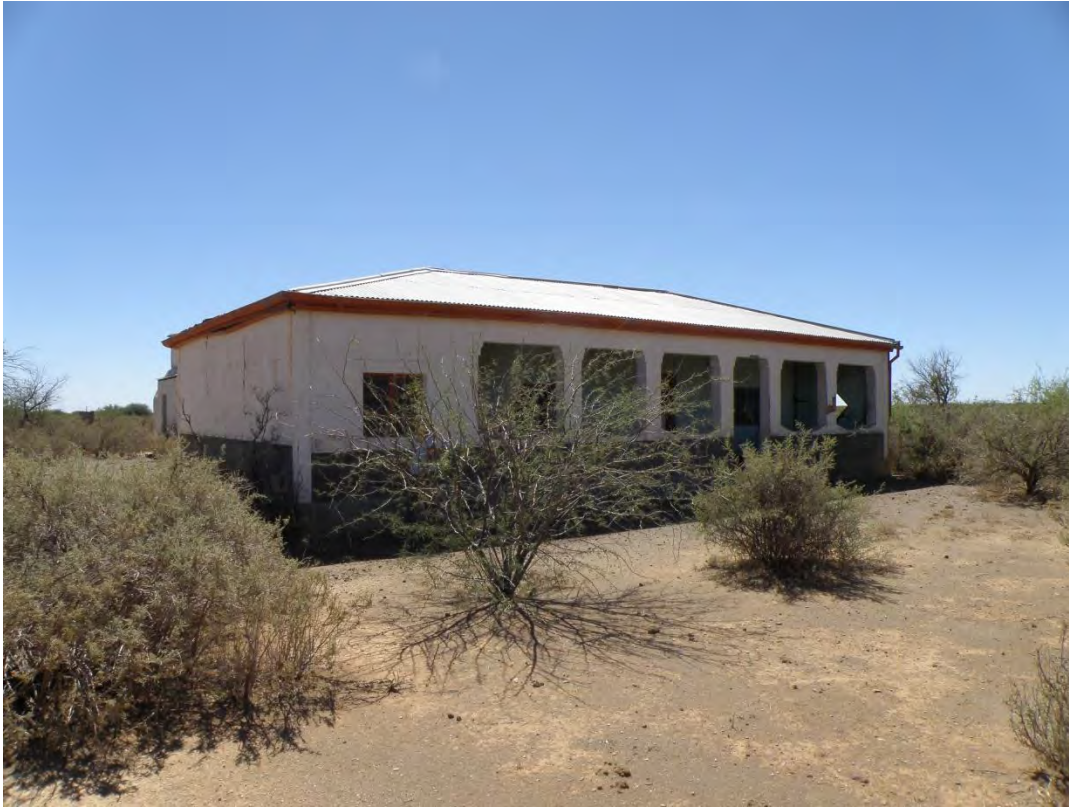
Reference	Built Heritage Site 4
SAHRIS ID	93485
Name	Roosand House
GPS Coordinates	-30.679897°; 21.320515°

*Figure 16: Main façade with stoep.*

- The building is an example of an early 20<sup>th</sup> century farm house.
- The building has been substantially altered and appears to have been functioning as a barn or store.
- Most of the buildings architectural character, detailing and fittings have been lost or removed. Only the columned patio remains.
- The building is in a poor state of repair.
- Internally the building has no fittings or features of historical significance.
- The immediate farm werf and context of the building is partially intact and adds limited value to the buildings cultural significance.

RISKS	<ul style="list-style-type: none"> <li>• The building is in a poor condition</li> <li>• Risk of squatting and vandalism if not actively used</li> <li>• Limited reuse opportunities due to poor condition</li> </ul>
OPPORTUNITIES	<ul style="list-style-type: none"> <li>• Opportunity for functional reuse</li> <li>• Part of the cultural landscape</li> <li>• Located on a main road</li> </ul>

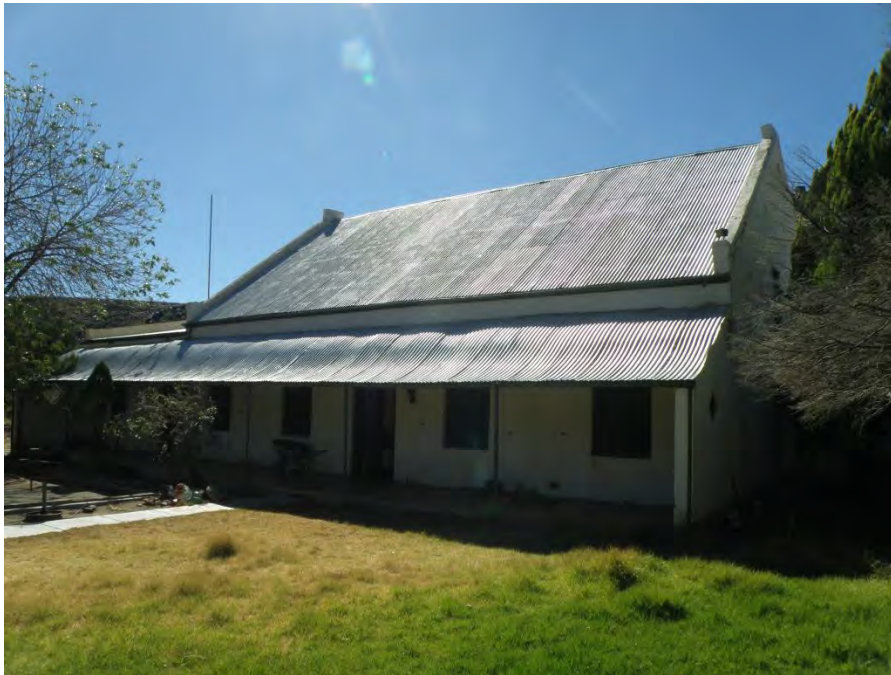
Reference	Built Heritage Site 5
Name	Groot Paardekloof Farmstead and outbuildings
GPS Coordinates	-30.80813900°; 21.3836990°

**Figure 14:** Groot Paardekloof main farm house

- The building is in a fair to good state of repair. The associated farm buildings are in a fair state of repair.
- Internally the building appears to be largely original with many original fittings and finishes in existence.

RISKS	<ul style="list-style-type: none"> <li>• Risk of squatting and vandalism if not actively used</li> <li>• Loss of historical context if adjacent buildings are demolished</li> </ul>
OPPORTUNITIES	<ul style="list-style-type: none"> <li>• The building is in a good condition</li> <li>• The building is readily accessible</li> <li>• Opportunity for educational purposes on early farmsteads</li> <li>• Research opportunities</li> <li>• Building can be easily adapted and reused</li> </ul>

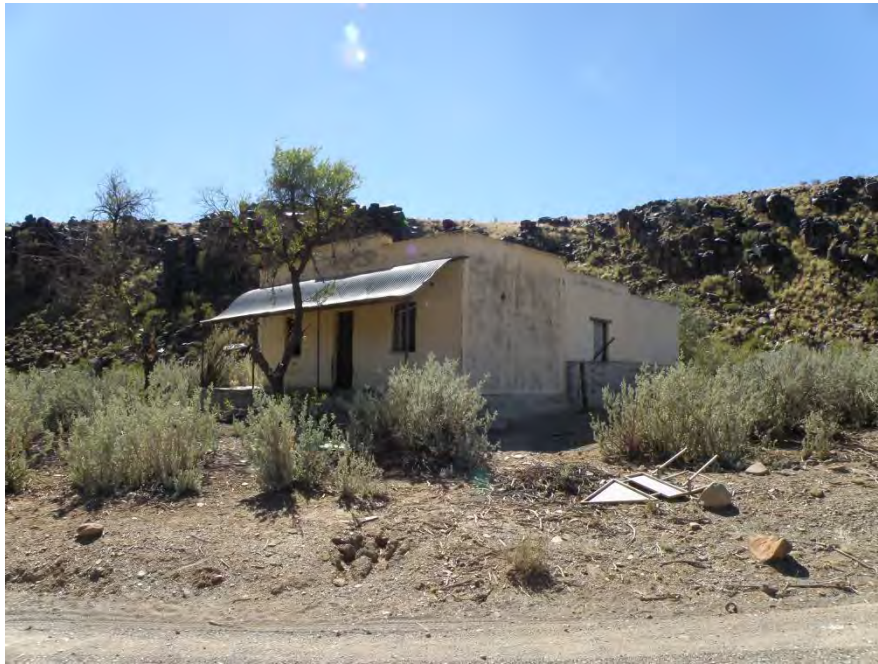
Reference	Built Heritage Site 6
Name	Groot Paardekloof School House
GPS Coordinates	-30.813193°; 21.386437°

**Figure 15:** Groot Paardekloof “School House”

- The building is a good example of a second generation farmstead dating from the latter half of the 19<sup>th</sup> century
- The building currently has a monopitched corrugated iron roof. This possibly replaced an earlier 'brakdak' (vernacular earthen flat roof).

- The building, while in a poor state of repair, appears to have had limited alterations and additions and has a visual and aesthetic unity to its architectural language.

- Internally the building is in a poor condition with few original fittings and finishes in existence.
- Externally the building, despite its ages and lack of maintenance retains many original fittings and features

RISKS	<ul style="list-style-type: none"> <li>• The building is in a poor condition and is at risk of collapse if no action is taken to protect it</li> <li>• Squatting &amp; vandalism</li> </ul>
OPPORTUNITIES	<ul style="list-style-type: none"> <li>• The building is readily accessible</li> <li>• Opportunity for educational purposes on early farmsteads</li> <li>• Research opportunities</li> </ul>

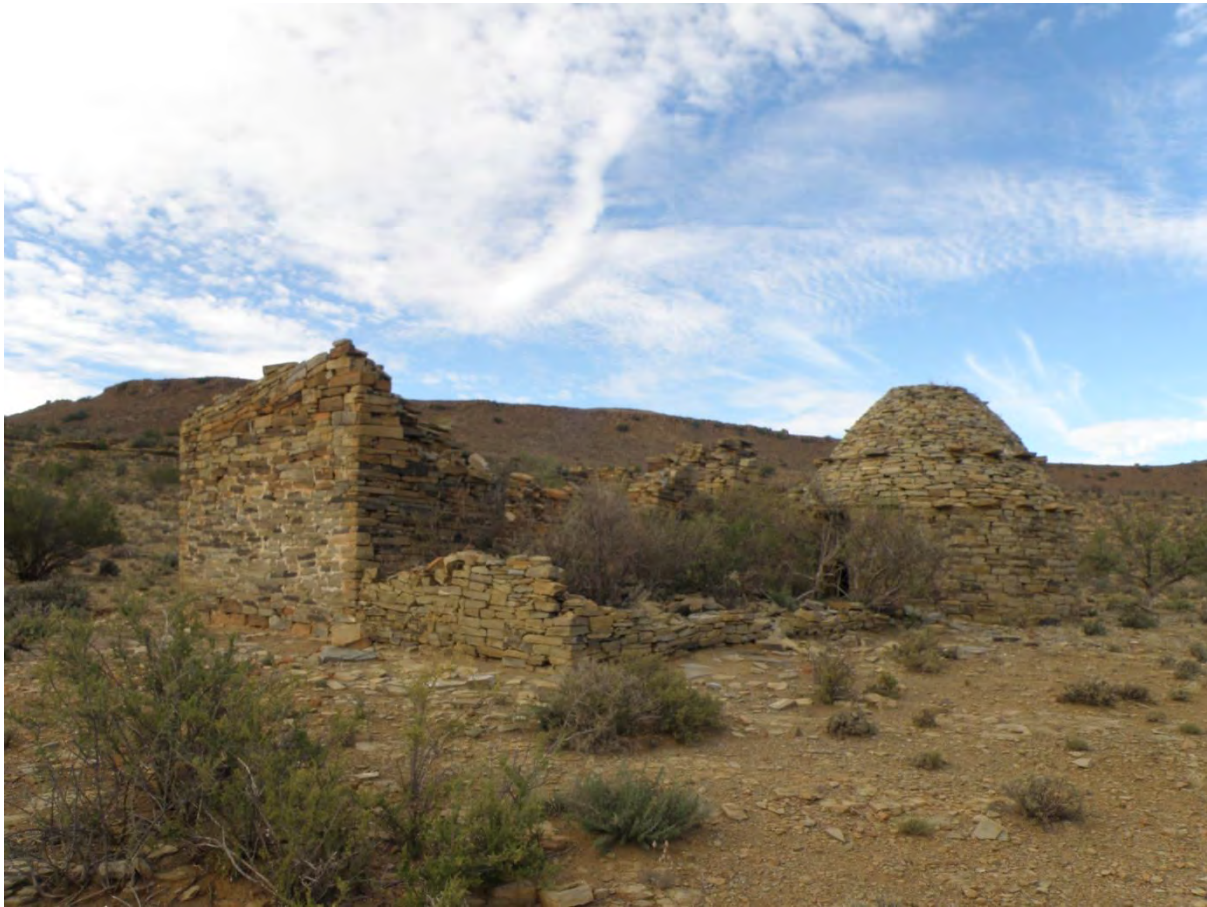
Reference	Built Heritage Site 7
Name	Corbelled House and Farmstead
GPS Coordinates	-30.87045900°; 21.52927400°

*Figure 17: Corbelled house with collapsed later addition*

- The building shows successive layers of additions and adaptations and is a historical record of the evolution of this type of building/architecture
- The building is in a poor state of repair with severe degradation of some of the later additions to the original corbelled building

RISKS	<ul style="list-style-type: none"> <li>• The farm on which the building is located is not owned by the SKA</li> <li>• The site can be severely degraded by too many visitors</li> <li>• The building is completely undocumented</li> <li>• The building is in close proximity to proposed access road for a new dish in the spiral arm.</li> <li>• The building is not listed</li> <li>• The corbelled house is structurally sound. Many of the surrounding building are in a poor condition</li> <li>• Risk of squatting and vandalism (limited due to remote location)</li> <li>• Loss of historical context if adjacent buildings are demolished, new infrastructure is introduced</li> <li>• Accessibility – a long way from main roads</li> </ul>
OPPORTUNITIES	<ul style="list-style-type: none"> <li>• Opportunity for educational purposes on early farmsteads, vernacular architecture</li> <li>• Research opportunities due to its undisturbed nature and the intact state of the werf</li> <li>• Accessibility – a long way from main roads (limits visitors)</li> </ul>

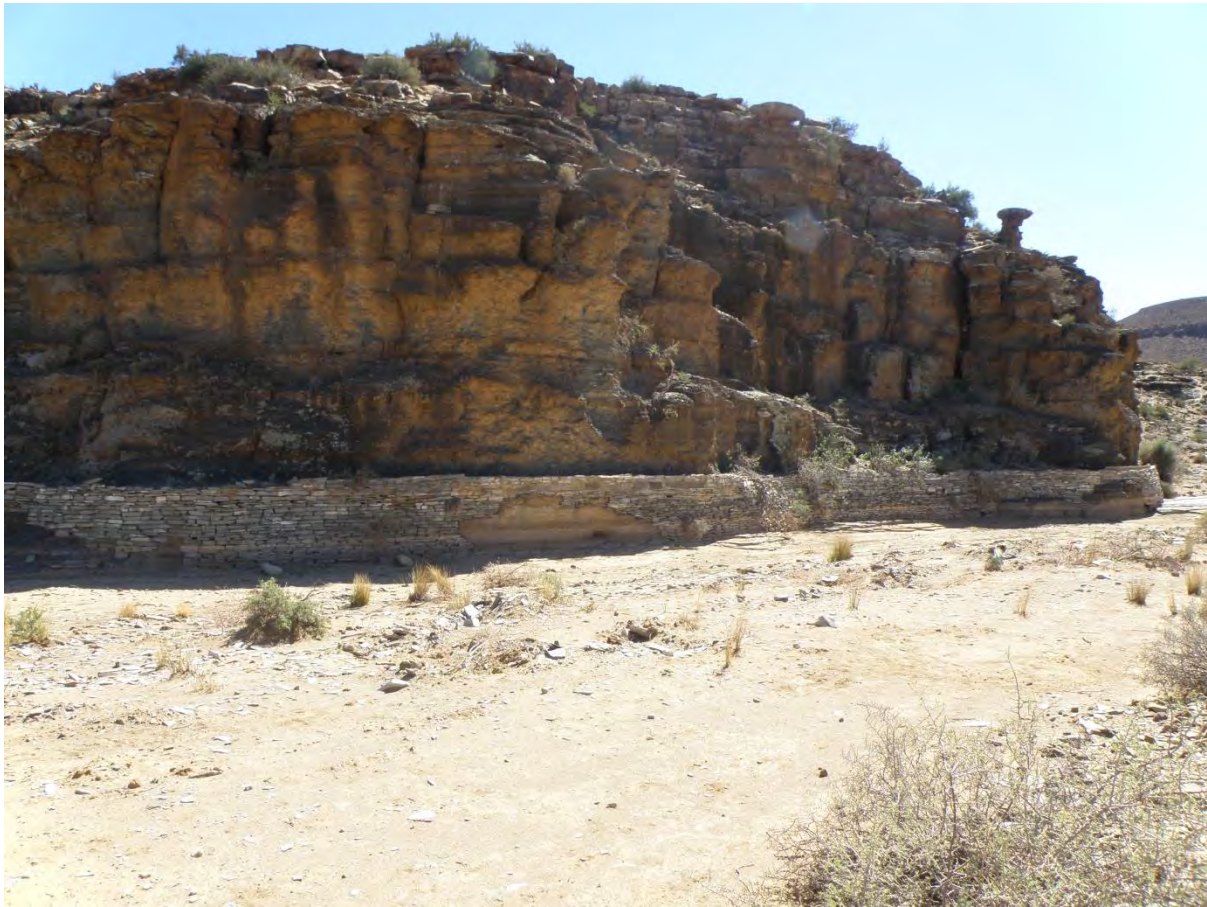
Reference	Built Heritage Site 8
Name	Retaining Walls
GPS Coordinates	-30.869151°; 21.346092°

**Figure 18:** Retaining walls along bas of cliff

- The structure is an unusual example of a dry stacked stonework integrated into a living rock wall
- The wall is very finely built and a landmark within its context
- It is an example of the engineering solutions and construction abilities of early farmers
- The setting of the wall is very picturesque
- The wall appears to be in a good condition

RISKS	<ul style="list-style-type: none"> <li>• Collapse due to natural decay / plant growth or flooding</li> </ul>
OPPORTUNITIES	<ul style="list-style-type: none"> <li>• Adds to the sense of identity of the cultural landscape</li> </ul>
