SAXUM MINING & TRADING CC

07 July 2009

Our ref: MRP 0907-216

BRIEF ASSESSMENT OF STERKFORTEIN CAVES

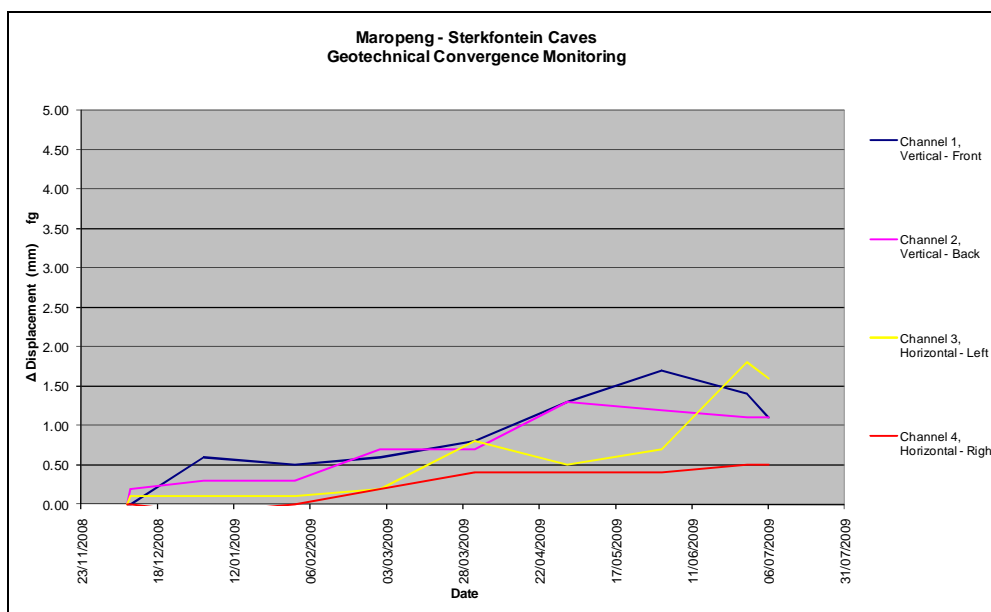
Figure 1 – Relative Displacement of Convergence Monitors

The data was very briefly assessed, specifically to check on the increasing reading for Channel 1. During the previous routine maintenance that was conducted on the system on 08 December 2008, the readings were zeroed. This was used as the starting point and an absolute displacement for each channel was calculated. For channel 1, there was a 1.8mm jump in the readings the day after calibration and this error was corrected for. The plot of the relative displacement readings, from 08 December 2008 to date is shown in Figure 1 and it indicates that there is a gradual increase in the readings up to approximately 1.5mm. This is considered to be within the error limits of the convergence units and mostly related to ambient temperature changes. Most probably as it got colder towards July, the steel wire connecting the footwall and hangingwall, against which the convergence monitor is mounted, has shrunk slightly and therefore showing a slight closure.

Based on these readings there is no cause for concern that there is any movement occurring within the rock overlying the entrance to the caves.

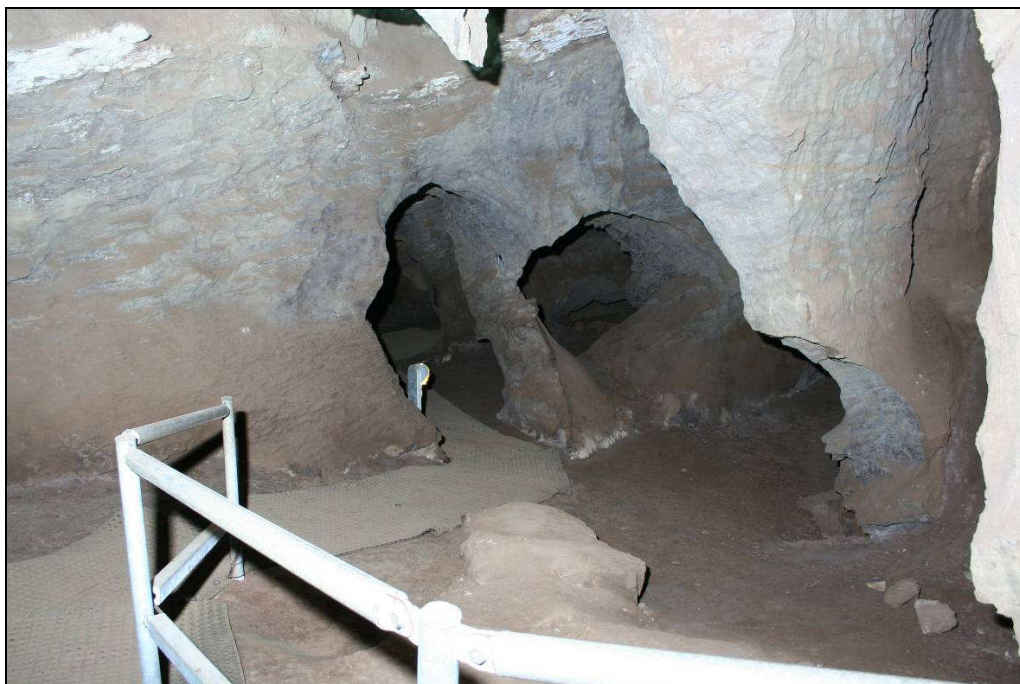
Figure 2 – Rock Wall in Access way between Elephant and Milner Chambers

Lower down in the caves, in the access way between the Elephant Chamber and the Milner Hall, rock fractures were recently noticed in the rock wall (sidewall) of the access way as shown in Figure 2. This route was subsequently closed to the public. You are concerned that this might be a major rock stability issue that is influencing a larger part of the cave system.

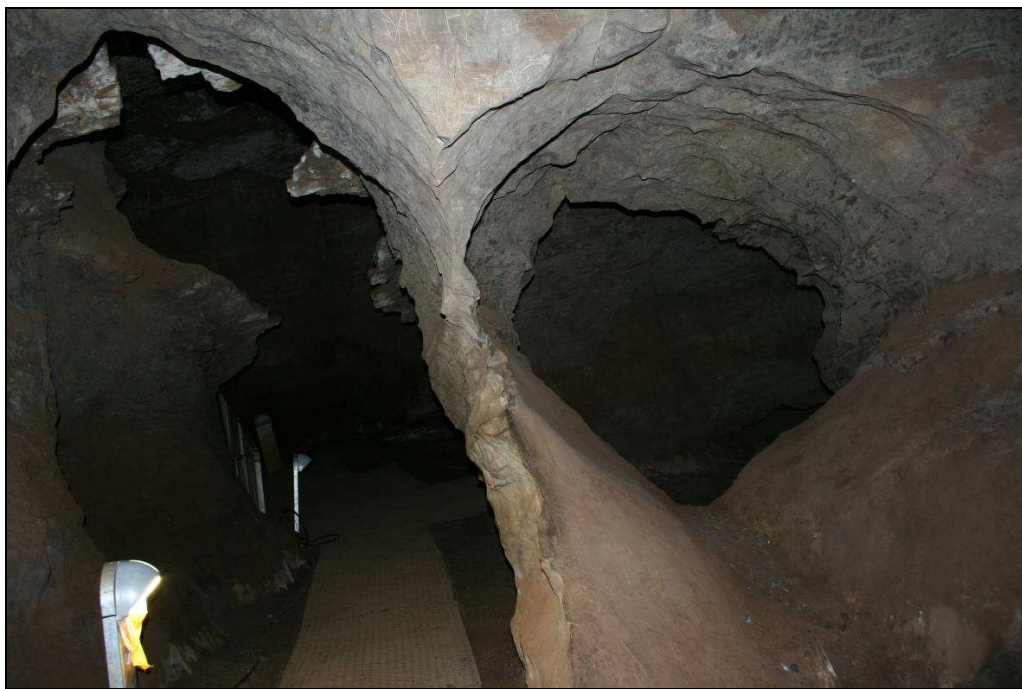
Figure 3 – Pillar of Rock indicating fracturing

The area in question consists of a very thin pillar or wall of rock, more or less in the centre of a semi-arch like opening in the rock mass. This is shown in Figure 3. The arch above this pillar consists of relatively competent rock with near vertical joints dissecting it and forms a pseudo-Voussoir arch.

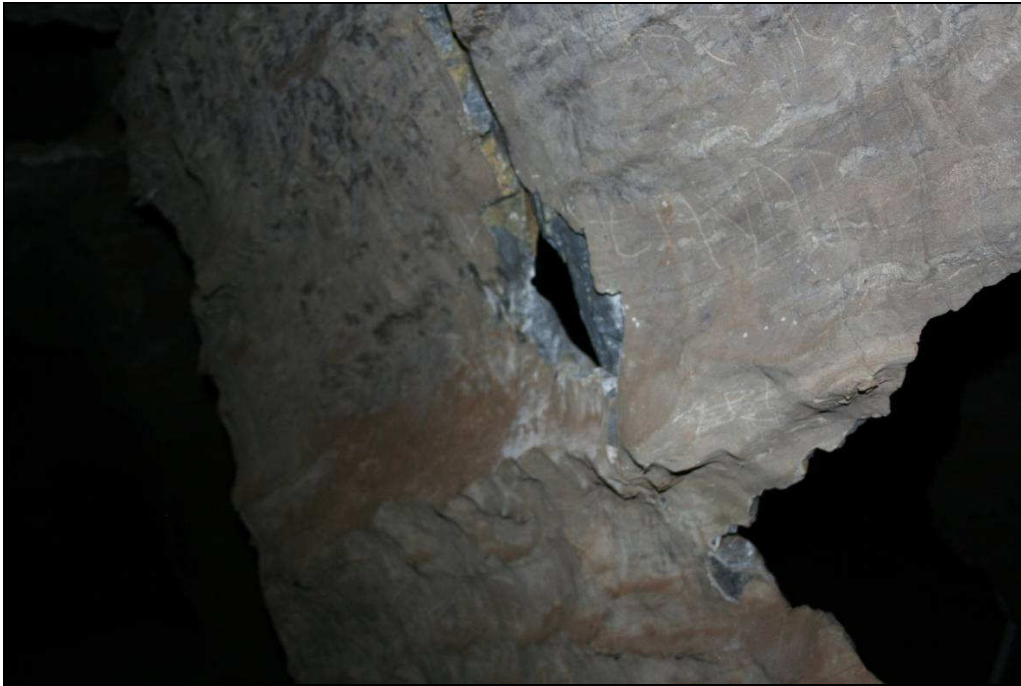
Figure 4 –Fracturing in rock wall

The peculiar angle of the rock wall as well as its physical dimensions in relation to the load acting on it, causes a stress concentration at its narrowest point, which is on the Elephant Chamber side and more or less at mid-height of the wall. This is shown in Figure 4.

It is considered to be a localised fracturing of the rock, directly related to the physical dimensions of the wall structure and the load acting on it. If this passage is to remain open to the public, it would be suggested to create a safe passage by placing interlinked arches in this section. There are more appropriate measures to support the rock, but this will change the aesthetics of the cave.

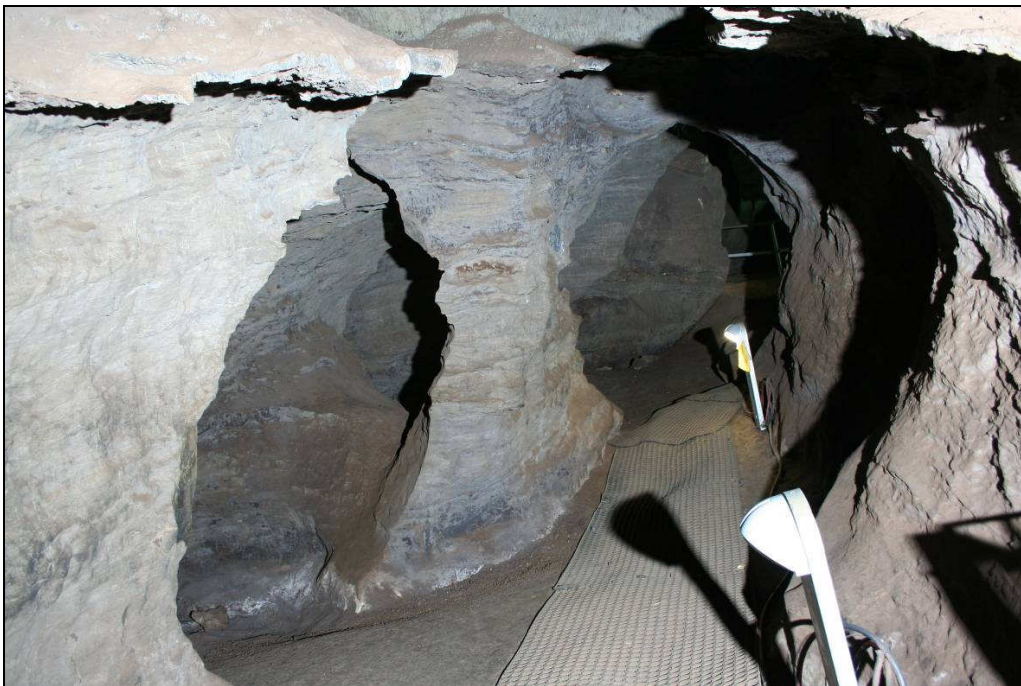
Figure 5 – Back of the rock wall on the Milner Hall side

If one observe the structure from the Milner Hall side where there is an increase in the thickness of the wall, there is no evidence of the stress fracture extending into it. This is shown in Figure 5. Also, the rock mass above the arch was inspected and there is no evidence of any displacement or movement on any of the joint structures above the arch.
