MEYER AND DU TOIT FARMSTEADS

Phase 2 – Heritage Impact Assessment Report

Issue Date: 27 May 2020

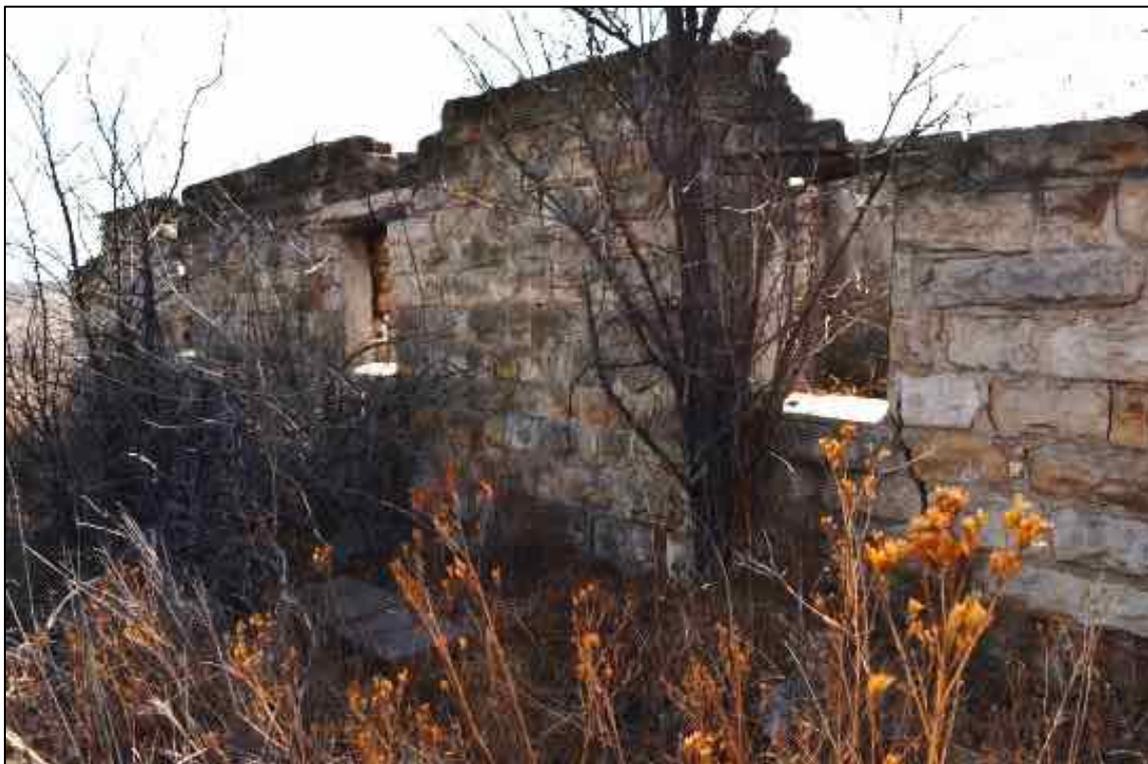
Figure 34 – The dwelling's south-eastern elevation and façade is the only facade that has remained reasonably intact (Photograph by Mauritz Naudé).

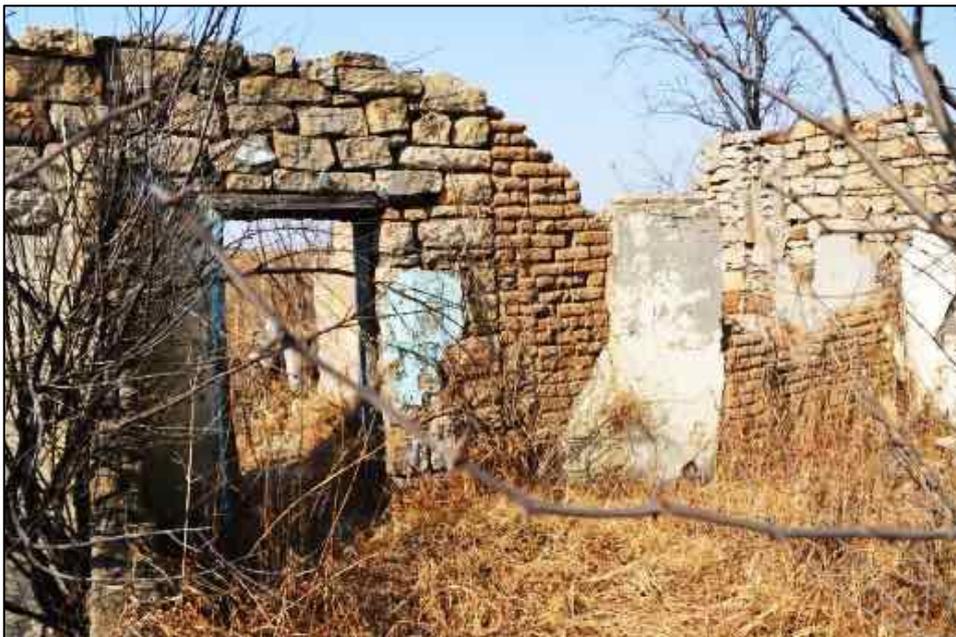
All the later additions were done in brick and they were plastered. The most significant brick addition was added to the front façade of the dwelling and left unplastered. All the walls are badly damaged as the building has no roof to protect them.

Figure 36 - Part of the exterior walling with clay bricks forming part of a later addition (Photograph by Mauritz Naudé).

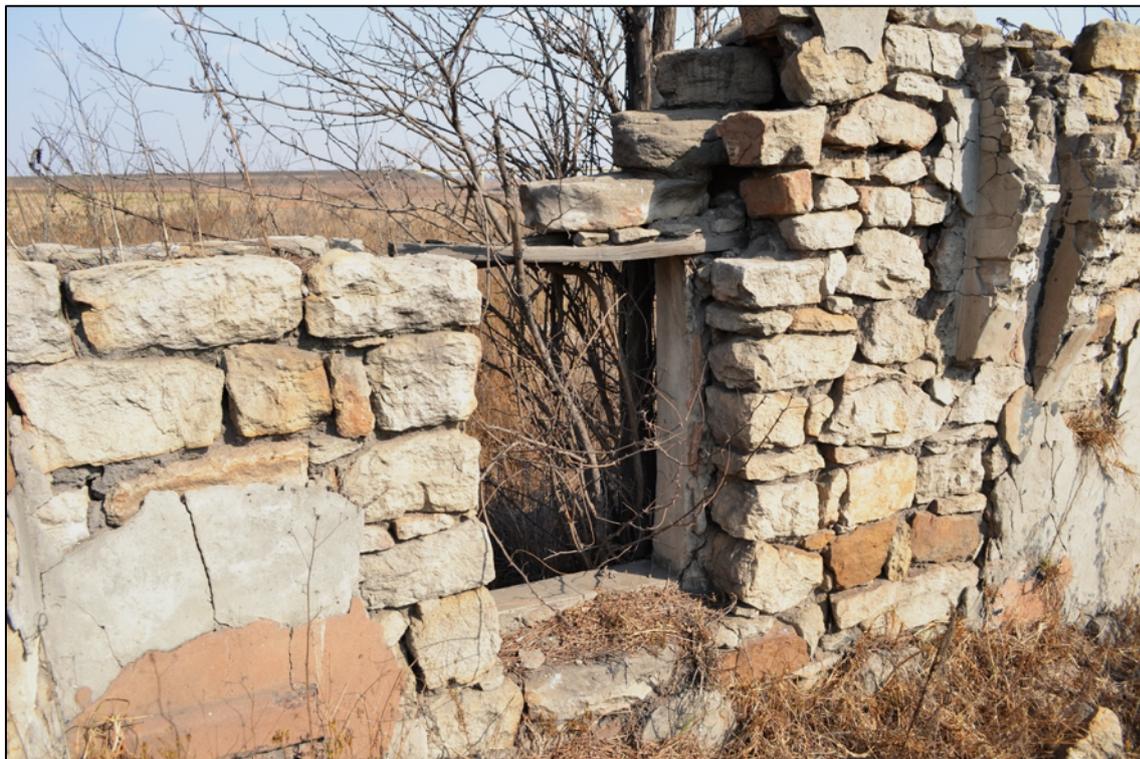
Figure 49 - Small window with remnants of the timber lintel at the top (Photograph by Mauritz Naudé).

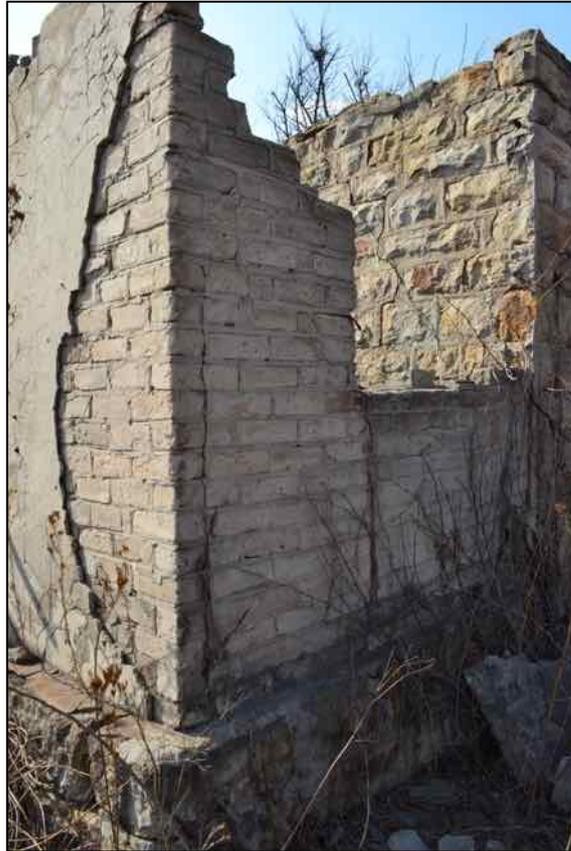
Figure 50 - Well-prepared sun-dried clay bricks exposed after the plastered was broken and had fallen off. These sun-dried clay bricks were used on this more recent addition to the dwelling (Photograph by Mauritz Naudé).

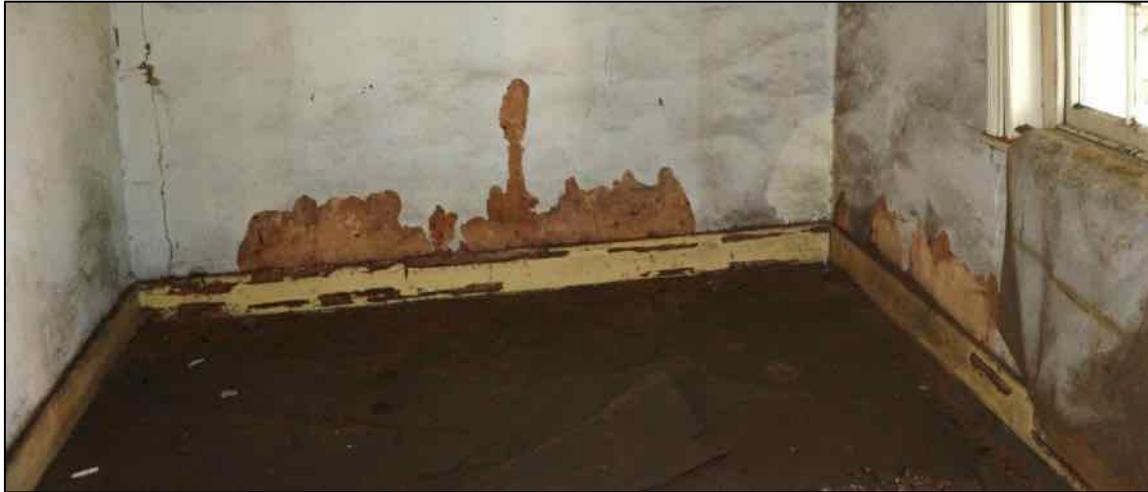
Figure 64 - The floor of the front room facing the front stoep - note the rising damp problem just above the skirtings (Photograph by Mauritz Naudé).

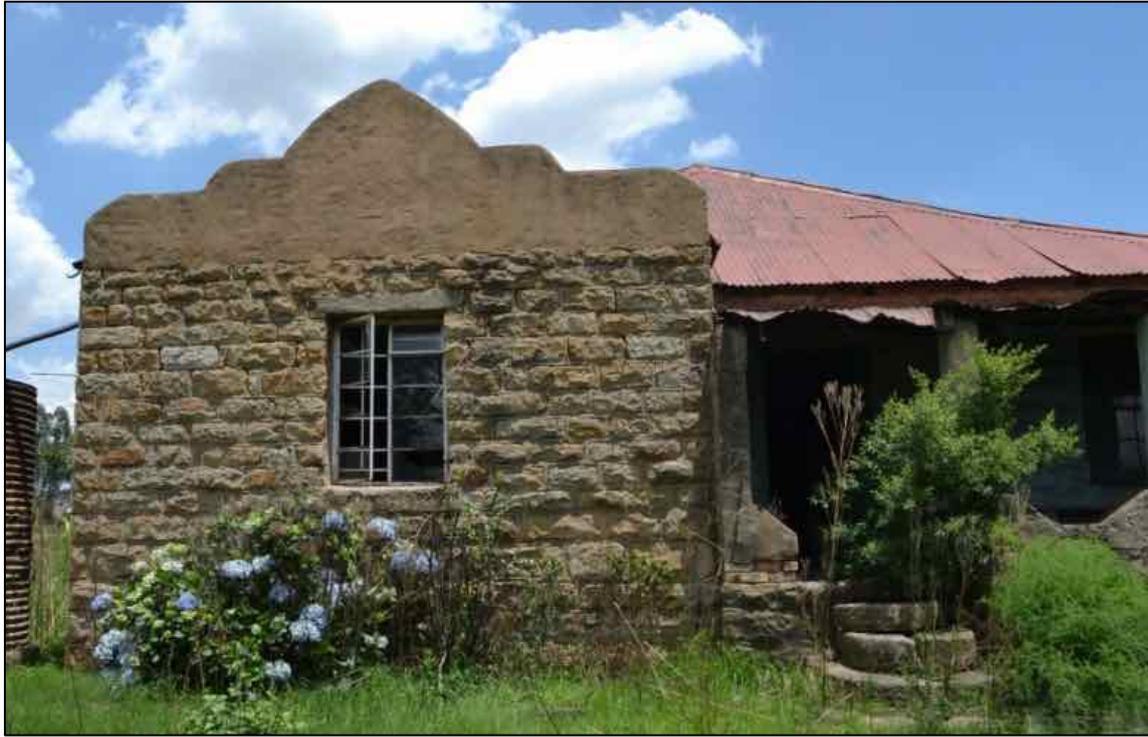
The dwelling also has a front gable with projecting parapet constructed with a plastered brick in a crude and unrefined fashion. The building may have had a gable previously and it may have been hit by lightning that toppled the parapet top part. The building may have burnt down resulting in severe damage to the top layers of the sandstone. The entire northern elevation has been retouched and the top four to five layers of coursework has been rebuilt. The stone coursing has been done in a different style than the original stonemasonry further down.

Figure 67 - Front facade with gable room executed in dressed sandstone with the parapet front gable done in plastered brick (Photograph by Mauritz Naudé).

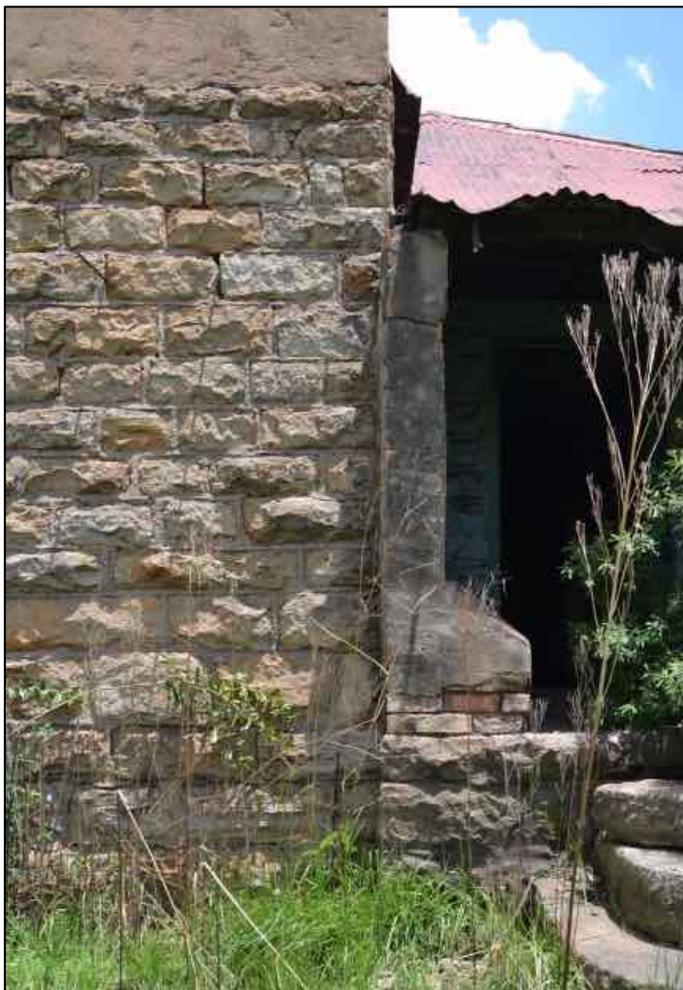
The veranda originally had a timber support structure for the roof which was later replaced with plastered brick columns. This may have been altered during the 1920s or 1930s.

Figure 73 - The columns of the front veranda were replaced with plastered brick columns while the foundation of the stoep is the same as the rest of the core structure (Photograph by Mauritz Naudé).

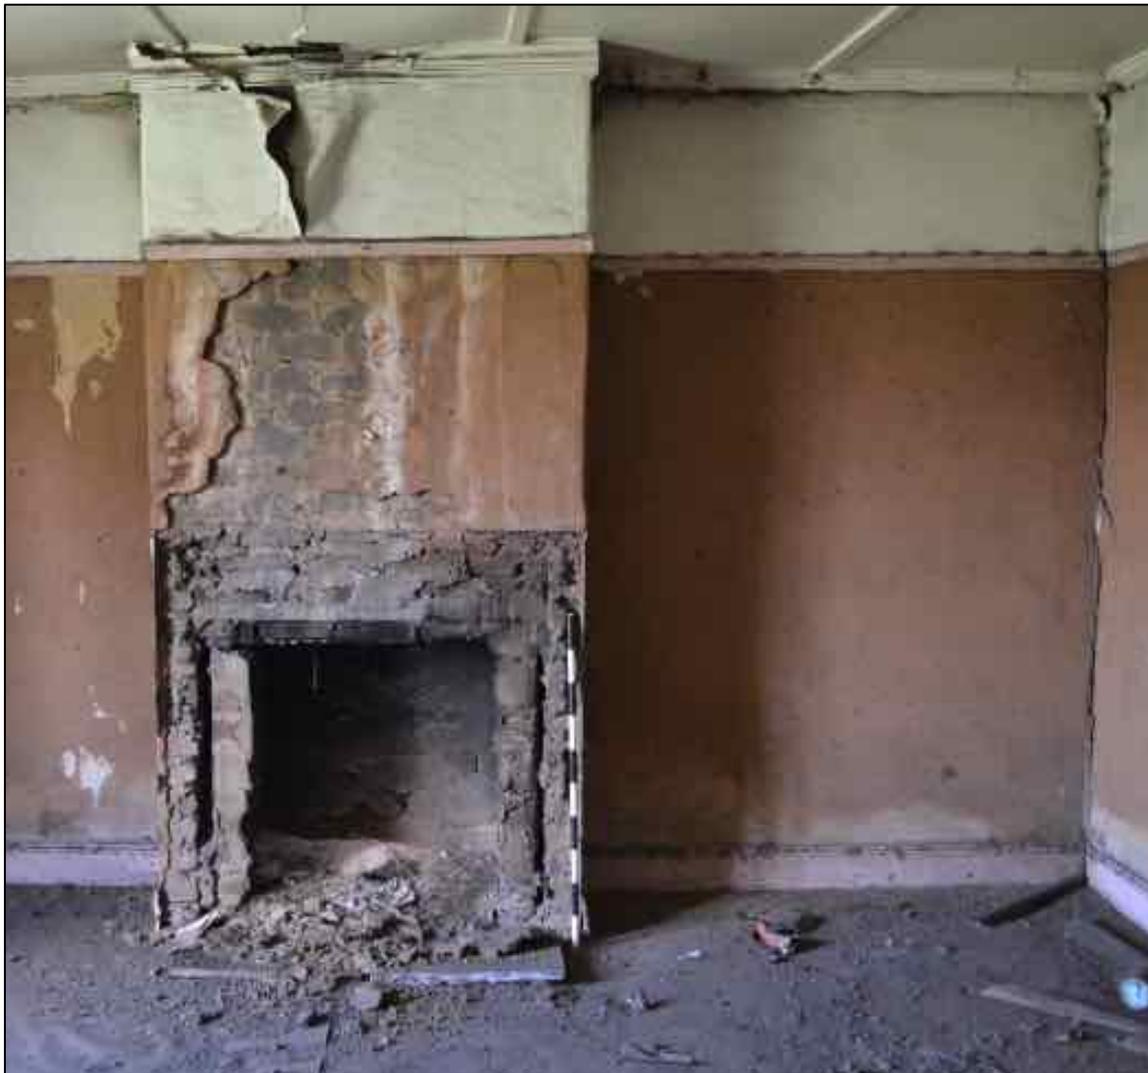
Figure 82 - Protruding fireplace in the lounge. The mantelpiece has been removed (Photograph by Mauritz Naudé).

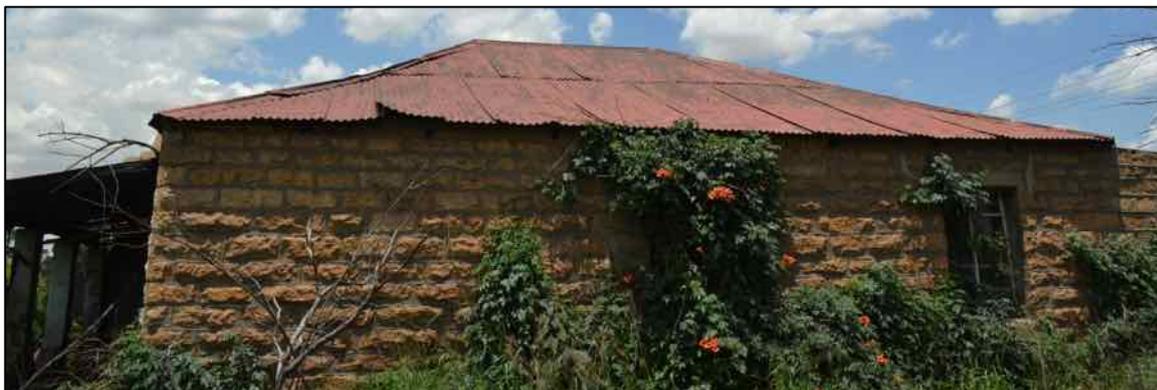
Figure 83 - The general condition of the corrugated sheet iron roof (Image by Mauritz Naudé).

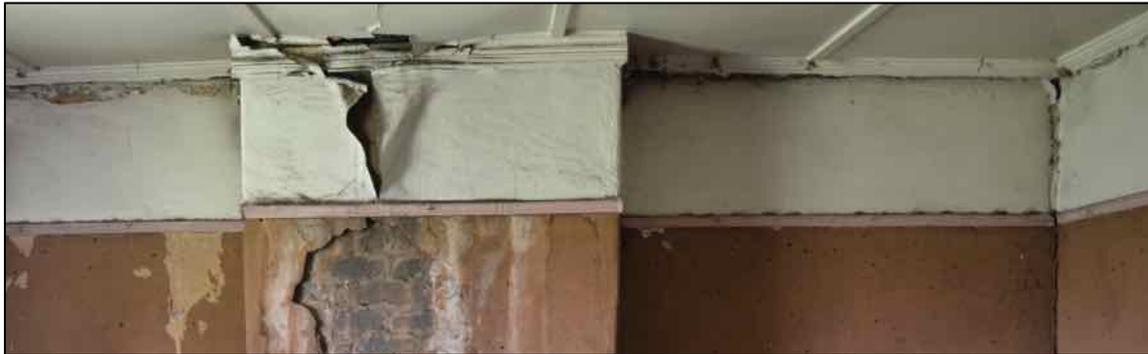
The ceilings were painted with high gloss enamel paint which is coming loose and peeling due to rainwater dripping through the roof.

Figure 87 - Gypsum boarding with pine planking and sealed with moulded cornices (Photograph by Mauritz Naudé).

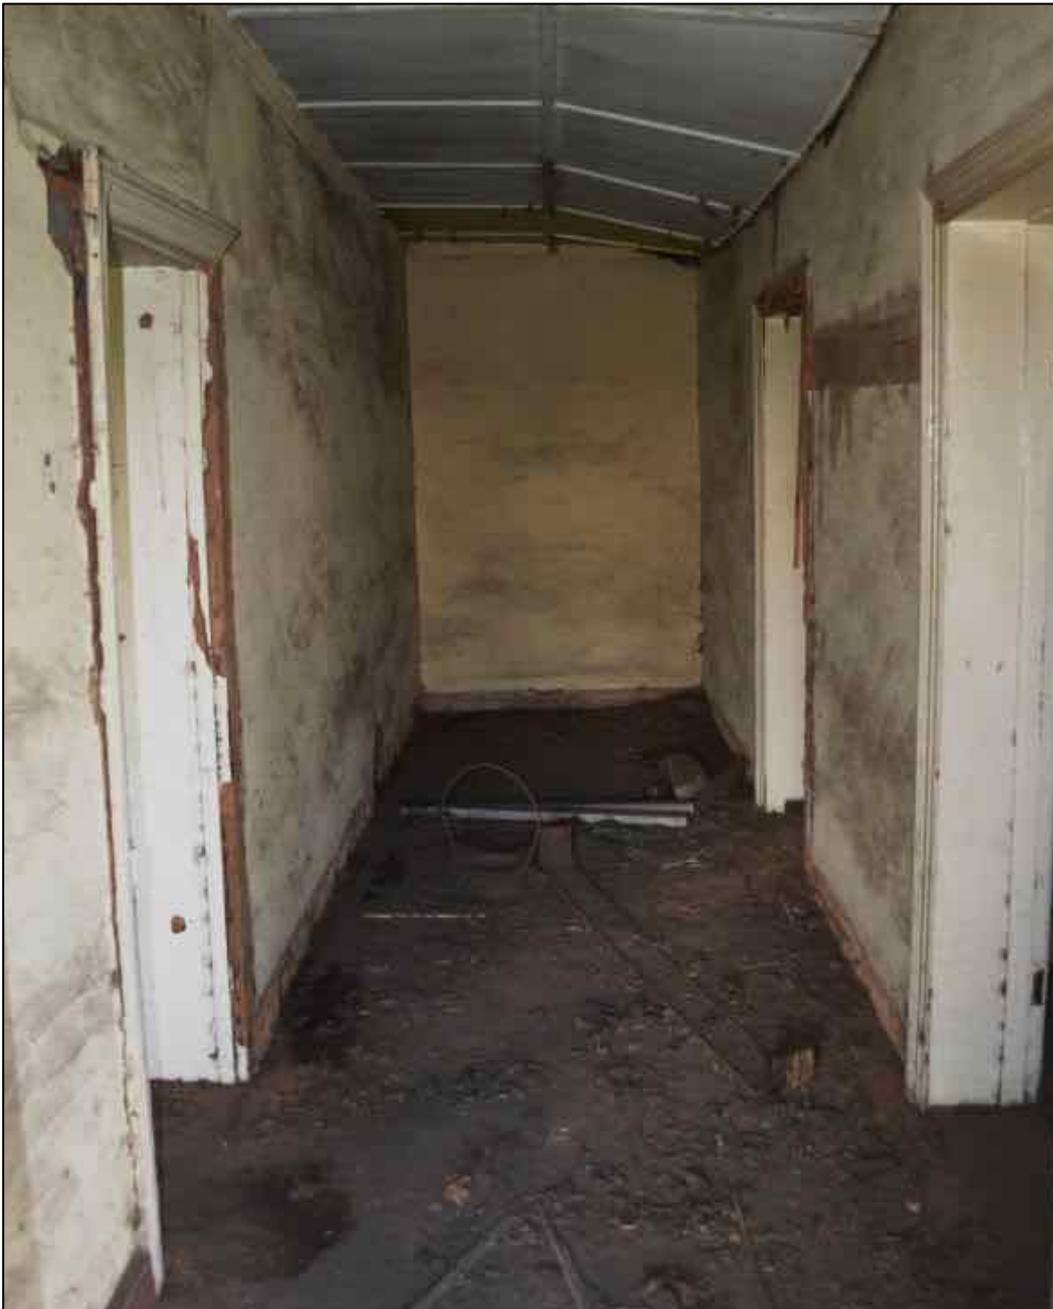
Figure 91 - All the interior entrances have timber door frames with simple molded architraves. All the doors have been removed (Photograph by Mauritz Naudé).

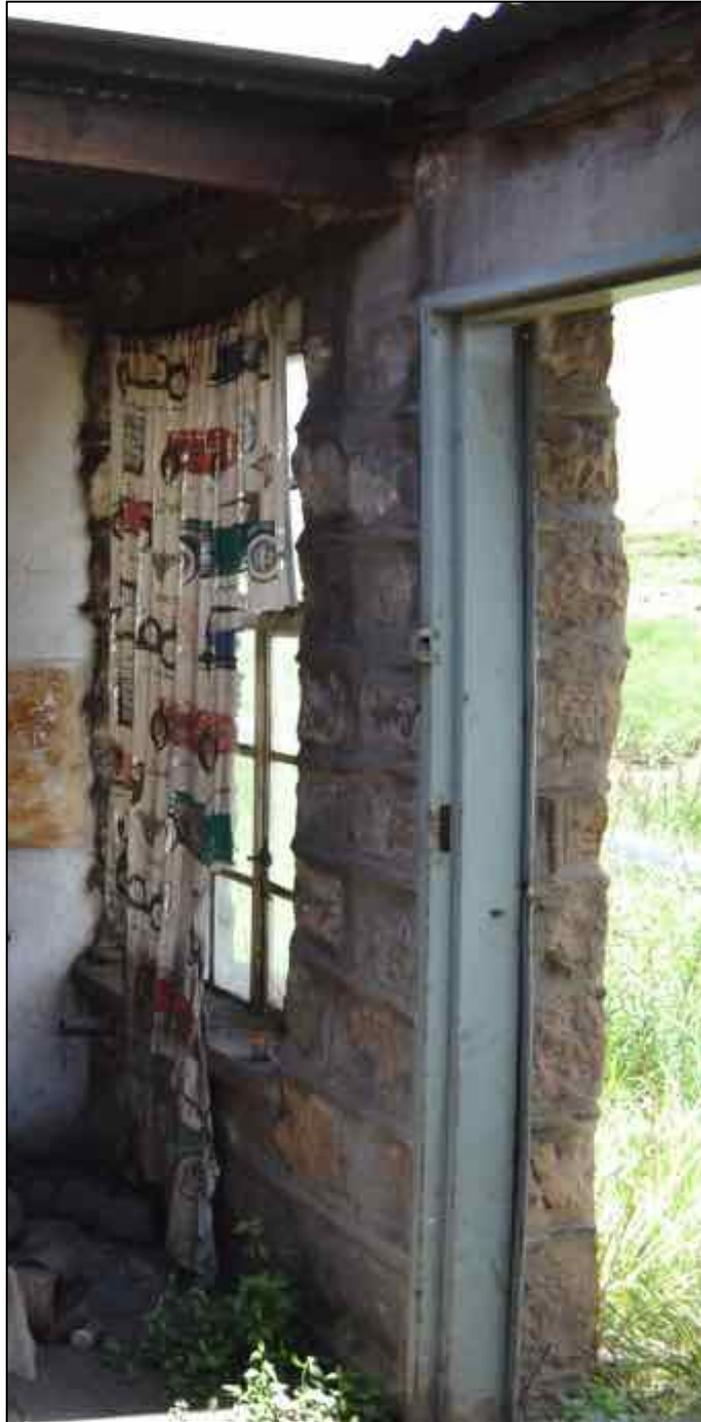
Figure 92 - The back door leading from the closed-back veranda has a standard steel frame - the door has been removed (Photograph by Mauritz Naudé).

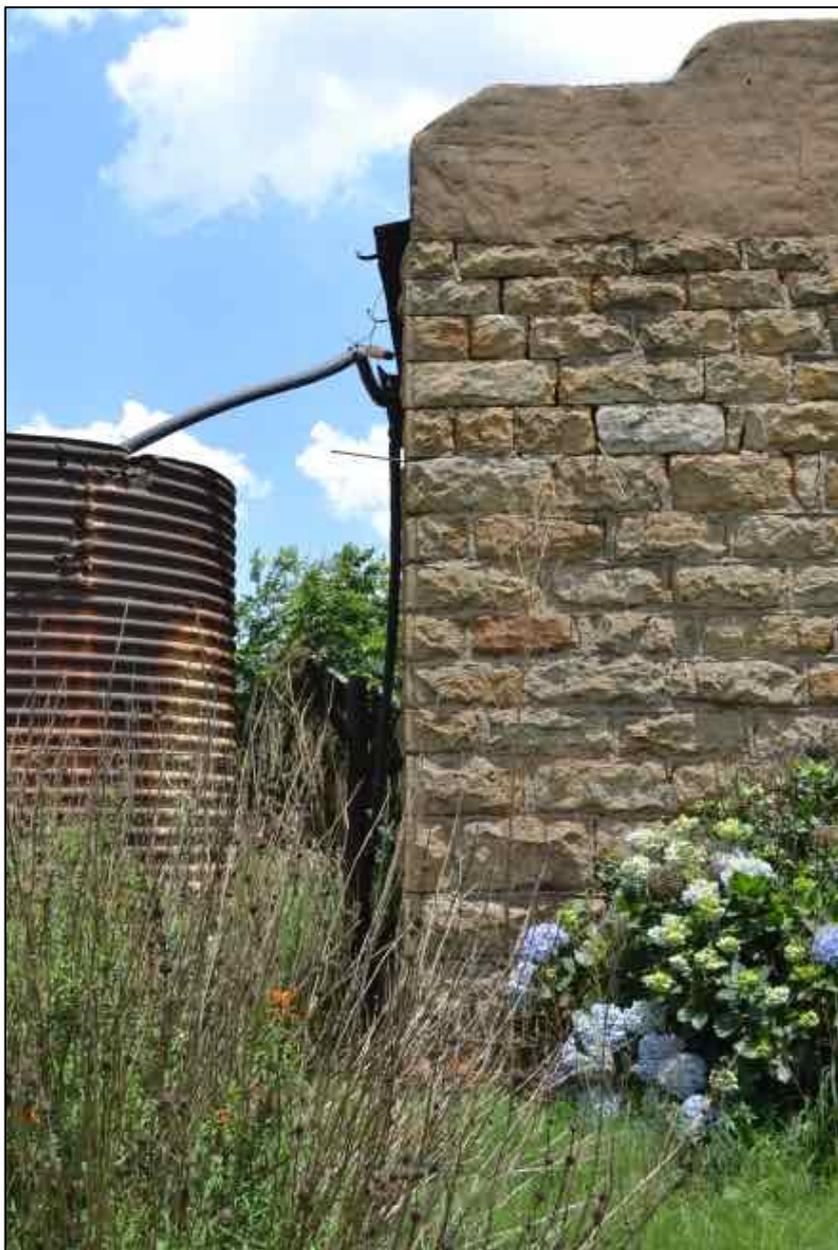
Figure 105 - Down piping was discarded and water from the gutter flowed directly into a water reservoir (Photograph by Mauritz Naudé).

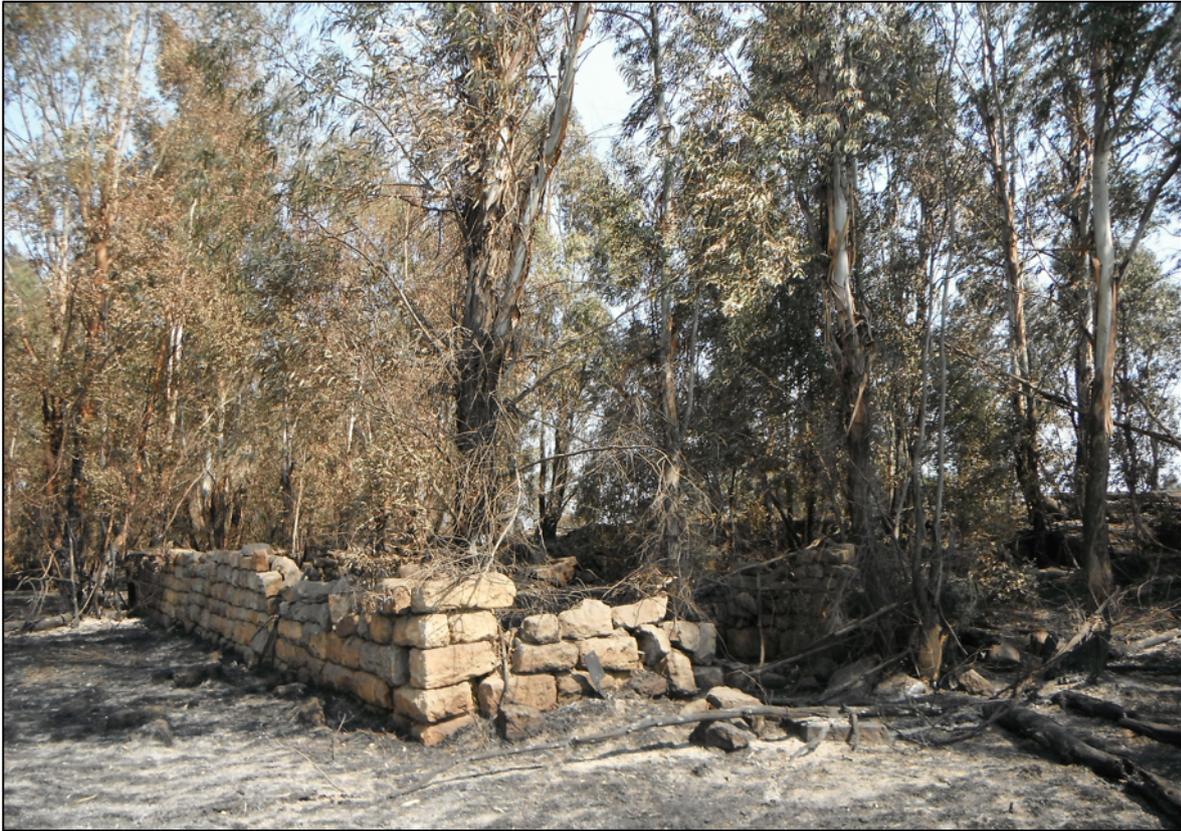
Figure 109 – The remains of a livestock enclosure identified some distance north-east of the farm dwelling. This structure appears to have been demolished (Photograph by Polke Birkholtz).
