Matakoma Consultants

**PERMIT APPLICATION FOR THE DESTRUCTION OF HISTORICAL SITES LOCATED WITHIN
PHASE 1 OF THE GARDENER ROSS GOLF AND COUNTRY ESTATE ON THE FARM
KNOPPIESLAAGTE 385 JR, GAUTENG PROVINCE**

ANNEXURE 3 - DOCUMENTATION OF HERITAGE SITES FOR APPLICATION

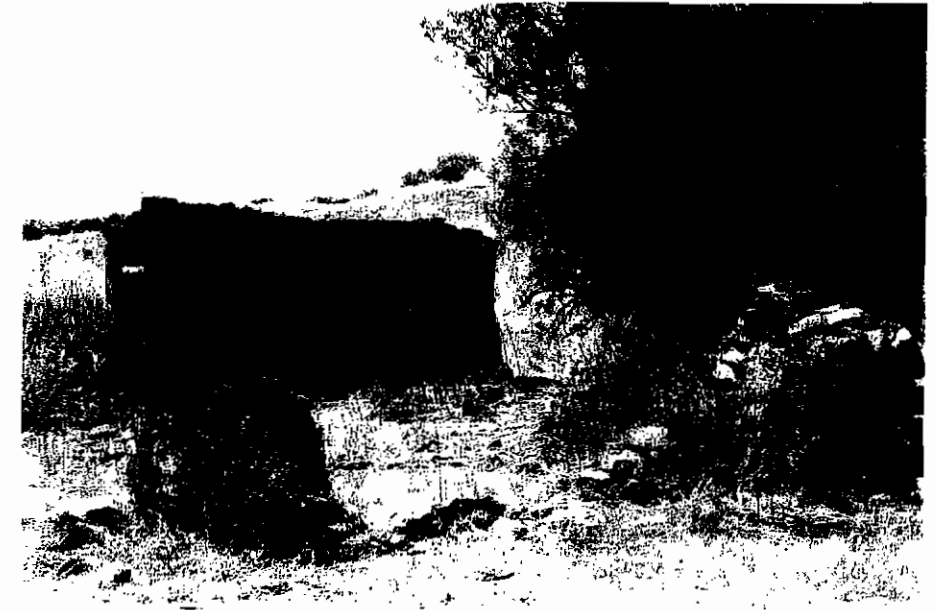
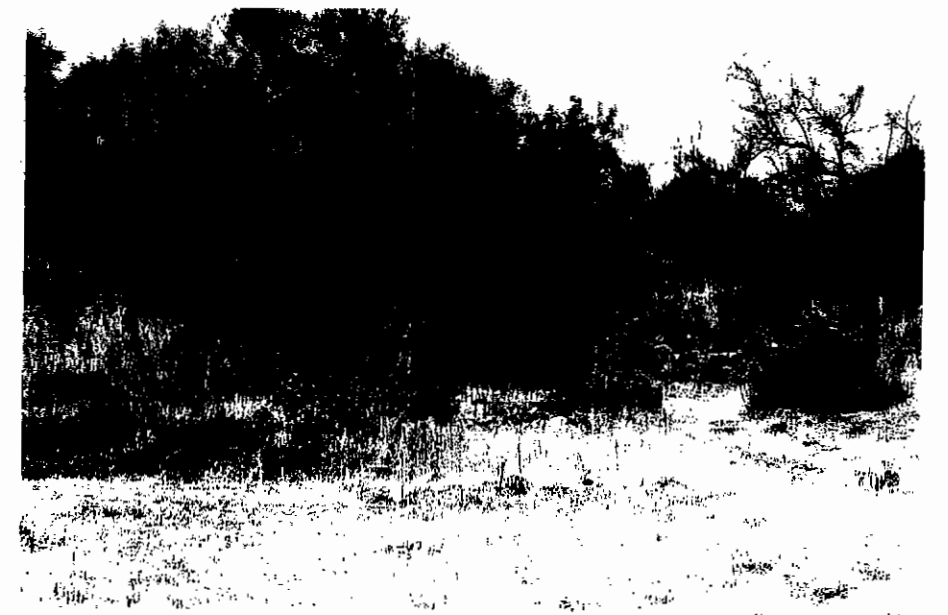
This structure is an isolated occurrence on the northern side of the ridge associated with mining activities in the area. Several dumps are located about 100m east of the site. It is unknown whether the structure can be associated with white habitation as the site also lacks outbuildings. The dwelling was constructed with clay and it is assumed that it had a compacted clay floor. The walls were poorly constructed with a combination of small stones and clay mortar that have eroded quickly after the roof disappeared.

Remains of a dwelling near the diggings. It was constructed with red clay compared to the other structures that were constructed with greyish clay material.

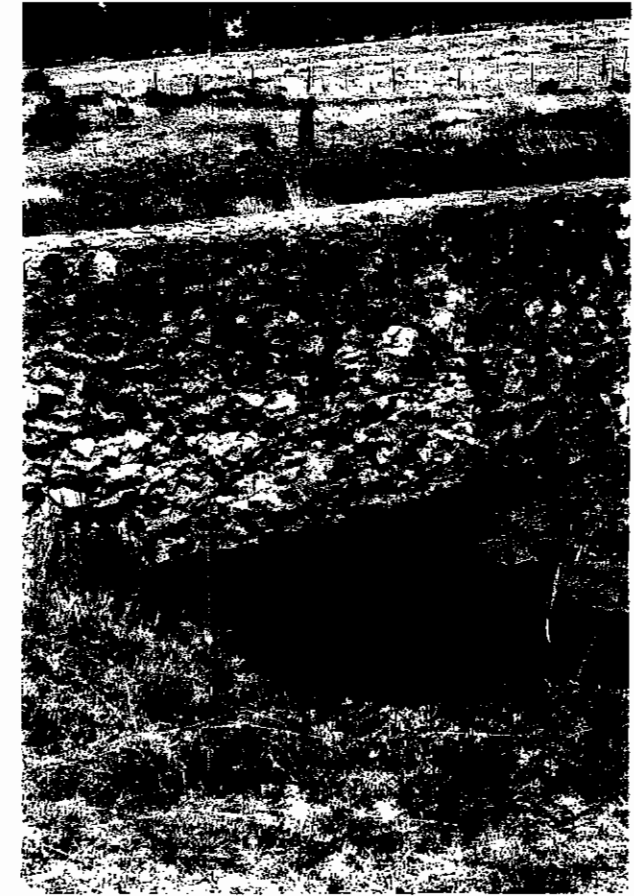
The bottom part of the weir is open and it seems as if the river bed has been washed away and that the weir walling have remained intact.

The structure can now only be described as a pedestrian bridge as it has lost its ability to contain water in the same way a weir or dam wall would. It was originally constructed the same way as the other weirs in the spruit - with stone and concrete. It uses the rocks in the flow bed as foundation and no other buttressing was used for supporting the wall. The top of the wall was also covered with a thin layer of cement to seal the top. At some stage in its history the lowest part of the wall must have disintegrated and slipped from underneath the wall allowing water to drain through without any resistance.

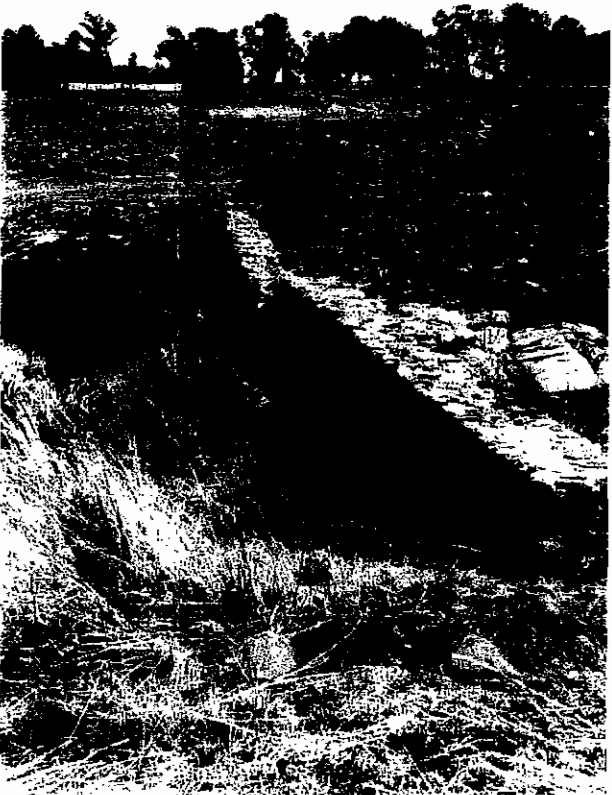
Dam wall or weir with a broken top supposed to operate as an overflow for flood water.

It consists of the remains of a stone weir constructed across the spruit. It is the second weir in the impacted area. It runs across the spruit for about 40 m and an overflow was created almost in its centre by chipping away the stone and concrete. The entire weir is constructed with stone and concrete and the top was sealed with a layer of cement. Prior to having an overflow in the centre water used to flow past the one end of the wall - on the southern end. The weir is used by the local cattle herder to cross the spruit.
