ARCHAEOLOGICAL PERMIT: SUBMISSION OF REPORT LA GRATITUDE

LA GRATITUDE, STELLENBOSCH

ARCHAEOLOGICAL EXCAVATIONS ON SITE OF AN EARLIER OUTBUILDING

OCTOBER 2004

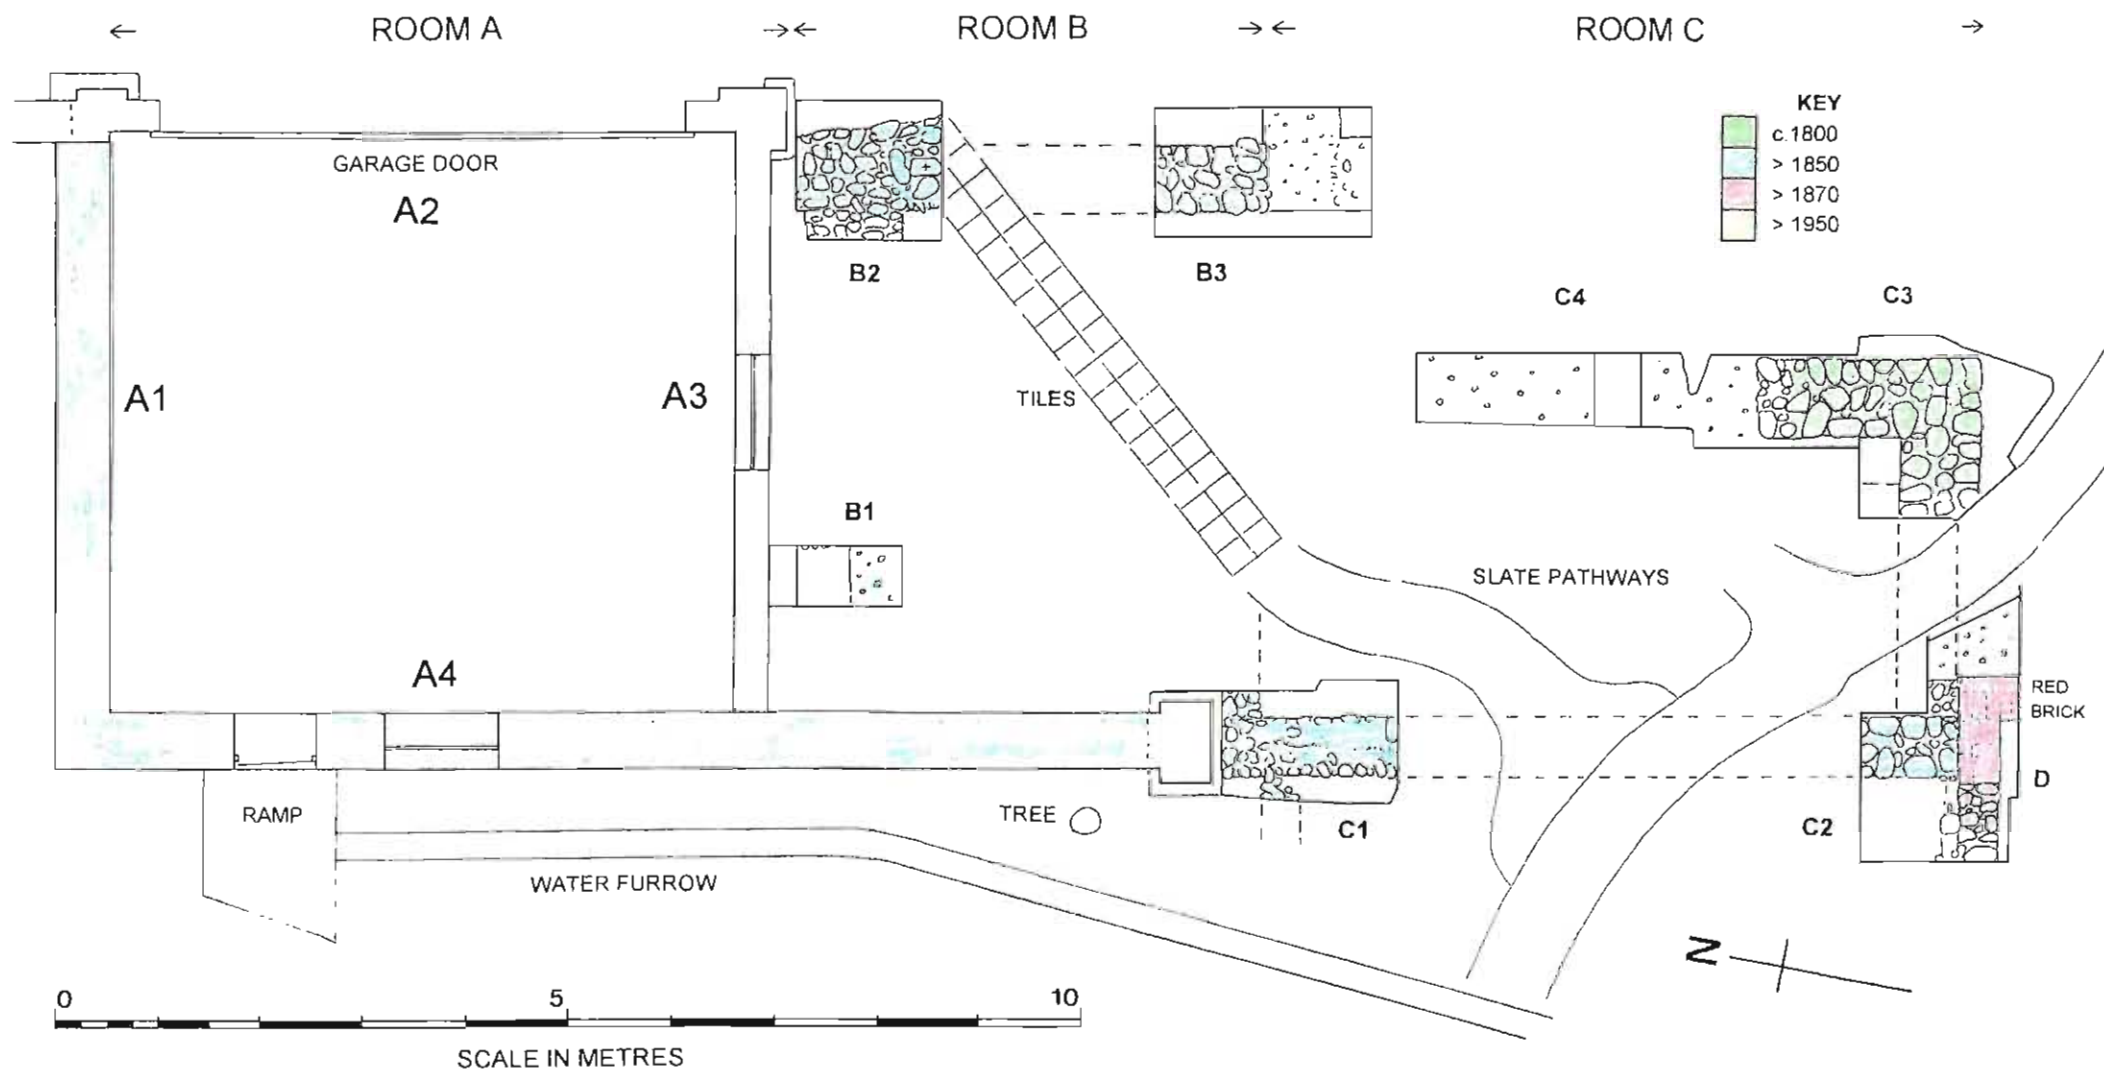
FIG.5 Site plan of the OB and the archaeological excavations. A preliminary chronology is provided (Vos 2004).

The garage is designated as Room A, the southern portions as Room B and Room C, with the small roomlet D at the extremity (**FIG.5**).

The unusually wide and deep foundation at section C3 could be the earliest (late 18th century ?) and was apparently incorporated in a later (early 19th century) foundation and structure with a 2.75 m interior width (see FIG.3), indicating a flat-roofed building. The sections B2 and B3 indicate a 19th c. structure, and it probably stopped at B3, with a "diagonal wall", of which no traces were found at B3. It may have been robbed for its stone. Signs of this wall are apparent at section C1 (see FIG.5). This represents the 5 m interior width of the OB as illustrated in FIG.4.

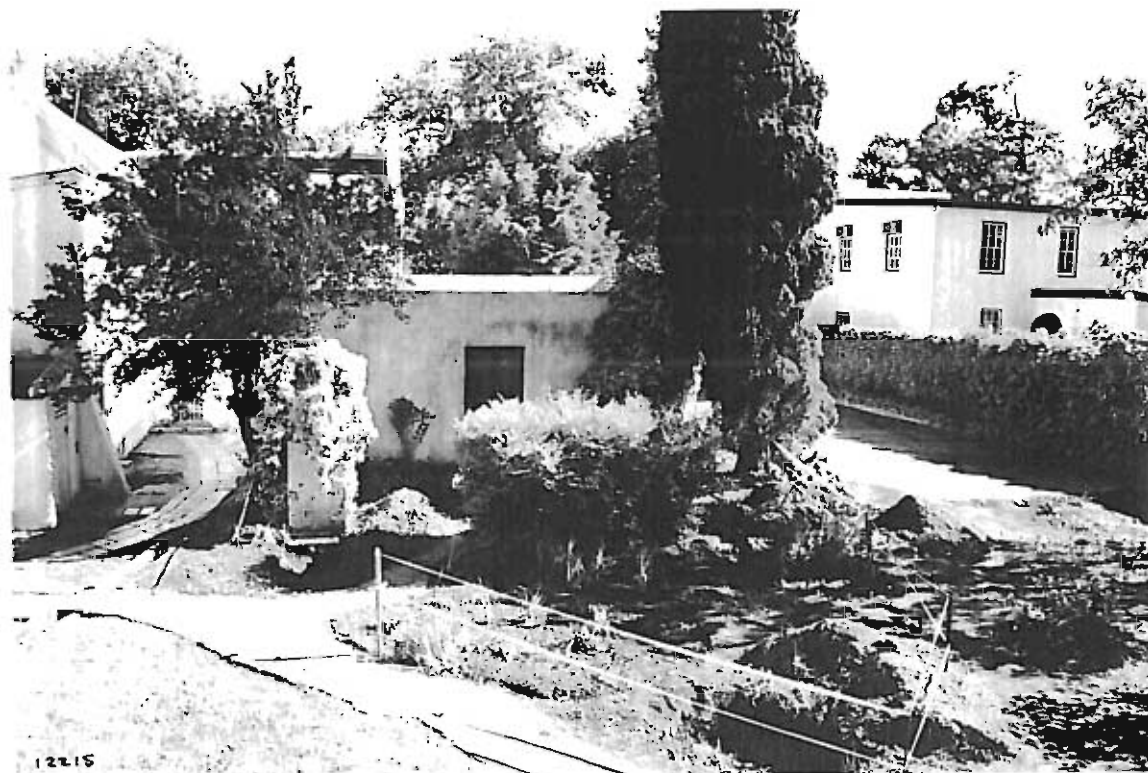
The walls of this building are about 52 – 55cm thick (walls A1, A4), but the modern (>1950) walls of the garage are about 30 cm thick (walls A2, A3).

According to the brick and clay mortar of the old walls, the building could date from the mid 19th century.

1. View of the site prior to the removal of most of the vegetation. Garage (Room A) is in the middle with the central window (looking N).

3. Interior features (walls, floors, ceilings) can all be modern as befits a modern kitchen.
4. Interior excavations of room A need to be monitored, as it ~~is~~ probably contains *in situ* floors, etc. These would be important to establish earlier functions of the building, as all other floor levels have been destroyed.

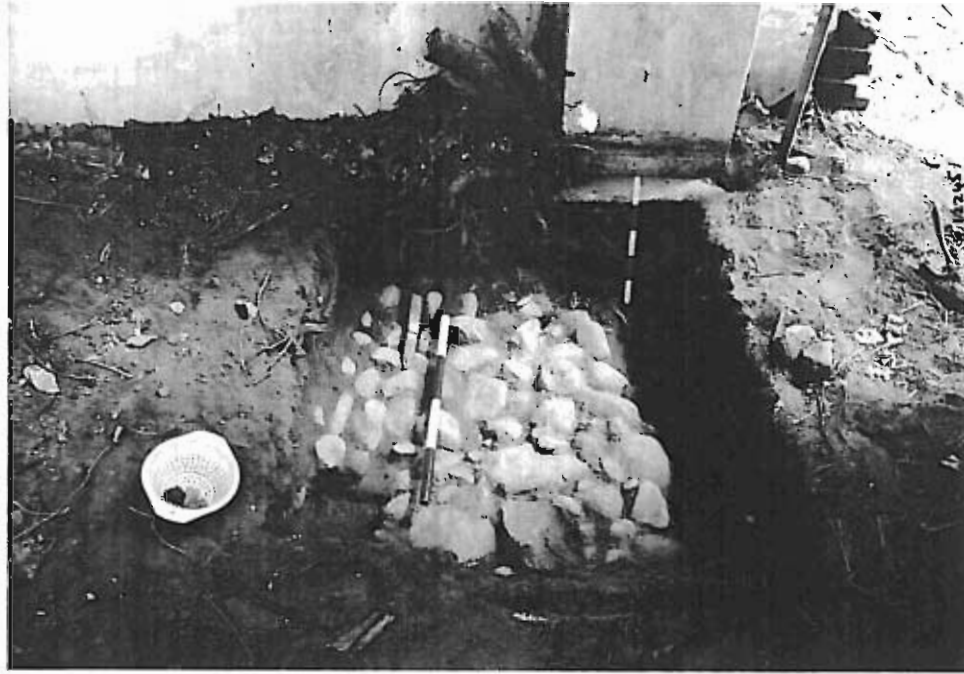
2. Section B2 against the eastern end of the garage. Note the flat laid stones on the left (scales 1m, 50cm)(looking N).

Section B2 revealed a wide, uneven cobbled foundation that splayed towards the southeast. All stones are river cobbles of quartzite and range in size from about 5 cm to 35 cm in diameter. It appears that the western cobbling of this foundation is laid flat and I interpret it as a portion of possible paving. This particular section was overgrown with thick roots of poison ivy, which made excavation difficult.

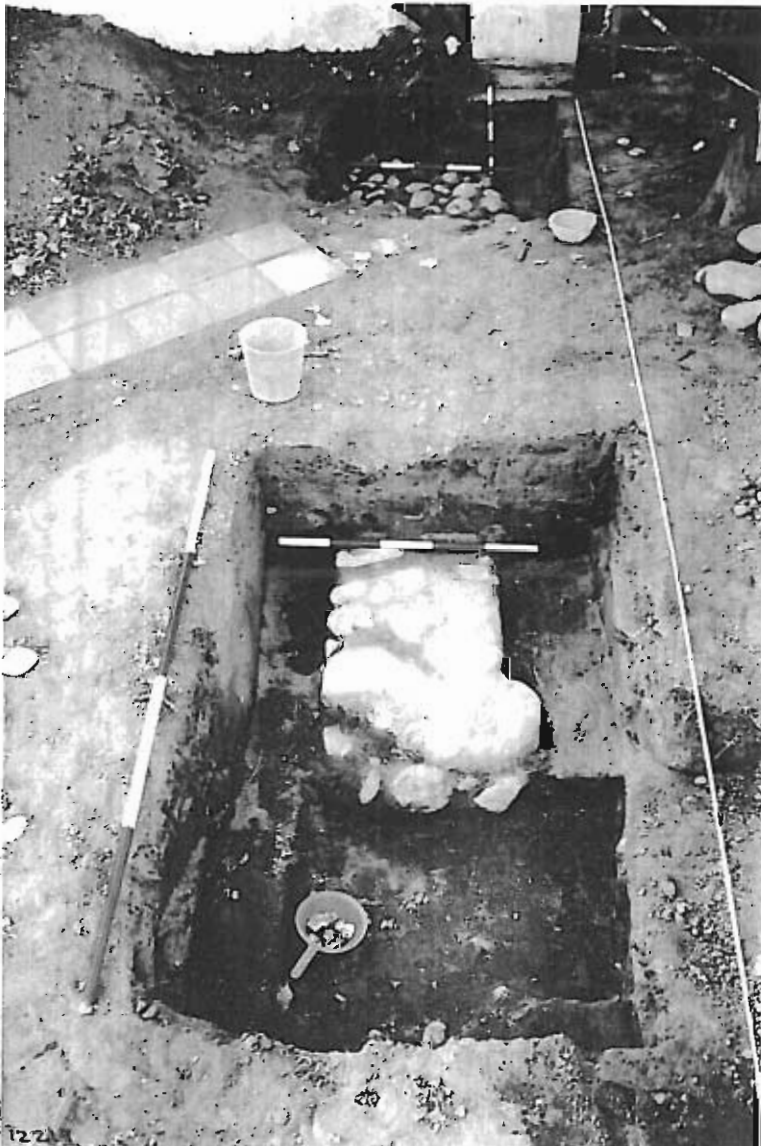
3. Section B3 where the foundation stones are clearly defined. In the foreground there is a shallow depression, the fill 2.1 having been excavated (scales 2m, 1m).

Section B3 showed a more standardized, defined foundation, which ended rather abruptly, as if meant to be. South of it, fill consisting of pebbles, a variety of plasters and reddish brick in soil, was again encountered in a shallow depression. It appears to be specific fill (layer 2.1) (see elevation drawing **FIG.6**).

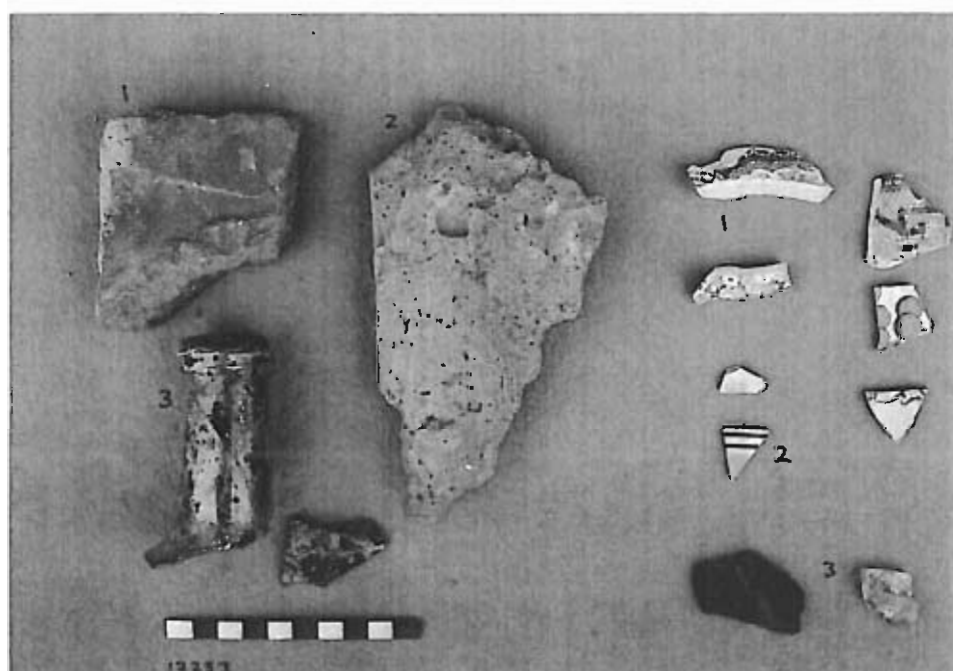
4. Artefacts from sections B2 and B3 (scale 10cm).

Section B2

1. Floor tile piece
2. Do, very thick, broken
3. Bottle top 1790-1800

Section B3 (19th c)

1. English fine earthenware (B & W)
2. Do, annular bowl fr.
3. Glass fr.

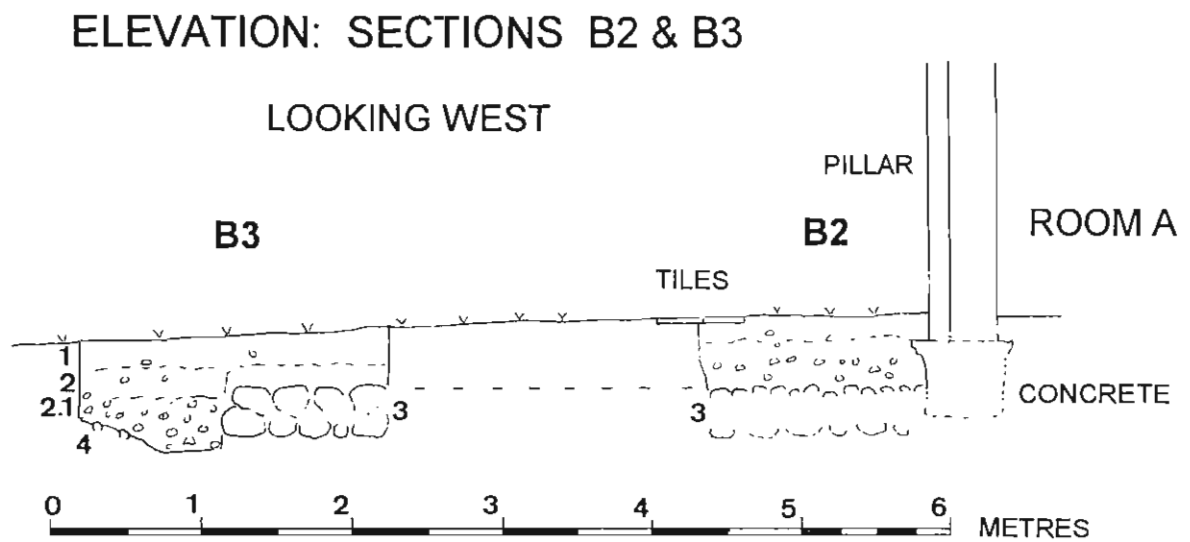
FIG.6 Elevation drawing of sections B2 and B3 (looking W).

1. GRASS & DARK SOIL
2. BROWN SOIL WITH SOME ARTEFACTS 19TH
- 2.1 FILL OF RED BRICK, PEBBLES & BROWN SOIL
3. FOUNDATIONS c.1850
4. STERILE YELLOW CLAYS & PEBBLES

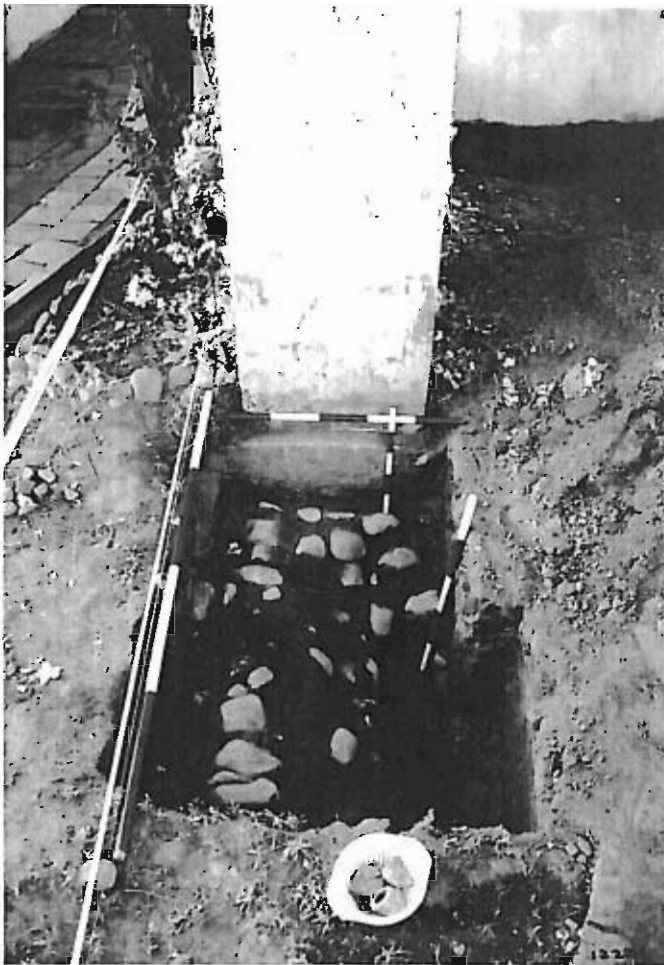
6. View of the same wall and and pilaster in cement, with section C1, which exhibits a narrow stone foundation (scales 2m, 1m, 50cm)(looking N).

Note that at section C1 the cobbling indicates a wall that could have linked up with section B3. Surprisingly, at the western side of B3, there is no indication of foundation stones! Note that the existing, eastern wall is built of old brick and clay mortar (c.1850) but the end-pillar is built in modern masonry and cement on concrete foundations, similar to that of the garage (>1950).

Section C1 also produced a defined foundation of 58 – 60 cm wide, with a depth of 90 cm below the surface. It showed signs of being robbed of stone. Slate pathways barred the way, but at **section C2** the foundation ended, and turned *at a right angle* diagonally eastward. It abuts a thinner foundation, the smaller stones lay in an orangey clay, with a remnant section of thin brickwork on top. It is interpreted as a portion of the small **roomlet D**. Above the foundation stones most of the artefacts represent 19th century refuse and the odd Chinese porcelain piece or glass of the 18th century.

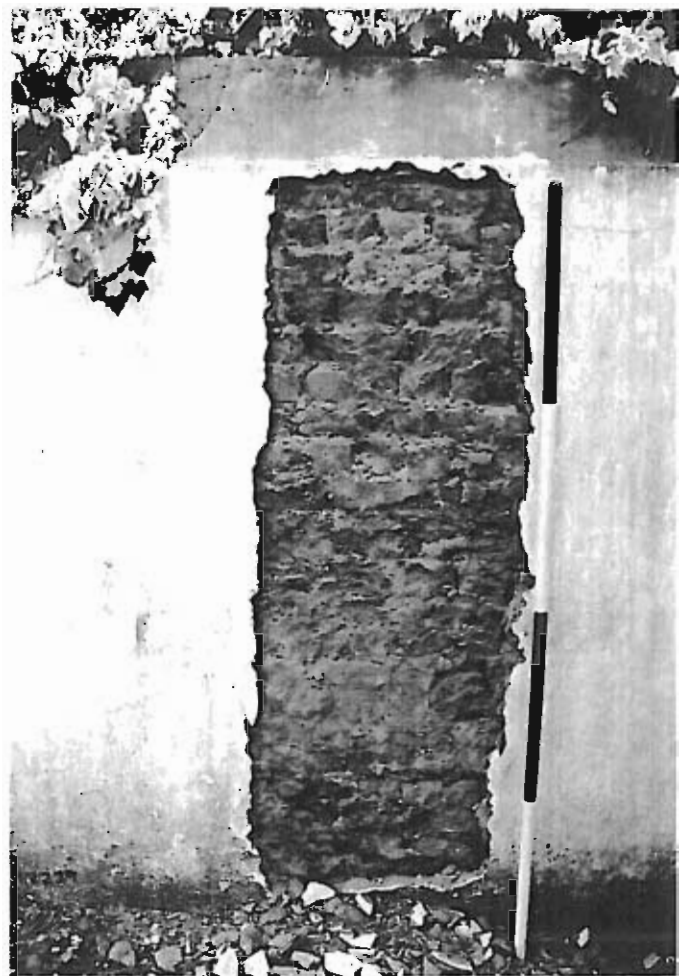
5. View of the existing wall B4 with its orange brick and clay mortars (scale 2m)(looking W).

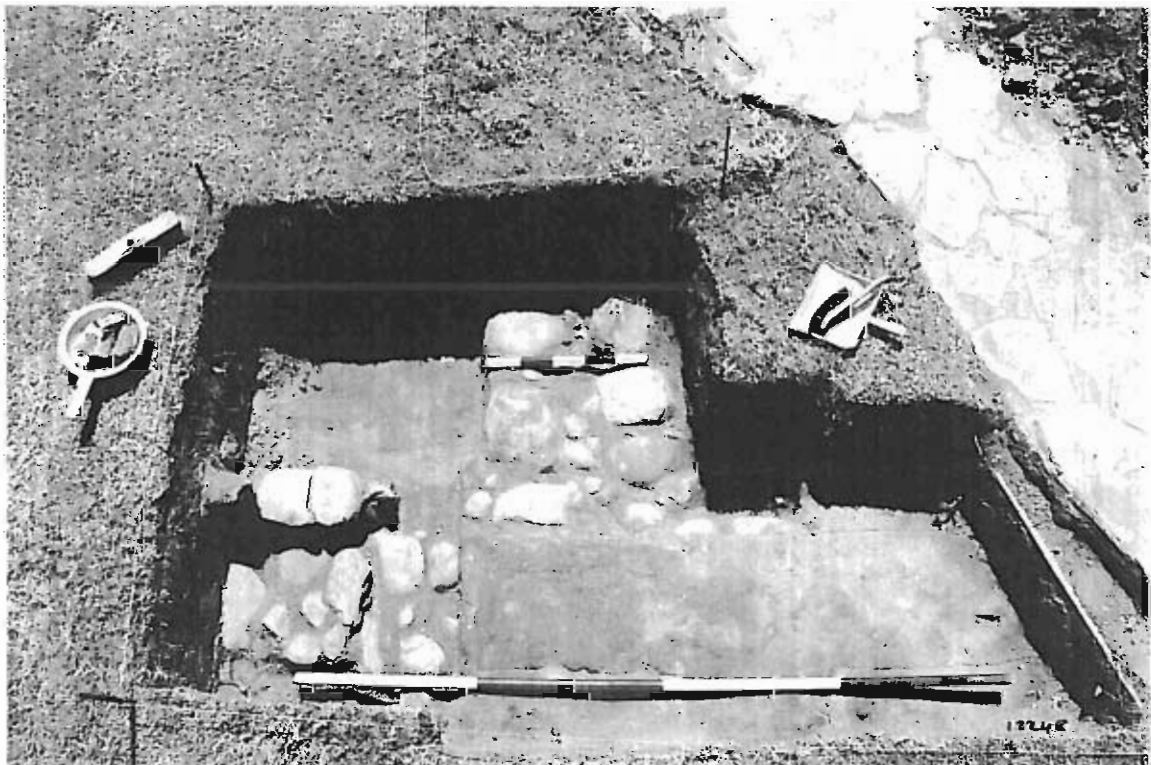
7. View of the corner section C2 with remnants of red brick walling representing a portion of roomlet D (scales 1m, 50cm)(looking N).

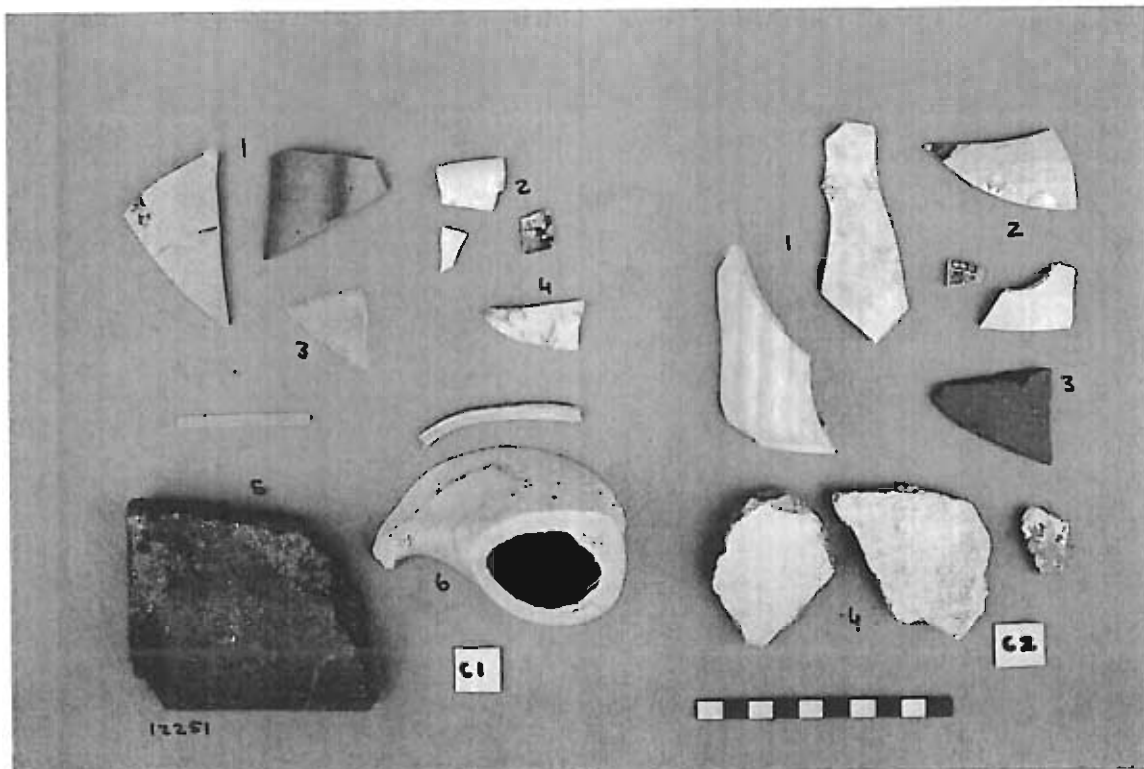
8. Artefacts from section C1 and C2 (scale 10cm).

Section C1

1. Stoneware jars
2. English fine earthenware
3. Glass fr.
4. Chinese porcelain 18th
5. Floor tile fr.
6. Bone (cow)

Section C2

1. English fine earthenware, jarlet
2. Do, variety
3. Stoneware
4. Plaster, white-washed

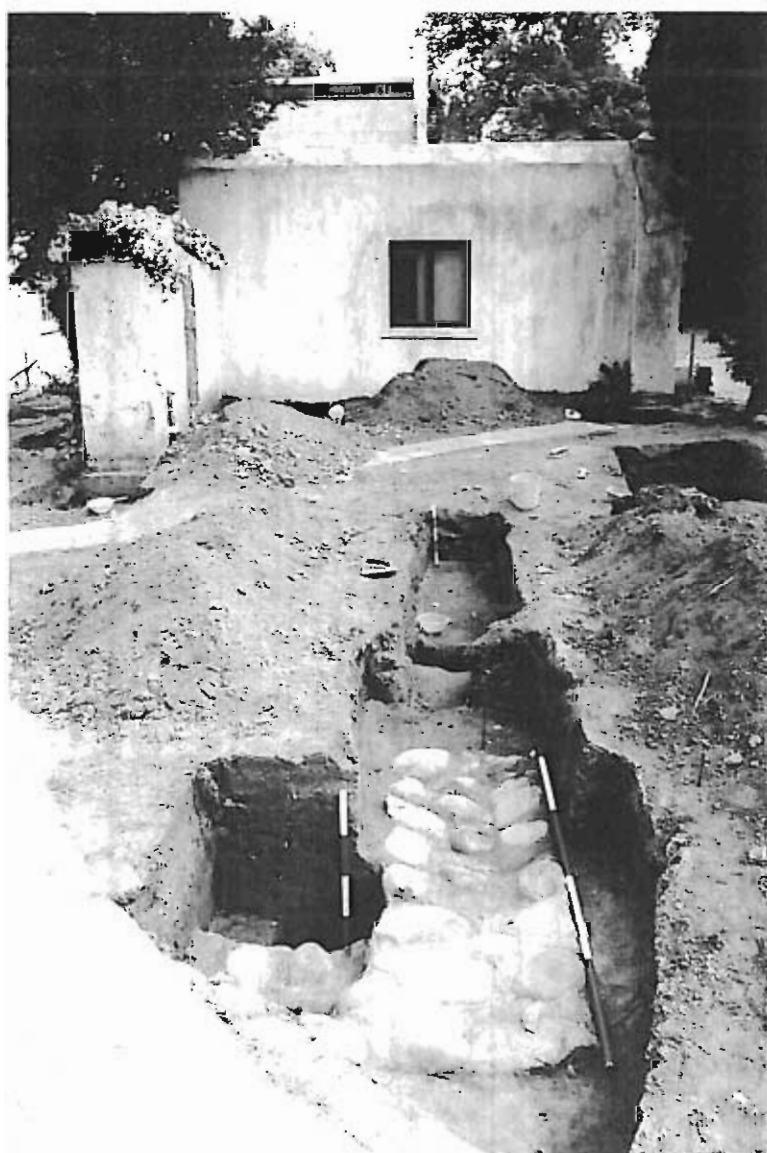
10. Close-up of section C3/4. Note the 80 cm width and the depth of 120 cm of the foundations (scales 2m, 1m, 50cm)(looking N).

Section C3 revealed a 75 – 80 cm wide foundation, but with large cobbles, laid and to a depth of 80 cm below the surface. From its building technique it appears to be different than the rest, probably a portion of an old structure or a high boundary wall. It is directly in line with the exterior gable of the homestead (see FIG.5) and may indicate an old 18th century boundary wall or one built by Borchers in 1800 (see also title page photo).

according to the 1929 plan (see FIG.3) it was incorporated into the OB, and was probably demolished after 1950. What is surprising, is that no portion of its northern section could be found in the trial **trench C4**. Only pebbles, plaster and reddish brick fill were encountered. The remnant foundations were certainly robbed for its stone.

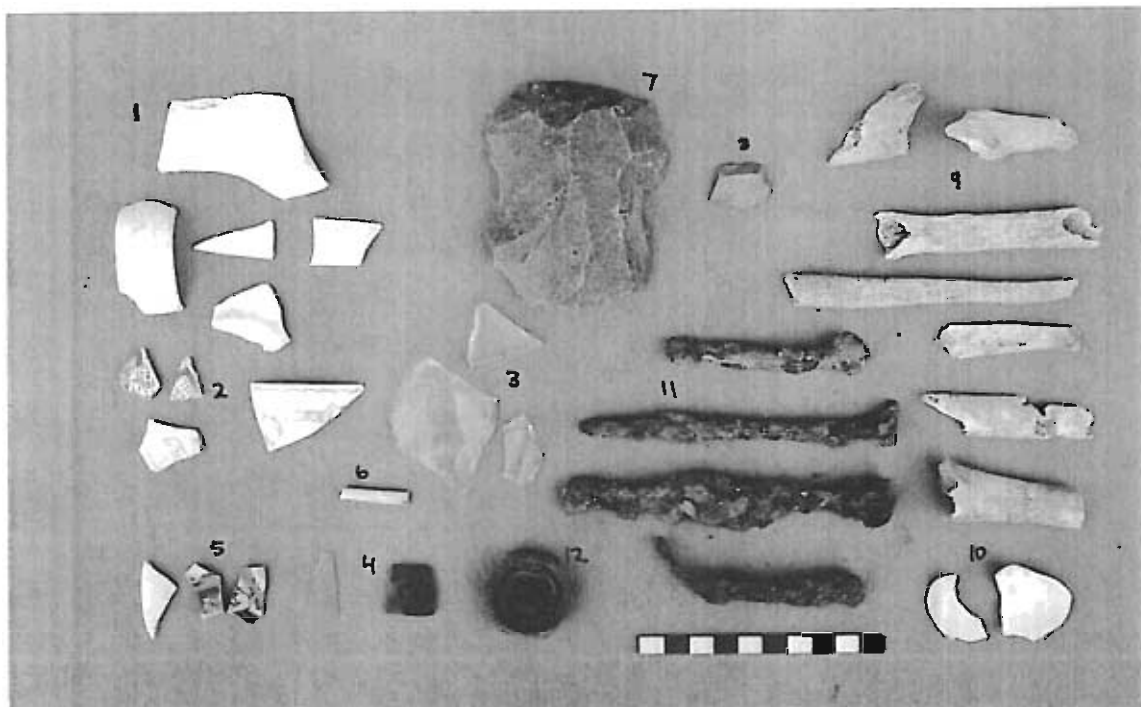
11. Artefacts from section C3/4 (scale 10 cm).

(all 19th century except where stated)

| 1. English fine ware, plain | 9. Bone fr., sheep |
| 2. Do, blue & white | 10. White mussel shell |
| 3. Glassware. | 11. Iron nails, rusted |
| 4. Glass fr 18 th c. | 12. Hexagonal brass screw top |
| 5. Chinese porcelain 18 th c. | |
| 6. Glazed pipestem | |
| 7. Acheulean stone tool (ESA, >100 000 y BP) | |
| 8. Silcrete micro flake (LSA, Holocene to recent) | |

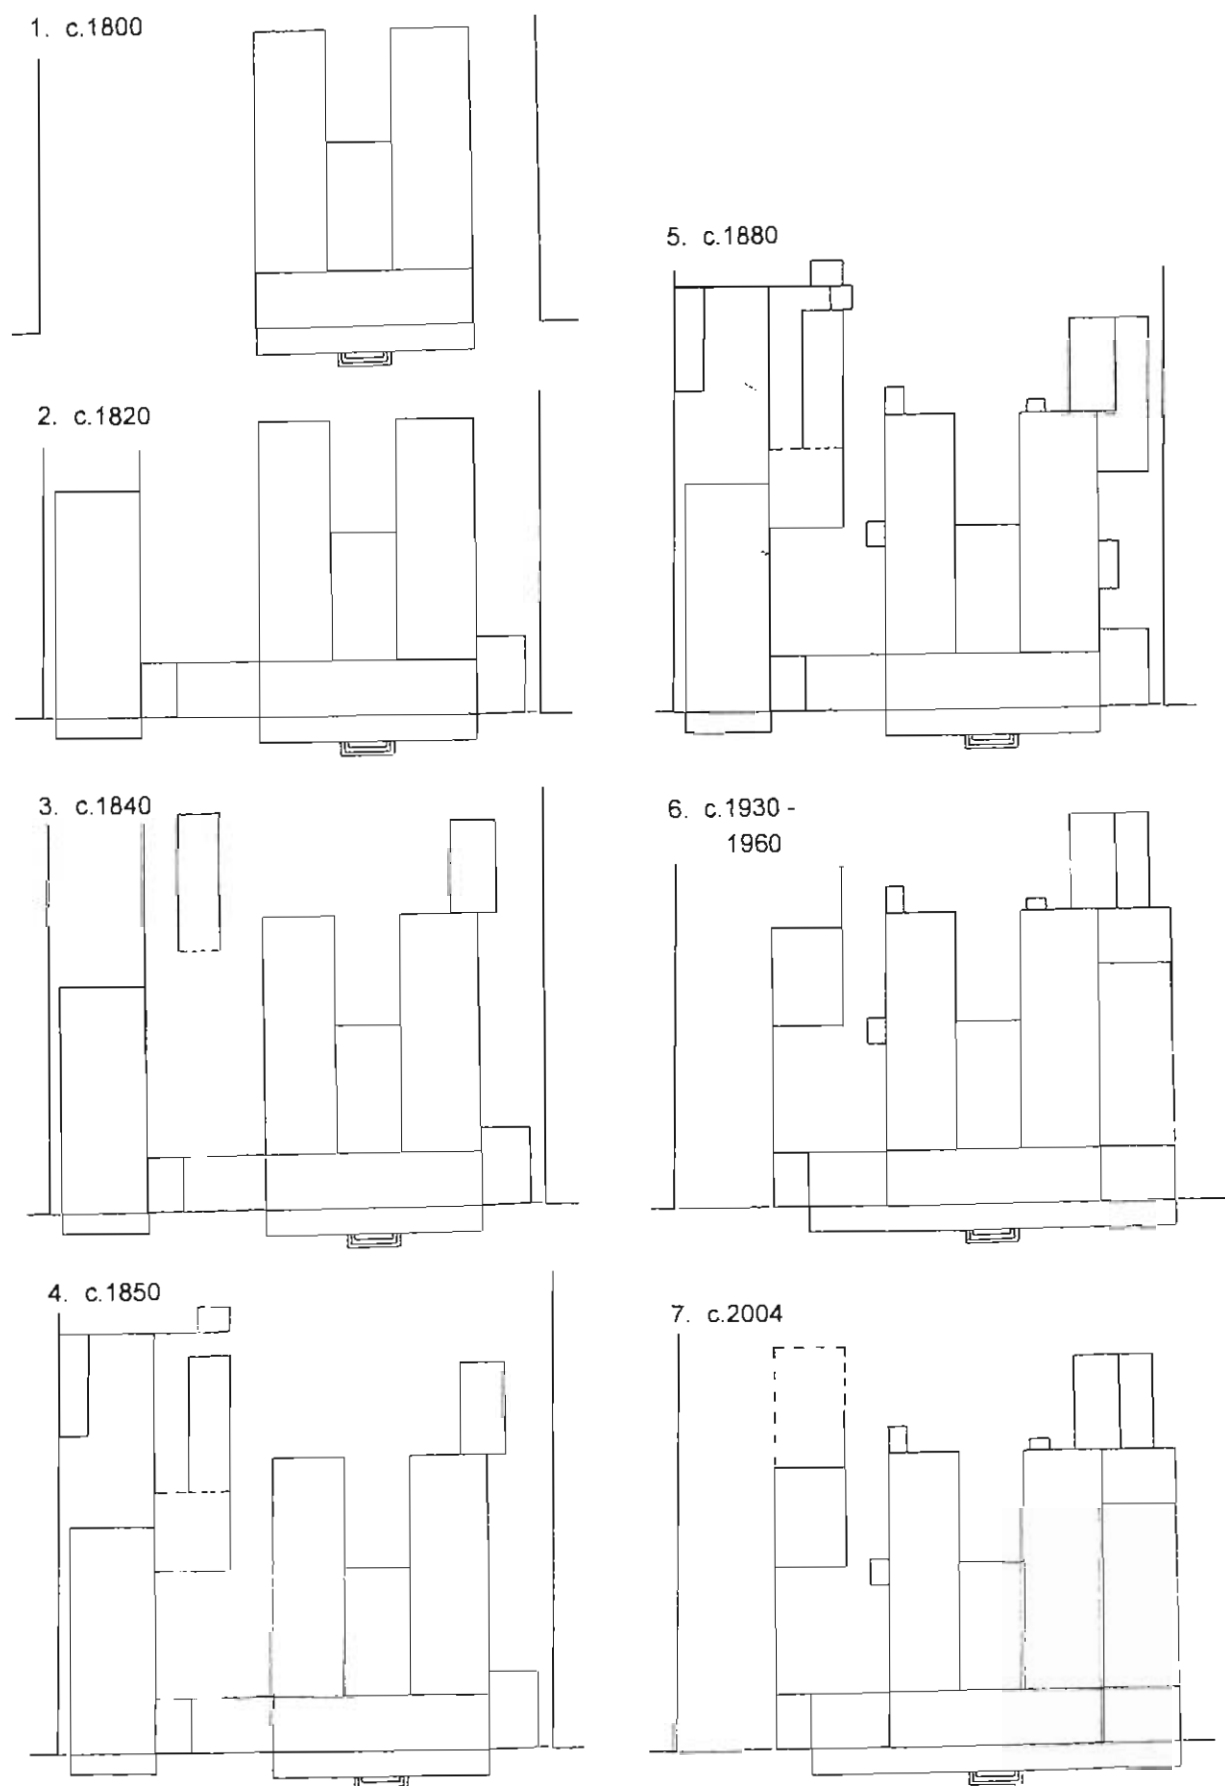
FIG.7 The 1926 La Gratitude drainage plan (inaccurate in its finer detail) was used as a basis for this preliminary draft of the possible development of the OB relative to the rest of the buildings. It covers the period from about 1800 to 1960 when numerous buildings, including the Hire House on the east and the long rectangular dwelling on the west side were demolished. The last example (7) is a possible scenario of reconstruction of the OB

Possible configurations of the development of the OB are considered in FIG.7.

1. Reconstruction of the OB is a viable option in the rehabilitation process of La Gratitude. The exact size of the OB has not been fully clarified. It could have been a building of two dimensions of respectively 5 and 3 metre interior widths, indicating at least two periods. This appears to be impractical for the requirements of the proposed kitchen. A full 5 metre interior width is probably a better option over the full length. The roof structure could be pitched or flat-roofed.

2. A pitched roof in thatch with a building with fenestration in early – mid 19th century style is an option. This would be more sympathetic with the c.1800 homestead. A modern building (flat or pitched) roof would have to be well-designed in order not to detract from the earlier homestead.
