TEST EXCAVATIONS OF OLD KLIPTOWN ROAD, FOR THE WALTER SISULU SQUARE OF DEDICATION

A Phase-2 report prepared for the Johannesburg Development Agency

MH Schoeman

May 2005

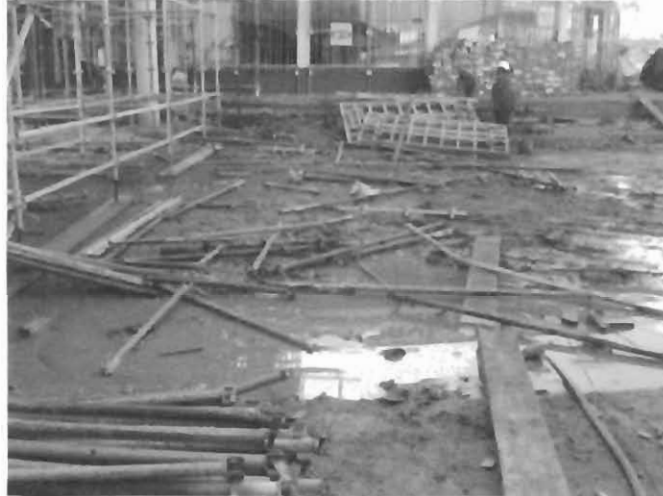
The Area I excavation cleared an area between the pre-cast cement curbs, where Old Kliptown road intersects with Union Road. The area was approximately 11.70m wide, whereas the excavation area was 6.60m wide. The curb was aligned 34° East of North. Little soil covered this area, as water had eroded the topsoil. Rubble and rubbish, however, had accumulated on the eastern side of the road (Figure 2). The excavation team in this area was lead by Ms Namono.

Figure 2. Photograph of Area I before excavation started, showing the rubble and rubbish, that had accumulated on the eastern side of the road.

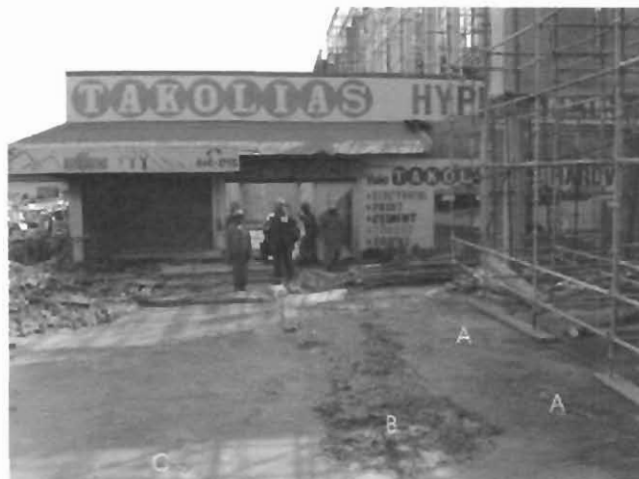
Excavations revealed that most of the area was covered by tar (Figure 3). The road, however, has been damaged. A trench cut through the road from east to west. This trench existed when construction started and the contractors subsequently used it when laying a power cable (Figure 3:A). There are also potholes (Figure 3:B).

Figure 3. Photograph of Area I at the completion of excavation showing that potholes (A) and a trench (B) had disturbed the tarmac and substrate. Edge stones also protrude through the tar (C).

The simple mitigation measures were sufficient to recover useful data. We established the road alignment, edges, depth below surface and condition of the road. It seems that extensive preparation of the road substrate will not be necessary as the original is still in tact and that little road repairs would be needed, except at the junction with Union road. The road surface, however, does need to be stabilised as the original tarmac has been eroded.

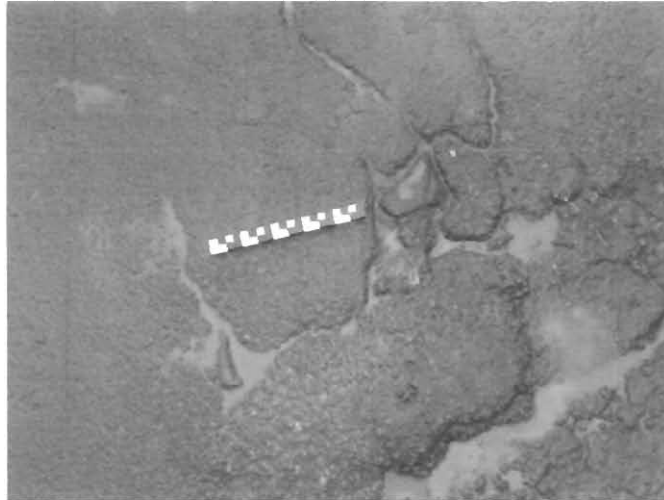
The current tar and cement curbstones are probably more recent additions to the junction. Towards the eastern side of the road the original edging stones seem to protrude through the tar surface. The most southerly stones are 98cm from the curb (Figure 4), whereas the most northerly is 1.66m away (Figures 3:C and 5).

Figure 4. Southern edge stone visible through eroded tar.

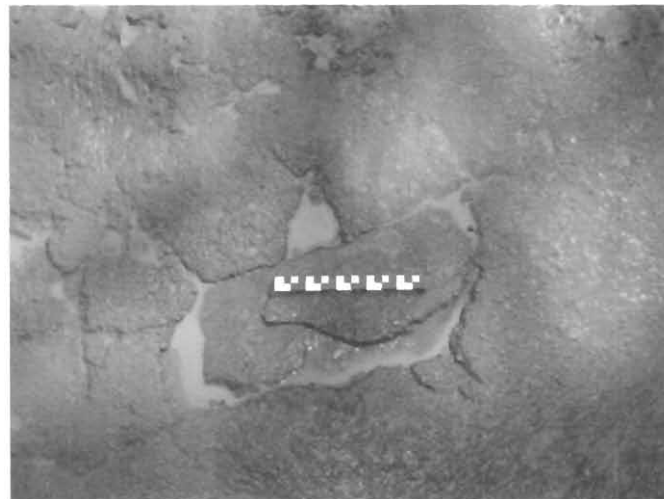
Figure 5. Northern edge stone visible through eroded tar.

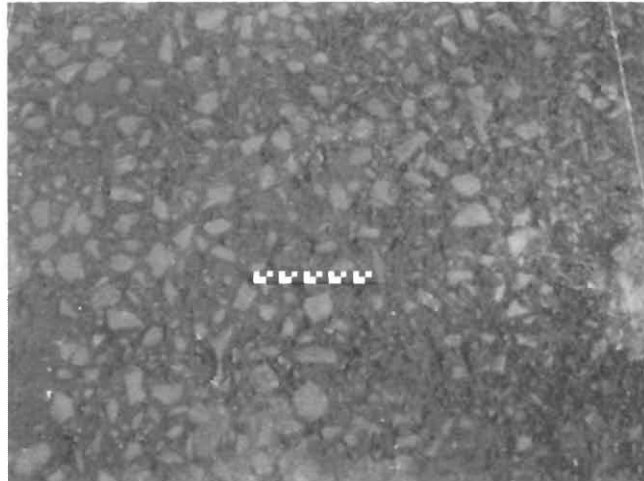
On the western edge the excavations exposed a concrete surface stretching towards the demolished building area. Moving east a tarred surface was found 0 to 5 cm below the current surface. A tarred curb slopes down for about 40cm after which the road flattens out. The preservation of the road varied. In some areas the tar was intact, in others the crusher stones were exposed (Figure 8) and backhoe marks scar the surface (Figure 9). The crusher stones were 3 - 8cm in diameter.

Figure 8. Photograph of the crusher stone where the tarmac has eroded.

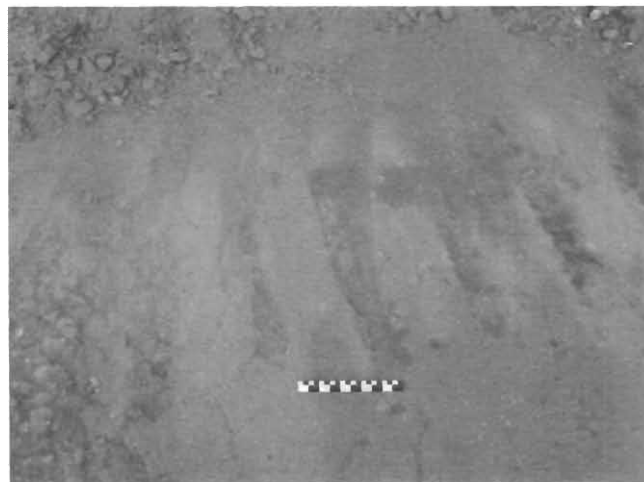
Figure 9. Photograph showing the backhoe disturbance of the surface in Area II.

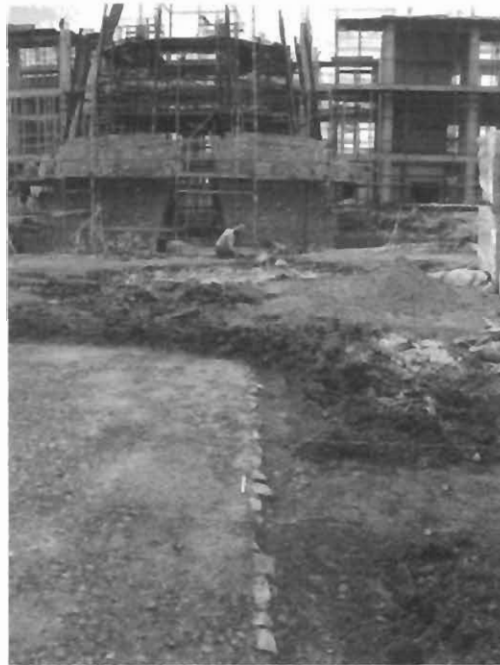
The eastern edge of the road was marked with edging stones (Figure 10), 10 - 25cm in length (Figure 11). The edging stones were aligned 25° East of North. From the edging stones there is a small drop to a gravel level, which spread to 1.5m from the edge. The gravel was mixed with cultural debris (glass bottle fragments, drink tops, brass clothing fasteners, bone, and plastic fragments). Under the gravel was a more consolidated layer of gravel, soil and stones. This was not excavated.

Figure 10. Photograph showing the line of edging stones marking the eastern edge of the road in Area II in the foreground.

We recommend that such treatment take into account to the edging stones on the eastern side, which seems to be a unique feature of the road.

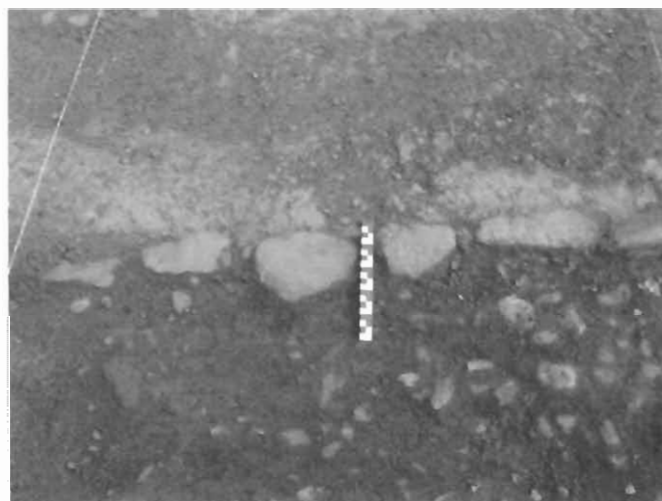
Figure 11. Photograph showing the edging stones, as well as their junctions with the tar and outside gravel.

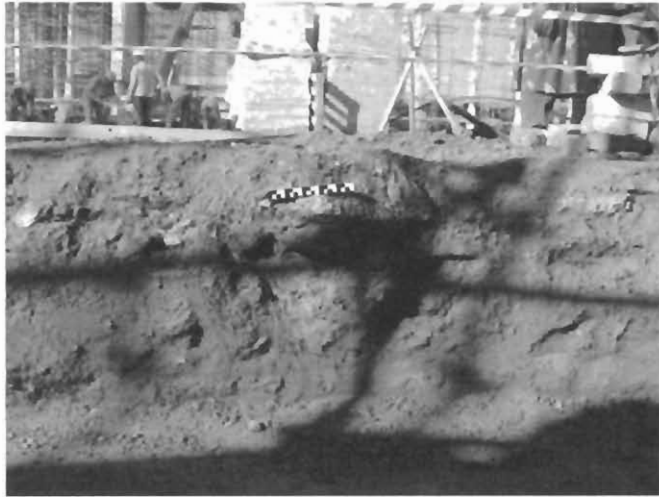
Figure 12. Photograph of the Area III section prior to excavation. The tar level is visible immediately below the scale.

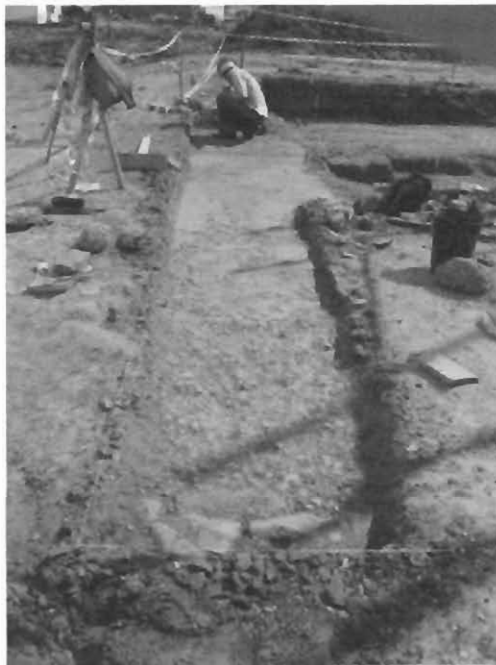
The trench measured 1 x 7m and spanned the whole width of the road (Figure 13). It was aligned east-west. The trench exposed the original road surface. This surface was between 8 – 20cm below the current surface level.

Figure 13. Photograph showing Trench III, which spanned the whole width of the road. The eastern edging stones are in the foreground.

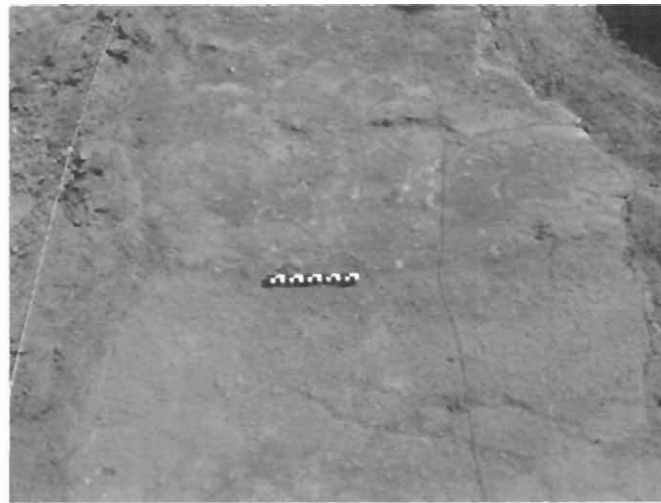
The Area III trench revealed a similar layout to the Area II excavation. At the western edge of the trench a forty centimeters wide area was covered with concrete and sand. Adjacent to it was a thirty centimeter wide raised cement area, probably part of a pavement. The cement sloped down to meet the tar road (Figure 14).

Figure 14. Photograph of the western raised curb.

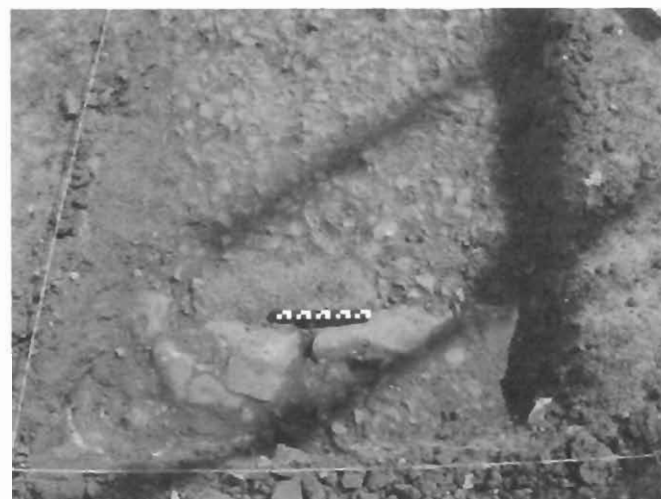
The road was 5.9m wide. The tar was mostly intact on the western half of the road, however the crusher stones were exposed on the eastern half. The edge of the road was marked with edging stones, which ranged in size from 10 –25cm in length (Figure 15). A mixture of rubble and cobbles was found from the curb to the end of the trench.

Figure 15. Photograph of the eastern edge of the road, which is marked with edging stones.

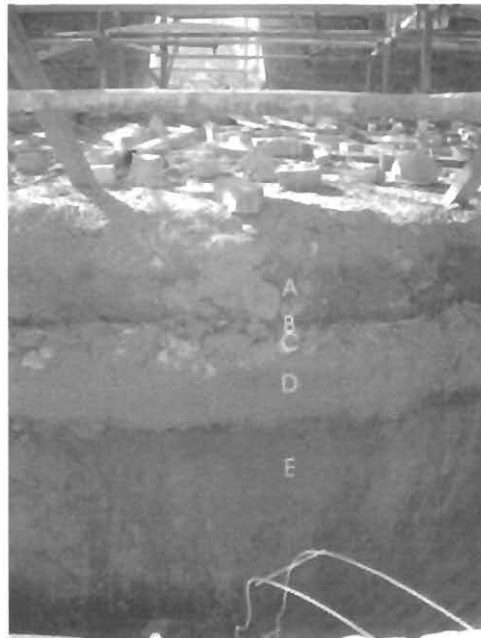
The section inside the memorial was photographed and the stratigraphy recorded. The surface soil on top of the tar was approximately 35cm deep (Figure 16:A). The tar level (Figure 16:B) was followed by a substrate of crusher stone (Figure 16:C), which was lying on pink compact earth (Figure 16:D). The pink compact soil rested on sandy natural ground (Figure 16:E). The compact earth and crusher stone, related to preparing the area for road construction, as they are not present in sections outside the road area.

Figure 16. Photograph showing the stratigraphy of the column inside the memorial. The layers are: topsoil (A), tarmac (B), crusher stone (C), compact earth (D) and natural ground (E).
