**Historical and Architectural Impact Assessment Report for the
Port Durnford State Forest, Umhlatuze, Uthungulu District
Municipality**

Historical and Architectural Impact Assessment Report for the Port Durnford State Forest, Umhlatuze, Uthungulu District Municipality

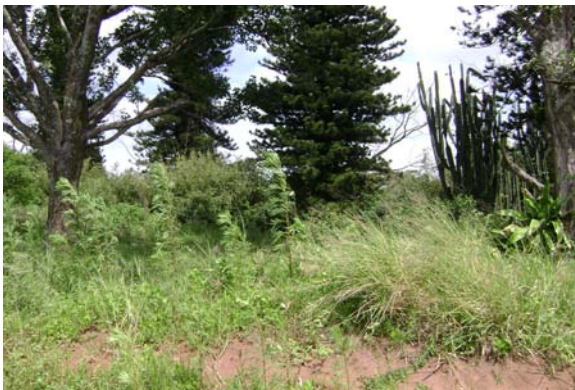
This is the first of the sites which has been demolished and bulldozed, and is really only evident from the uneven ground covering foundations, and the established trees. It appears as an early site from two pieces of evidence: the map above compiled in 1934, shows the forester's house in between the rail reserve and the adjoining Lot 171. In addition, Marwick notes in his volume, *KwaMahlathi*, that Forester F Noffke took up residence in Block A (this site) in 1915. However, what the material condition of this building was is uncertain, particularly as Marwick talks of the early foresters living in wattle and daub huts. "This officer eventually took up residence at Block A on 1 September 1915.'(Marwick:1984:42) The 1937 Aerial photographs shows an indistinct but substantial building at this spot, and also a collection of buildings at the position on Fig A which shows the Umhlatuze Station. In addition, there exists a potential site which would also have been demolished, as seen on Fig 7.

Fig 4: Showing site

Recommendations: since this seems to be the oldest habitation site, the presence of an archaeologist during site clearing is recommended.

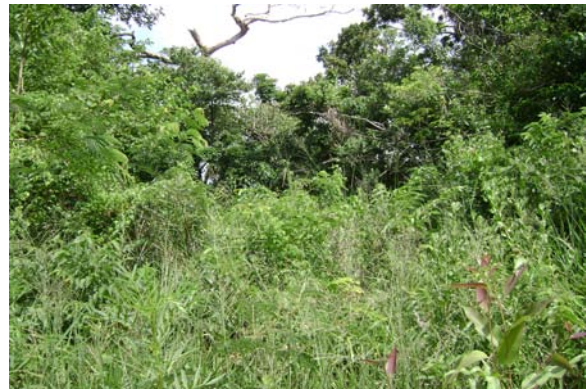
Fig 5: Showing site and vegetation

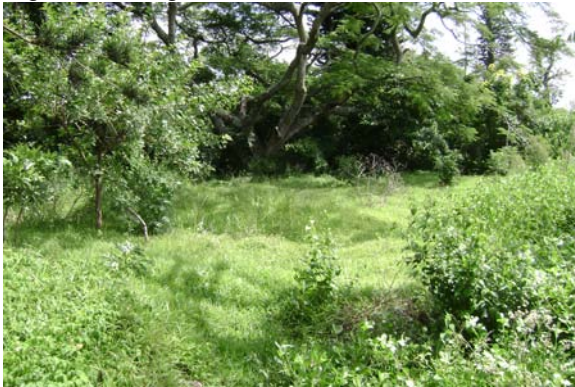
Fig 6: Showing site overgrown with grass

Condition of site: ruin

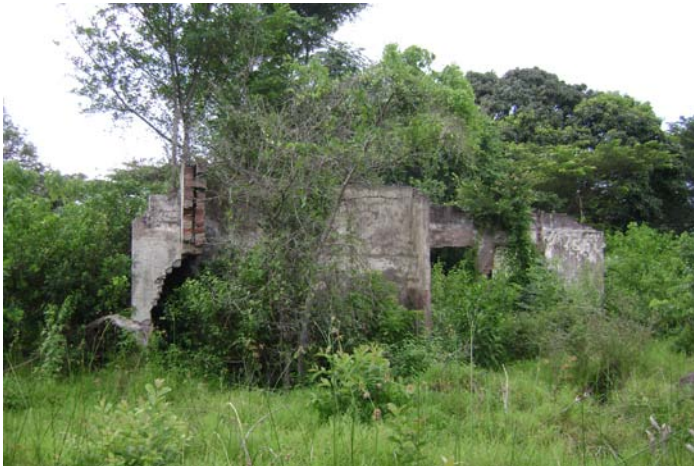
The remains of a dwelling, and concealed rainwater tanks are what is left of this site. The building has been largely destroyed, but some walls still remain to eaves level. The building is of conventional brick and mortar construction, and gauged from the occasional coursing built pre-World War II. No evidence has been found as to what this structure looked like, although its position may be seen on the 1937 aerial photo. (Fig 8)

Fig 9: ruined walls as remains of domestic structure

Condition of site: ruin except for water tanks

Recommendation: none and demolition of the rainwater tanks is recommended

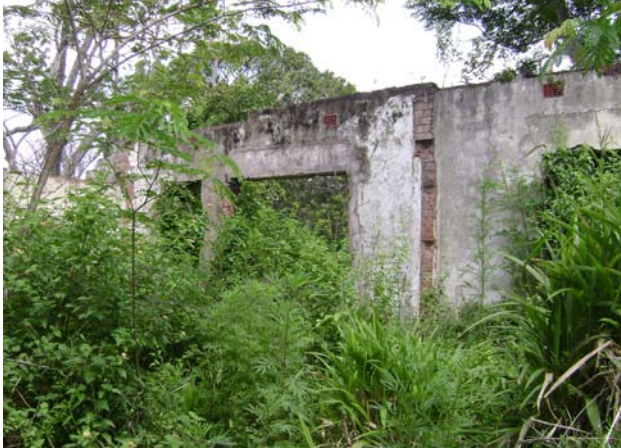
Fig 10: showing walls

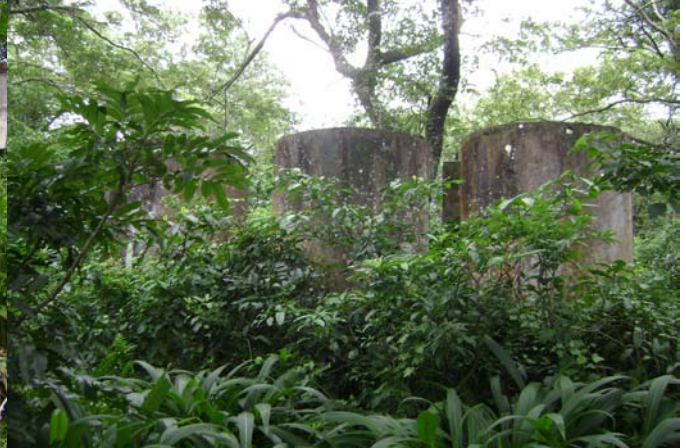
Fig 11: rainwater tanks

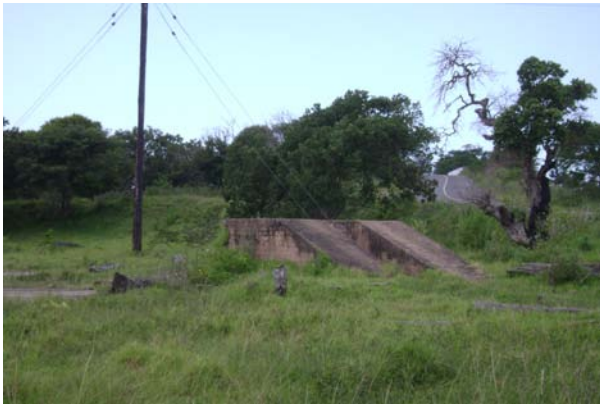
Fig 13: remnant of sawmill- loading ramps

Condition of site: ruin except for loading ramps

Recommendation: none and demolition of the loading ramps is recommended

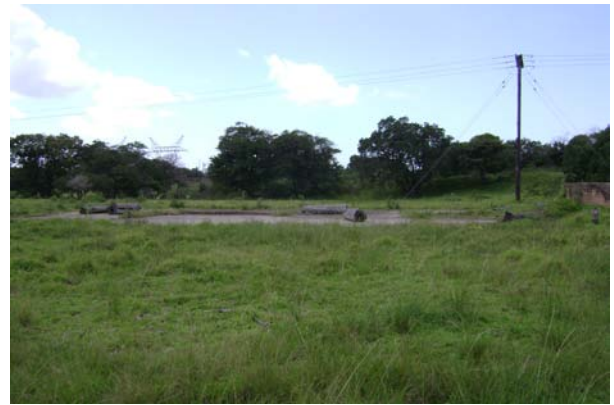
Fig 14: concrete platform and ramp (right)

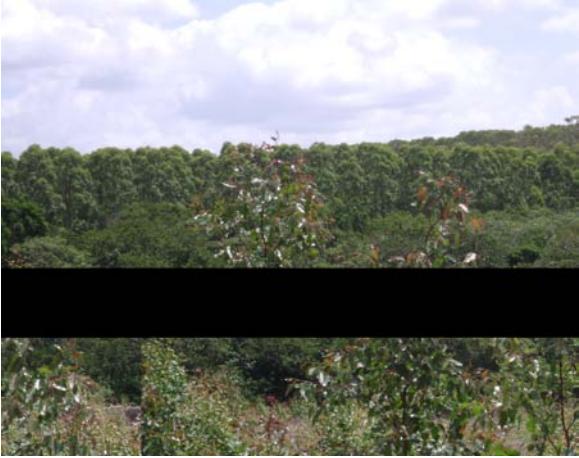
Fig 16: new trees over rubble

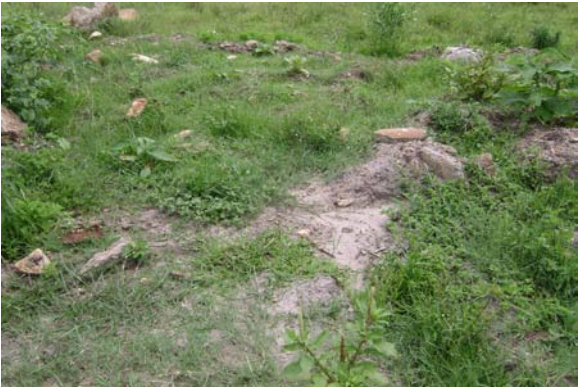
Fig 18: debris on site

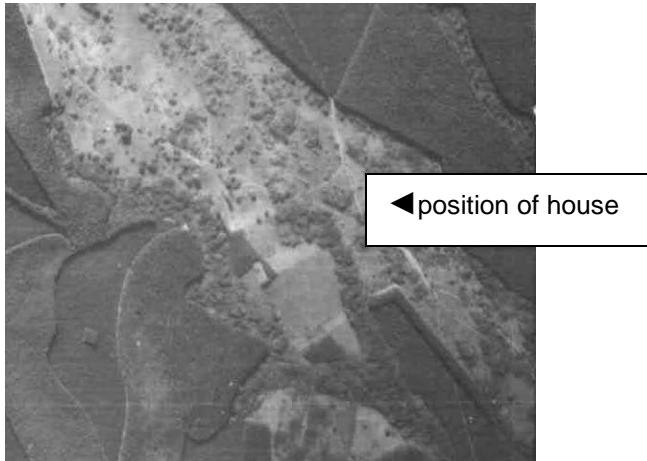
Fig 20: possible position of house

Condition of site: overgrown ruin

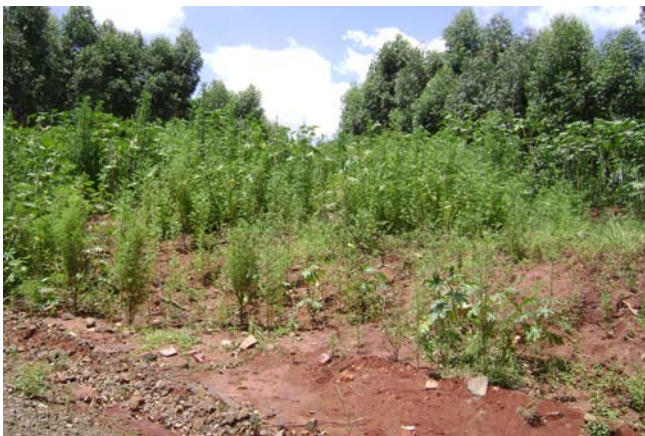
Fig 21: site of demolished house

Condition of site: overgrown ruin

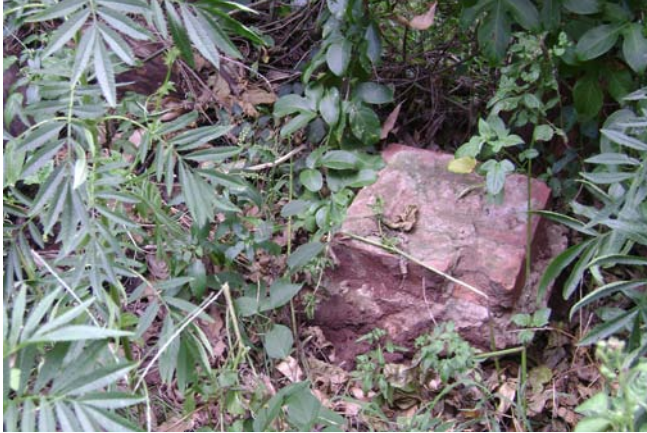
Fig 23: remnant of pillar in undergrowth

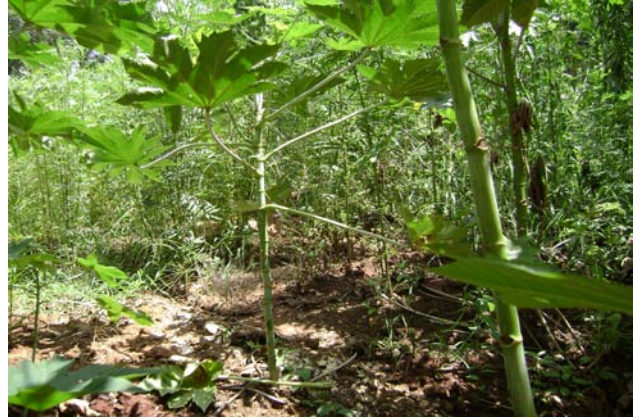
Fig 24: edge of foundation below soil

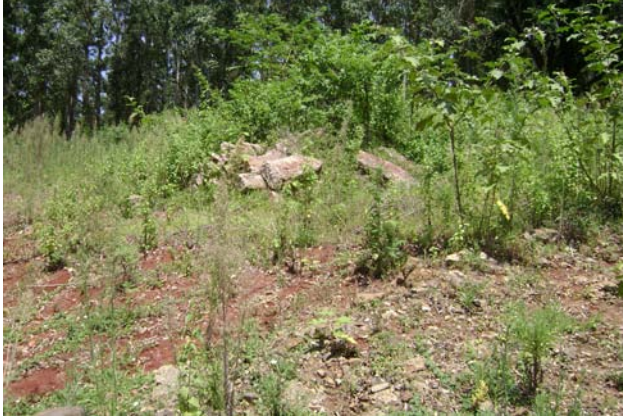
This site is identified as a Forester's encampment on the maps in Fig 2 and 3. Extensive bits of brick walling exist on the surface which has been extensively bulldozed. A water tower still stands.

Fig 26: bulldozed foundations with rubble on top

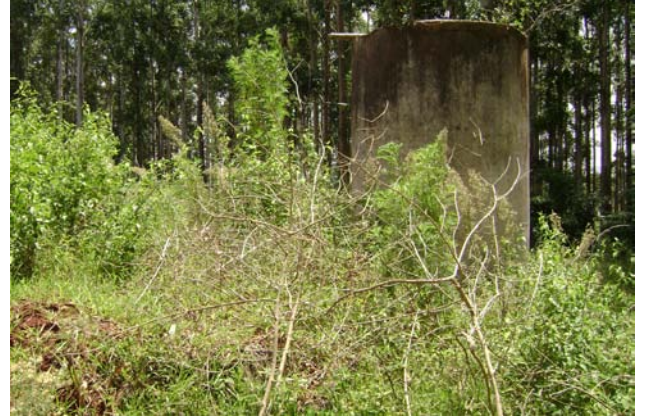
Fig 27: remaining water tower

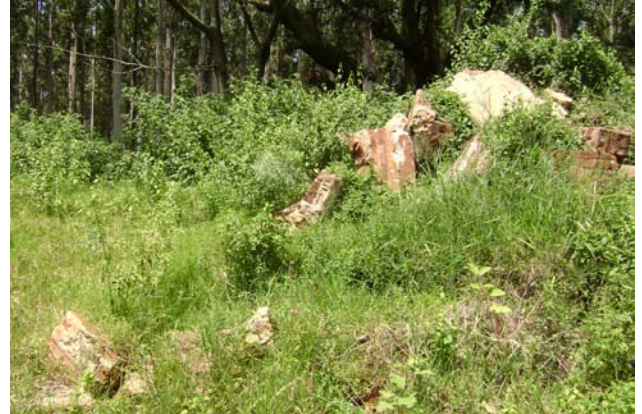
Fig 29: close up of foundation rubble

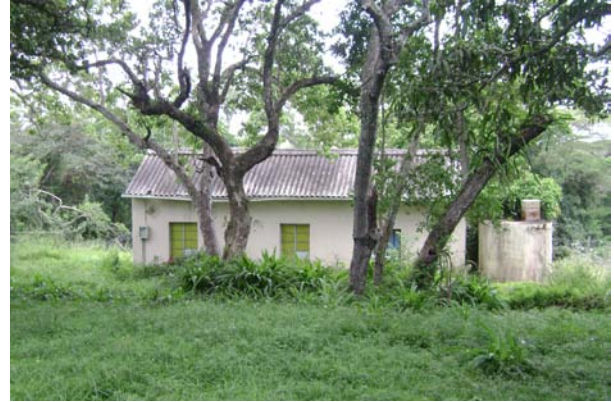
Buildings no 1, 2, 7 and 8 are enclosed housing complexes, largely of latter construction but no 7 likely to fall in within Amafa protection. Building no 3 is a small cottage, possibly built in the 1950's. Building no 4 is a garage complex and has little to merit if except for a large shed. Buildings no 5 and 6 are ill-maintained, ill-inhabited and have little merit, although they are likely to be older than 60 years.

Fig 46: derelict building no 5

Recommendation: should demolition be requested, this group of buildings is not significant with regards to the heritage of the province of KwaZulu-Natal.

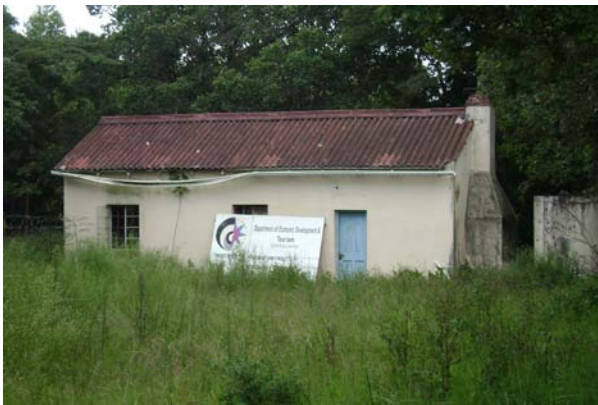
Fig 47: derelict building no 6

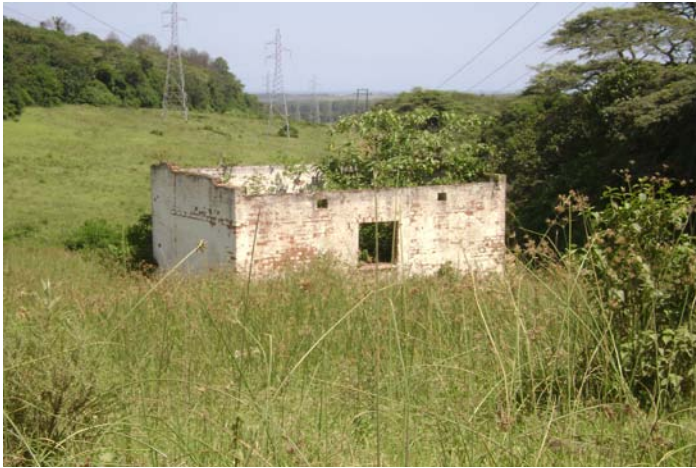
Fig 51: ruined structure

This is a partly demolished structure south of the main entrance. It was no identified as part of the archaeological impact assessment. It was built in around 1940.

Condition of site: ruin

Recommendation: should demolition be requested, this ruin is not significant with regards to the heritage of the province of KwaZulu-Natal.

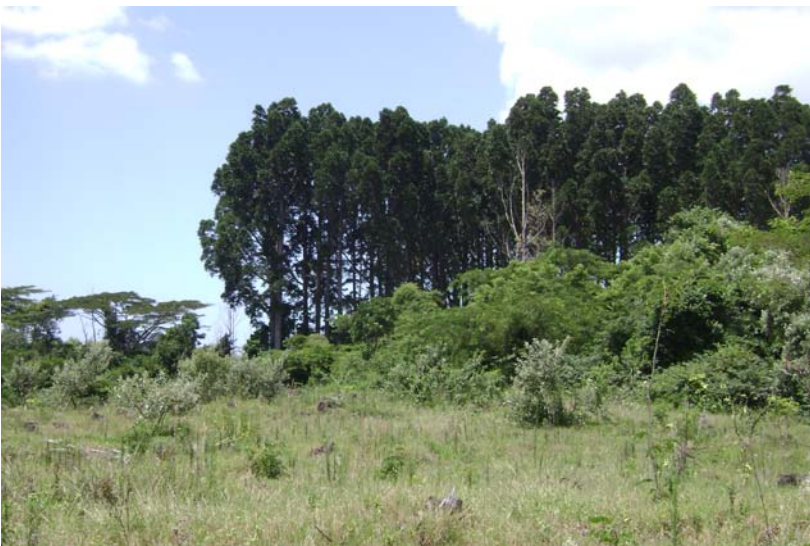
The author wishes to elicit the support of *Amafa aKwaZulu Natali* for the provisional protection of the large stand of Queensland Kauri Pine (*Agathis Robusta*) which were among the first trees planted at this plantation, before 1920 and which form a unique feature in the history of forestry.

Fig 55: Kauri pines
