# Archaeological Impact Assessment of two outbuildings on the historic werf at Weltevreden Farm, Ptn 14 of Farm 1646, Franschoek

21 January 2013

**Hugo Pinto**

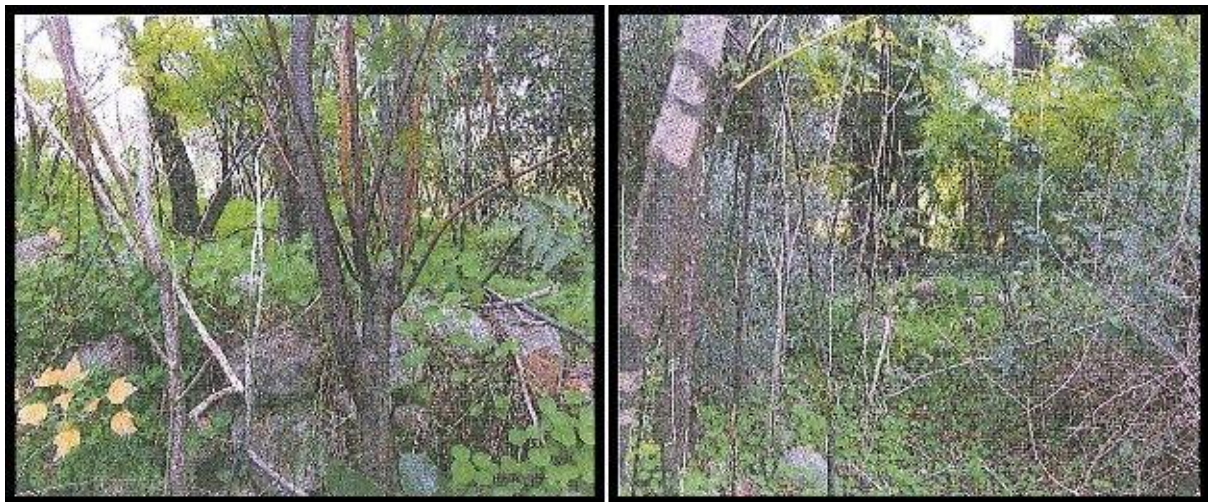
*Fig. 7: Photograph of structural remains to west of West Barn.  
(after: Patrick 2007, pp. 135)*

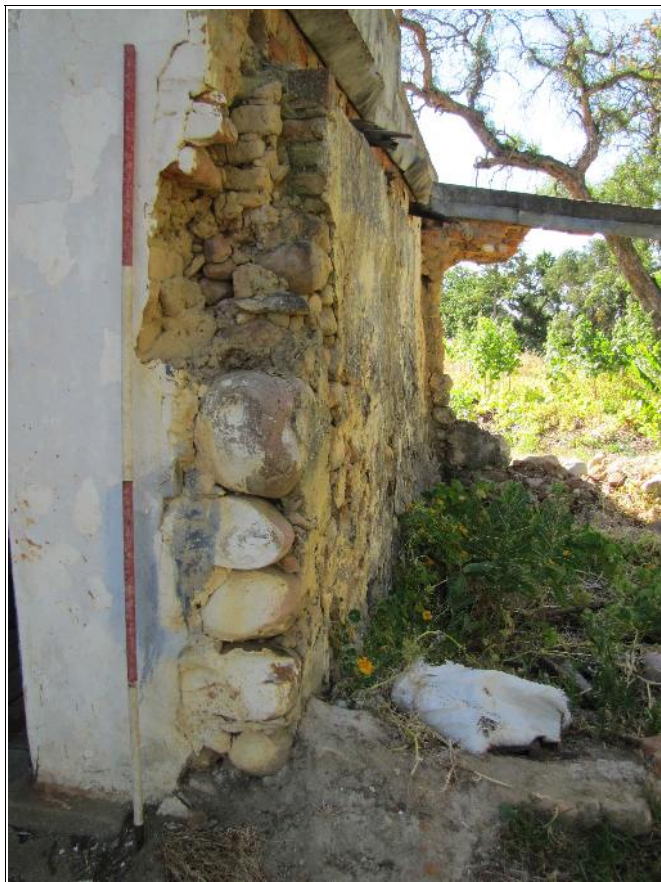
*Plate 1: Photograph showing keyed-in continuation of wall 26 to the north.*

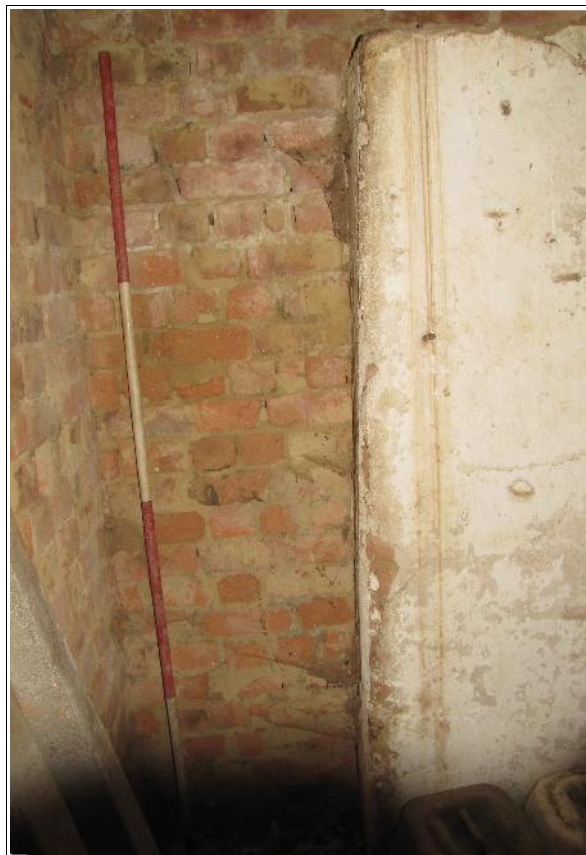
*Plate 2: Section 10 showing interface between walls 25 and 26.*

yellow/brown soil mortar and painted white, the only exceptions being the internal faces of garage wall 25 where the brick coursing was left exposed (section 10; Plate 2).

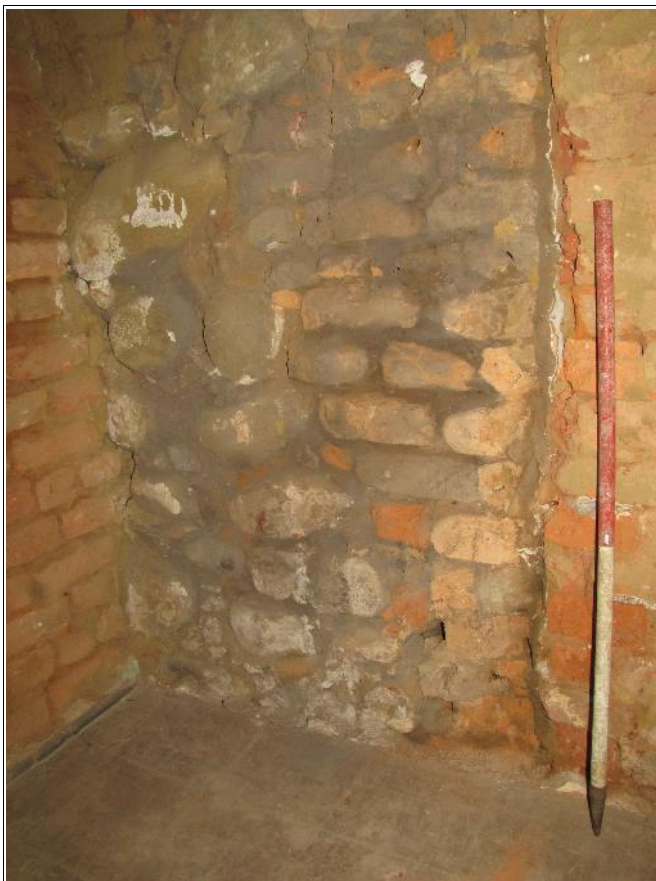
Plate 3: Section 2 showing plaster on jamb of doorway 18.

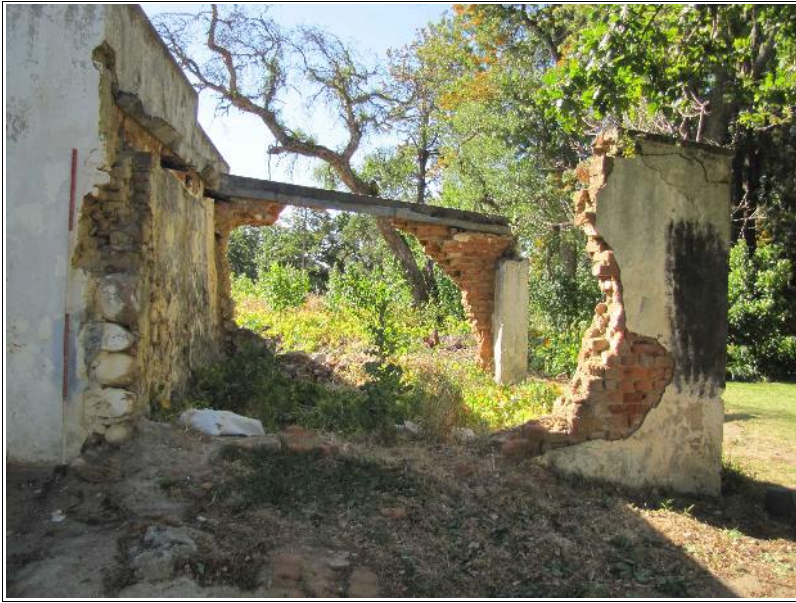
*Plate 4: 'Dilapidated Structure' at the north end of West Barn.*

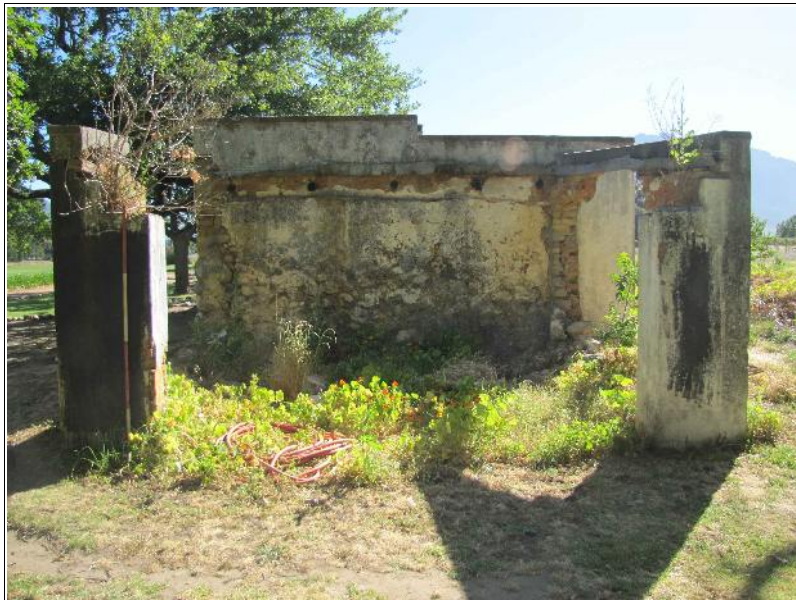
*Plate 5: Photograph showing double-doorway to north elevation of 'Dilapidated Structure'*

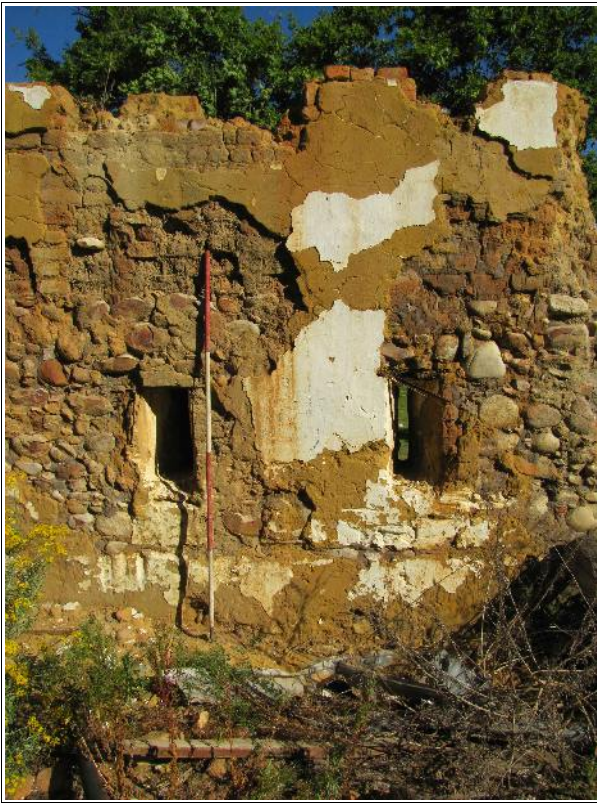
Plate 6: Photograph showing dilapidated render and exposed fabric of wall 27.

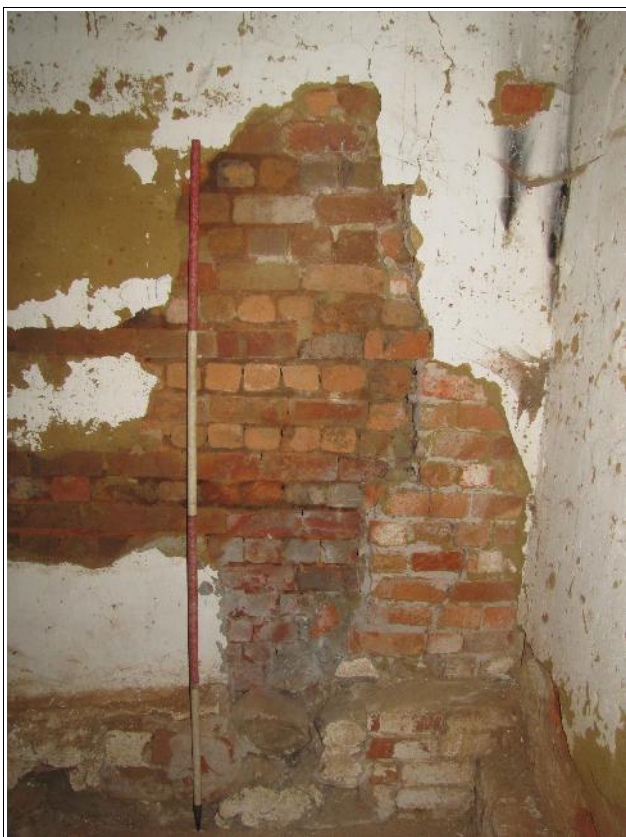
*Plate 7: Section 11 showing end gable wall 31 overlying stone-built wall 27.*

Wall 31 represents the existing northern end-wall of the East Barn building (Fig. 19). The western end of wall 31 was exposed in section 11 and the eastern end was also photographed, with both ends of wall 31 overlying the stone-built Phase 1 wall 27 (Plates 7 and 8). The building's northern elevation was probably re-built as wall 31 after the Phase 1 walls had fallen into disrepair and partially collapsed. This re-build could have also been prompted by the re-configuration of the building's roof structure from a presumably original double-pitch roof to a single-pitch roof, sloping down from west to east. This is indicated by the surviving rafter slots, which are higher on the Phase 4 western elevation wall 28 than those along the eastern elevation wall 27.

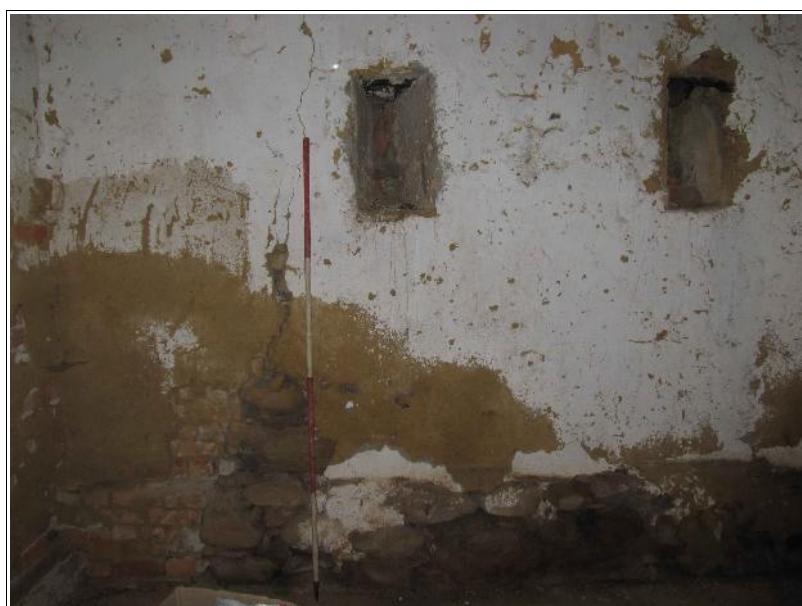
*Plate 8: Eastern extent of end gable wall 31 overlying eastern elevation wall 27.*

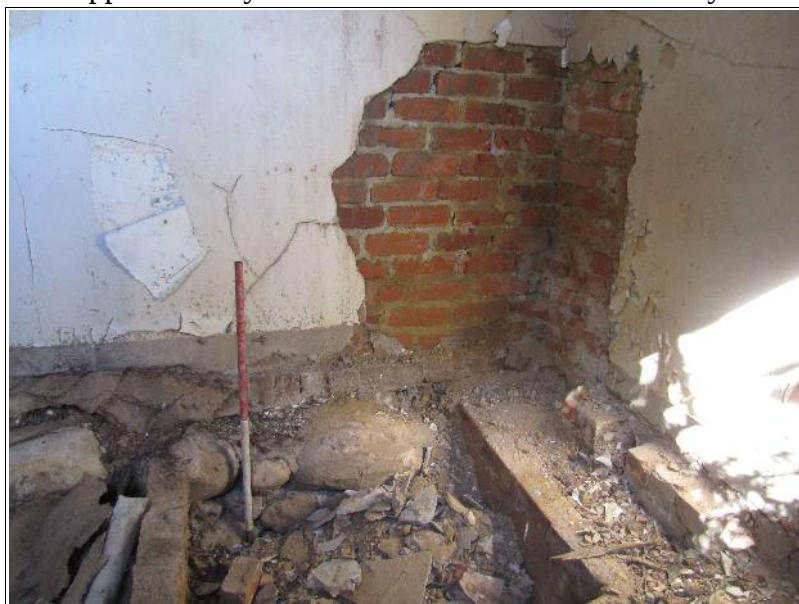
*Plate 9: Section 12 showing east-west wall 28 overlying stone-built footing of wall 27.*

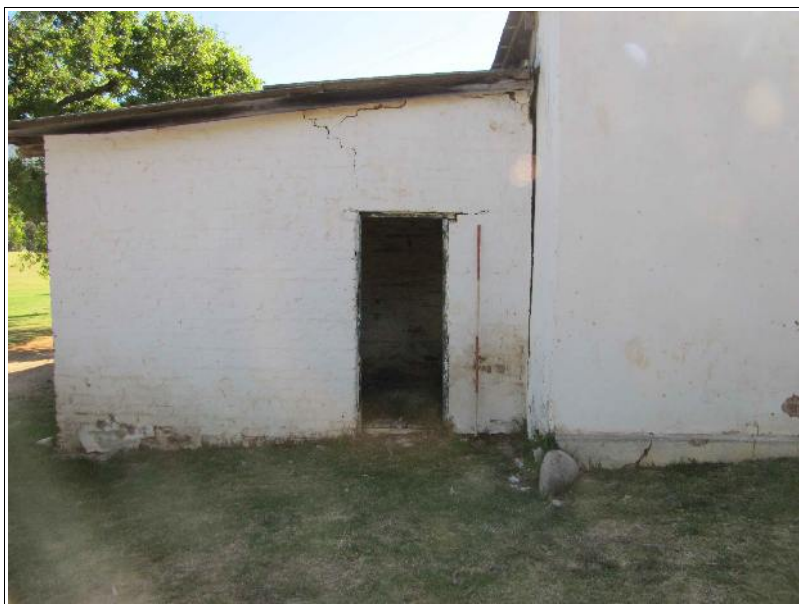
end of the *afdak*. Both Room 8 and the square pillars adjacent to the building clearly abutted Phase 1 wall 27 (Plate 10).

*Plate 10: North wall 32 of Room 8, abutting eastern elevation wall 27*

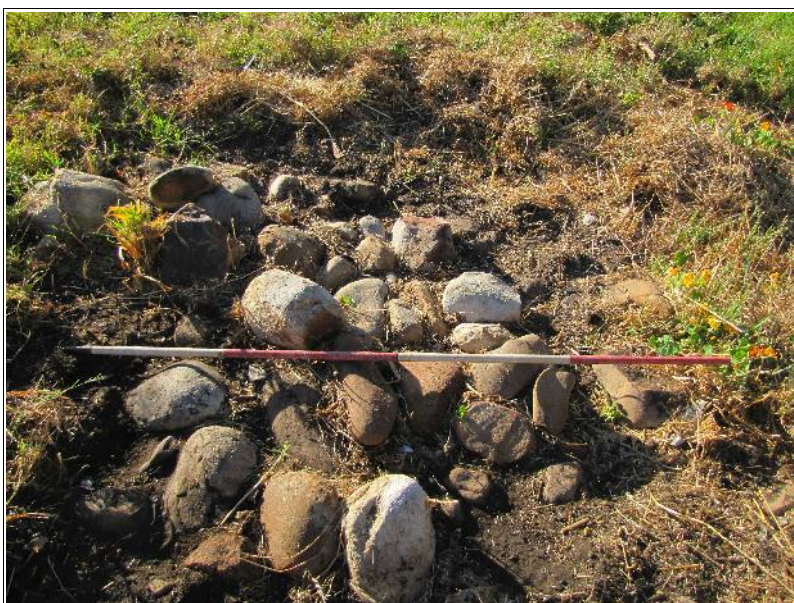
Plate 11: Concentration of boulders on ground surface.

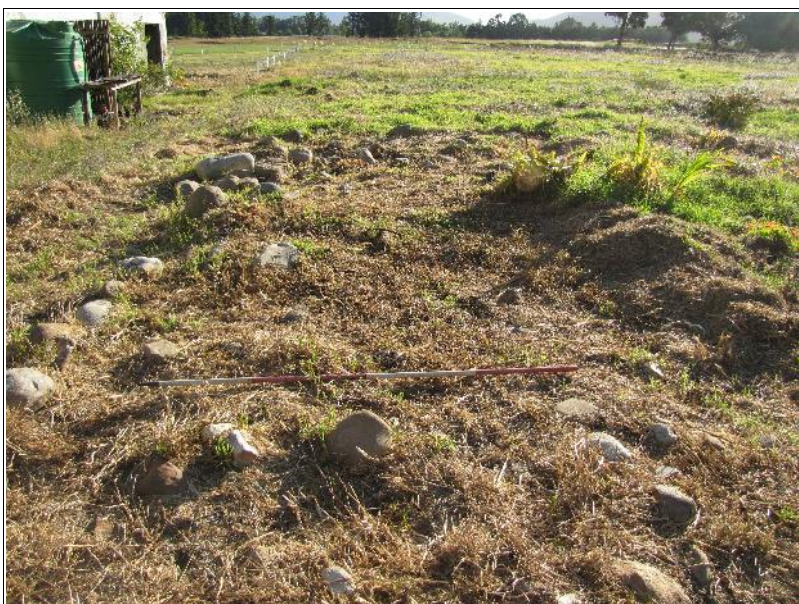
*Plate 12: Raised ground surface with exposed boulders adjacent to West Barn, looking south.*

However, the fact that sandstone boulders were found on the ground surface with no topsoil covering, together with the raised ground surface relative to the surrounding area (Plate 12) and, in particular, the low coursed walling recorded in 2007 (Fig. 7), does suggest the exposed boulders represent remnants of walling or a concentration of rubble resulting from a collapsed structure in this area. On the other hand, it is also possible that this area was used as a general dump of rubble from demolitions or alterations to structures elsewhere on the farm.

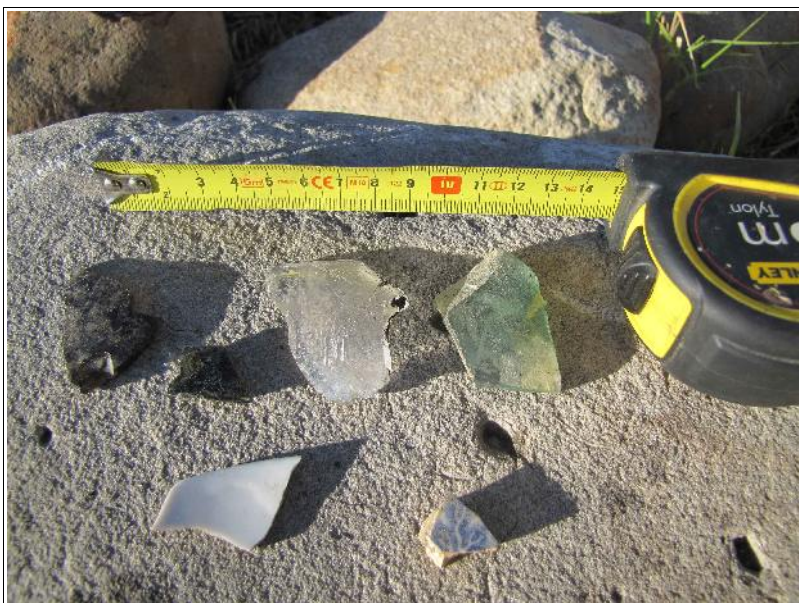
of clearing overgrowth. A sample of these is shown in Plate 13. These artefacts, however, were found loose and without a secure context in the vegetation overlying the sandstone boulders, and as such cannot be used to establish a date for this possible structure.

*Plate 13: Sample of artefacts exposed during vegetation clearing.*
