RDR 1 Photos

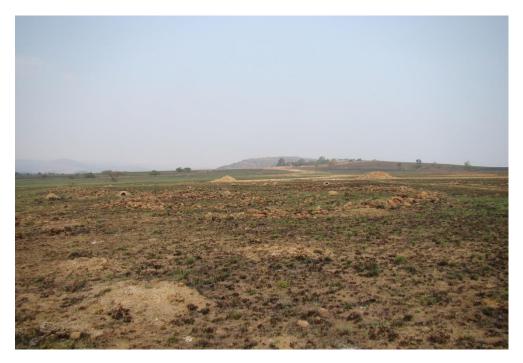
Photo 45: The entire area surrounding RDR 1 C is level with the ground surface. Road networks have previously impacted on the remains of the stone walls.

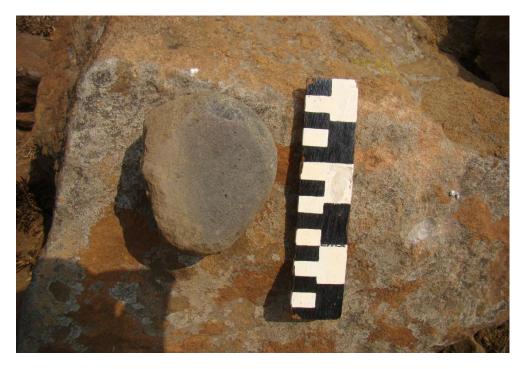
Photo 46: An upper grinder observed in RDR 1 C.

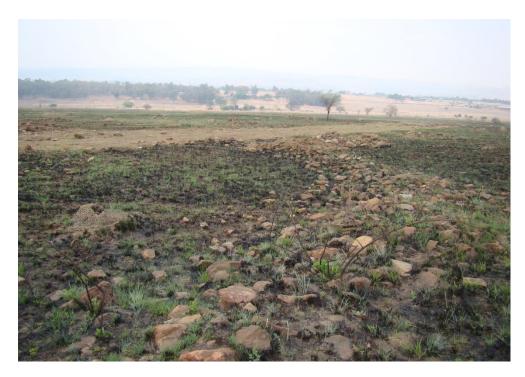
Photo 47: The condition of the walls is visible in this picture.

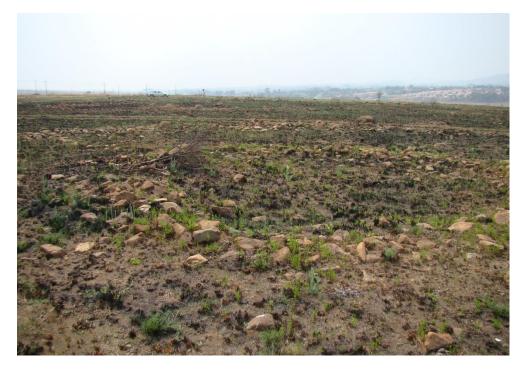
Photo 58: Some of the units can be identified when the velt was burnt.

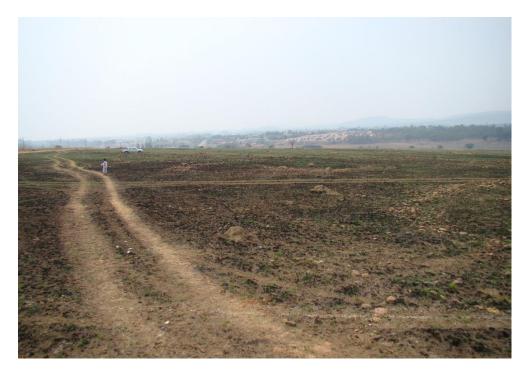
Photo 49: Impacts from previous road networks are visible in the area of RDR 1 C.

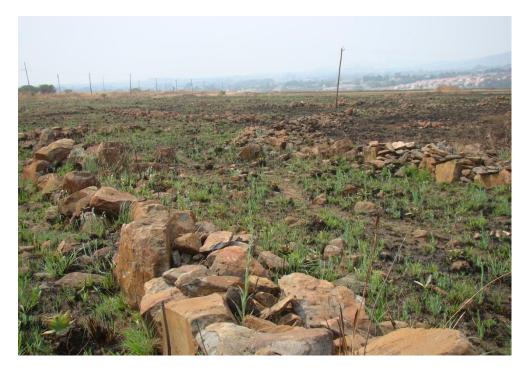
Photo 50: The stone walls from D, E and F are interlinked. Some sections of the walls are on the ground surface, whereas the foundation stones of others are clearly visible (see layout plan Fig. 5).

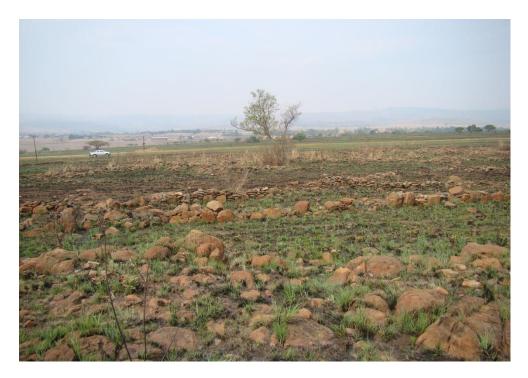
Photo 51: The stone walled complex in section RDR 1 D & E.

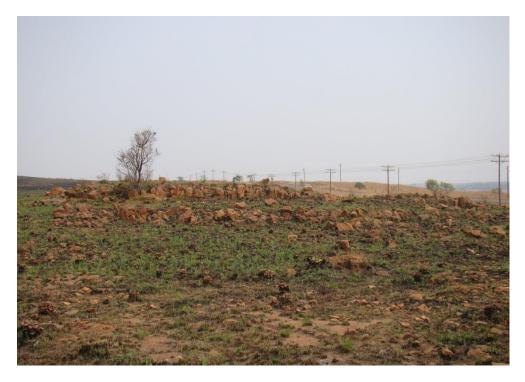
Photo 52: A small natural outcrop forms part of the stone walled complex at section RDR 1 F.

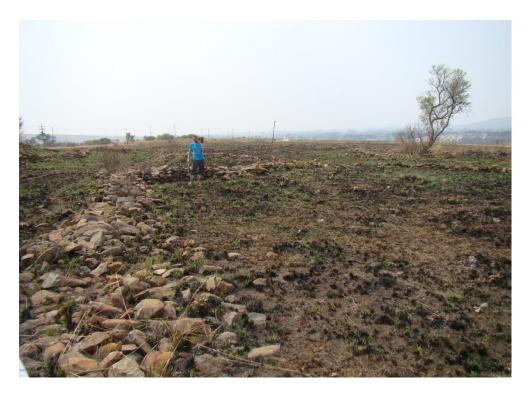
Photo 53: The condition of the walls are visible in this picture.

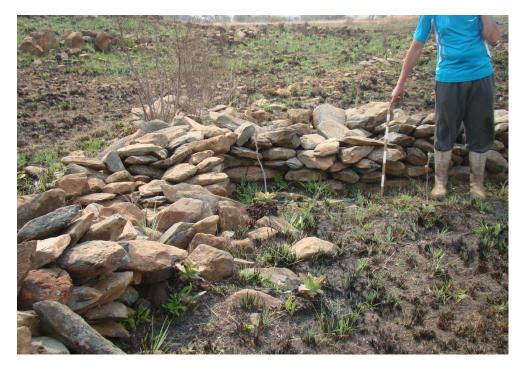
Photo 54: Some of the sections are in the region of 600mm high.

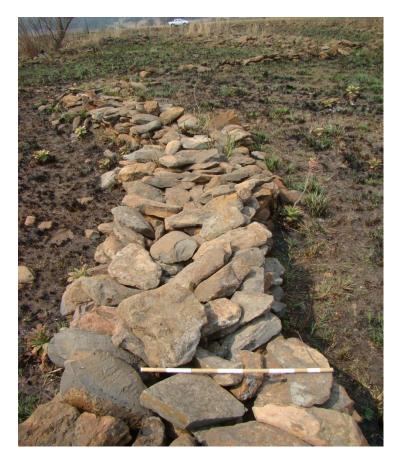
Photo 55: Some of the walls are in the region of 1000mm wide.

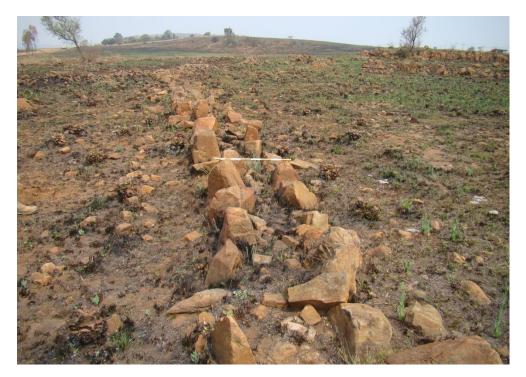
Photo 56: The stone foundations are distinctly larger stones in this section.

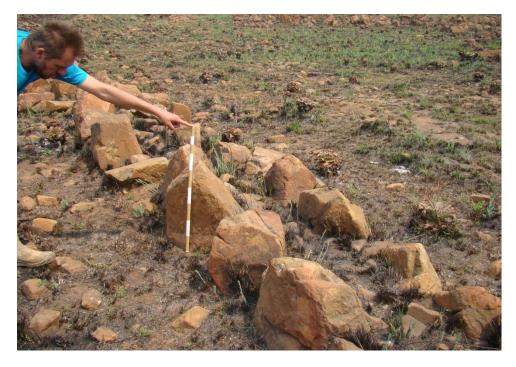
Photo 57: Detail of some of the large foundations stones.

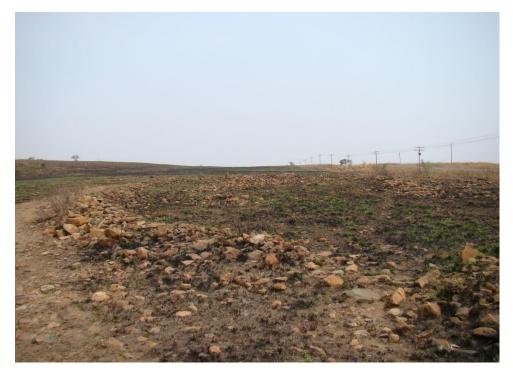
Photo 58: RDR1 G has been impacted upon by the tarred road (R36) which cuts through this unit. The walls are not generally in good condition.

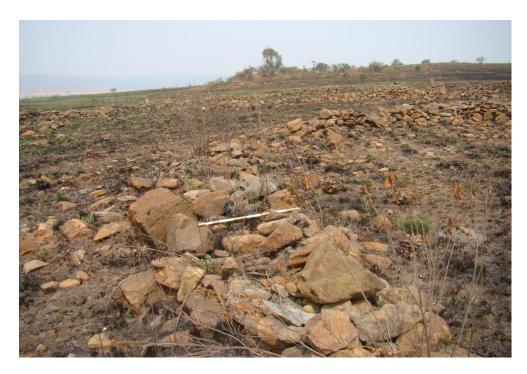
Photo 59: Detail of the walls in RDR 1 G.

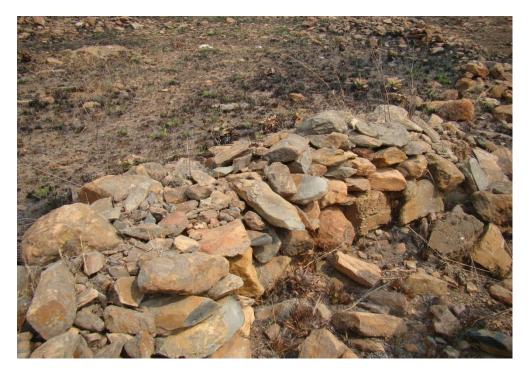
Photo 60: A section of the wall in RDR 1 G that is still in a good condition.

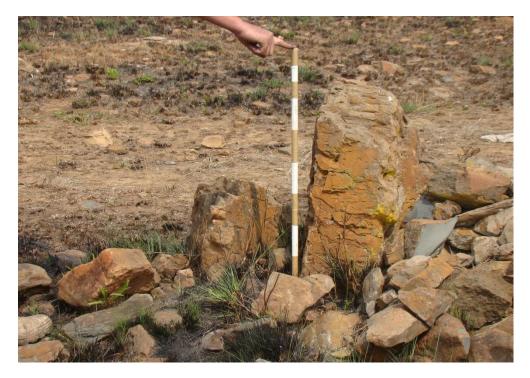
Photo 61: An upright stone which used to be part of an entrance.

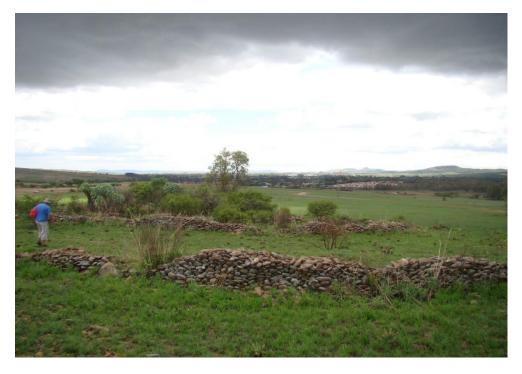
Photo 62: RDR 1 I is the best preserved of all the stone walls in the RDR 1 group. It is situated on a small hill and distinct (see layout plan in Fig. 5).

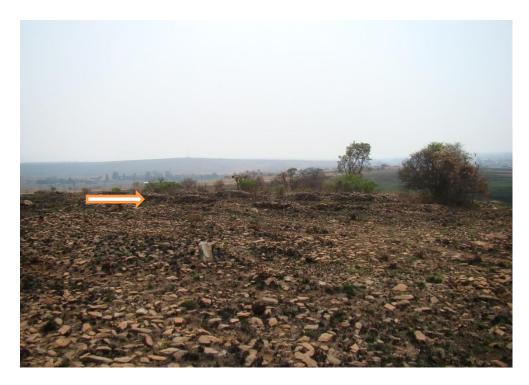
Photo 63: RDR 1 I in the background (arrow). The stones in the foreground are scattered throughout the hill area and used to be part of the larger stone walled complex.

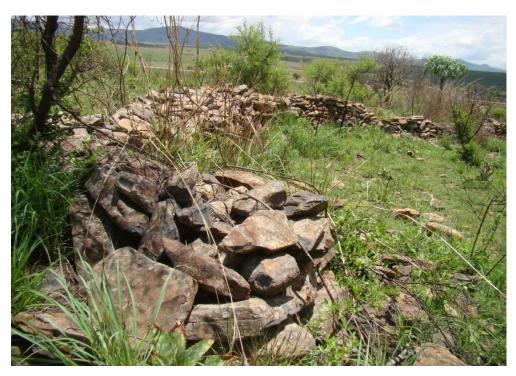
Photo 64: The condition of some of the walls in RDR 1 I.

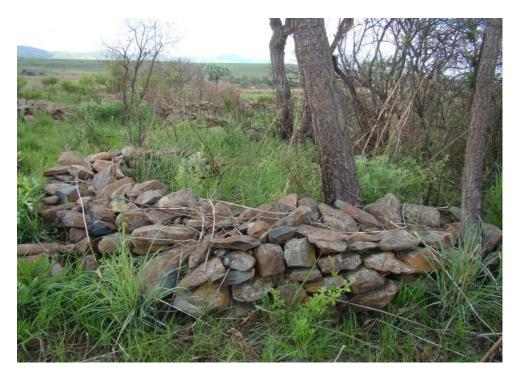
Photo 65: This specific circular wall is still in a very good condition.

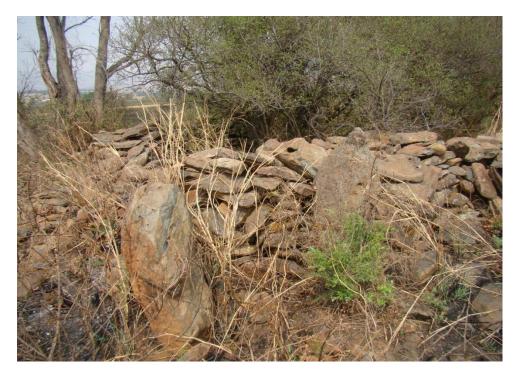
Photo 66: Upright stones mark the entrances in this unit.

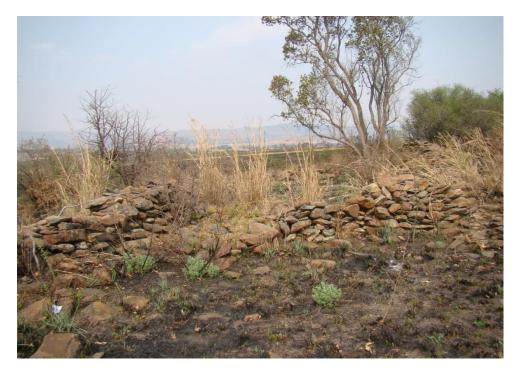
Photo 67: The entrance section of RDR 1 I as it is reach from the bottom of the hill.

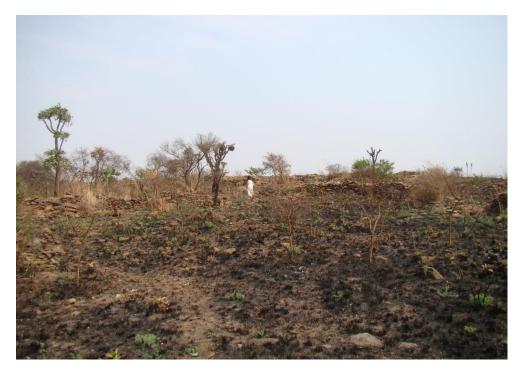
Photo 68: View from RDR 1 I from below the hill.

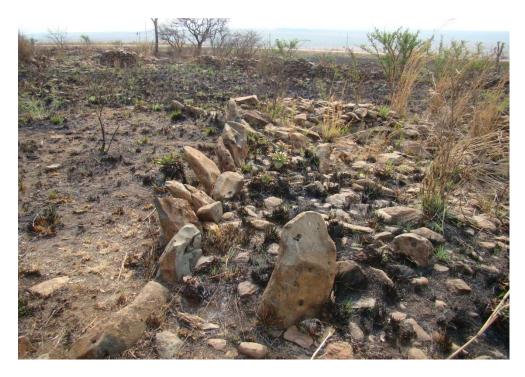
Photo 69: Large foundation stones are also distinct in this section.

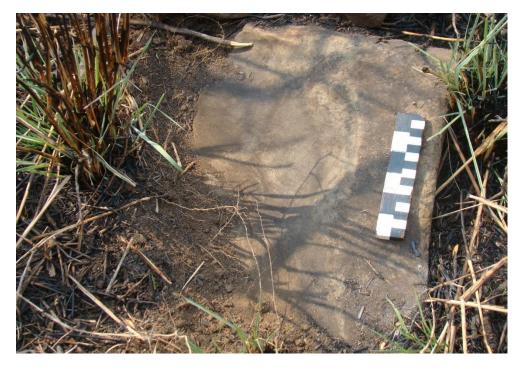
Photo 70: A lower grinder was observed in one of the units.

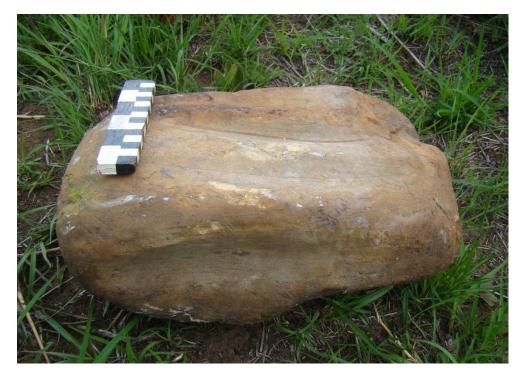
Photo 71: A stone for sharpening implements was observed in one of the units.

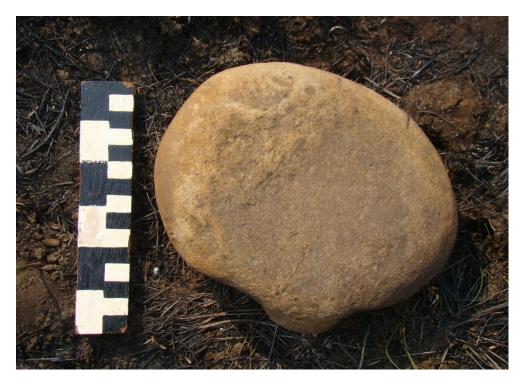
Photo 72: An upper grinder was observed near the entrance of the complex.

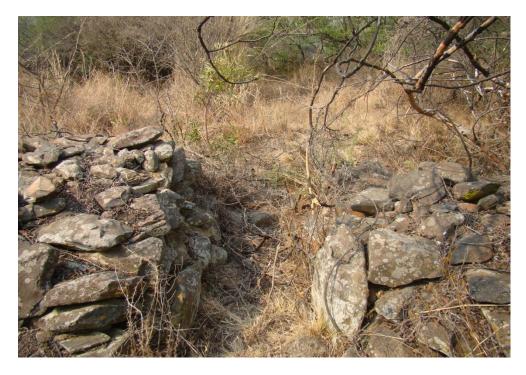
Photo 73: A neat entrance to one of the units is still visible.

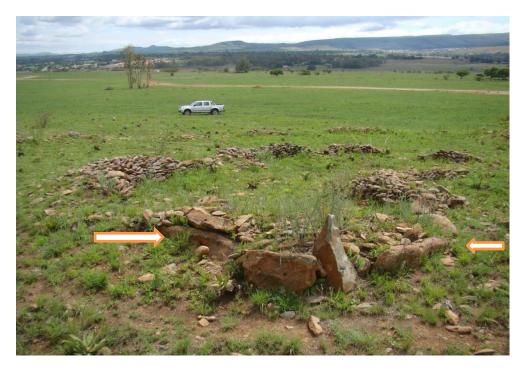
Photo 74: RDR 1 J is situated on the slope of the hill. It is characterised by large stones which were incorporated into the units.

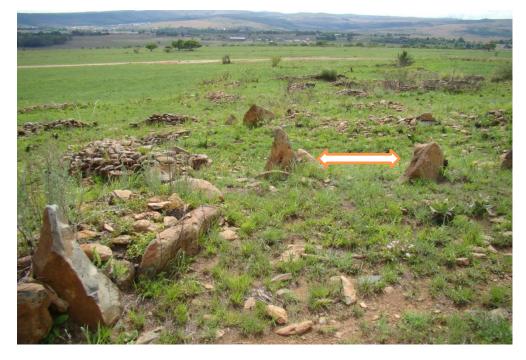
Photo 75: Upright stones mark the entrances of the units.

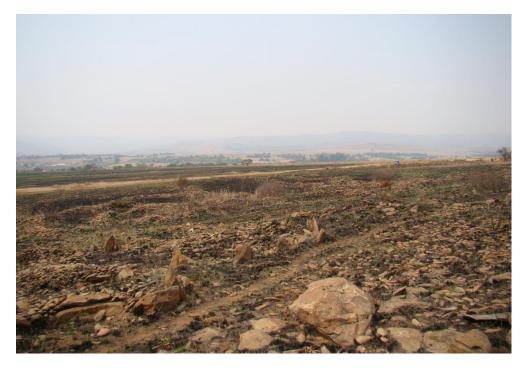
Photo 76: A view of RDR 1 J after the velt was burnt.

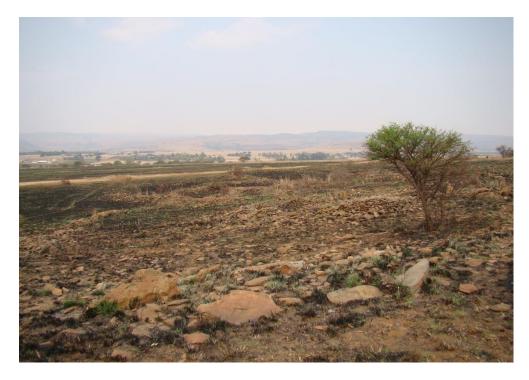
Photo 77: A view of RDR1 J. The walls are distinct but not in a good condition.

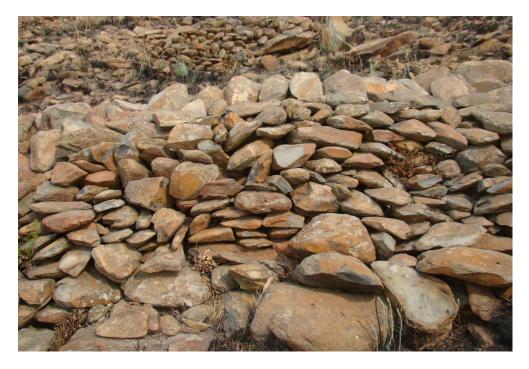
Photo 78: One particular neat section of a wall in RDR 1 J.

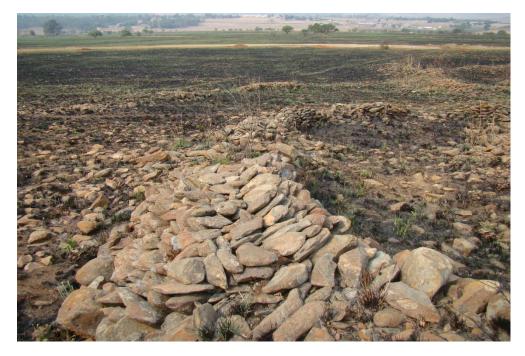
Photo 79: The extent of the walls in RDR 1 J is visible in this picture.

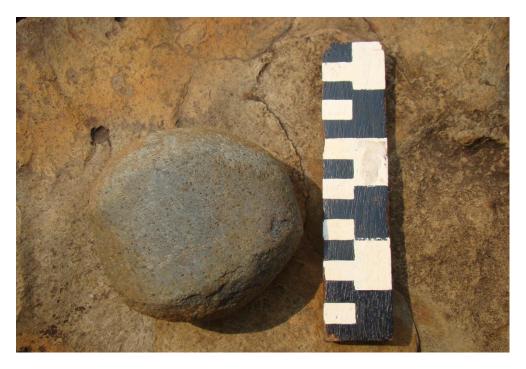
Photo 80: An upper grinder was observed at the foot of RDR1 J.

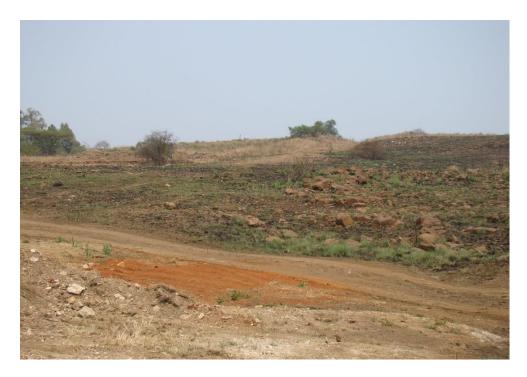
Photo 81: RDR 1 J as viewed from below. The road networks have already impacted upon the stone walls.

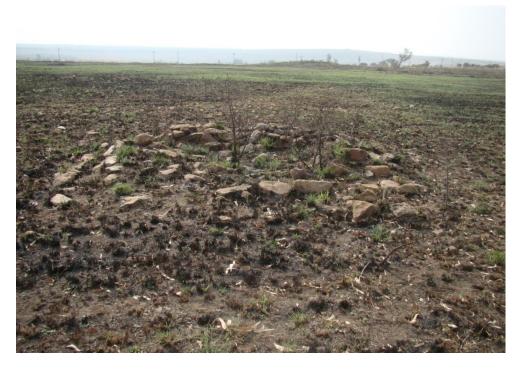
Photo 82: A small circular unit below the slope is also associated with RDR 1 I & J.

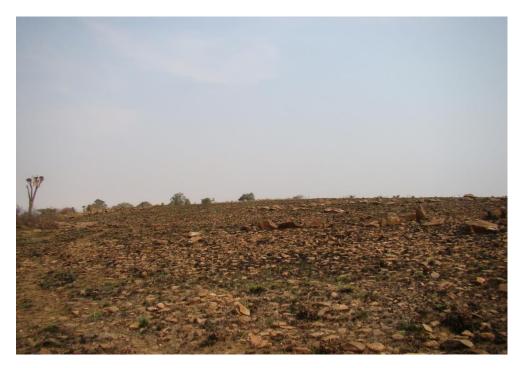
The section on the hill above RDR 1 I, J & K is associated with sections I & J and K.

Photo 83: The larger foundation stones are mainly visible with most of the smaller stones scattered throughout the area.

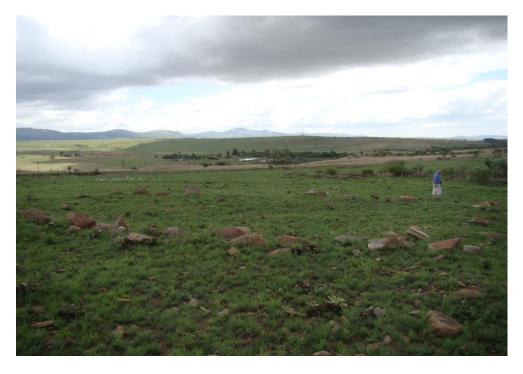
Photo 84: The large foundation stones are clearly visible against the background of new growth, which obscure the smaller stones as seen in Photo 83.

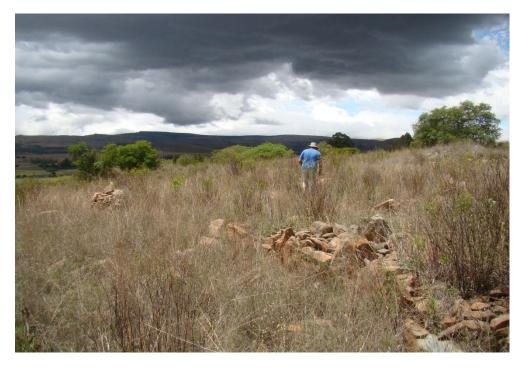
Photo 85: Some of the walls of RDR 1 K, on top of the hill, are still visible. The entire section at the bottom is already destroyed.

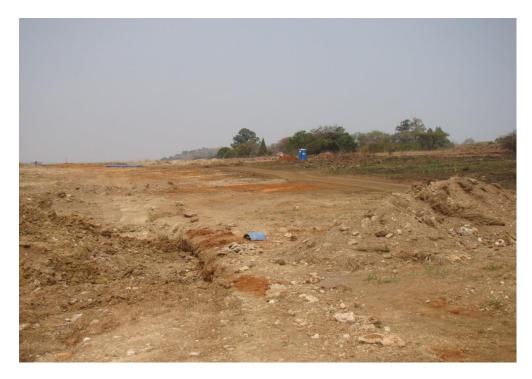
Photo 87: RDR 1 J & K are destroyed in this section.

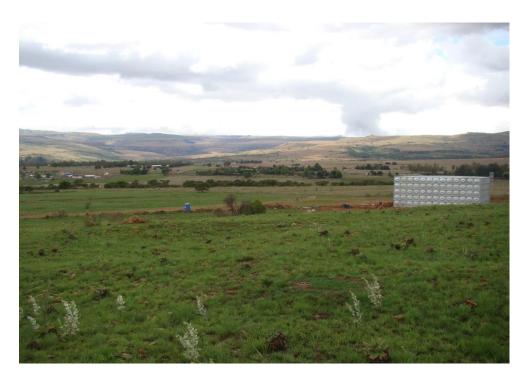
Photo 88: A water reservoir was built on the bottom section of RDR 1 K.
