## REDECORATION OF ALBERT LUTHULI HOUSE- GROUTVILLE

21 July 2015

## **REPORT AND RECOMMENDATIONS**

### **REDECORATION OF ALBERT LUTHULI HOUSE GROUVILLE**

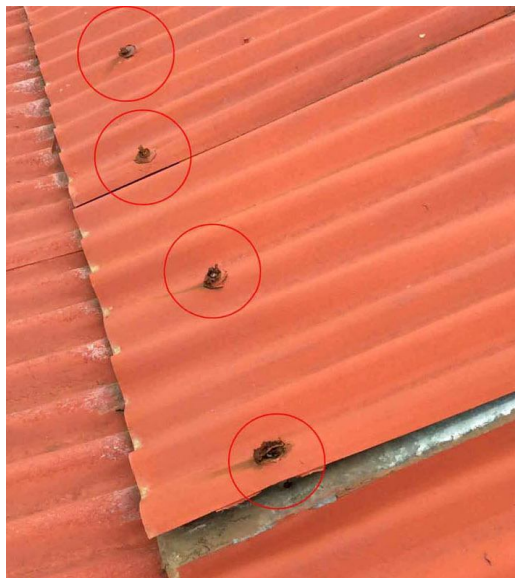
- 3.2. The current 'S' profile roof sheeting needs to be securely fixed; as many of the roof fixing screws have rusted through (some of these are missing completely) and the moisture resisting washers are brittle from constant sun exposure (Fig.1). It is suggested that these get replaced throughout. For extra precautionary measures, due to the age of the sheeting, an extra set of roof fixing screws are to be used. The missing / damaged screws are to be replaced where necessary.

Fig. 1: Loose fixing screws

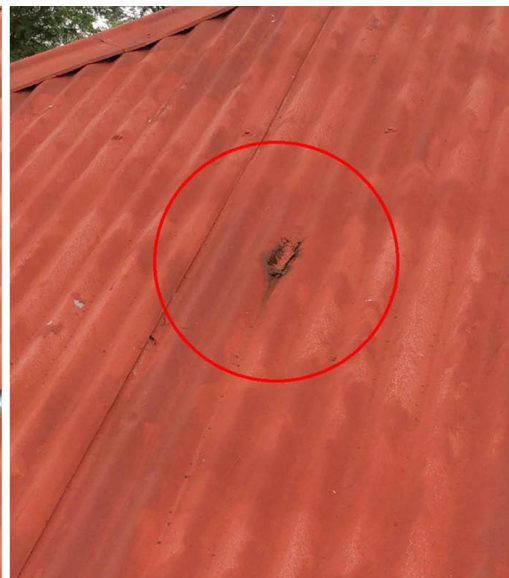
Fig. 2: Rusted sheeting

- 3.3. All rusted roof sheets are to be replaced with double galvanised 0.53mm thick red Colourbond 'S' pattern typology to match existing, however a maximum of five sheets will only be needed (Fig.2).
- 3.4. Large scale concentrated rusting is occurring on one of the roof sheets covering the verandah (Fig.3). This is caused by inadequate waterproofing/ flashing at the discharging end of the roof valley (Fig.4).

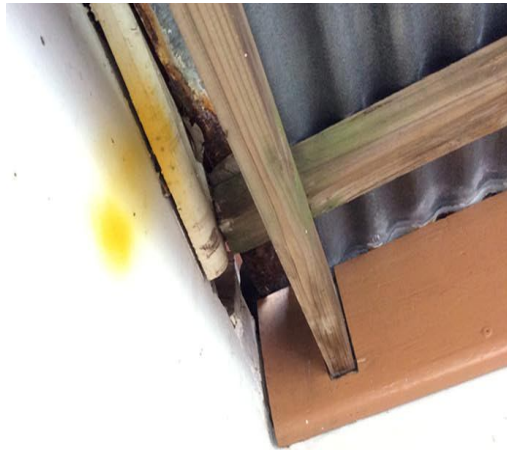
Fig. 3: View from verandah

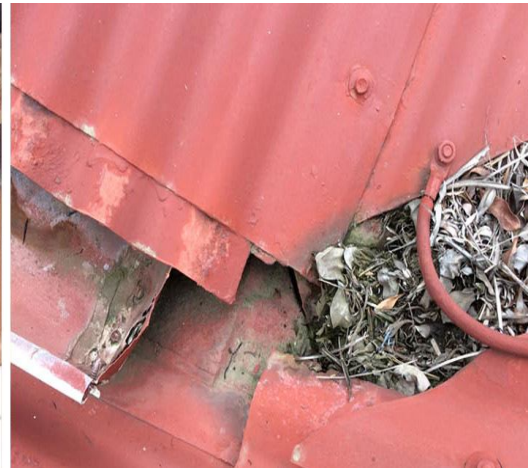
Fig. 4: Gap in flashing evident

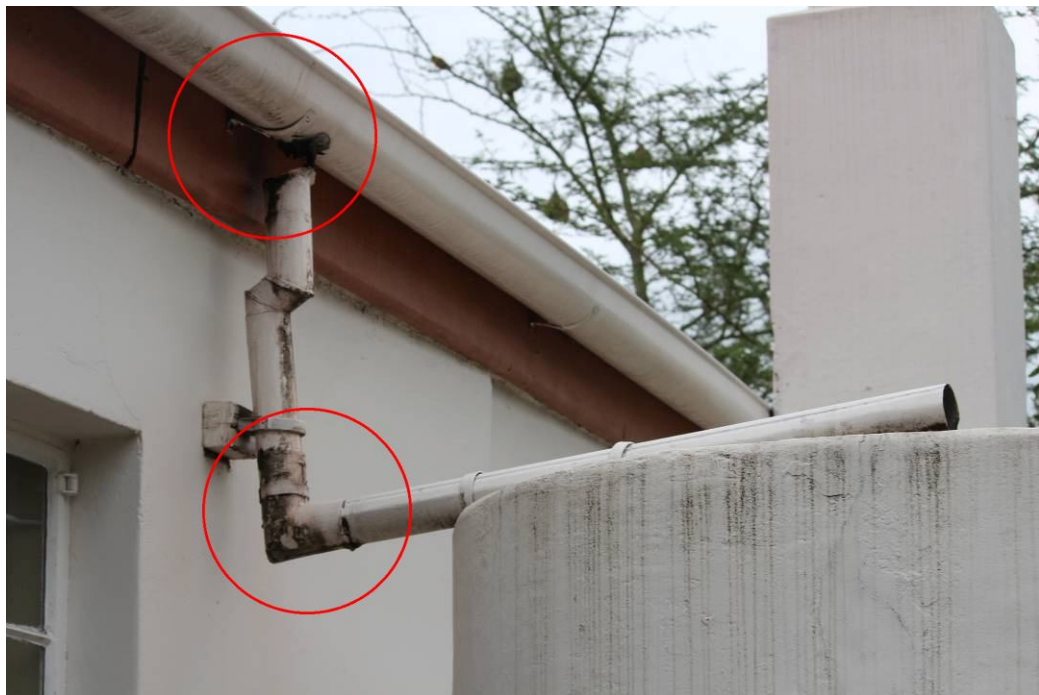
Fig. 5: No connection between gutter and rwdp

restored. Many of the gutters and downpipes are showing signs of severe rusting, while many of these have now failed altogether (Fig.5)

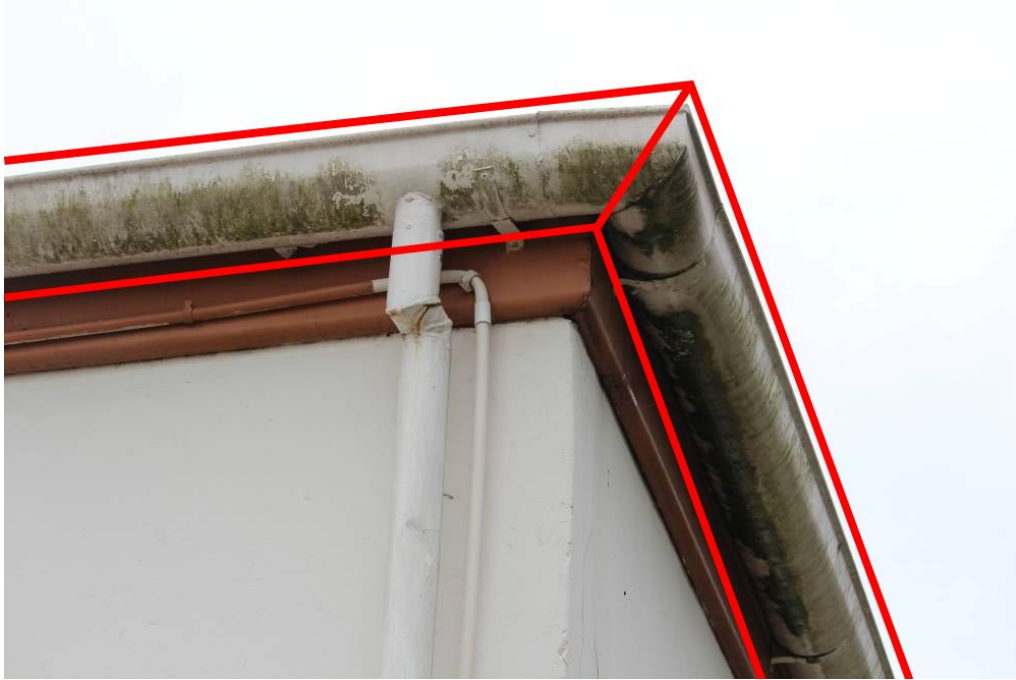
Fig. 6: Proposed new guttering

- 3.9. A national search is being undertaken to find a company that may manufacture 'half round' guttering of non erosive material. (Fig.6).

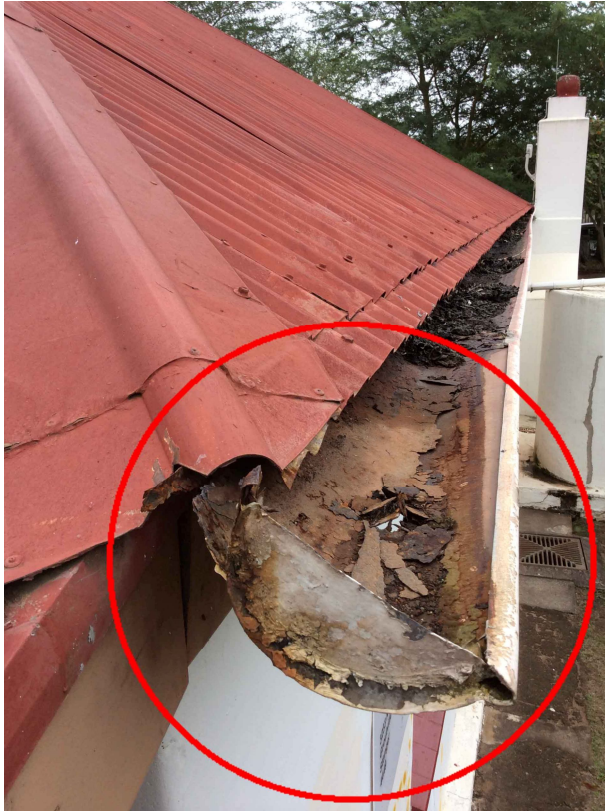
Fig. 6A: Totally corroded gutters!

- 3.10. We would now advise that all the gutters be replaced throughout and they should be ordered in white zinc-aluminium. The coating is integral and the alloy is rust resistant thereby avoiding the necessity to paint galvanised iron, which is eventually susceptible to rust, near the coast (Fig.6A).

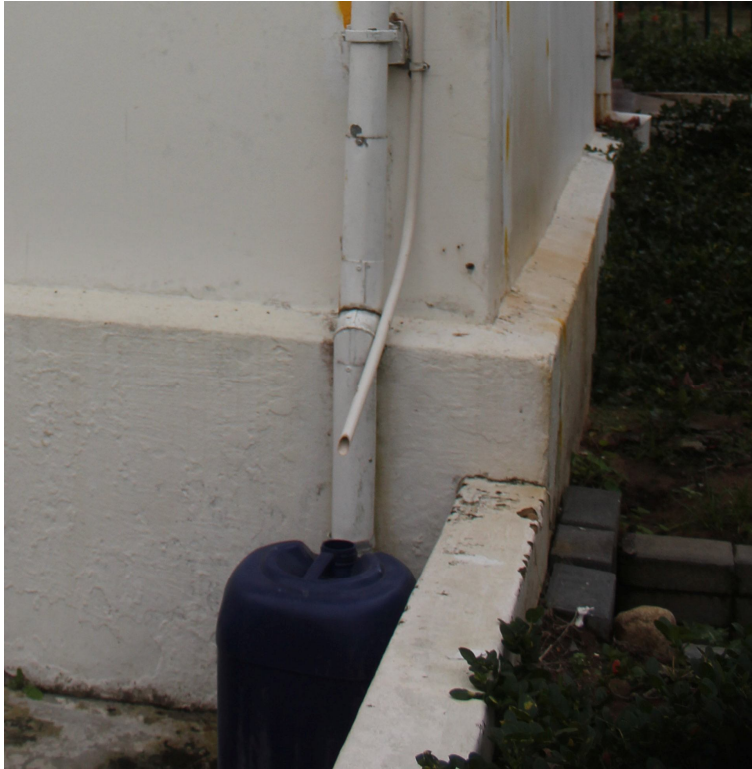
Fig. 7: All surrounding moisture sources to be removed

- 3.11. The main function of a down pipe is to successfully dispel water away from the building (this is even more important considering the building walls are constructed from mud bricks) The down pipes should be replaced throughout and are to be made from white zinc-aluminium material as to match the new guttering. Most are to be redirected to dispel water into the existing rainwater collection tanks. Changes in direction are to be mitred to match the existing.
- 3.12. Air-conditioning condensation pipes are unsightly and should be led directly into rainwater downpipes. The one instance at the house is a probable cause of damp damage to the wall on the front elevation. This pipe is to be redirected, as to now discharge into the nearest rainwater tanks (Fig.7). This includes garden sprinklers.

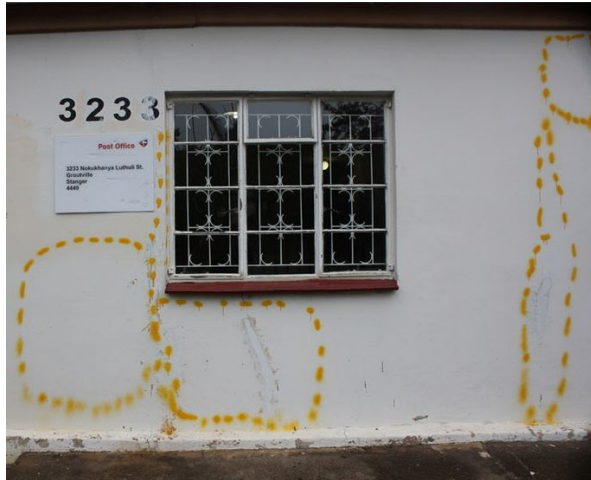
Fig. 8: Marked hollow plaster sections

- 4.1. However prior to this the existing plaster defects need to be attended to. These have been carefully marked on the elevations with spray paint. Loose plaster was located by tapping or else marked where the sand texture of the previous repairs is too coarse (Fig.8 & 9).
- 4.2. The protective coating of paint has been specified by Plascon. The external building facade is to be repainted throughout (Appendix 9.1).
- 4.3. To assess the materials used in the original construction a core sample was taken and analysed by Contest. It provided the mix to be used as well as the need for fine sand (Appendix 9.2).

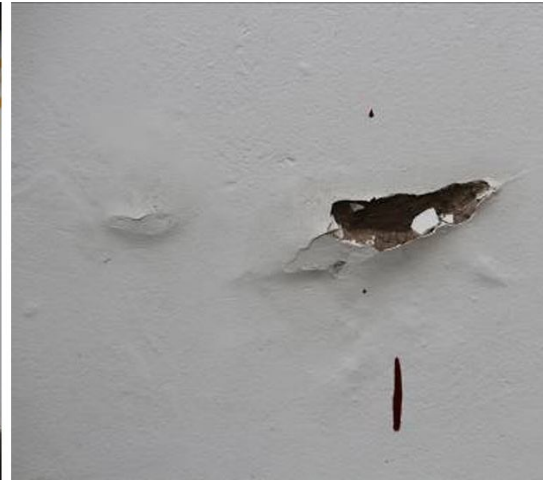
Fig. 9: Coarse plaster sand

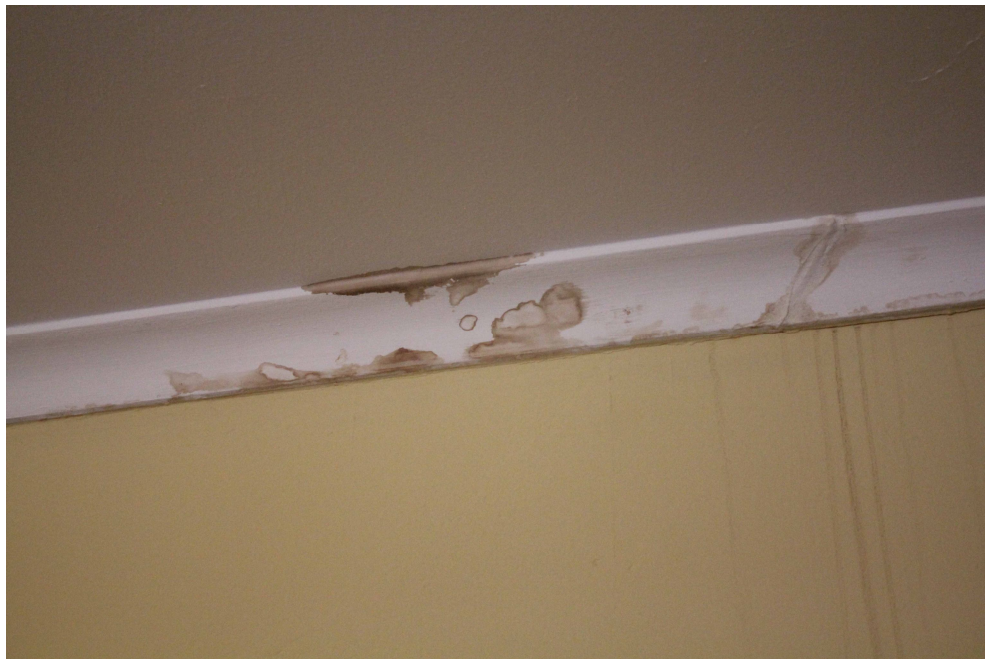
4.4. An internal water leak is clearly evident, as this has created a swelling and discolouring of a section of cornicing and stain marks along the painted wall (Fig.10).

Fig.10: Internal leak probably from air-conditioning unit over.

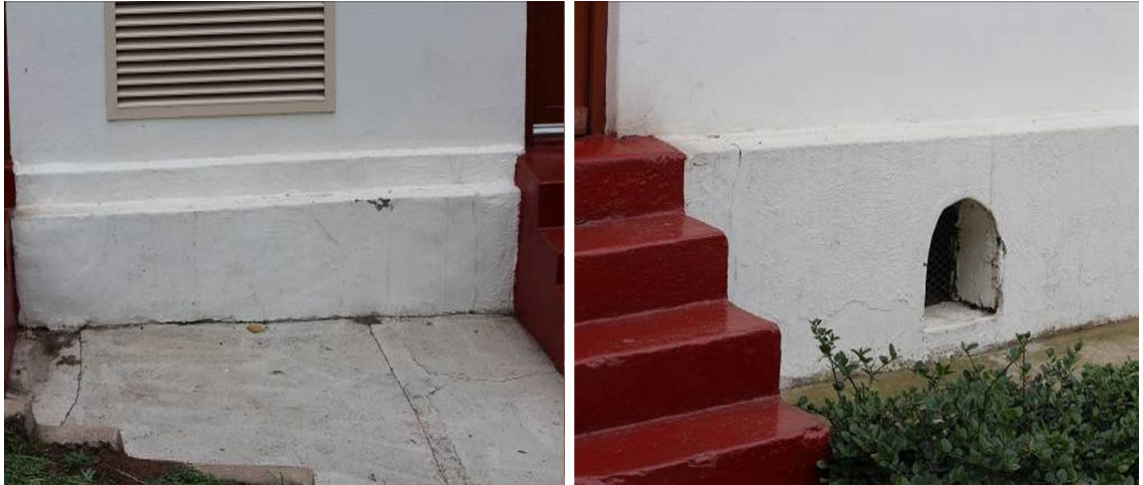
Fig.11: Substantial concrete plinth Fig. 12:Underside vent on south side

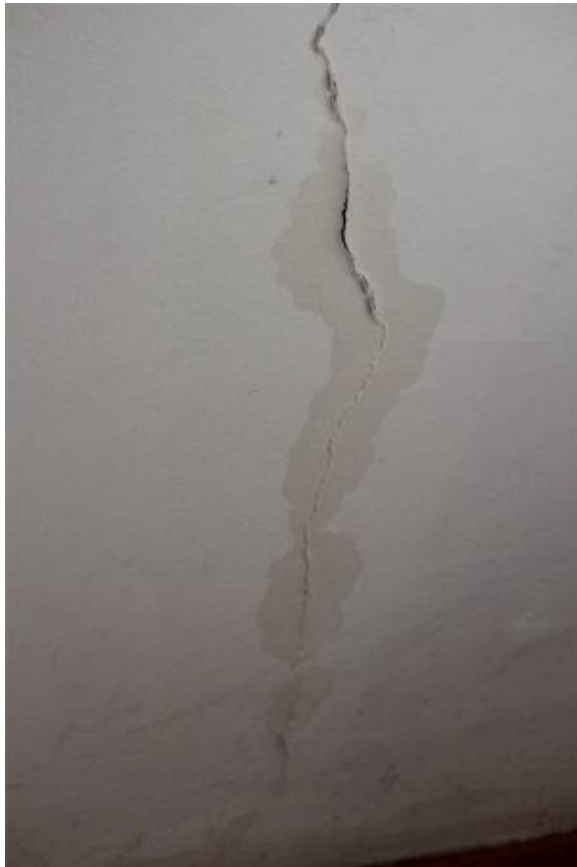
There are minor cracks in this mass concrete wall, probably due to a lack of available reinforcing, but these are of no consequence. These must be monitored in later years however (Fig.13).

Fig. 13: Minor cracks in concrete plinth

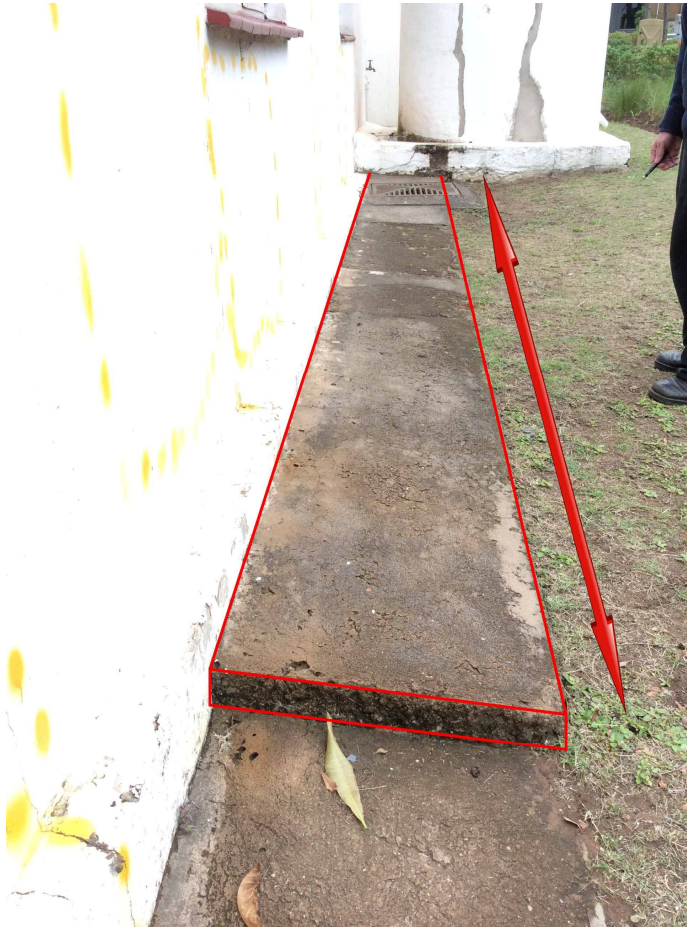
Fig. 14: Section to be lowered

5.4. The roadside north elevation is the source of most of the current problems on site; especially since the natural ground level is too high here, the site is inherently damp and the gutters are in a poor state over. To make double sure, it is recommended that the current skirting slab be demolished and recast at a lower the level, to that of the northern section. The garden is to be trimmed downwards to suit. This includes the existing ventilation grille(Fig.14).
