Bo-Kaap Erf 142718 & 142719, 38 & 38A Rose Street
**Section 34 Application to Heritage Western Cape in terms of the National
Heritage Resources Act**

**Report on Existing Housing Condition and Assessment of Recommended
Work on City Owned House in Bo-Kaap.**

**Compiled by Dieter Bossow of Architects Associated for the City of Cape Town.
June 2018.**

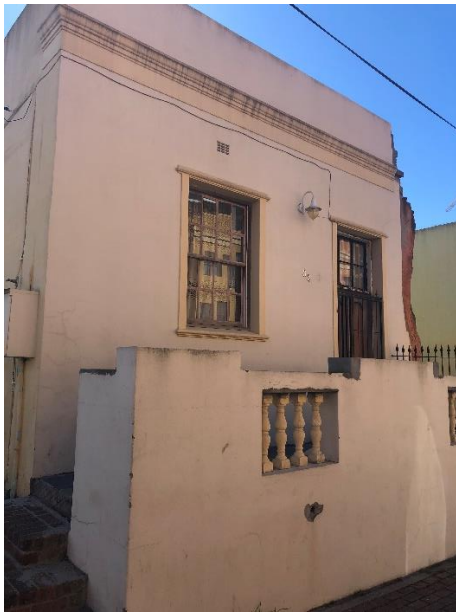
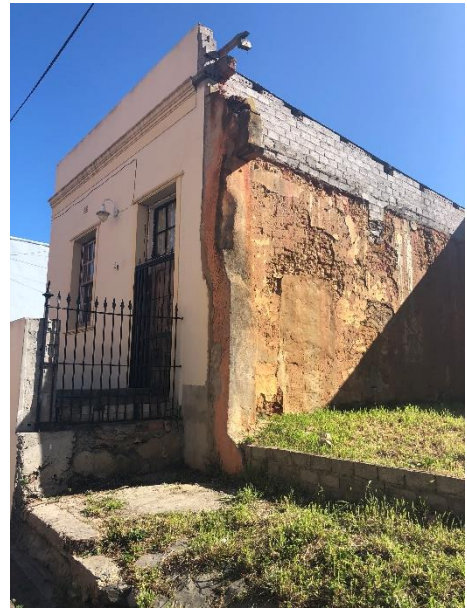
Doors and window have been retained, cornice is intact, walls are painted.

Front façade

Front facade

Refurbish window and doors and re-seal
Make good plaster and paint at stub wall.

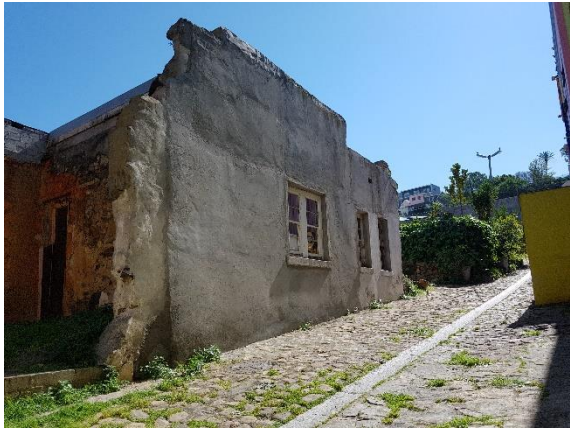
Since demolition of corner shop walls and parapets have deteriorated badly

Berg Lane façade

Remove loose plaster, re-plaster and paint, fit fascia and bargeboard to roof edge
Refurbish bedroom 1 and kitchen windows, make good plaster and paint
Make good building corners where walls had been demolished.

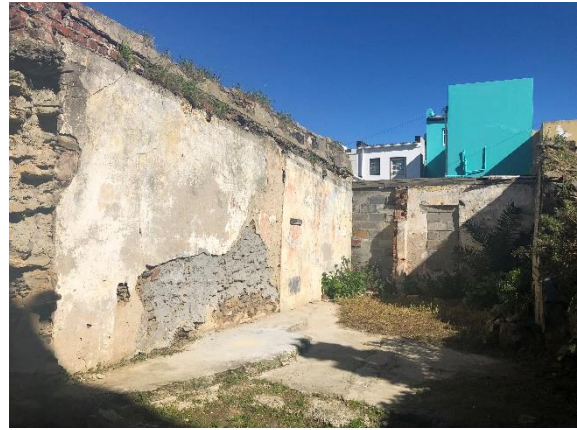
Open yard erf 142719

Build new yard walls as shown

Make good end of retaining wall, plaster and paint

Make good paving laid to falls

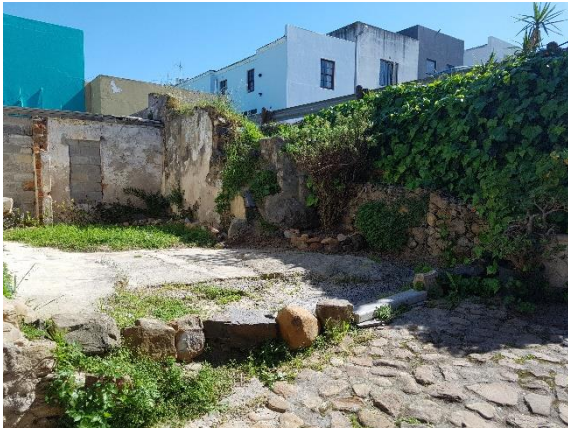
Thick stone retaining wall at the rear with public parking behind at a higher level.
The yard has been roofed illegally preventing natural ventilation to the bathroom.

Open yard, retaining wall, public parking behind

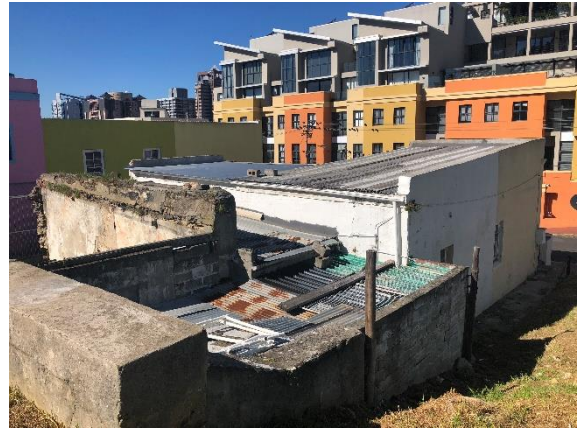
Roofs are visible and require refurbishment. The original roof structure over the main section of the house has been replaced, with walls raised and falls redirected.

Roofscape

Check roof for leaks, replace roof sheets and seal at parapets, where required.

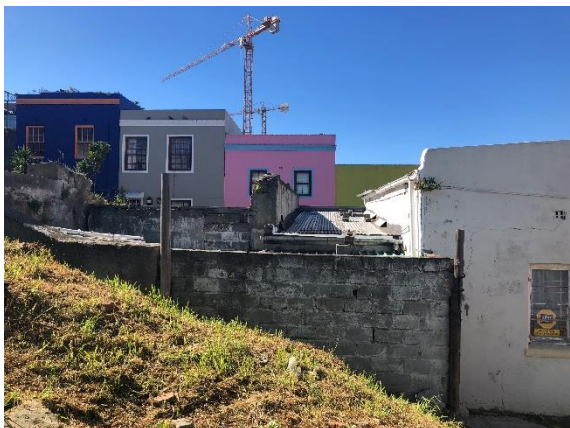
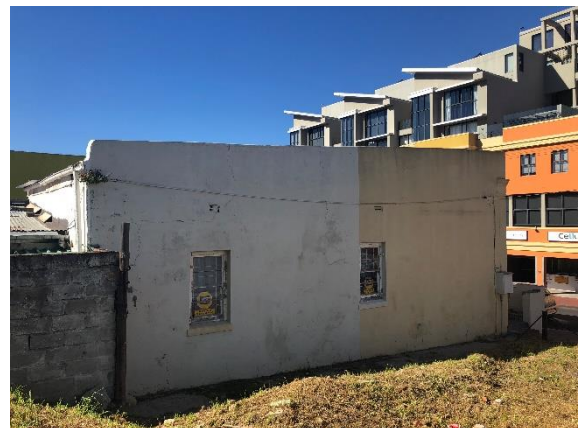
Rear façade requires attention

South façade backyard

South façade

Refurbish windows and paint

Plaster blockwork wall and paint

Remove loose plaster, re-plaster and paint

Make good parapet walls, waterproof and seal to roof sheets

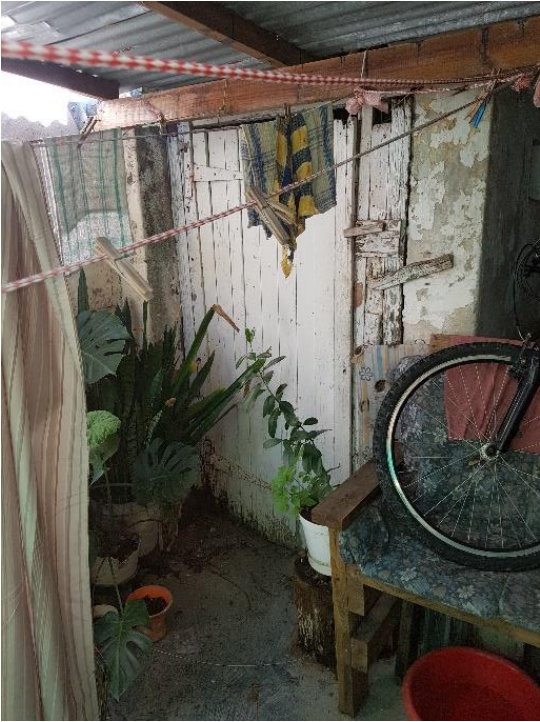
Outside toilet requires some refurbishment.

Yard – outside toilet

Replace existing door and frame, remove loose plaster and paint inside and out

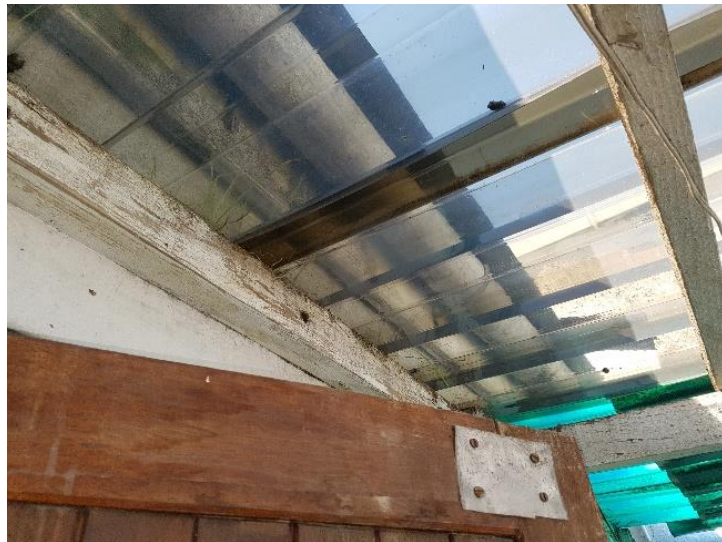
Yard roof

Remove part of roof as shown , make good where removed

Repair cement paving

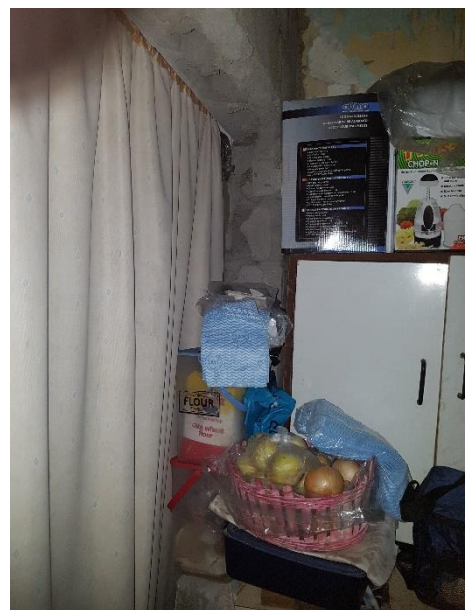
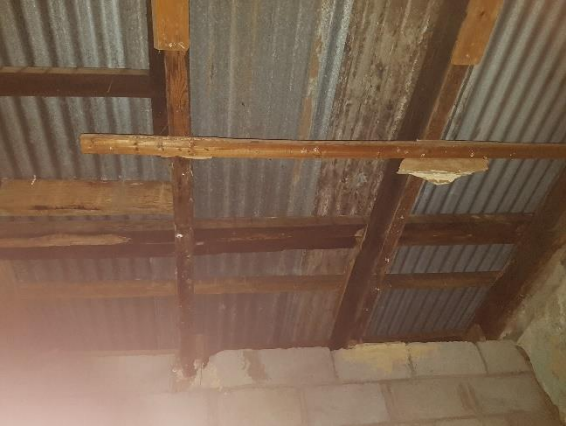
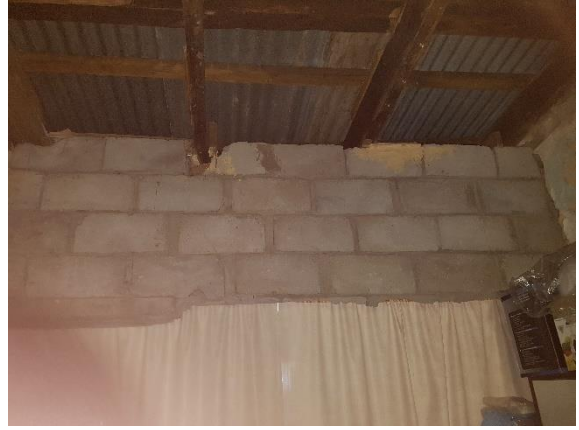
The interior of the dwelling has been extensively refurbished, except for part of the kitchen.

Kitchen - unfinished

Kitchen unfinished

Plaster raw walls and paint

Fit new plasterboard ceiling with insulation on new bracing to existing rafters
