Bo-Kaap Erf 141385, 4 van der Meulen Street

**Section 34 Application to Heritage Western Cape in terms of the National
Heritage Resources Act**

**Report on Existing Housing Condition and Assessment of Recommended
Work on City Owned House in Bo-Kaap.**

**Compiled by Dieter Bossow of Architects Associated for the City of Cape Town.
June 2018.**

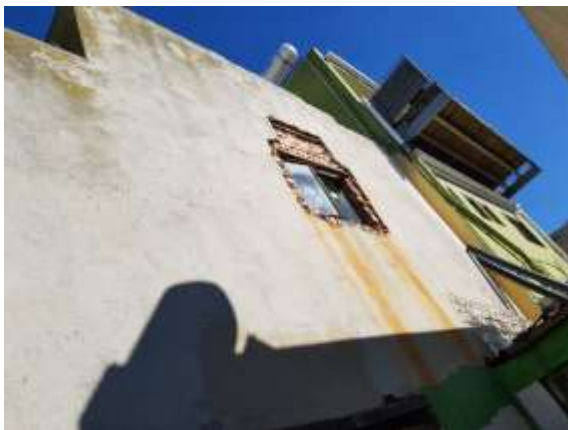
Kitchen Yard

The exterior of the dwelling is generally in good condition, apart from some untidy water pipe reticulation in the yard. Walls are generally plastered and painted, apart from courtyard walls.

Increase size of bathroom as shown on the drawings, fit new sanitary ware and gully.

Replace kitchen door with side light as shown

Repair plaster around existing windows as shown and paint

Service existing windows and re-paint

Repair plaster and paint

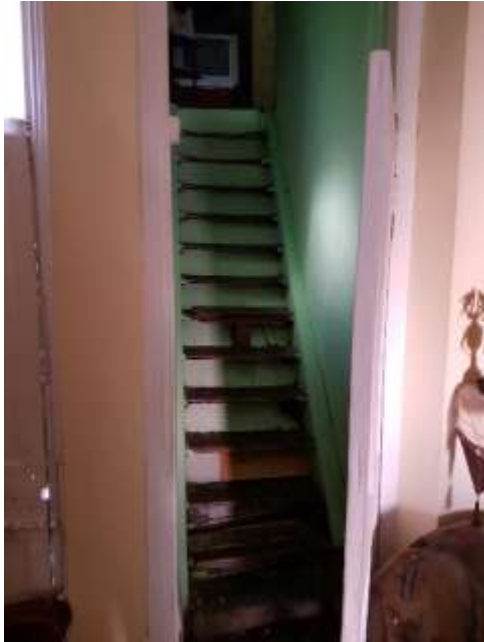
The interior of the dwelling has been extensively refurbished and is generally in good conditions. The stair to the first floor does not conform to building regulations and must be rebuilt as shown on the building plans. The existing bathroom is inadequate and needs to be enlarged.

Existing stair (to be replaced)

Demolish existing and build new stair as shown

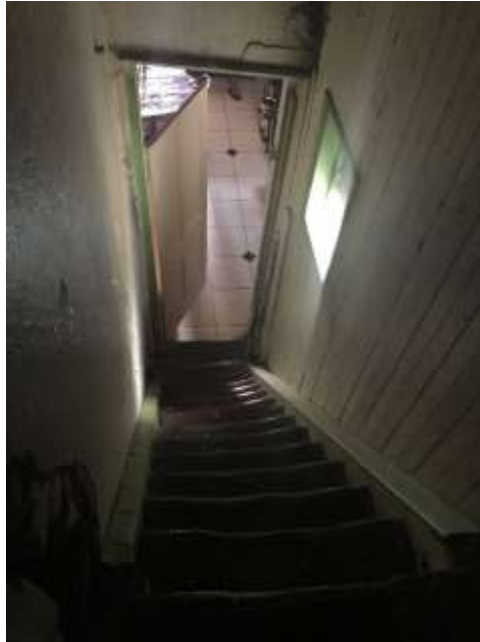
Stair (to be replaced)
