**Kwazulu-Natal Children's Hospital : Phase 2C  
External Façade & Roof Repairs : Nurses' Home.**

## 1.0 OVERVIEW

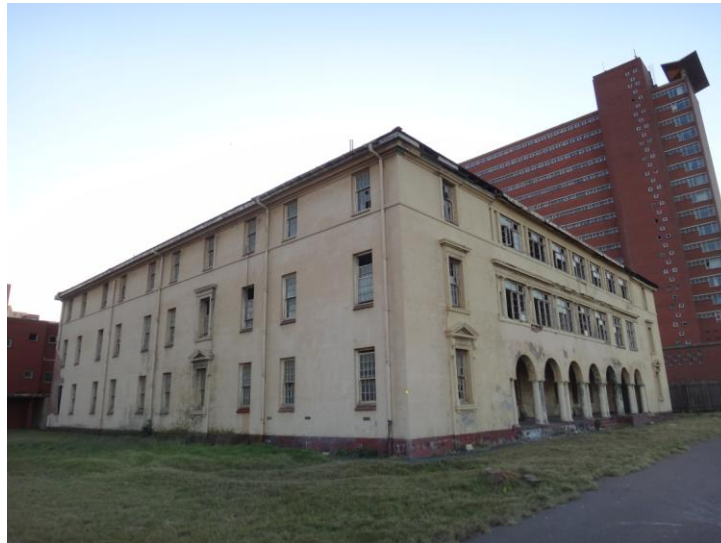
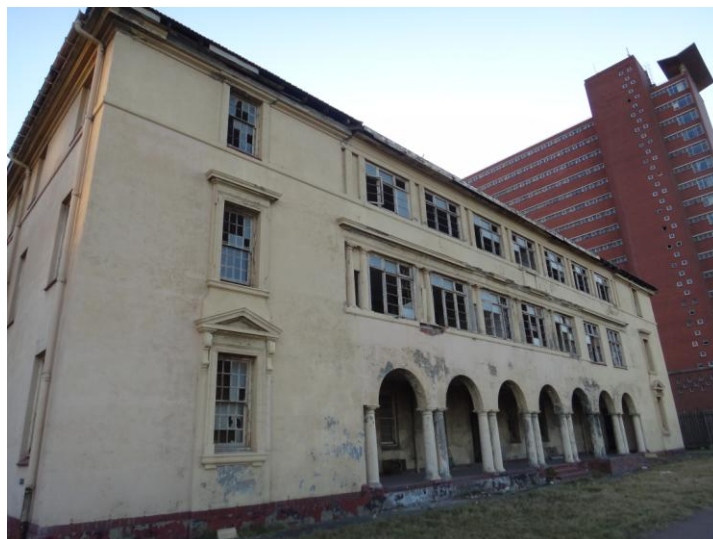
Most of the glass in the windows has been smashed causing more water ingress.

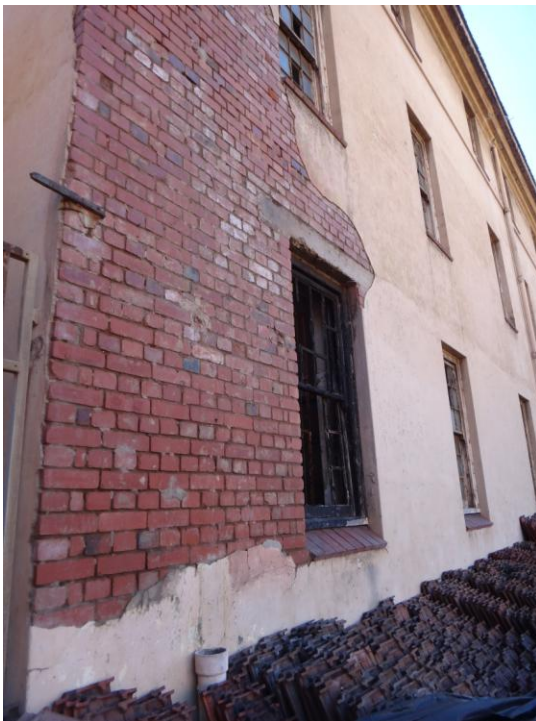
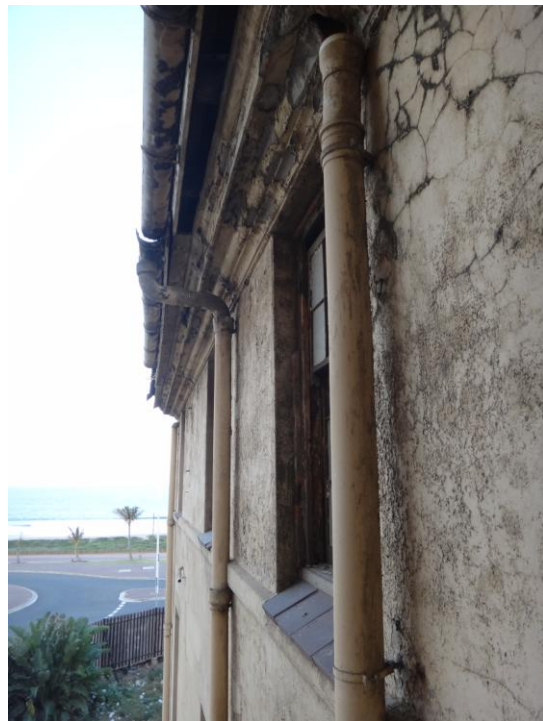
English bond brickwork.

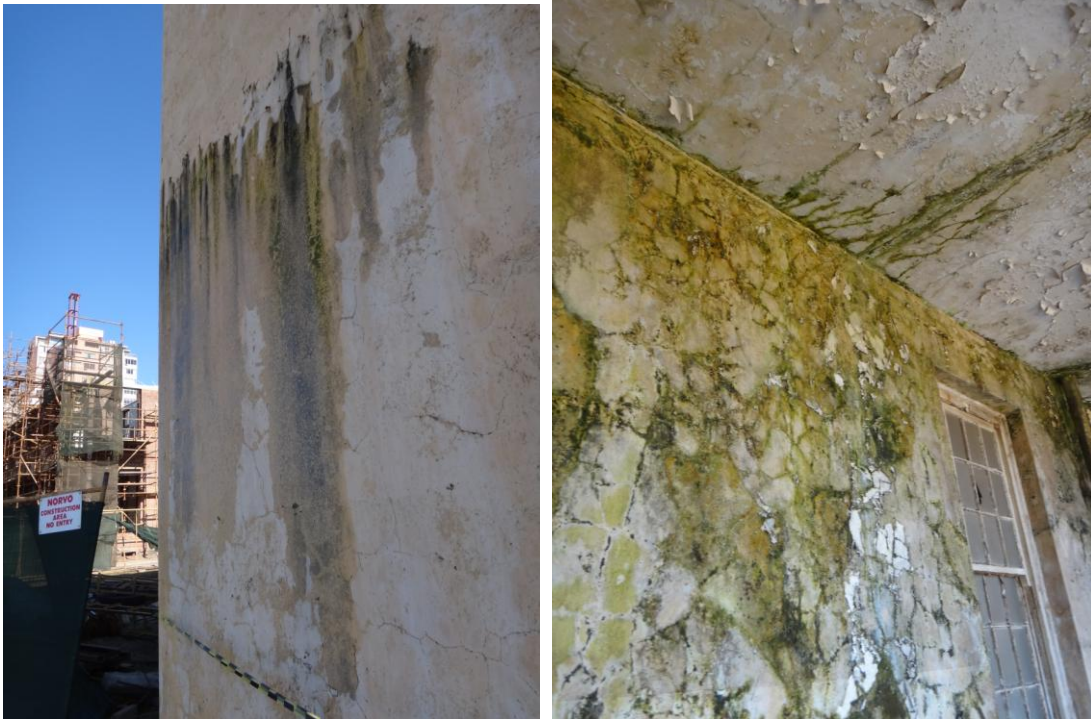
Damage to walls caused by water ingress.

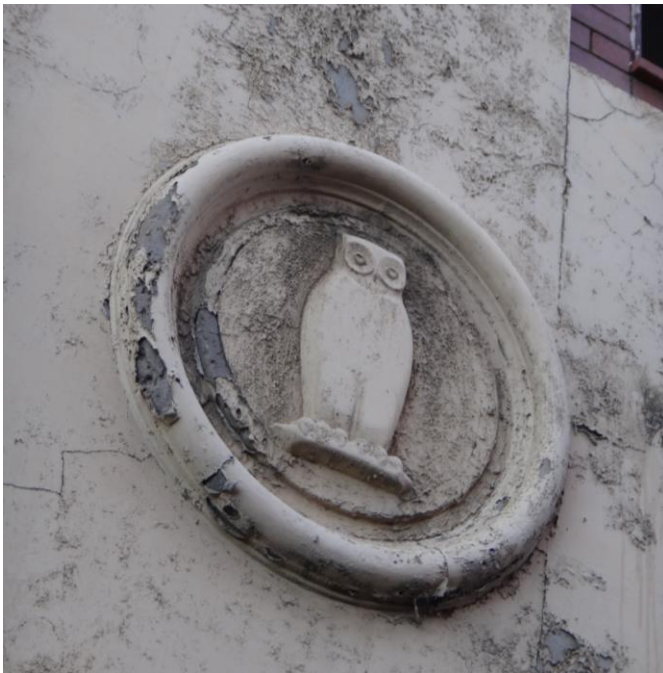
Where possible, the loose plaster will be removed but the mouldings around the windows will be retained. The plaques to the north façade will be retained. The missing plaques will be re-instated from photographic evidence.

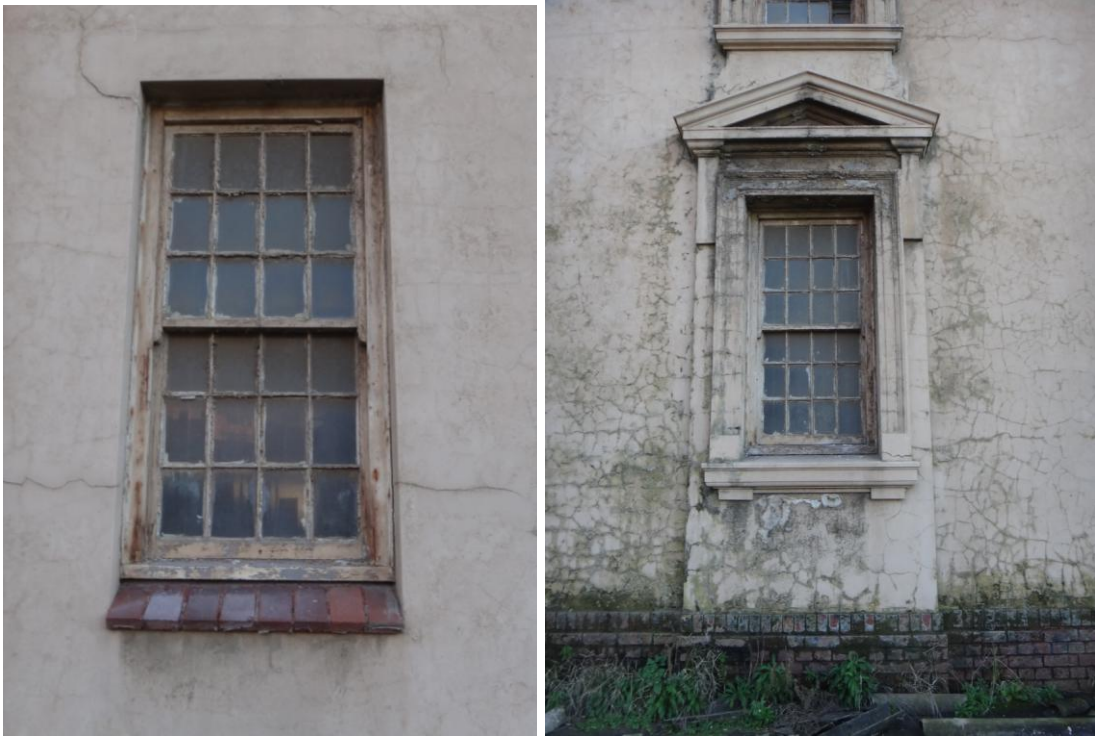
### 3.4 External Doors

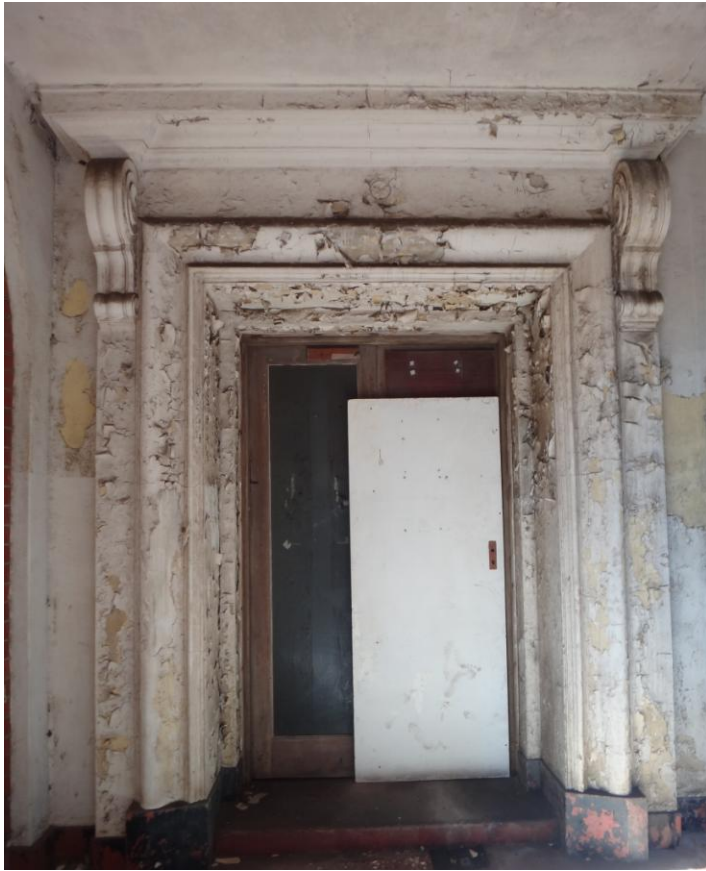
Original front door to Hospital Road.

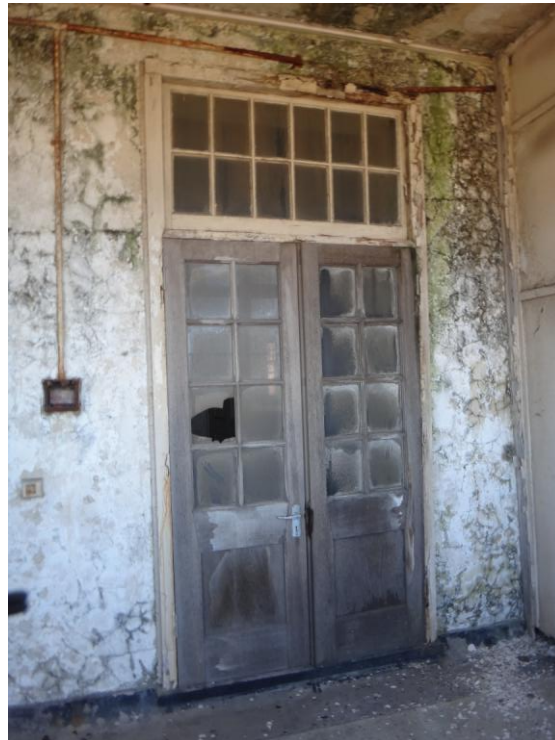
French teak glazed door to veranda, to be repaired where possible.

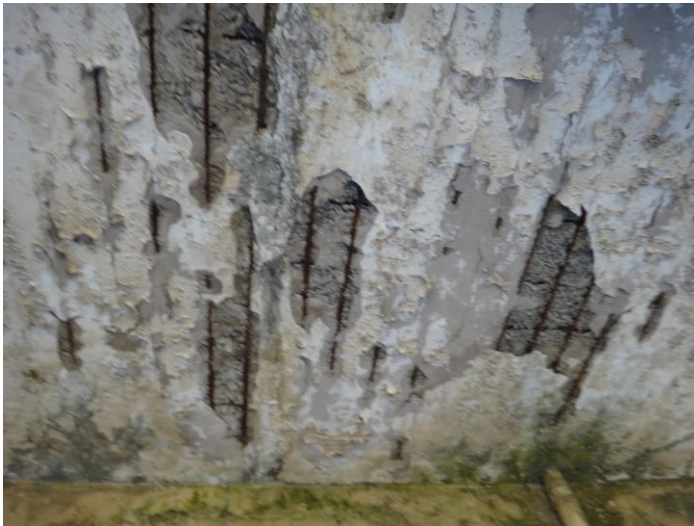
Corroded reinforcing to veranda floors. Floors are to be replaced.

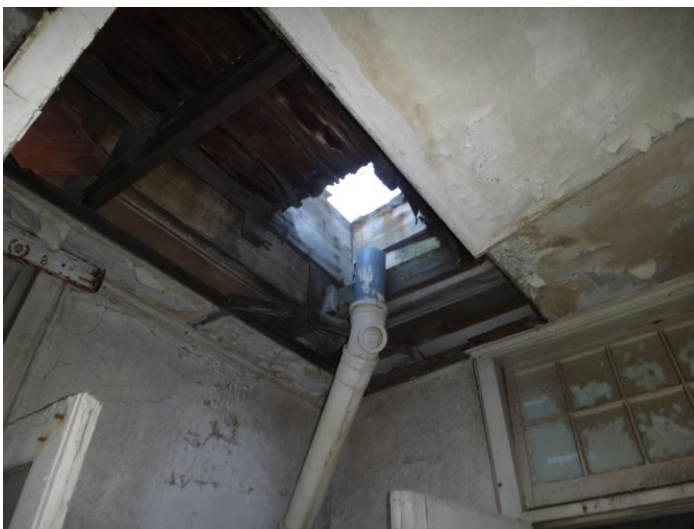
Roof over second floor veranda to be removed.

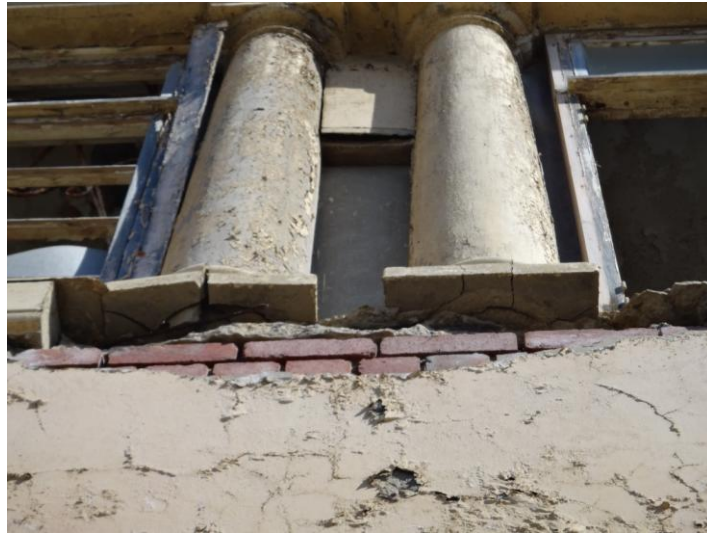
String courses to be replaced where rotten or where they have fallen off.

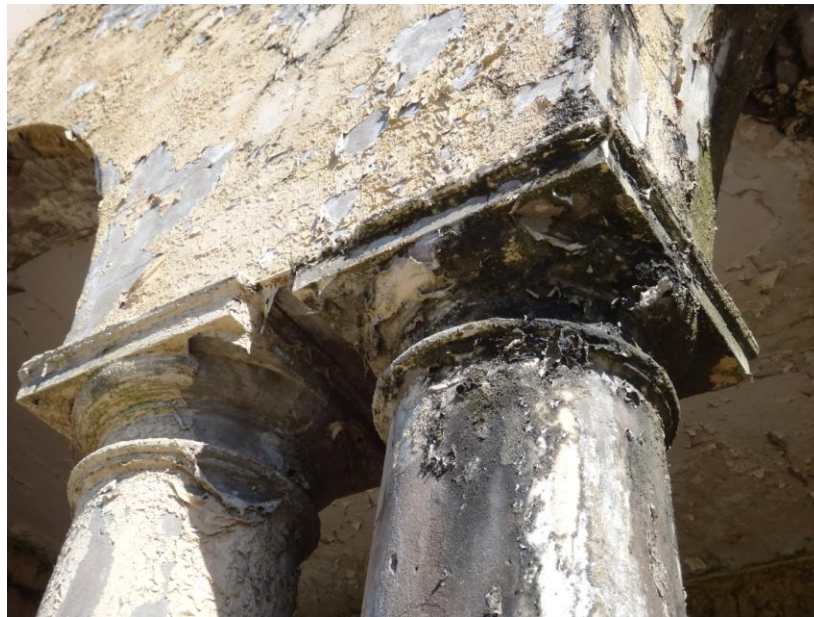
Damaged and chipped Tuscan Doric columns to be repaired.

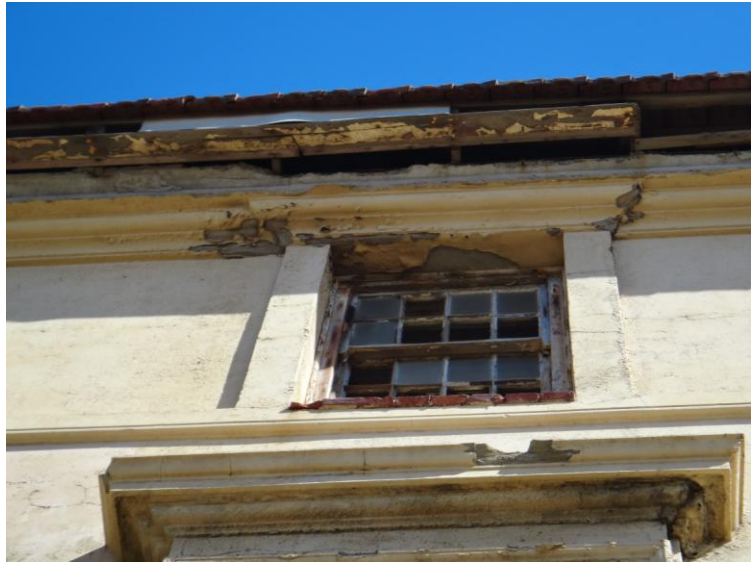
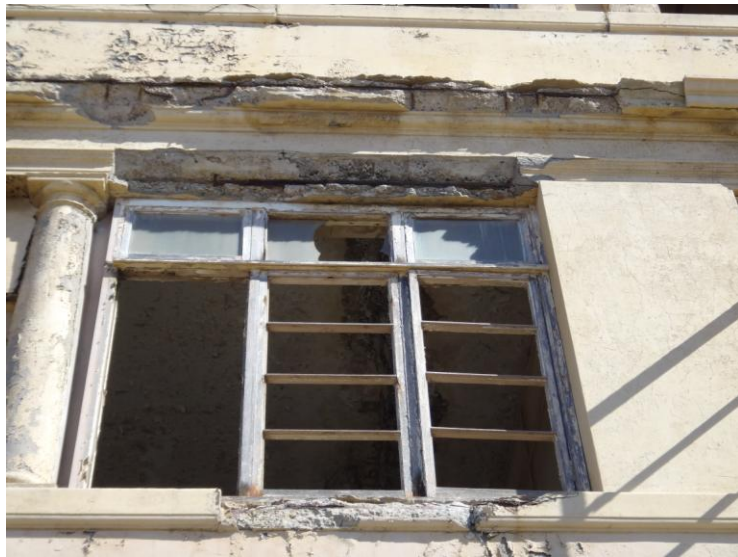
Corroded ring beams and lintels.

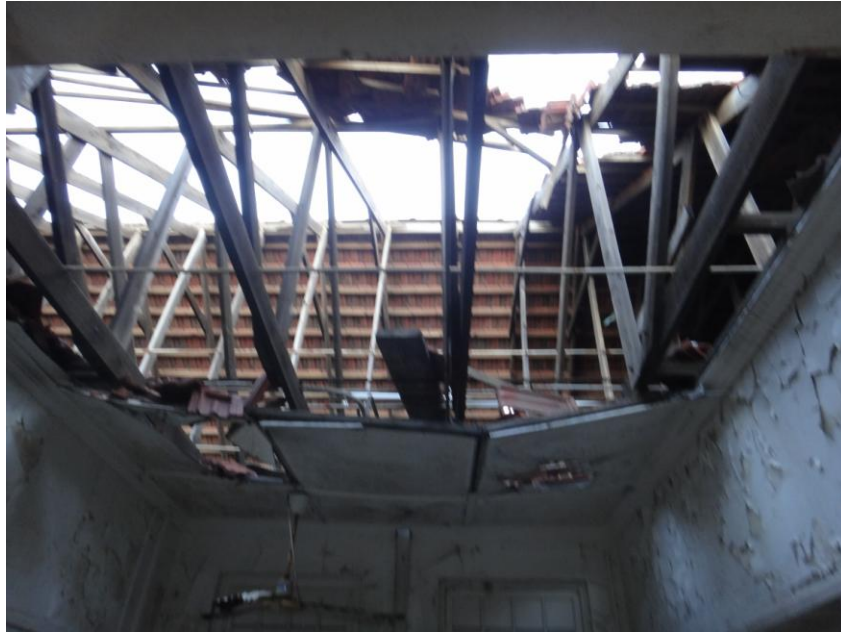
Collapsed roof allowing water ingress and consequential damage.

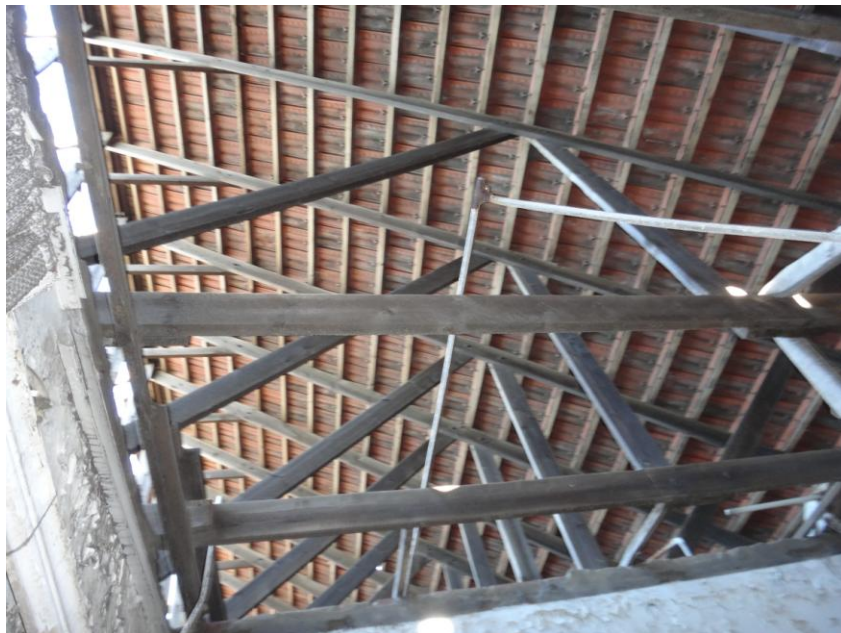
### 3.8 EXTERNAL WORKS

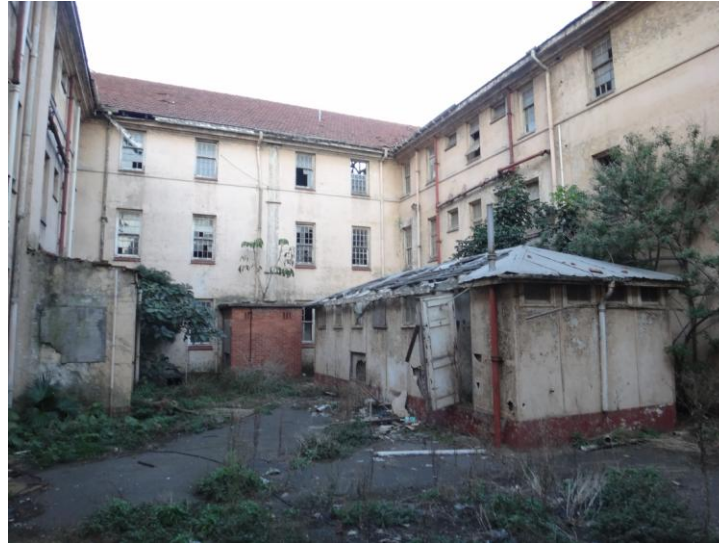
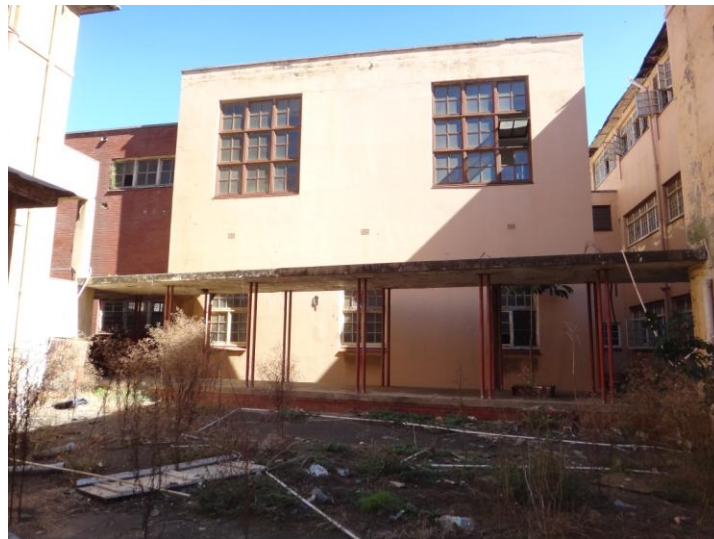
The courtyard has been neglected with shoddy outbuildings being erected and the surface having been asphalted. The outbuilding and walkway are to be removed and the external fabric of the building is to be reinstated. The asphalt will be removed.
