SOLAR PV PROJECT: ROBBEN ISLAND WORLD HERITAGE SITE

HERITAGE MONITORING REPORT 200m AC CABLE TRENCH

SAHRA CASE NUMBER: 10232

FEBRUARY 2017

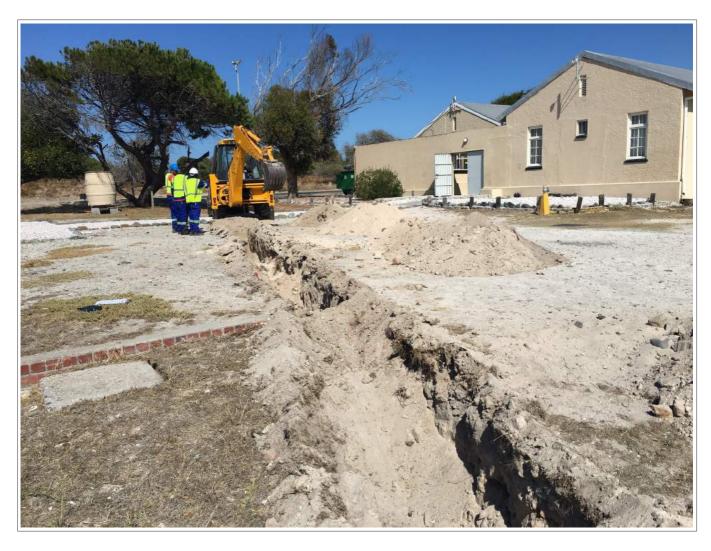
Figure 2. Trench B and surrounds.

Trench B was longer and the sand was much the same as in Trench A – light-brown beach sand with isolated shell fragments, tree roots and old building rubble and beach cobbles. A rusted insulated electrical cable was found in the north section of segment 10-20m. A low-lying brick walled structure was found in segment 20-30m, cutting the trench north-south; it is likely that this demarcates the driveway leading into the adjacent building. In segment 40-50m, a laver of orange-coloured round cobbles and red clay bricks, with granite slabs was found, appearing to be an old foundational layer. It was not large, but in section had a width of approximately 2 m, and was located approximately 0.7 m (from the surface) under a tar road beneath the shelly driveway. In segment 50-60, an old glass Bashews cooldrink bottle was excavated. In the remainder of Trench B, several water pipes and cables related to the drains and adjacent building to the north hindered the smooth process of excavation.

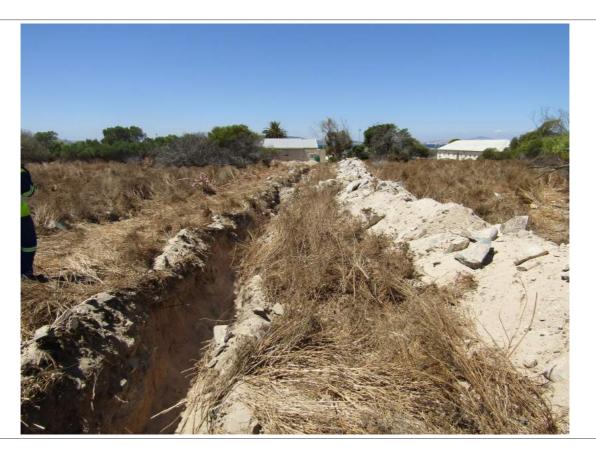
Figure 5. View of Trench D, looking east.

Trench D was excavated in the field west of the road. This field was covered in moderate to dense ground cover and several trees, although trees were avoided during excavation. Sand was light whitish brown on the eastern side, with plant roots and animal/insect burrows visible in section. Towards the middle of the field, large rounded beach cobbles appeared, likely related to the structure found in segments 30-40m and 40-50m. Several fragments of weathered tortoise bone were scattered across the field and two pieces of sheep bone (one vertebral fragment and one rib fragment) were identified in the spoil heap in the 30 to 40m segment. Two pieces of historical decorated porcelain were found, one in segment 10-20m in the north section, another in segment 20-30m. A rusty old drill bit was also found in segment 20-30m.

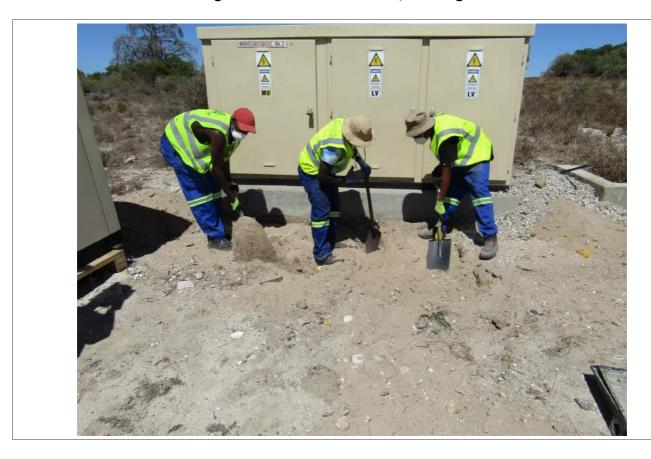
Figure 6. Excavation of Trench F.

Trench F was excavated in the small portion of field between the end of the road and the electrical substation. The area was previously disturbed with cables and other electrical infrastructure. It was very sandy, with a shelly substrate but no stratigraphy. No archaeological material was excavated.

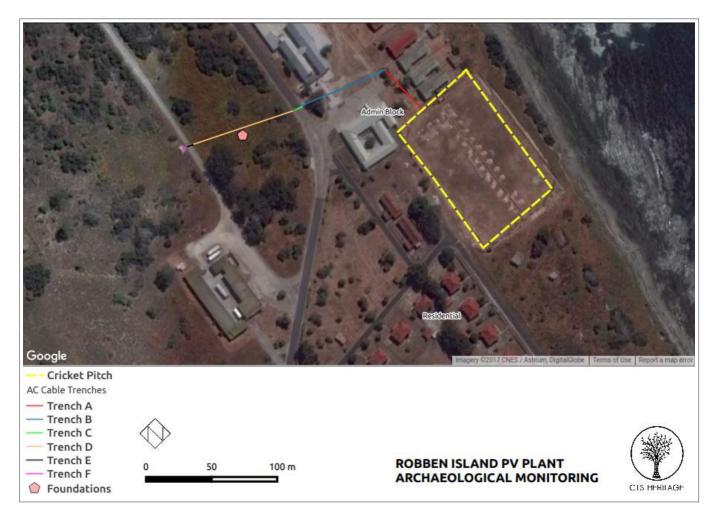
The remains of a structure were found in the centre of the field, consisting of a concrete slab on the southern side, and laminar slate slabs, bricks and beach cobbles running through Trench D. This site is recorded on the South African Heritage Resources Agency with Site ID 92779 (Figure 14). Related to these foundations were ceramic water pipes, an electrical cable, and a piece of metal piping with a hole in one end. Another of these metal pipes was found further west along the trench spoil heaps. The TLB was unable to excavate some of this foundational material, and thus left a small portion, along with the piping, in situ. AC cables would then be laid on top of this in this particular portion.

Figure 14. Satellite image indicating the position of foundations found in the field, which extends into Trench D (Foundations = Site ID 92779).

We did not find it necessary to preserve any of the materials found, as their significance is relatively low and conserving them further adds no value to the significance of Robben Island WHS. The foundations found remain in tact in the portions that were not excavated (trenches cut through foundations without demolishing the entire structure, in both cases – Trench B and D). Therefore the foundations that were cut remain on either side of the trench, maintaining and protecting their provenance.

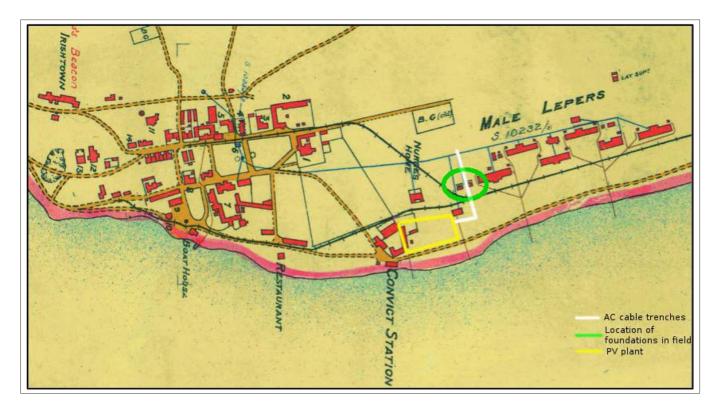
The trenching excavations for the AC cables from the Cricket Pitch site to the electrical substation on Robben Island uncovered some interesting features and remains. The historical artefacts point to activities on the island several decades ago, mainly showing where water pipes and electrical cabling was laid to provide services to historical structures which may no longer be present on the surface. Figure 15 shows the likely location of the foundations found in Trench D, which according to this 1894 map, are remains of the demolished male leper wards.

Figure 15. Extract from the Robben Island Noting sheet, circa 1894. Note the location of the old cricket pitch (now PV plant), and AC cable trenches in white. The structures circled in green are likely associated with the foundations identified through trenching activities in the field.

The discovery of the posible location of the Male Leper Wards is significant; to know that remnants of the foundations of these remain relatively intact beneath the surface, as well as the position of them adds greatly to the knowledge of Robben Island as a World Heritage Site and a National Heritage Site. Associated cultural material is rather limited, but adds insight into the history and use of the buildings. Stratigraphically, the proximity to the beach accounts for the sandy layers that make up the majority of all six trenches. Rubble was found in several parts of the trenches which speaks to the historical structures of the area and the buildings and walling located there.
