**ARCHAEOLOGICAL IMPACT ASSESSMENT REPORT ON THE REDAN
ENGRAVING SITE: SPRINGFIELD COAL MINING PROJECT SITUATED
BETWEEN VEREENIGING AND MEYERTON, IN THE SEDIBENG
DISTRICT MUNICIPALITY, GAUTENG PROVINCE**

Assessment conducted under Section 38(3) of the National Heritage Resource Act (No. 25 of 1999)

September 2020

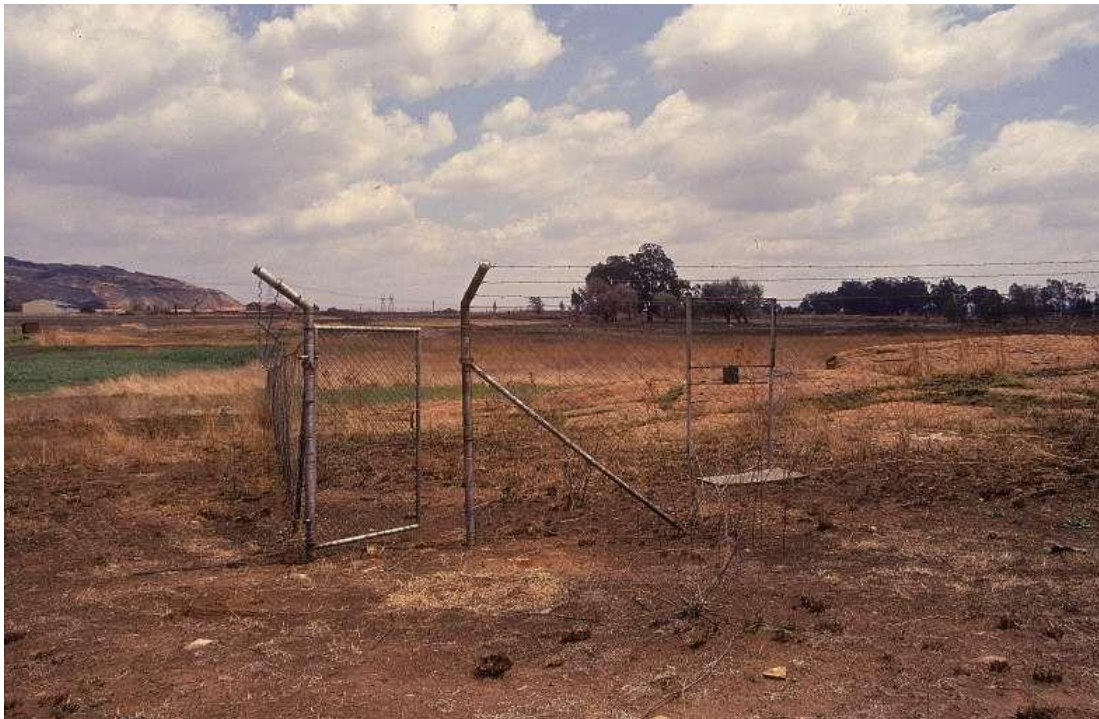
Figure 11. The Redan engraving site was fenced around the time that it was declared a National Monument in 1971. The fence was subsequently torn down by vandals. Photo credit: African Rock Art Digital Archive RSA RED1 13

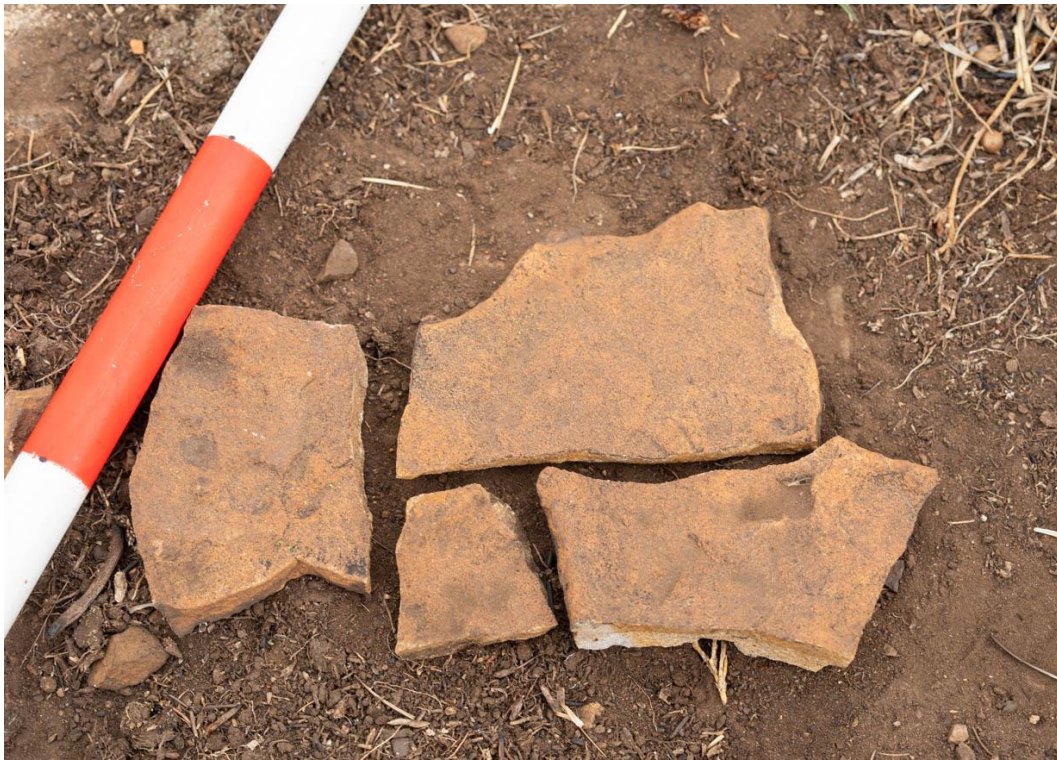
Figure 13. Fragments of engraved rock found at the base of Rock J on 1 September 2020. The rock surface is cracking as a result of natural weathering

The surface of the engraved sandstone outcrops consists of an outer crust from about 10 to 20 mm thick. This crust is friable and as a result some of the rock surfaces are breaking off or crumbling to sand. Some of the engravings have been damaged and destroyed as a result of weathering. The engraved surfaces might also be susceptible to cracking caused by alternating heating and cooling of the rock surface in the winter months when freezing temperatures are reached. It is not known how many of the 273 engravings have been and are being destroyed in this way.

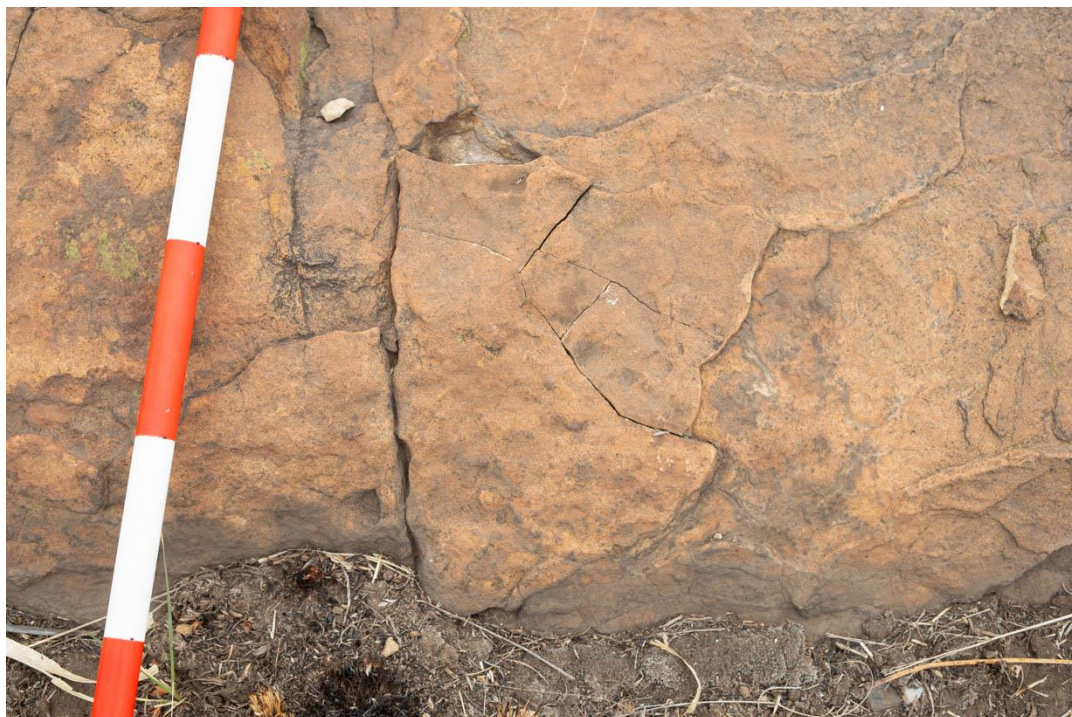
Figure 14. The fragments could be refitted onto the part of the rock from which they originated

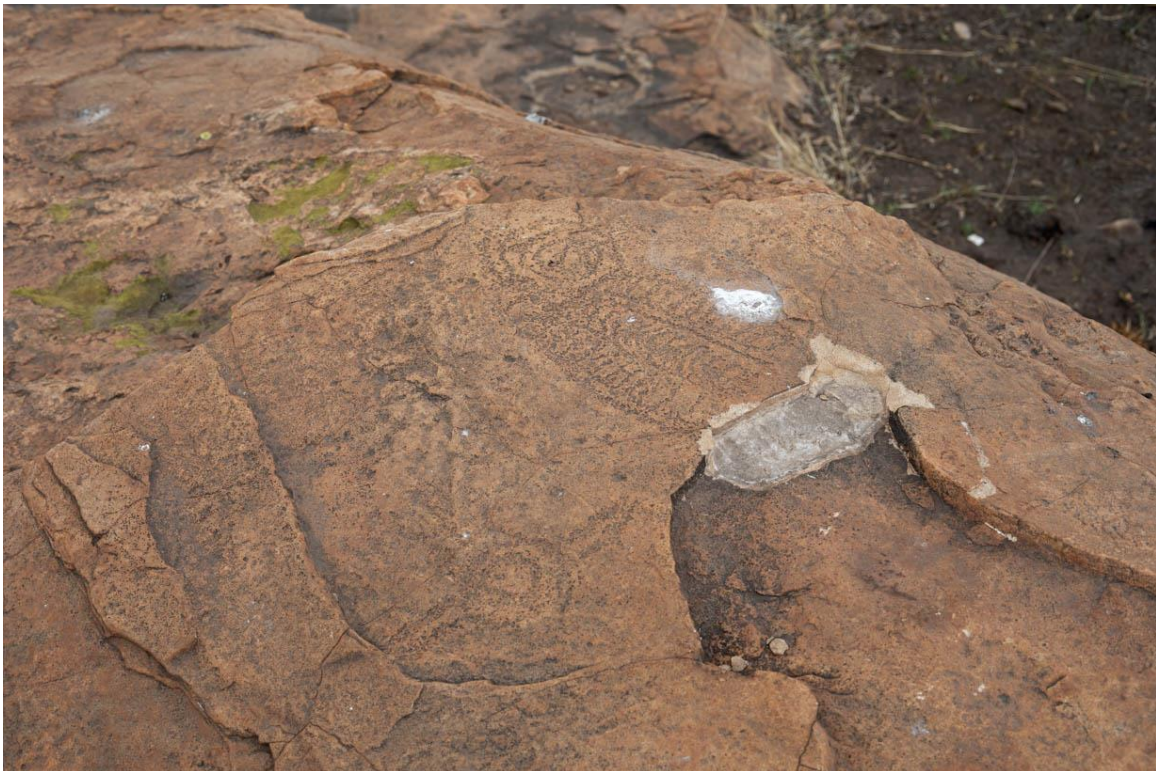
Figure 15. Natural weathering is a severe threat to the Redan engravings. It has caused part of this engraving to crack and crumble. This process is occurring on many of the rocks on the outcrop. Rock L

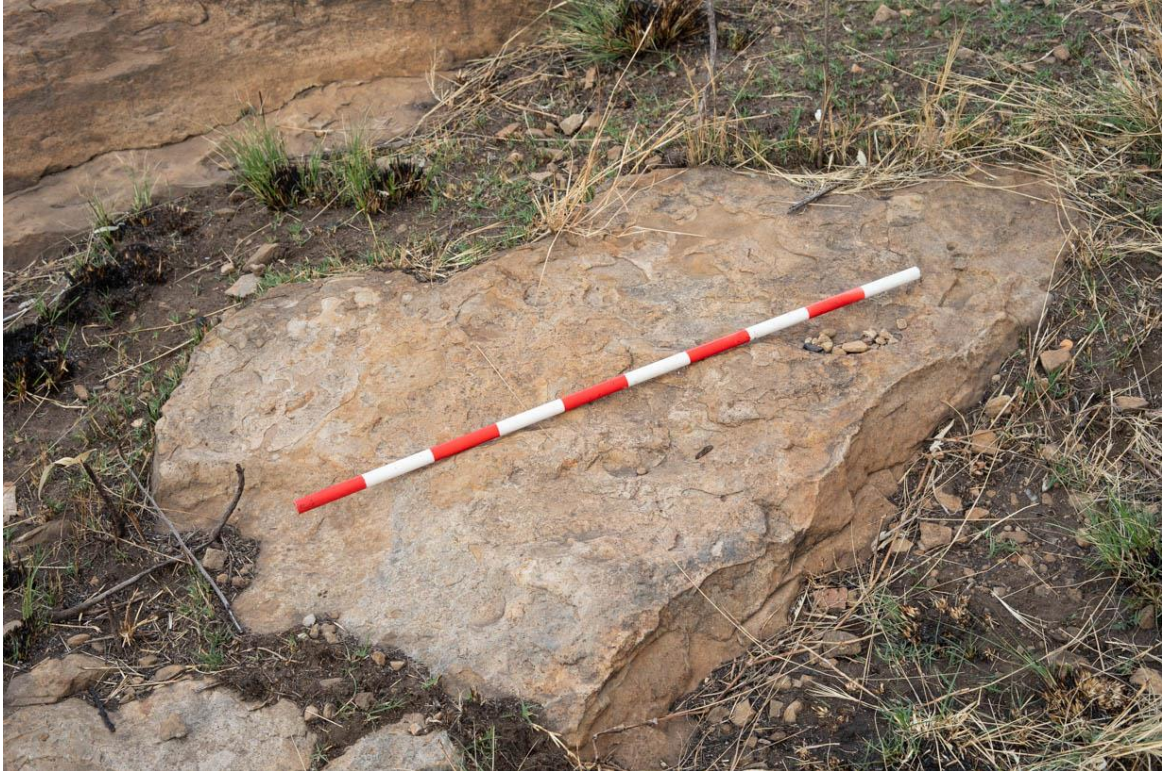
On the day of the on-site inspection it was noted the veld had been burnt fairly recently (within the past month). Photographs of the Redan engravings from the African Rock Art Database (www.sarada.co.za) from the late 1960s to 2000 show that the veld surrounding the site was burnt. A review of the area over the past 30 years using Google Earth shows that fires could be annual occurrences at the Redan engraving site (see Chan 2017). Sandstone surfaces flake and crack under high temperatures caused by fires. It appears that at Redan the engravings made on rock surfaces close to ground level have been damaged by fire. Photographs of Rocks G and H, for example, taken on the on-site visit in 2020 shows that they have probably flaked extensively as a result of fire damage.

Figure 17. Rock G appears to have flaked extensively, most likely because the heat of fires has caused the surfaces to flake off

The destruction caused by fire could be reduced or eliminated by controlling the growth of vegetation (grass and shrubs) in and around the engraved outcrops. Grass growing in between and around the outcrops must be kept short so that fire cannot come close to the engravings. This is especially important in the autumn and winter months when the grass is dry and flammable. The relatively few shrubs and small trees and their position in relation to the engraved outcrops do not appear to be a threat to the engravings. They should therefore not be pruned or removed.

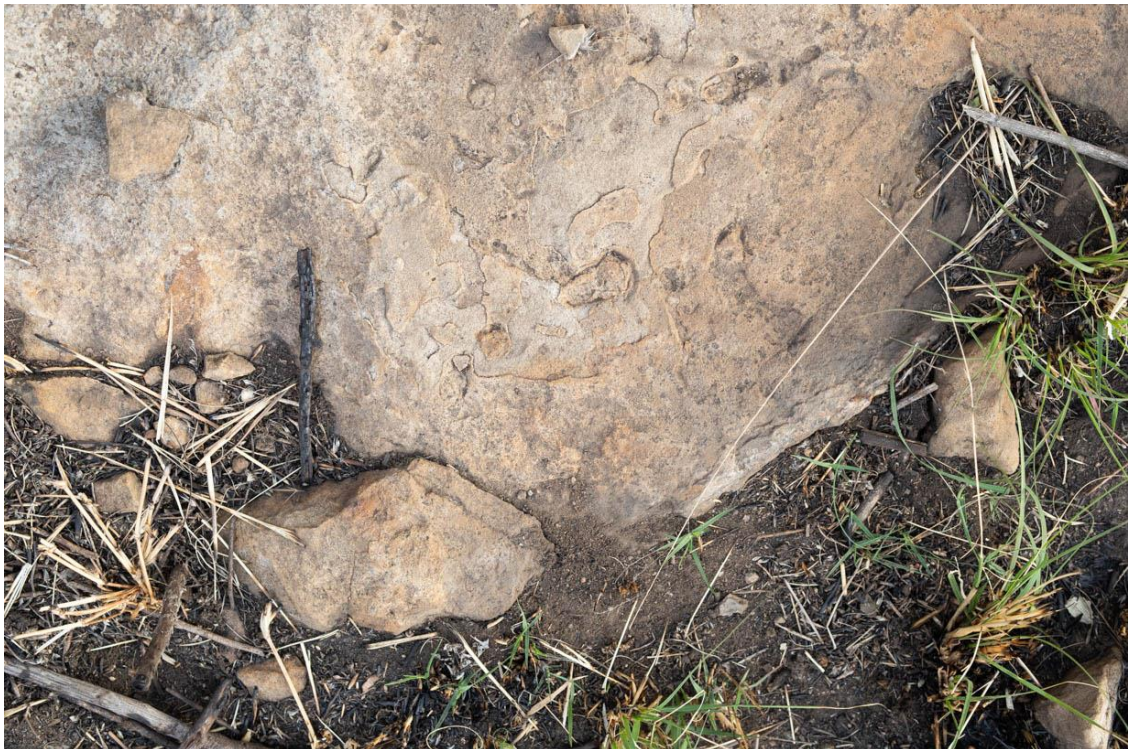
Figure 18. Close up photograph of the damage caused to the engraved rock by the heat of fires. Rock G

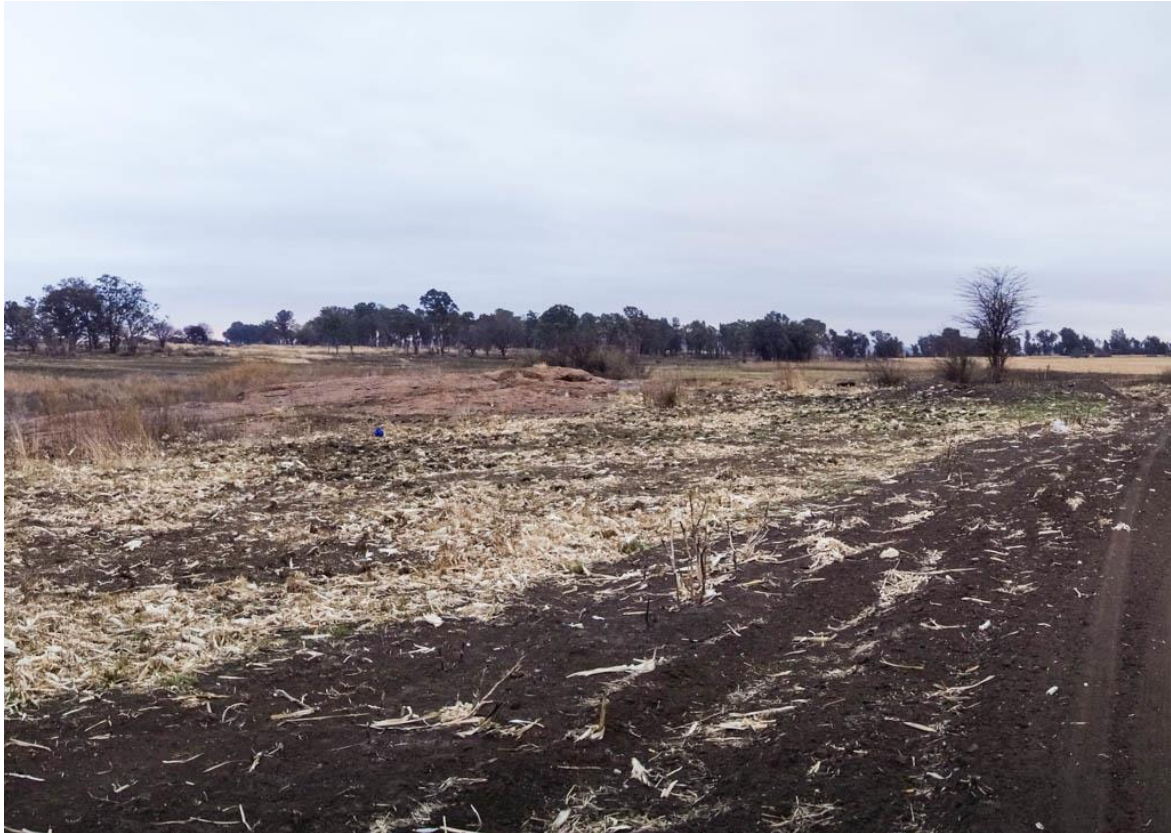
There is currently no access control to the engraving site. There is a dirt track off the M61 immediately south of the Springfield Junior Secondary School that passes west of the agricultural field and within a few metres east of the engraving site. A farm road passes a few metres from the site, so it is very easy to access. The site is therefore very vulnerable to theft, vandalism and any other damage.

Figure 19. View of the outcrops of sandstone that comprise the Redan engraving site and the farm road that passes within a few metres of the site

In order to combat graffiti, littering and theft, people should not be permitted to visit the Redan engraving site without the knowledge and permission of the landowners or their designated representatives. Further measures and arrangements regarding access to the site should be addressed in the CMP. It is important that other stakeholders, including tourism authorities, are considered in compiling the CMP.

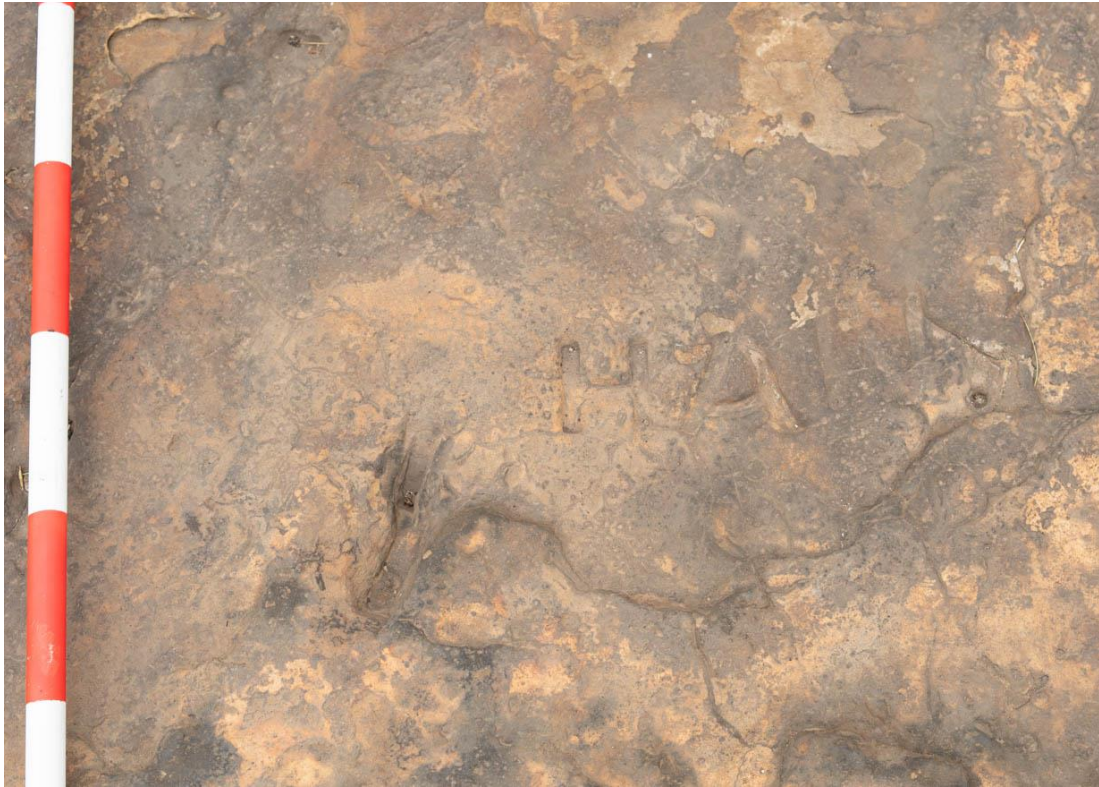
On the day of the site inspection vehicle tracks were noted around the engraving site and in one area it seemed that a vehicle may have driven on some of the rocks (fortunately not engraved). A few scratches were noted on one of the engraved outcrops. There are some engraved initials on one surface that are probably historical in nature (i.e. older than 60 years).

Figure 20. Historic graffiti at Redan engraving site. The initials 'HAW' have been carved into the rock
