# Revel Fox & Partners

### **HERITAGE APPLICATION TO UNDERTAKE EMERGENCY RESTORATION INTERVENTIONS TO FIRE GUTTED HOMESTEAD BUILDING ON THE NON-PAREILLE FARM**

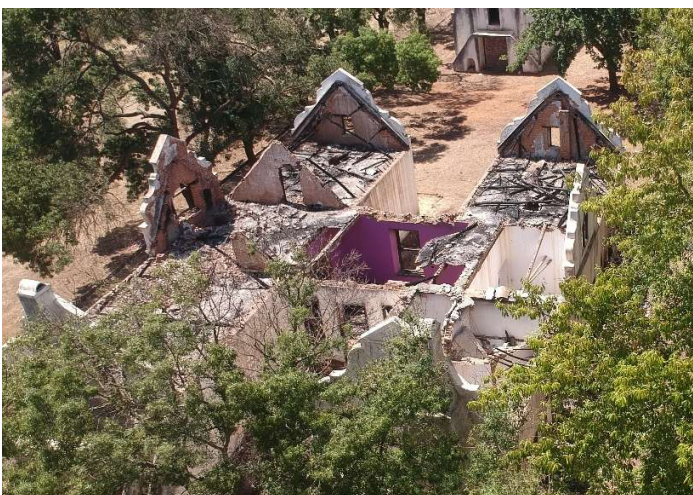
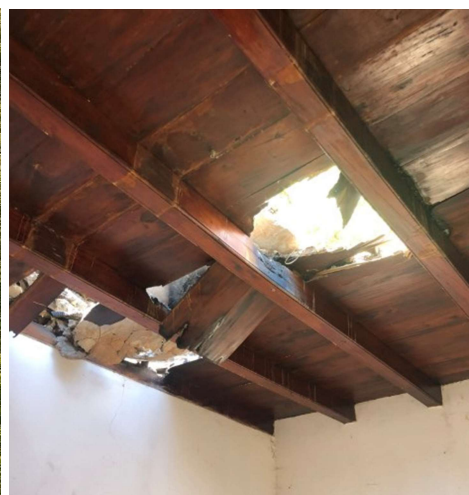
i) The entire roof structure (thatch and trusses) are completely lost due to fire damage. What appears to be yellow wood tie beams and ceiling boarding in the south east wings could be salvaged and re-used.

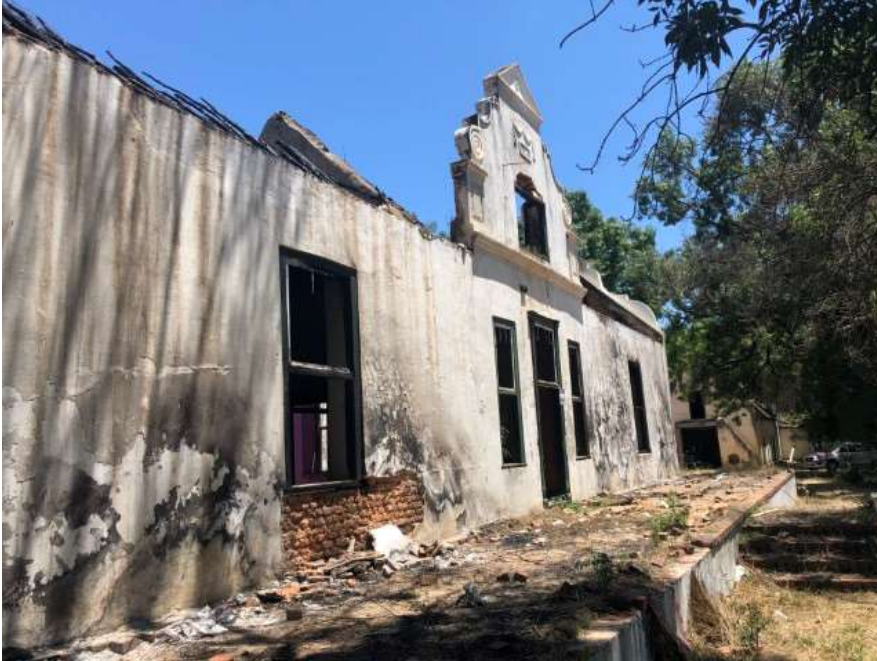
ii) Walls substantially intact with minor laitance on surfaces) – if anything, the clay bricks set in clay mortar have simply baked harder. Areas of now exposed but still-adhering clay scratch coats survive on portions of the wall surfaces.

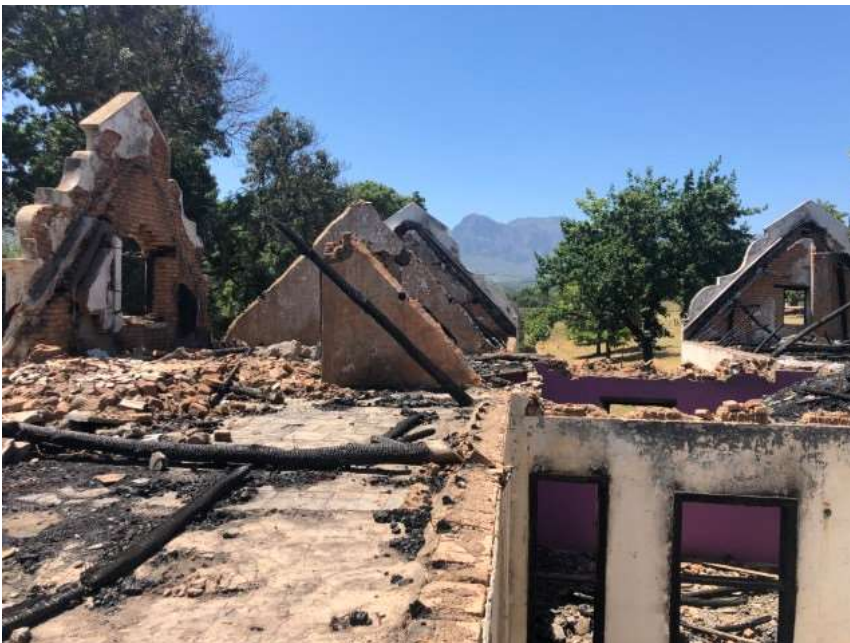
iii) All gables are potentially dangerous – requires propping to stabilize.
