## **1st Phase**

**Cultural Heritage Resources Impact Assessment for proposed rapid bus service, Paul Kruger Street, Pretoria, Tshwane.**

**June 2011**

**Report compiled by Sidney Miller and Dr. Udo S. Küsel.**

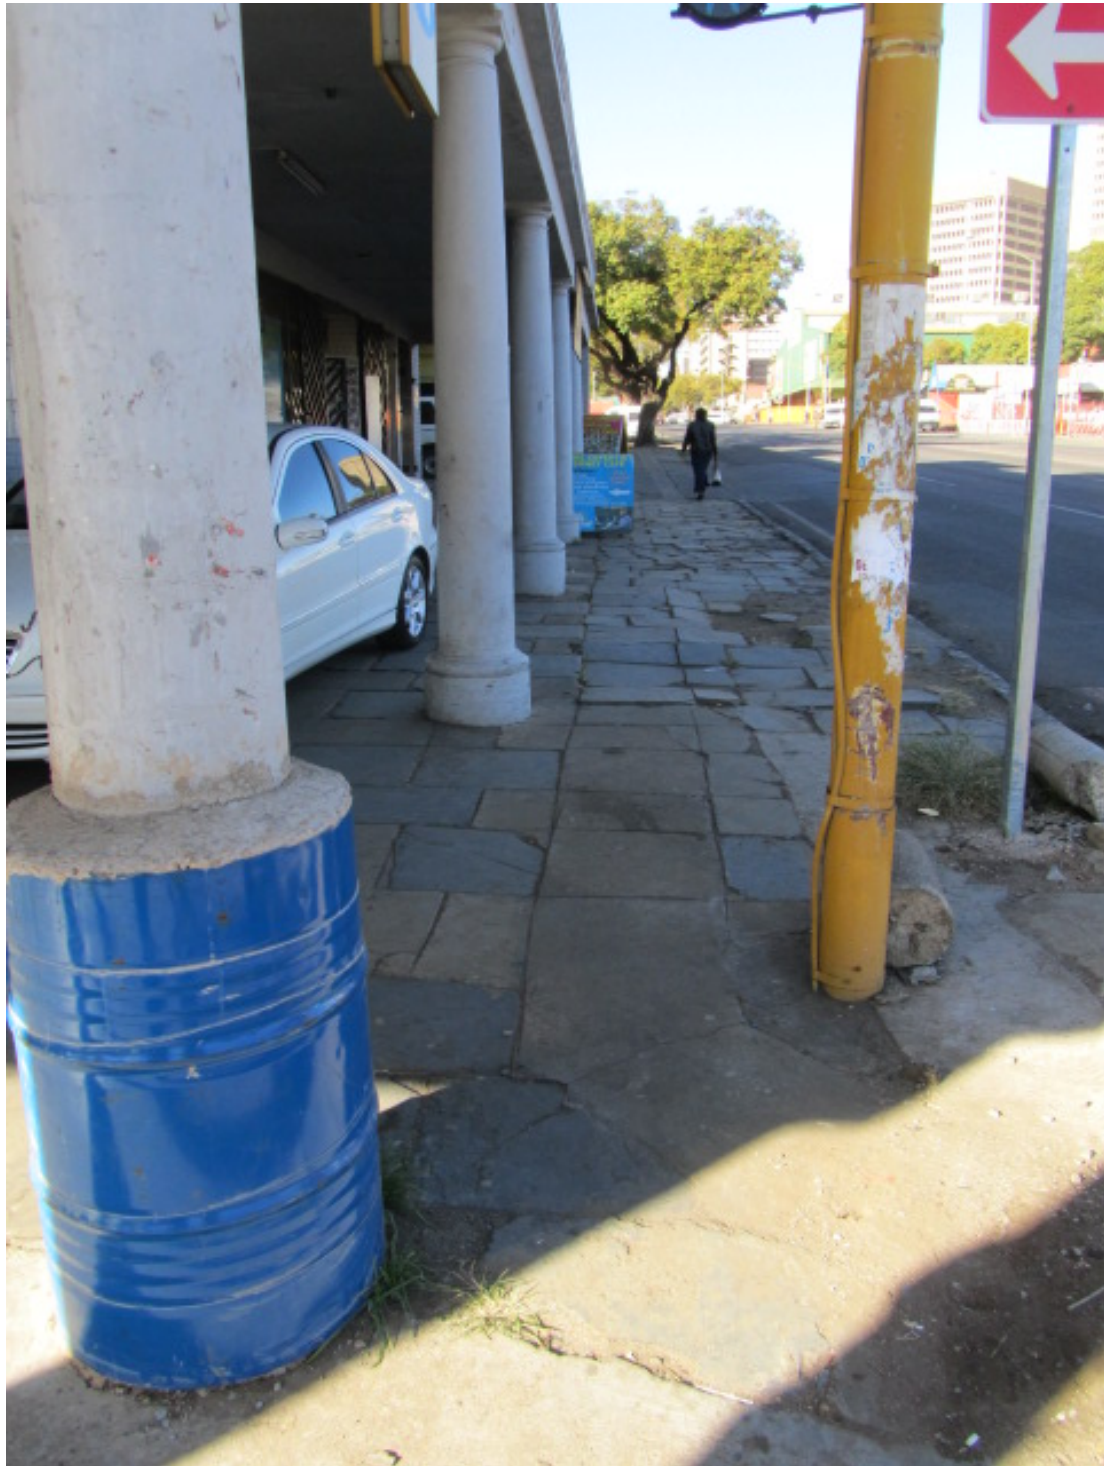
**Figure 30.** Historical slate sidewalk in front of ‘protected building’. Granite curb stones, and pillars. Note absence of greening. (P803).

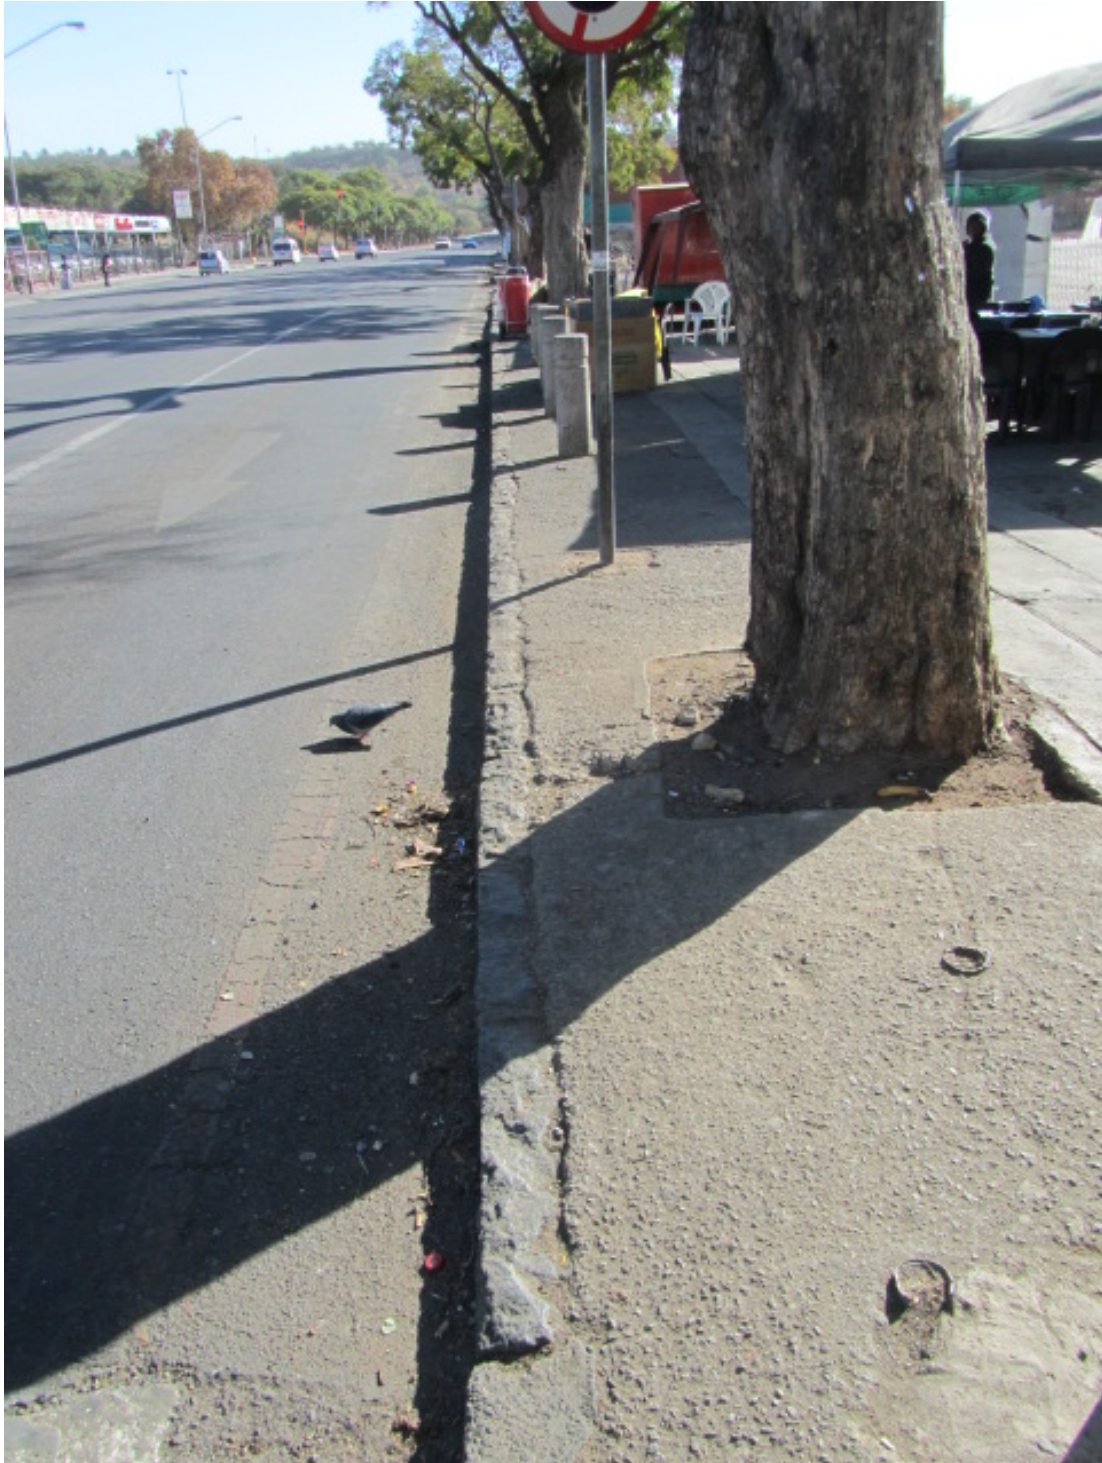
*Figure 39. Original granite curbing. (P816)*

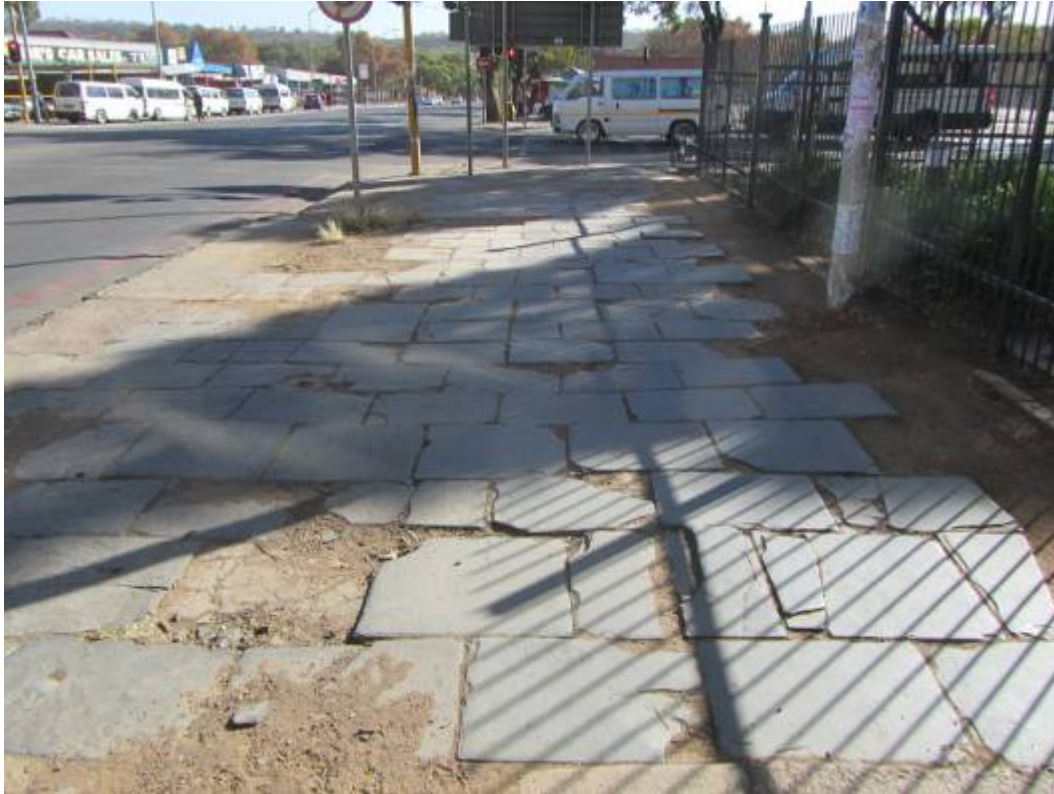
**Figure 46.** Historical slate paving. Protected building as noted in 1991 replaced by modern building to the right behind fencing. (P819)

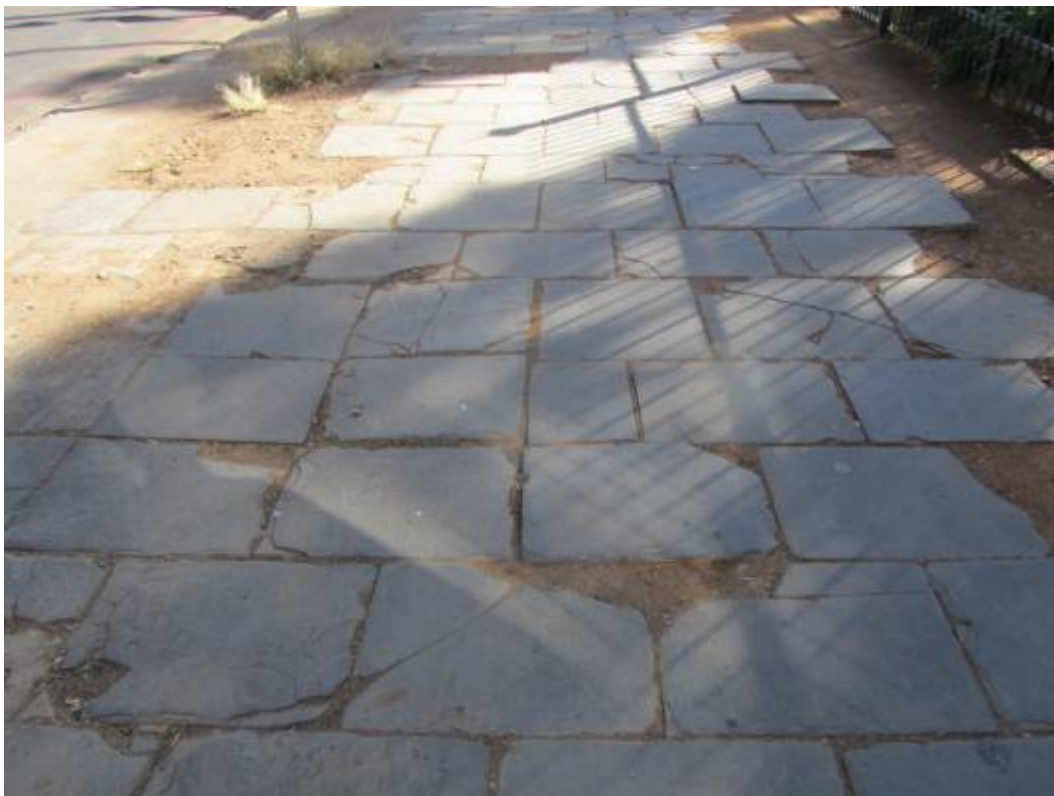
**Figure 47.** Historical slate paving. Protected building as noted in 1991 replaced by modern building to the right behind fencing. (P820)

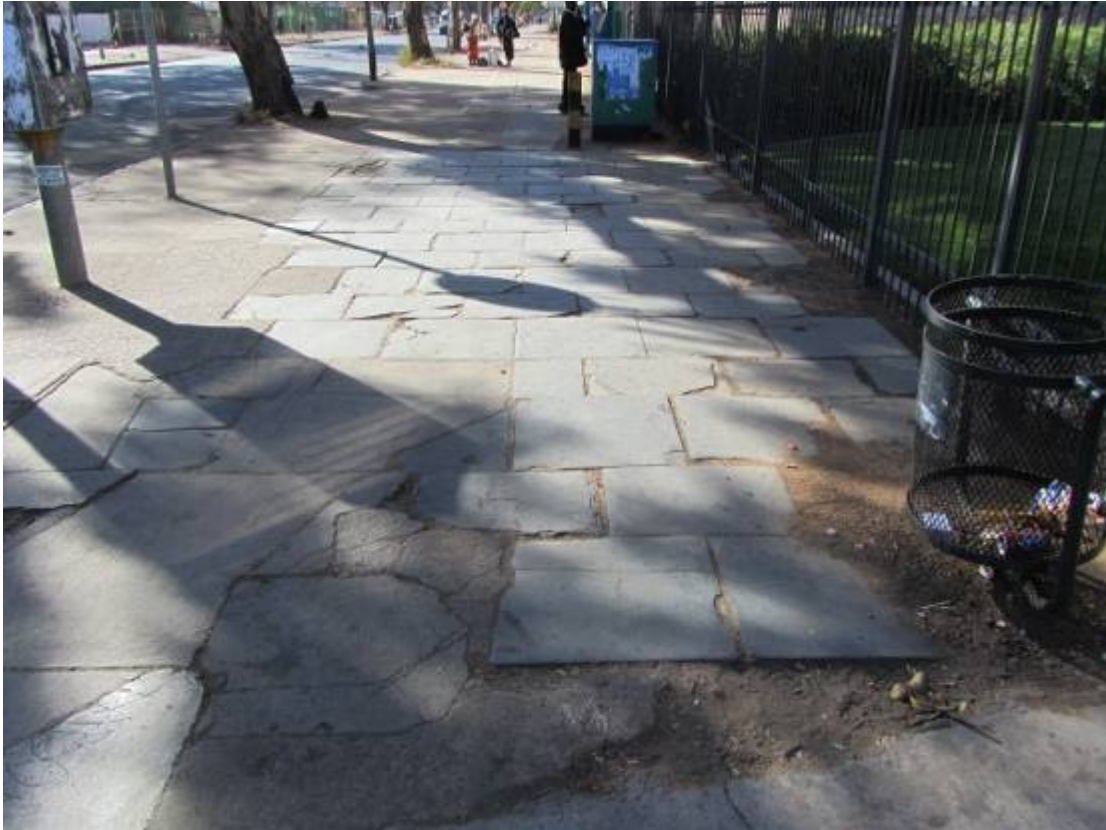
*Figure 48. Historical slate paving. Protected building as noted in 1991 replaced by modern building to the right behind fencing. (P821)*

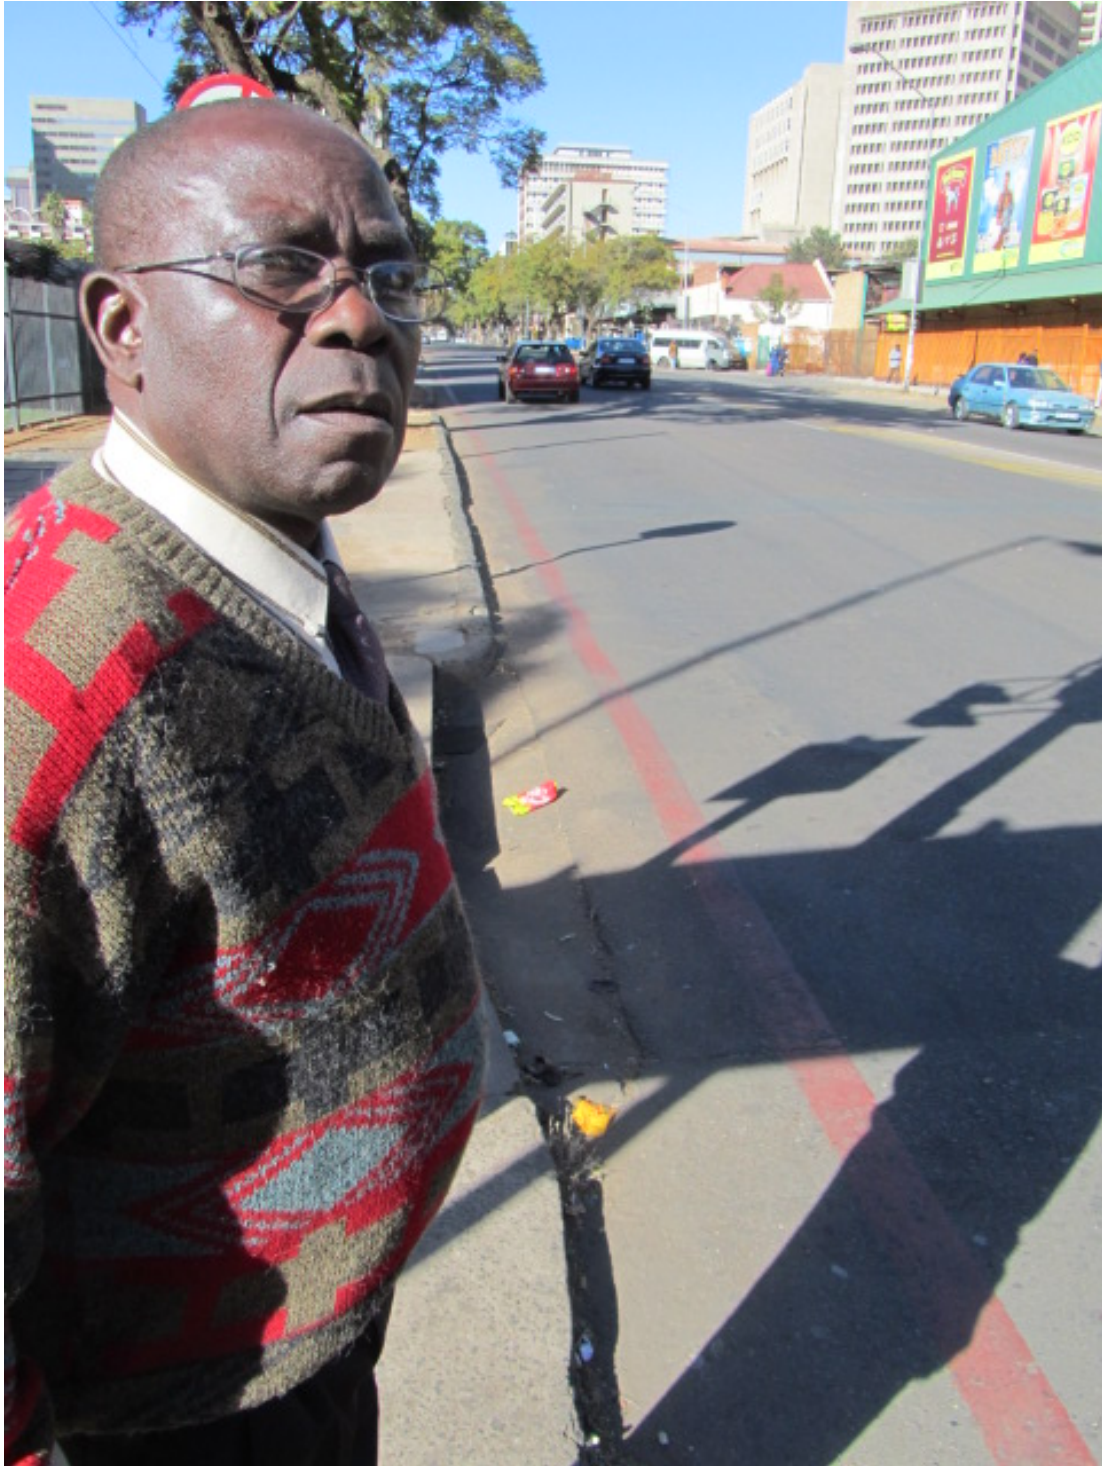
*Figure 50. A concerned citizen overlooks the granite curbing stones along Paul Kruger Street. (P824). The image also captures the ‘protected building’ behind the taxi in the centre of the image. Also notice absence of trees along western side of Paul Kruger Street*

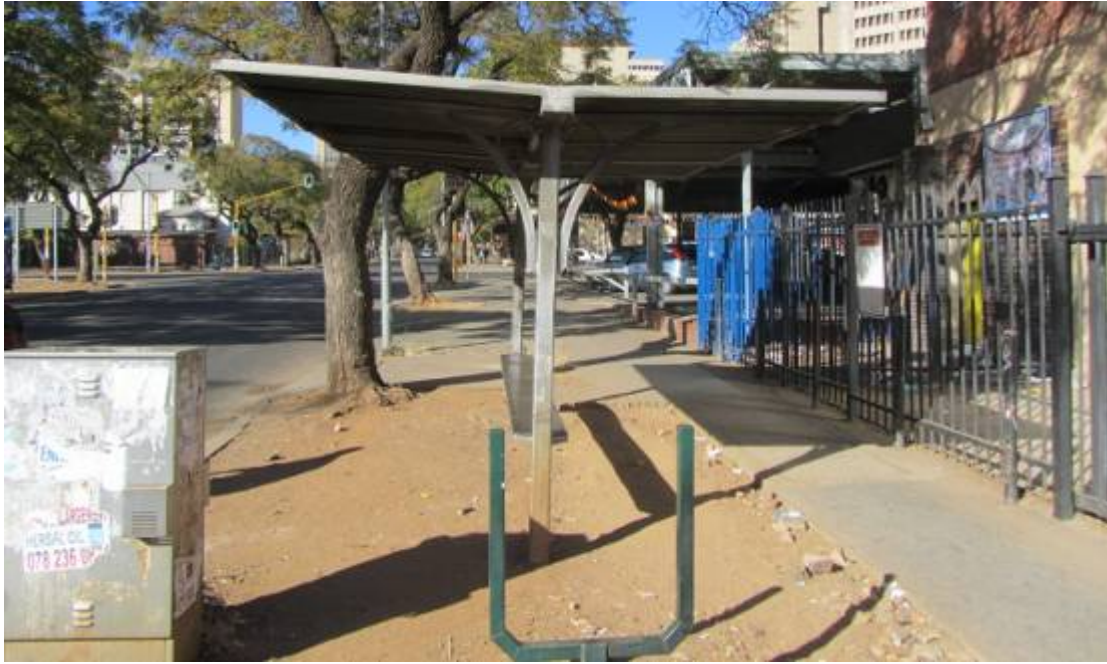
**Figure 54.** *Inadequate paving and sorrowful street furniture. In other countries around the world garbage is removed from the container. Here the container is removed without the garbage. (P 830)*

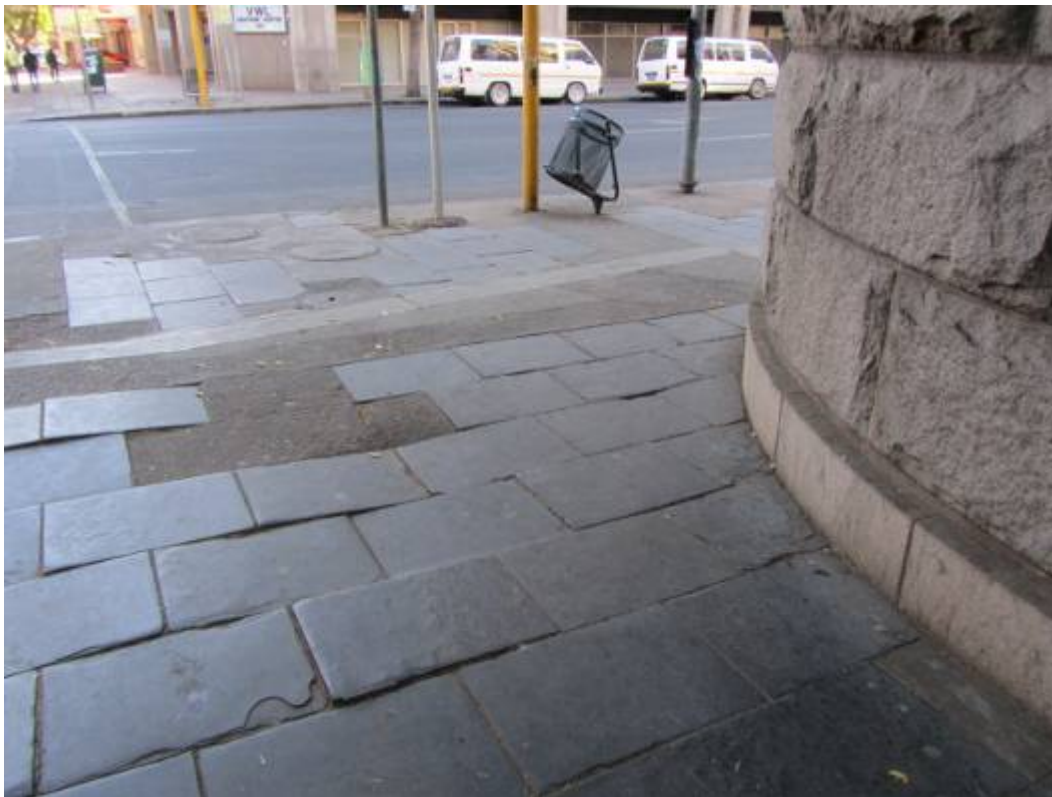
*Figure 122. Historical slate paving adjacent to historical building. Note discontinuation owing to services and unsafe surface. (P 921).*

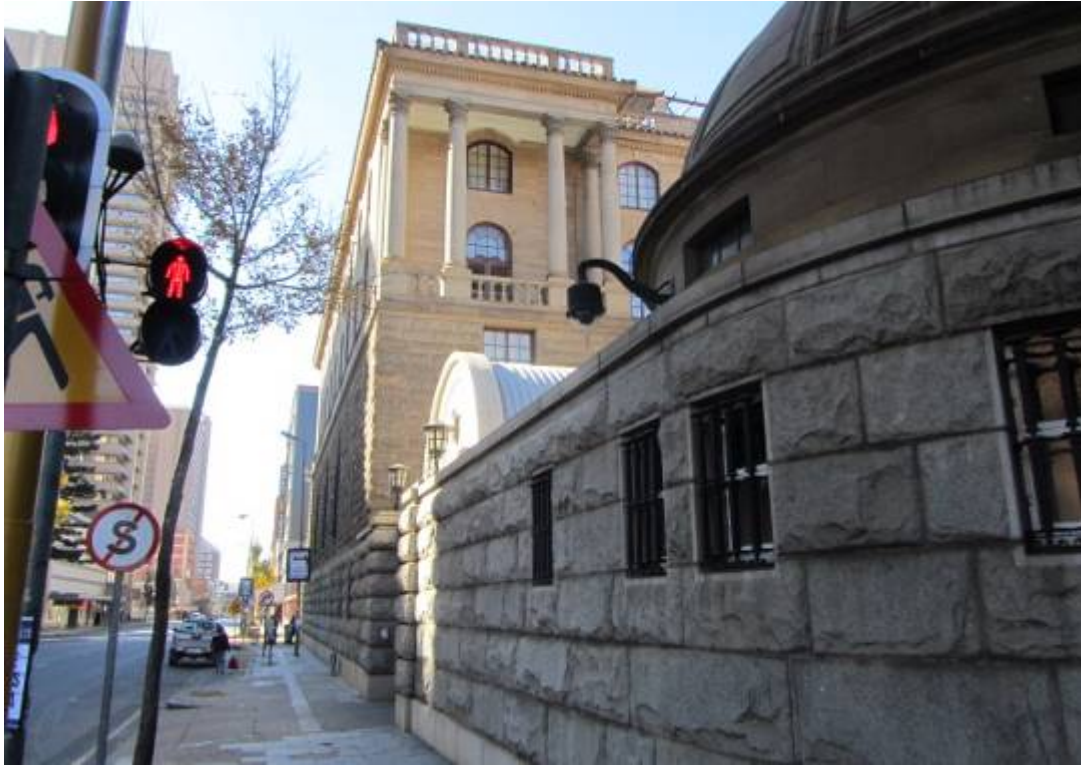
*Figure 123. Discontinuation and interrupted occurrence of historical slate paving along foundations of historical buildings. (P 923).*

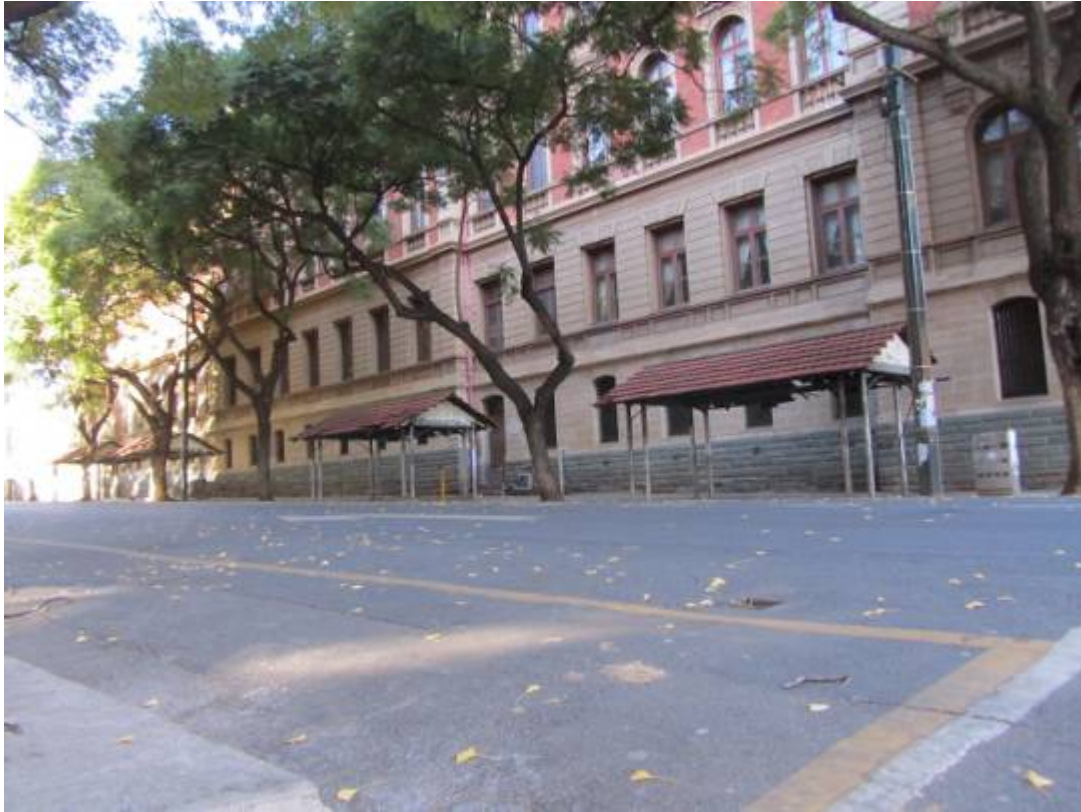
*Figure 125. Protected historic bus shelters in need of repair. (P 925).*

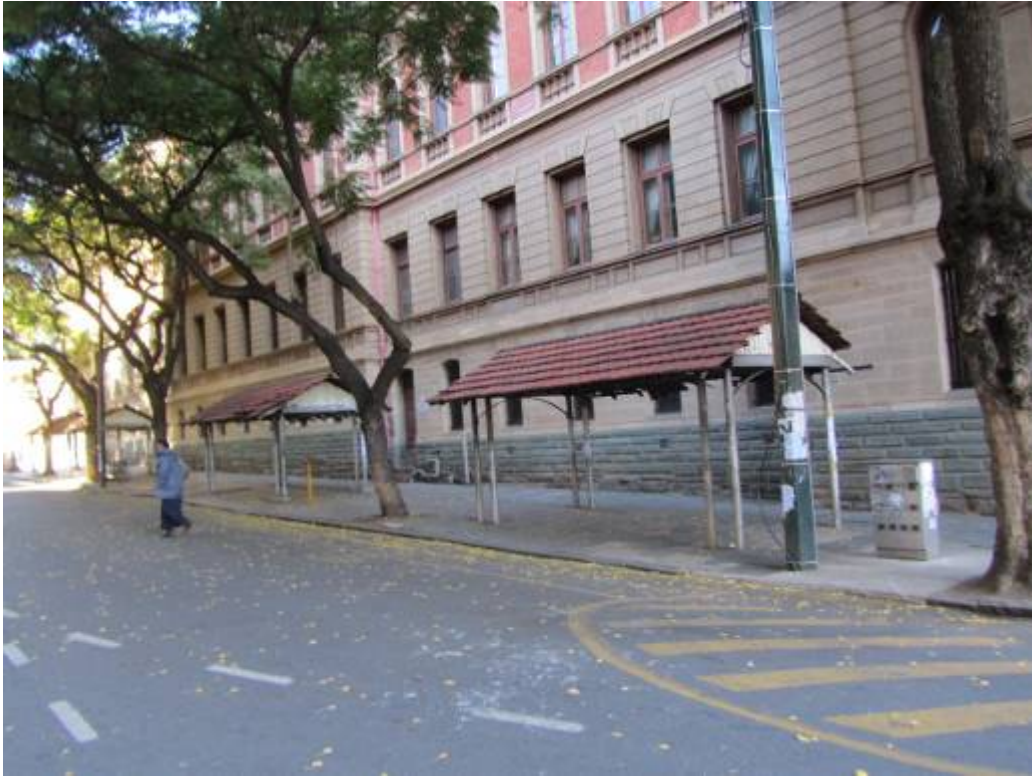
*Figure 127. Protected historic bus shelters in need of repair. (P 927).*

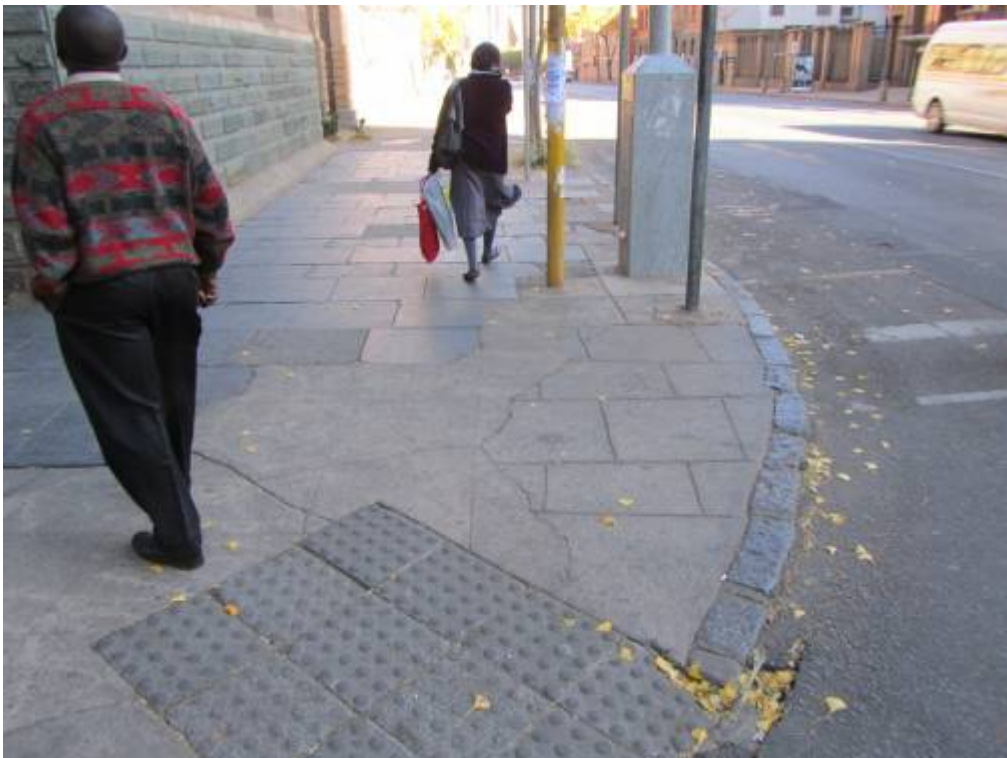
*Figure 128. Concrete interruption in historic slate paving. (P 928).*

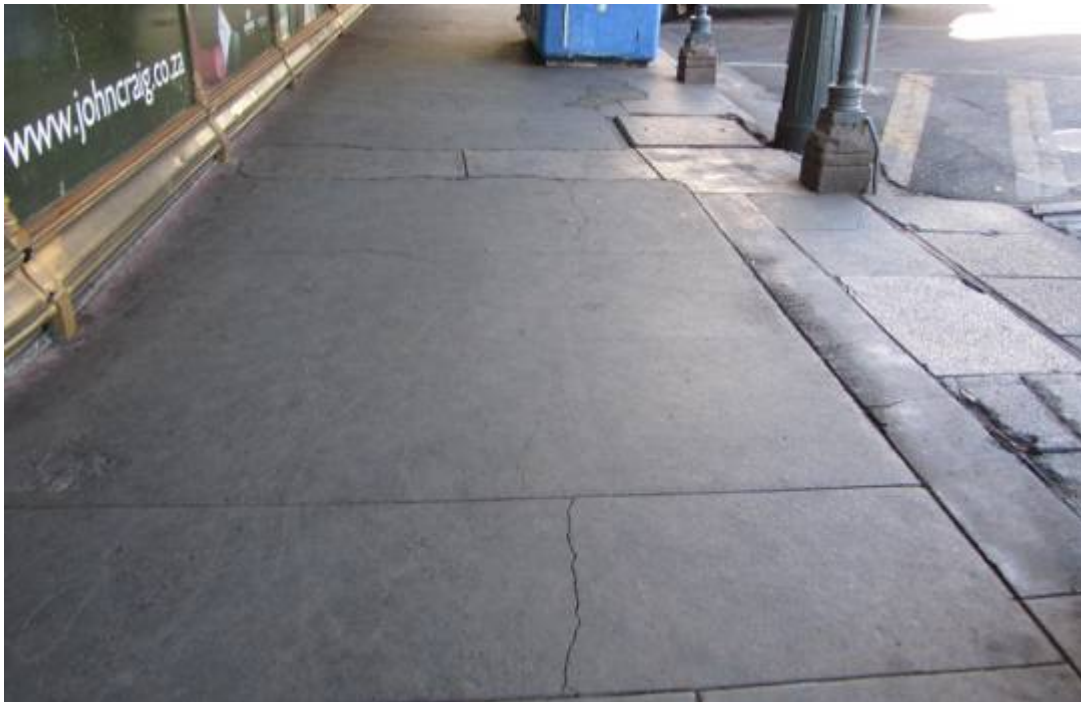
**Figure 163.** *The paving adjacent to this historical building is a dog's breakfast of cement and concrete. The main problem with large areas of concrete is always unsightly cracking. With blocks or paving bricks this can easily be remedied. (P 966).*

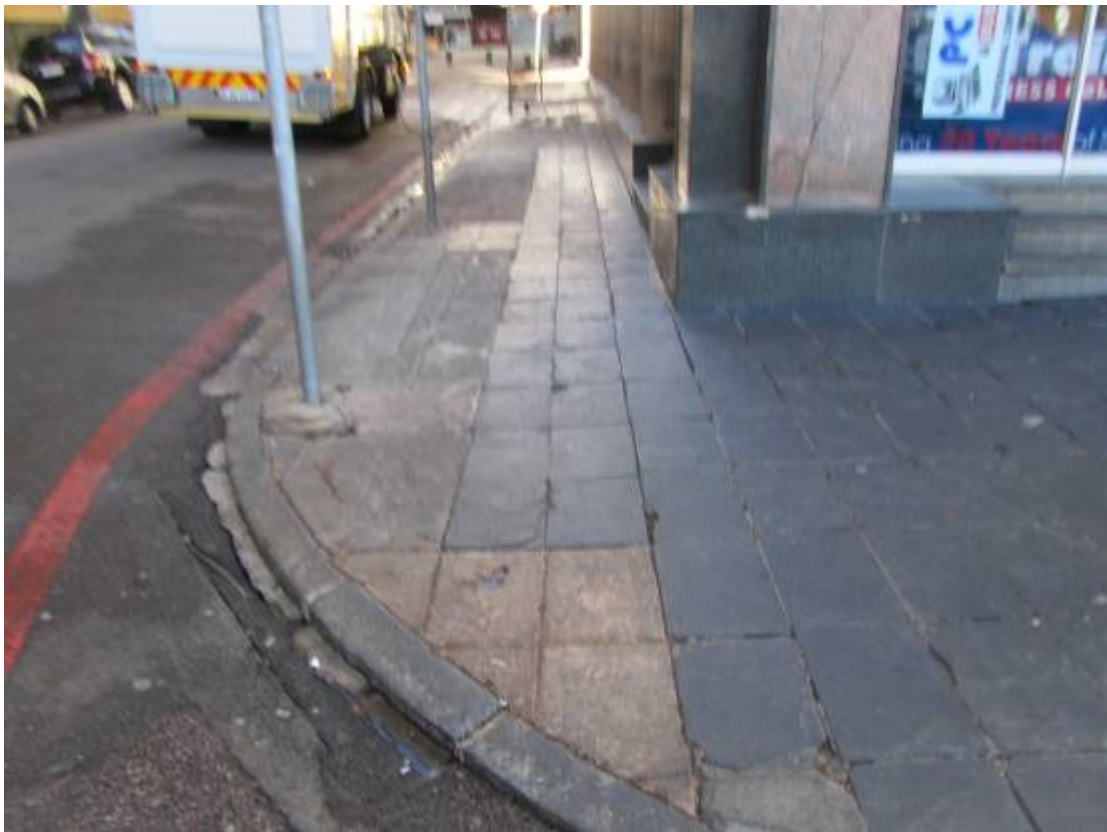
*Figure 171. Although some historical slate survives the general condition of this section is not satisfactory. (P 974).*

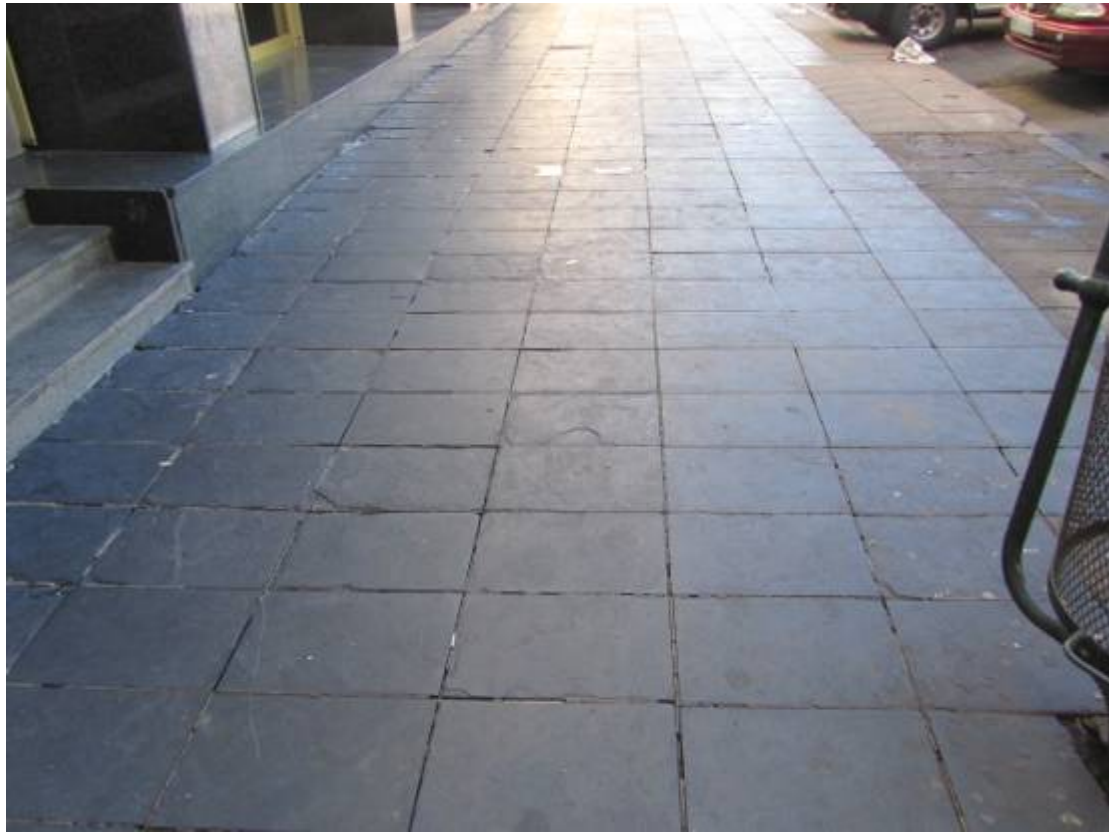
**Figure 172.** Well preserved slate paving in front of historical building. (P 975).

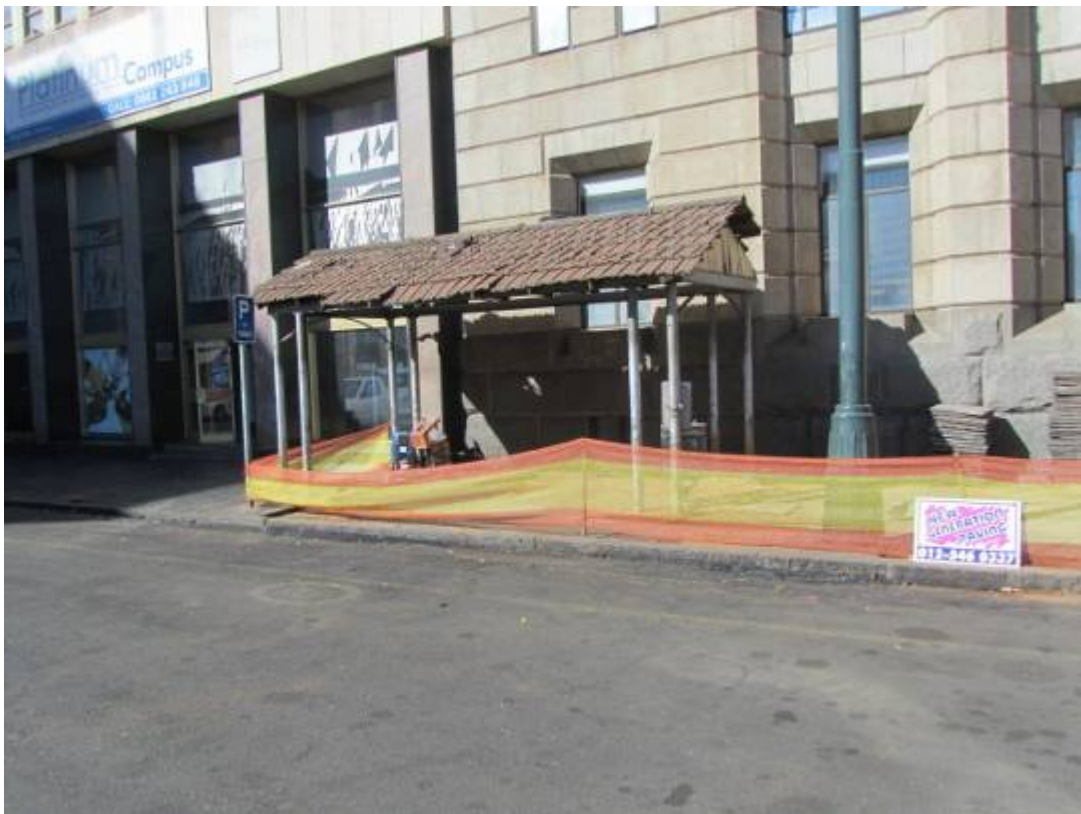
*Figure 175. Historical bus shelter badly in need of repair. . (P 978).*

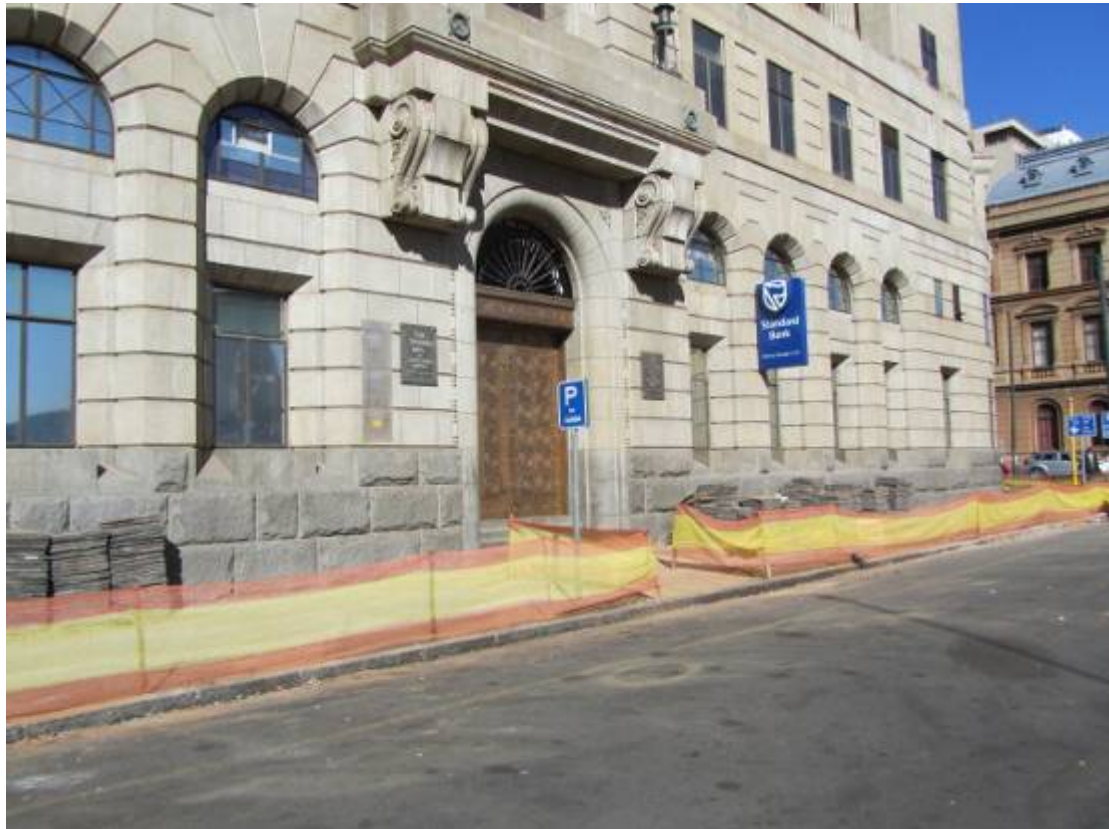
*Figure 176. Slate paving in front of historical building being lifted. (P 979).*

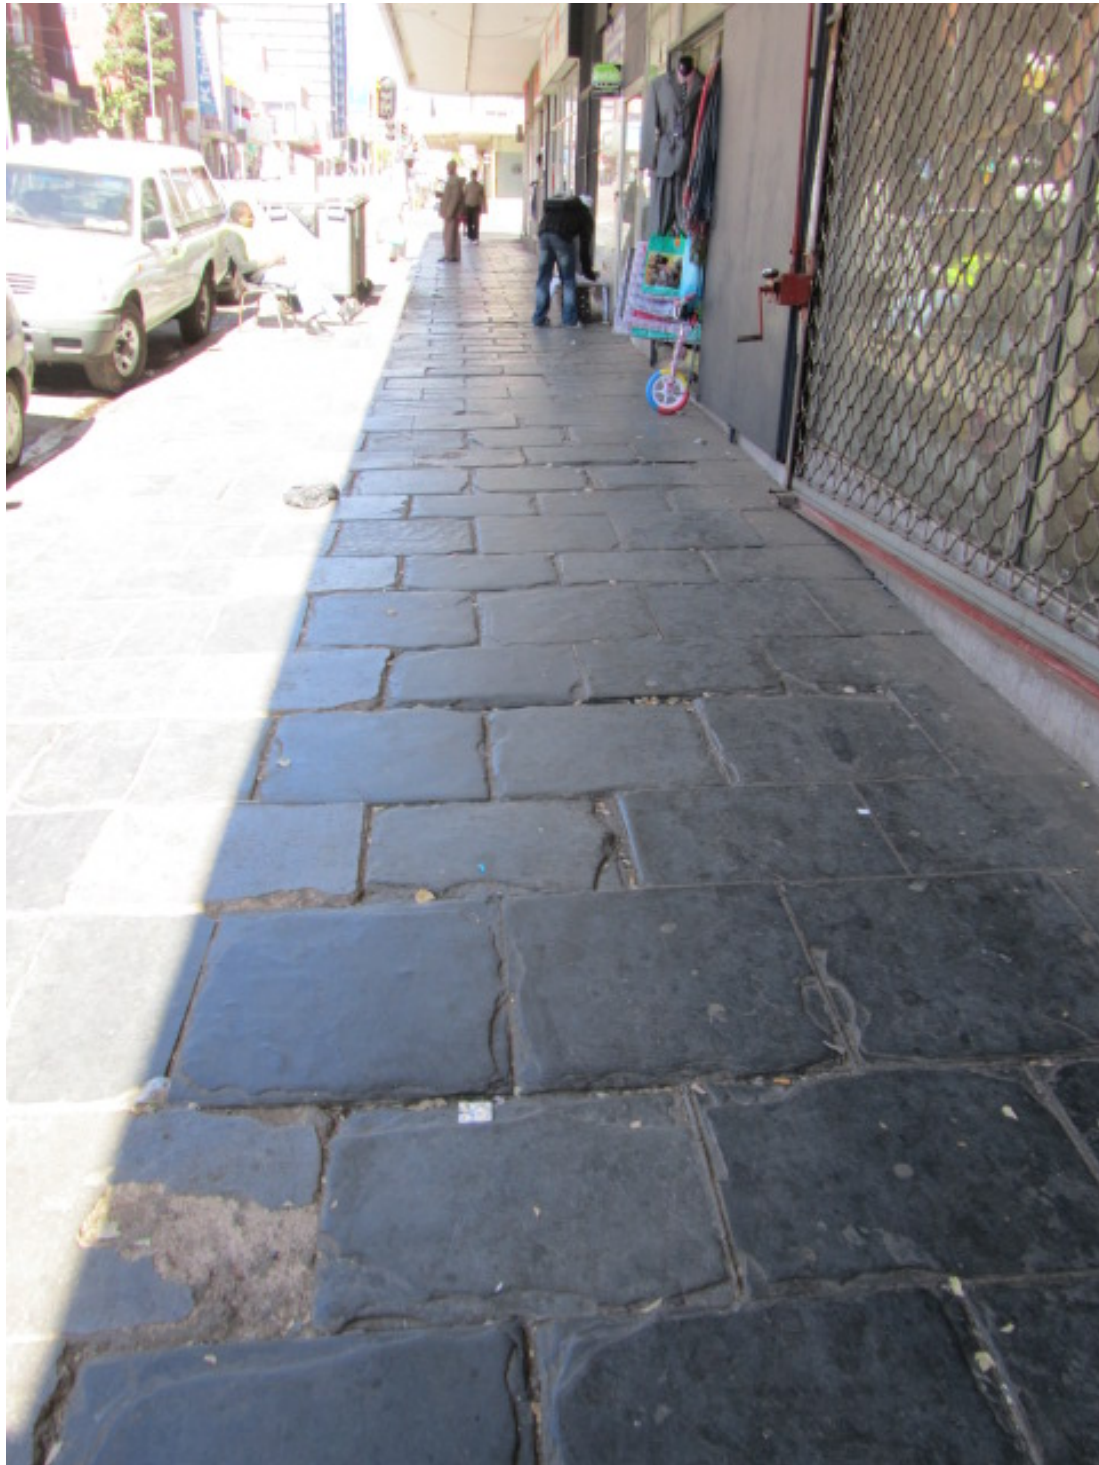
*Figure 223. Remnants of historical slate paving and granite curbing defining old roadway. (P 1023)*

13.3 All, or most of the historical curbing and paving, must be retained or replaced in-situ.

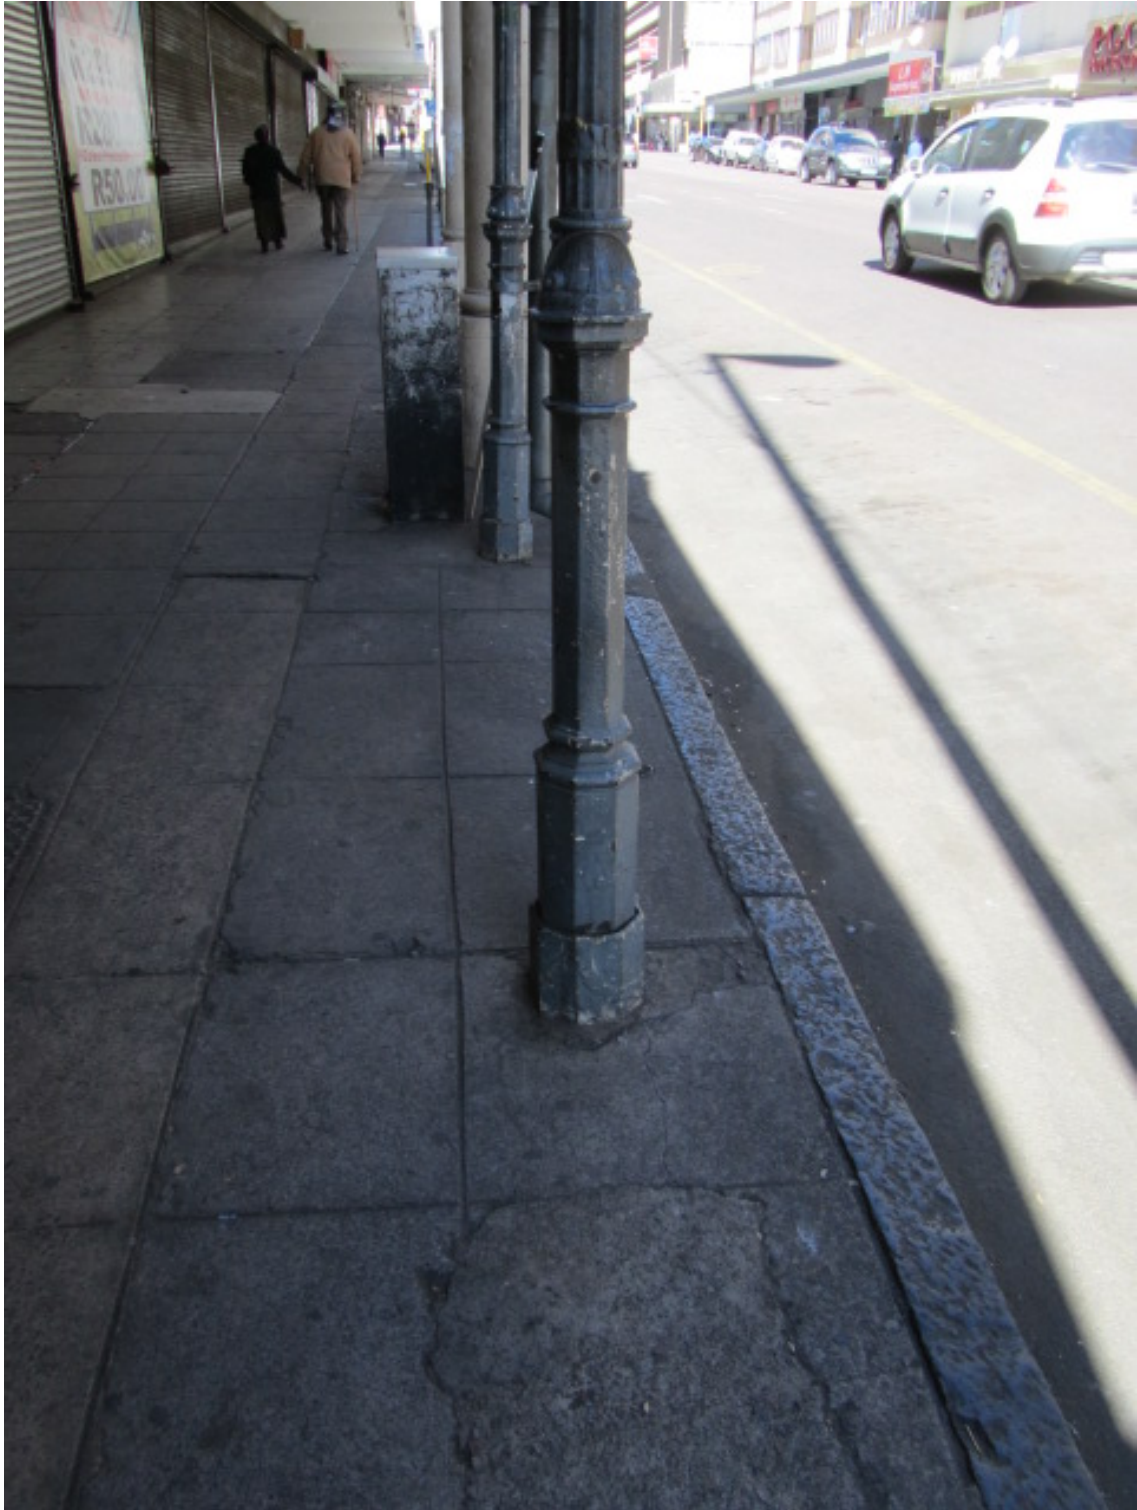
*Figure 234. Variety of paving material and historical pillar footprint. Note Granite curbing. (P 1034)*

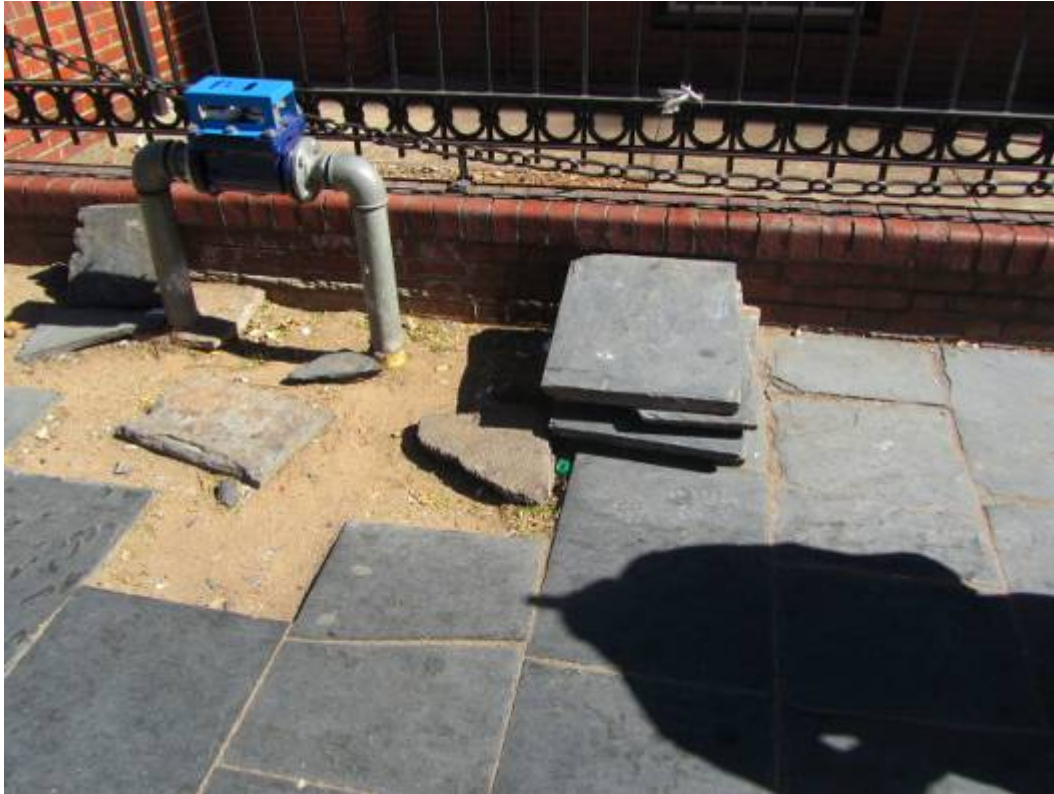
*Figure 275. Maintenance and repair is the responsibility of Tshwane. Why do this happen? (P 1073)*

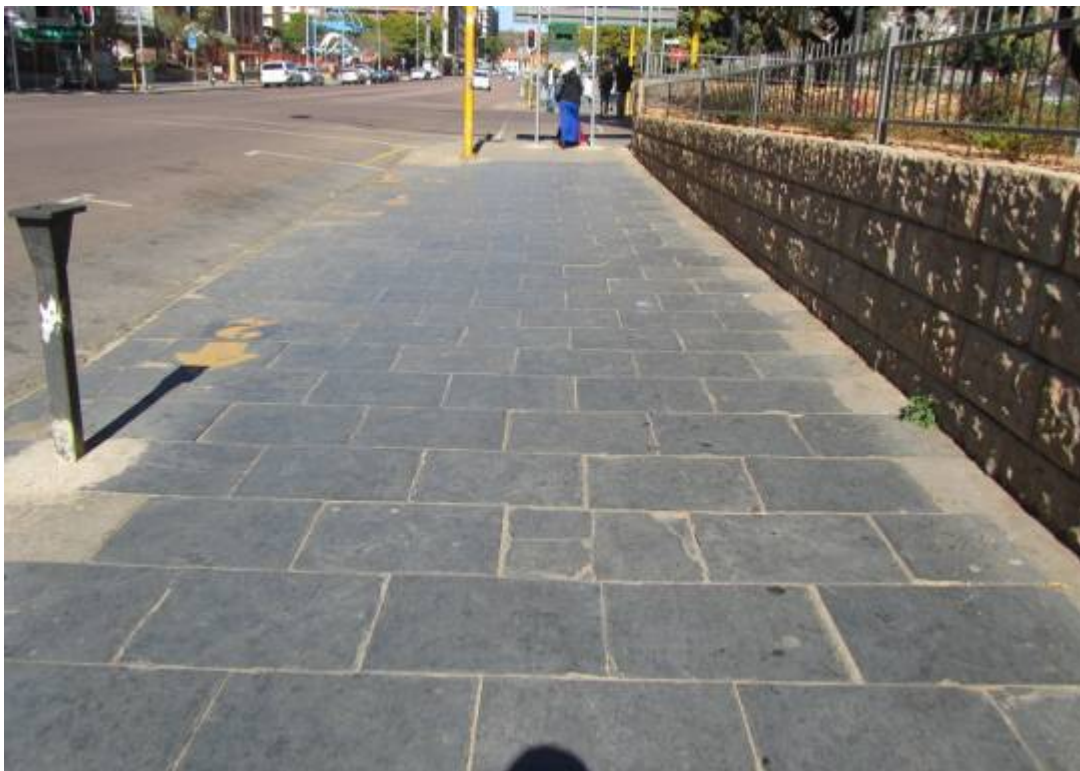
*Figure 276. All street furniture has impact on paving. This now disused parking meter shows how not to implement and retire street furniture. (P 1074)*
