## **1st Phase**

**Cultural Heritage Resources Impact Assessment for proposed rapid bus service, Paul Kruger Street, Pretoria, Tshwane.**

**June 2011**

**Report compiled by Sidney Miller and Dr. Udo S. Küsel.**

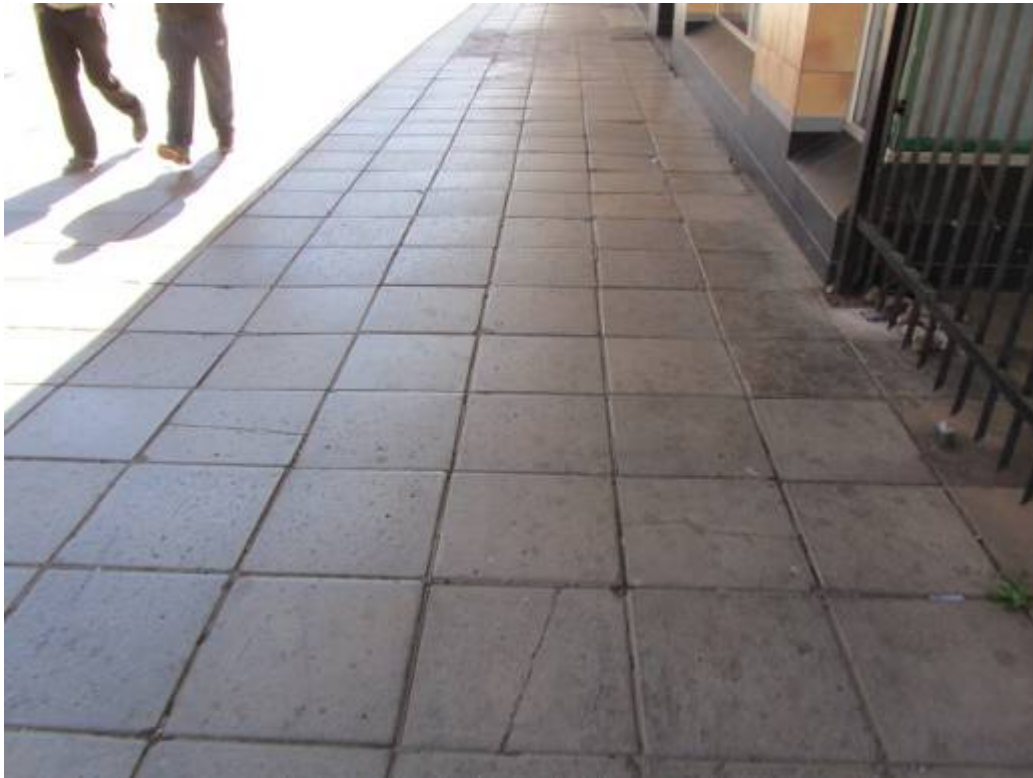
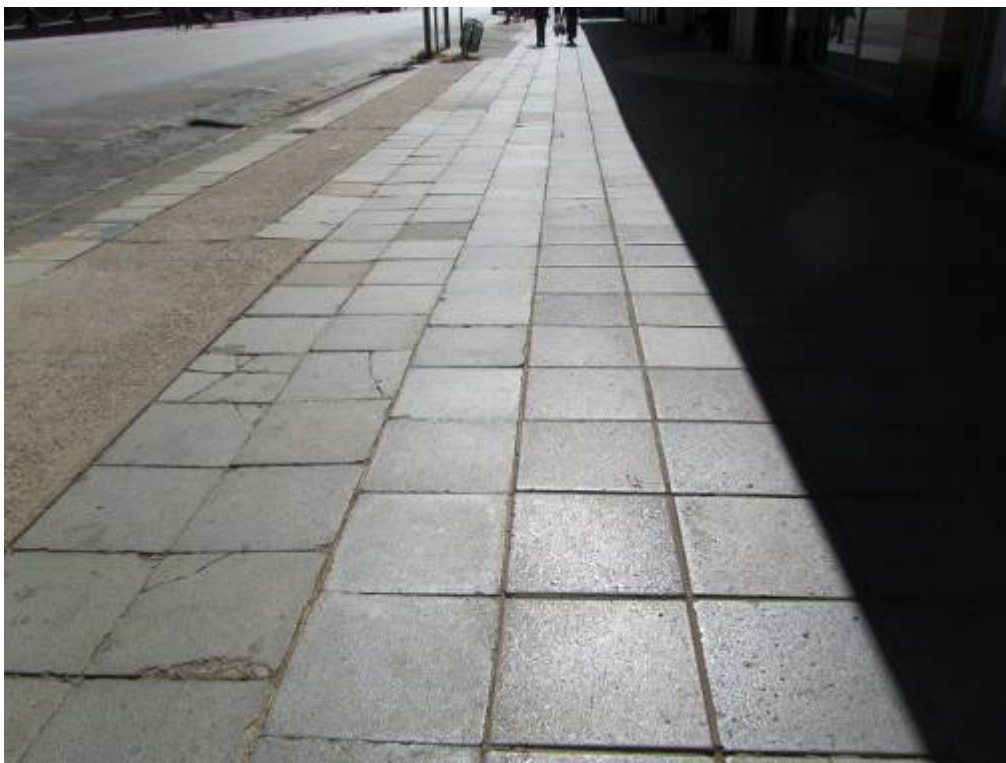
**Figures 279 and 280.** *This earlier type of cement block pavers can be attractive if uniformly laid to a design. There should be a 'repair policy for paving after service trenching and reinstatement. (P 1080 and (P 1081).*

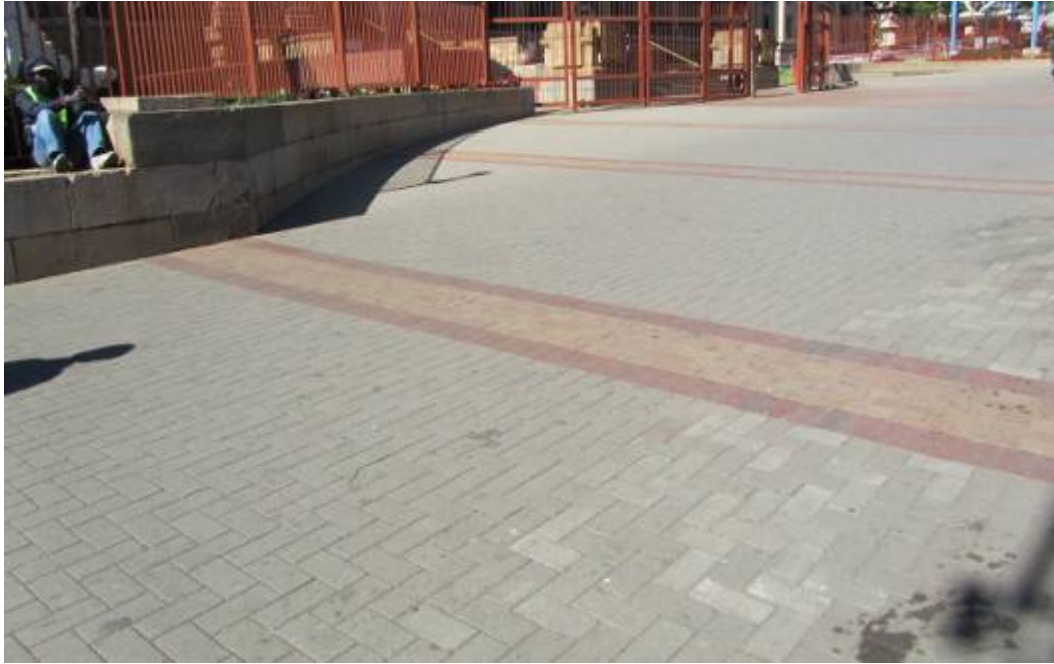
**Figure 287.** *With the renewal of the building some years ago the original paving was removed and replaced. Although attractive and well placed, it is the last option where original paving exist. (P 1085)*

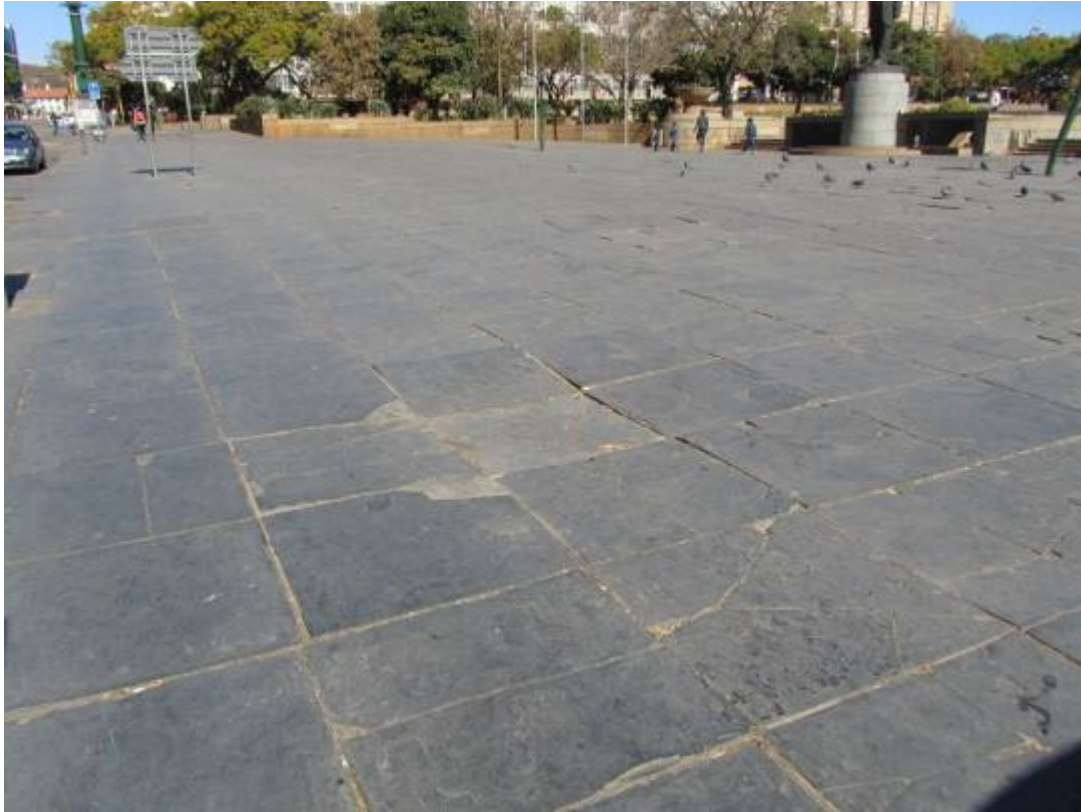
***Figure 290. Protected paving. Repair only where public safety requires. (P 1087)***

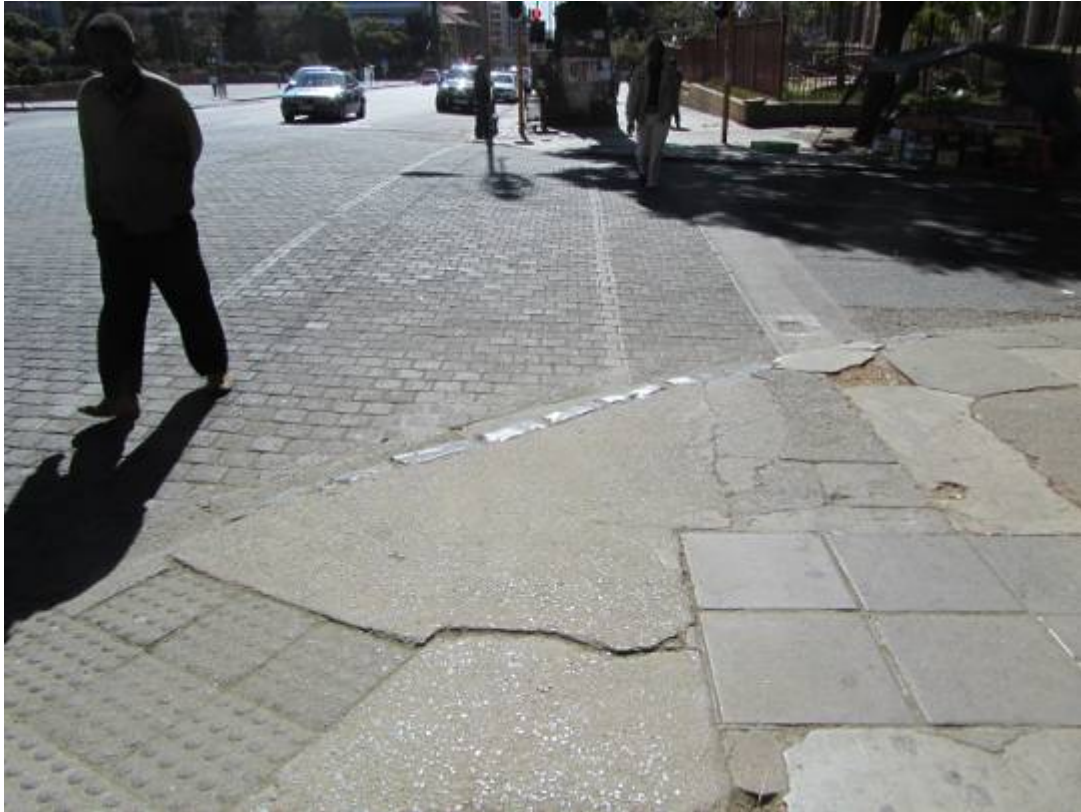
*Figure 293. New road paving as part of 'Museum walk' renovation several years ago. Paving in view not repaired. (P 1118)*

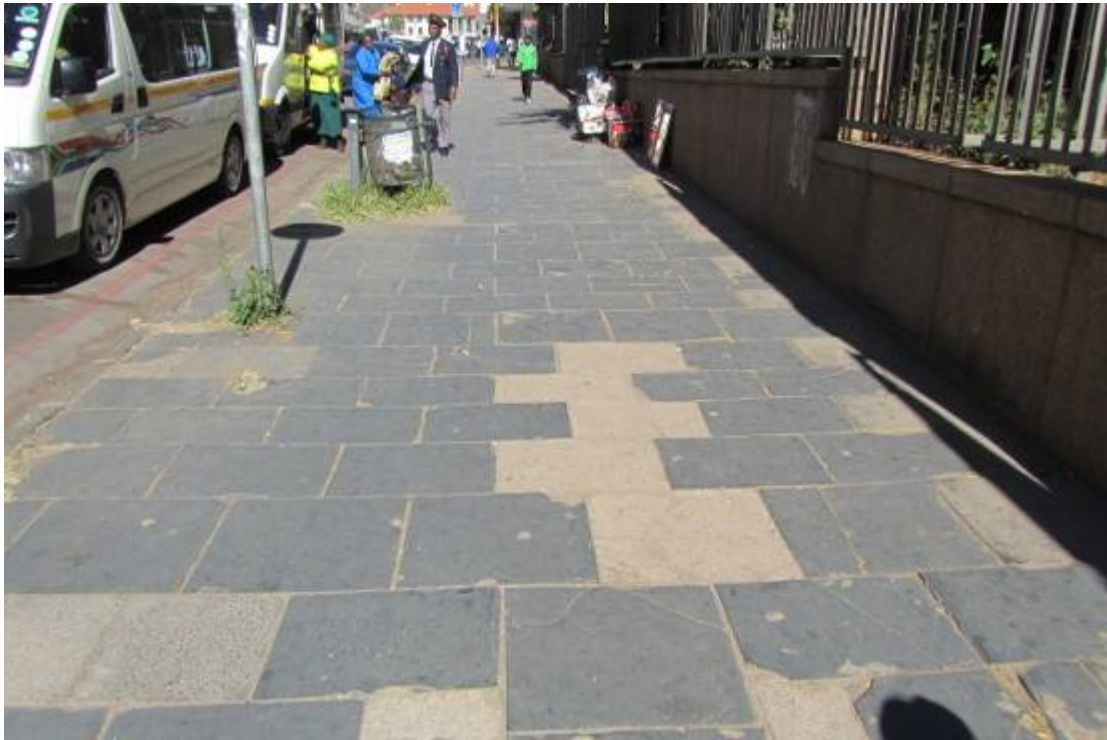
**Figure 303. Protected paving. Repair necessary. (P 1131)**

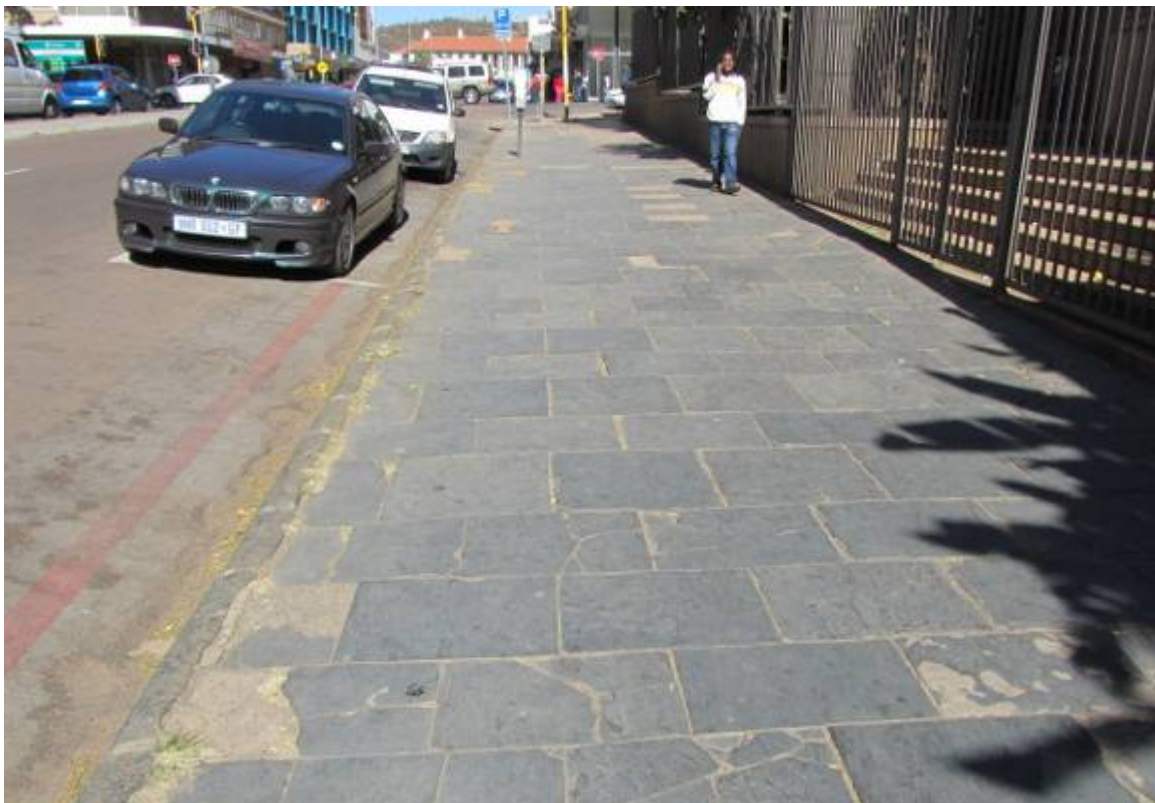
**Figure 304. Protected paving. Repair necessary. (P 1132)**

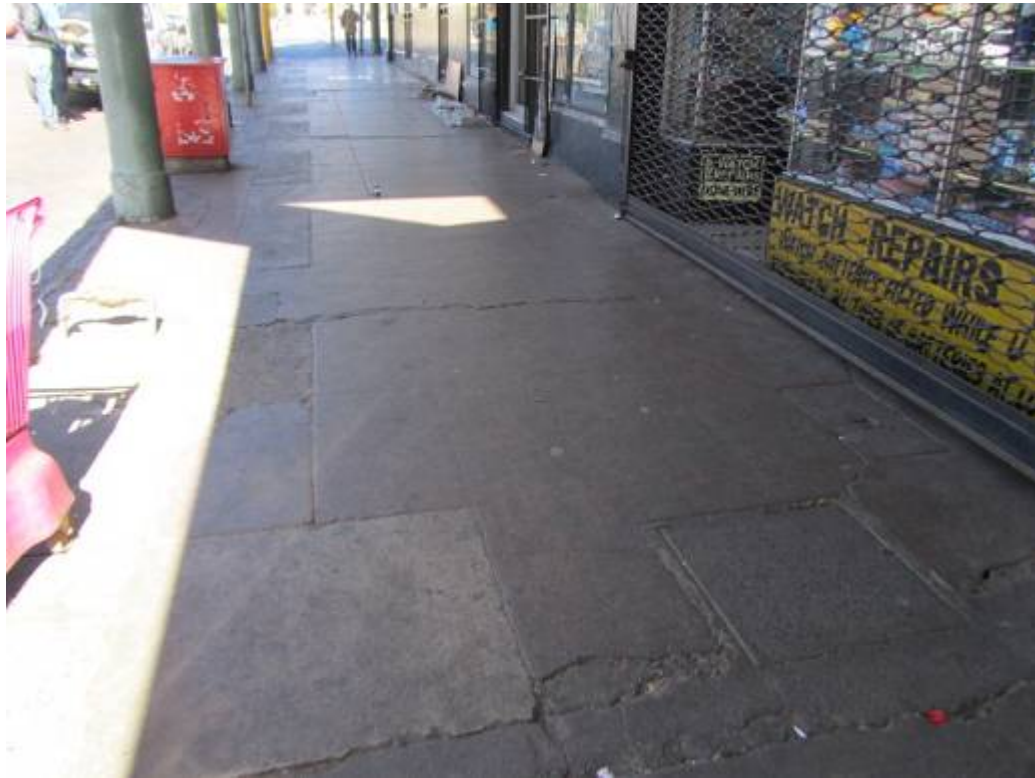
**Figure 327.** *These ferro-granolite concrete panels may be indicative of historic paving. Similar panels were found in earlier blocks. Unfortunately they were also damaged and badly repaired over time. (P 1100)*

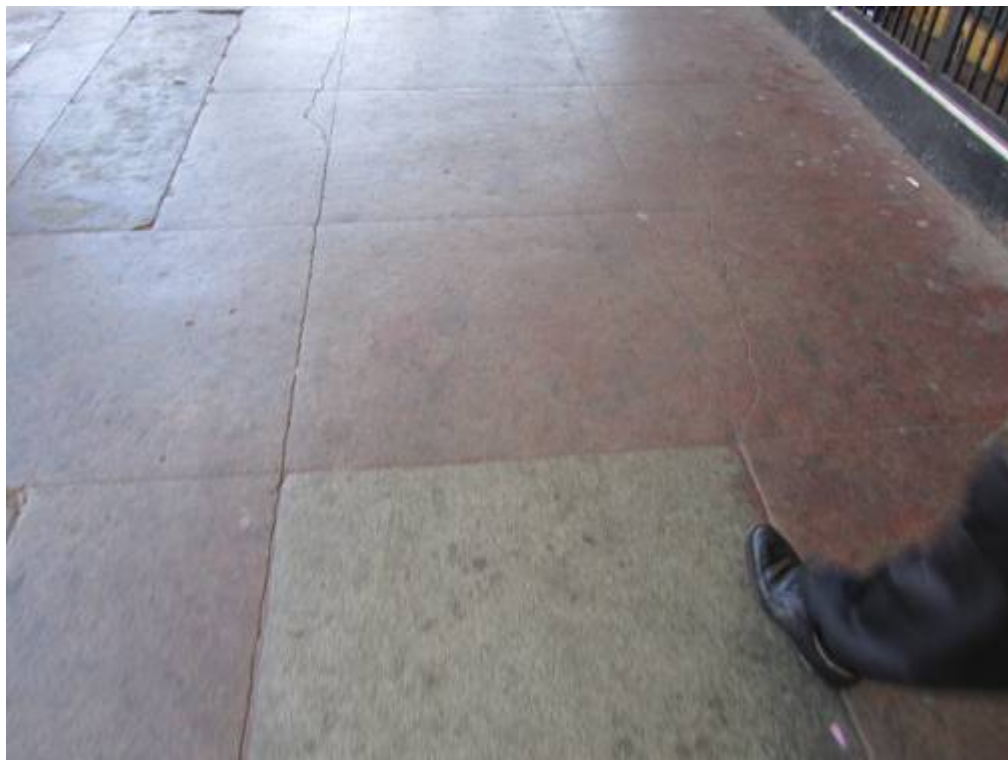
**Figure 328.** *Detail of ferro-granolite panes and repairs. (P 1101)*

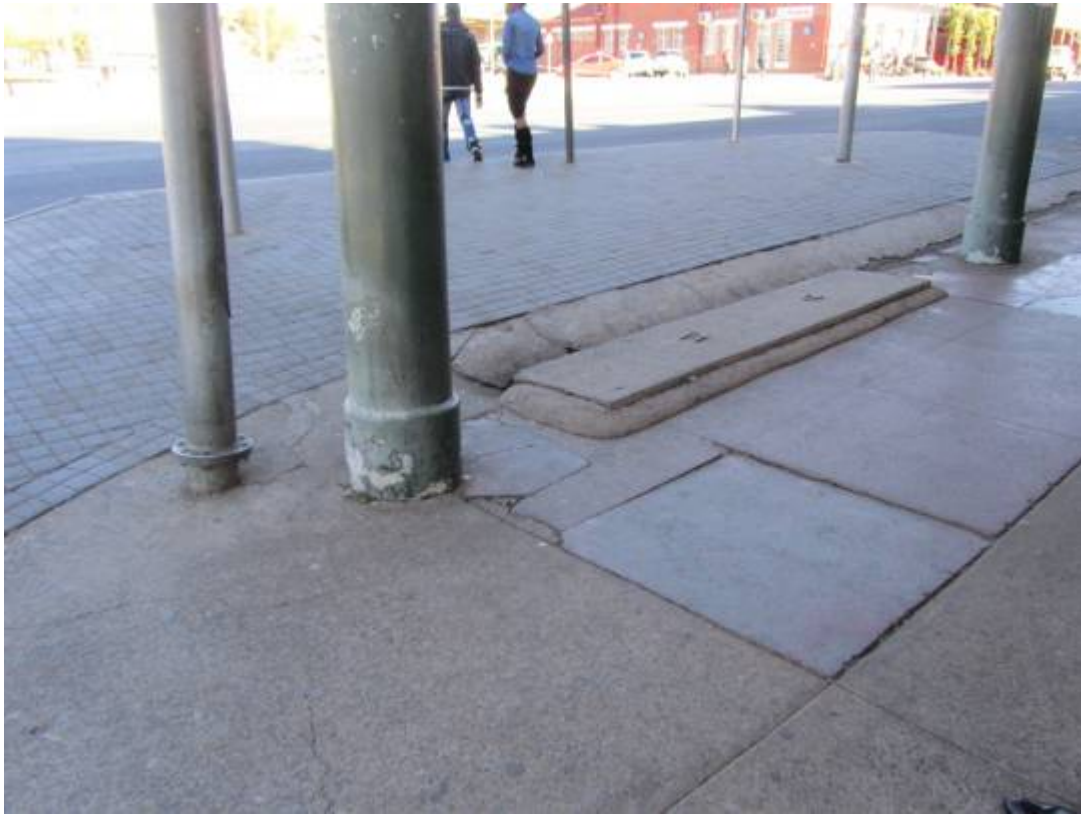
**Figure 329.** Roadway, sidewalk level irregularities. (P 1102)
