# NEWCASTLE MUNICIPALITY

**RE: Historical and Architectural Report: St Dominics Curro School St Dominics Street (ERF 392, ERF 1 of 382, R/382, Rem of Erf 1, Erf 15571 ) NEWCASTLE**

1. BUILDING TYPE: Swimming Pool
2. PRESENT USE: Not used at present as it is dilapidated

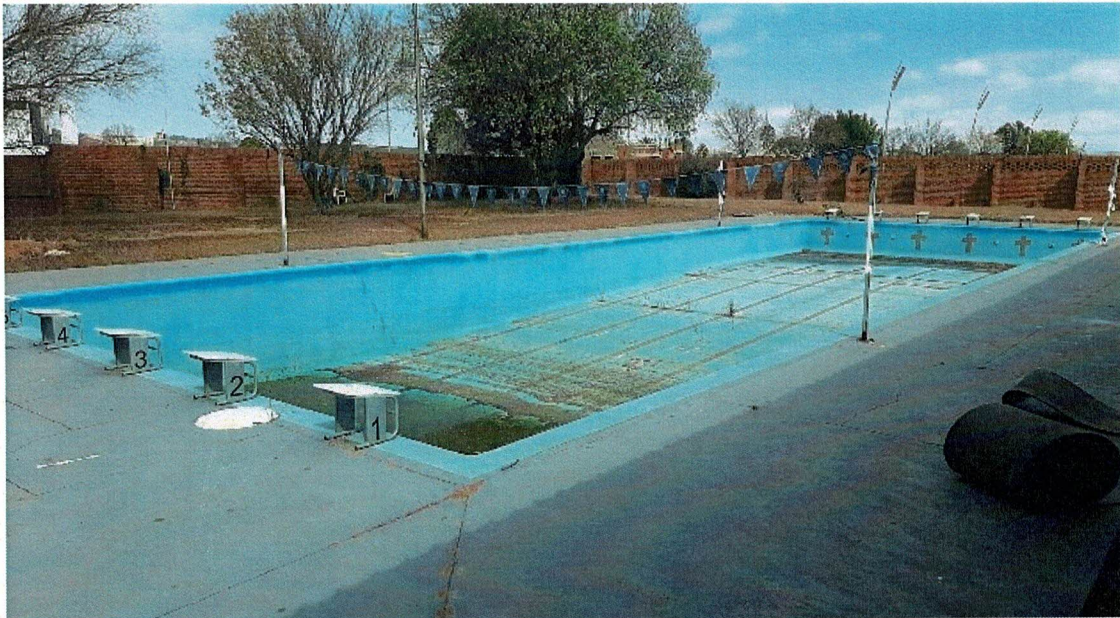
General view of swimmingpool. It has been out of use for the last three years since major cracks have lead to leaks that are not economically viable to fix.

I would advise to give consent to demolish this building.

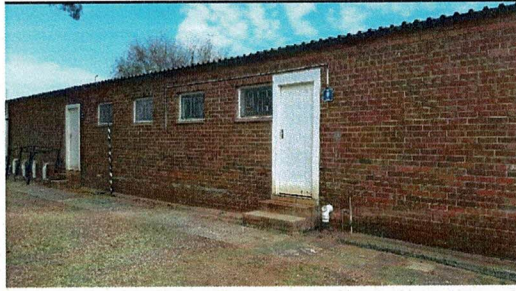
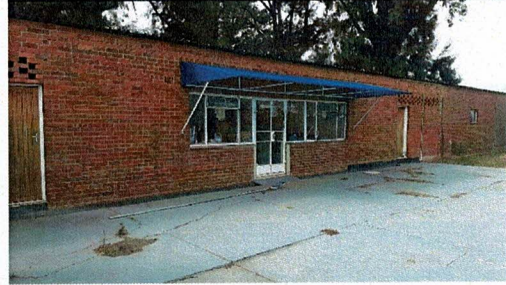
The outside and inside of the northern façade. The façade incorporates administration space for use during swimming events, a store room and ablution facilities. Its constructed of red bricks and a flat corrugated iron roof. The doors and windows are a combination of steel frames and simple wooden doors.

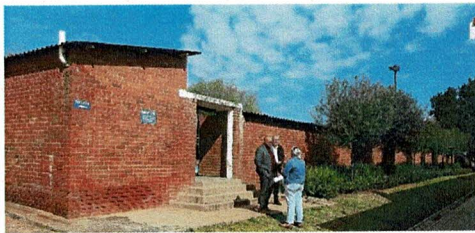
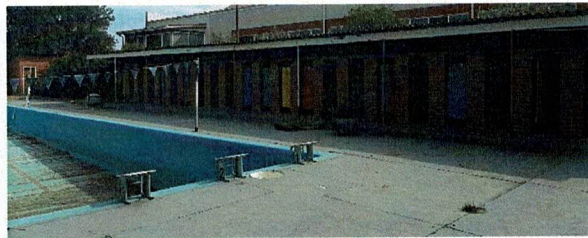
The western façade shows the depth of the administration building on the left. The western façade consist mainly of the changing cubicals with the colourfull wooden swinging doors on the inside. The entrance to the swimming pool is also located here.

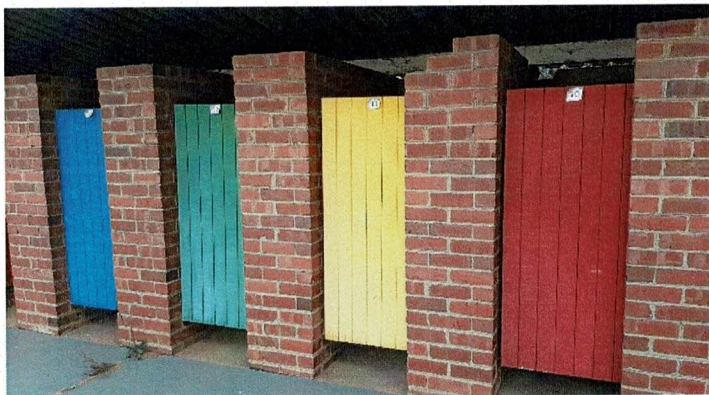
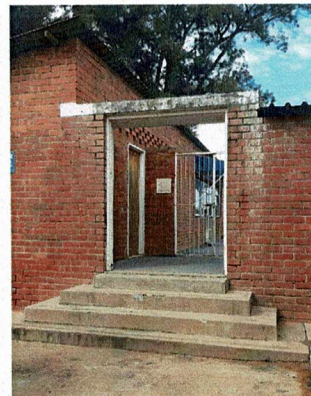
The closer view of some of the wooden swing doors. The entrance consist of the opening between the northern and western facades, filled in with brick work on the sides and a concrete lintel on top and simple concrete steps leading down to ground level. The roof consist of corrugated iron.

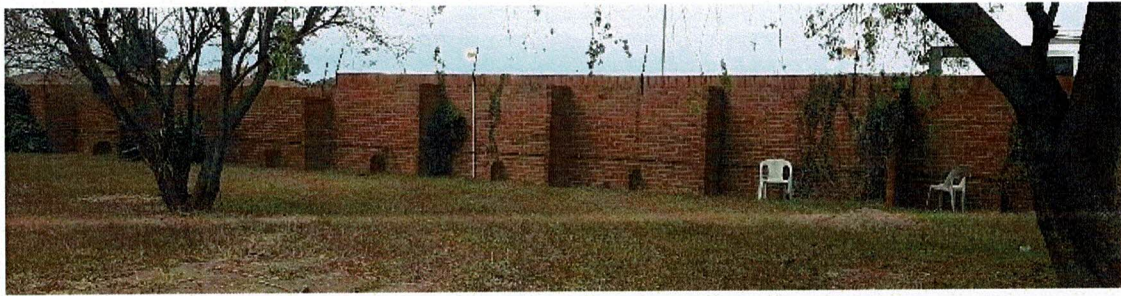
The eastern façade consists of a brick wall of stretcher bond and soldier course, supported with simple brick buttress retaining walls on the inside. Apparently there used to be wooden seating against the walls.

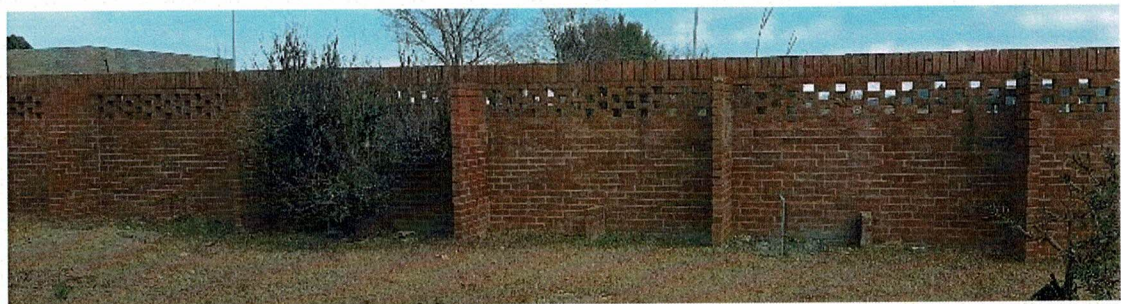
The southern façade is similar to the eastern façade except for the pigeon hole openings beneath the soldier course top bond.

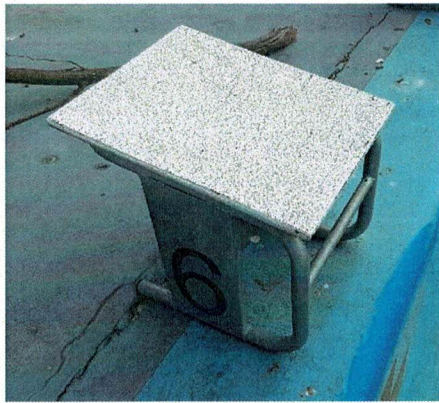
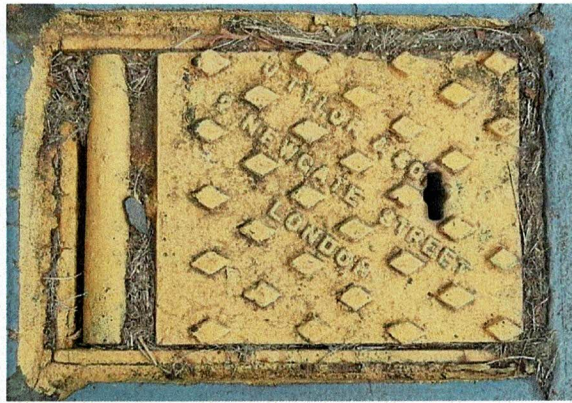
A starting block and a steel drainage cover are some of the historical components that can be salvaged and be incorporated into a “wall of remembrance”.

It is suggested that a “wall of remembrance” be created in any future development. It can consist of a number of the starting blocks and the old wooden doors being salvaged and incorporated with a collage of old photographs and text narrating the history of the swimming pool at the school.
