SITE INSPECTION AND DOCUMENTATION OF HISTORIC STONE WALLS ON STANDVASTIGHEID 210/REM FOR THE PROPOSED KARUSA WIND ENERGY FACILITY, SUTHERLAND MAGISTERIAL DISTRICT, WESTERN CAPE

Required as pre-construction mitigation by SAHRA.

SAHRA Case ID: 218

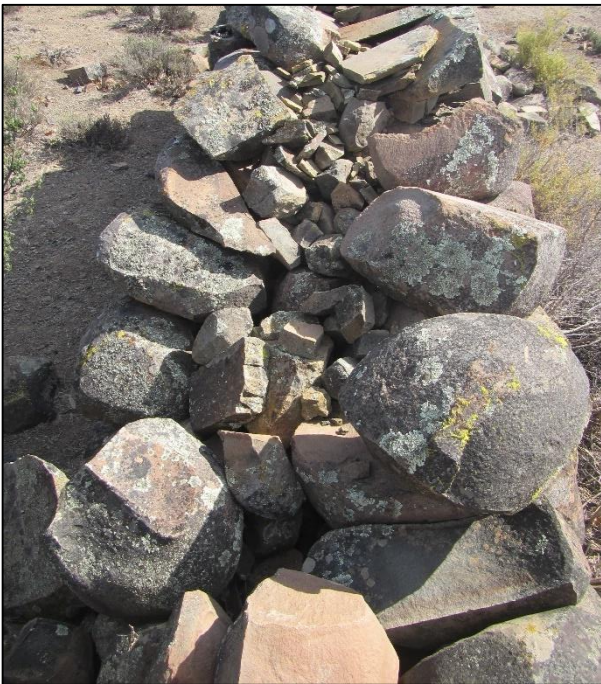
The structure is typically historical in its construction technique with two skins of rocks on the outside and a fill of 'rubble' in between (Figure 12). The top of the wall was capped with large slabs that stretched across the entire width of the wall (Figure 13), although for the most part these slabs were missing, even in the collapsed areas. The rocks used in the construction are mostly unmodified blocks collected from the surrounding landscape, but it is clear that at least some blocks were dressed in order to get them to the desired shape (Figures 14 & 15). Most of the rocks were angular, although in general they were of mixed shapes with blocks, slabs and rounded rocks all included. In one area, however, it was noted that a distinct change in rock type occurred with rounded and sub-angular rocks being used to the east and almost exclusively slabs to the west (Figure 16). This may have been the result of sourcing rocks from different places. The rubble fill contains rock fragments and, towards the base, probably some finer gravel and sand. The rock fragments would be largely gravel collected from the surrounding landscape, but could very likely include dressing flakes chipped off the rocks during construction. The limited number of such flakes alongside the wall suggests they were collected up and dropped into the wall cavity.

Figure 12: View of the top of the wall where the capping slabs are missing and showing the 'rubble fill between the two stone 'skins' (waypoint 067).

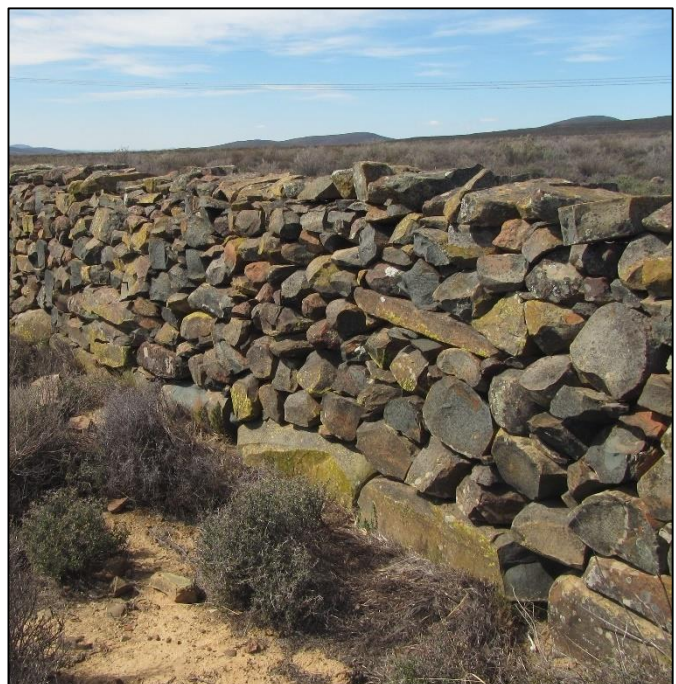
Figure 13: View of the wall where the full height is preserved. The cap stone slabs are visible on the top (waypoint 079).

079	S32 54 16.2 E20 37 43.0	The western end of a 40 m long section of very well-preserved walling standing to full height (1.3 m). A few stone dressing flakes were noted on the ground here (although the ground was not specifically searched for such flakes).

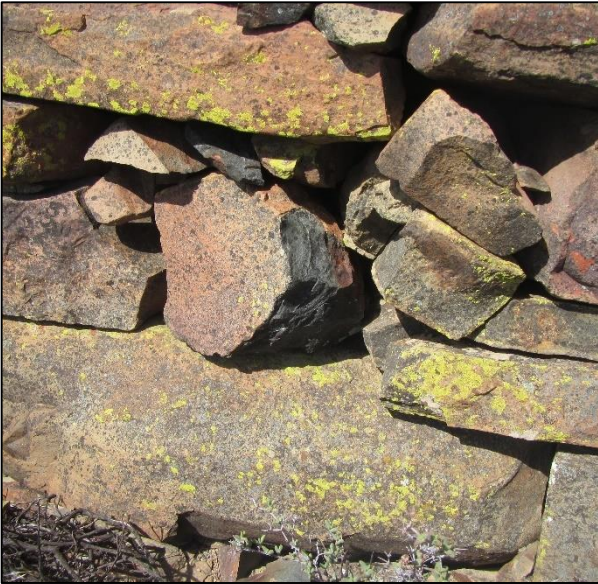
Figure 14: Close-up photograph of a section of walling showing a dressed stone in the centre (waypoint 079).

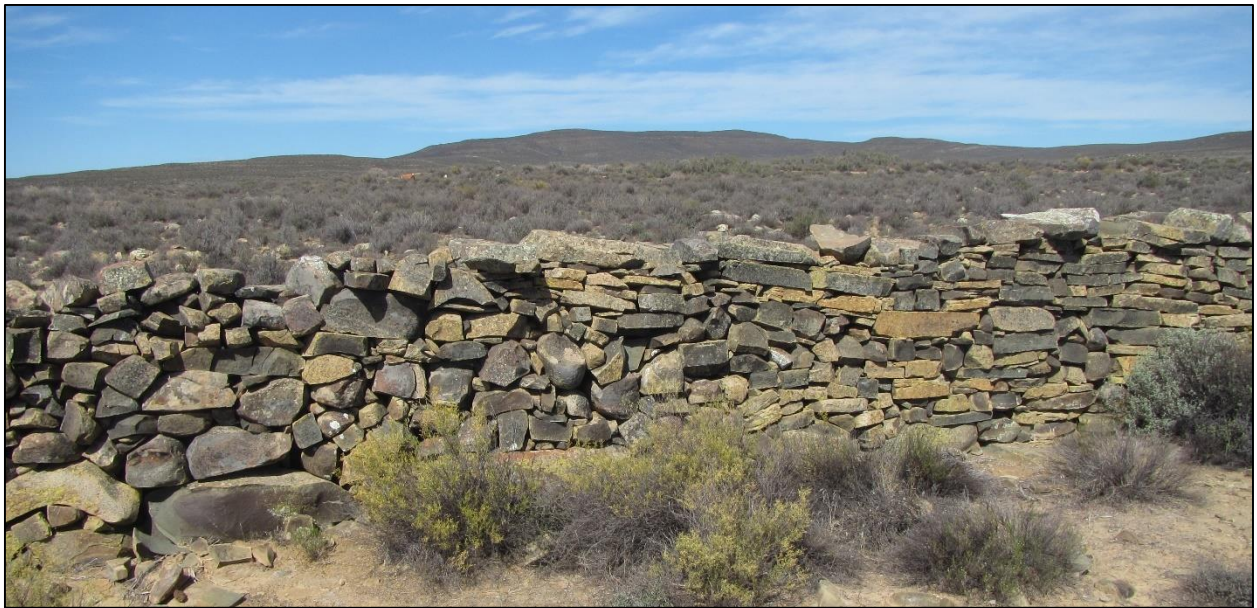
Figure 16: View of the wall at a section where the type of rock used changes from rounded and sub-angular rocks to slabs (waypoint 082).

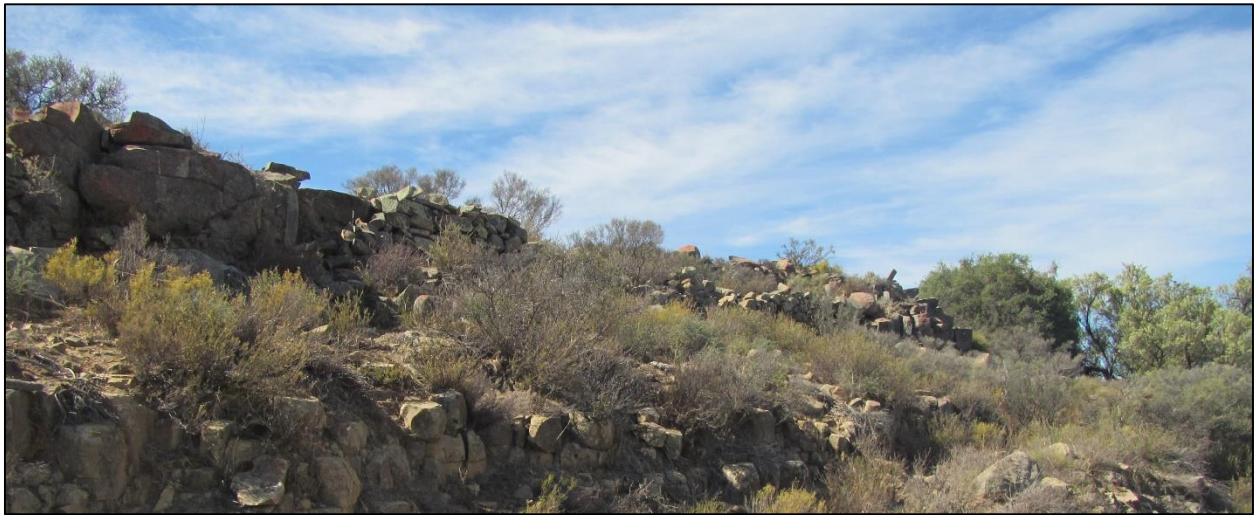
Interestingly, the wall builders also made use of the low cliff running along the northern side of the river. A low wall has been built along the top of this cliff in order to incorporate the cliff within the wall (Figure 17). The walls along the cliff are, however, very poorly preserved and even absent in places, whether by design or because the rocks have been removed is unknown.

Figure 17: View of the low cliff running along the north side of the river in one area and with a low stone wall along it in places (waypoint 100).

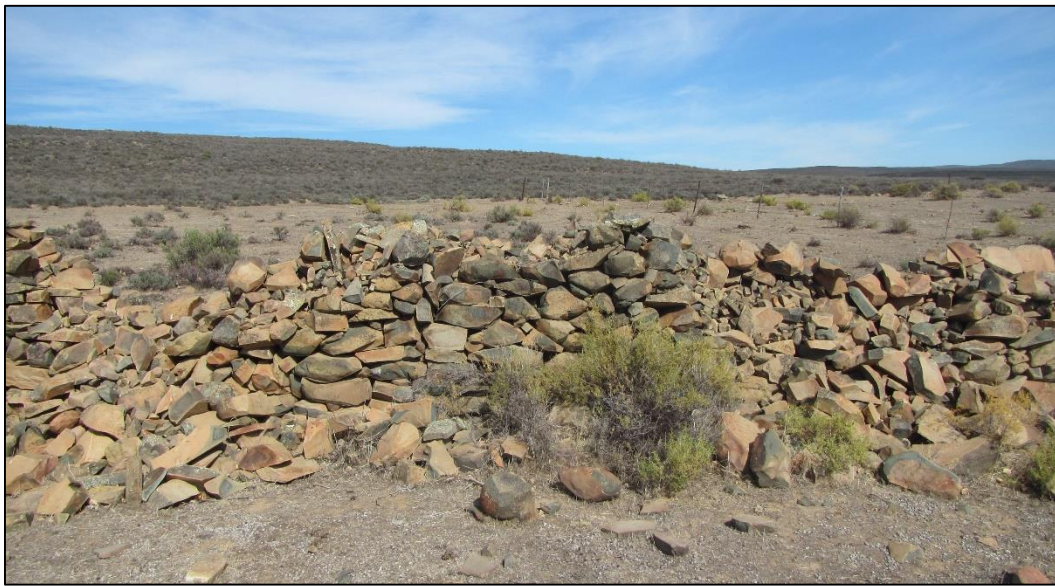
about 1.0 m high. The standing sections, although incomplete, showed no difference in construction methods from the generic example provided in Figure 11 above.

Figure 20: View towards the west-southwest of the section of walling at KSW2 (waypoint 069).

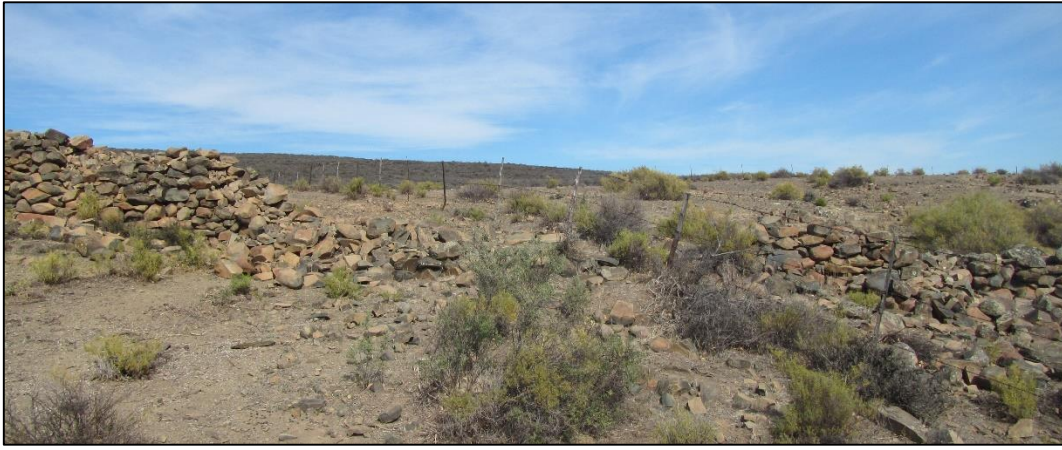
Some 15 m to the north of this point was where the wall is completely broken down to allow the wire fence line to cross (waypoint 068; Figure 21). As a result of this survey a recommendation was made to move the road alignment 15 m to the north to take advantage of this area where the wall was already completely demolished. This alternative is shown in Figure 19 and has now been instated as the preferred alternative and will be the routing for construction.

Figure 21: View towards the west-southwest showing the place where the stone walling has been demolished to ground level to allow for the erection of a wire fence (waypoint 068). This is the point through which the new road will now pass.

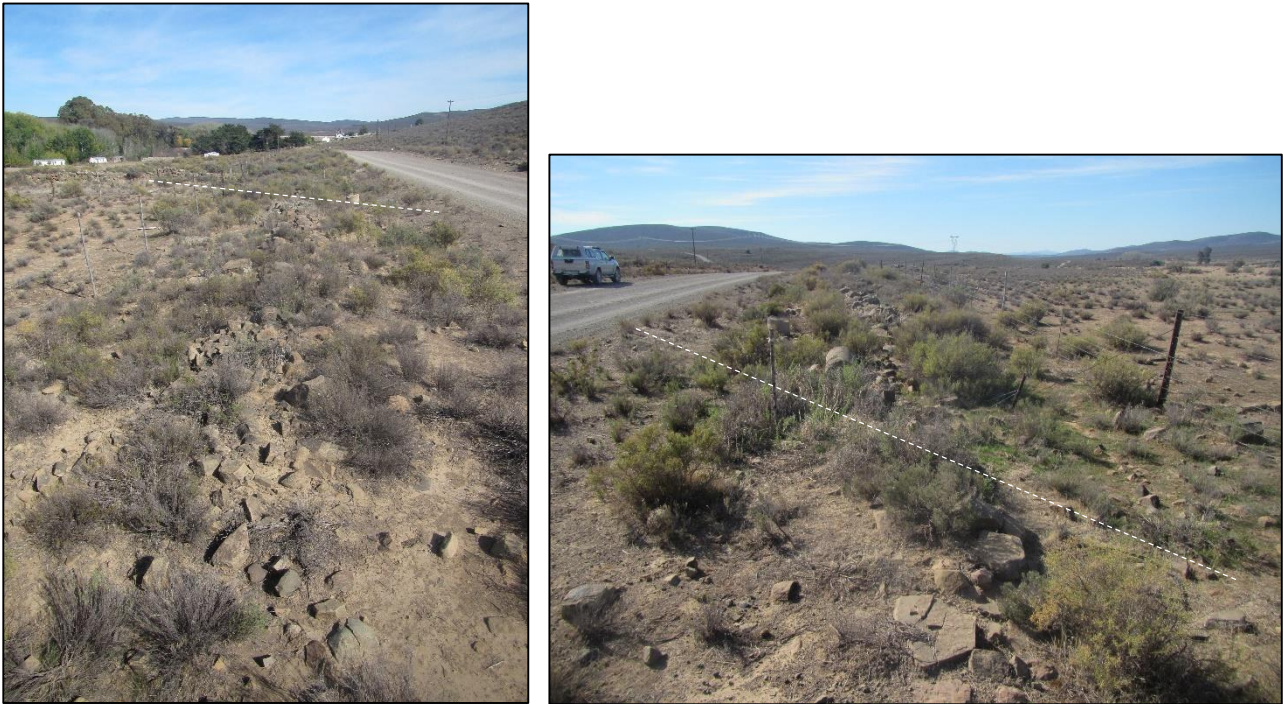
This section of wall lies alongside the main public access road to the north of the river and is located at the north-eastern end of the proposed new road alignment. It is almost completely broken down to ground level. There are actually two walls intersecting at this point (at waypoint 061) and the road alignment crosses through both of them, running just to the southeast of the meeting point (Figure 22). The east-west wall lies within the road reserve and it is this section that has been virtually entirely demolished and removed as noted previously (Figures 23 & 24).

The wall in this area is only about 0.1 m high at most here with only the very lowest course of rocks and some smaller loose fragments still present. Towards the east, however, there are progressively

more and more rocks present as evident in the distance in Figure 24. When the wall crosses to the south side of the fence (out of the road reserve) it is far better preserved, but is still in very poor shape being mostly tumbled. This is some 70 m east of the proposed new road crossing point. Towards the west the wall essentially fades out.

Figures 23 & 24: View towards the west (left) and east (right) along the remains of the walling at KSW3 with the position that the new road would have crossed marked by the dashed white lines.

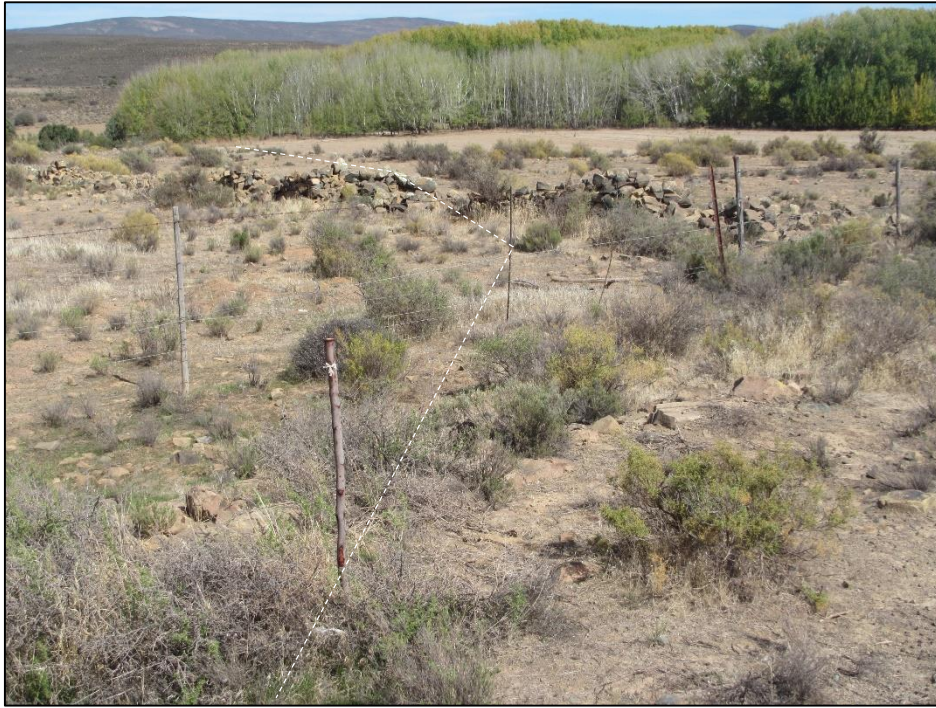
The section of walling running at 90 degrees to the road is somewhat better preserved but is still largely destroyed (Figures 25 & 26). It varies between about 0.2 m and 0.4 m high with many tumbled rocks lying alongside it. The two walls in this area are far too poorly preserved to be able to establish their original height, but one can still see that the width conforms to that observed elsewhere and the two skins and a rubble fill were still evident. There is no reason to suspect that these walls were built any differently to the schematic diagram in Figure 11 above.

Figure 25: View towards the southwest along the originally proposed road alignment (white dashed line). The alternative alignment that will be implemented lies out of view just to the right.

Because of the T-junction in the walling which preserves structural information concerning the layout of the walls, it was suggested that the bend of the new road could be moved some 15 m towards the northwest in order to bypass this junction. This alternative alignment is shown in Figure 22. It is now considered the preferred alignment and will be implemented during construction.

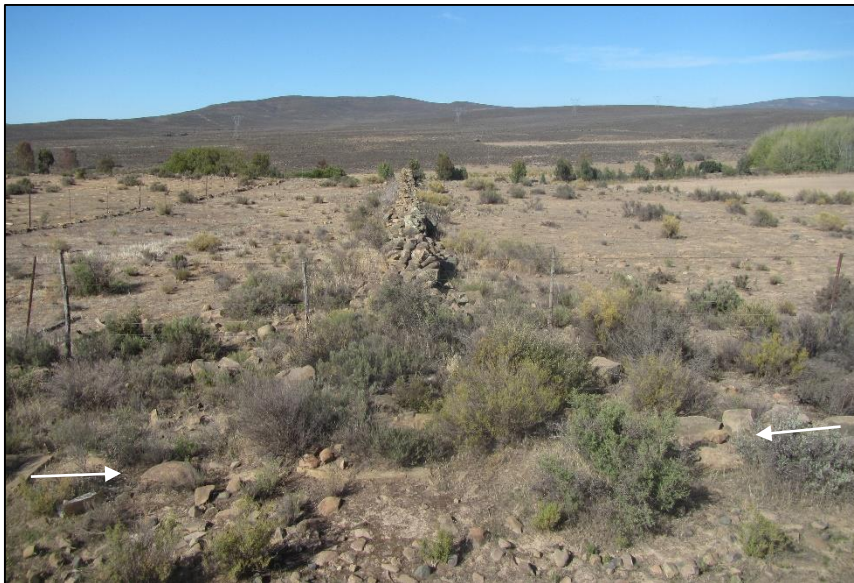
Figure 26: View towards the south along the wall running away from the gravel road. The remains of the east-west wall are in the immediate foreground of the photograph (arrowed). The new preferred alternative to be implemented will cross through the right hand part of this view to avoid the wall in the centre.

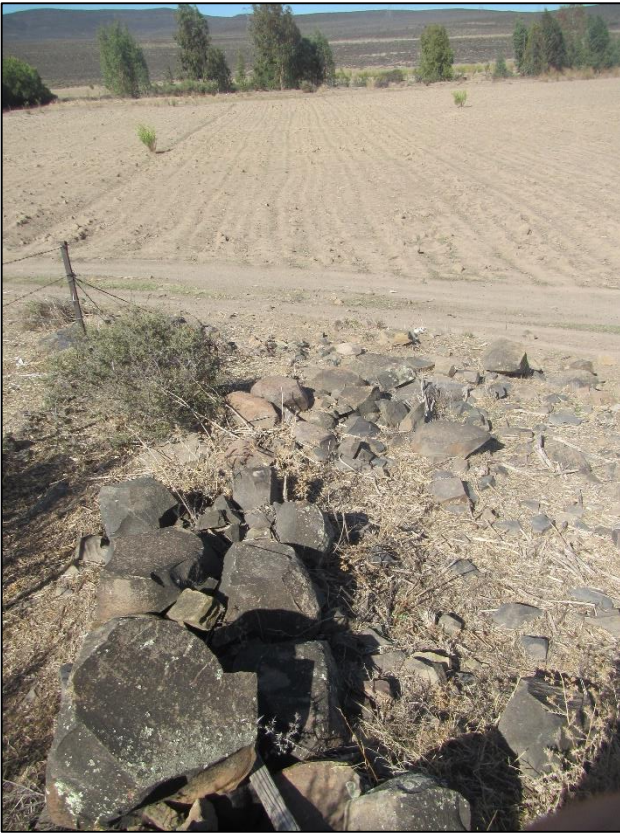
View towards the Southwest across the arable lands from waypoint 063 showing the area from which walling has been completely removed.

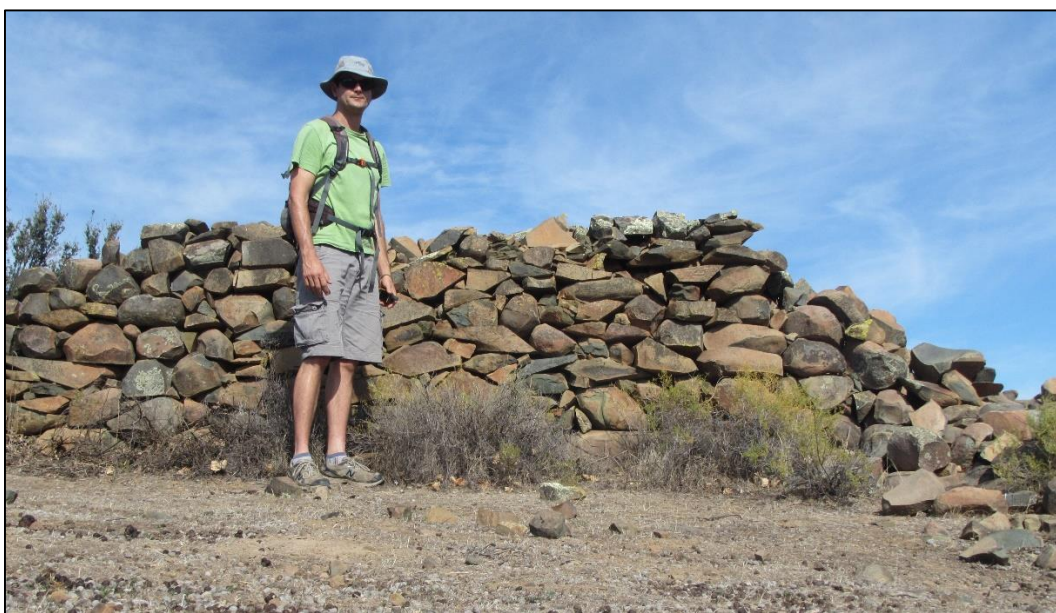
View towards the west of the walling at waypoint 067.

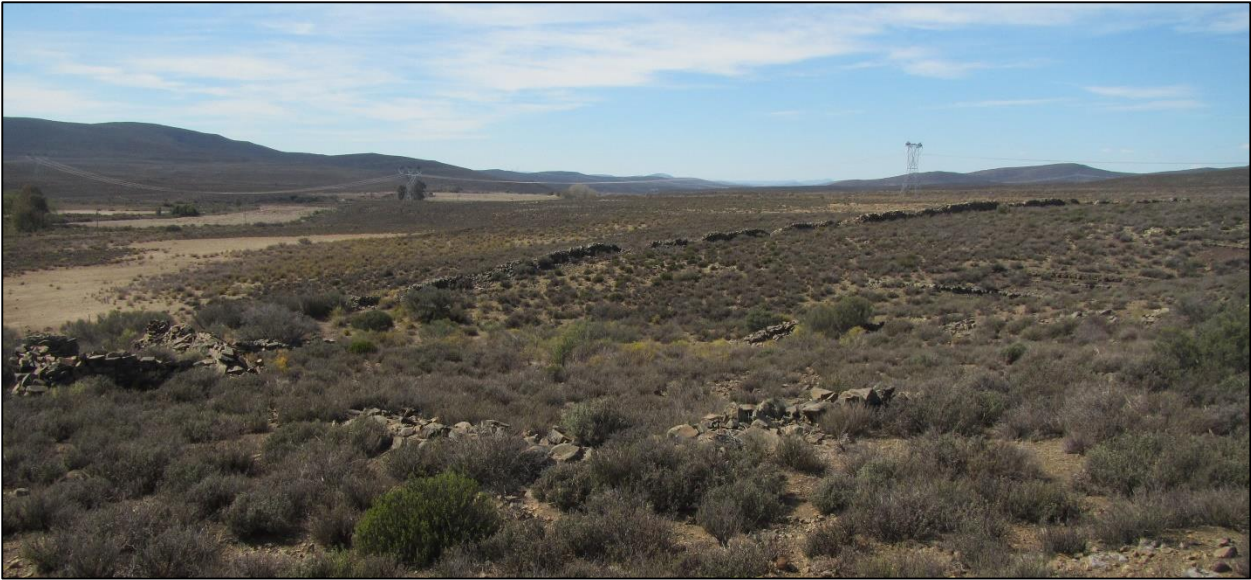
View towards the east across the ruined kraal at waypoints 071 to 075 (visible in foreground at centre and middle ground towards the right) with the main wall in the background.

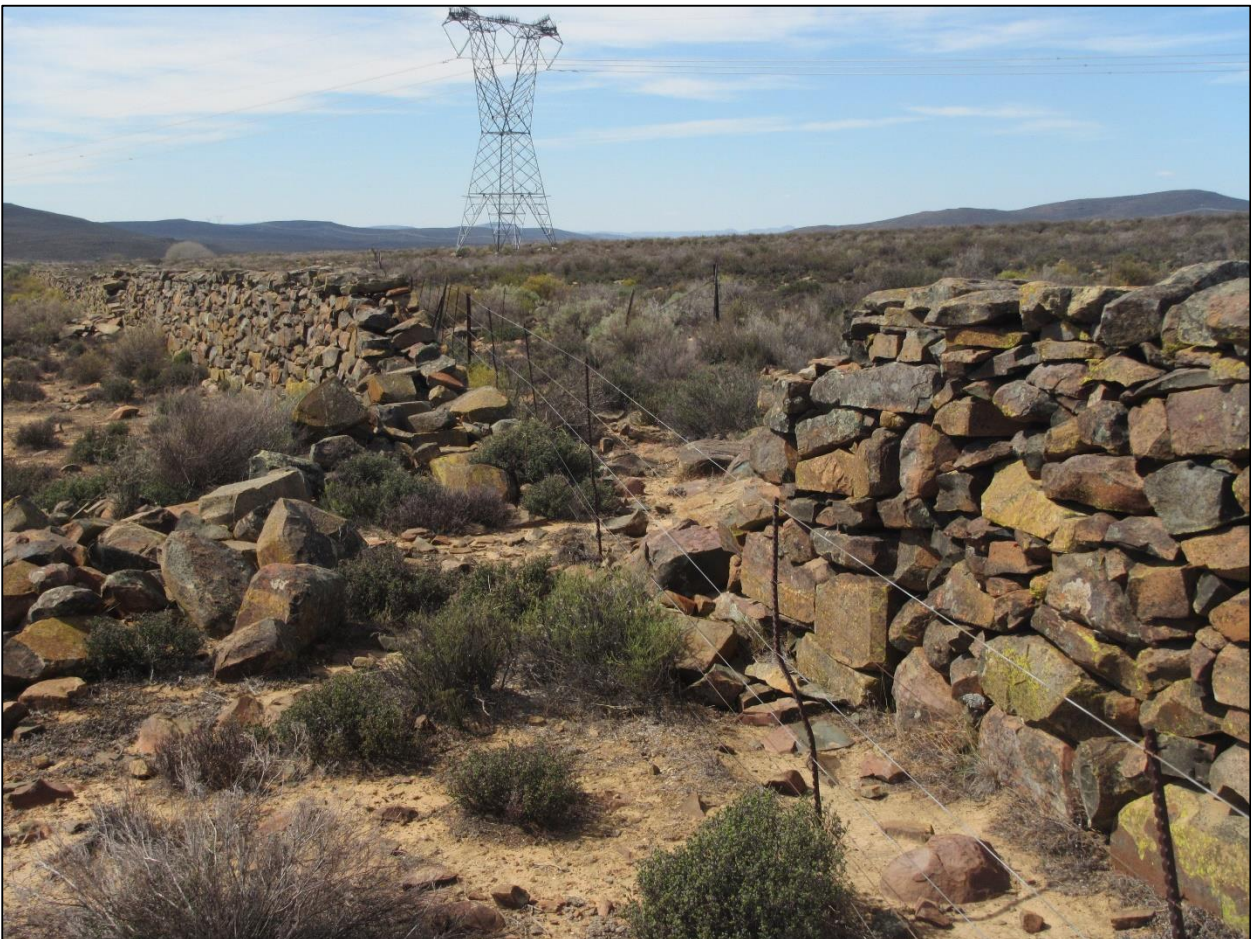
080	S32 54 16.0 E20 37 44.8	Point at which the farm fence crosses the wall and the end of the standing walling referred to in 079 above. The wall is broken right down to ground level and the rocks have been moved away to the side.
081	S32 54 15.5 E20 37 53.9	Point at which the walling has been broken down for an Eskom service road to pass through. The wall is broken right down to ground level and the rocks have been moved away to the side.
082	S32 54 14.8 E20 38 03.0	The western end of a section of wall that is built with mostly cobbles instead of the usual dominance of slabs. This point is 45 m east of a slight corner in the wall.
083	S32 54 14.0 E20 38 05.5	Eastern point on a low section of walling forming an alcove against the main wall. Only the 'foundation' remains visible. It was not possible to be totally certain that this was a stone alignment.
084	S32 54 13.8 E20 38 05.3	Point on the above alcove.

View towards the east showing a place at waypoint 080 where the wall has been demolished to facilitate wire fence construction.

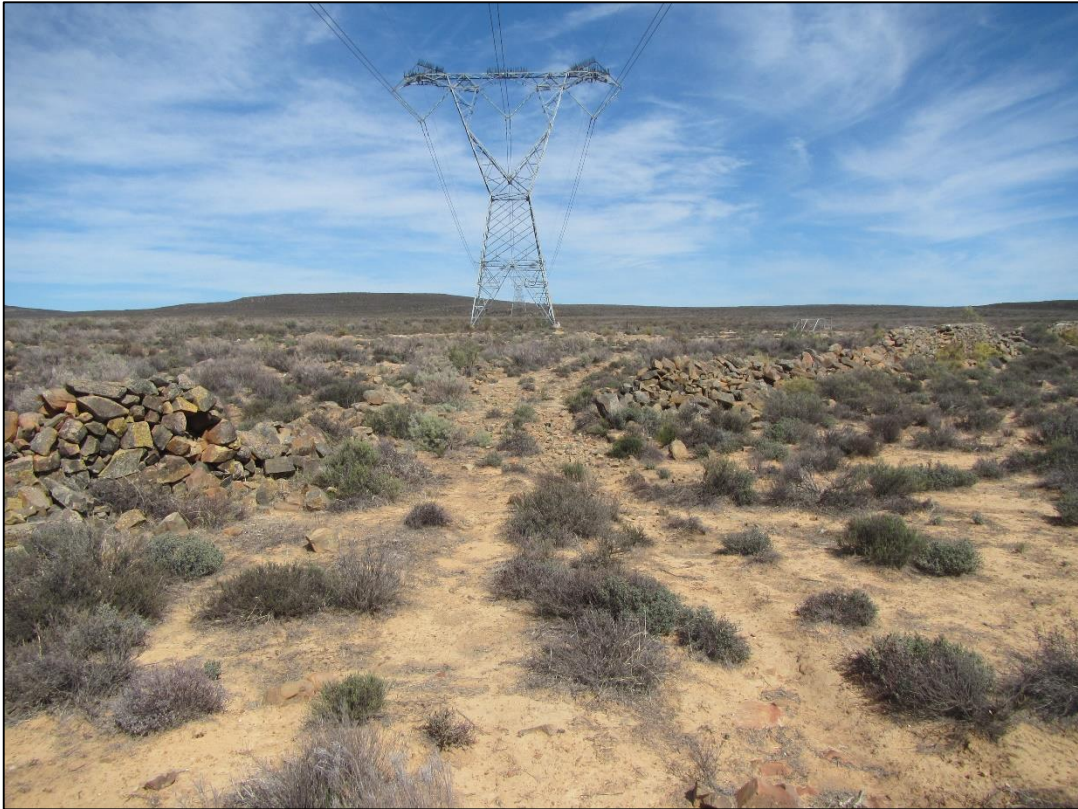
More recent damage has occurred with the construction of Eskom power lines across the property. A service track runs alongside the lines and in two places the walling has been demolished to allow this track to pass though (e.g. waypoints 081 & 102). The rocks have just been pushed to the side. The servitude for these lines was registered in 1989 so the destruction must have occurred in or shortly after that year.

View towards the southwest showing a place at waypoint 081 where the walling has been demolished for an Eskom service road to pass through it.

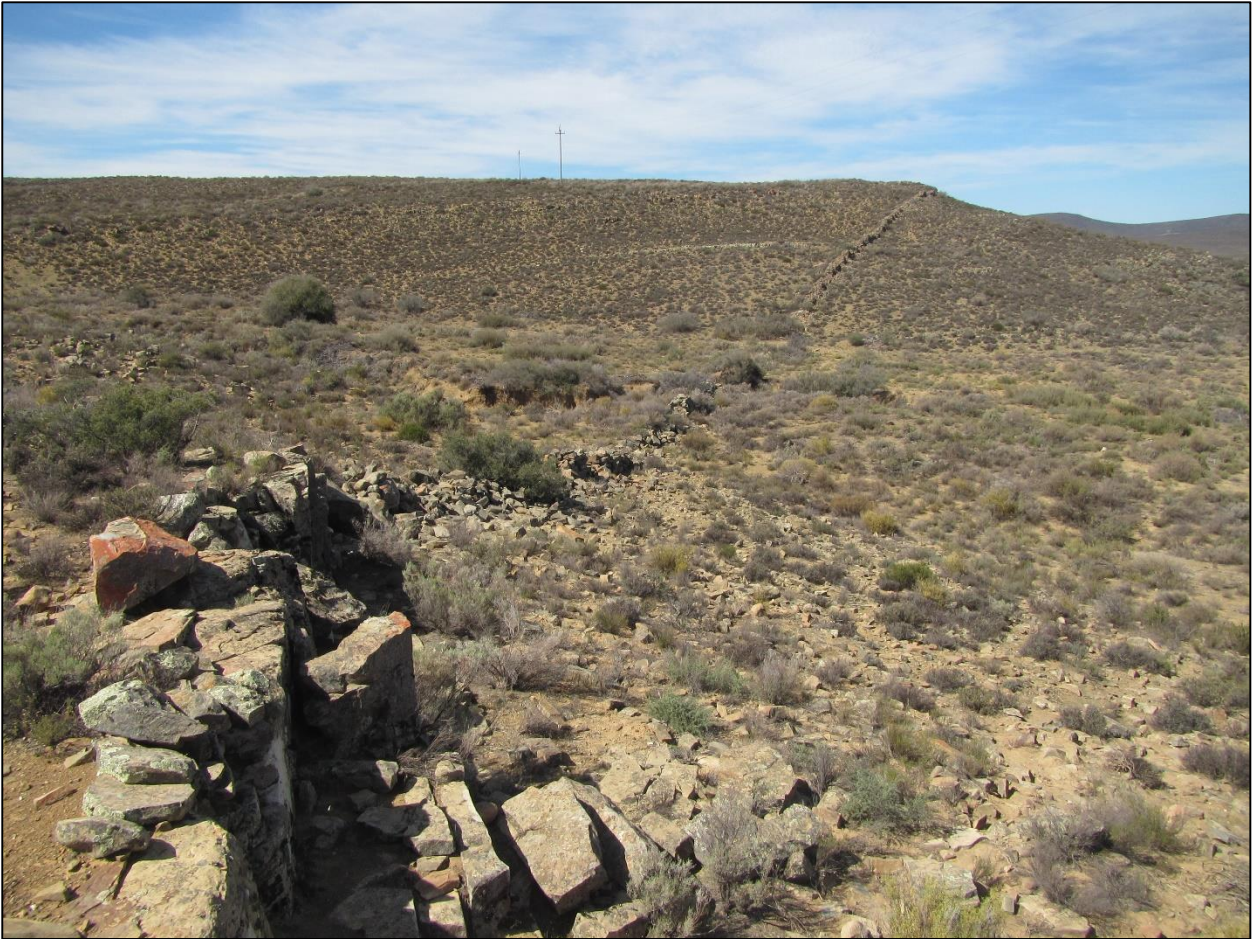
View towards the southwest from waypoint 108 showing the stone walling extending from the point where the natural cliff line ends. A few rocks are also evident on top of the low cliff in the foreground.
