**DESTRUCTION PERMIT APPLICATION
REPORT
FOR
KANGALA COAL PROJECT**

UNIVERSAL COAL PLC

MARCH 2013

Project Number: **UNI2131**

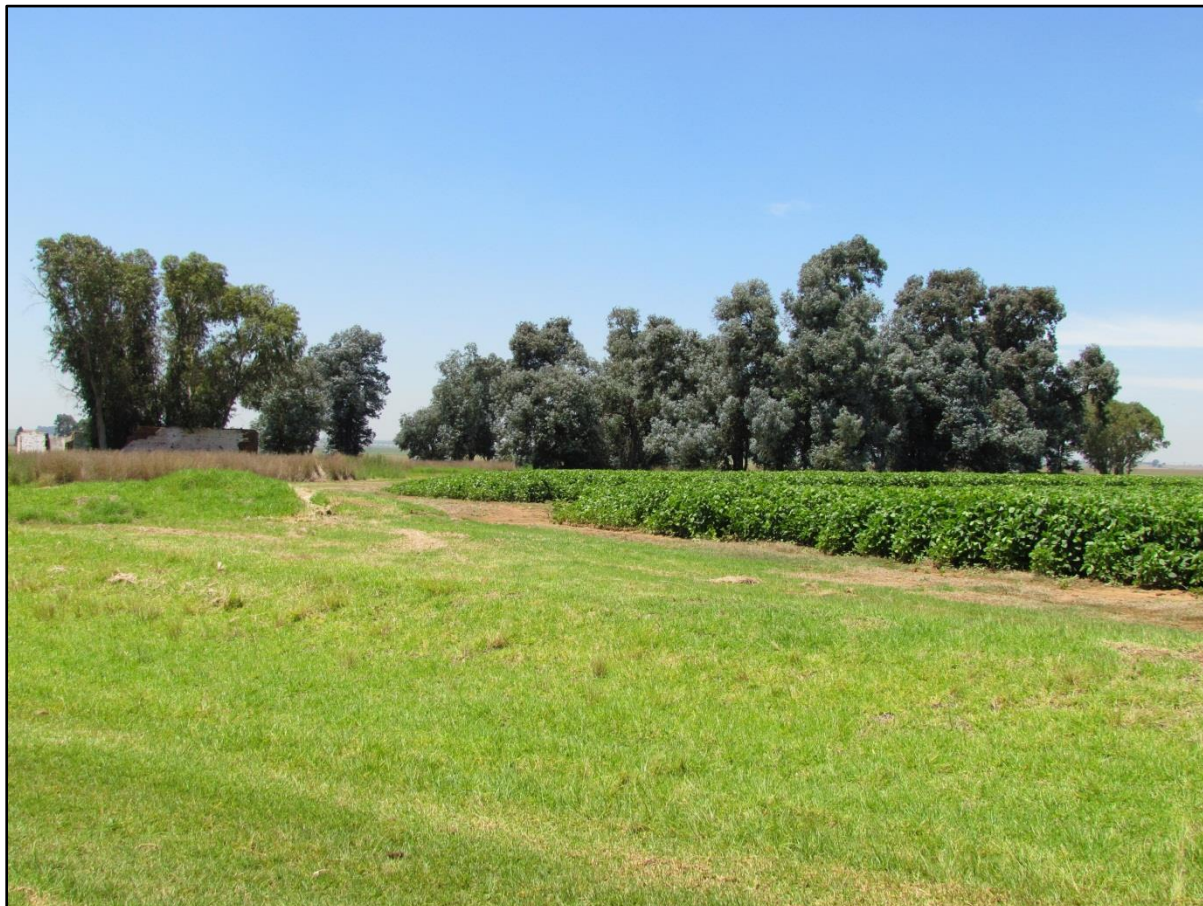
Site 2 was situated on a gentle slope near a grove of various *Eucalyptus* species illustrated in Figure 3-1 below. The *werf* was surrounded by agricultural fields as indicated in Figure 3-1 and Plan 5 in Appendix A. Location and other relevant details are summarised in

Figure 3-1: Eastern view of Site 2

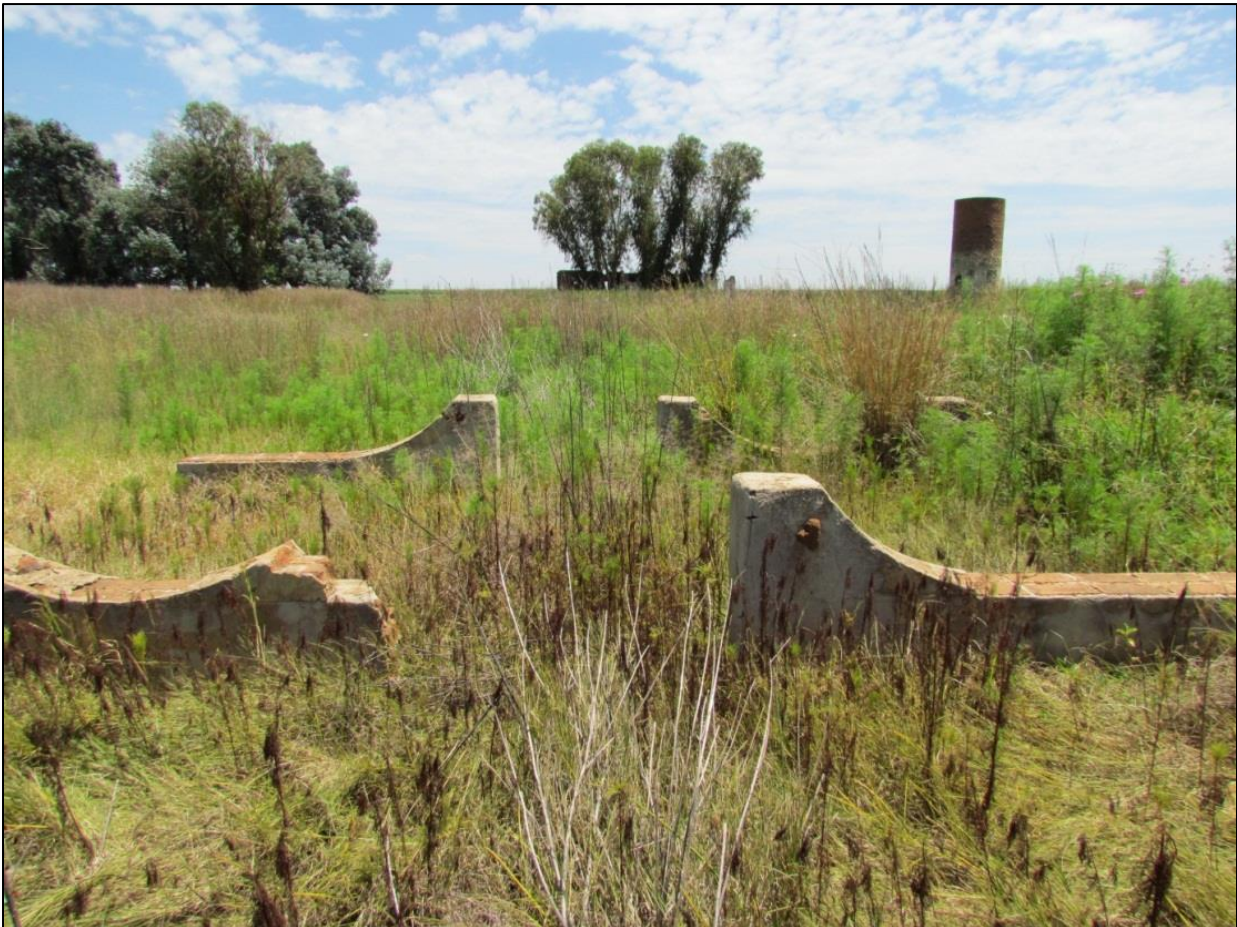
Figure 3-2: Eastern elevation of the main structure. Note the entrance gate and water tower

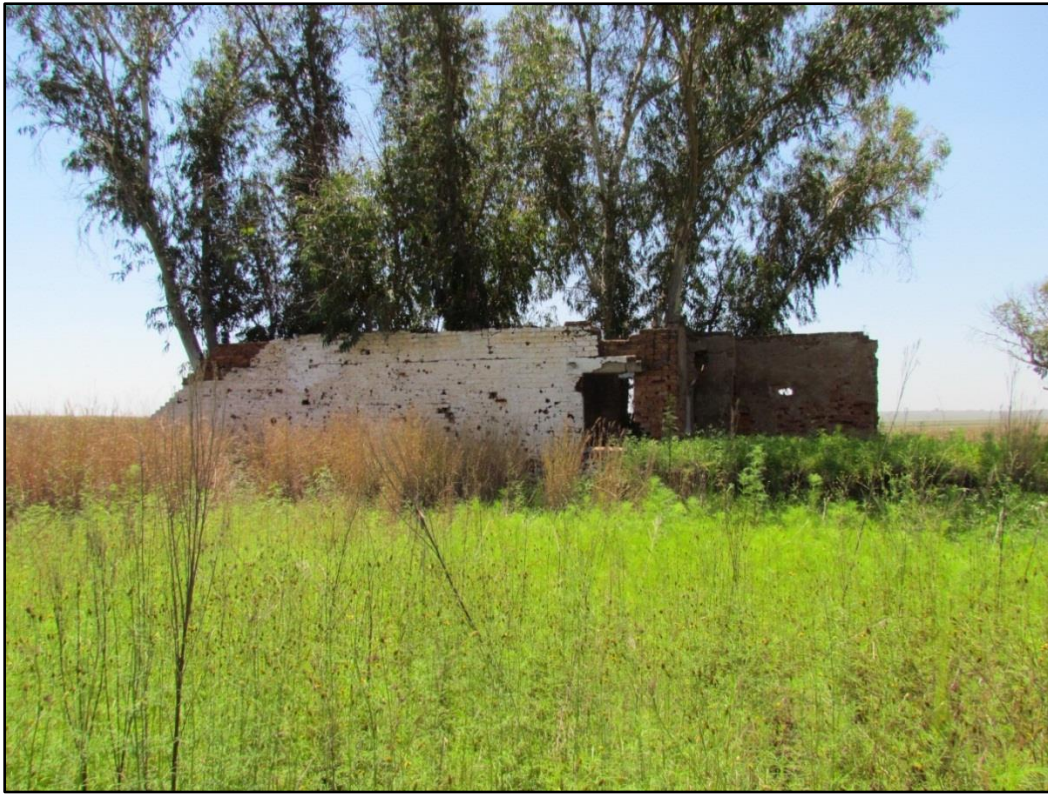
Figure 3-3: Western elevation of the main structure at Site 2

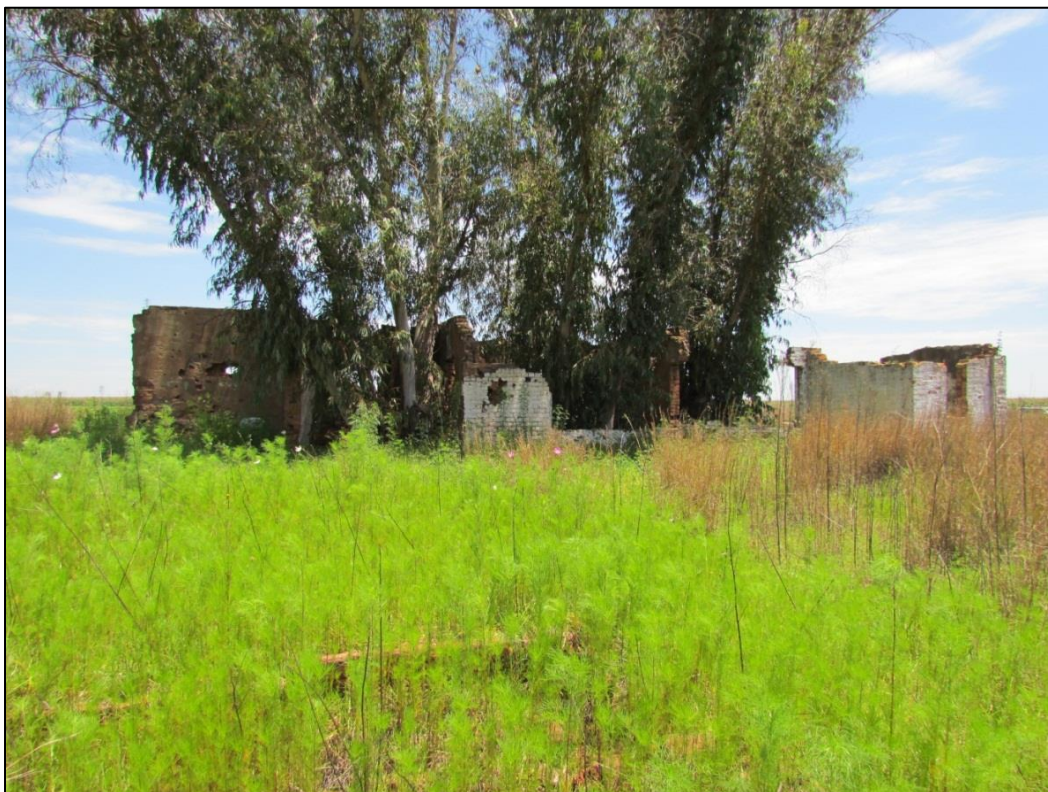
The main residential structure illustrated in Figure 3-3 to Figure 3-6, as well as Plan 6, was a brick and mortar building. A total of six Blue Gum trees growing through three rooms of the structure as shown in Figure 3-4. Walls were constructed with fired clay brick indicated in Figure 3-7. The bricks are fired bricks due to the presence of vitrification within the material. The mortar used consists of cement with river sand inclusion indicated in Figure 3-7. The visible foundations provided an approximate surface area of 17 m x 8.5 m as indicated in Plan 4a. The exterior walls were constructed using the cavity-wall technique as seen in Figure 3-8. The walls were quite high, measuring 3.5 m high.

Figure 3-4: Eastern elevation of the main structure at Site 2

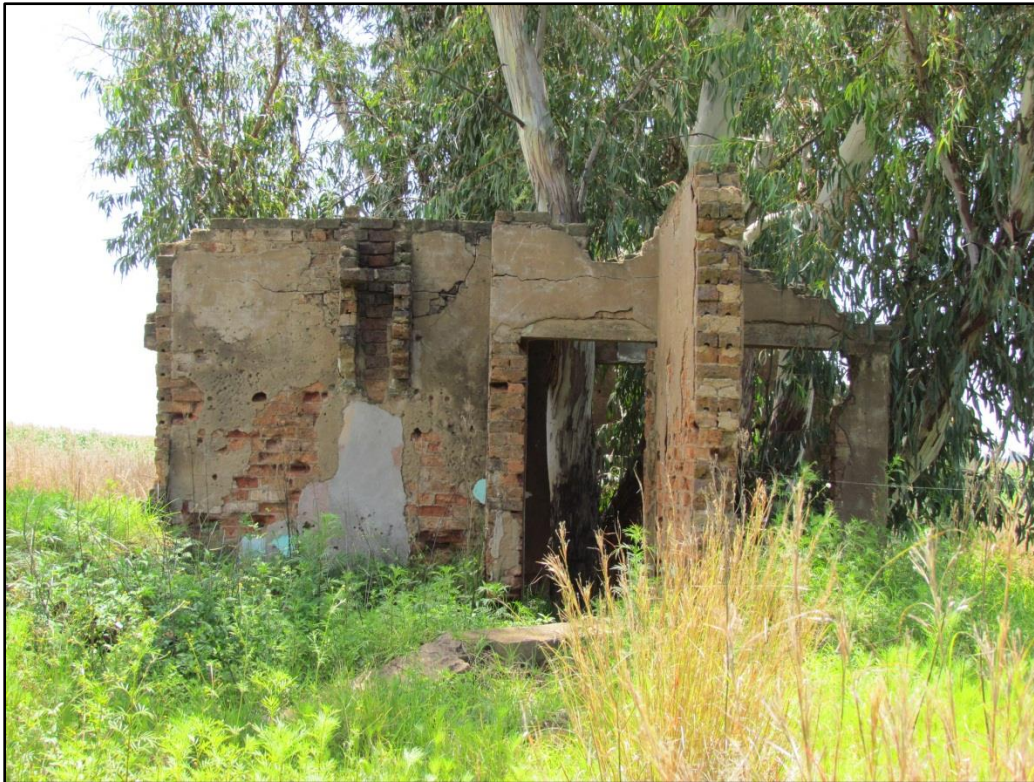
Figure 3-5: Southern elevation of the main structure at Site 2

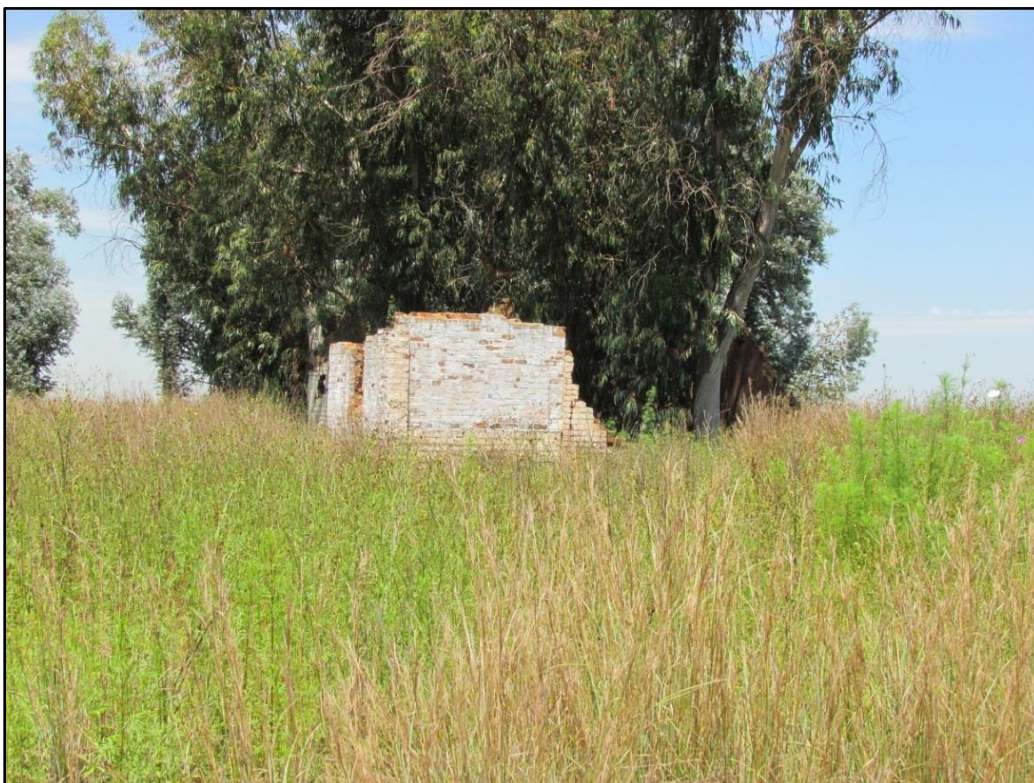
Figure 3-6: Northern elevation of the main structure at Site 2

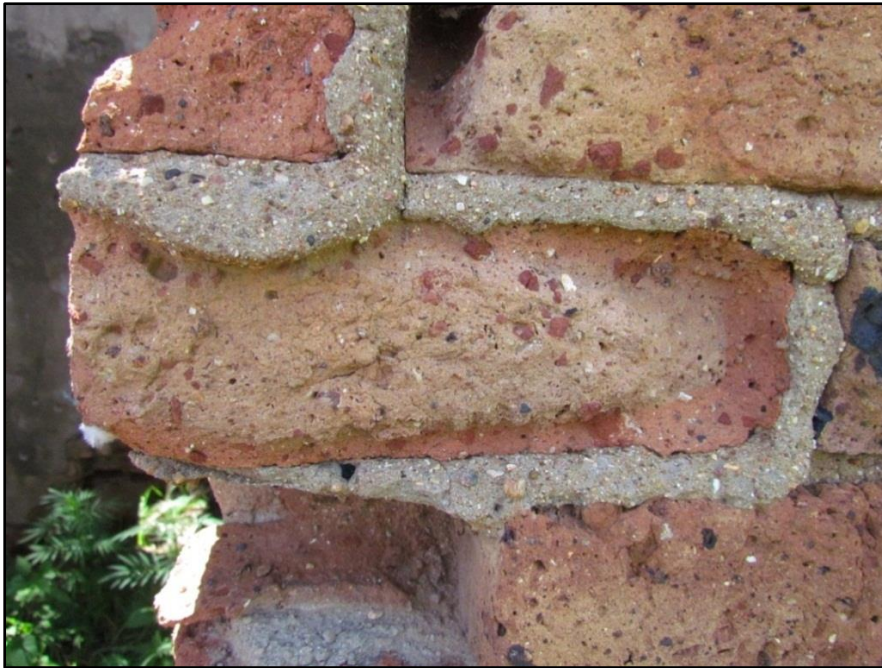
Figure 3-7: Close up view of fired bricks with cement and riversand mortar used in the construction of the main structure

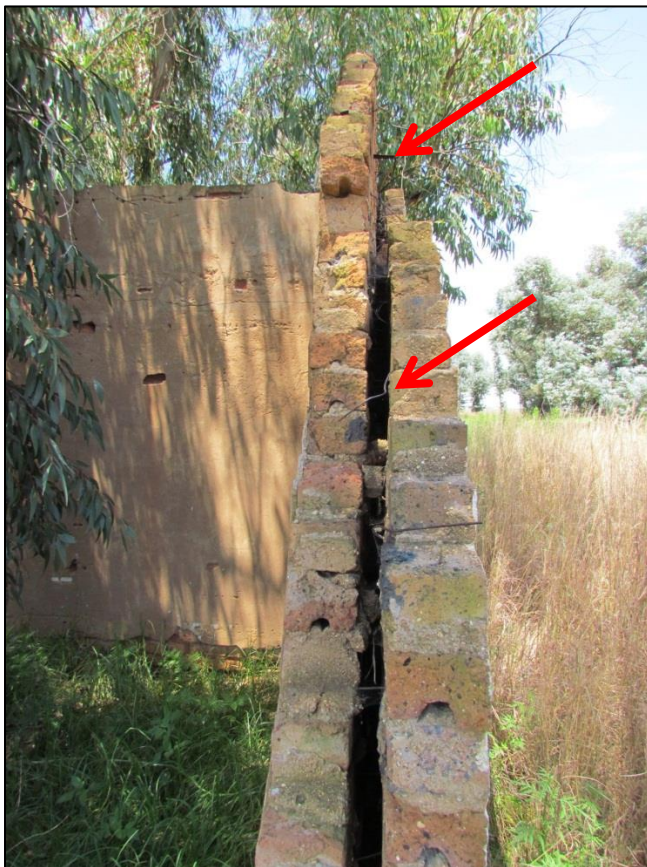
Figure 3-8: Close up of exterior cavity-wall at Site 2. Note metal wire reinforcing in the cavity.

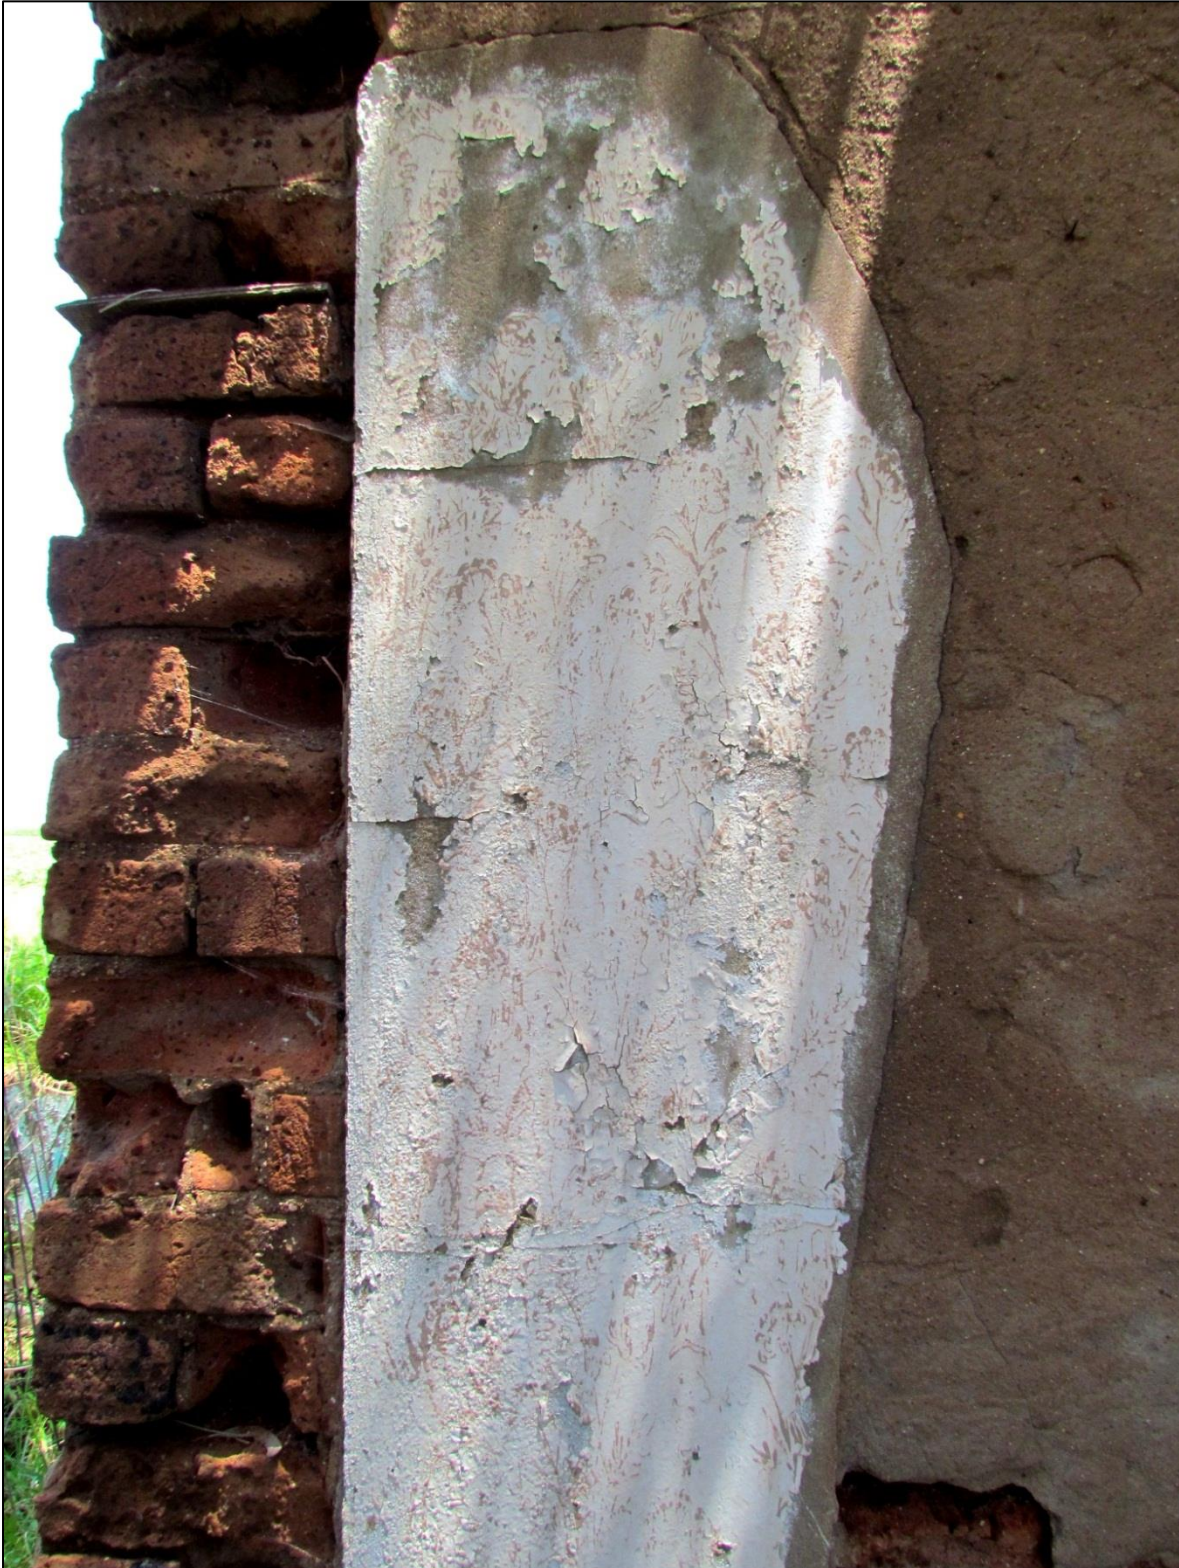
Figure 3-9: Section of wallpaper on the western wall of the entrance hall at Site 2

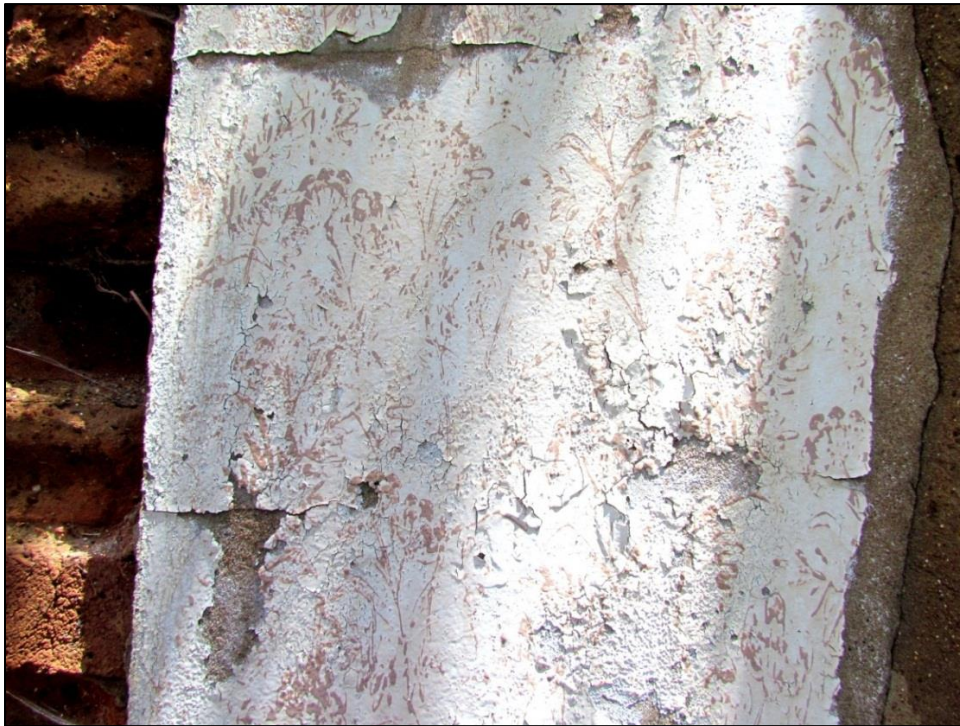
Figure 3-10: Close-up of wallpaper from entrance hall of Site 2

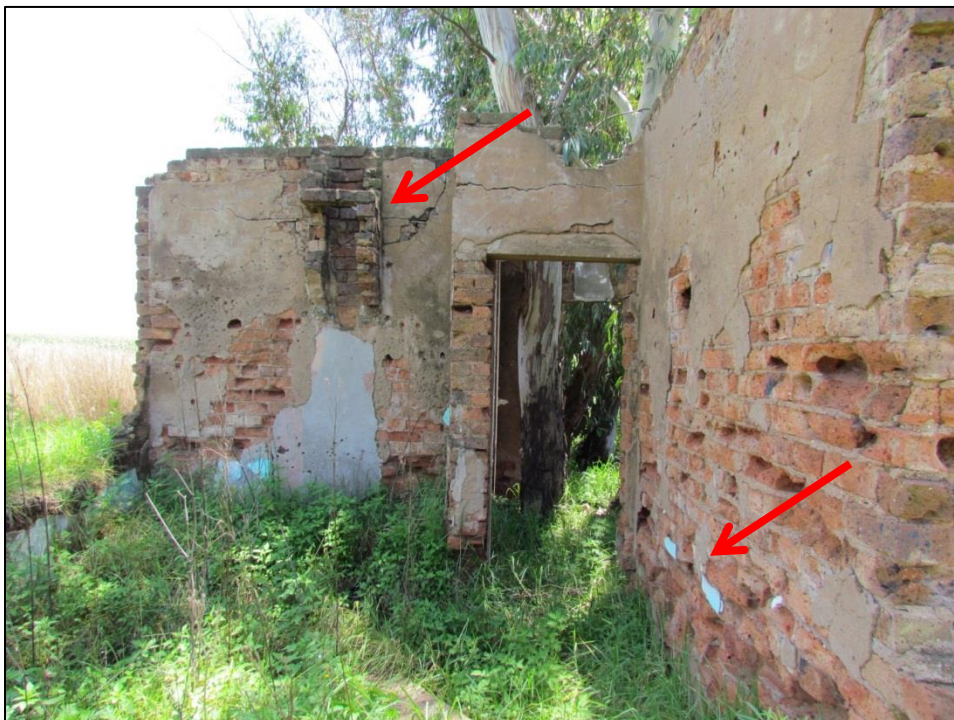
The kitchen, identified by the remnants of a chimney indicated in Figure 3-11 and Figure 3-12, located on the eastern side of the entrance hall measured 4 m x 3 m. The eastern and southern walls of the kitchen have collapsed and a small section of plaster painted in light blue remained on the eastern wall.

Figure 3-11: North Elevation of site 2 and view of kitchen area. Note remnants of kitchen chimney and light blue paint indicated by the red arrows

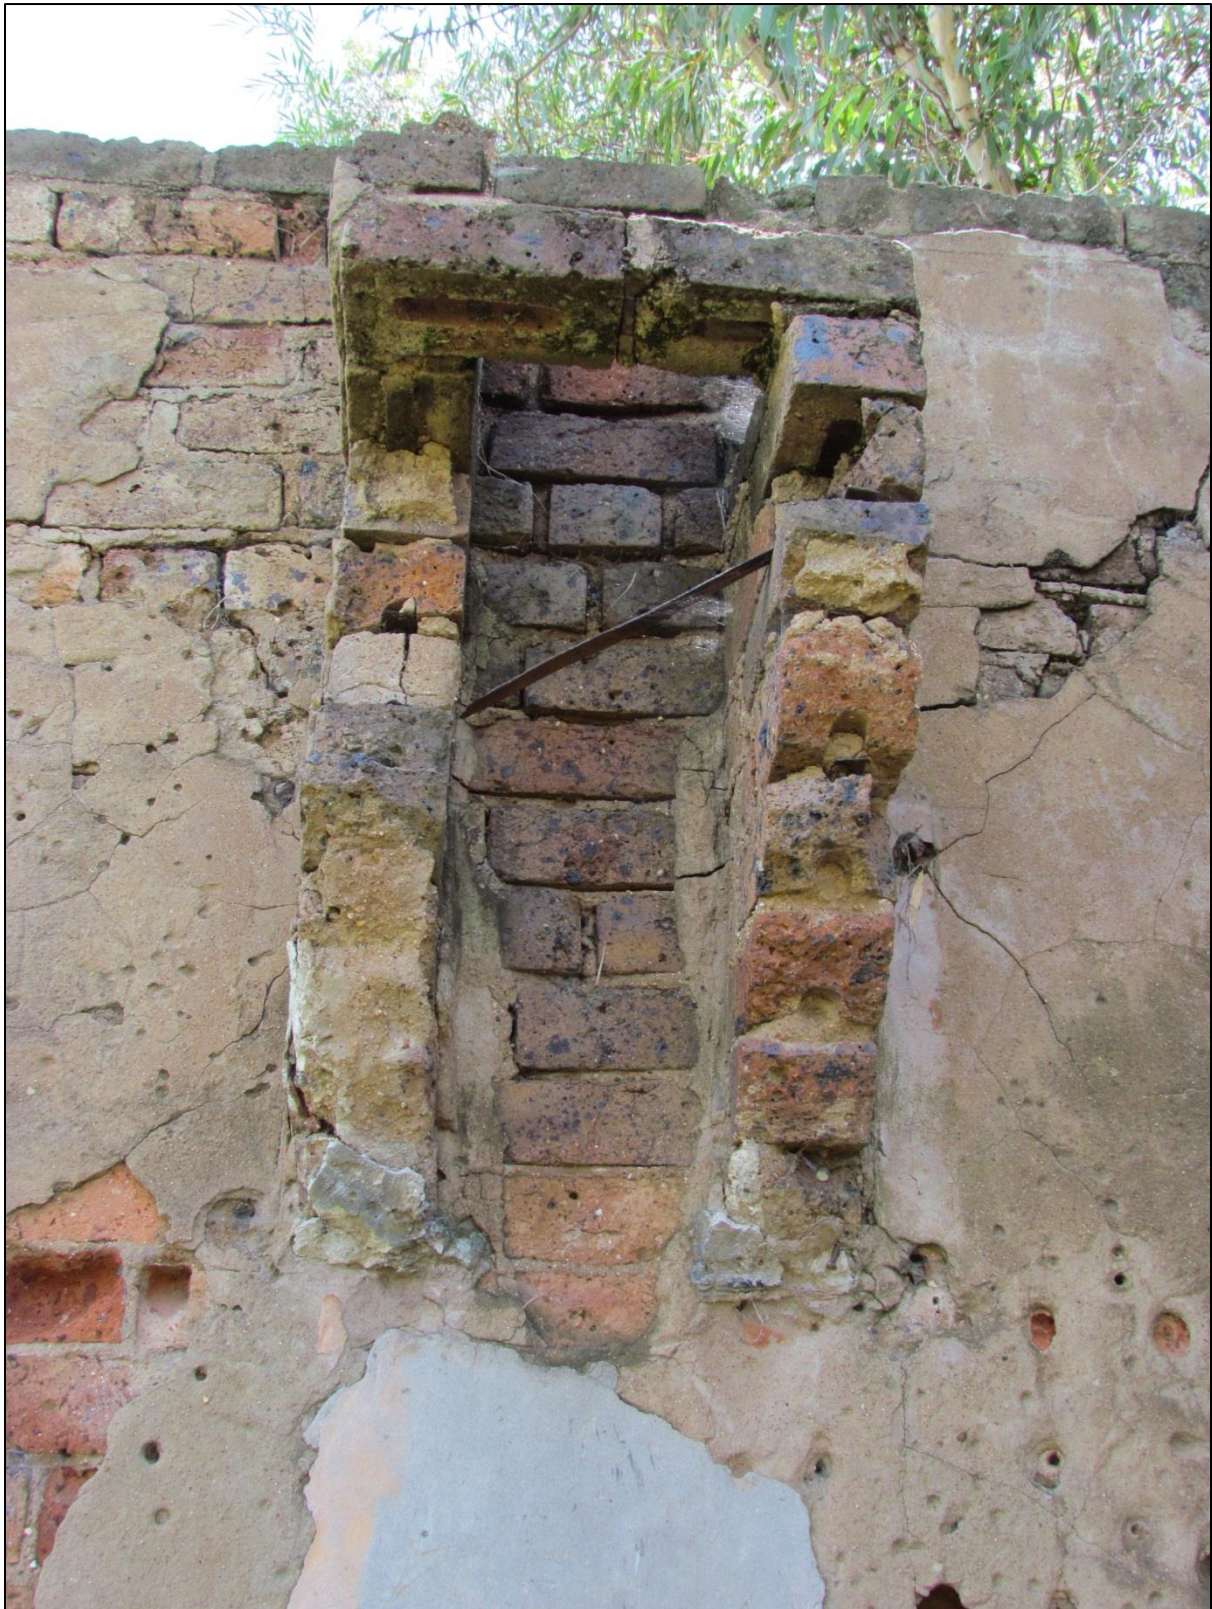
Figure 3-12: Close-up of kitchen chimney with metal flat-bar reinforcing visible

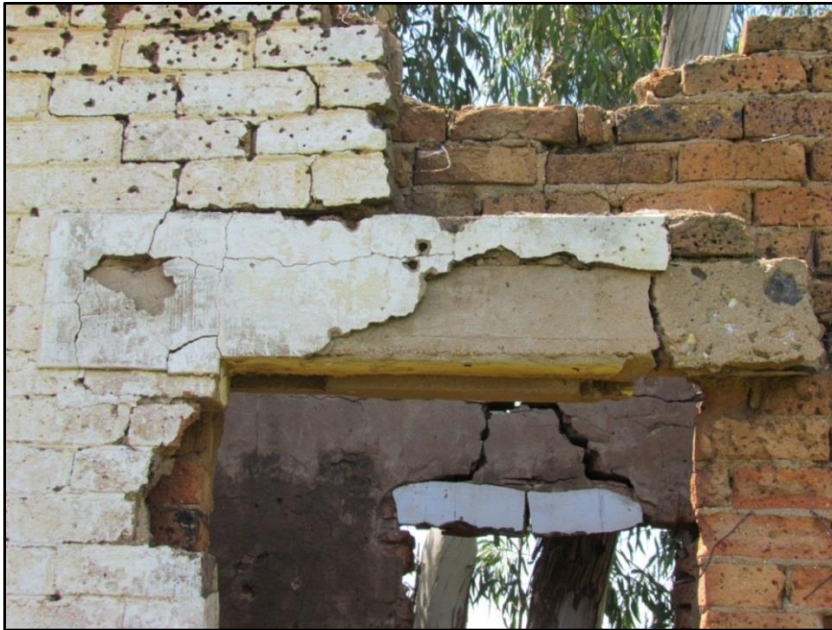
The small room adjacent to the entrance hall measures 3 m x 2.5 m with concrete lintels above the door and window shown in Figure 3-13. These lintels are in very poor condition and seem to be extremely unstable.

Figure 3-13: Window and door lintels in the small room adjacent the kitchen at Site 2

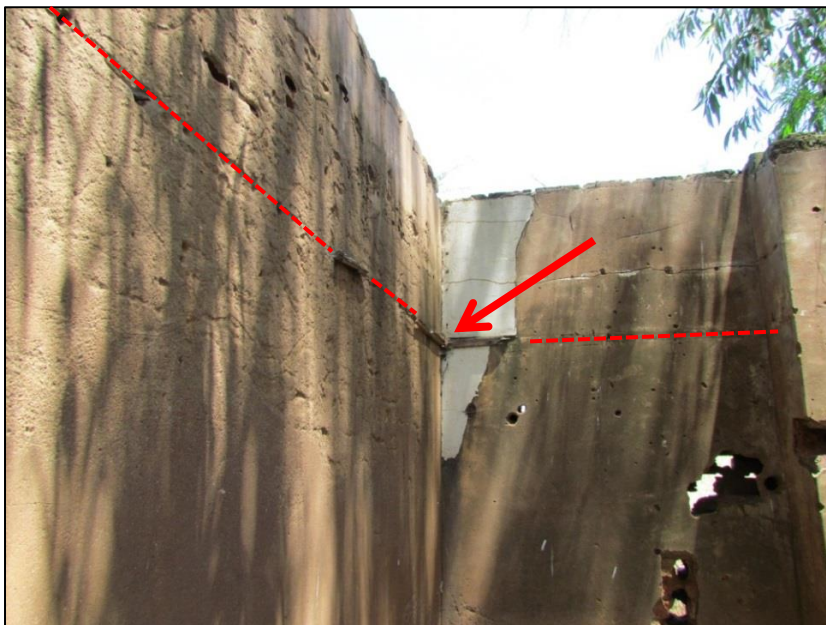
Figure 3-14: Section of wooden dado rail located approximately 2.5 meters above the floor level on the wall of the living room in Site 2

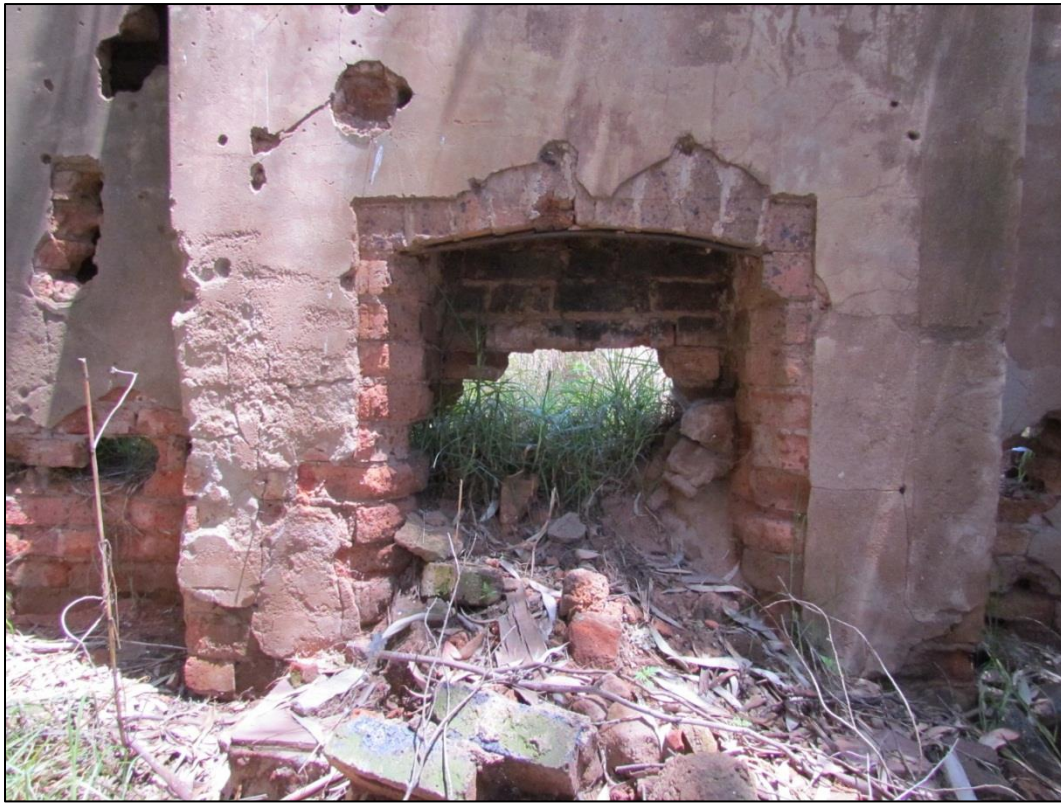
Figure 3-15: Fireplace located in living room in Site 2

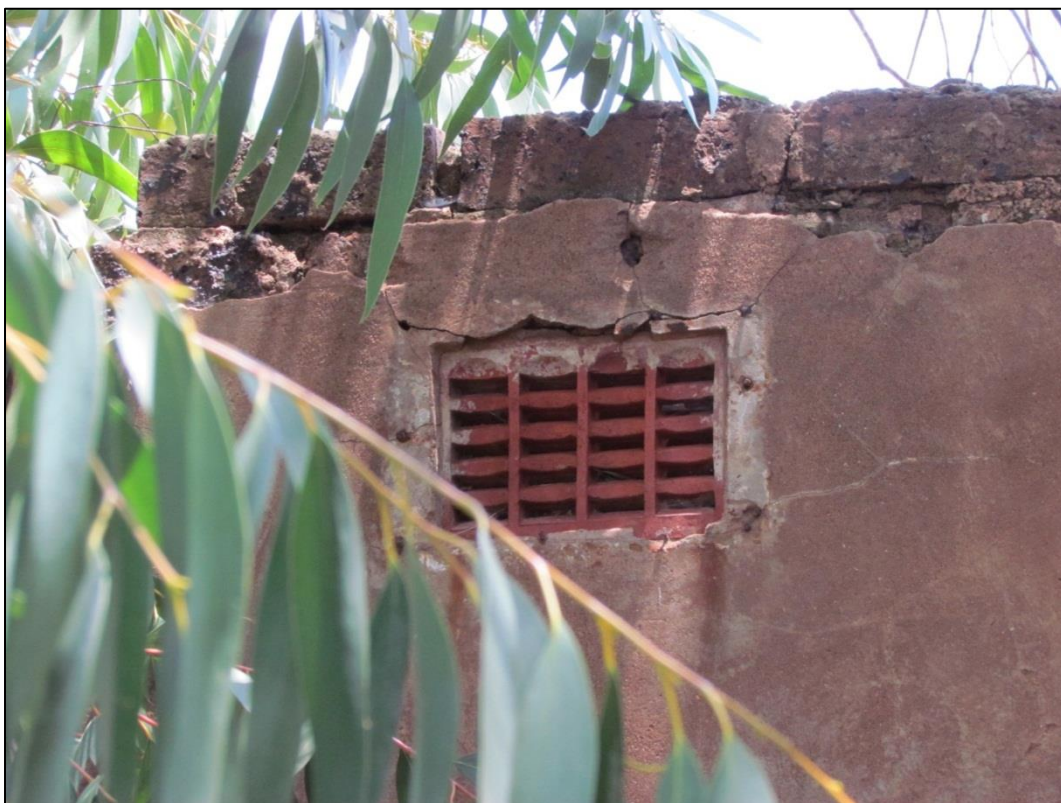
Figure 3-16: Air vent located at the top of a wall in the living room in Site 2

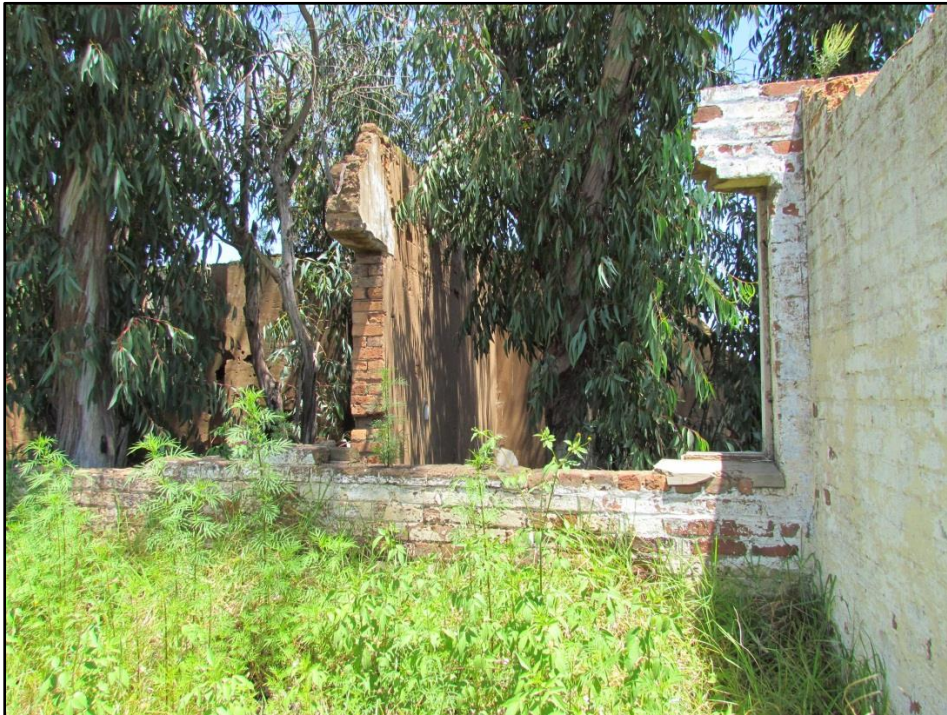
Figure 3-17: Western view of the living room and main bedroom

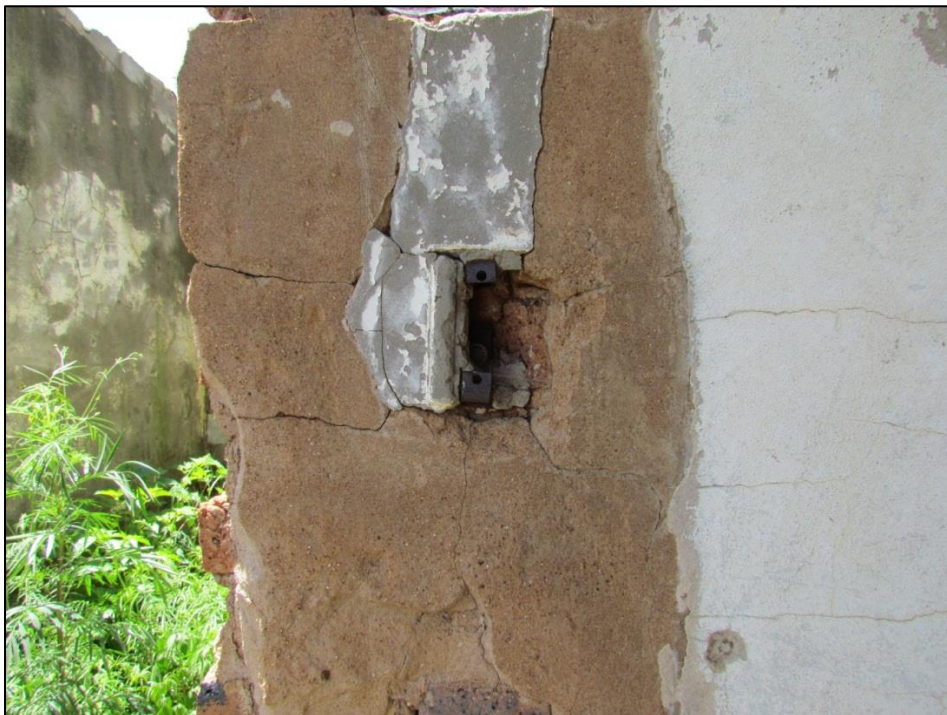
The main bedroom measured 5.5 m x 4.5 m with an en-suite bathroom and a window on the eastern wall as indicated in Figure 3-17. A possible electrical switch was identified on the eastern wall of the main bedroom illustrated in Figure 3-18.

Figure 3-18: Remains of a switch on the eastern wall of the main bedroom at Site 2

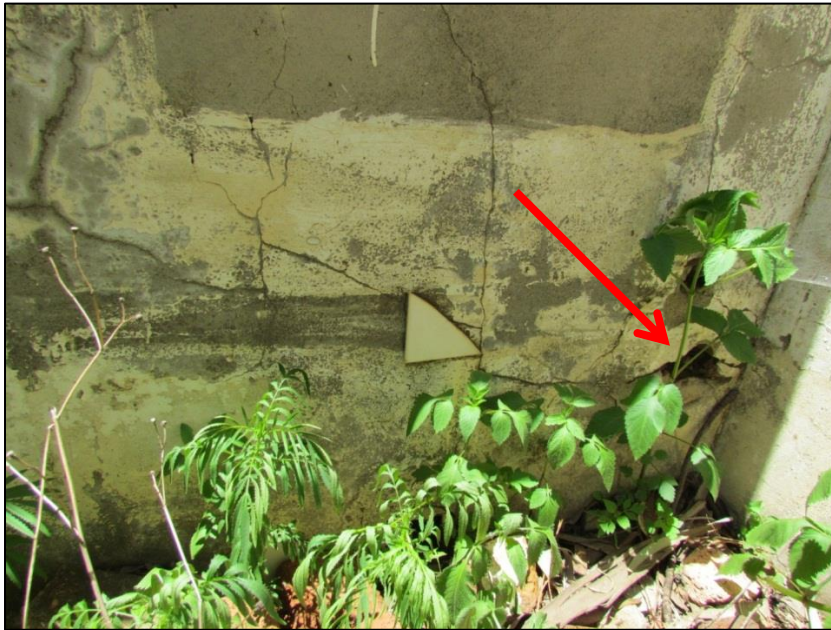
Figure 3-19: Interior view of washroom with fragment of white tile. Note pipe outlets for sink

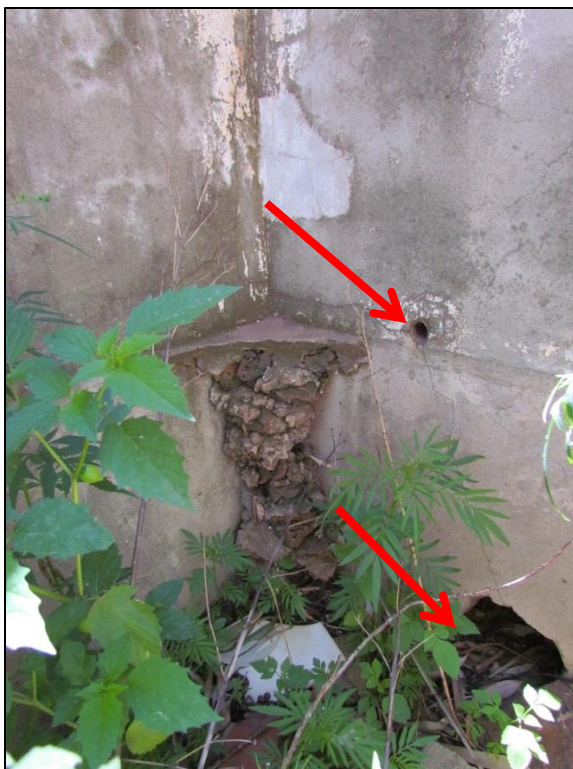
Figure 3-20: Interior view of the washroom with close up of bath support. Note the pipe inlet and outlet for the bath

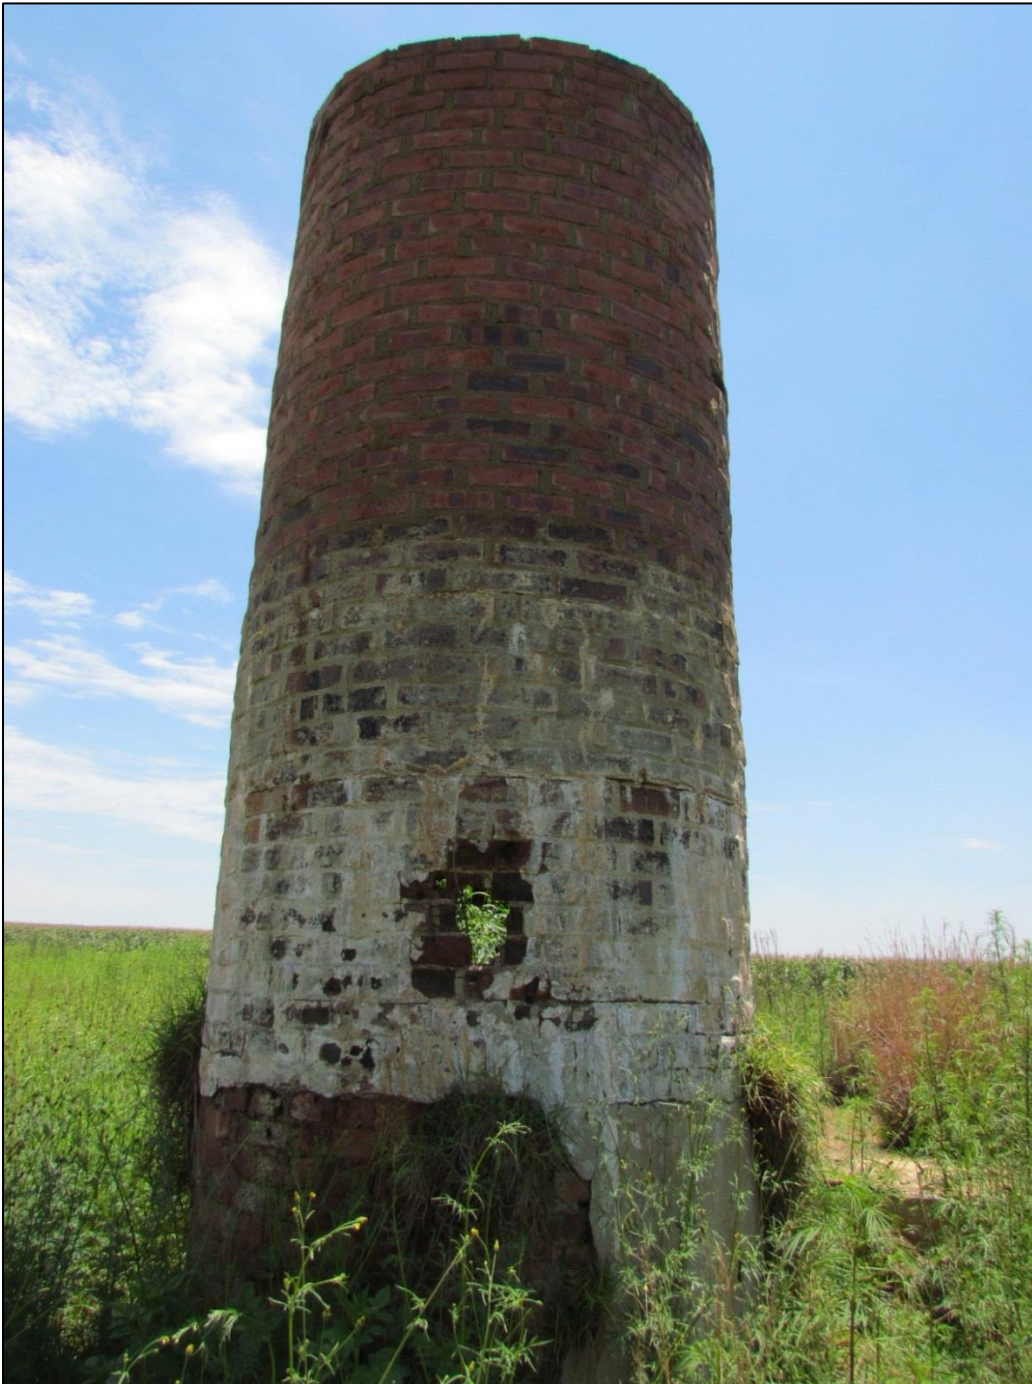
A brick water tower was situated 43 m north-east from the main structure. The brick water tower illustrated in Figure 3-21 is approximately 7 m high and its radius measures 1 m. The bricks used to construct the water tower are similar to those used in the residential structure. A water pump, borehole and reservoir foundation (2.7 m radius) are located adjacent to the water tower, as shown in Figure 3-22 to Figure 3-24. The reservoir foundation would have been part of a corrugated farm dam reservoir. A 10 m x 1.5 m long brick water trough is also located near the water tower as shown in Figure 3-25.

Figure 3-21: Brick water tower located north-east of main structure at Site 2

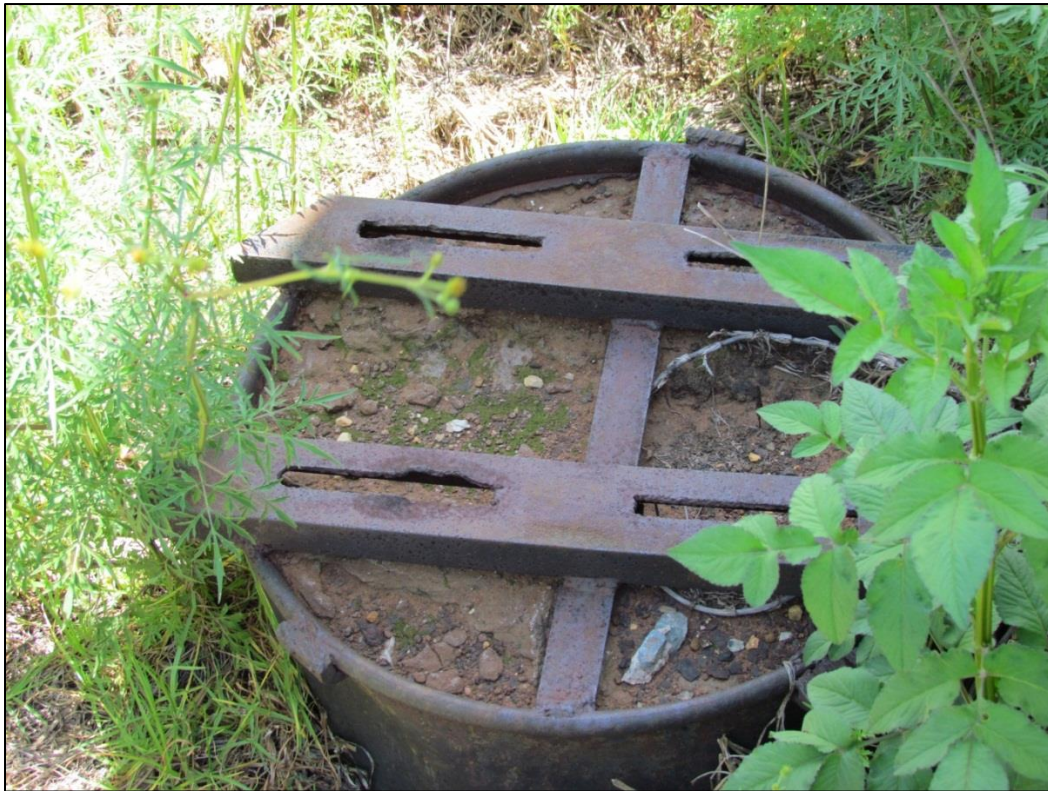
Figure 3-22: Borehole pump housing noted adjacent to water tower near borehole.

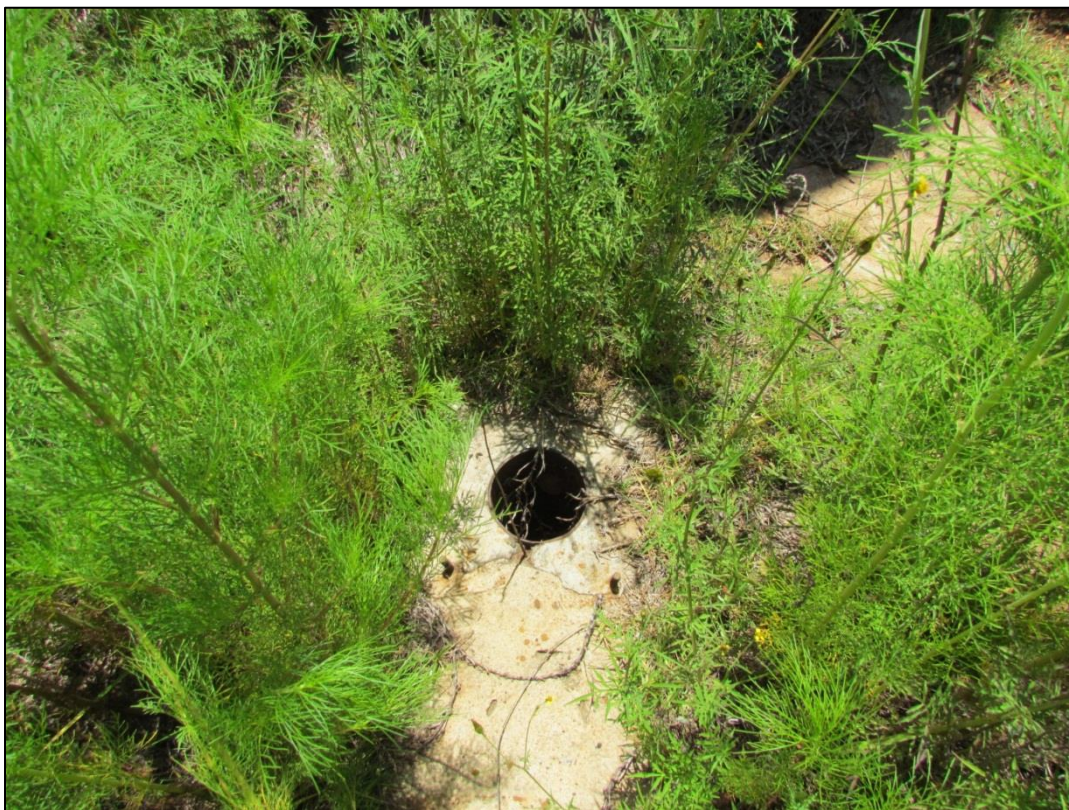
Figure 3-23: Borehole at Site 2 next to water tower.

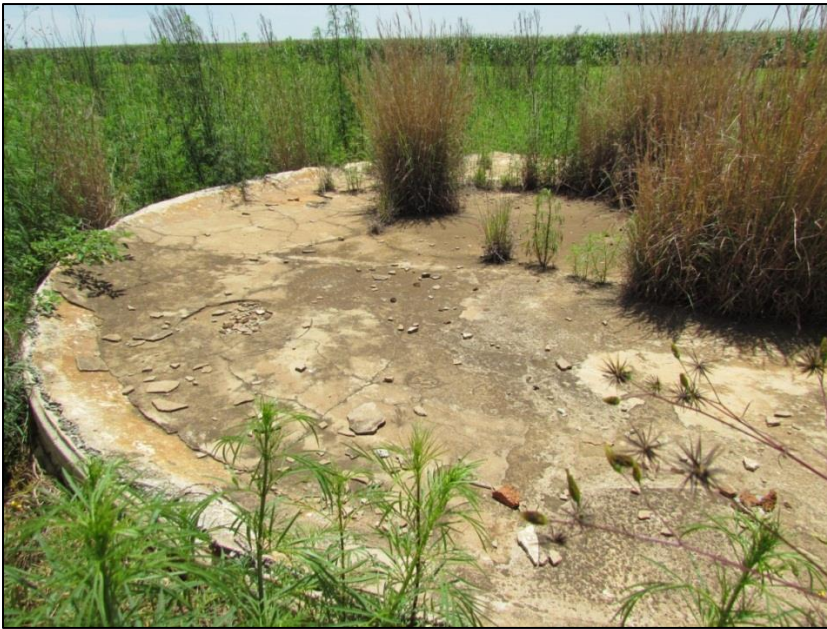
Figure 3-24: Reservoir foundation located next to water tower at Site 2

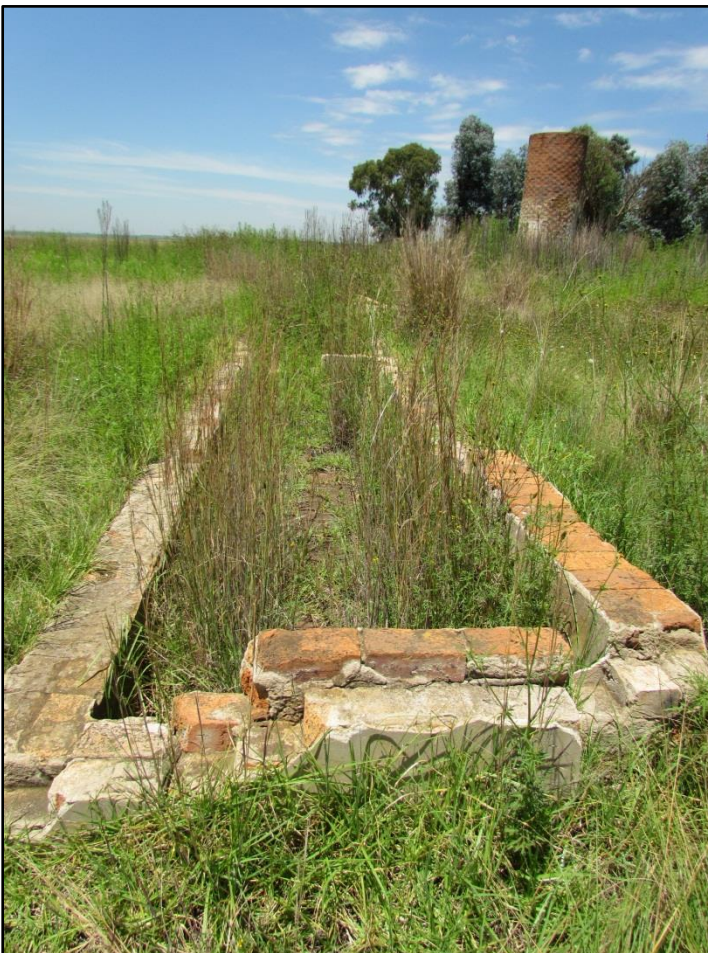
Figure 3-25: Brick water trough

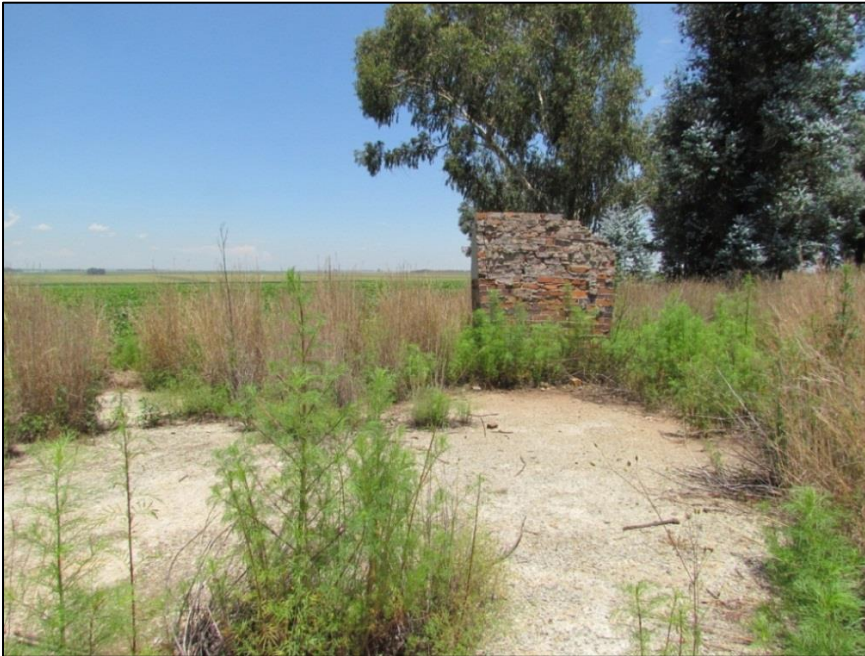
Figure 3-26 indicates one of concrete foundations measuring 10.3 m x 8.3 m. The second concrete floor measures 17.9 m x 10.9 m. The concrete floors may have been the foundations of a storage shed or workshop area. A brick structure measured 2 m x 2 m and is located north-east of the concrete floors indicated in Figure 3-27. The third foundation (6.1 m x 4.2 m) is situated adjacent to the main structure and very close to the outhouse toilet pit.

Figure 3-26: Large concrete floors located south-east of the main structure at Site 2
