**DESTRUCTION PERMIT APPLICATION
REPORT
FOR
KANGALA COAL PROJECT**

UNIVERSAL COAL PLC

MARCH 2013

Project Number: **UNI2131**

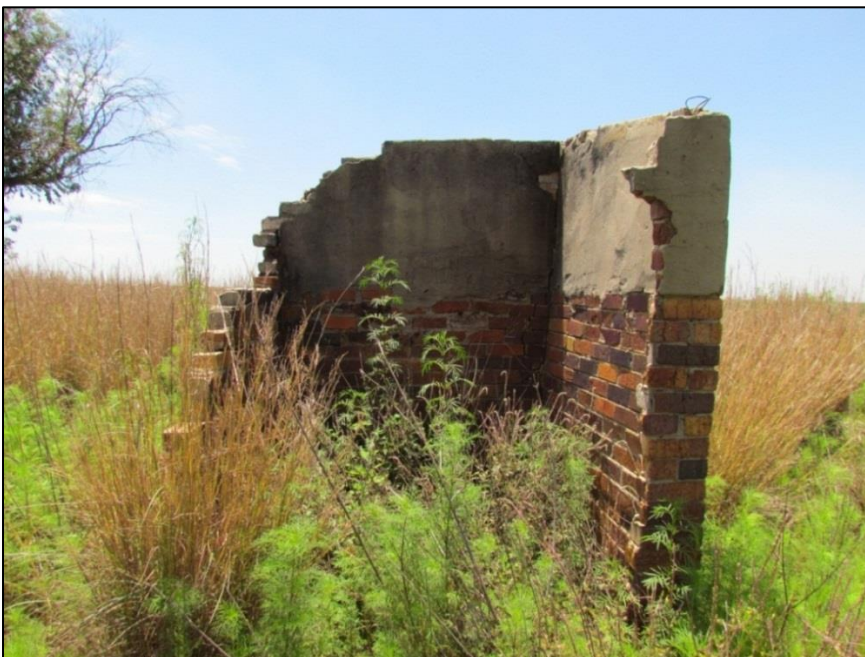
Figure 3-27: A small brick structure located north-east of the concrete floors

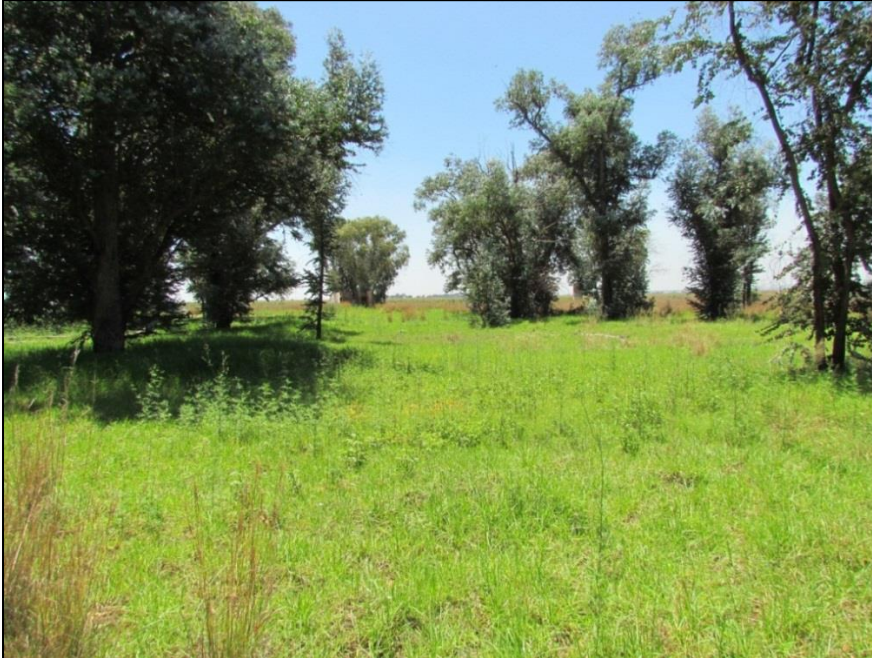
A cleared area located 25.4 m south from the residential structure is surrounded by *Eucalyptus* species trees as shown in Figure 3-28, as well as Plan 5 and Plan 6. The area includes dilapidated foundations and concentrations of rocks which may be the remains of stock enclosures, as indicated in Figure 3-29.

Figure 3-28: Grove of various species of *Eucalyptus* trees south of residential structure

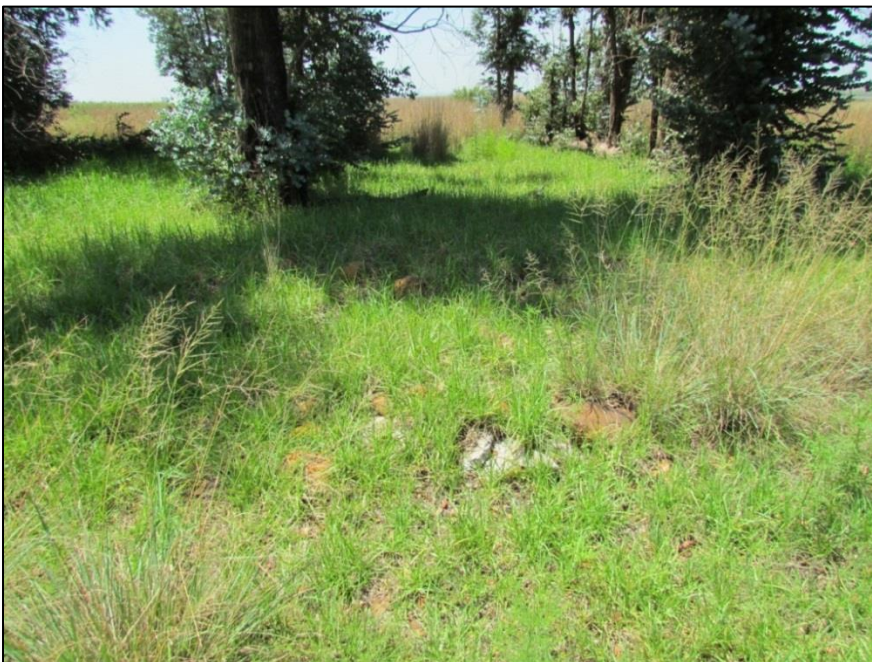
Figure 3-29: Concentration of rocks in open area that may indicate stock enclosures located south of the main structure at Site 2

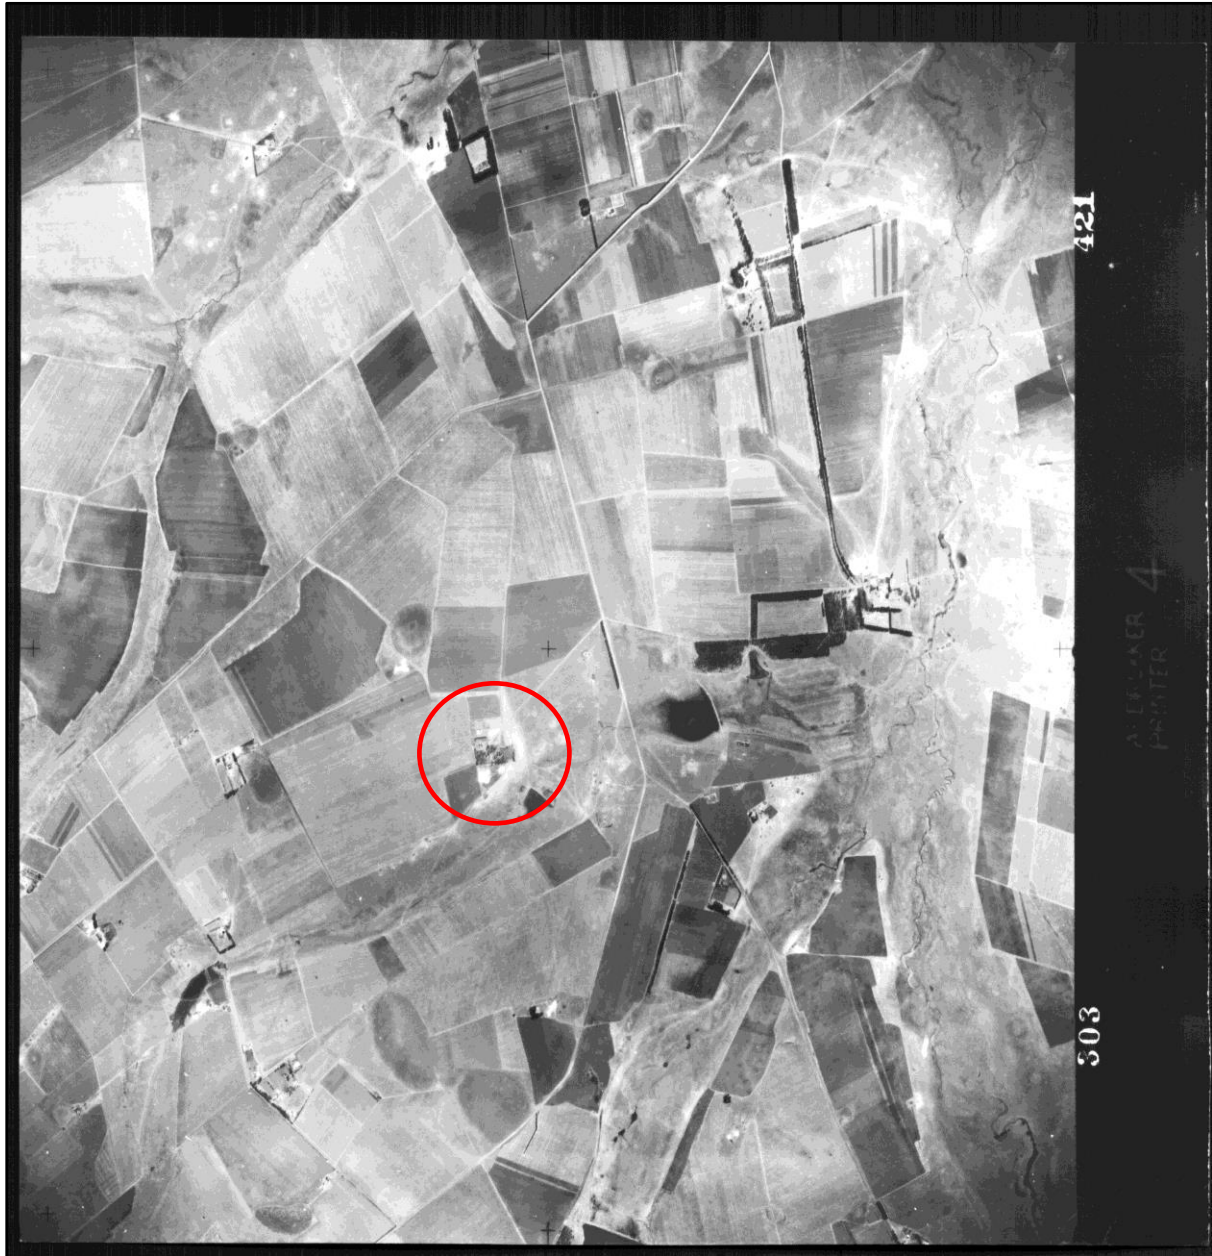
A 1953 aerial photograph illustrated in Figure 5-3 shows Site 2 with well-established fields, roads and trees within its surrounds. This aerial photograph confirms that the structure and its surrounding infrastructure are older than 60 years old.

Figure 5-3: Structure identified by Fourie (2009) present on an aerial photograph dating to 1953 (303_006_00421)
