**New Multi Product Pipeline
(NMPP) Project**

The Mitigation Of All Heritage
Sites Affected By The NMPP

2684358-UM-PL1- ENV-RP-002

<Heritage Impact
Assessment >

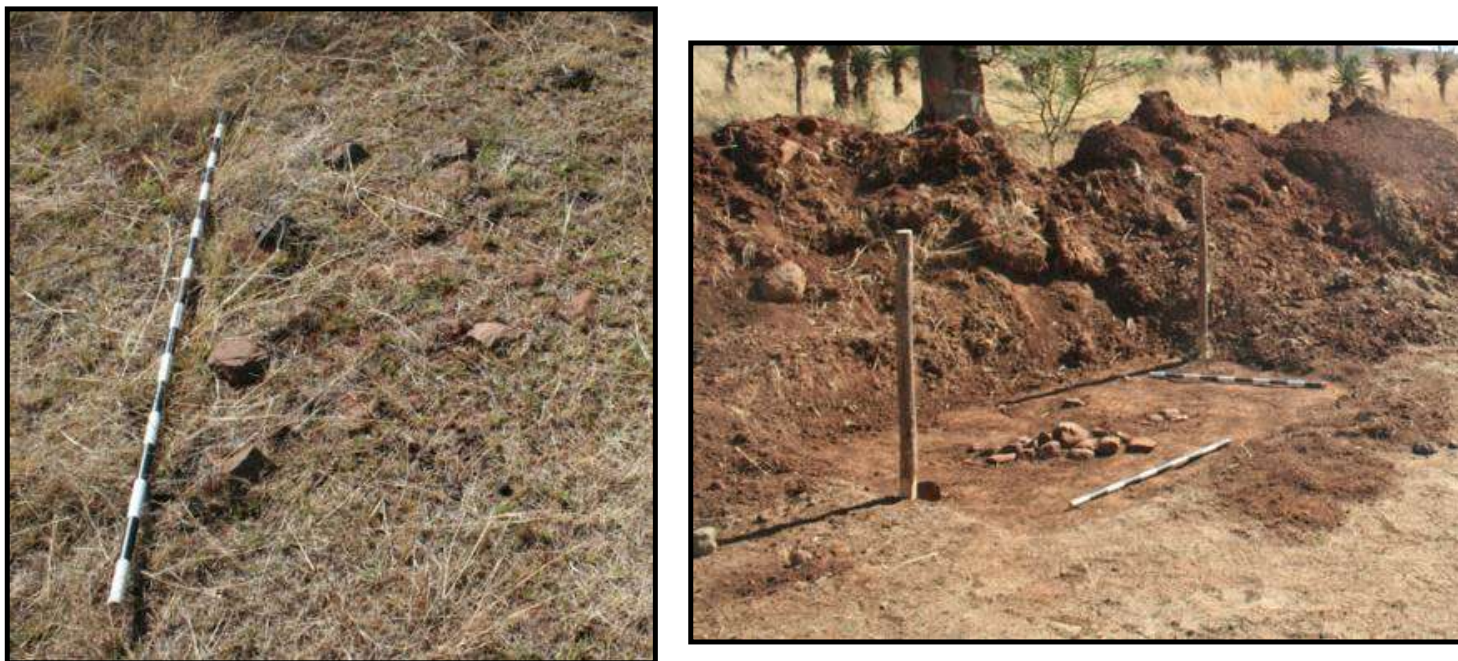
Fig. 178: Before and After Photographs of Grave at GLK066_74²³

²³ Note the change in the size of the stone cairn
*

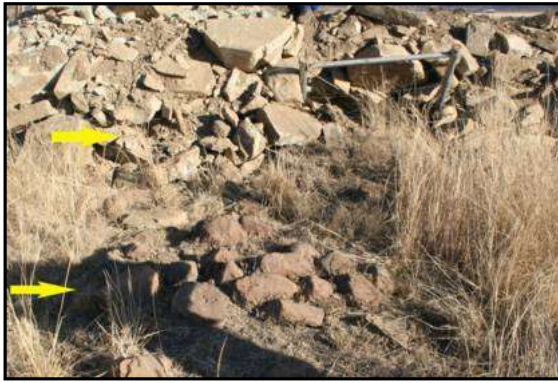
Fig. 184: Stock Pile of Rocks over One Grave at GLK118a²⁴

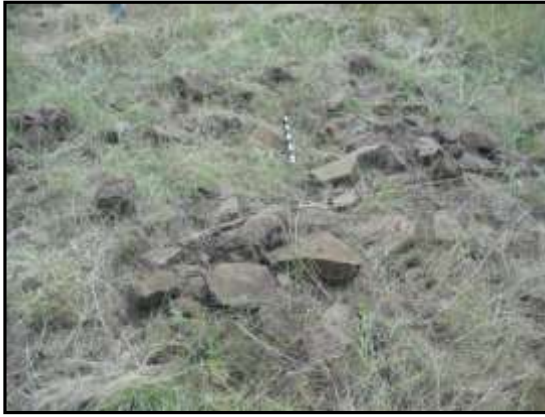
Fig. 200: Grave at GLK122c

Significance of site: The site is of high significance

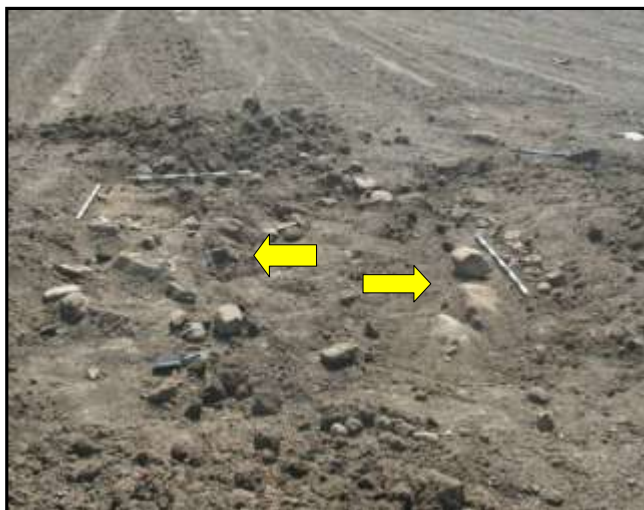
Fig. 202: Excavated Grave Area at GLK122c

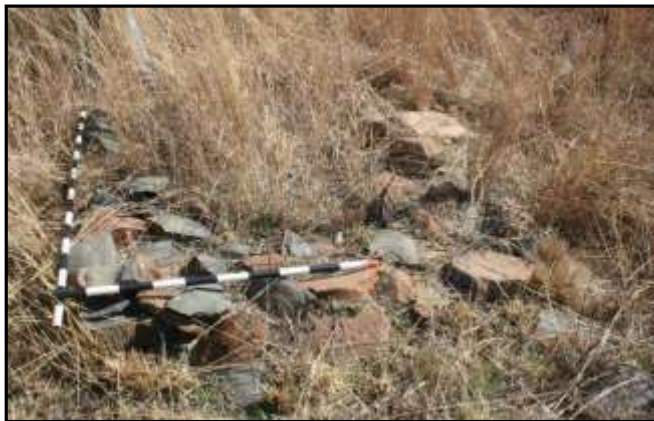
Fig. 206: 2009 Photograph of the Grave

The grave was demarcated with metal and wooden poles and was fenced off before the RoW clearance (fig. 206 shows the grave in 2009). Two HIA were on site during RoW clearance. Subsequent to RoW clearance, the grave was covered by trenching spoil (fig. 207). This is the first grave of the damaged sites that has definite living descendents. Transnet may need to compensate the descendents.

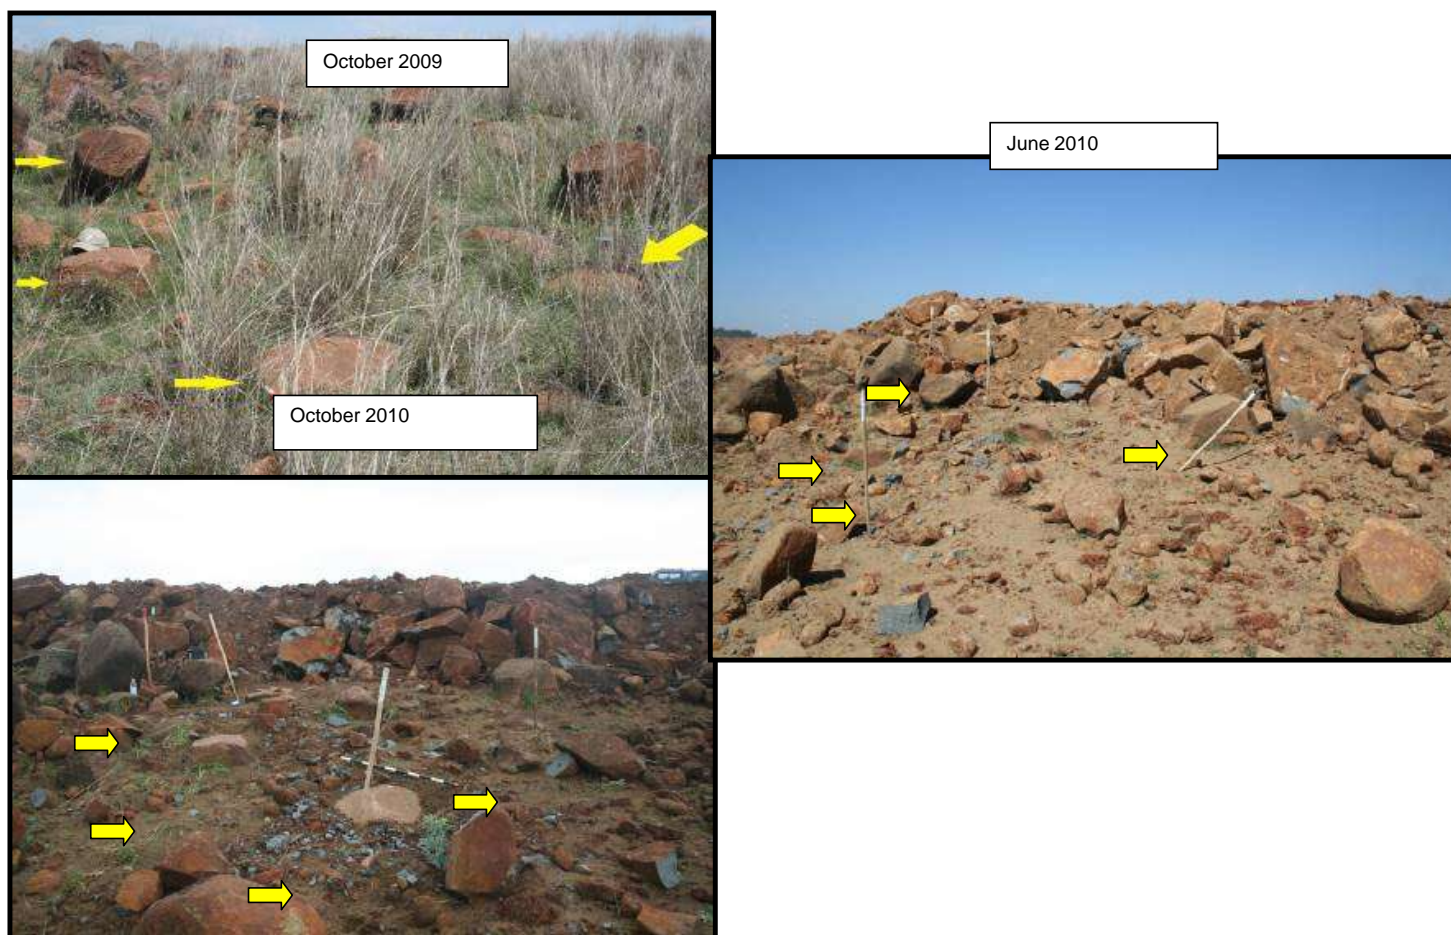
Fig. 213: Location of Four Engravings at GLK078_290 Before/After Damage

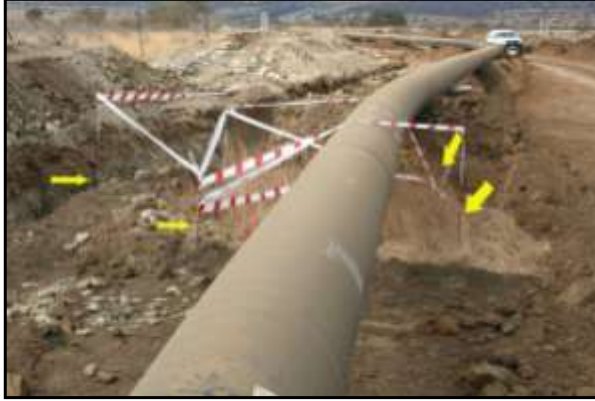
Fig. 221: Example of Low Negative Impact
