**New Multi Product Pipeline
(NMPP) Project**

Mitigated Heritage Sites
Damaged by the NMPP

2684358-UM-PL1- ENV-RP-001

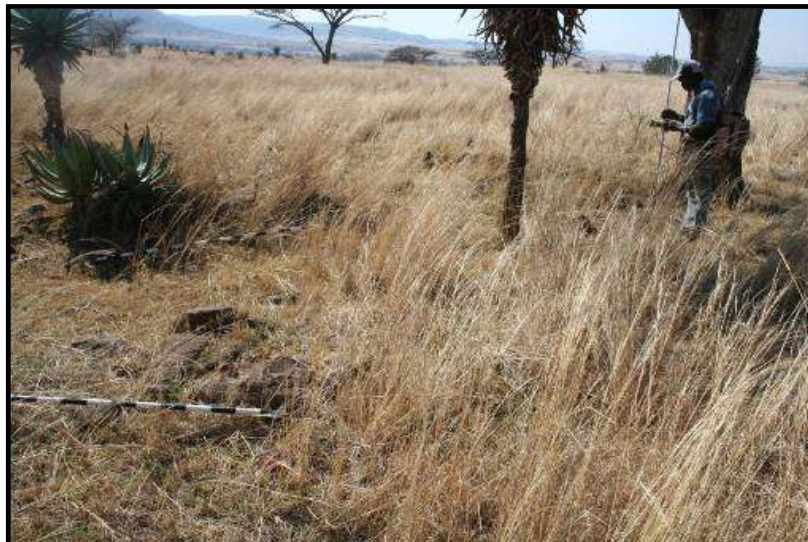
FIG. 4:

PHOTOGRAPH OF GLK066_75 IN 2009

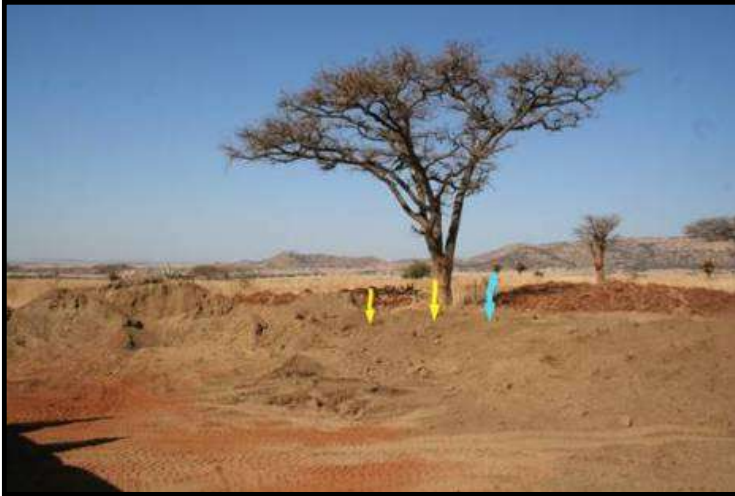
FIGURE 6: FEATURE 75 AT GLK066_75 AFTER 2ND ROW CLEARANCE⁴

Assessment of Damage: The initial assessment suggested that the entire stone wall had been removed by RoW clearance and then topsoil was deposited on top of the site (fig. 6). The stone wall was originally ~10cm – 20cm above ground level and with a similar depth. The southern part of the kraal still exists and was used as a comparison.

⁴ Yellow arrows indicate probably location of grave, blue arrow indicates location of the kraal.

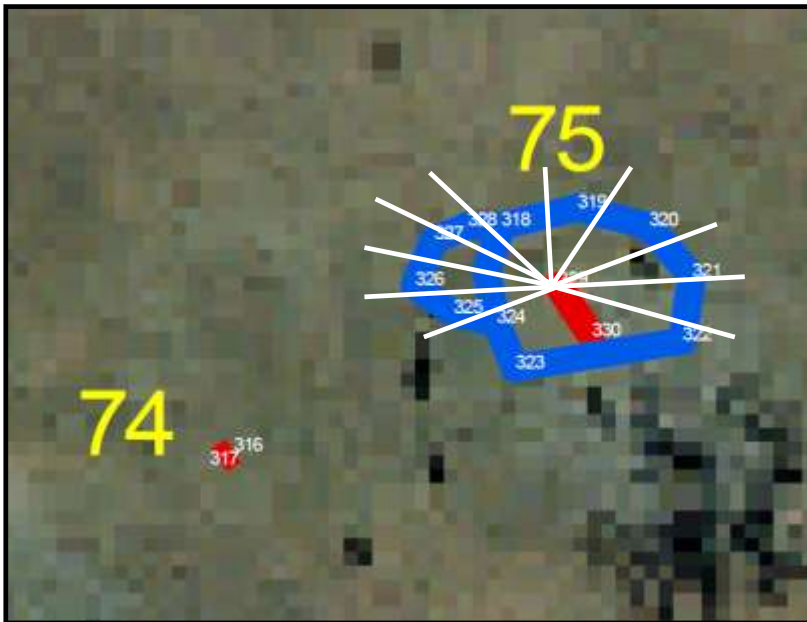
FIG.

I placed several excavation lines in a wheel spoke alignment from the middle of the kraal, for the assessment (fig. 7 - 8). The excavations used the site map (fig. 5) to determine where the walling would occur. The excavations went down to the original surface – visible by the layer of grass. If the stone wall existed, then the excavation lines would locate an *in situ* wall. If no walling was observed, then it implies that it has been removed by the RoW clearance.

EXCAVATION LINES AT GLK066_75

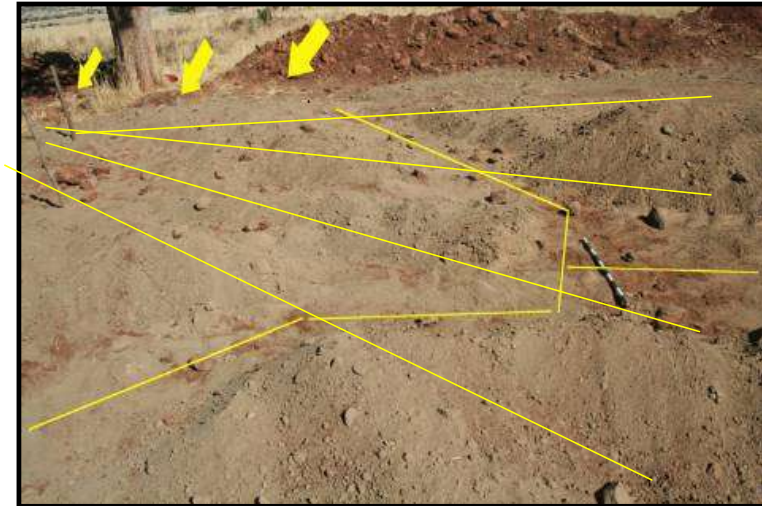
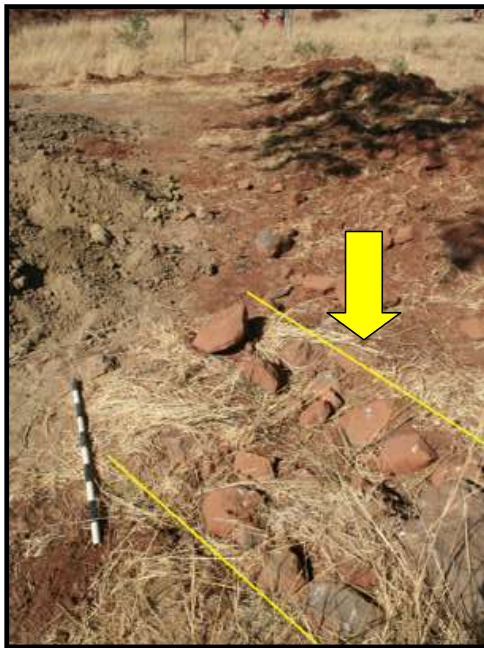
FIG. 8B:

The excavations located parts of the primary wall. These remains were the basal stone layer. Most of the secondary wall has been cleared and I only located isolated stones. It appears that at least 75% of the kraal has been damaged in some manner. Figure 8b shows parts of the undamaged wall. It is not possible to repair the kraal wall.

⁵ Yellow line = location of stone wall; yellow arrow = undamaged stone wall

EXCAVATIONS AND REMAINING PART OF STONE WALL AT GLK066_75

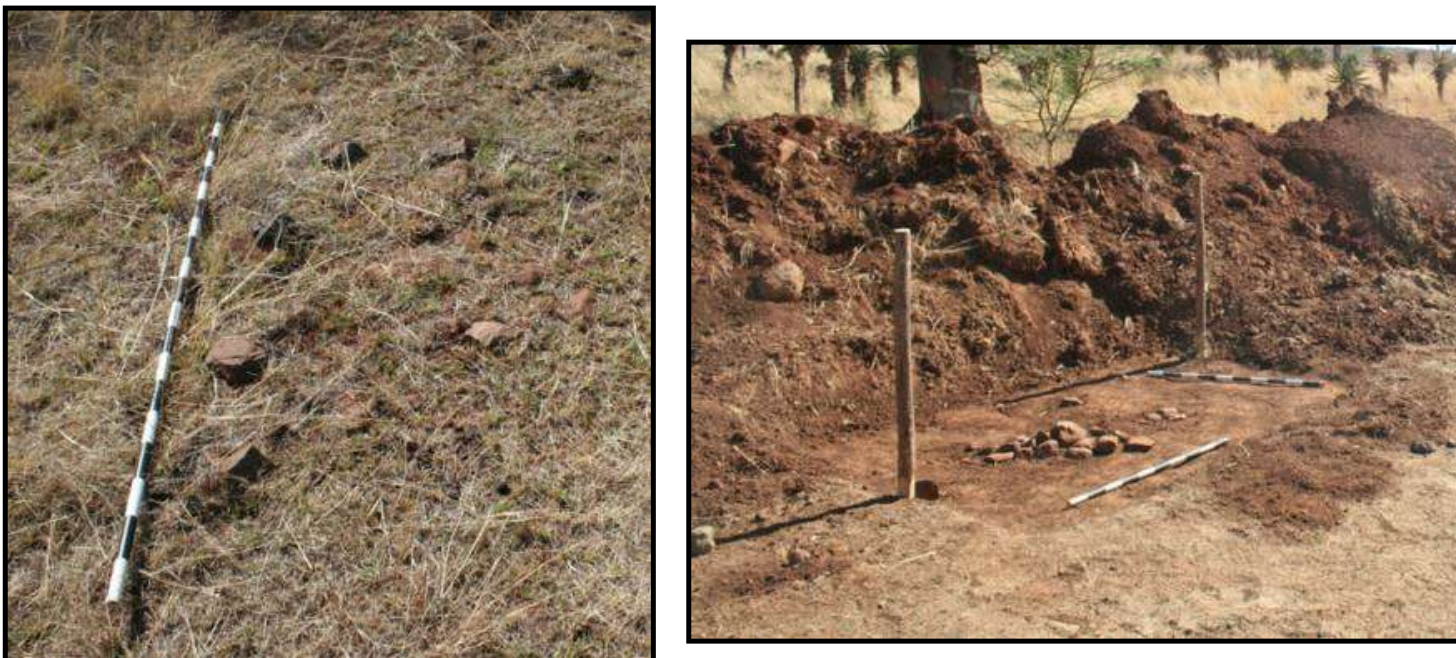
FIG. 9: BEFORE AND AFTER PHOTOGRAPHS OF GRAVE AT GLK066_74⁶

The cairn at GLK066_74 has been mostly removed and only a few *in situ* rocks remain. The cairn at GLK066_75 has been partially affected, and minimally damaged.

⁶ Note the change in the size of the stone cairn

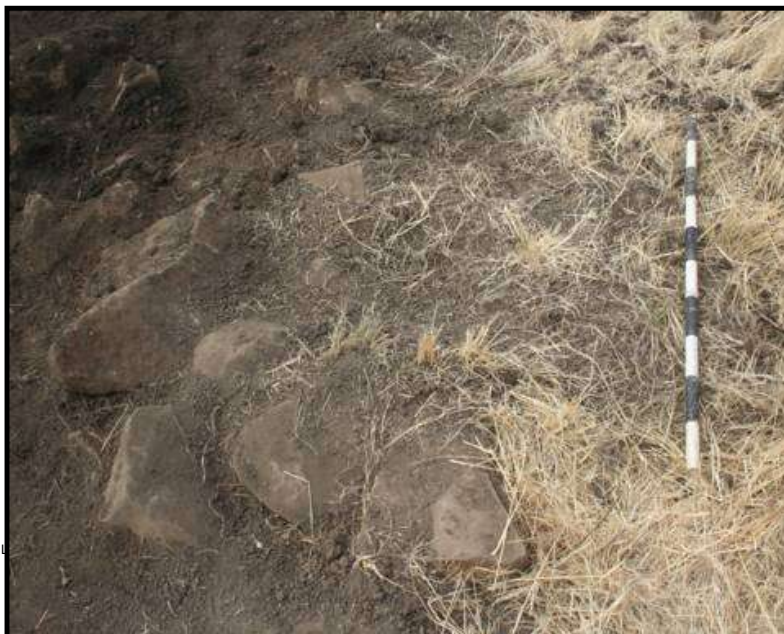
Assessment of Damage: The graves were technically not damaged and have been cleaned. The associated walling was also cleaned. There was however, an infringement on the site and this forms part of the pattern of demarcated heritage sites being ignored by the contractor.

FIG. 13: GLK118_96 GRAVE AFTER CLEANING

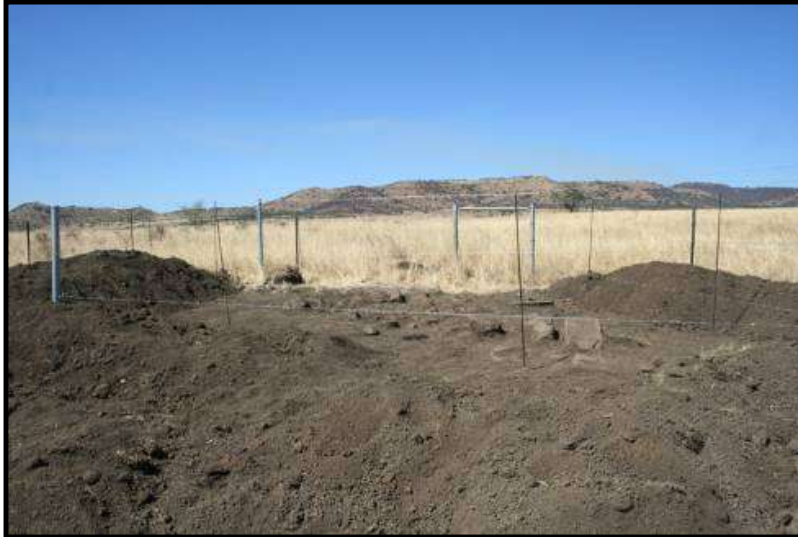
FIG. 13: GLK118_96 GENERAL AFTER CLEANING

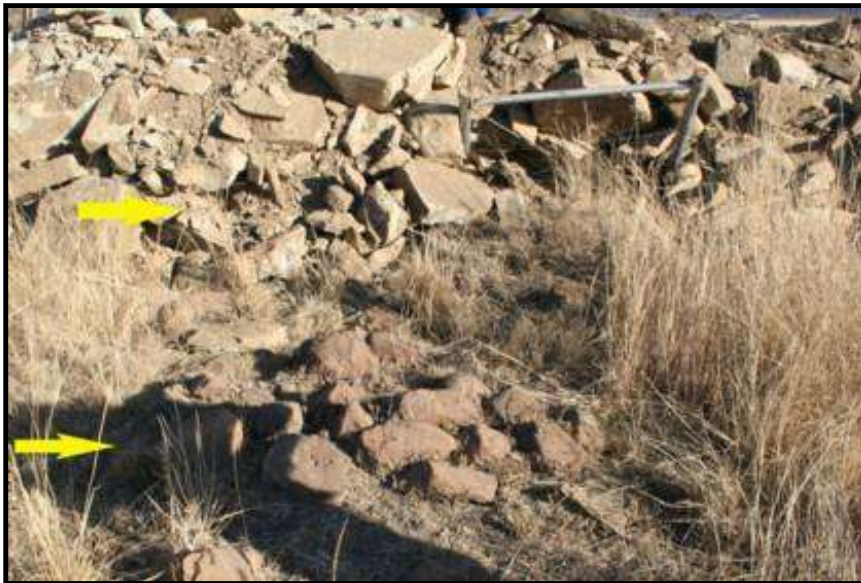
Assessment of Damage: The graves were technically not damaged and have been cleaned. The associated walling was also cleaned. There was however, an infringement on the site and this forms part of the pattern of demarcated heritage sites being ignored by the contractor.

FIG. 15: STOCK PILE OF ROCKS OVER ONE GRAVE AT GLK118A⁷

⁷ Top arrow indicates the covered grave
Document Location On J: Drive
24

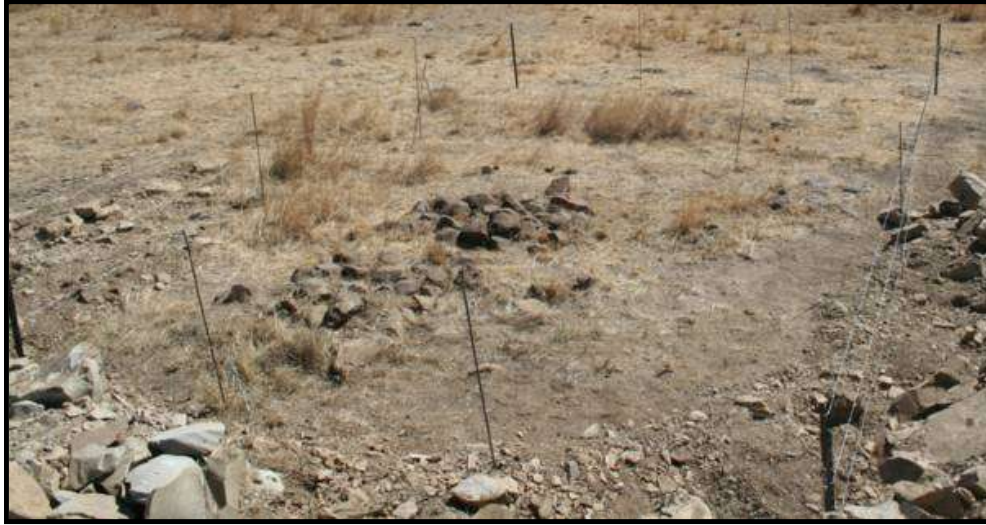
FIG. 16: CLEANED GRAVES AT GLK118A

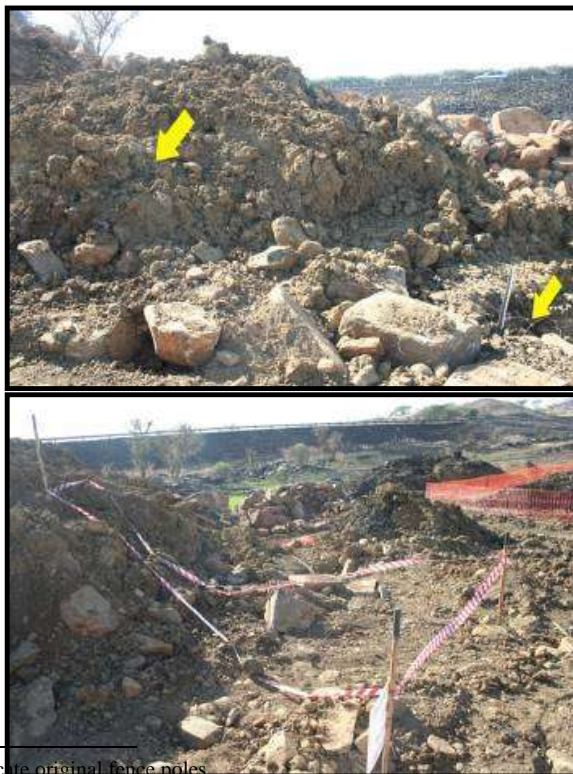
The grave has been damaged in several ways. The fenced off area has been ignored and damaged. The stone cairns are visibly missing due to trenching spoil material being placed on top of it (fig. 21). Site instructions were given for the grave to be covered with protective material during blasting activity; however, I am not sure if this was undertaken. All work activity in the area of the grave had to cease until further notice as from June and a site directive for this was given from Transnet. This meant that the pipe could not be placed into the trench, nor could any backfilling occur.

FIG. 21: STOCKPILE OVER DEMARCATED FENCING⁸

⁸ Yellow arrow indicate original fence poles
Document Location On J: Drive
28

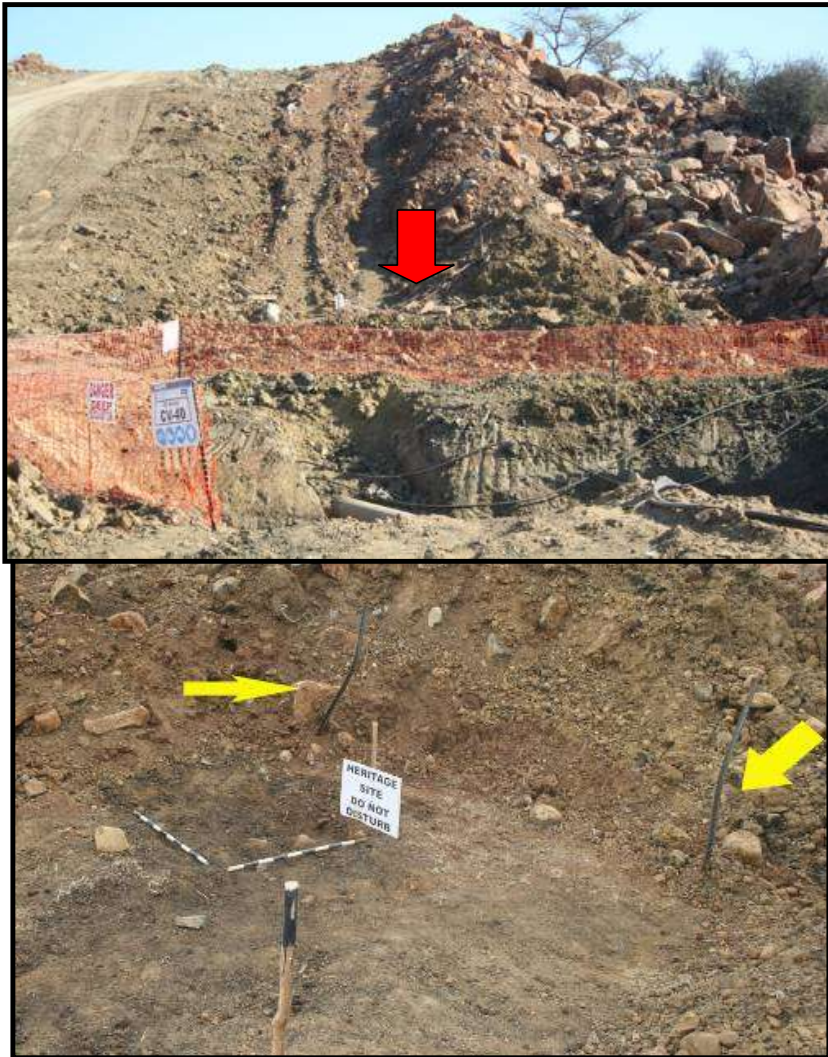
FIG. 22: BACKFILLING AFTER THE AREA HAD BEEN CLOSED⁹

⁹ Red arrow indicates the location of the possible grave.

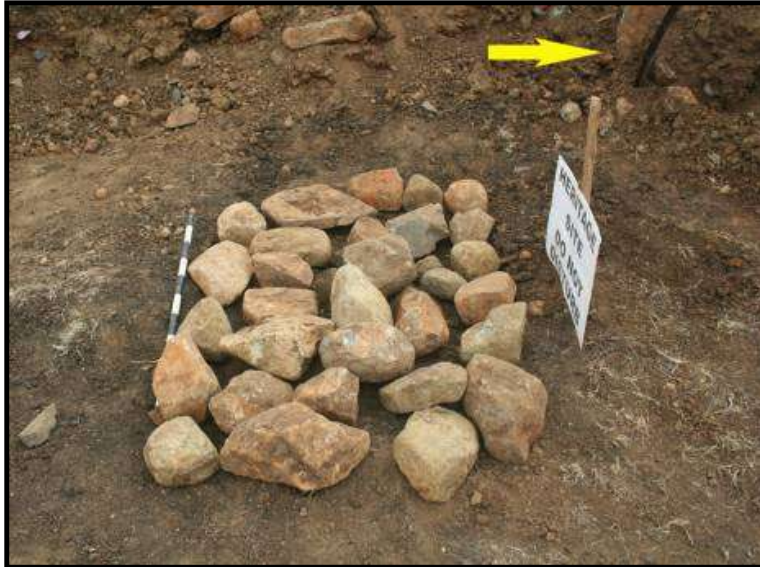
**FIG.
24:**

The trenching team has removed the poles demarcating the outer edges of the grave. The demarcated area was cleaned of the stockpile and the some of the original cairns were exposed (fig. 23). Some of the rocks are missing. I placed some stones to indicate the position of the possible grave (fig. 24).

Assessment of Damage: The area was cleaned and the outline of the possible grave was demarcated. A few of the rocks from the cairn are missing.

POSSIBLE GRAVE WITH STONES DEMARACTING THE AREA

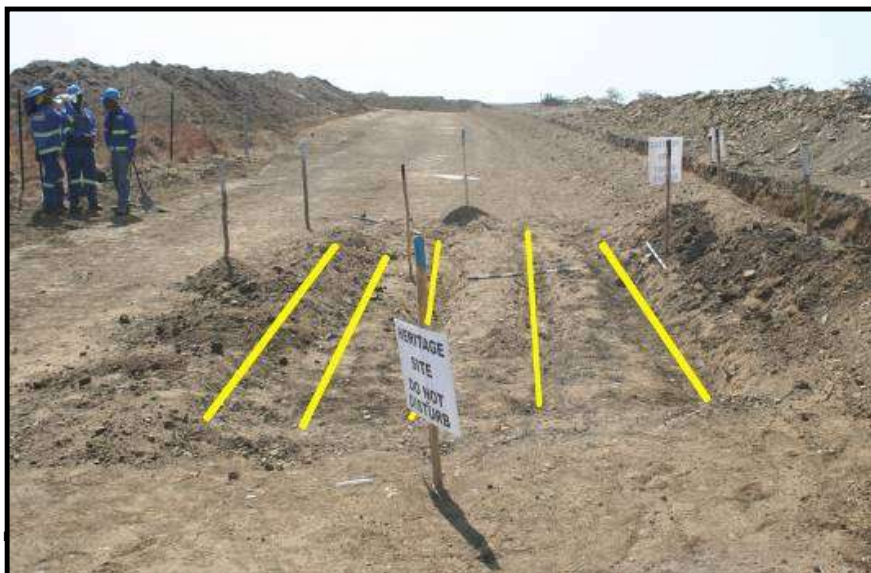
Assessment of Damage: The entire cairn has been removed and presumably the grave itself.

FIGURE 28: POLES INDICATING THE EXTENT OF THE GRAVE AND THE EXCAVATION TRENCHES

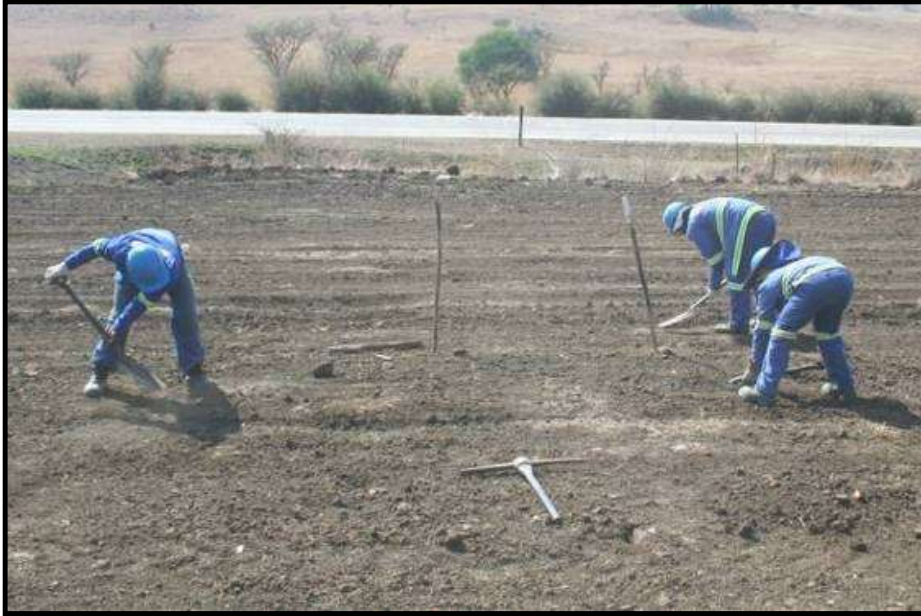
Assessment of Damage: The entire cairn has been removed and presumably the grave itself.

FIGURE 31: CLEARED AREA WHERE THE GRAVE OCCURRED

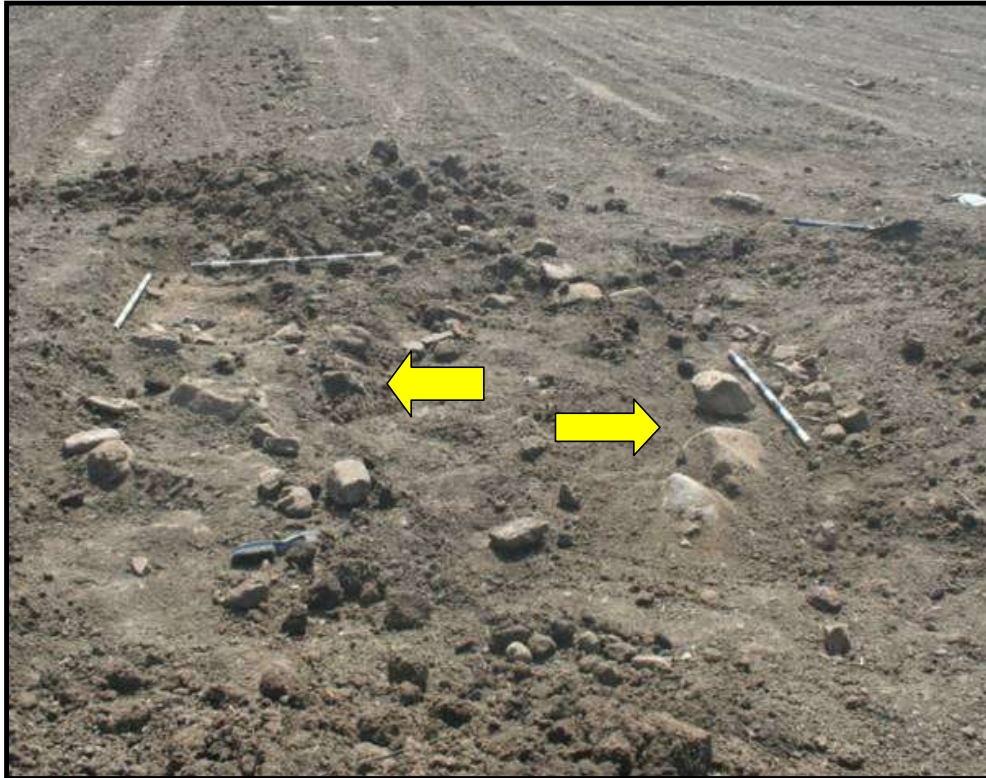
The stone cairns are missing due to additional construction activity. The excavations could not locate any concentration of stones, although two possible areas were noted (fig. 32). I believe that these two possible areas are the result of natural rock formations and not the graves. The area was fenced off after the excavations. The grave ~50m uphill was not damaged.

FIGURE 32: EXCAVATED GRAVE AREA AT GLK122C

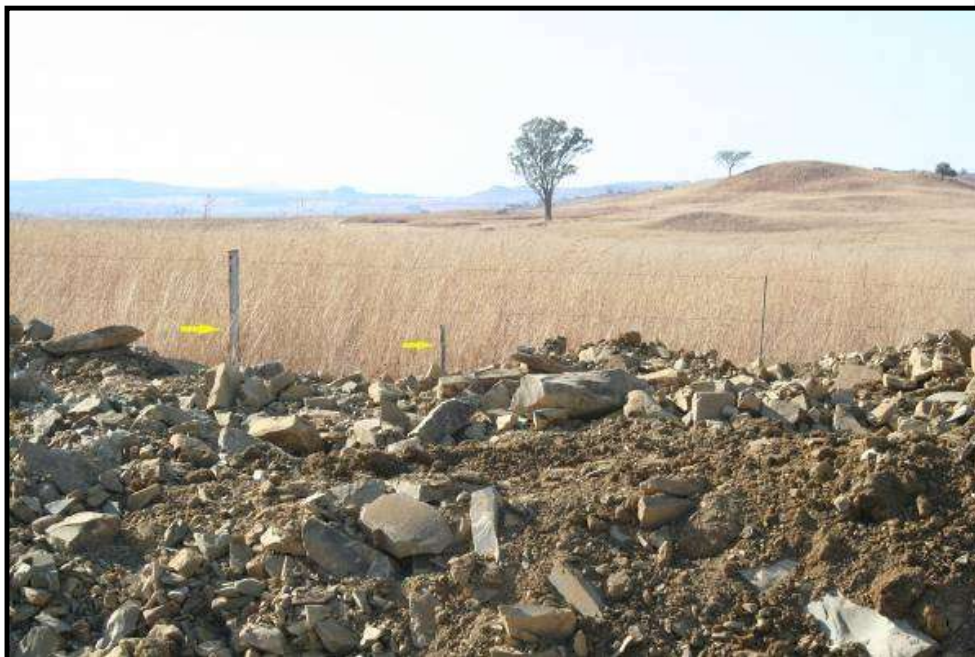
Assessment of Damage: The graves are technically not damaged and they have been cleaned. There was however, an infringement on the site and this forms part of

the pattern of demarcated heritage sites being ignored by the contractor. The living descendants may claim that the ancestral spirit needs to be appeased.

FIGURE 37: TRENCHING SPOIL OVER GRAVES AT GLK063A GRAVE 16A

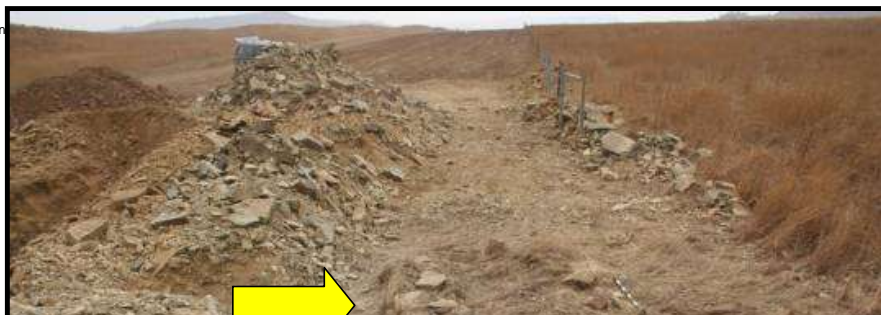
FIGURE 38: CLEANED GRAVE AT GLK063A-GRAVE 16A

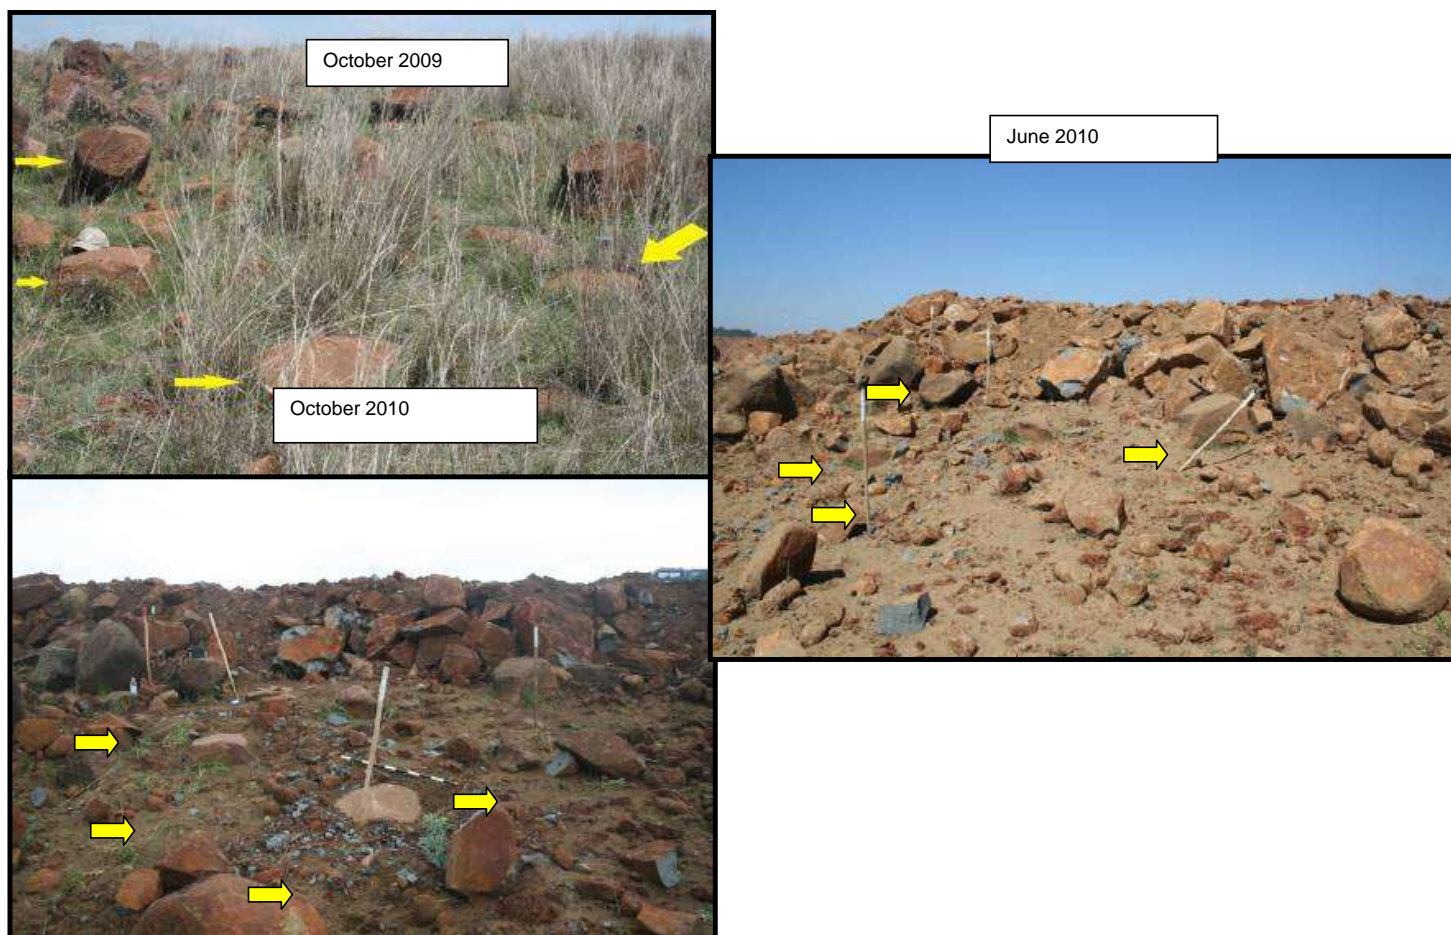
These four can be seen in figure 43. Fig. 43 also indicates the impact of blasting has had by covering most of the engravings with sand and broken rocks. Note all the broken (grey-blue) rocks around the engravings. The broken rocks are probably the cause of the scratching and impact points on the engravings.

FIGURE 43: LOCATION OF FOUR ENGRAVINGSAT GLK078_290 BEFORE/AFTER DAMAGE

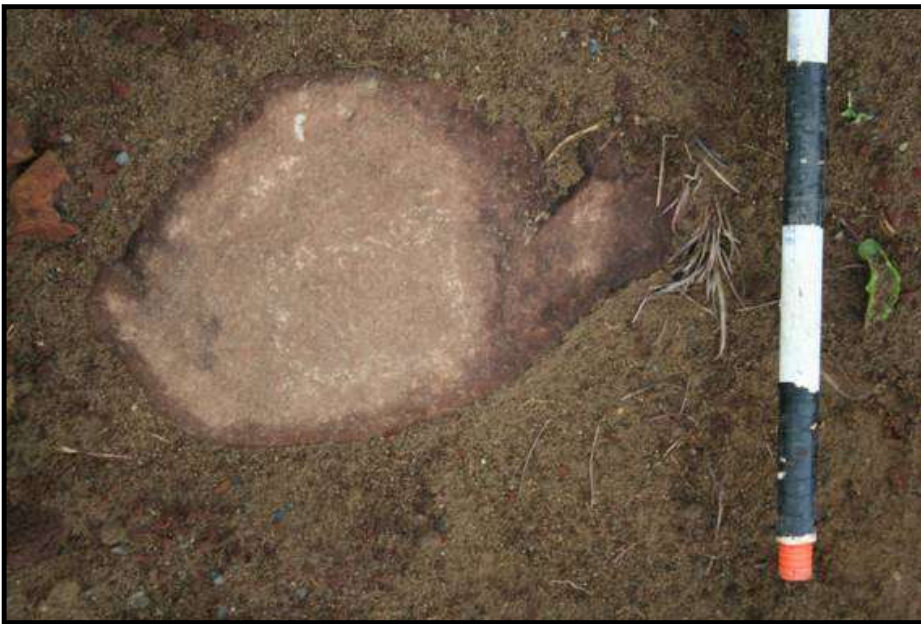
Engraving 2117 (fig. 45) consists of a pecked rectangular image and some indeterminate pecking. This engraving has not been damaged.

**FIGURE 45:
BEFORE/AFTER
IMAGES
OF
GLK078_290_2117**

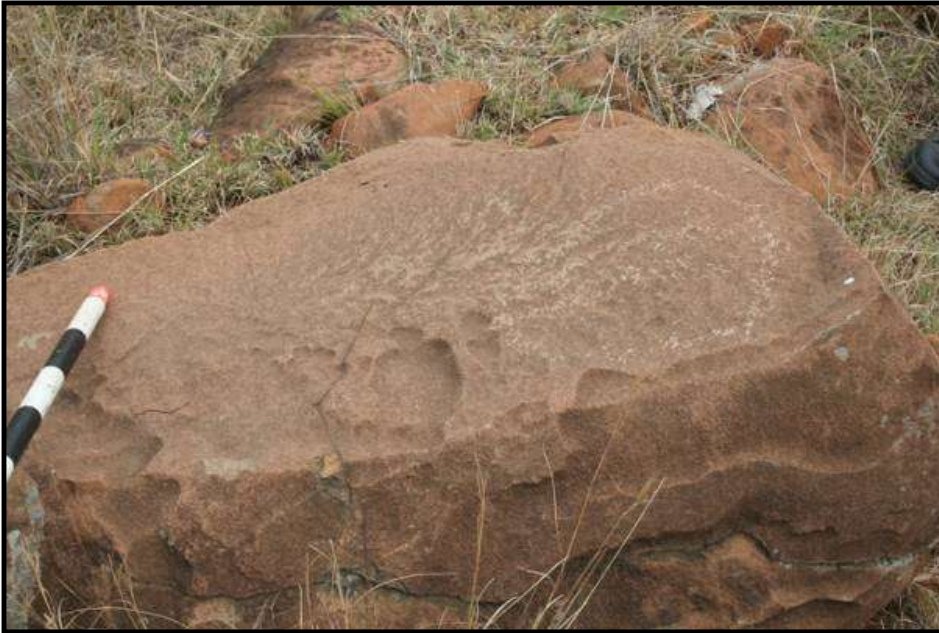
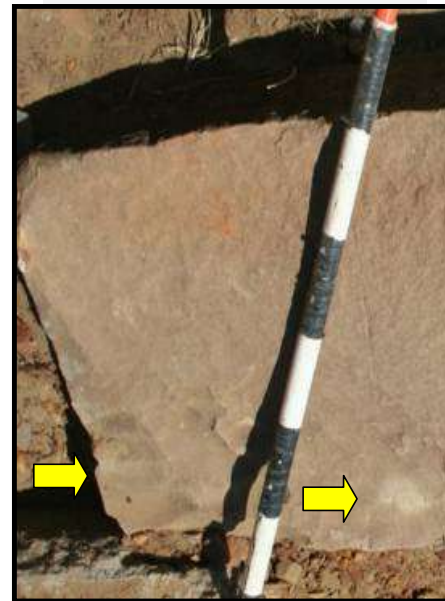
Engraving 2118 (fig. 45) consists of a two rectangular-oval-type of pecking that are joined on one side. There are four impact points that have left the rock slightly scratched. The engraving itself has not been damaged. This specific engraving was spray painted by the surveyor's assistant while we were locating the engravings (I was discussing the excavation method with the TLB operator while the surveyor located the next batch of engravings). He had sprayed the rock to indicate where the pole should be as it could not be placed firmly into the ground. Afterwards I asked him if he could see the engravings, and then I showed him other engravings. I then pointed out where he had sprayed, whereupon he immediately saw the engravings. The spray paint did not interfere with the engraving and it can be removed with the correct equipment. I believe this was purely accidental.

FIGURE 45: BEFORE/AFTER IMAGES OF GLK078_290_2118

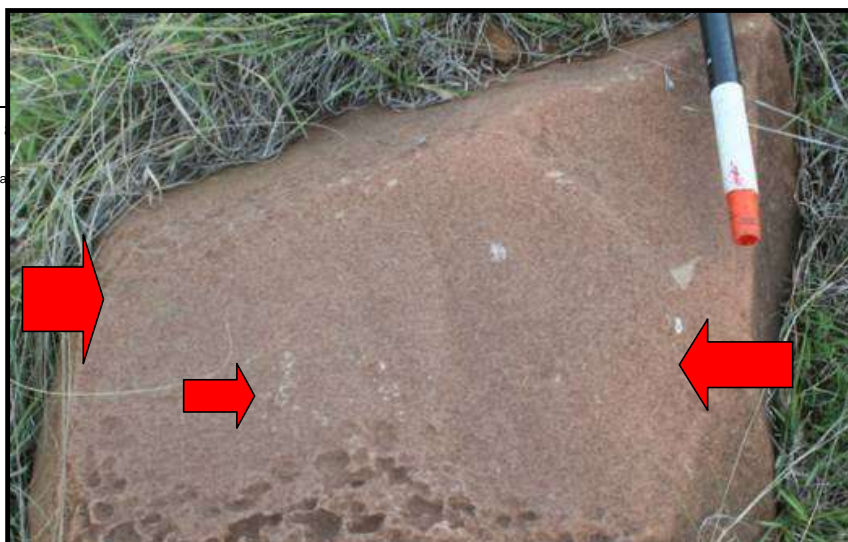
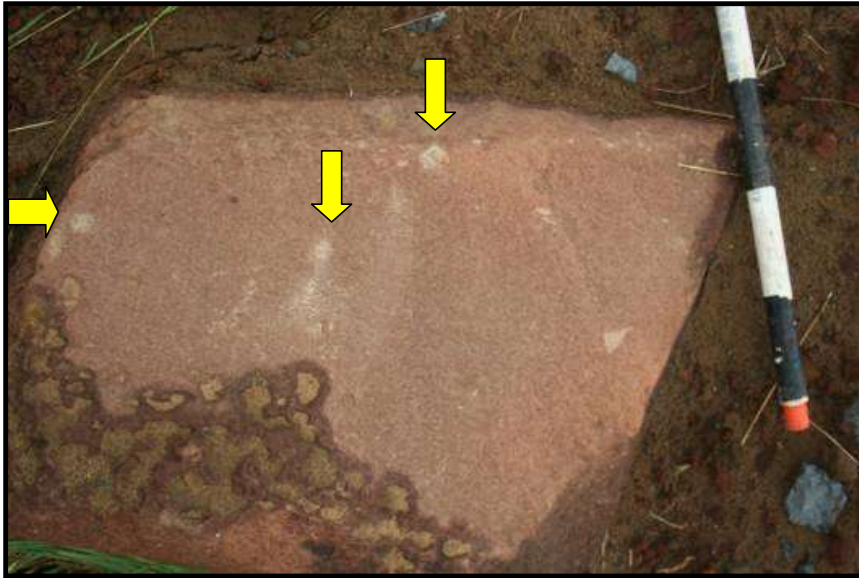
Engraving WP20, (fig. 46) consists of indeterminate pecking and several lines that have been scratched into a checkerboard-like pattern. These scratching are very faint. There are five impact points on this engraving, of which some occur over the faint scratching.

FIGURE 46: BEFORE/AFTER IMAGES OF GLK078_290_WP20¹⁷

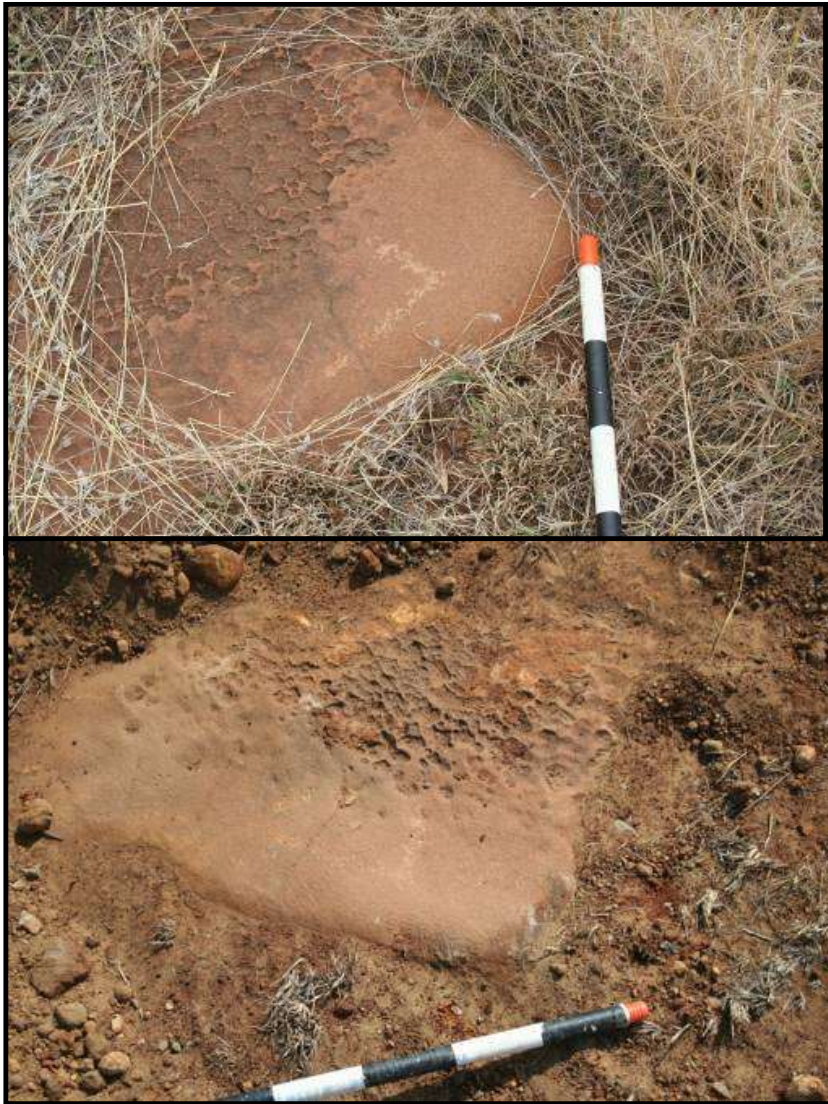
Engraving 2119 (fig. 47) consists of a semi-rectangular pecking. It has not been damaged even though it was at the bottom of the spoil heap.

FIGURE 47: BEFORE/AFTER IMAGES OF GLK078_291_2119

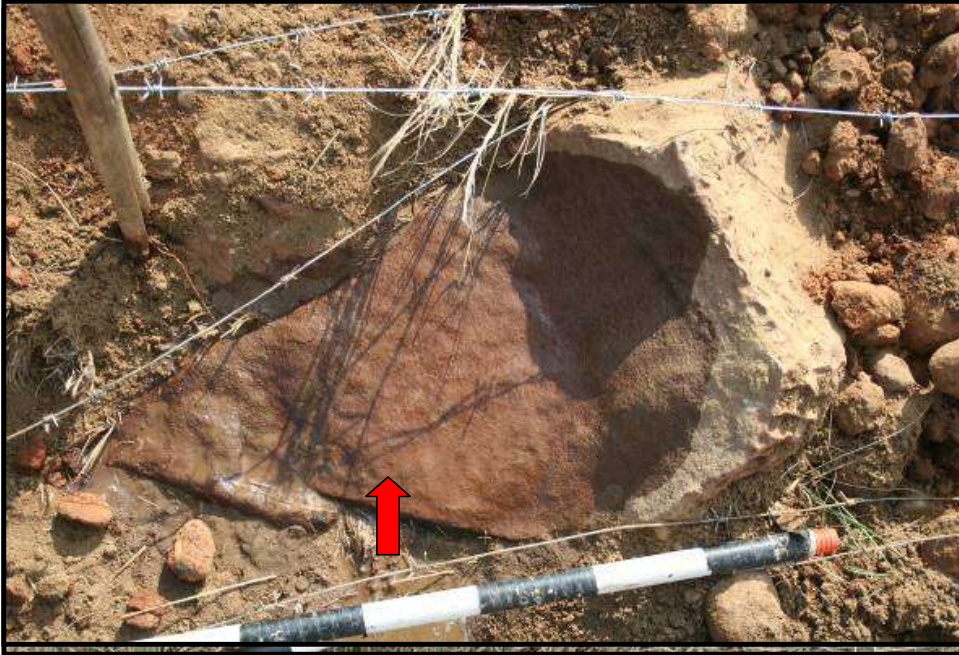
Engraving 2120 (fig. 48) consists of two oval circles that have been pecked. The engravings have not been damaged despite being underneath the spoil heap. The 'after' photograph in fig. 48 does not show the engravings clearly. This is because it had rained and the soil was muddy and had slightly stained the engraving. I tried to wash off the mud but it did not work. The engravings are however visible on site.

FIGURE 48: BEFORE/AFTER IMAGES OF GLK078_291_2120

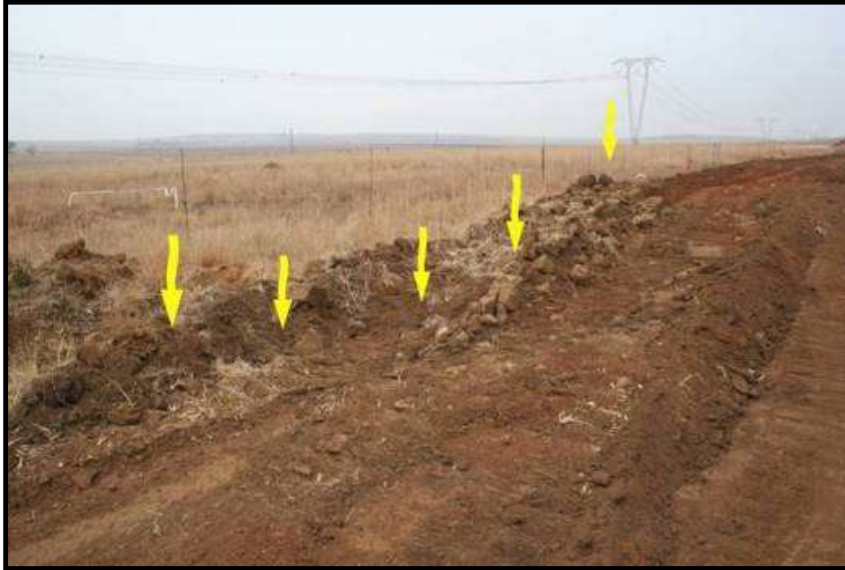
The kraal wall has been slightly damaged by heavy machinery driving over it (fig. 49). The kraal has been fenced off.

FIGURE 49: DAMAGED KRAAL AT GLK078¹⁸

¹⁸ Yellow arrows indicate the damaged area of the kraal.

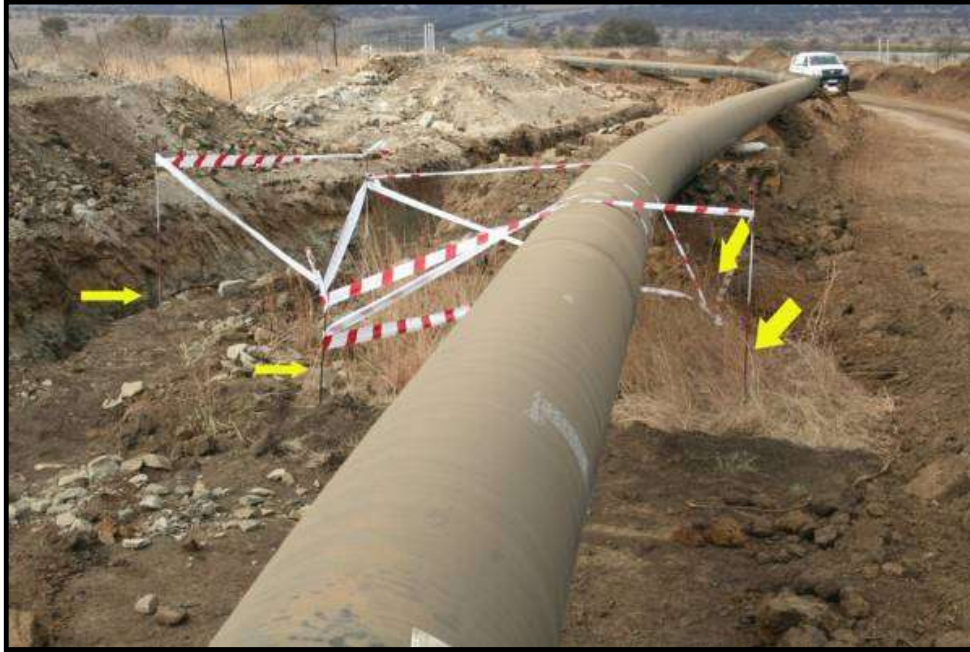
Several gravesites have had low negative impacts. These consist of the pipeline being placed above the grave, or its fencing. The impact is thus not on the grave itself but on the heritage zone (fig. 50). All of these sites have been noted and no work was to occur at these sites unless an ECO or an HIA was on site. This was to ensure that the graves were not damaged. I was never called out to supervise these sites, and neither were the independent ECOs. I did resurvey the graves along this section, and none had been damaged. The 1953 topographical map indicates that there are houses associated with all of these graves, although there are fewer houses in 1937. There would thus be living descendants who could claim these graves, especially if any get damaged.

FIGURE 11: EXAMPLE OF LOW NEGATIVE IMPACT
