**New Multi Product Pipeline
(NMPP) Project**

Damaged Graves at KP370+600

2684358-UM-PL1- ENV-RP-003

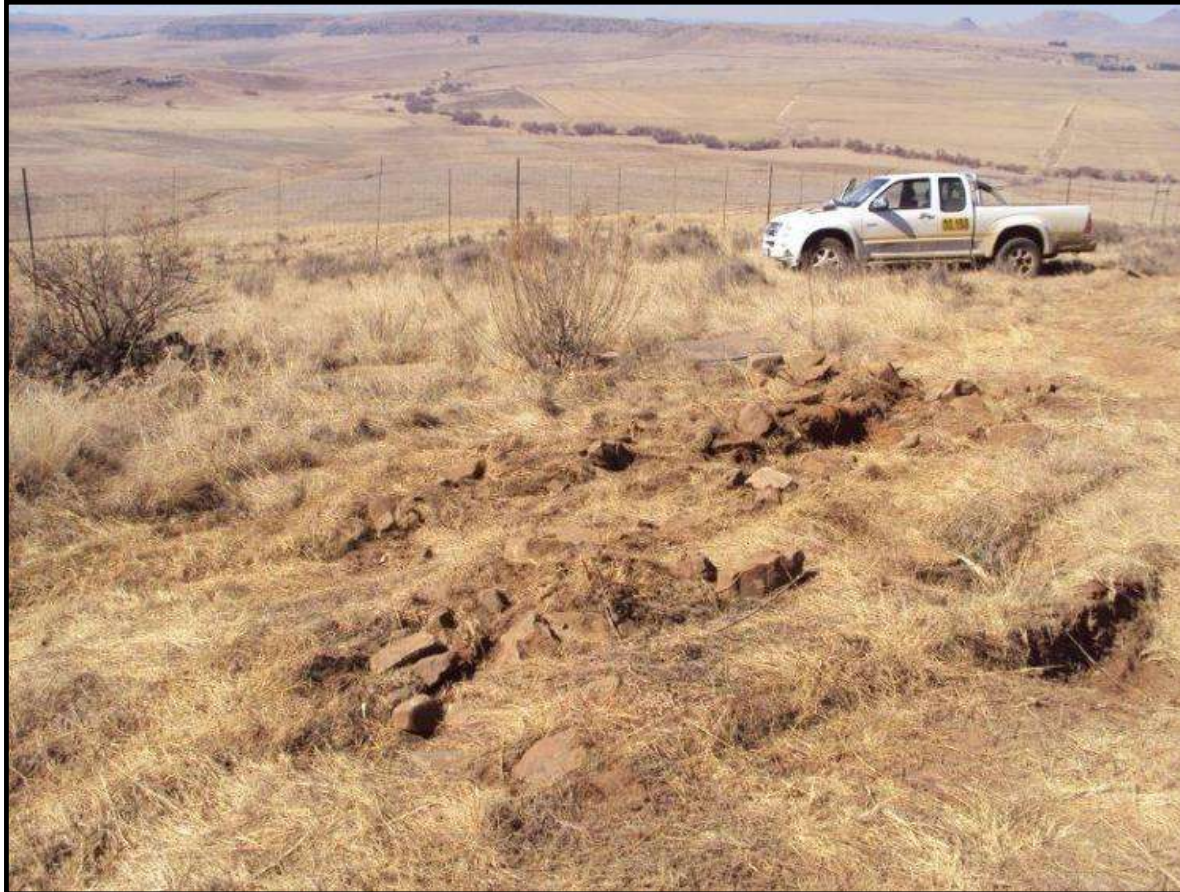
Fig. 1a: Ten graves prior to mitigation

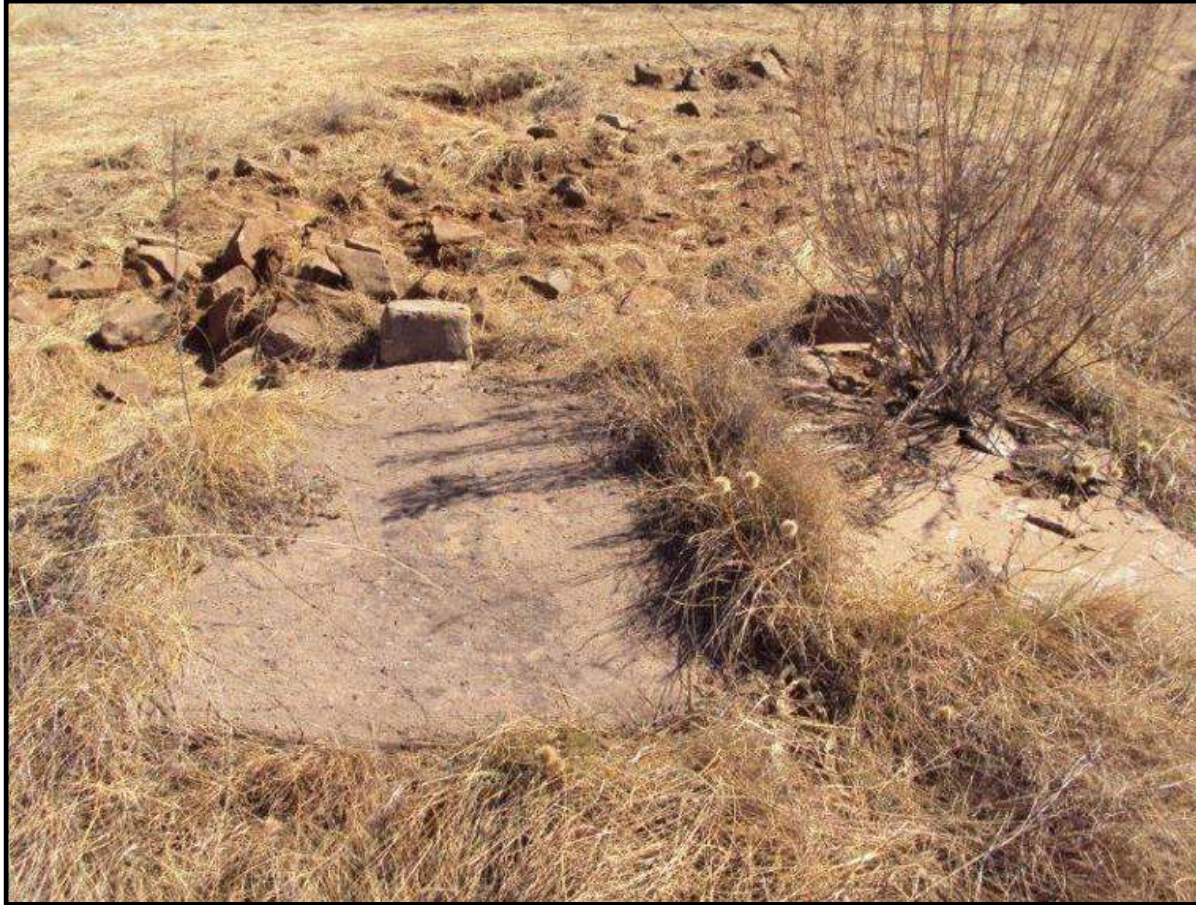
Fig. 1b: Eight Graves prior to mitigation

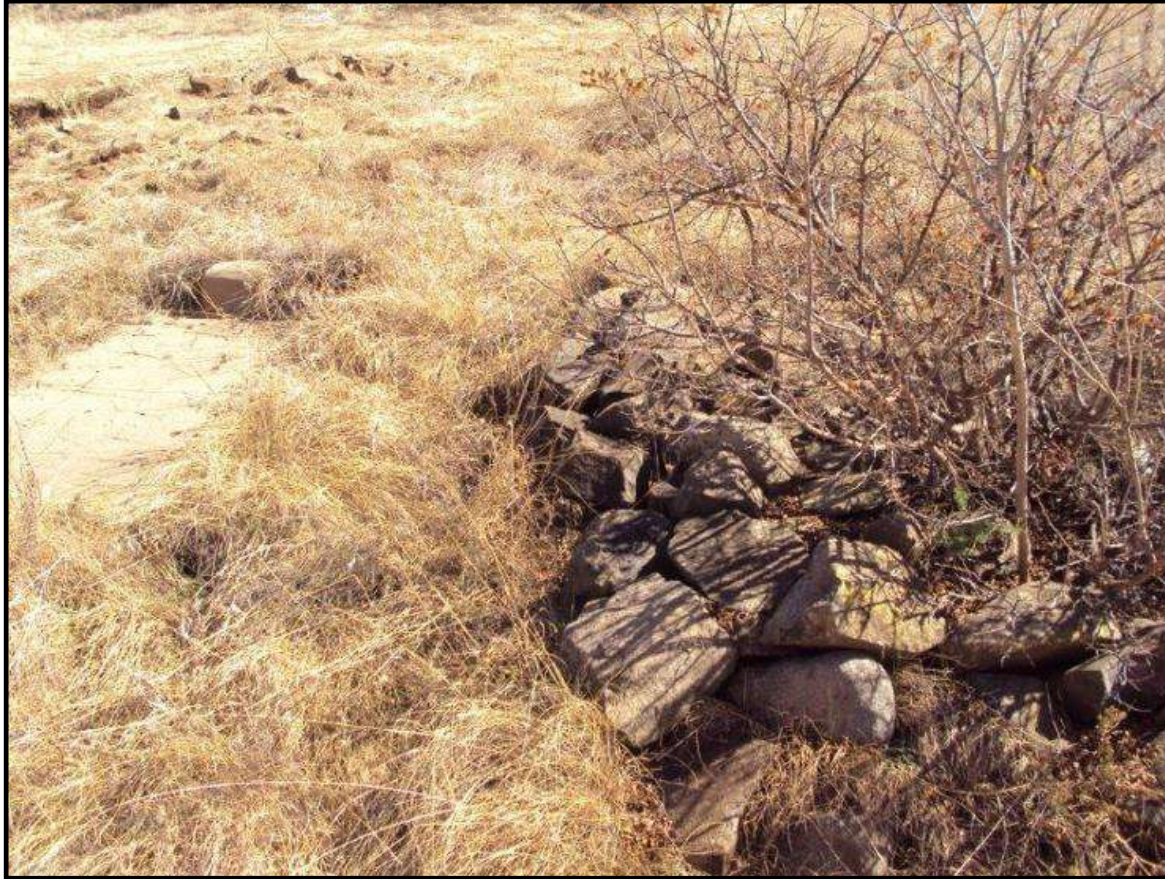
Fig. 1c: five Graves prior to mitigation

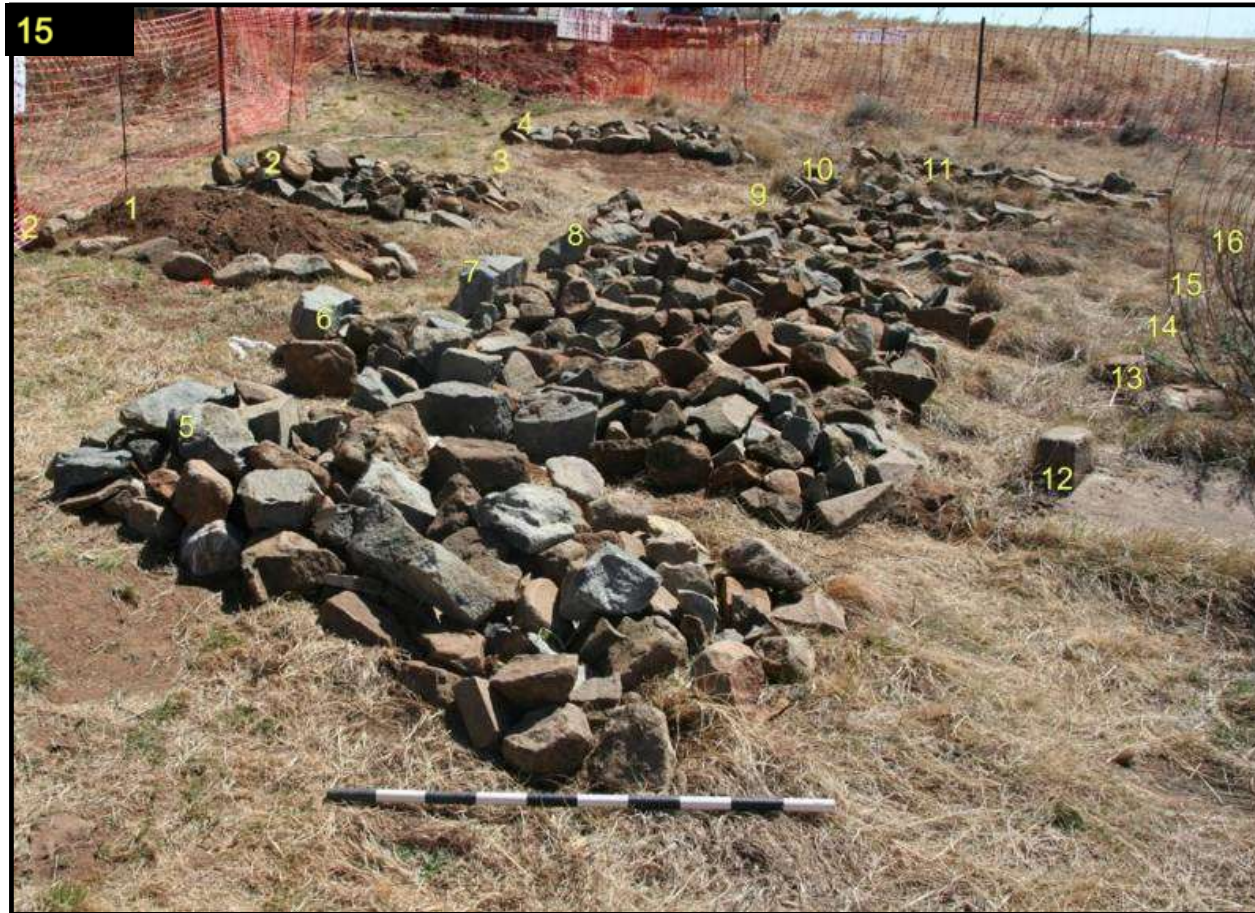
Fig. 2: Positions of restored graves

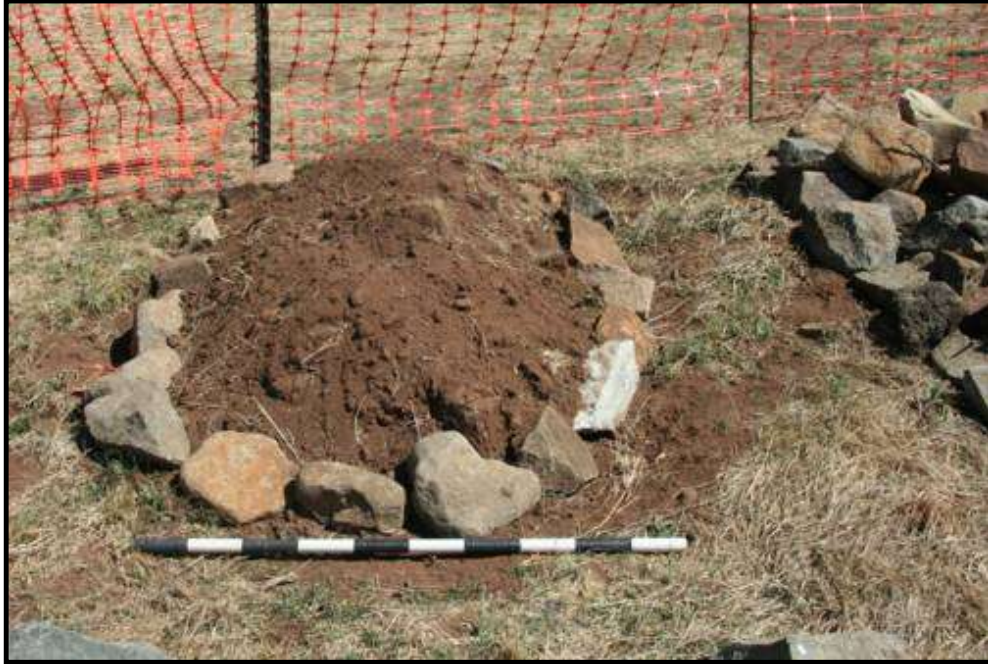
Fig. 3: Grave 1

Grave 1 consists of a circle of stones with a central mound of sand. There is no record of this grave in the initial photos (fig. 1); however, they may be part of the indentation without stones. It appears as if the entire grave cairn has been removed.

The grave has been incorrectly restored.

The boundary fence pole occurs within 30cm of the grave. This could have affected any skeletal remains underneath the surface, as there is no knowledge of where the grave was exactly placed.

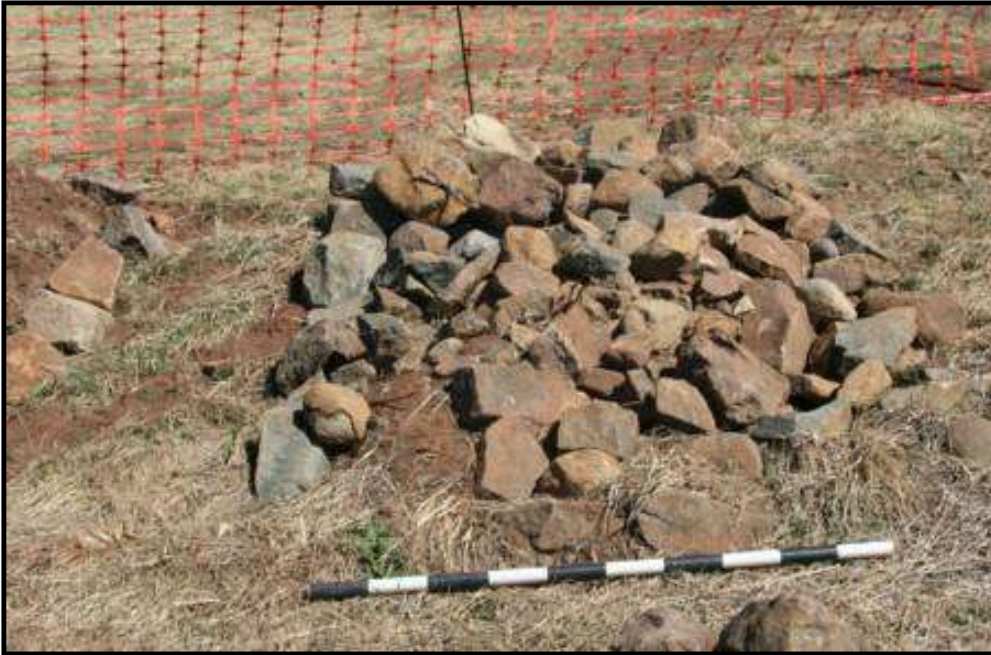
Fig. 4: Grave 2

Grave 2 consists of a pile of stones that have been piled on top of a recent infill of sand.

The shape of the grave is rhomboid and not semi-circular as is the norm.

The grave has been incorrectly "restored"

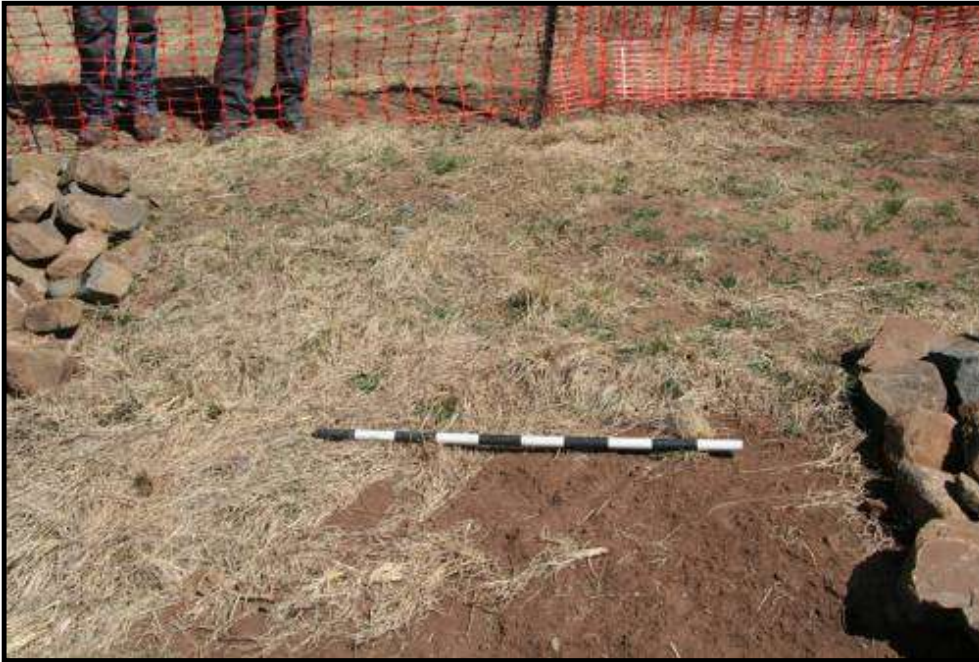
Fig. 5: Grave 3

Grave 3 is a possible grave that was missed during the “restoration”.

I think it may be a grave as there was a depression between two graves, but it had not been covered with stones.

The living descendants should be consulted to assist in this matter.

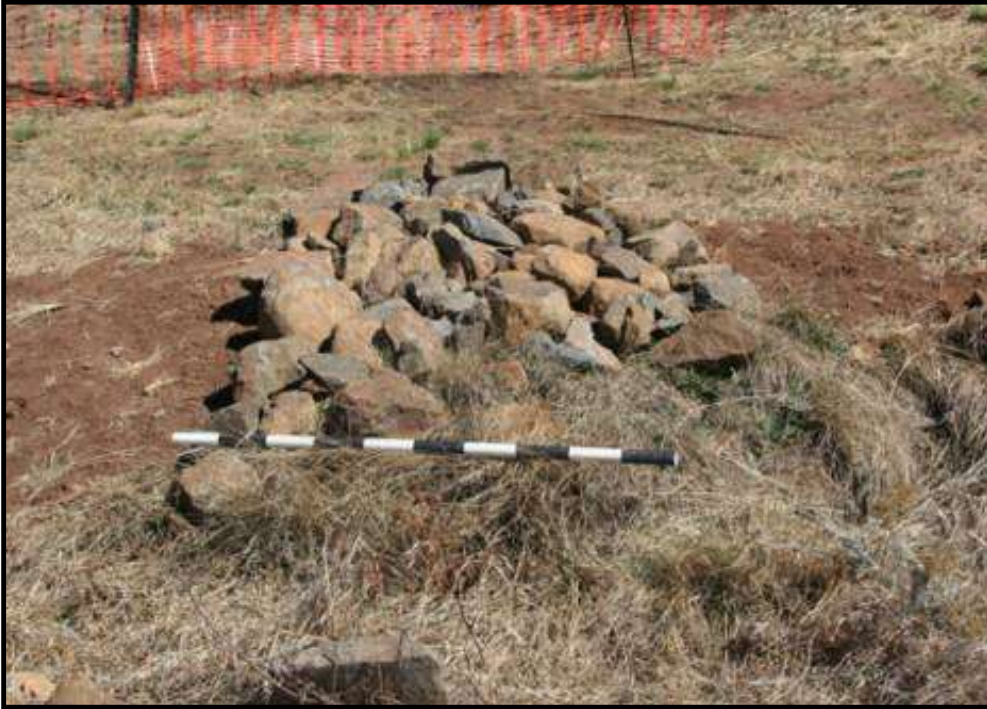
Fig 6: Grave 4

Grave 4 has partially restored with loose rocks from the area.

The upper half of the grave has been mostly affected by 'restoration'.

The grave is rhomboid in shape and does not resemble a traditional grave.

A headstone has been placed on this grave

The grave has been incorrectly "restored:"

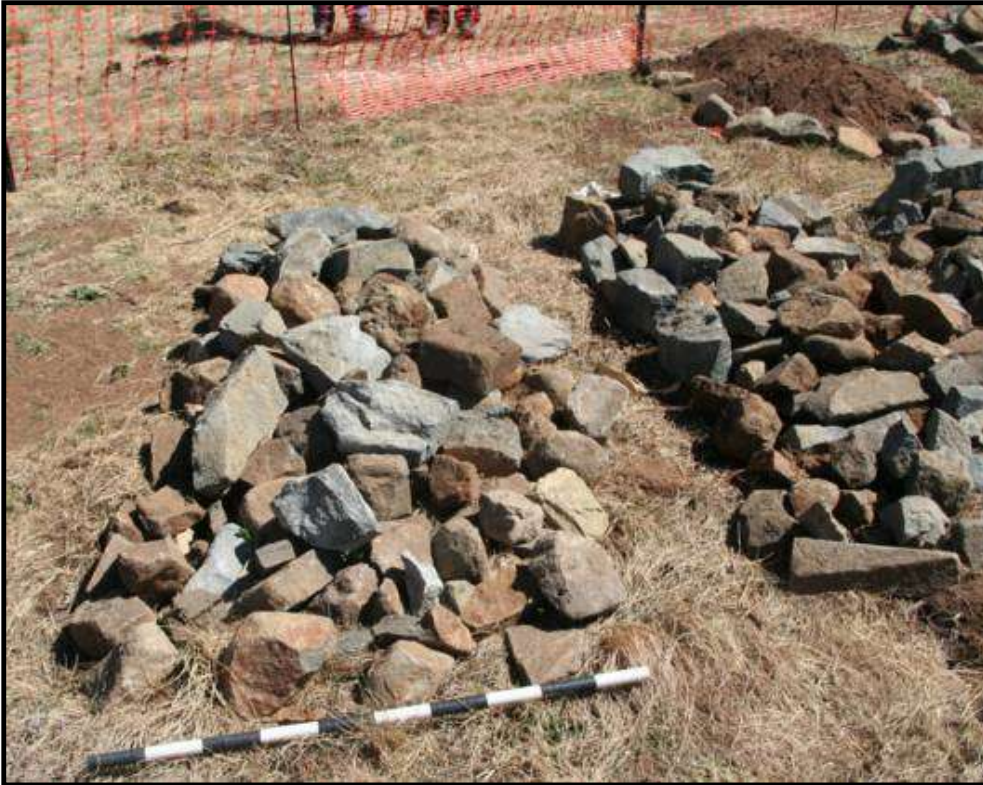
Fig. 7: Grave 5

Grave 5 has partially restored with loose rocks from the area. The upper half of the grave has been mostly affected by 'restoration'. The grave is rhomboid in shape and does not resemble a traditional grave.

A headstone has been placed on this grave

The grave has been incorrectly "restored:"

There may be a grave to the left of Grave 5, and this was not covered in rocks.

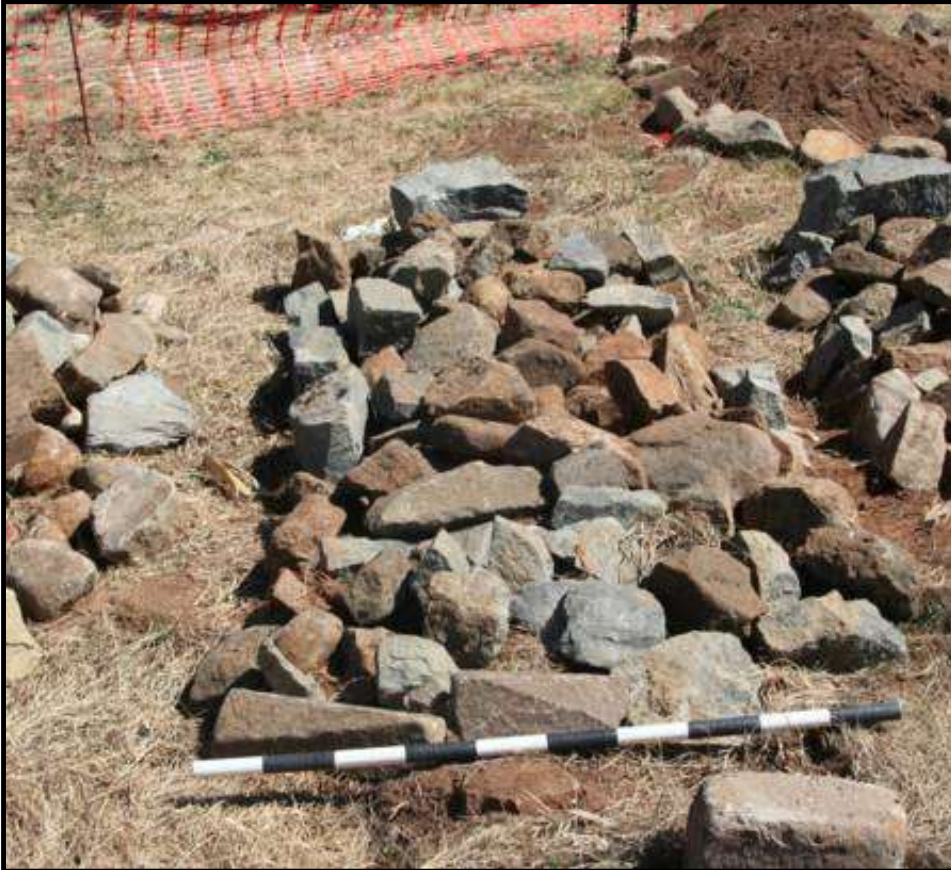
Fig. 8: Grave 6

Grave 6 has partially restored with loose rocks from the area. The entire grave has been mostly affected by 'restoration'. The grave is rhomboid in shape and does not resemble a traditional grave.

A headstone has been placed on this grave

The grave has been incorrectly "restored:"

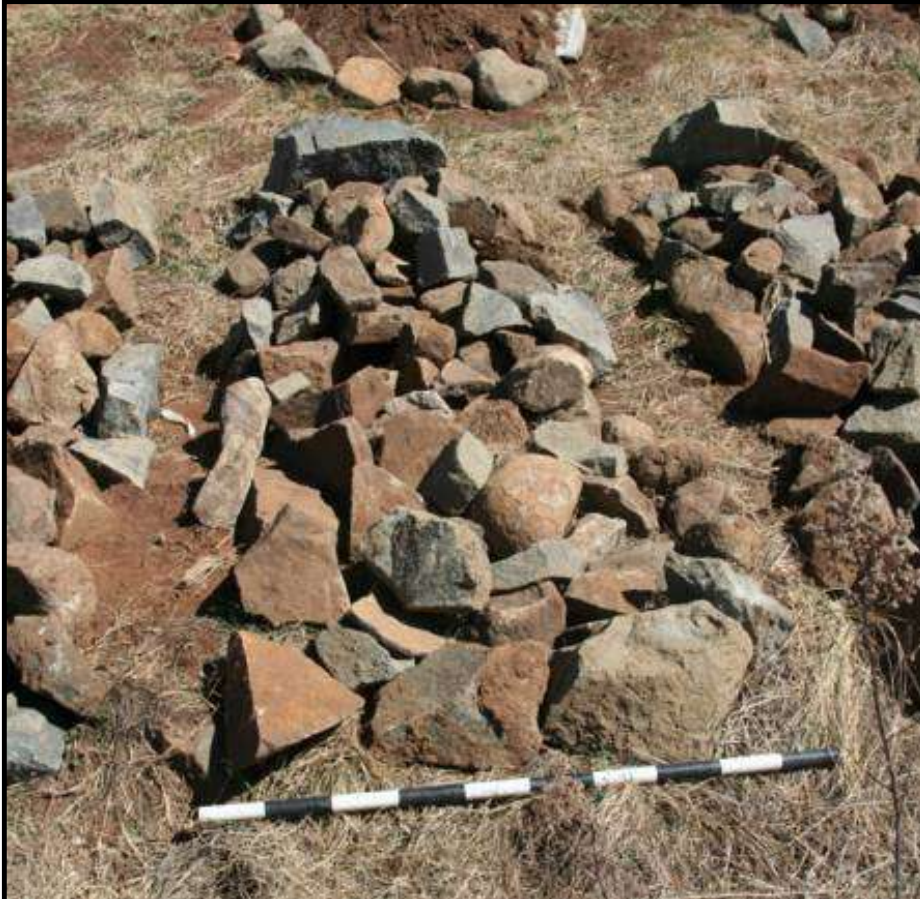
Fig. 9: Grave 7

Grave 7 has partially restored with loose rocks from the area. The entire grave has been affected by 'restoration'. The grave is rhomboid in shape and does not resemble a traditional grave.

A headstone has been placed on this grave

The grave has been incorrectly "restored:"

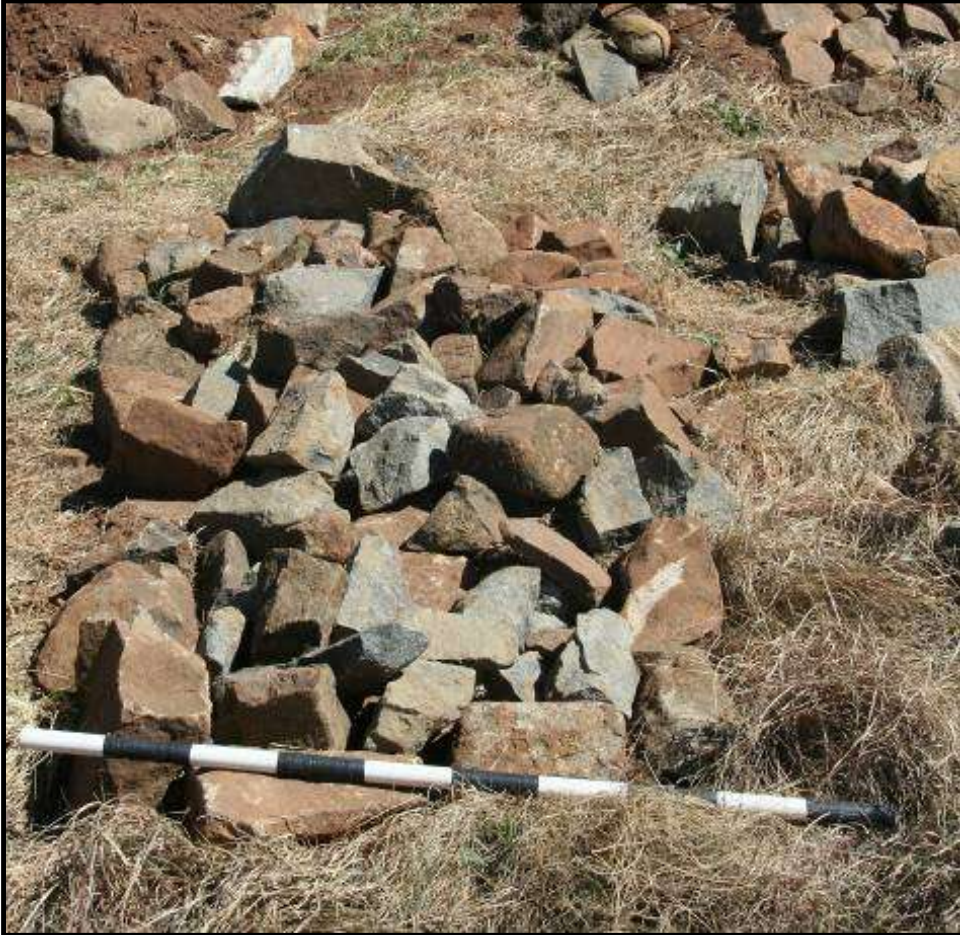
Fig. 10: Grave 8

Grave 8 has partially restored with loose rocks from the area. The entire grave has been affected by 'restoration'. The grave is rhomboid in shape and does not resemble a traditional grave.

A headstone has been placed on this grave

The grave has been incorrectly "restored:"

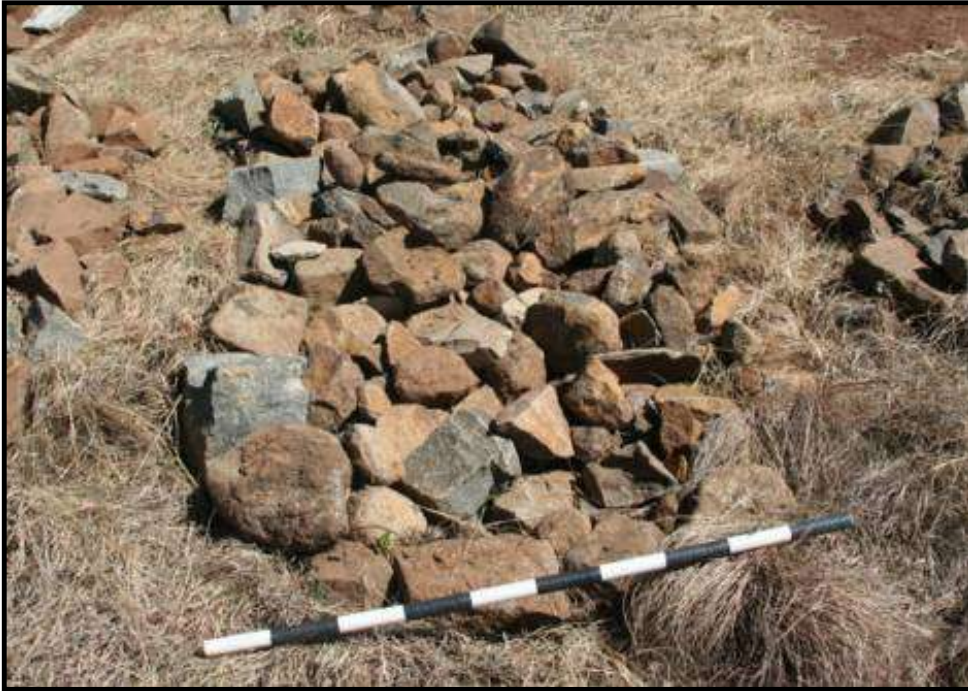
Fig. 11: Grave 9

Grave 9 has partially restored with loose rocks from the area. The entire grave has been mostly affected by 'restoration'. The grave is rhomboid in shape and does not resemble a traditional grave.

A headstone has been placed on this grave

The grave has been incorrectly "restored:"

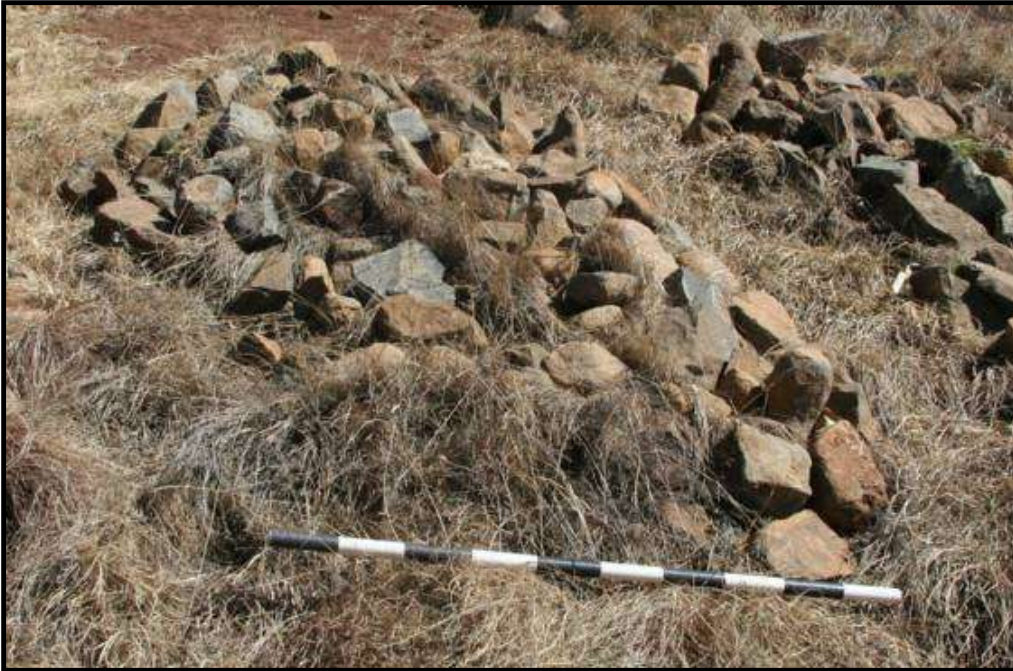
Fig. 12: Grave 10

Grave 10 has been partially restored with loose rocks from the area. The grave is generally in the correct shape however, the lower end is too narrow.

A headstone has been placed on this grave

The grave has been incorrectly "restored:"

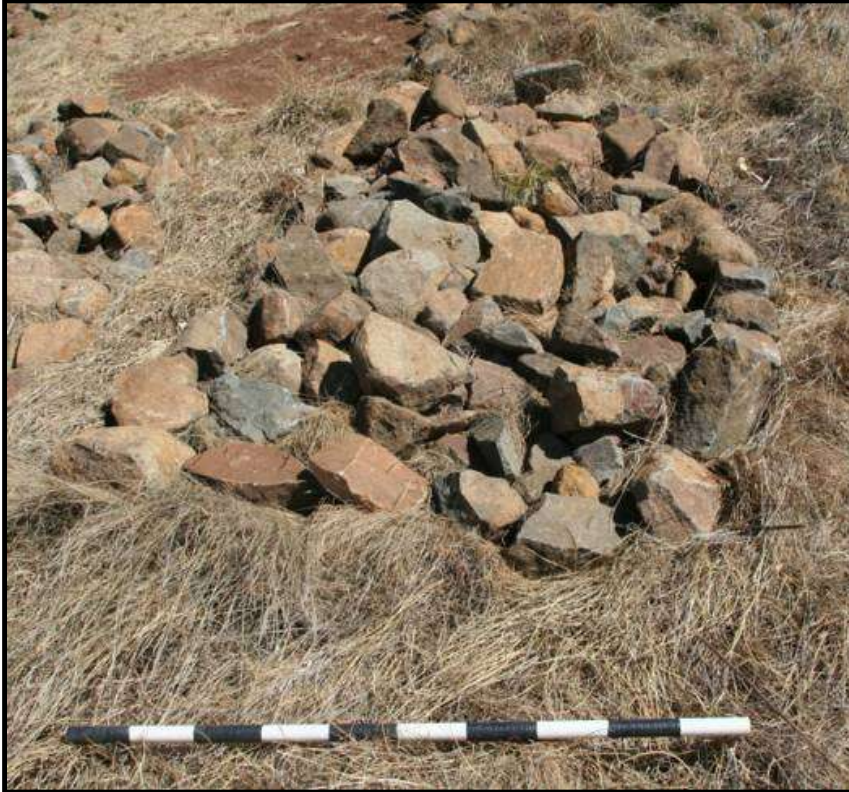
Fig. 13: Grave 11

Grave 11 has been partially restored with loose rocks from the area. The grave is generally in the correct shape however, the upper end is too narrow.

A headstone has been placed on this grave

The grave has been incorrectly "restored:"

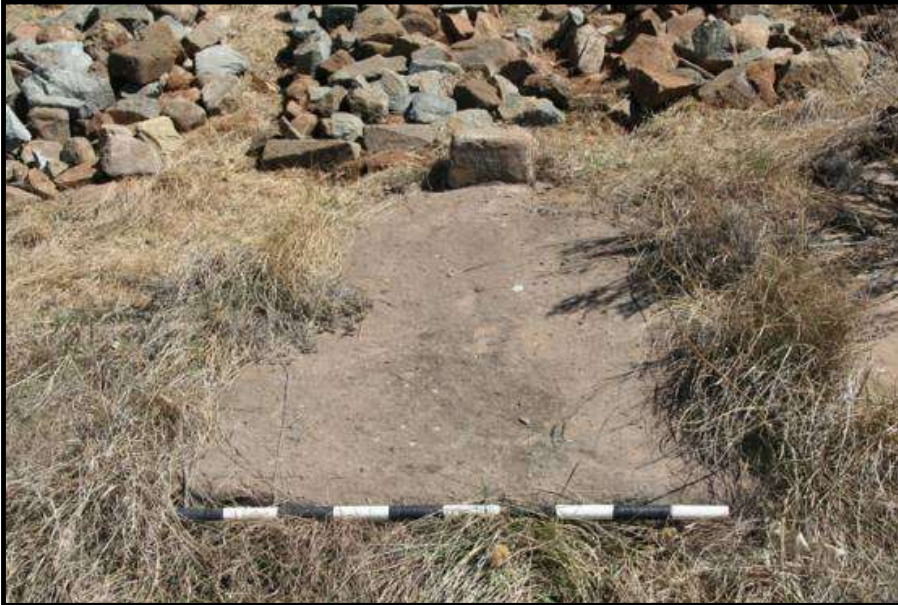
Fig. 14: Grave 12

Grave 12 consists of a mud and cattle dung capstone and head stone. There is no writing or dates on the headstone.

The grave is in a good condition however, the headstone has been slightly damaged.

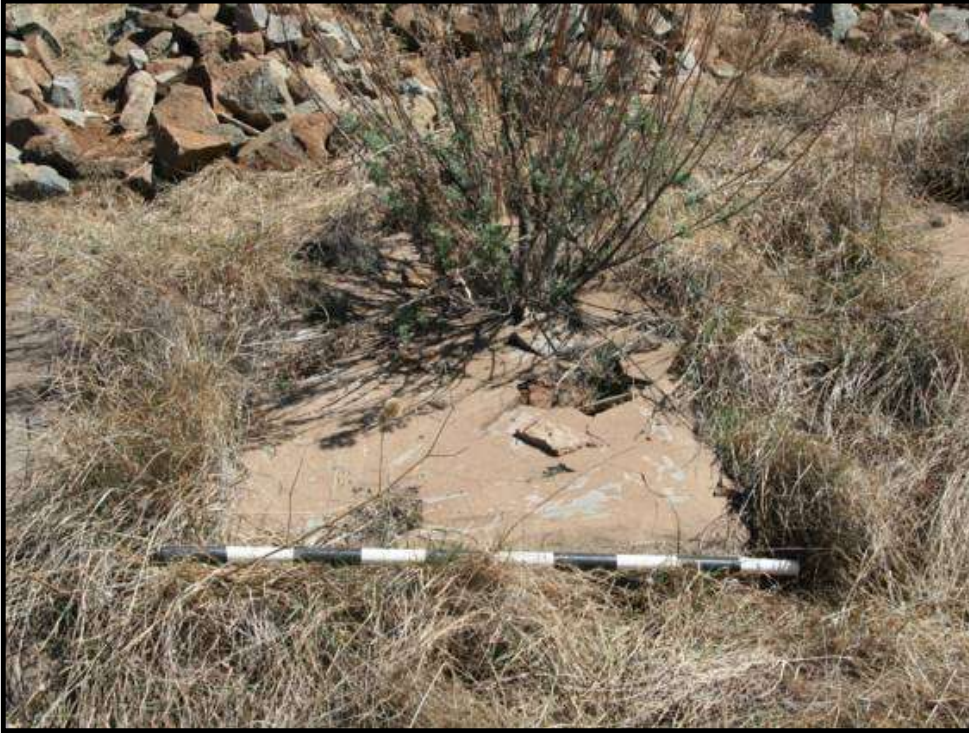
Fig. 15: Grave 13

Grave 13 consists of a mud and cattle dung capstone and head stone. There is no writing or dates on the headstone.

The grave is in a good condition but appears to have been partially damaged at some stage. I do not believe the capstone was damaged by NMPP as the edges of the fragments have a patina on them.

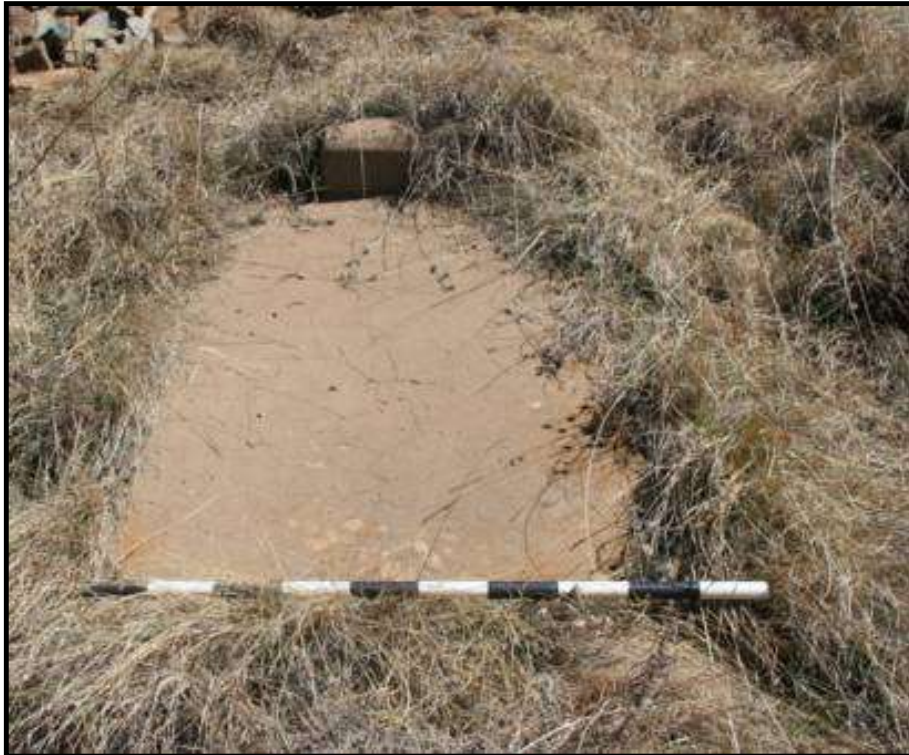
Fig. 16: Grave 14

Grave 14 consists of a mud and cattle dung capstone and head stone. There is no writing or dates on the headstone.

The grave has not been damaged

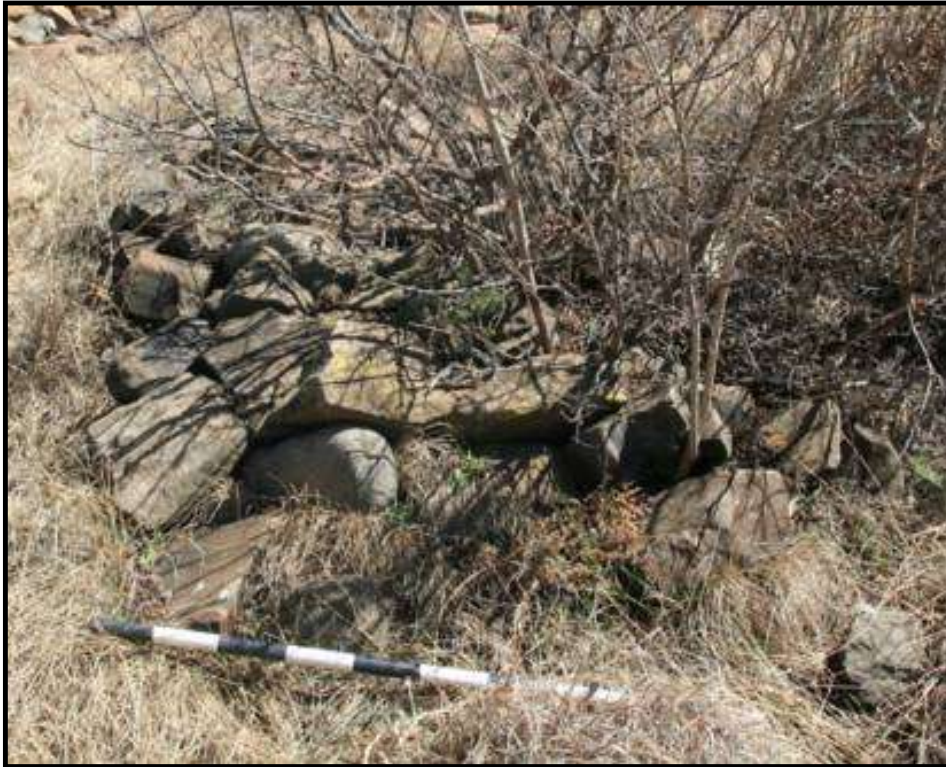
Fig. 17: Grave 15

Grave 15 consists of a stone cairn~1m wide and 1.8m long. The centre of the cairn has collapsed inwards; however, this is a natural occurrence, and not the result of the contractor.

The grave appears to be in its original condition and should be used as an example when restoring the other graves.

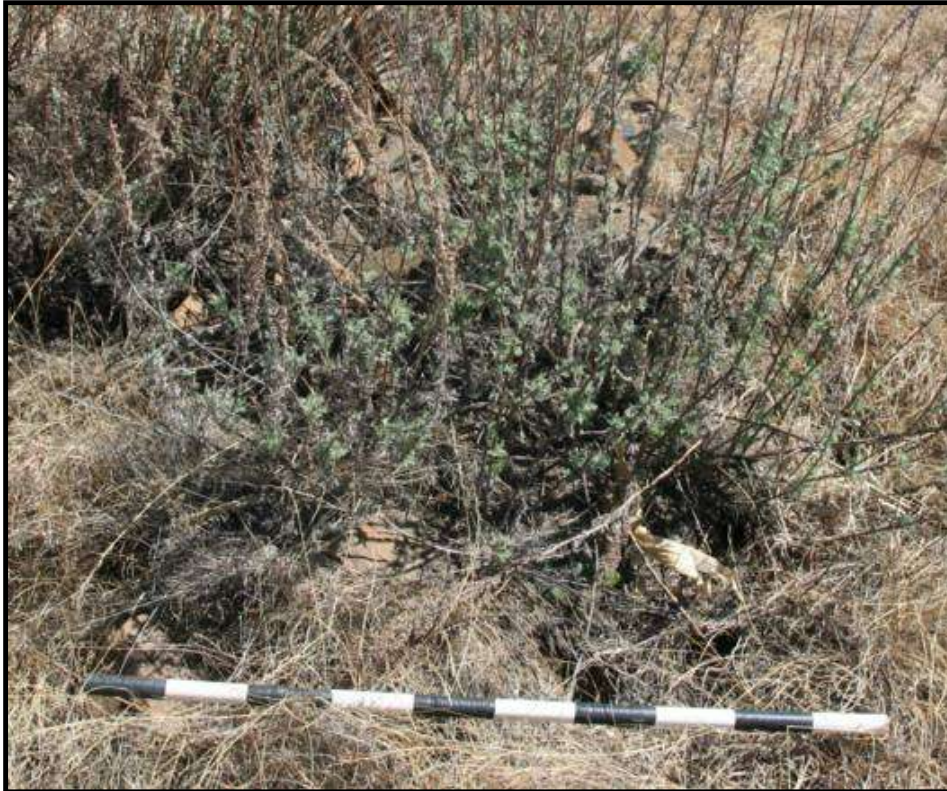
Fig. 18: Grave 16

Grave 16 consists of a stone cairn~0.9m wide and 1.5m long. The centre of the cairn has collapsed inwards; however, this is a natural occurrence, and not the result of the contractor.

The grave appears to be in its original condition and should be used as an example when restoring the other graves.
