## **Assessment of historic sites and buildings**

**2021/03/01**

### **Voortrekker Monument: proposed investigation regarding the inherent presence of moist in the structure**

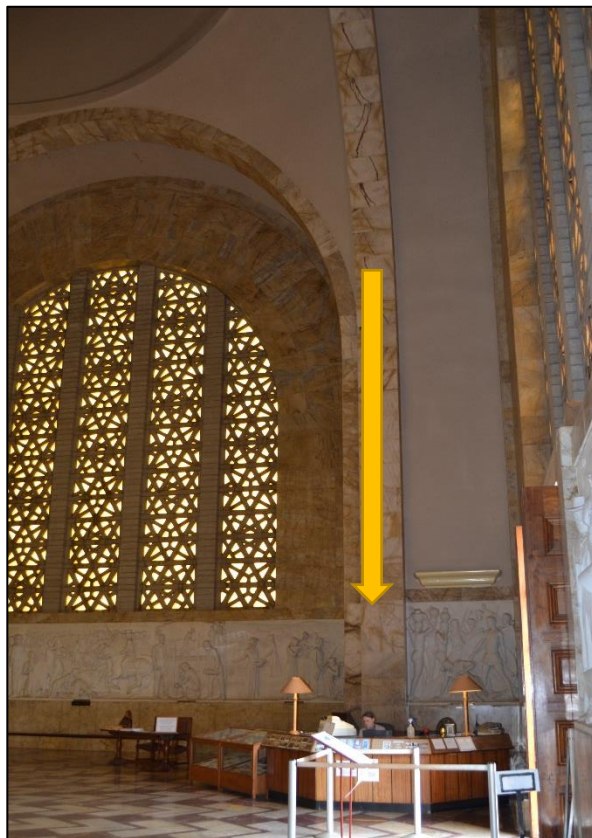
It is feared that the moist along the top parts of the structure would alter the cohesiveness of the building materials of the ceiling, causing it to crumble and fall on staff or members of the public. It is also possible that the marble tiles (slabs) mounted onto the intrados of the internal arches may become loose and fall on staff members and members of the public. These marble tiles are not tiles in the traditional sense but panels of approximately 1m X 600mm in size and 30mm thick (see pictures below).

*Figure 1. Location of work station of staff member in relation to arch clad with marble panels (Photograph: M. Naudé 2020)*

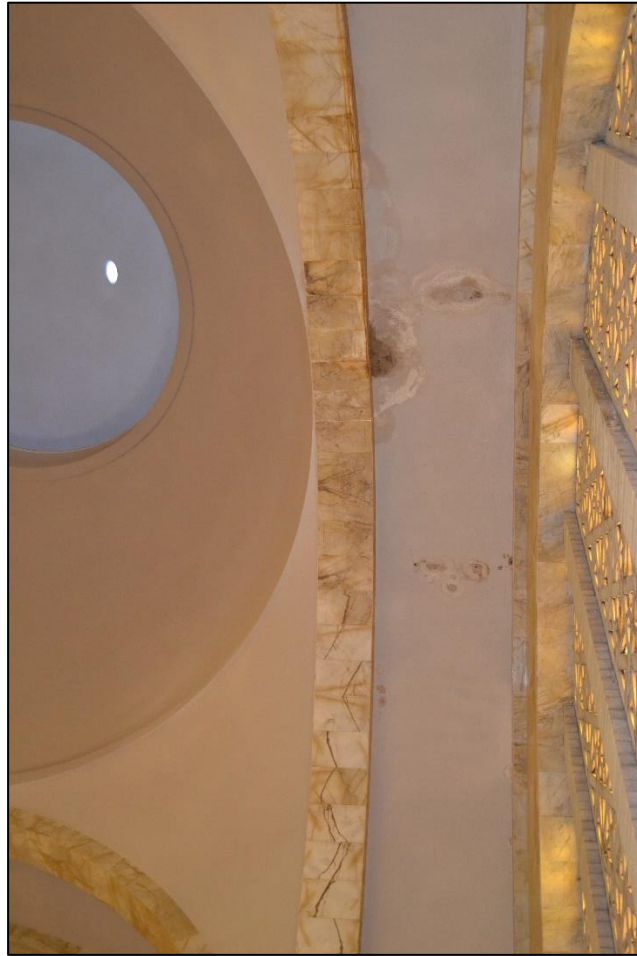
*Figure 2. Areas where moist caused dark spots along the plastered ceiling inside the curve of the ceiling – southern side  
(Photograph: M. Naudé 2020)*

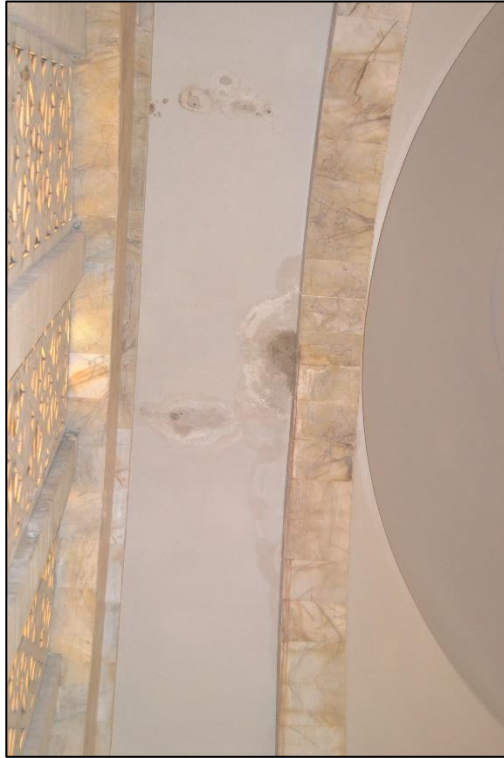
*Figure 3. The same moist area but from another angle (Photograph: M. Naudé 2020)*

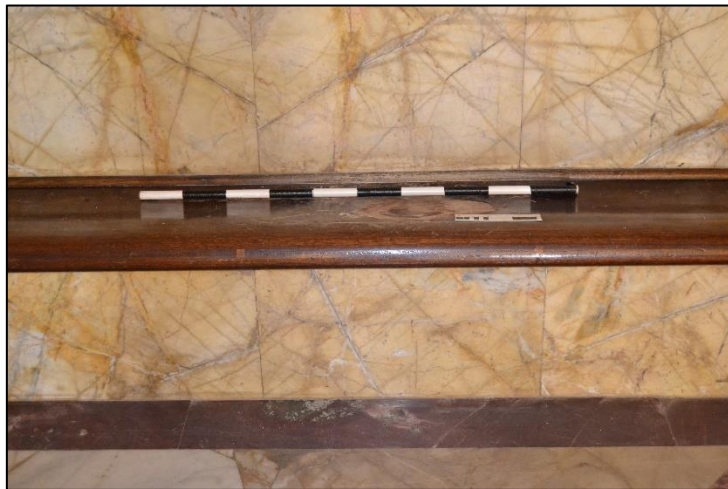
*Figure 4. Moist has been dripping on the wooden seats along the wall of the southern side of the interior (scale bar 1 m long) (Photograph: M. Naudé 2020)*

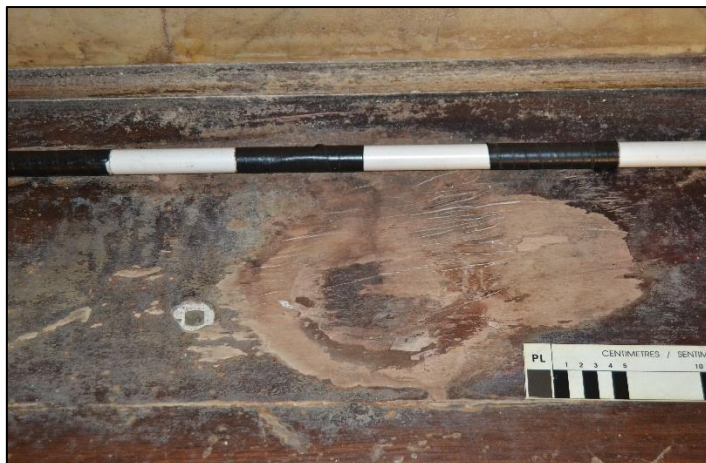
Figure 5. Dripping water has damaged the wooden seat surface (scale bar sections – 10cm long) (Photograph: M. Naudé 2020)

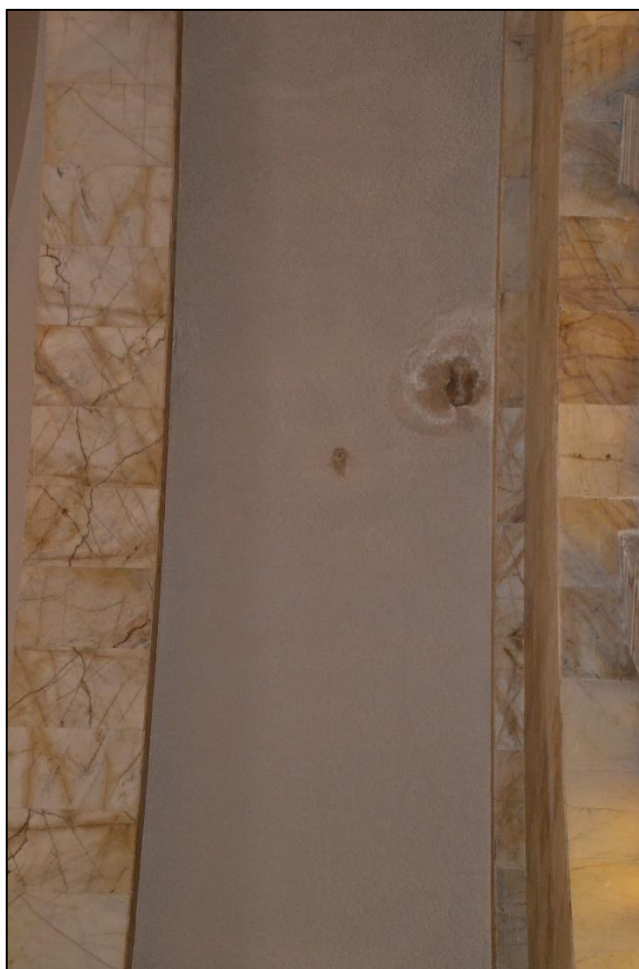
Figure 6. Second set of dark patches where moist degraded the plaster along the arched ceiling of the southern elevation (Photograph: M. Naudé 2020)

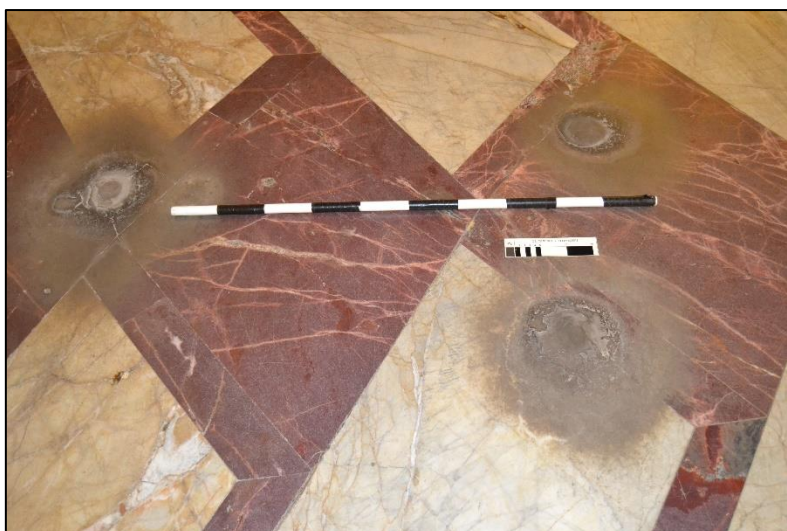
Figure 7. Dark patches on the floor along the southern side of the interior where dripping water caused colouration and slow disintegration of the floor tiles (scale bar – 1m long) (Photograph: M. Naudé 2020)

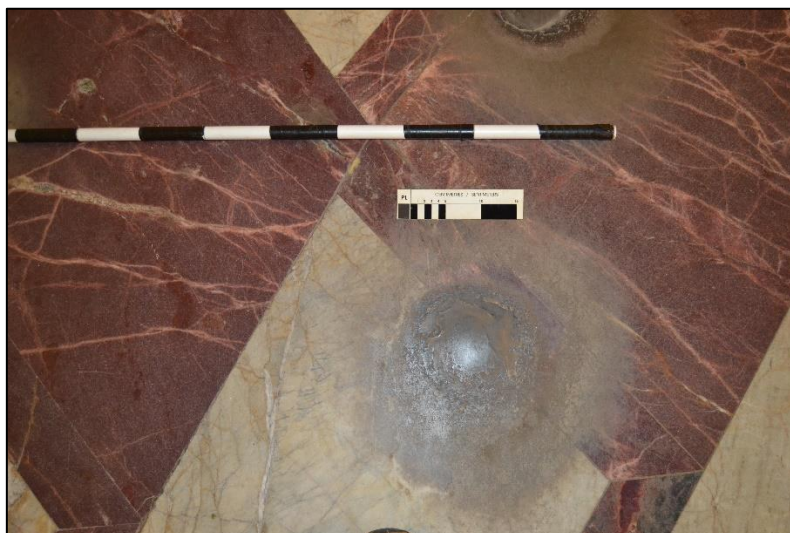
Figure 8. Extent of the water damage to the floor due to dripping from the ceiling (scale bar 1m long) (Photograph: M. Naudé 2020)

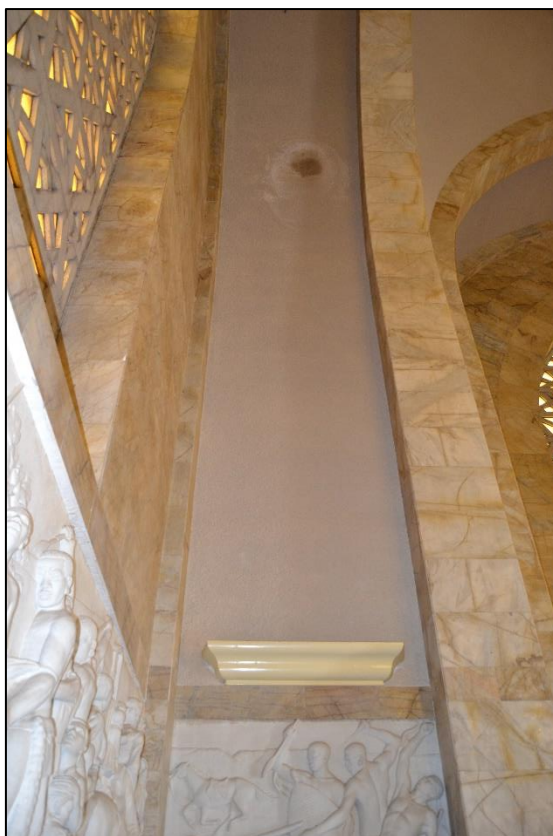
*Figure 9. Colour patch on the curved ceiling along the south western corner (Photograph: M. Naudé 2020)*

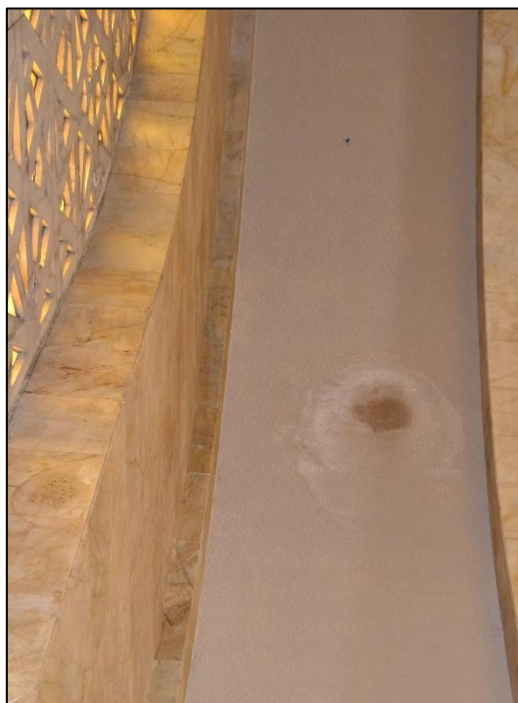
*Figure 10. Close-up of the patch on the curved ceiling in the south western corner (Photograph: M. Naudé 2020)*

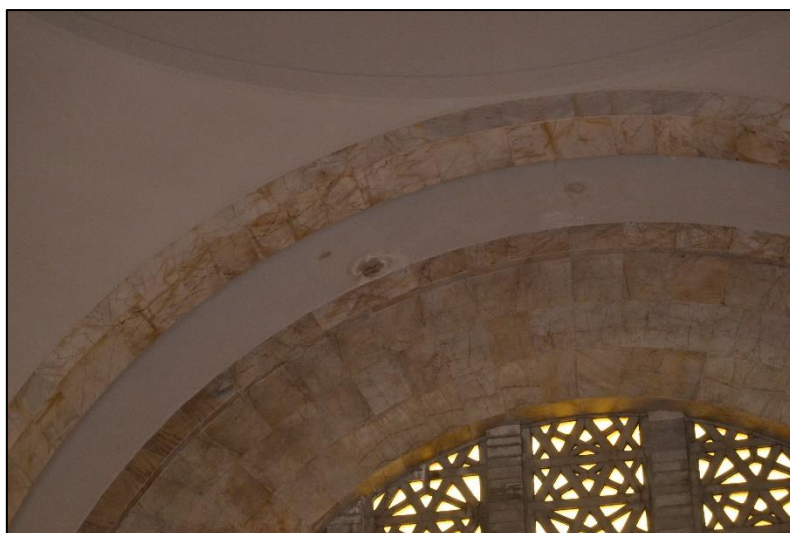
One of the critical aspects of the moist penetration is the chemical reaction the moist may have with the cohesiveness of the large marble panels that were used to clad the various internal arches. The most serious area is the arch directly above the entrance where a falling panel may cause the death or injury to a staff member, a tour guide or a tourist.

Figure 11. Dark patch above the entrance to the interior of the building (Photograph: M. Naudé 2020)

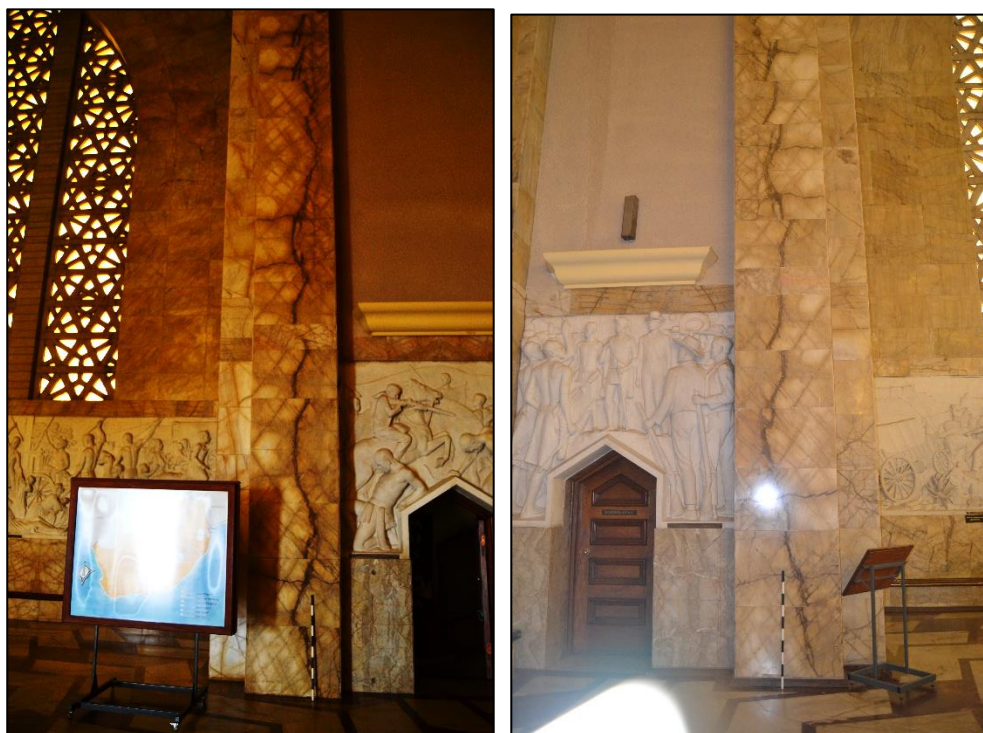
Figure 12. Vertical cracked marble panels along the intrados of two corner arches (Photograph: M. Naudé 2020)

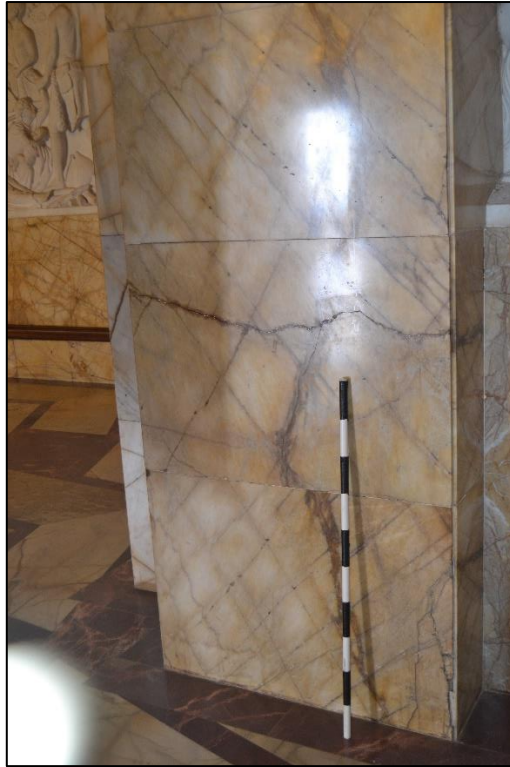
*Figure 13. Horizontal crack in one of the marble panels (Photograph: M. Naudé 2020)*
