SPIER FARM

DOCUMENTATION OF BUILDINGS I (1778) AND II (1817)

MAY 1994

H. N. VOS

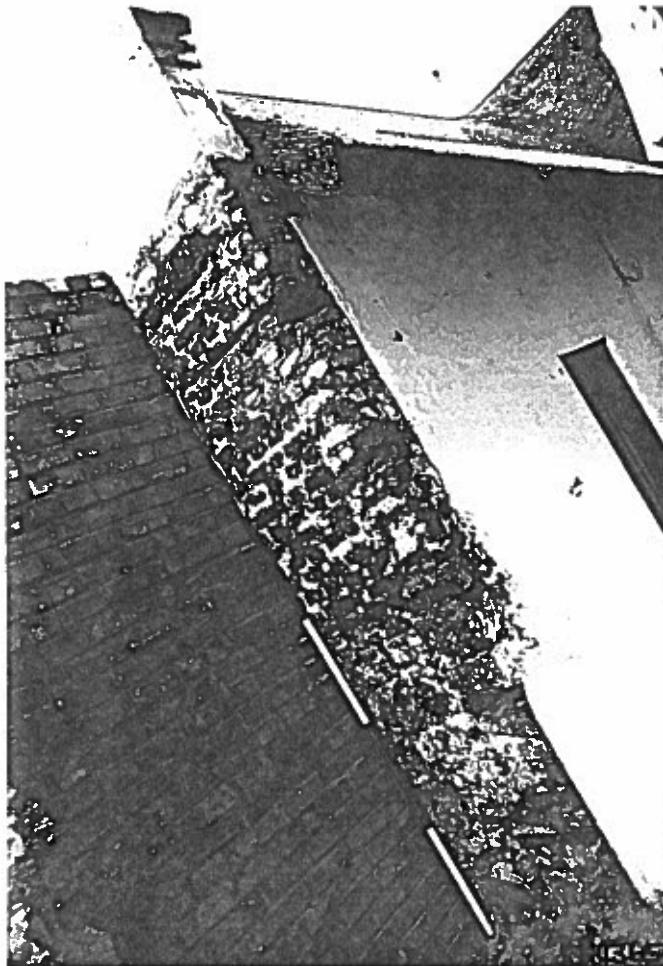
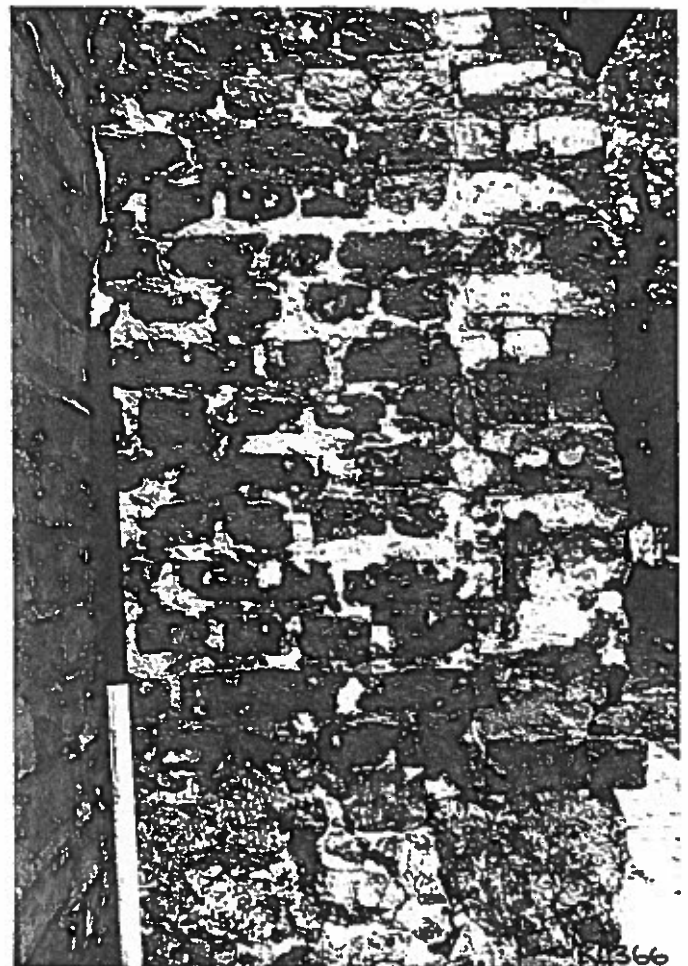
1,2. At the southwestern corner (D1) the building technique of the walls was sufficiently exposed. The granite, as waterproofing, was built-up exceptionally high, followed by well-fired orange brick in a yellowish clay mortar (scale: 2 m).

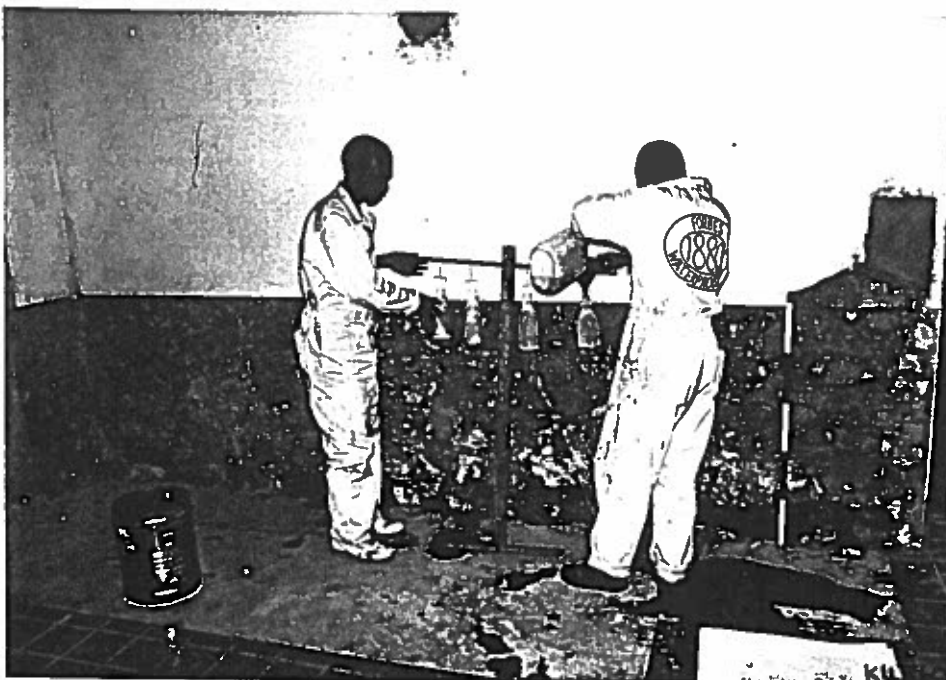
3. As the building had no raised stoep, contractors were called in to waterproof the stone walls.

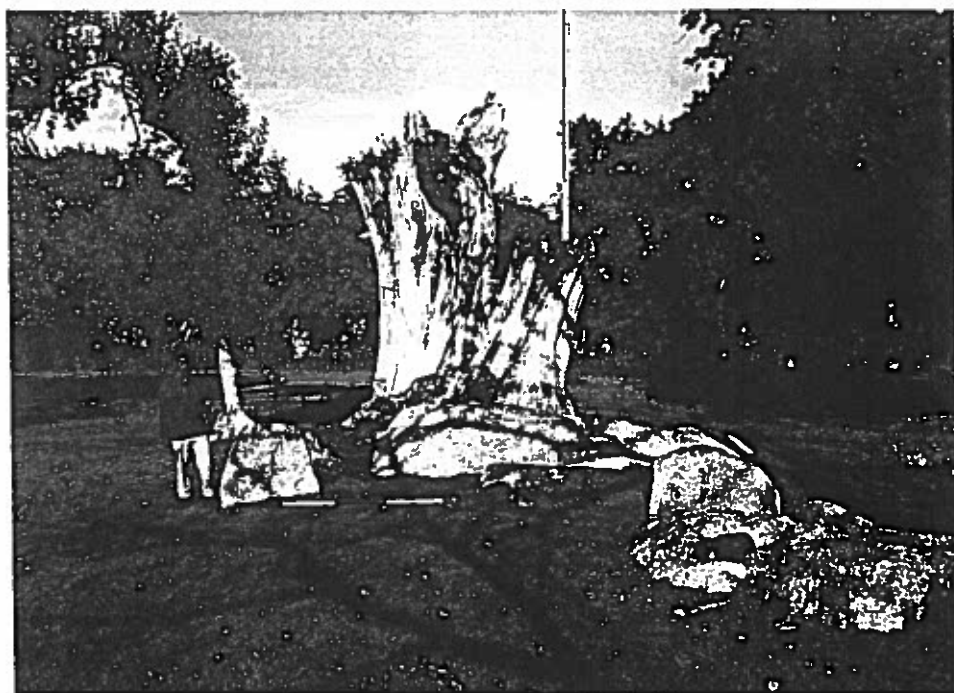
4. In the midst of the open werf, the remains of a particularly old blue-gum stood guard over the granite outcrops. There are definite signs that these were quarried for the Spier buildings. Small artefacts were also found in the vicinity.

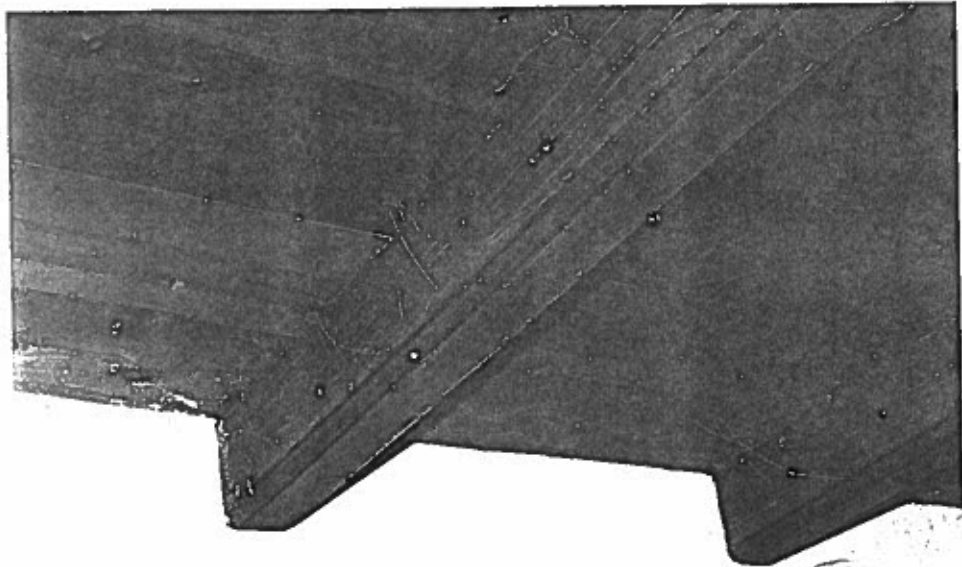
5. The yellowwood beams, moulded in the late 18th century fashion originate from the Cape Town station. They, and the ponderosa pine ceiling, were fitted around 1970.

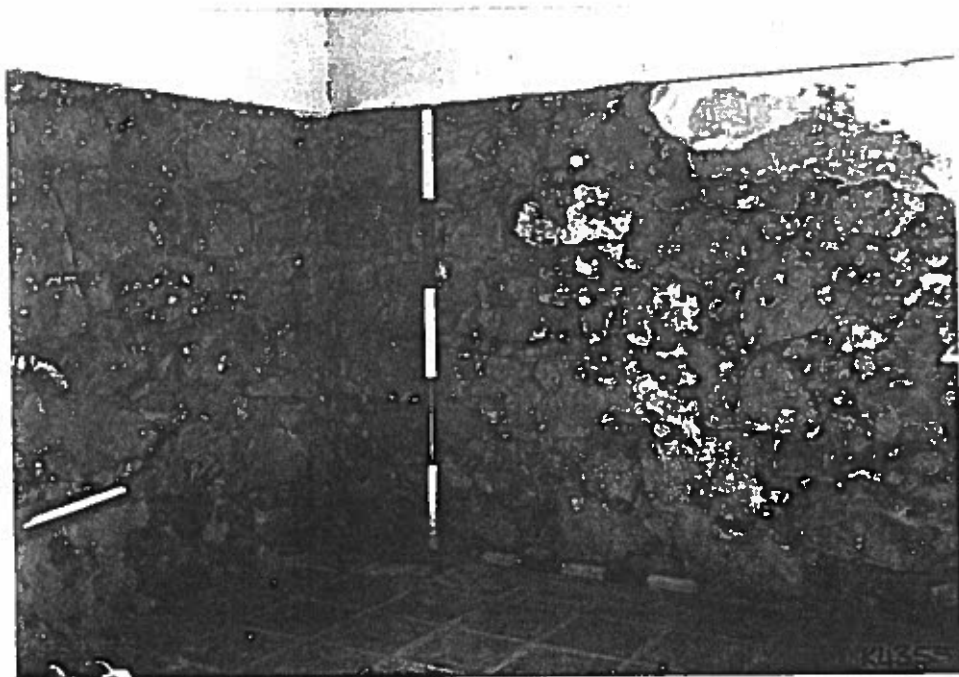
6. In room A1/2 some of the granite are white-washed directly (scales: 100 and 50 cm).

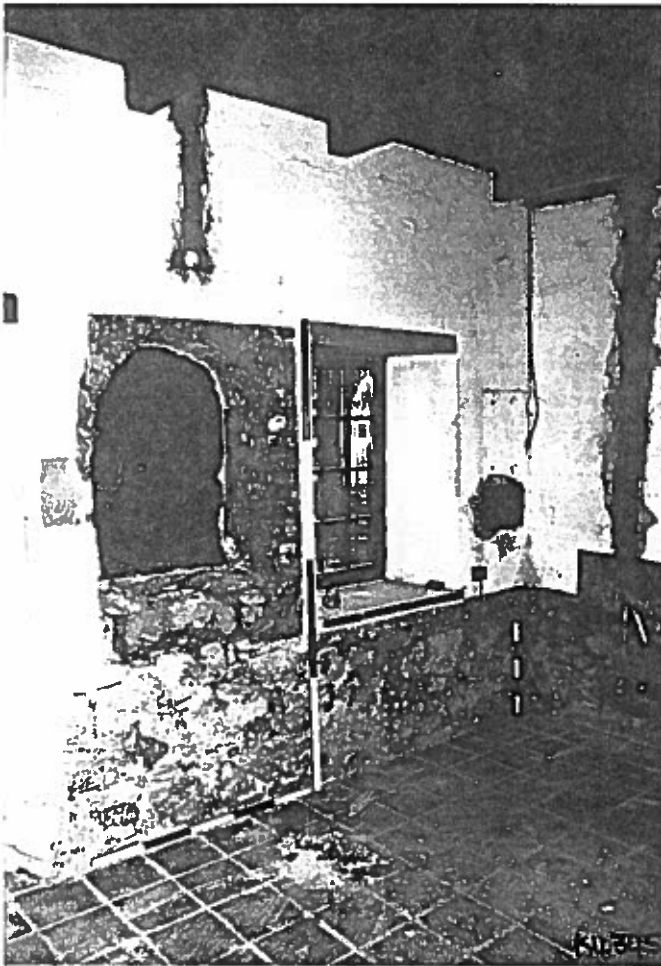
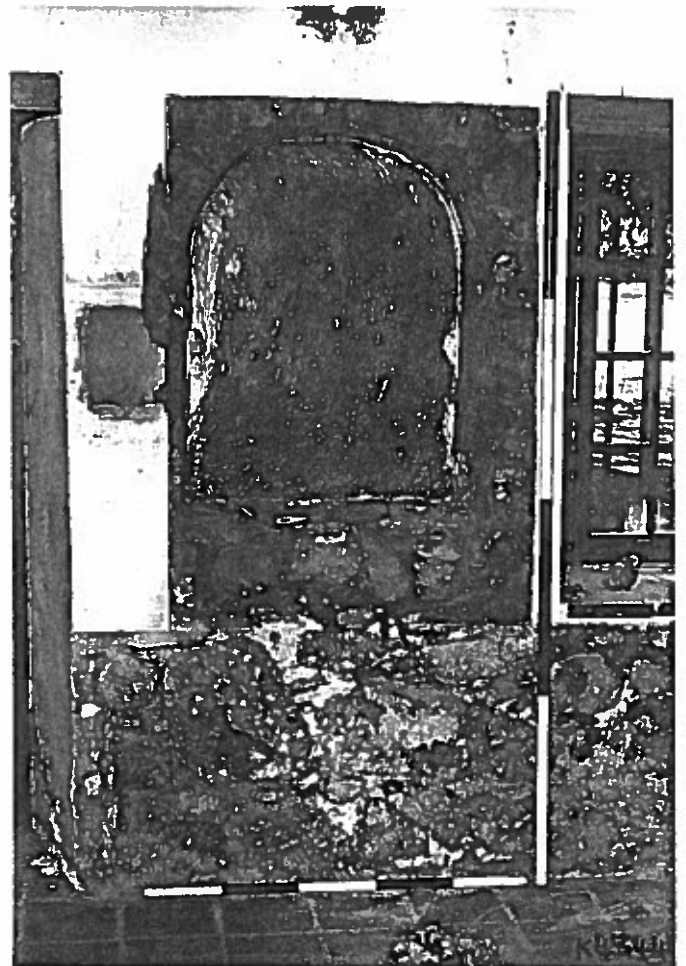
12,13. The niche in room B, facade wall 2, was specifically built to be exposed. It probably formed part of the innovations effected during the early 19th century.

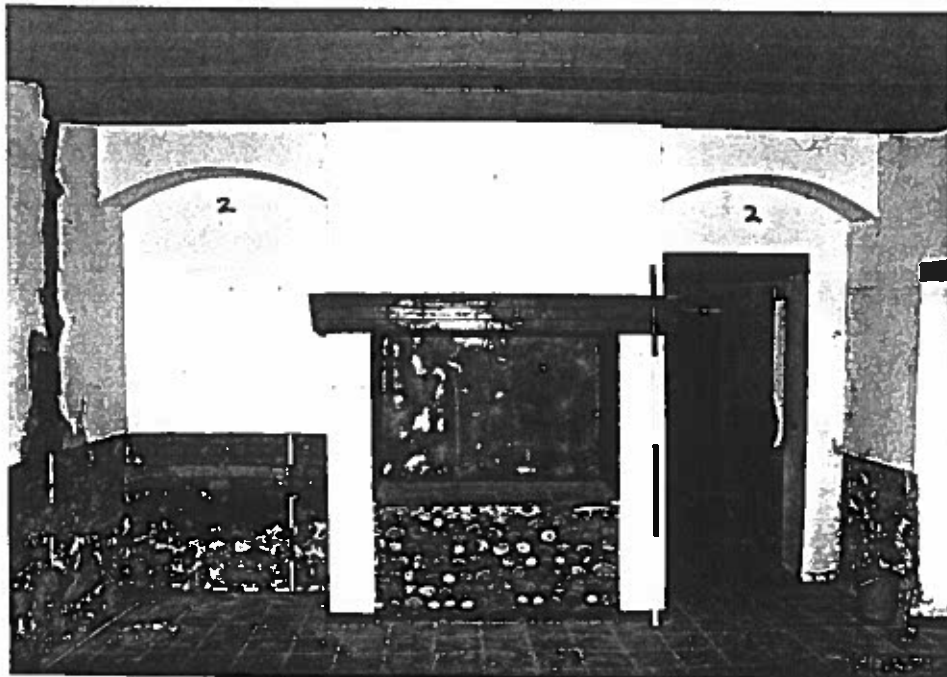
14

14. The present grate (1) is once again modern, but incorporates an 18th century oak beam, derived from Cape Town station. Note the enigmatic wall alcoves (2) on either side of the hearth.

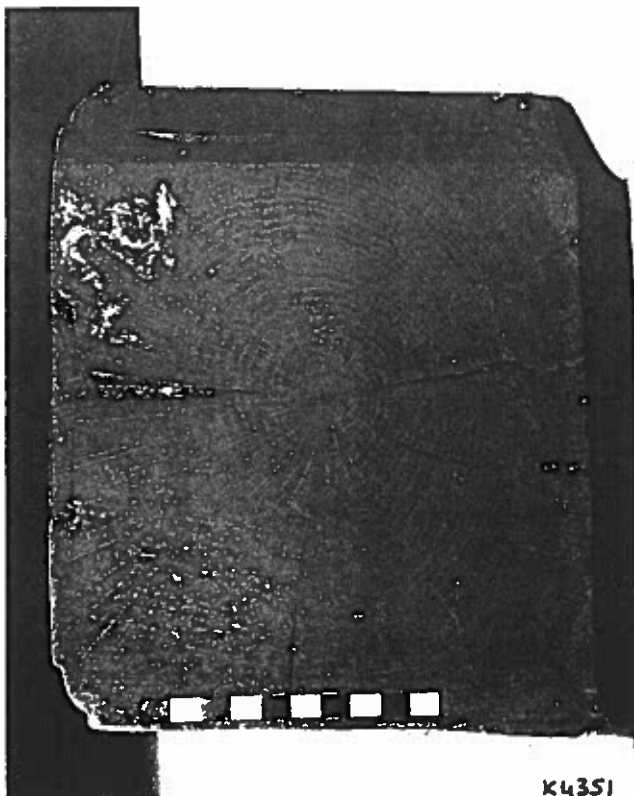
15. The oak hearth-beam originally formed part of a ceiling beam of good quality. The tree was older than 60 years when felled. Note the quarter circular mouldings of a size typical of the 18th century.

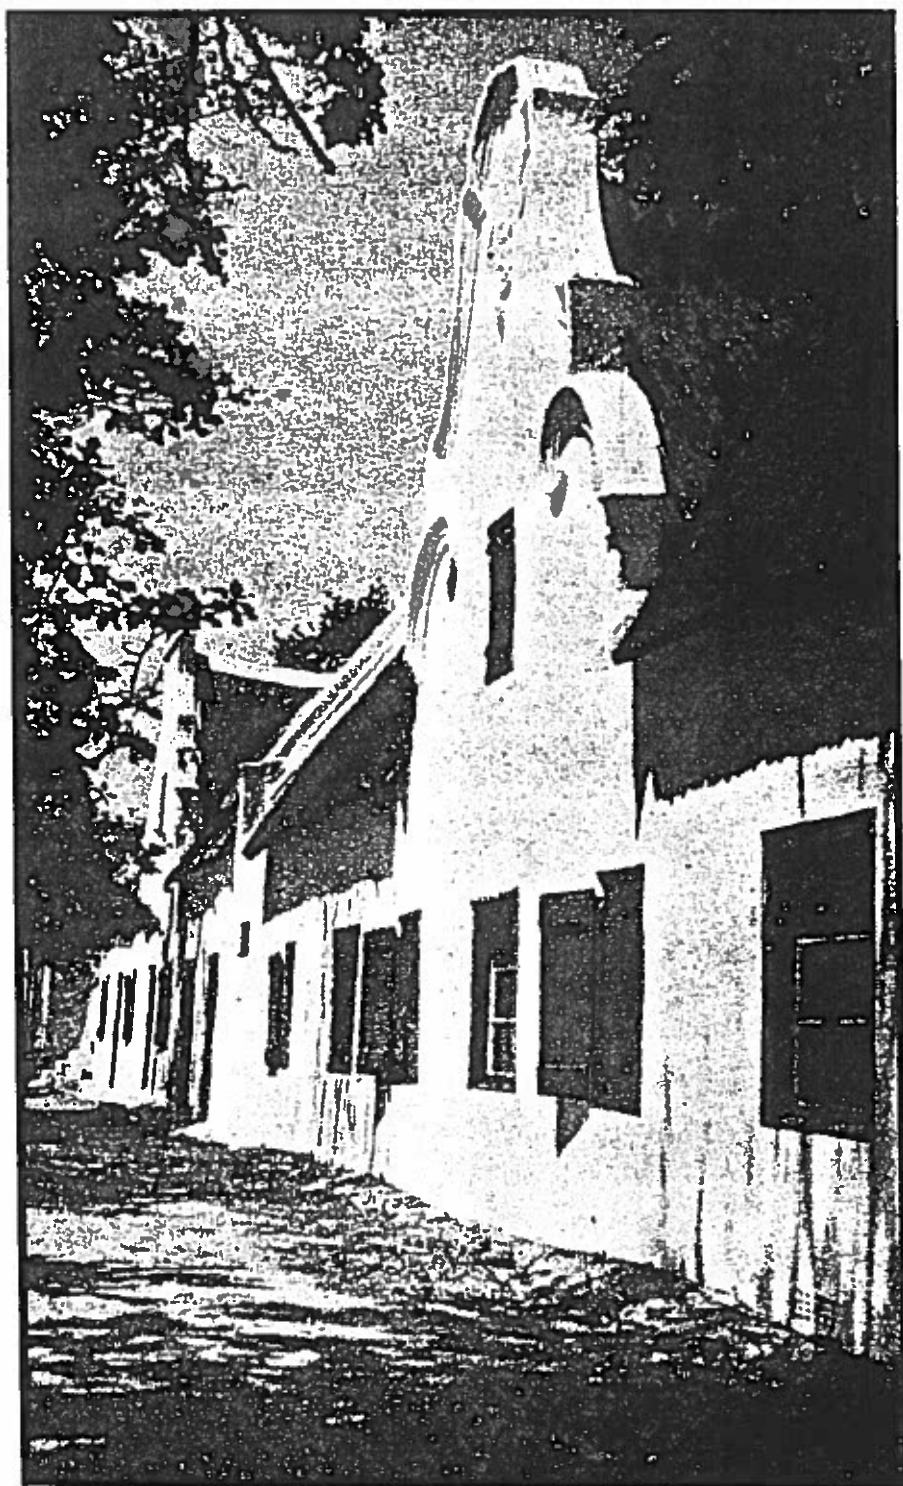
FIG.10.1 Building I was renovated prior to 1965. Note the blocked-up front door with a single casement (Walton 1965:plate 12).

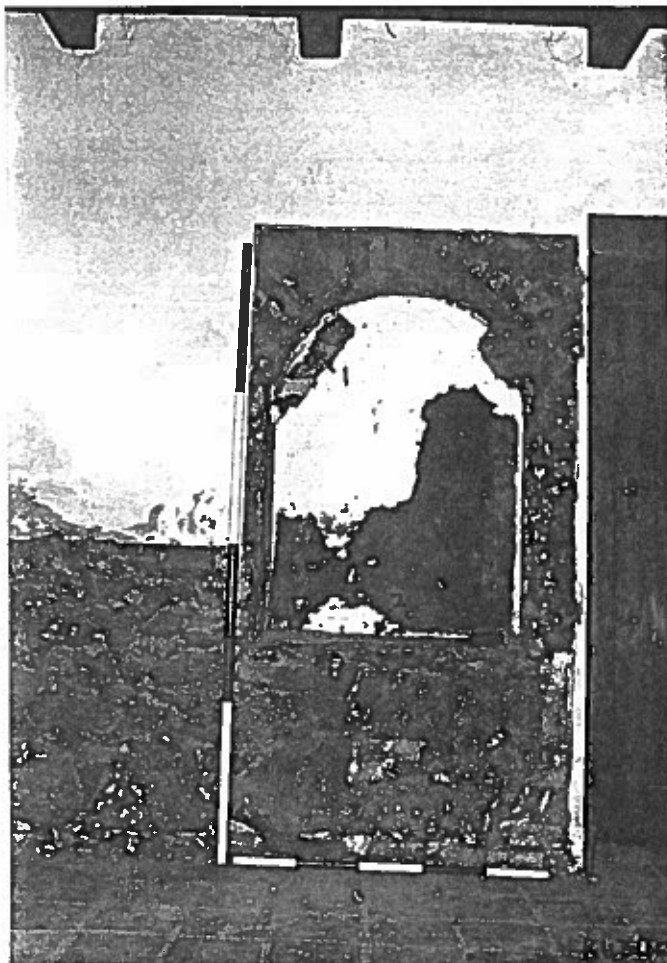
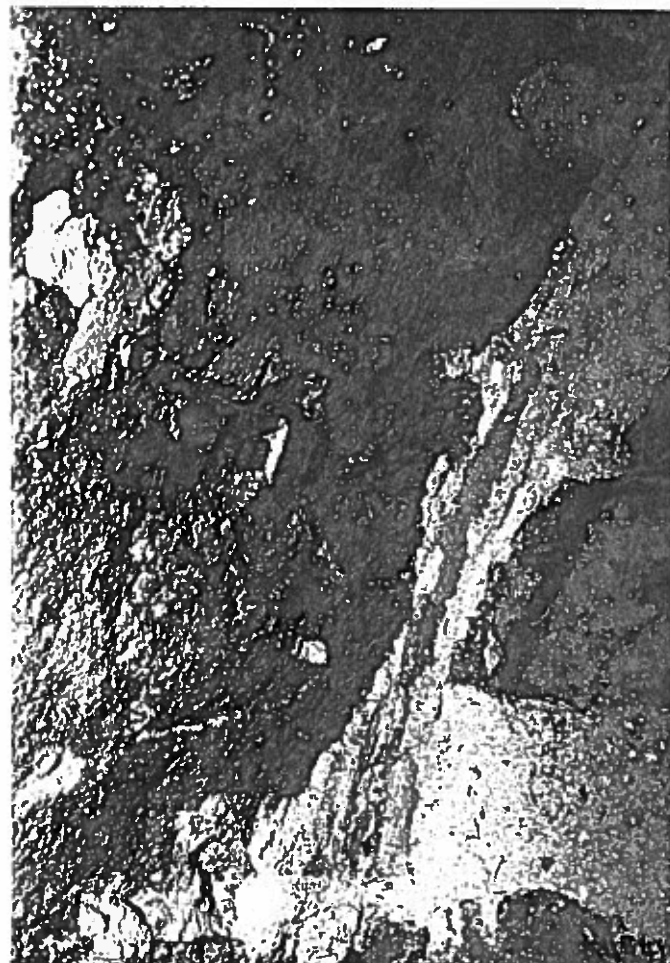
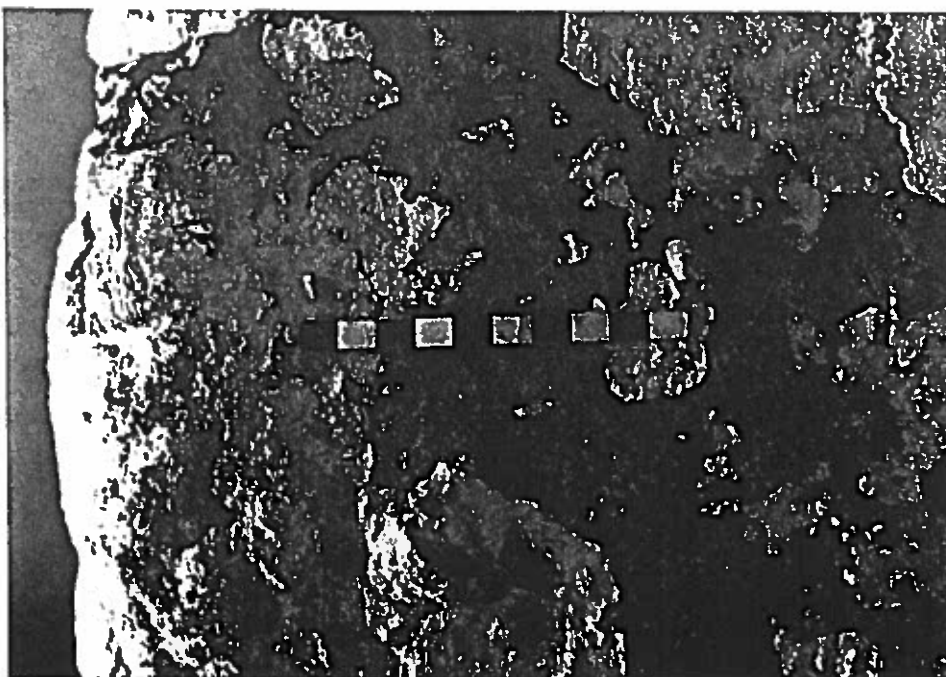
16,17,18. The other niche, in room C, wall 4, was slightly larger, and cuts into the stone wall. The vaulted arch was plastered and painted grey (1) (photo 17) and the stone sill (2) was white-washed (photo 18) (scale 2 m).

The niche in wall C4 is the most significant feature of this room. It is somewhat larger (1280x940 mm) than the one in room B (960x800 mm). Their similar style and technique indicate that the two are contemporary. The height of the brick is about 60 mm, which would normally suggest an early 18th century date. The yellowish dagha betrays it as being of the late 18th/early 19th century. The hard, shell-lime plaster with a white lime-wash was succeeded by one which is a light and dark grey, corroborating the idea that it was originally an open niche. The white-washed sill confirms this. Signs of blackening of the lime-wash suggest candles, or smoke from a fire. Was there a grate on this side of wall C1, incorporating the same chimney? Or did a fire occur in the building?

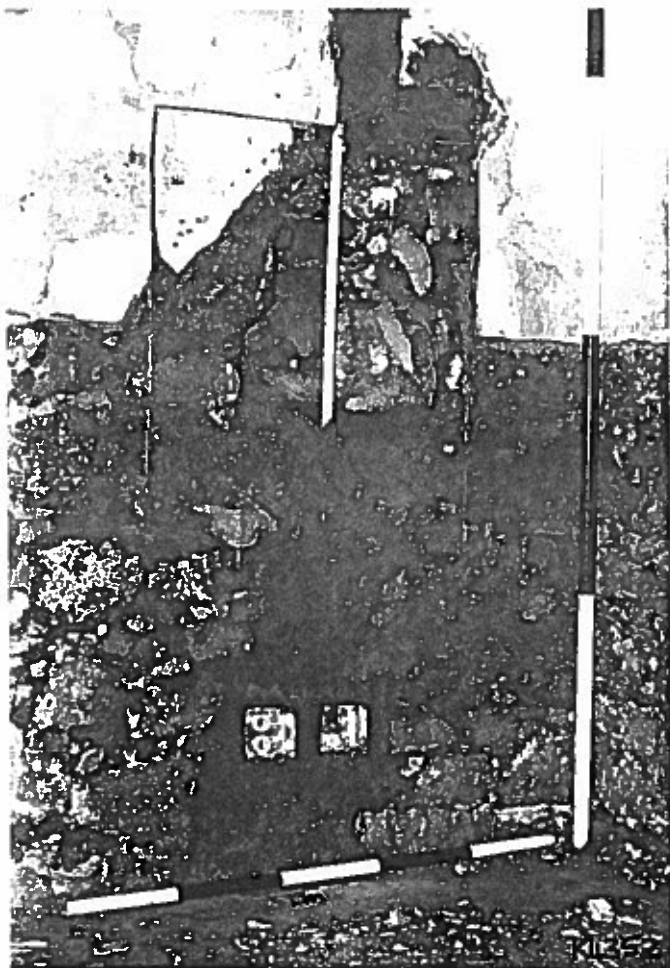
19. In room C, the exterior wall C3 was partially exposed to show the neat building technique in granite (scale 2 m).

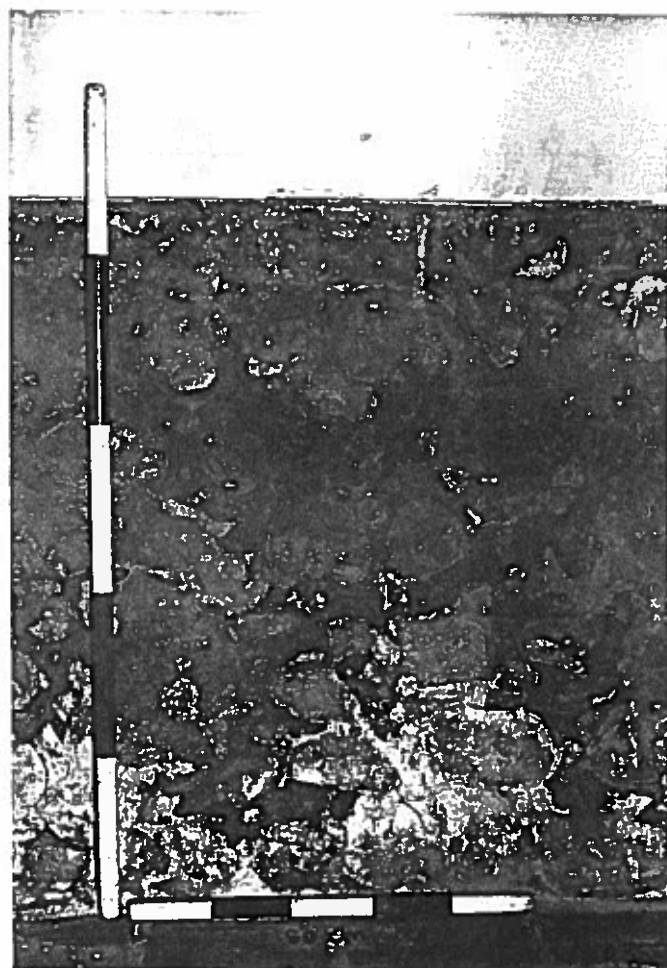
20. In contrast, the interior wall C2 was constructed of cobbles in the lower section. Signs of fire were present, probably residues of the earlier hearth that was demolished.

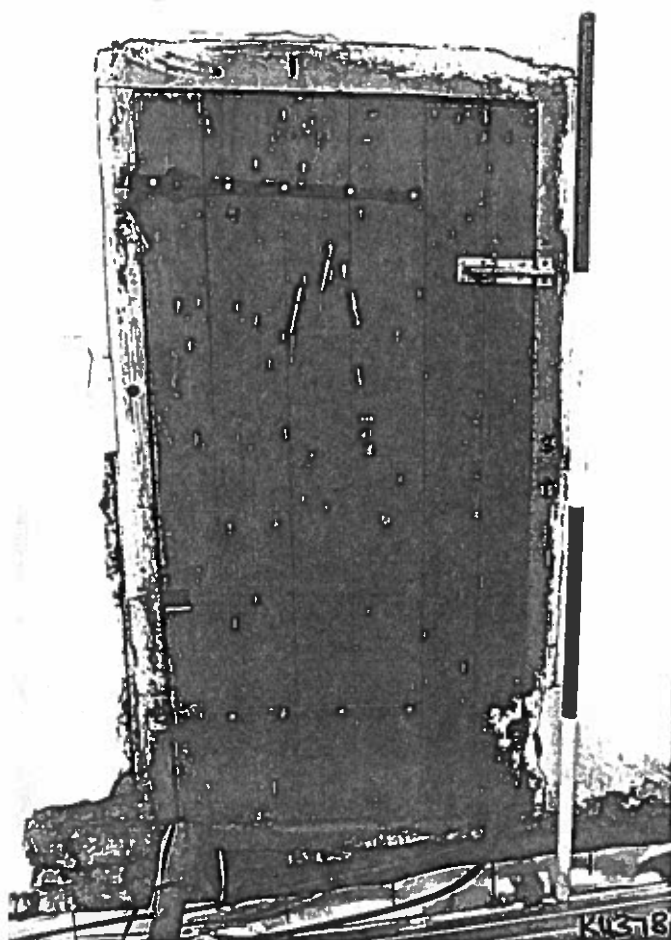
23. During the 19th century the door case was installed in the southern end-gable. The case (1) is old, with pintle-hinges (2) and catch (3). Presumably the original door deteriorated and its strap-hinges (4) were re-used on the present door.

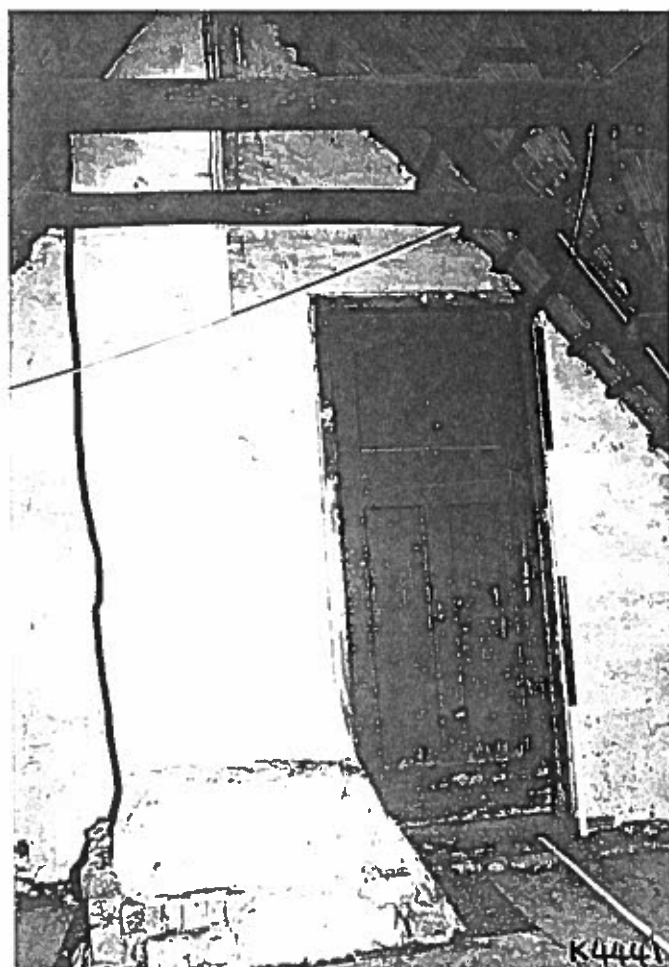
24. The chimney of the small hearth in room B1 is certainly modern, as is the dividing wall with its c.1930 door.

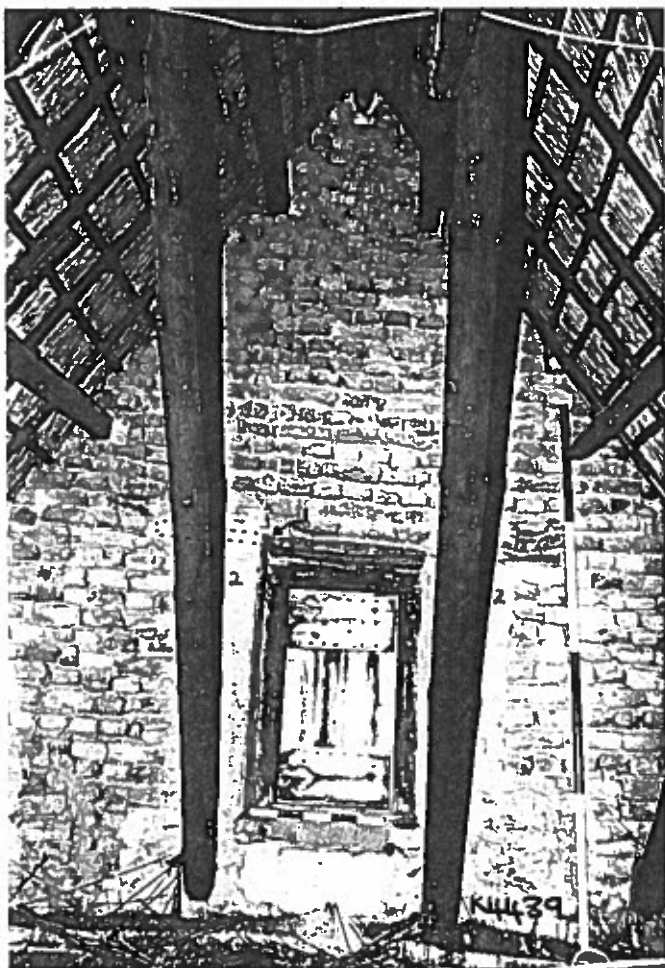
26

The central gable (B2) contains a long lintel (1,6 m) which originally spanned a double casement which was replaced, around the middle of the 19th century or later, by the window visible in the Elliott photographs. The gable itself is built of an orange-coloured brick set in a yellowish mortar. The latter indicates that, on this farm, yellow mortar had already superseded grey mortar by 1778 (if the gable date can be trusted). This is much earlier than in the town of Stellenbosch.

26. The inner side of the central gable (1778) reveals some interesting details. The long lintel (1) indicates that a double casement preceded the single casement. Notice how the sides have been blocked-up (2). The pintles (3) indicate that the casement swung inwards and were therefore glazed (shutters were always attached to the outside of the case).

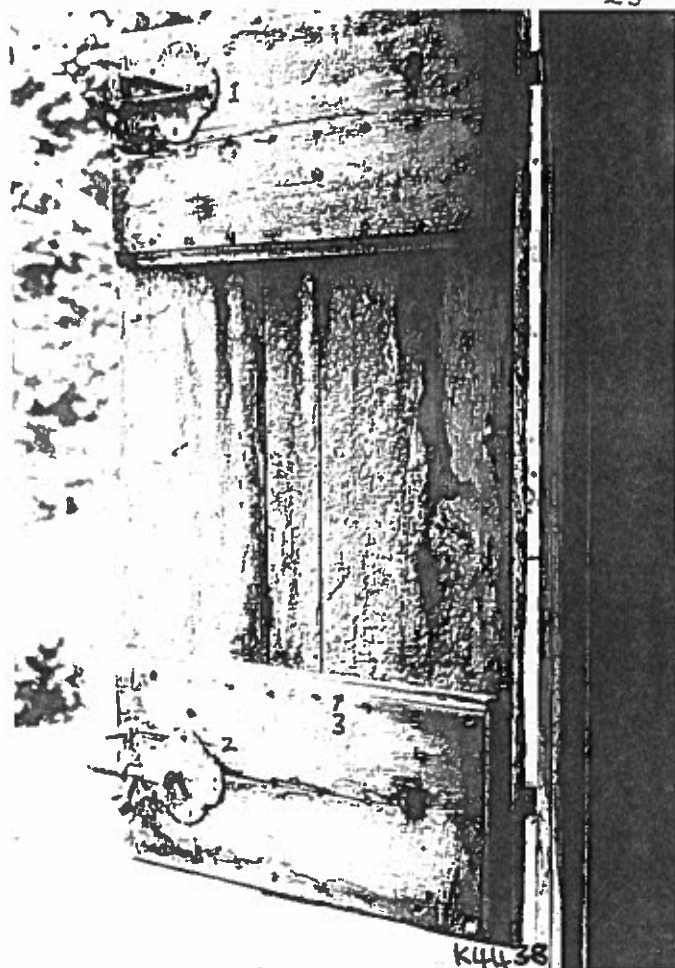
27

27. The 18th century shutter, showing its spring latch (1) and sliding bolt (2). Note the delicate moulding (3).

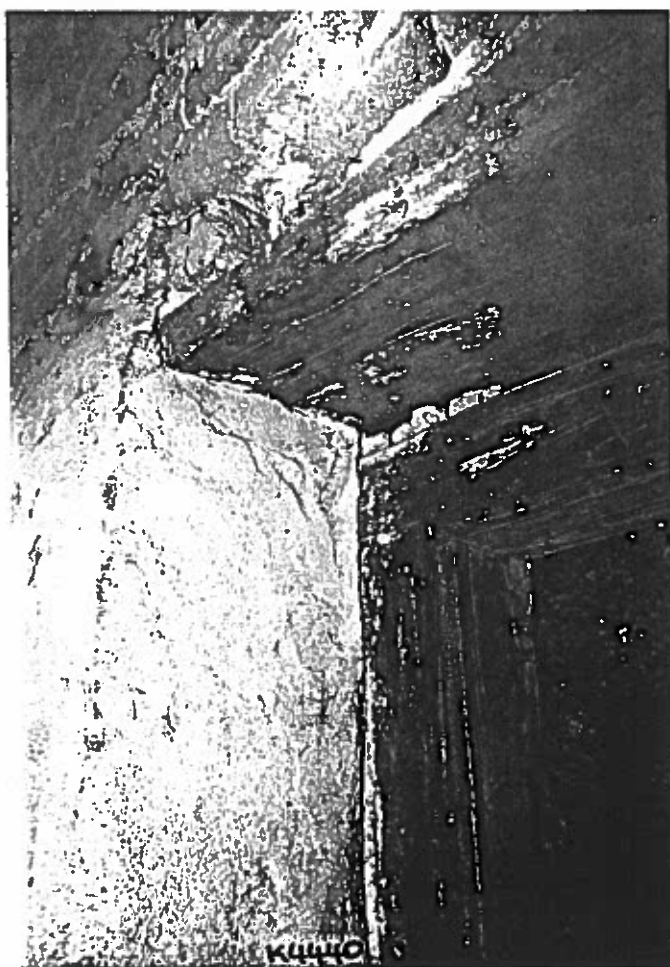
28

28. A close-up that shows the simple lintel, casement and blocked-up section.

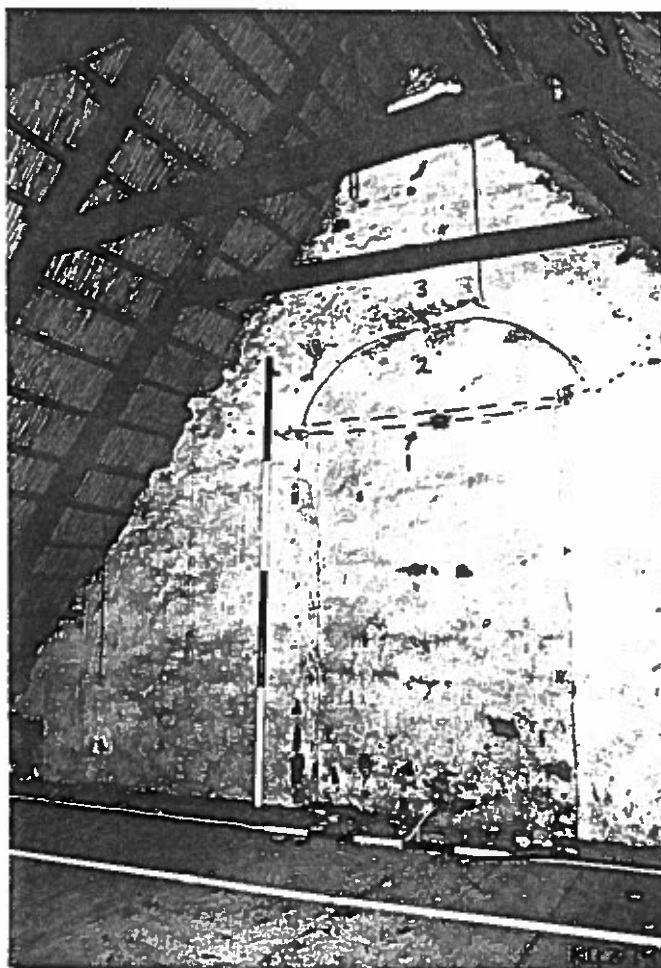
In the northern end-gable (A1) there was once a door, but this was removed and the openings bricked-up during the 19th century. In the process of removing the lintel, the relieving arch caved in. A wooden staircase or ladder would originally have given access to the loft. From all indications, this building dates from the mid to late 18th century. When the "1817" building was erected next to it, the aperture for the loft door on the north side was bricked up and a "new" door installed in the southern gable. Within the dividing walls in the loft, two similar doors of the 1930s were built. In 1950 Walton (1965:5) made a drawing of a loft at Spier, probably representing one of the two cottages (FIG.10).

25. The earliest loft door was situated in the northern end-gable. For some reason it was blocked-up in the 19th century. In the process when the lintel (1) was also removed, the filler part (2) below the relieving arch (3) collapsed.

"Restoring" a door in the northern end-gable is questionable, since it would be exposed to winter rains and liable to leak. The former door in this position was wisely bricked-up, probably when the adjoining building was erected. Seen in context, the gable should stay as it is. In order to enhance the authenticity of the interior, the ceilings could be varnished

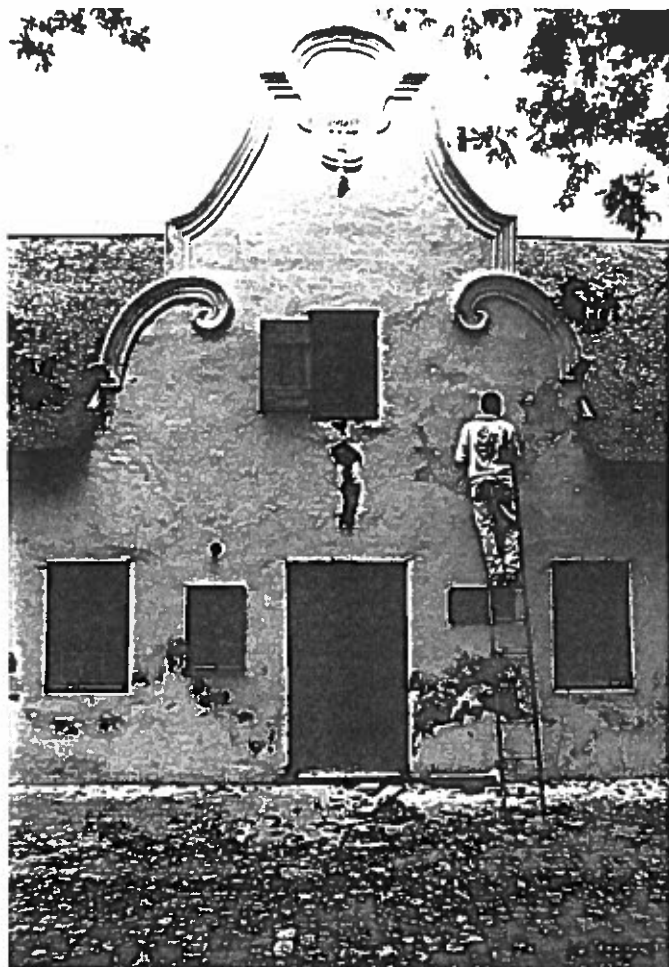
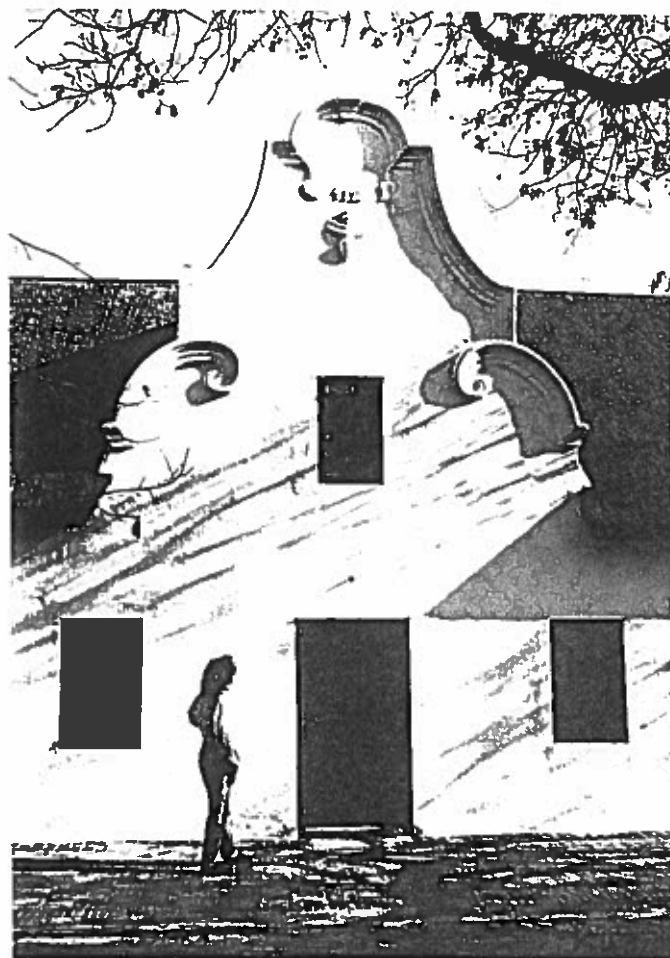
29,30. During the recent renovation, the unsightly paraphernalia was removed, the woodwork painted green and the gable given a fresh coat of lime.

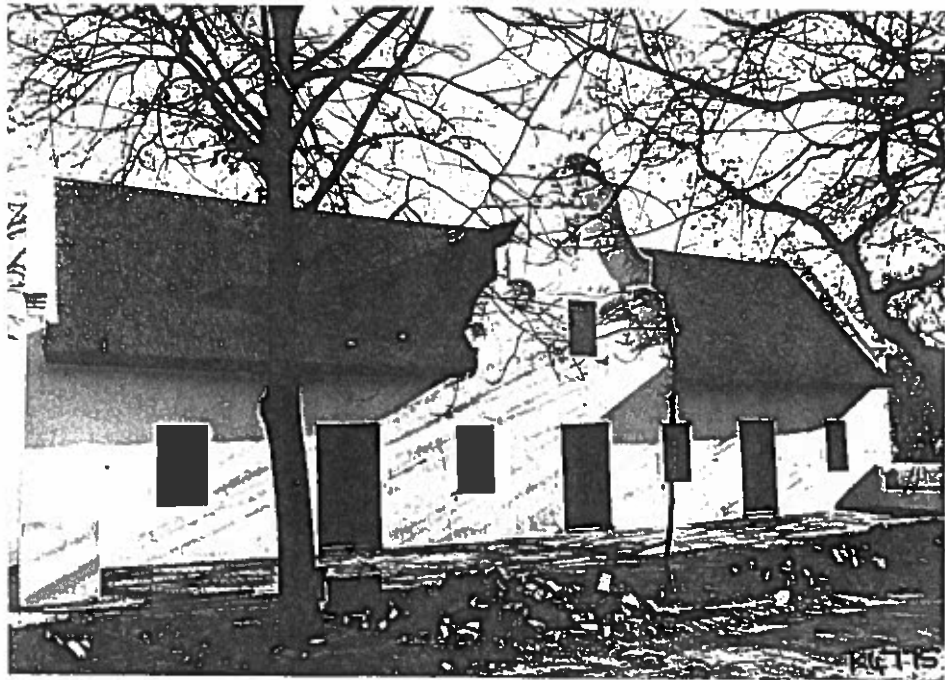
32. The renovated building retains much of its 18th century charm though the woodwork is distinctly early 20th century.

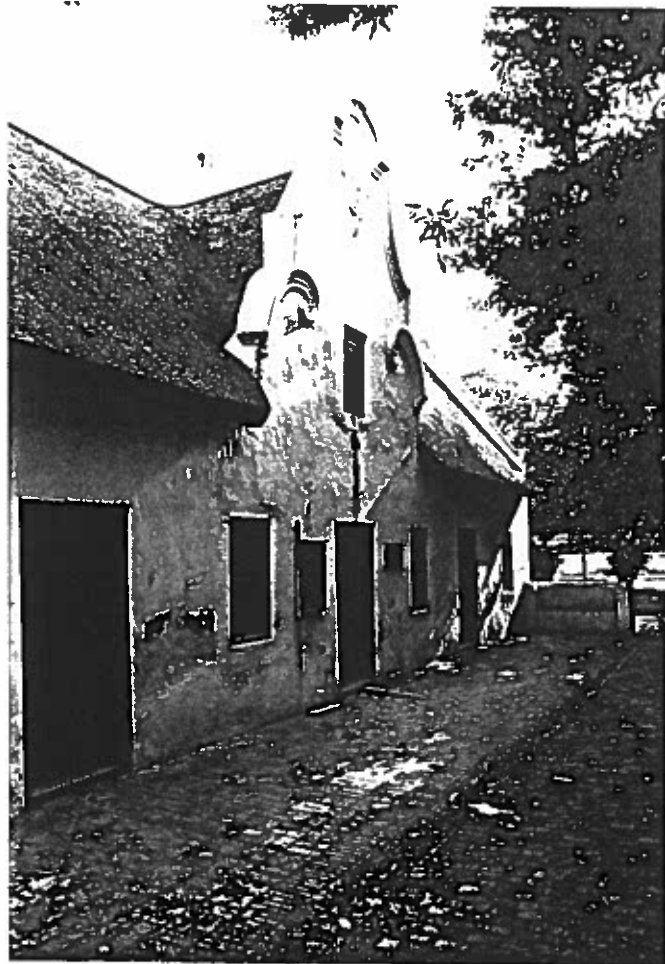
32.1 The graceful gable is beginning to tilt slightly forwards and may need attention in the near future. Although the paving is distinctly modern (c.1970), it is practical without pretending to imitate old surfaces.

The tilt of the front gable may have to be stabilized or corrected by means of anchor rods. For breathing purposes, walls and particularly gables, should only be white-washed, although a waterproof paint may be used inside. A practice which enhances the "authenticity" of a structure, is to leave one or two small sections of wall inside the building without plaster, in order to reveal the granite behind.

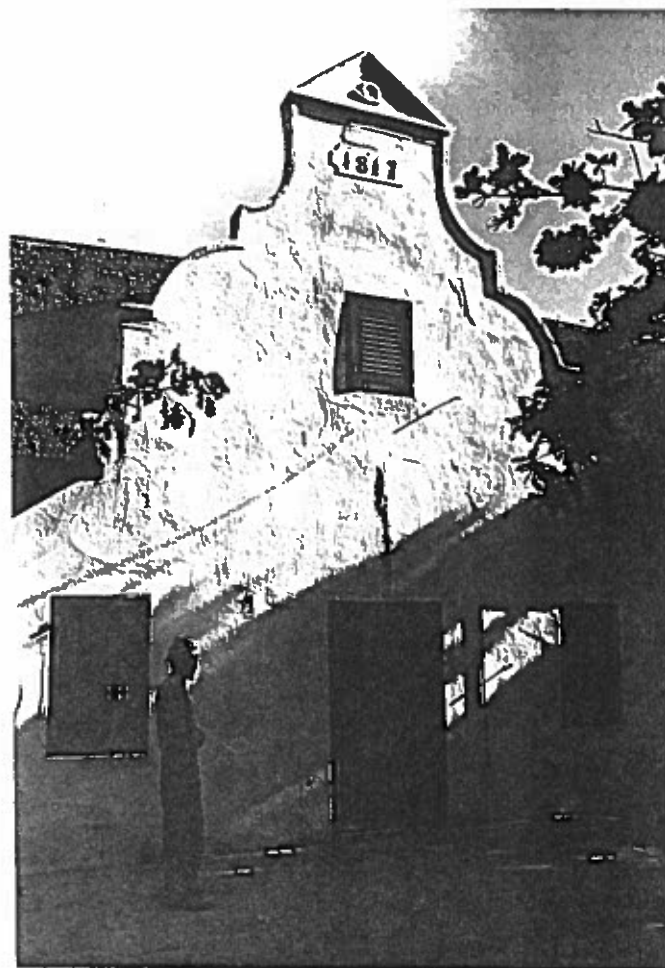
35

35. Prior to the renovation all the woodwork was incorrectly unpainted. The shutters of the casements were removed (see photos 56,57).

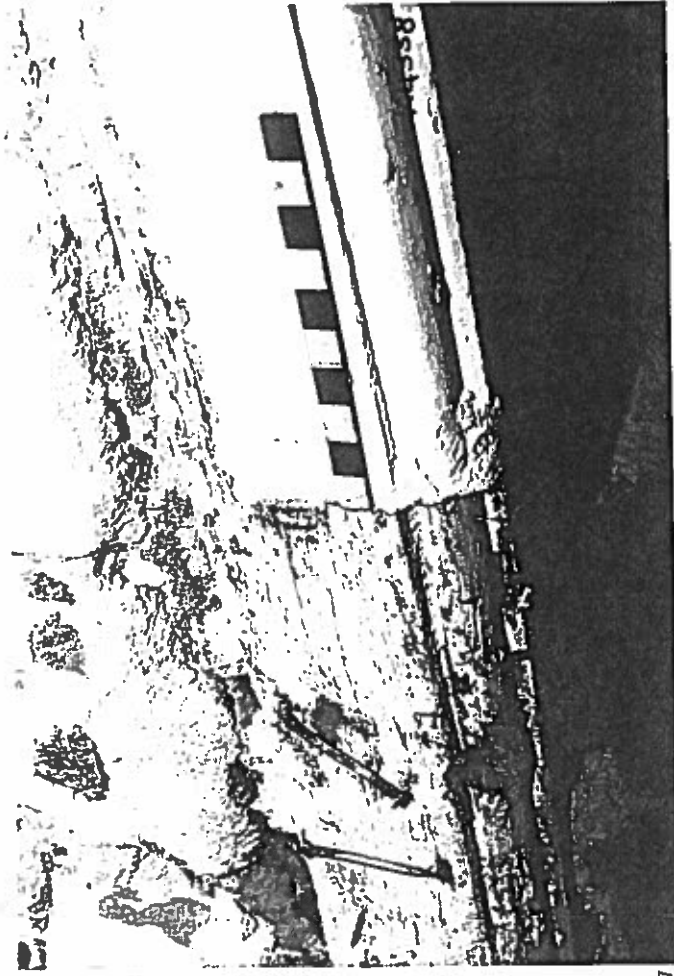
36. In room A, wall 2, the northern window is a modern innovation, filling the position of the old grated door. The relieving arch confirms that there was always an opening below.

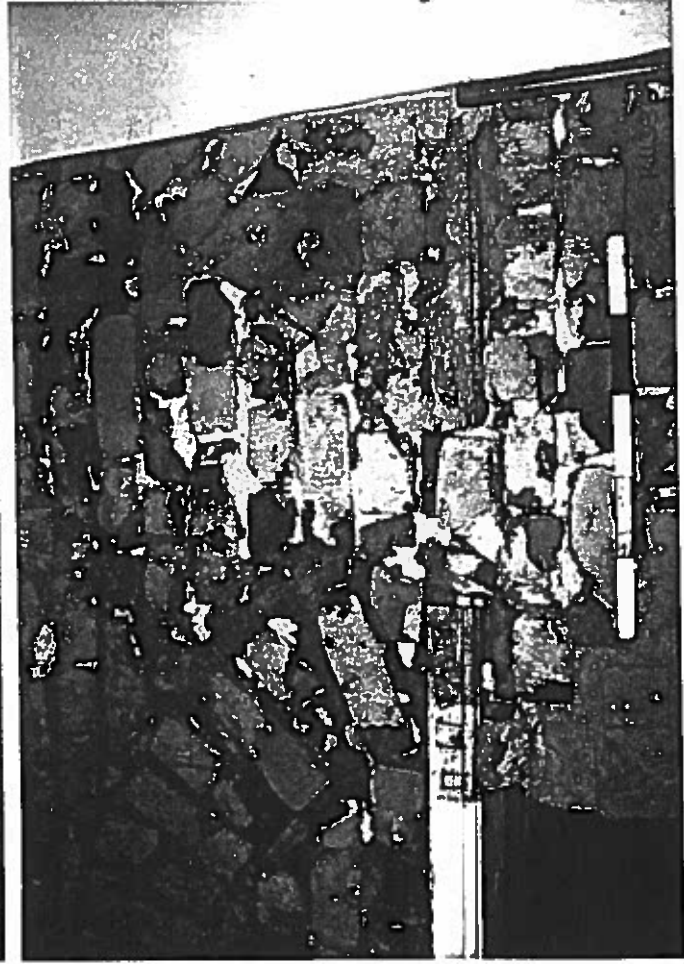
37. The original lintel is still in situ and is typical 18th century. Note that it was painted a reddish brown at one stage.

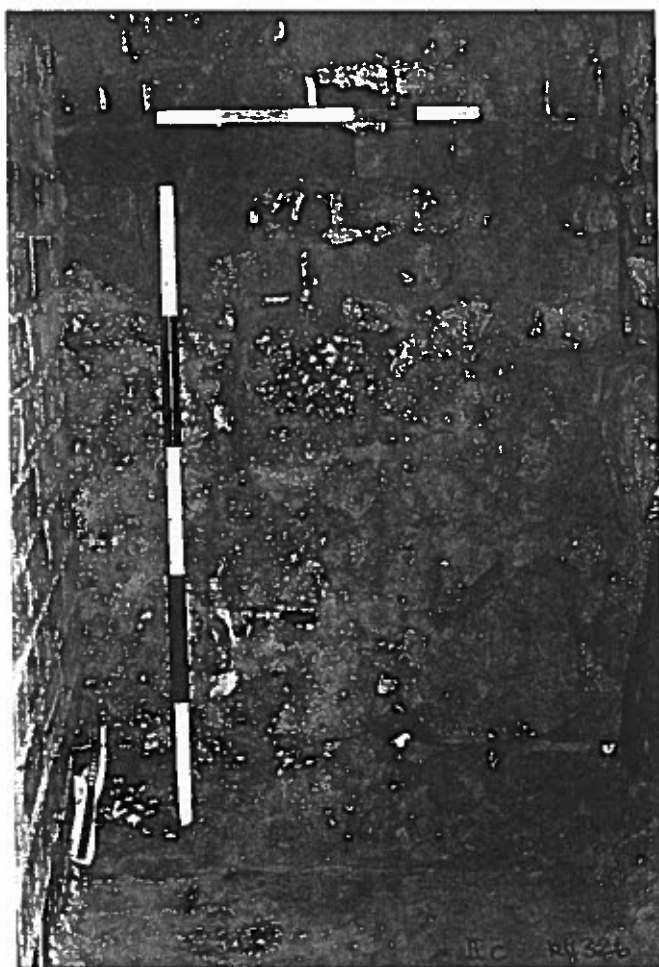
39. The granite in Building II was only drawn-up to about the 800 mm level, and a larger brick size was used beyond that (room C3/4).
