SPIER FARM

DOCUMENTATION OF BUILDINGS I (1778) AND II (1817)

MAY 1994

H. N. VOS

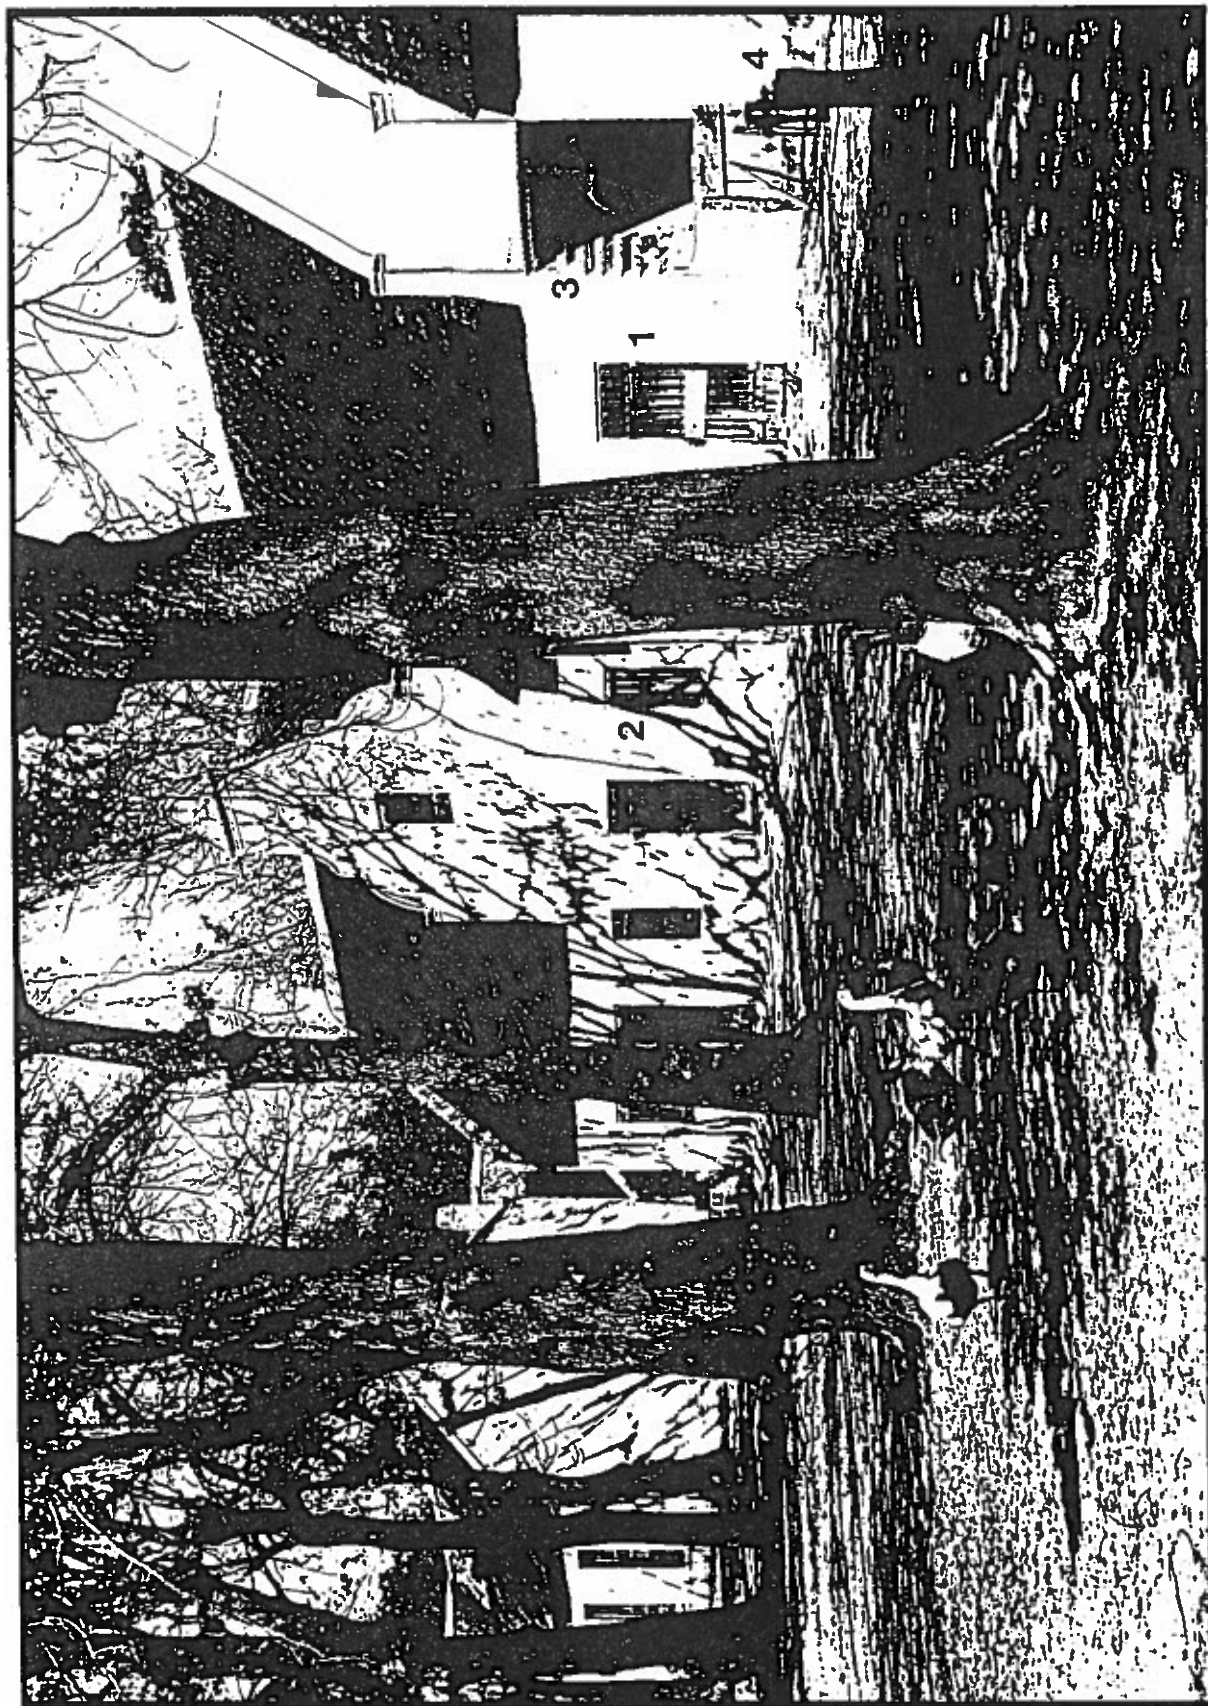
FIG.11 In the early 20th century the building still contained a lattice door (1), while some of the windows were provided with bars (2). Note the brickwork that protrudes (3) and the vice towards the right (4) (Elliott 2492).

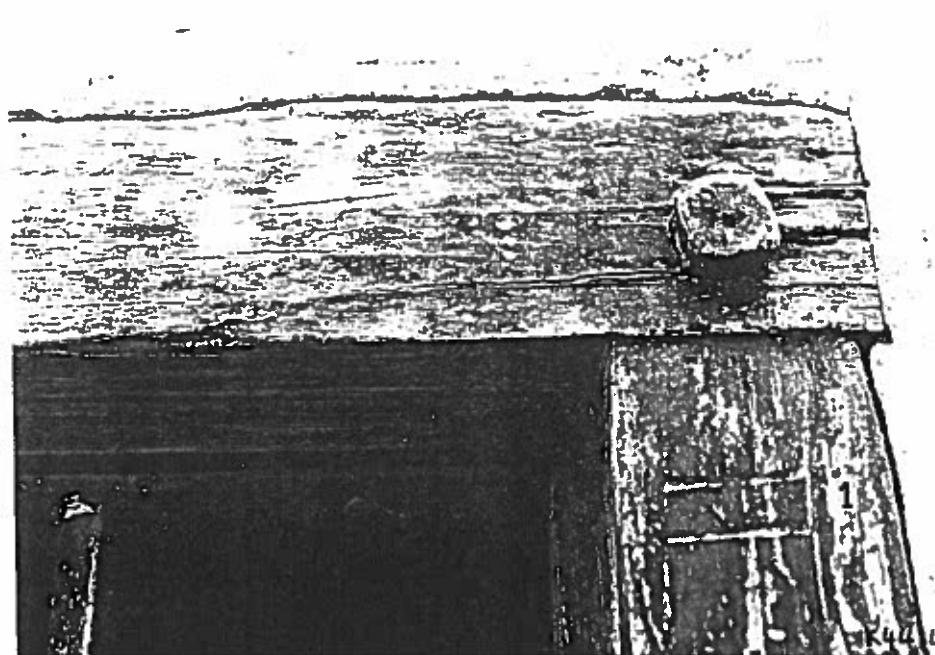
46. In this close-up of casement B2, two notches (1) are clearly discernable. At least three casements are marked with respectively one, two or three notches, indicating a single craftsman.

The entrance door (c.1900) and the window (B2) (c.1975) are both of recent date. The window frame is 18th century and has two notches incised on the outside (upper stile, right). The two casements in wall A2 have in the same position, respectively one and three notches. Presumably these represent old carpenter's marks for joining purposes, as well as for fitting the right shutters and windows to the appropriate frames. The casements are provided with modern bars (c.1975). The front door is identical with the one of the 1778 building, both from Fairfield House. Interestingly enough, the older frame show signs of having had a vertically divided door at an earlier stage, since a pair of hinge marks are clearly discernable on both sides.

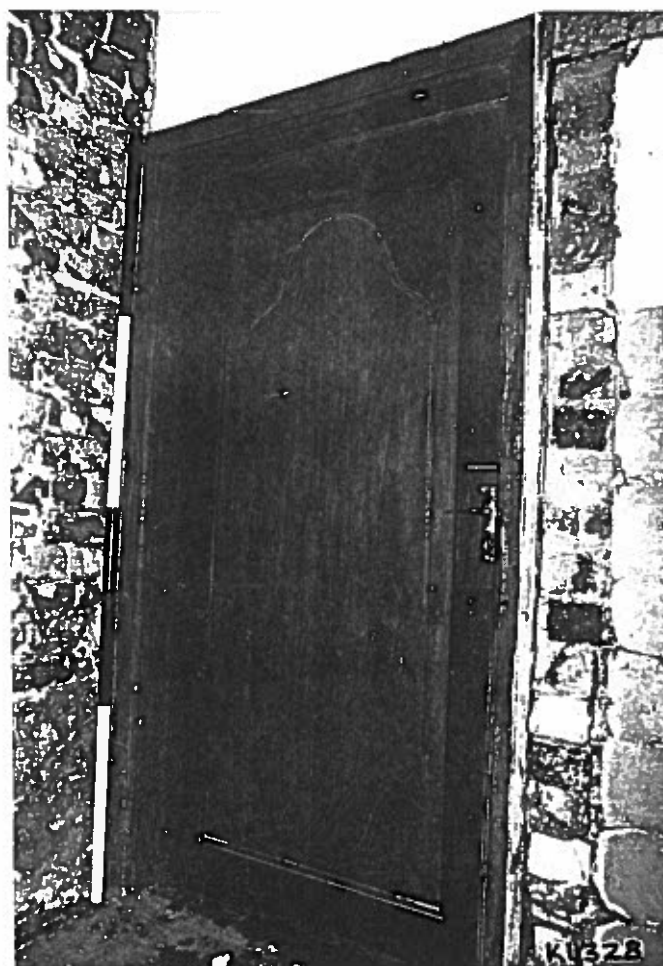
47. The door with its yellowwood panel with teak surround (room C) probably formed part of a late 18th century dwelling in Tulbagh. Three similar doors are located within the 1822 building.

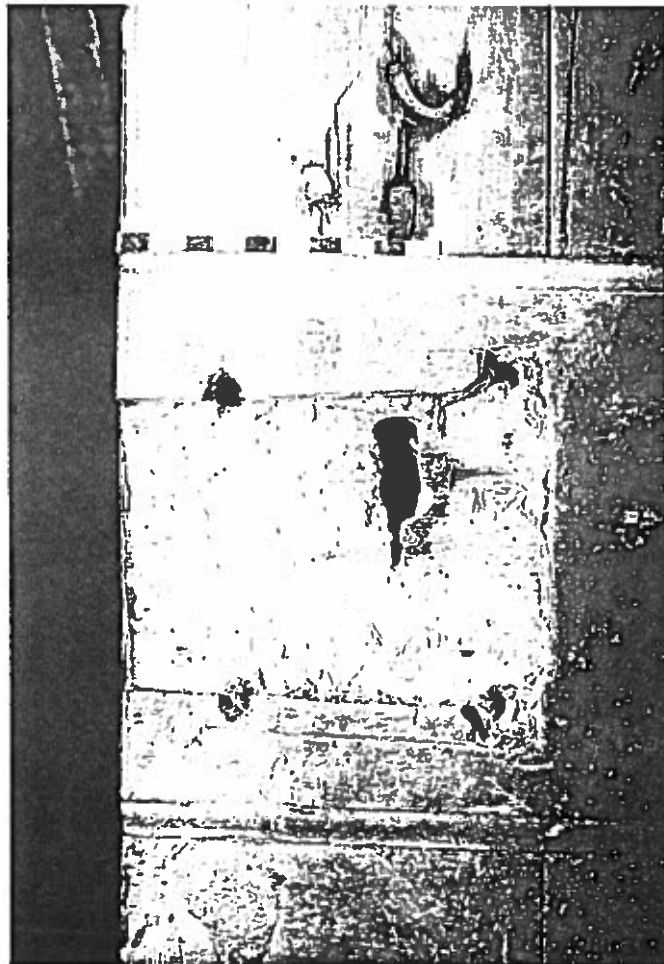
61. The inside of the loft door reveals that its old lock was removed not too long ago.

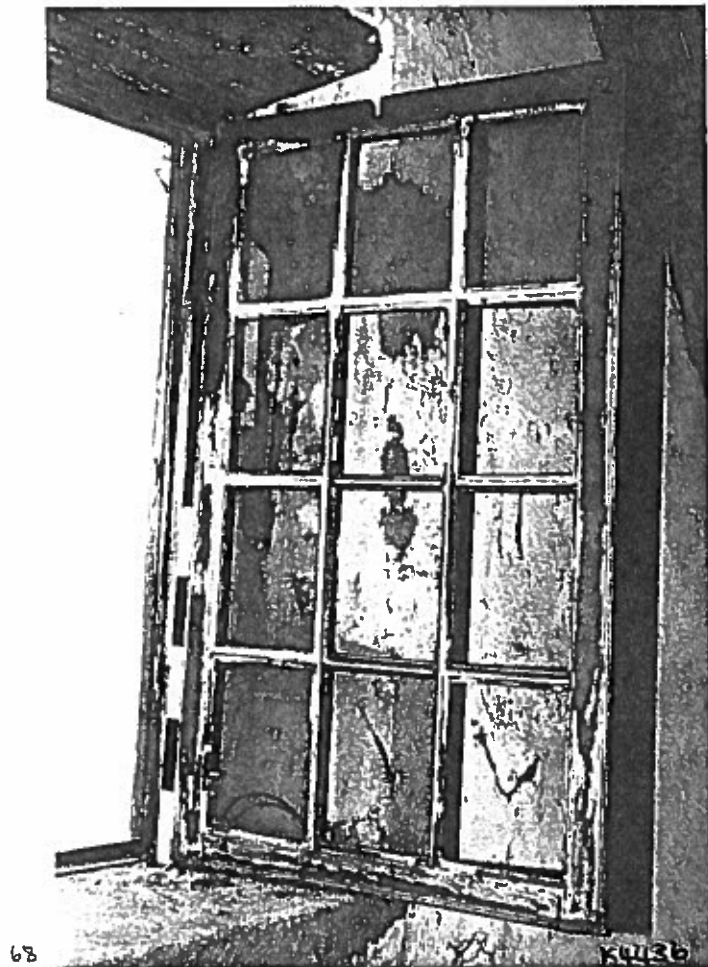
68,69. The northern end-gable contains an old lintel (1) and a 19th century casement window. The window frame with its double moulded line (2) is unusual. A close-up shows the upper righthand pane section (69).

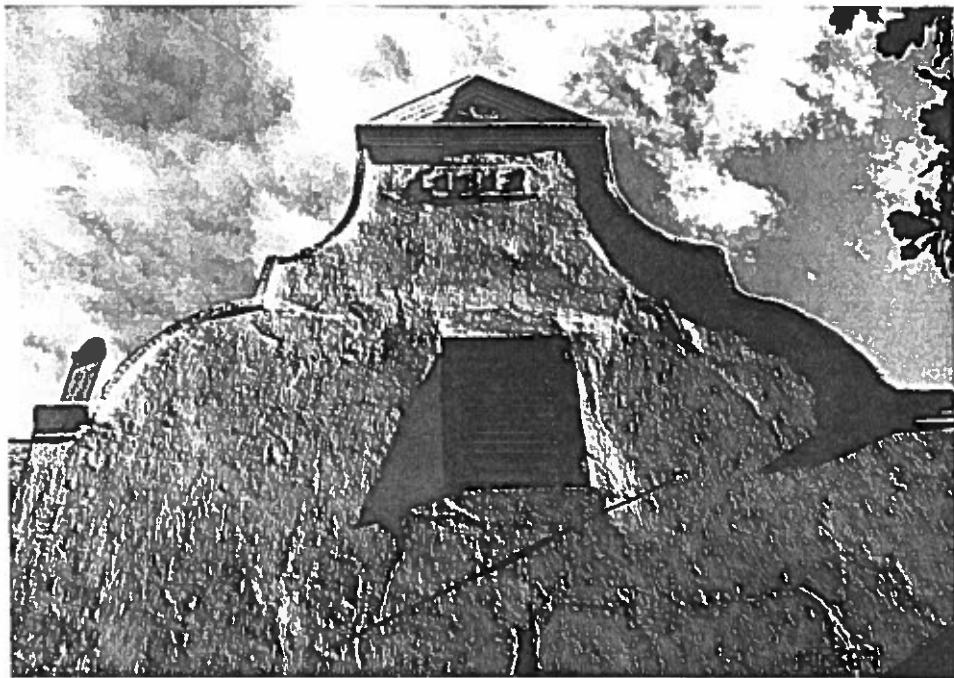
70. The plasterwork of the old gable has been left untouched for some time. It appears that the present window (and certainly the louvred shutter) is a later addition. Did this gable, like the one dated 1778, once have a double casement window?
