# ZILVERMYN AT SIMONSBERG

### FIRST PHASE: GENERAL VISUAL ASSESSMENT OF THE SILVER MINE INDUSTRIAL COMPLEX

OCTOBER 2004

H.N. VOS

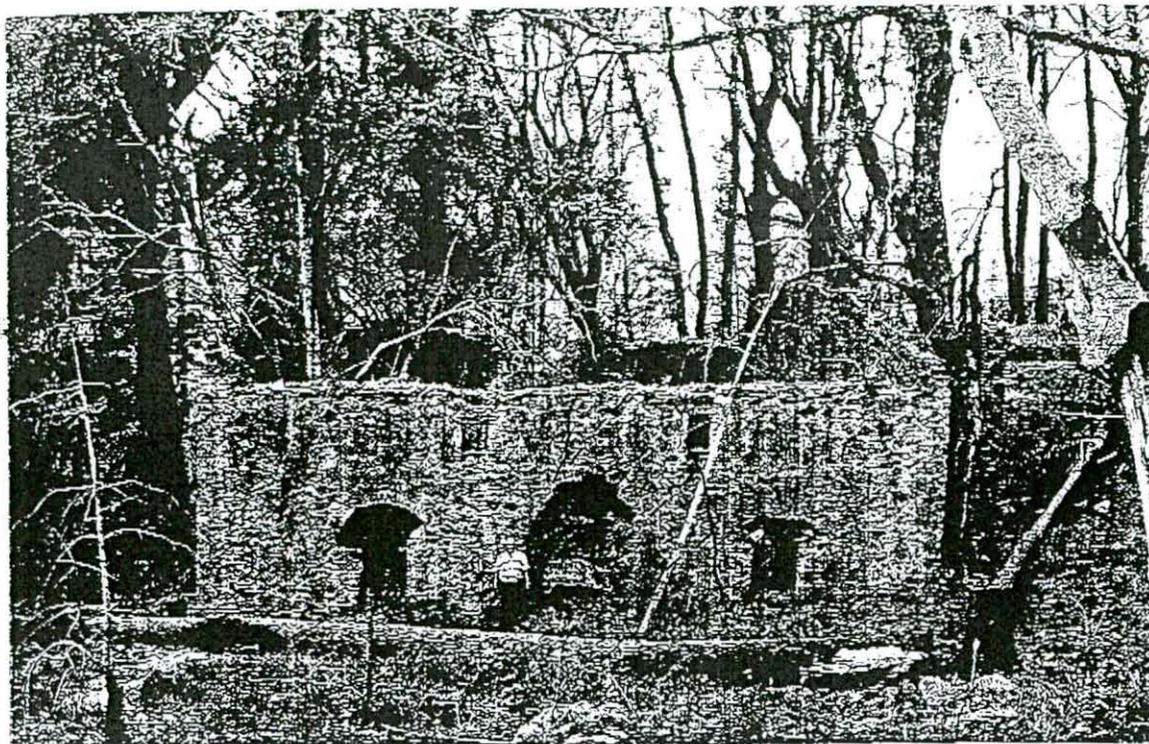
1. Exterior view of the western side facing Simonsberg. A tree demolished the section marked in black (Oct. 2000).

The building is completely overgrown, inside and outside, with dense acacias, indigenous trees and oaks. Consequently it was impossible to photograph its ruinous state. A tree collapsed over a significant portion of a 5 metre tall stonewall, and on the opposite side a large portion of wall collapsed as well. In 1992 and 2001 I took some photographs, when it was in a much better condition (see Lucas 2000) (**FIG.2**).

1. Clearance of inside and about a 20 metre surround.
2. Cutting and pruning of large trees (exotic + indigenous).

1. Stabilisation of ruins to prevent further collapse (plastering, some supportive struts and even minor reconstruction).
2. Excavation and clearance of fill to expose building.
3. Accurate documentation of mill and associated structures.
4. Reconstruction towards stabilisation of the complete structures.
5. Possible restoration of structures.
