WHITBY LODGE
ARCHITECTURAL STATUS REPORT &
RECOMMENDATIONS

DATE: 25th August 2013

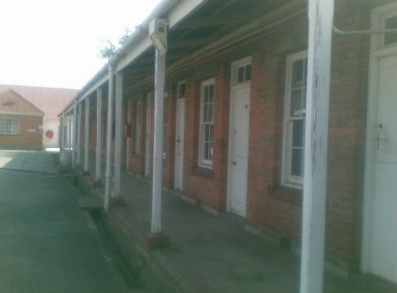
<p>Front Facade</p>	<ul style="list-style-type: none"> • Timber Posts are rotting and paint is flaking. Structurally not sound and aesthetically unpleasant • Veranda floor dull and unpleasant • Asbestos gutters and downpipes pose a health concern 	<ul style="list-style-type: none"> • All timber posts to be removed and cart to waste. New laminated and vanished profiled as existing posts to be fitted • Veranda floor slab to be prepared with self-levelling screed and lay 152x152mm quarry tiles. • Safely remove all asbestos gutters, downpipes and any fixing straps and cart to waste.

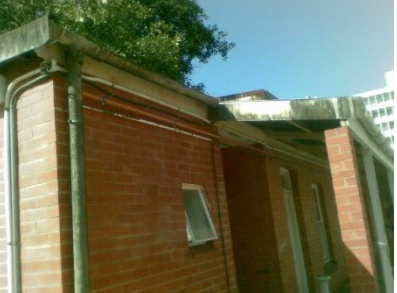
<p>View from Ablution Extension</p>	<ul style="list-style-type: none"> • Asbestos gutters and downpipes pose a health concern. • Asbestos cement Barge boards moulding and pose a health hazard 	<ul style="list-style-type: none"> • Safely remove all gutters, downpipes, barge boards and fascia boards and cart to waste. Fit new seamless aluminium gutters and downpipes.

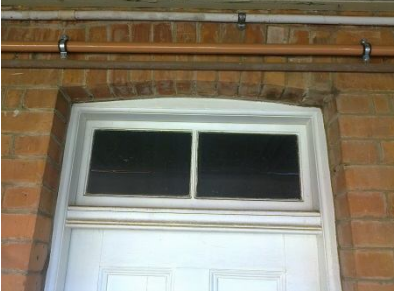
<p>Original Brick on Edge Door Lintel</p>	<ul style="list-style-type: none"> • Brick on edge door cill to be maintained throughout building • Door found to be acceptable 	<ul style="list-style-type: none"> • Clean up bricks and joints. • Doors generally found to be in good condition, however new ironmongery is to be fitted. New Gloss enamel paint to doors and frames.

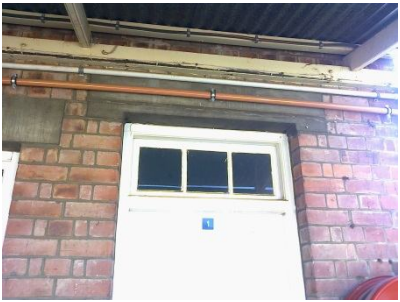
<p>Plastered Concrete Lintel to door</p>	<ul style="list-style-type: none"> • Door is not the same as one shown above • Plastered concrete lintel introduced in lieu of brick on edge to door head. 	<ul style="list-style-type: none"> • Remove door and frame then carefully chisel out the lintel above. Add supports to underside of exposed soffit. Rebuild brick on edge lintel curved profile to new door and frame as specified.

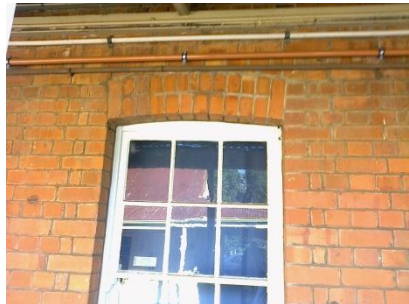
<p>Original Brick on Edge Window Lintel</p>	<ul style="list-style-type: none"> • Brick on edge cill to window head. • Exposed electrical pipes and copper pipes 	<ul style="list-style-type: none"> • Clean up bricks and joints • Windows generally found to be in good working order. Repaint window and frame. Mechanism not functioning well to be oiled and tested.

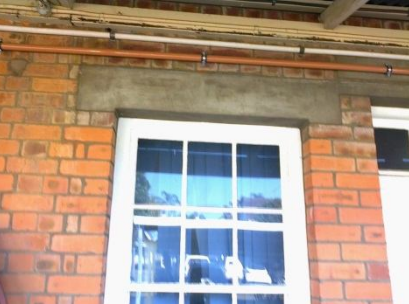
<p>Plastered Lintel to Window</p>	<ul style="list-style-type: none"> • Plastered concrete lintel introduced in lieu of brick on edge 	<ul style="list-style-type: none"> • Remove door and frame then carefully chisel out the lintel above. Add supports to underside of exposed soffit. Rebuild brick on edge lintel curved profile to reused window. Repaint window as specified.

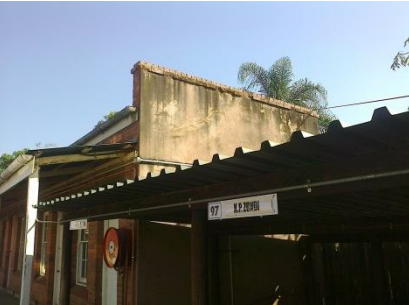
<p>Brick on Edge Coping</p>	<ul style="list-style-type: none"> • Brick on Edge coping falling in places throughout parapet wall apex. • Moulding plaster to end wall 	<ul style="list-style-type: none"> • Remove all brick on edge coping all-round the parapet wall. New brick on edge coping to be built there. • Clean plastered wall and make good where necessary. Paint with approved wall paint. Colour to client's approval

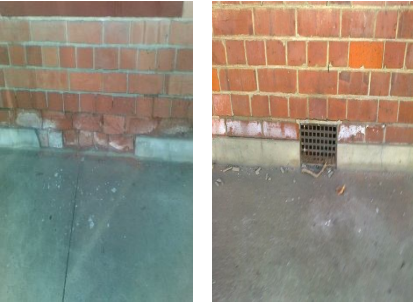
<p>Brick Erosion Metal Air Vents</p>	<ul style="list-style-type: none"> • Steel Air Vents possibly the building had timber suspended floors • Eroding bricks in areas at the foot of the wall close to veranda floor. 	<ul style="list-style-type: none"> •

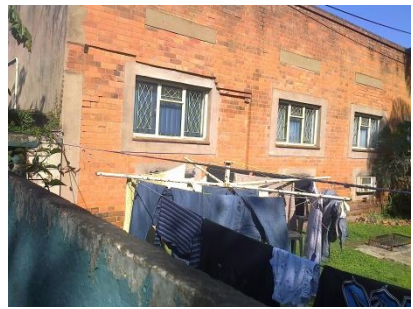
<p>Recessed back Wall</p>	<ul style="list-style-type: none"> • Stepped brick around the 1st window. • Consul air-conditioning units with a plaster render band around opening. 	<ul style="list-style-type: none"> • Windows are facing into adjacent house yard. From a security perspective this exposure poses a danger of break in from that side. • Level up the wall by adding single skin brick wall from point of recession all the way to the ground.

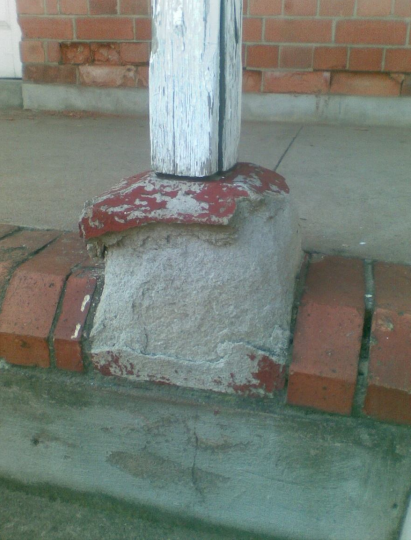
<p>Consul Air-Con Units to Offices</p>	<ul style="list-style-type: none"> • Disintegrating concrete plinths to timber posts. • Chamfered Brick on edge brick course to veranda edge. 	<ul style="list-style-type: none"> • Break all plinth and build new as shown on Architect's detail. Finish it with quarry tiles as shown on detail. • Clean up chamfered brick on edge and fill up joints with mortar. Key in mortar in joints evenly.

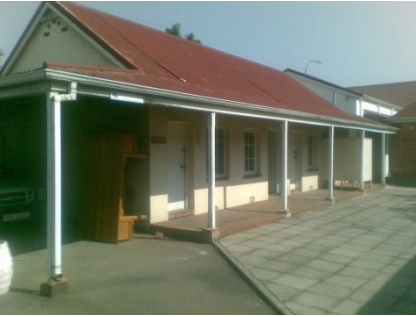
<p>Front Facade</p>	<ul style="list-style-type: none"> Plastered walls and design timber posts painted white. Corrugated Iron roof sheets Concrete paving slabs to courtyard 	<ul style="list-style-type: none"> All door heights to be increased as they don't conform to normal door head height standards Plaster to be evened out and made good. Concrete pavers to be removed and re-compaction of subgrade done and new interlocking concrete pavers laid.

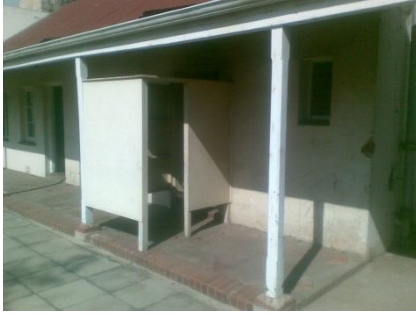
<p>Visual Barrier to Ablution</p>	<ul style="list-style-type: none"> Make shift timber and board visual barrier to female toilet entrance fixed along veranda. 	<p>Remove timber barrier and make good to walls and veranda floor.</p>

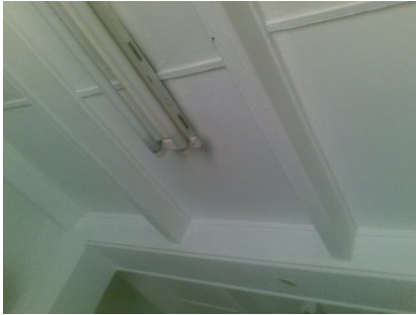
<p>Existing Ceilings</p>	<ul style="list-style-type: none"> Plasterboard ceilings in good condition. 	<ul style="list-style-type: none"> Remove plasterboard ceilings and fit new suspended ceilings with better thermal properties. Aluminium shadowline to edges.

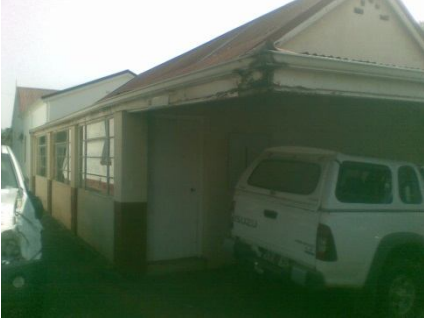
<p>Hanging Roof without support</p>	<ul style="list-style-type: none"> • Timber post rot and fell leaving roof suspended over parking. Extremely dangerous situation. 	<ul style="list-style-type: none"> • Add structural support immediately to hold the dead load of the roof. New laminated timber support posts to be added when new roof structure is being constructed.

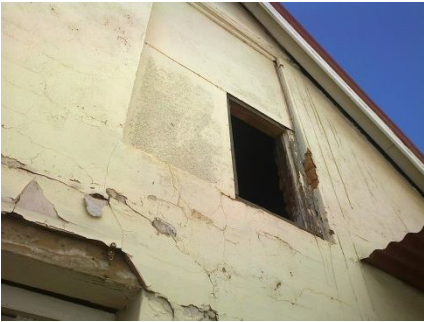
<p>Timber Board Panel</p>	<ul style="list-style-type: none"> • Timber panel fitted to close off opening to roof space. • Failing wall plaster above toilet window. 	<ul style="list-style-type: none"> • Investigate interior to see reason for such a huge opening, if its only roof space remove timber panel and brick up opening. Plaster and paint as specified. • Hack out plaster in severely damaged sections and re-plaster wall. Ensure its level with existing plaster.

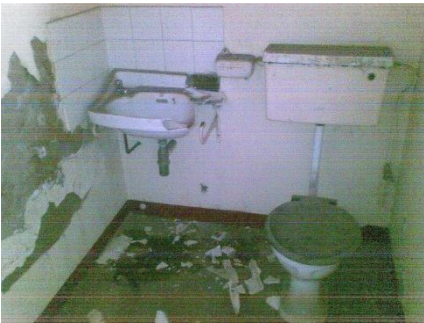
<p>Vandalised Toilet Fittings</p>	<ul style="list-style-type: none"> • Vandalised sanitary fittings in women's toilet. • Vandalised wall tiles and damaged walls. 	<ul style="list-style-type: none"> • Toilets to be redone as shown on architect's drawing.

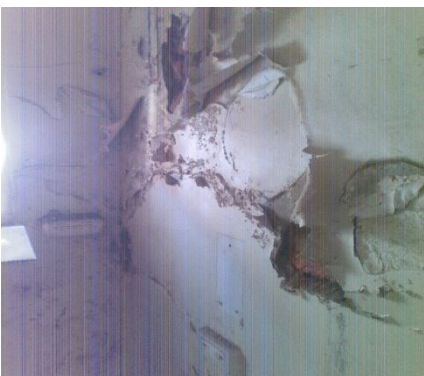
<p>Flacking Plaster in Toilet</p>	<ul style="list-style-type: none"> • Severe flacking of wall paint. • Plaster cracks and collapse. 	<ul style="list-style-type: none"> • Hack out plaster and redo entire wall. Finish as specified.

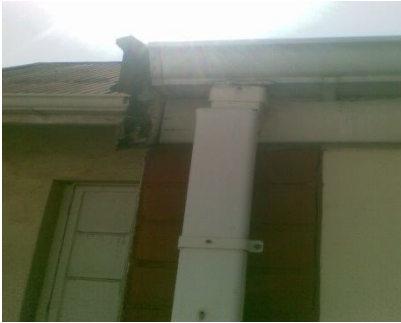
<p>Rotting Barge Board</p>	<ul style="list-style-type: none"> • Rotting timber barge board. • Seamless aluminium gutters leaking and clogged. 	<ul style="list-style-type: none"> • All timber barge boards, fascia boards and aluminium gutters to be removed and replaced as shown on Architectural drawing.

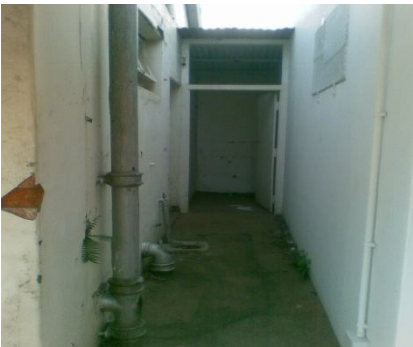
<p>Passage to Gents Toilet</p>	<ul style="list-style-type: none"> • Chirped walls and uneven plaster • Cast iron vent pipes and sewer connections • Unfinished passageway to male toilet 	<ul style="list-style-type: none"> • Even out plaster and fill chirped areas. • All sanitary plumbing to be removed and redone. • Hack out concrete floor and compact hard core then cast the concrete slab with quarry tile finish.

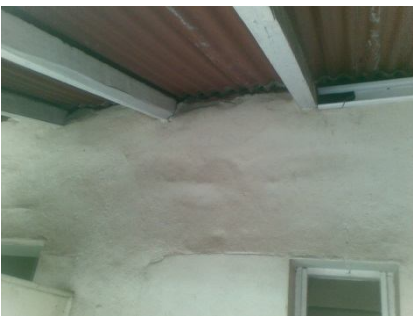
<p>External Wall above toilet door</p>	<ul style="list-style-type: none"> • Veranda plaster uneven and badly done • Painted timber beams to veranda 	<ul style="list-style-type: none"> • Hack out plaster and re-plaster wall. Even out with rest of façade. Finish as recommended. • Timber beams to be removed and replaced with laminated and varnished timber beams

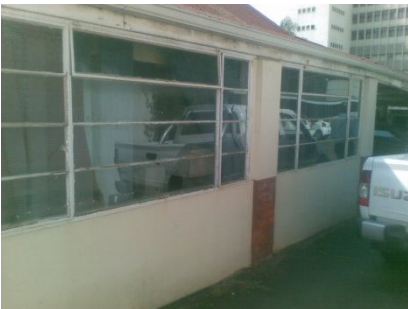
<p>Back side windows & walls</p>	<ul style="list-style-type: none"> • Rear end of building along passage to Langalibalele Street 	<ul style="list-style-type: none"> • Remove windows and replace with new steel windows as specified by Architect. • New roof to overhang 300 – 400mm beyond wall facade.

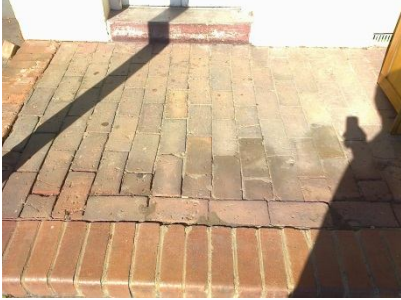
<p>Veranda Paving bricks</p>	<ul style="list-style-type: none"> • Worn out brick paving to veranda. • Bullnose Brick on edge to veranda. 	<ul style="list-style-type: none"> • Remove all brick pavers to veranda. Compact sub soil as recommended by structural engineer. Cast concrete slab and finish with quarry tile.
---	---	---
